**MINERALS PROGRAM INSPECTION REPORT**  
**PHONE: (303) 866-3567**

| <b>MINE NAME:</b><br>Tallahassee Pit | <b>MINE/PROSPECTING ID#:</b><br>M-1999-003 | <b>MINERAL:</b><br>Sand and gravel | <b>COUNTY:</b><br>Fremont |
| <b>INSPECTION TYPE:</b><br>Monitoring | <b>WEATHER:</b> Clear | <b>INSP. DATE:</b><br>April 29, 2024 | <b>INSP. TIME:</b><br>10:10 |

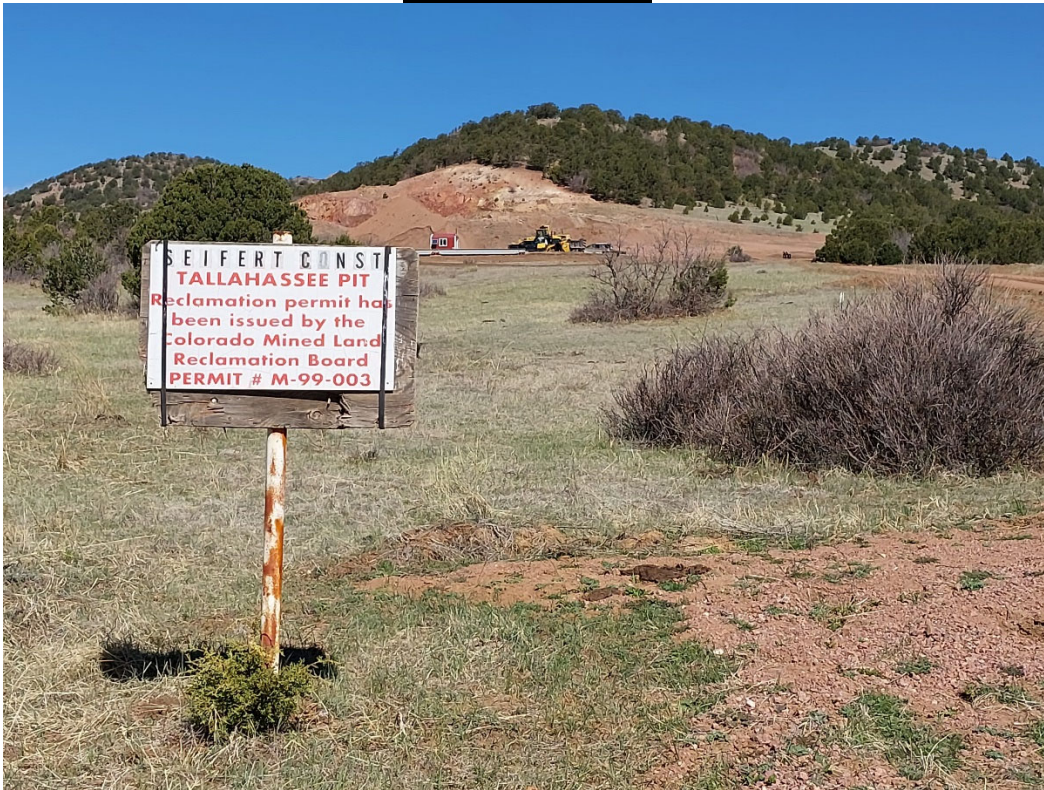
There is a sign posted at the entrance of the mine site off County Rd. 2 and all permit boundary markers were verified; see photos #1 and #3 - #8 at the end of this report. Note: Not all markers were photographed during the inspection.

Photo #1: Permit sign at site entrance.

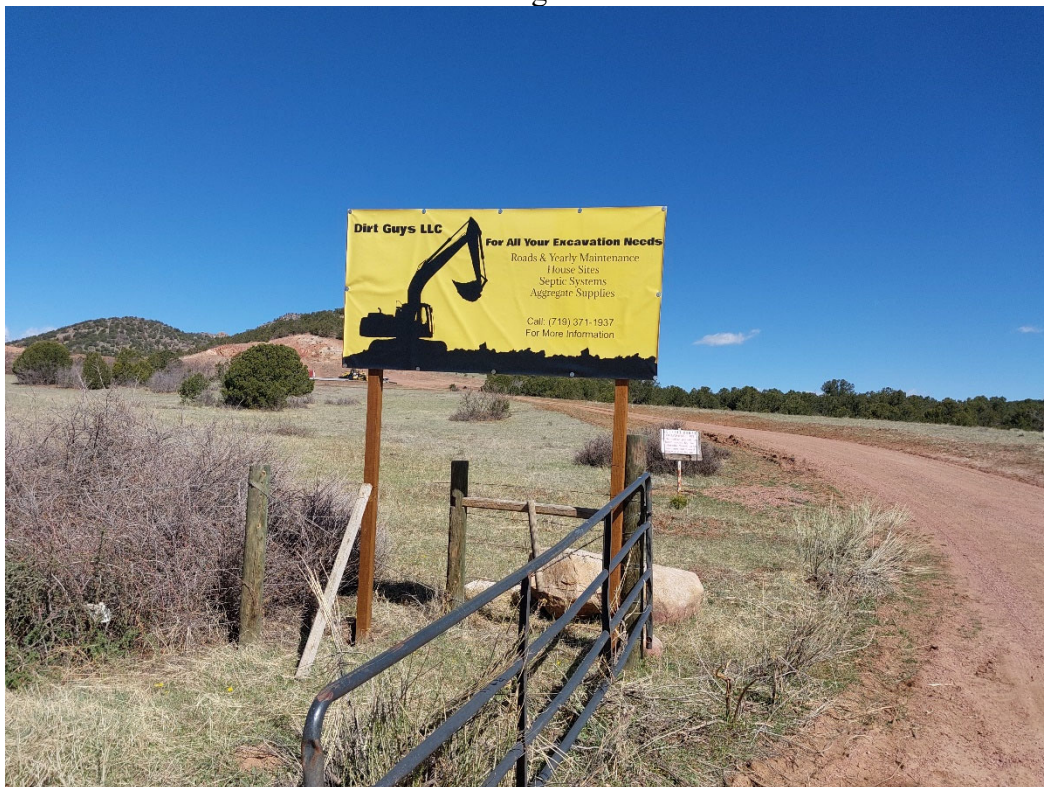
Photo #2: Landowner's sign at the mine entrance.

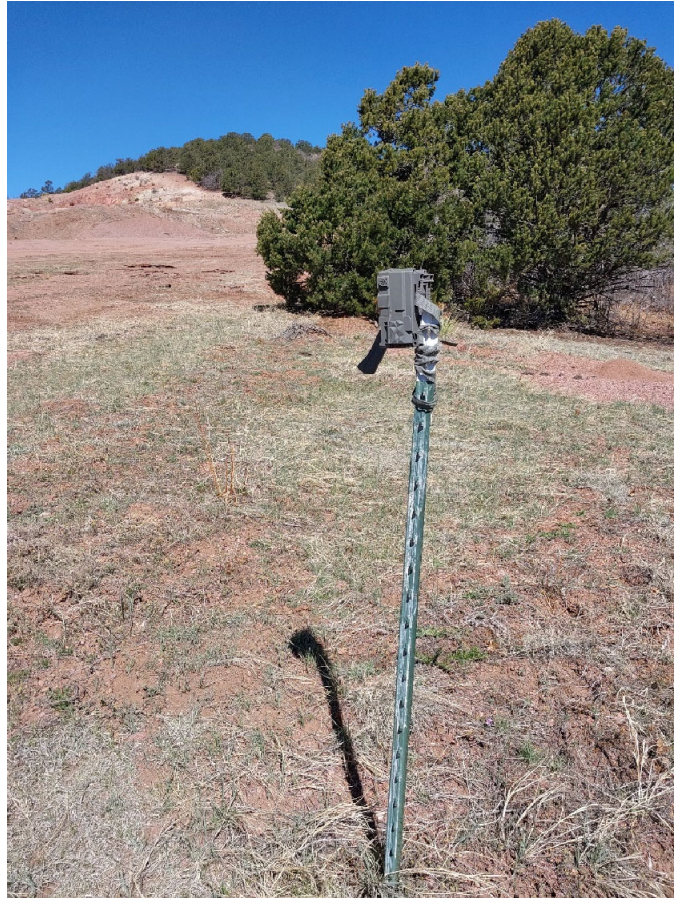
Photo #3: Permit boundary marker, east of access road and on south end of pit area; looking northwest.

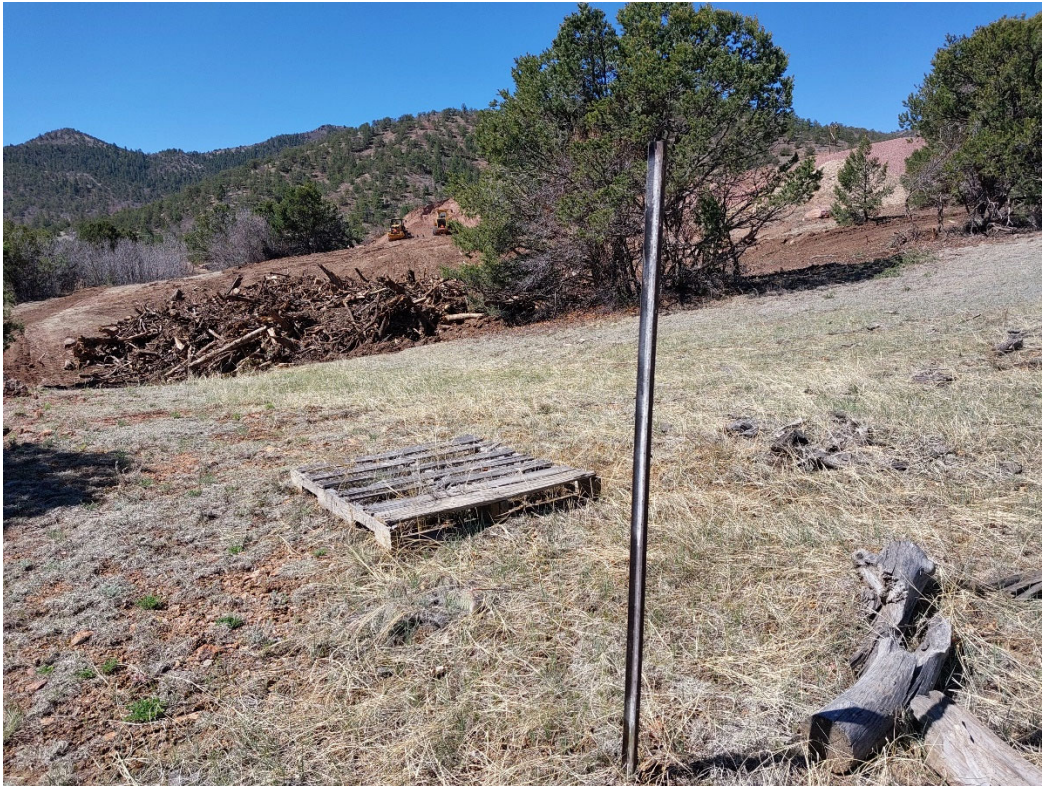
Photo # 4: Permit boundary marker, northeast corner of permit; looking southeast. Woody material stockpile can be seen to the left.

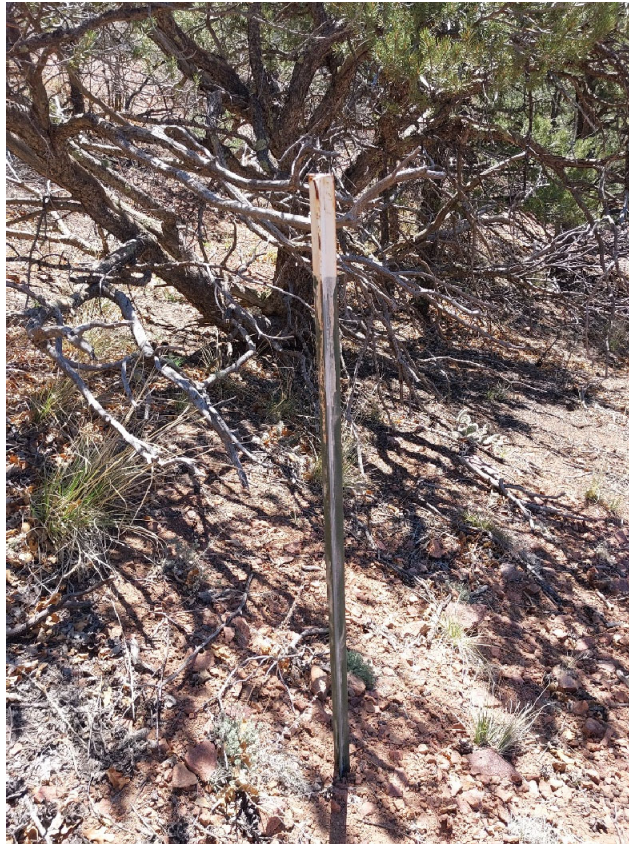
Photo #5: Permit boundary marker located at north corner of permit area, north of the highwall; looking south.

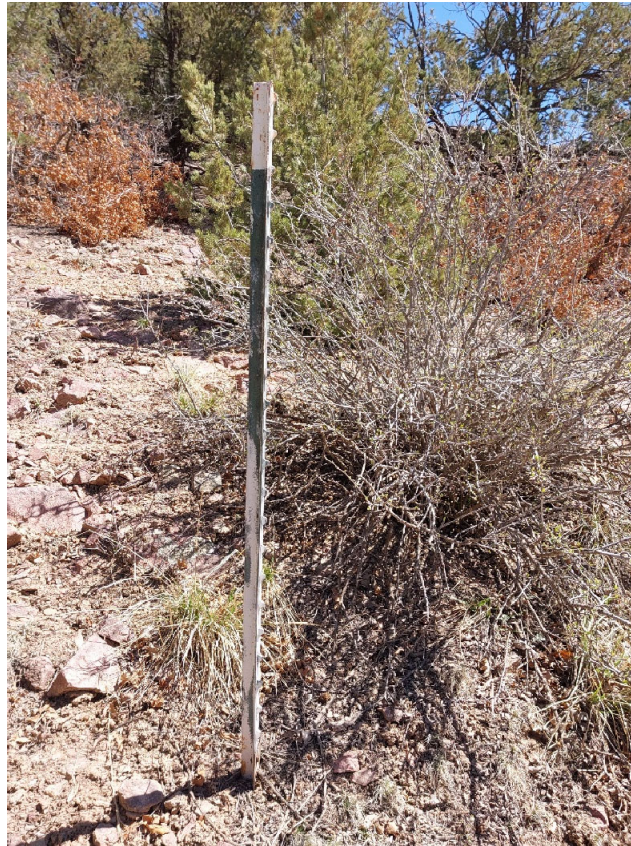
Photo #6: Permit boundary marker located at west corner of permit area; looking south southeast.

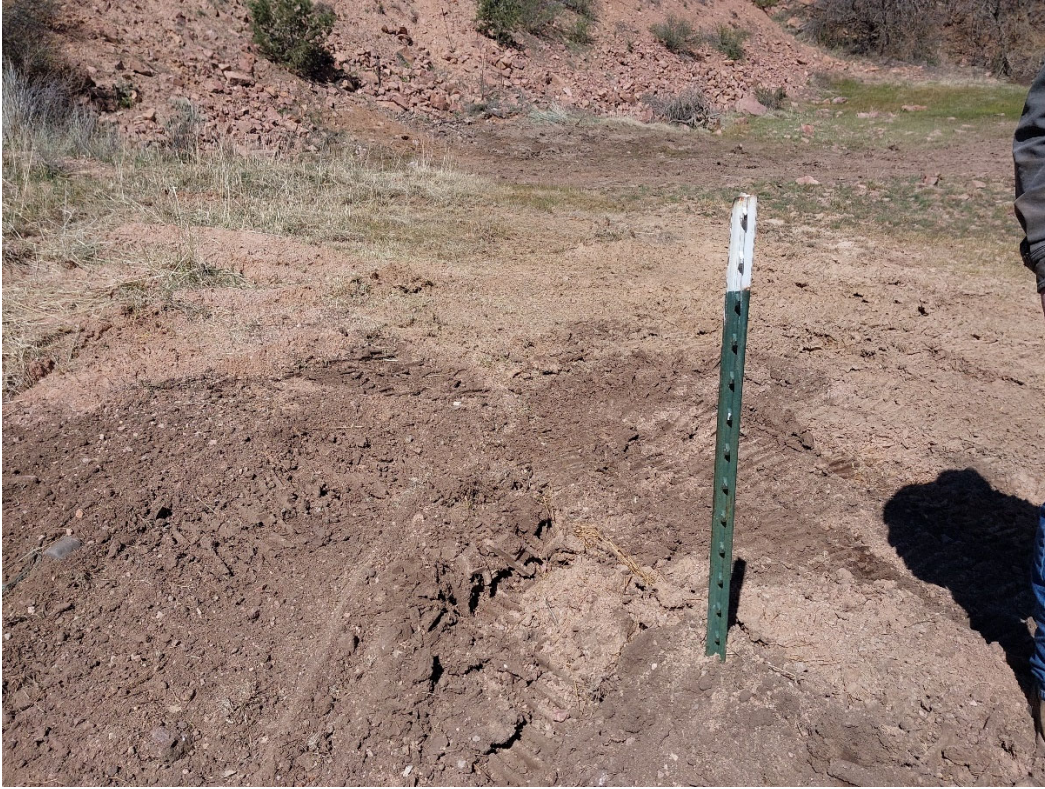
Photo #7: Permit boundary marker located at south end of permit area, looking north.

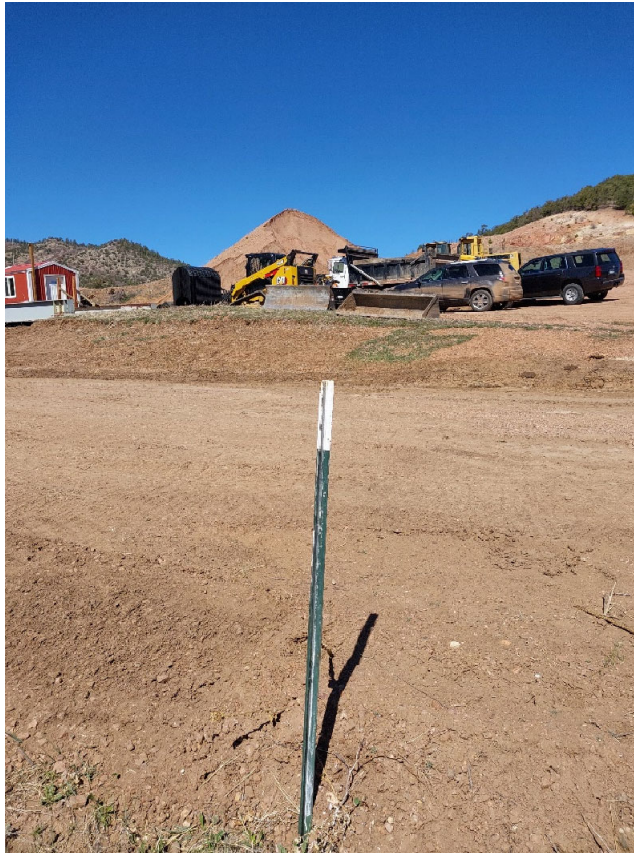
Photo #8: Permit boundary marker located west of the access road; looking north northwest. Equipment and implements can be seen in the background of the photo. The highwall can be seen in the far background on the right and a material stockpile can be seen in the central far background.

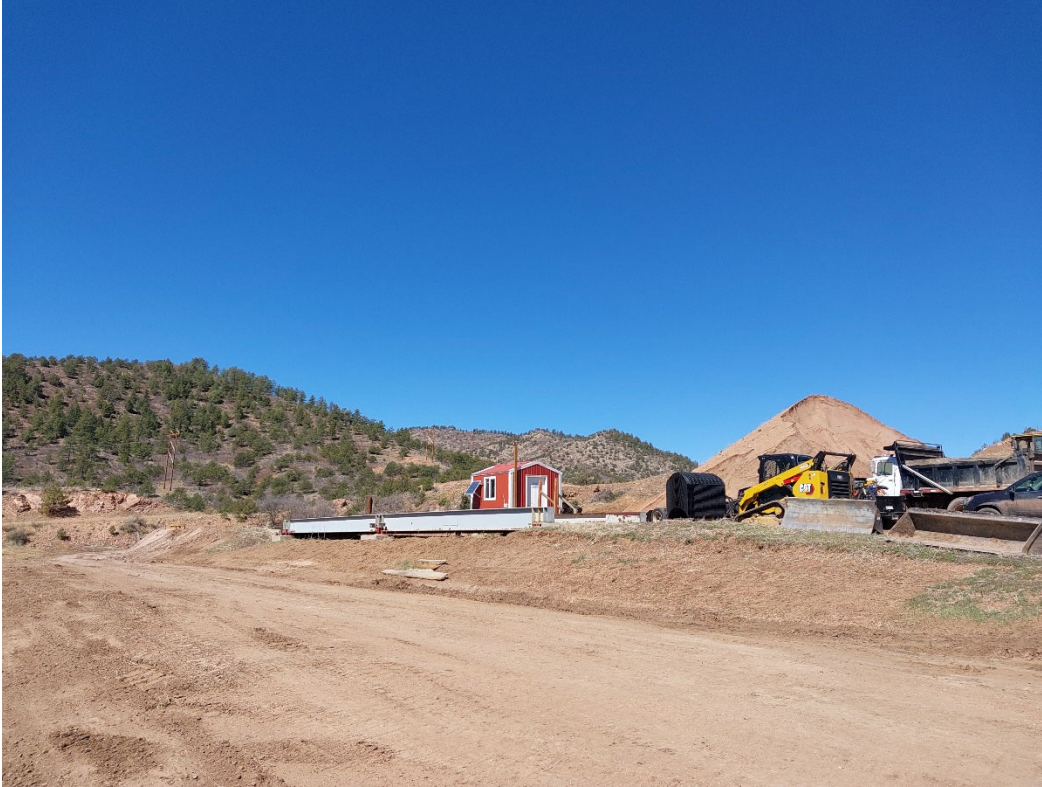
A scale and scale house are installed on the southeast side of the permit area. There were no issues with the structures observed.

Photo #9: Scale with the scale house behind it can be seen in the center. Equipment and implements seen on the right with the material stockpile seen in the background. An internal haul road can be seen in the foreground.

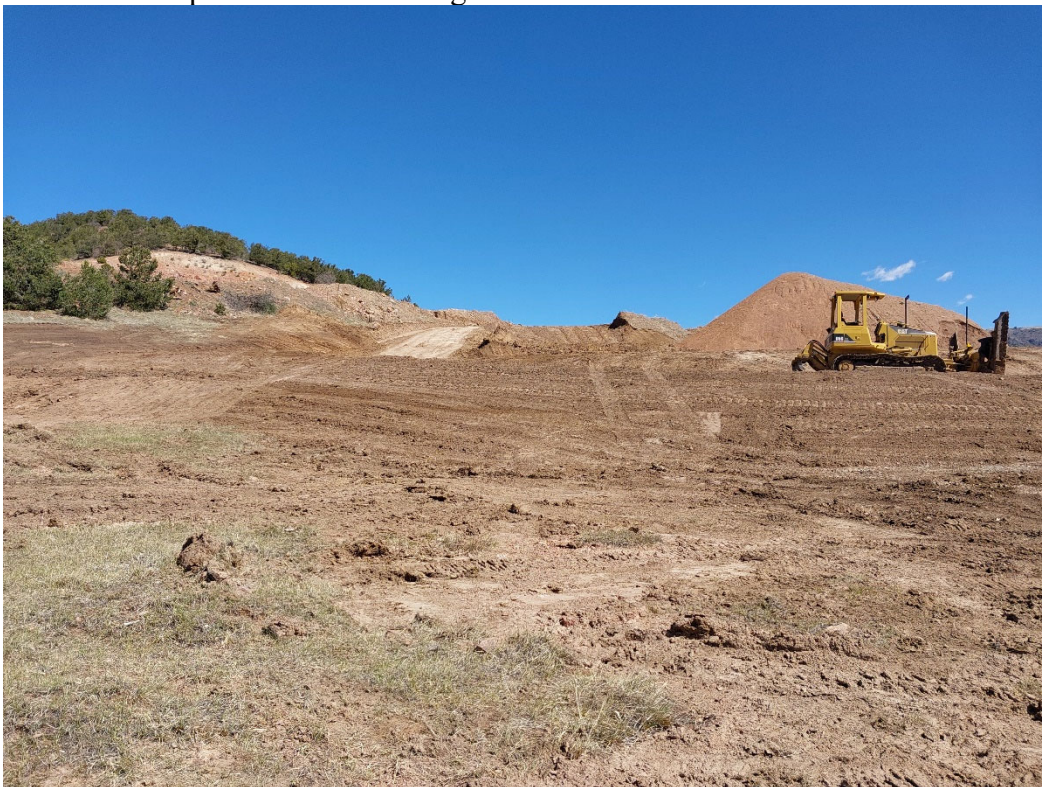
Photo #10: View from the south corner of the permit area, looking to the northeast. A Dozer can be seen in from of the material stockpile on the right, the west end of the highwall and internal access road on the left of the photo.

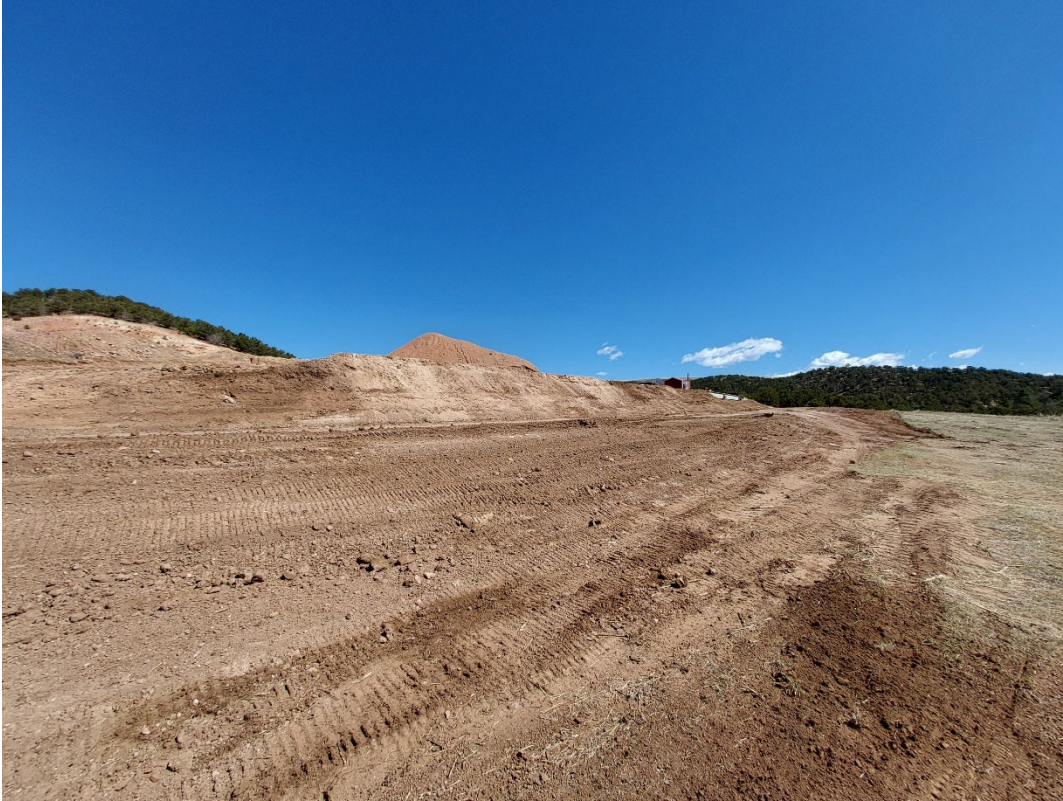
Photo #11: View of affected area from the south, looking to the northeast. An internal haul road can be seen in the foreground, the scale access road is at a higher grade. Above the scale access road, the material stockpile can be seen in the background just left of the center of the photo. The highwall can be seen on the left side in the background.

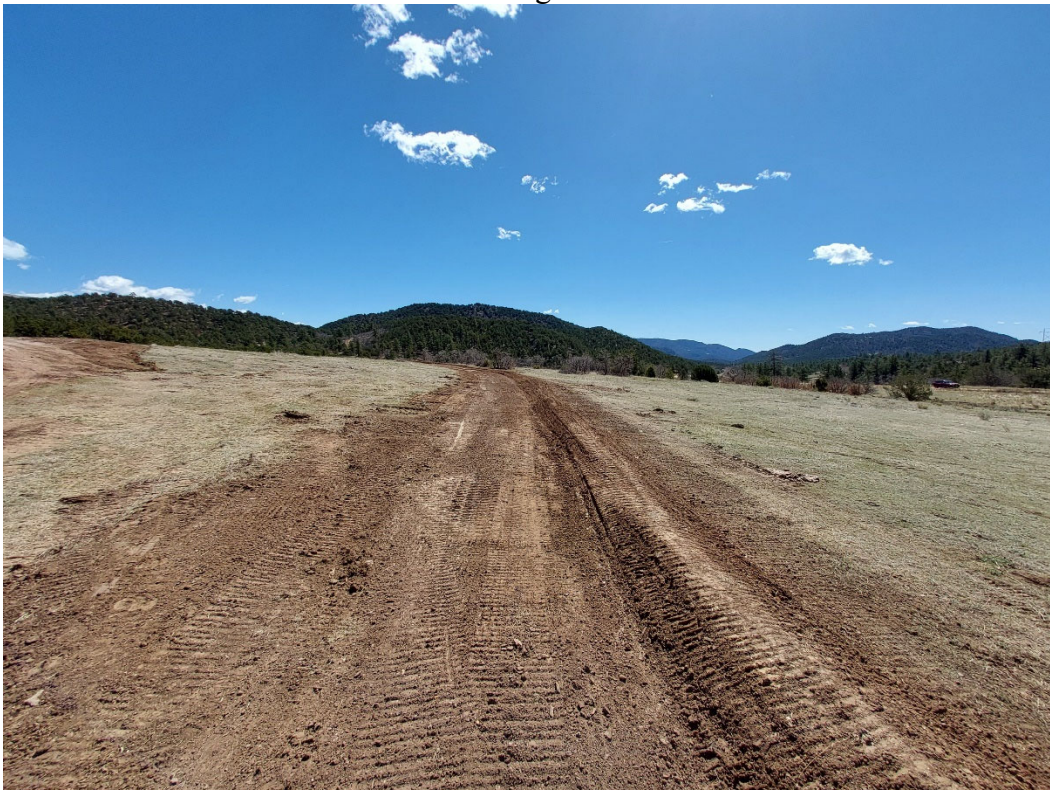
Access road and internal haul roads appeared to be stable. However, Mr. Cooper is considering improving haul roads to allow for better drainage.

Photo #12: Access road viewed from the southeast of the pit area, looking south.

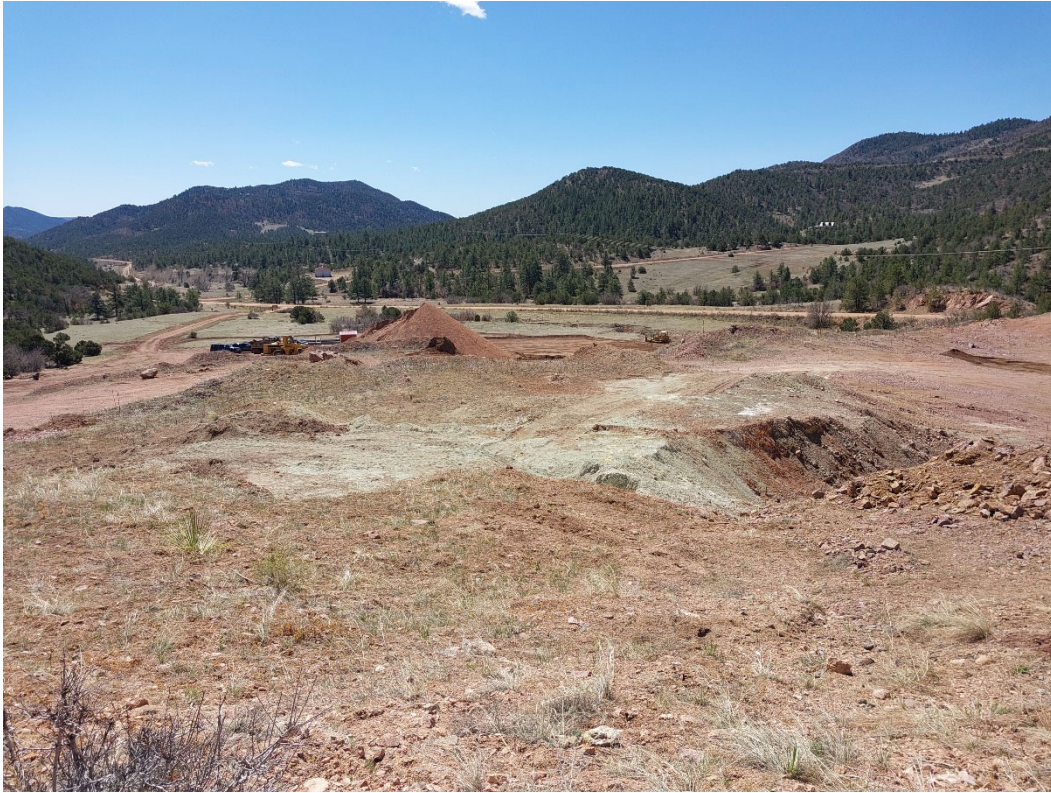
Photo #13: View of the affected area from the north side of the permit area, above the highwall, looking southwest. In the foreground, the pit area can be seen. The material stockpile can be seen and the access road to the left of it in the background.

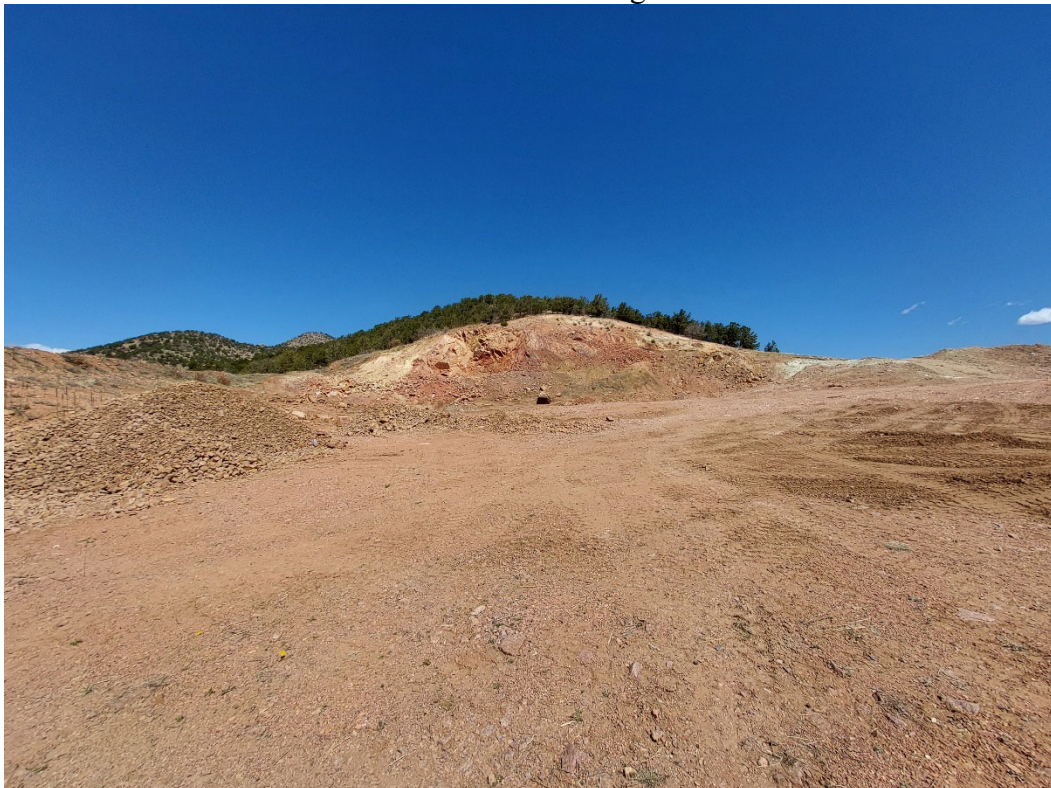
Photo #14: Highwall located in the northwest of the affected area, viewed from the pit floor; looking north.

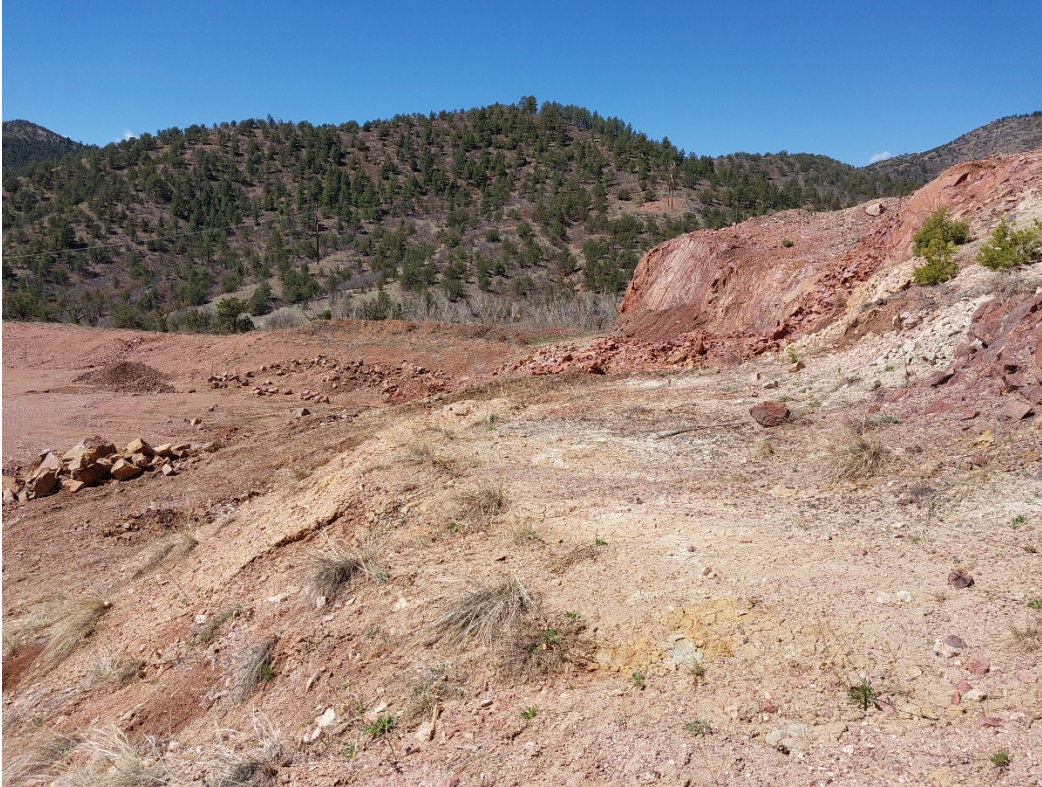
Photo #15: Highwall viewed from the east, looking west.

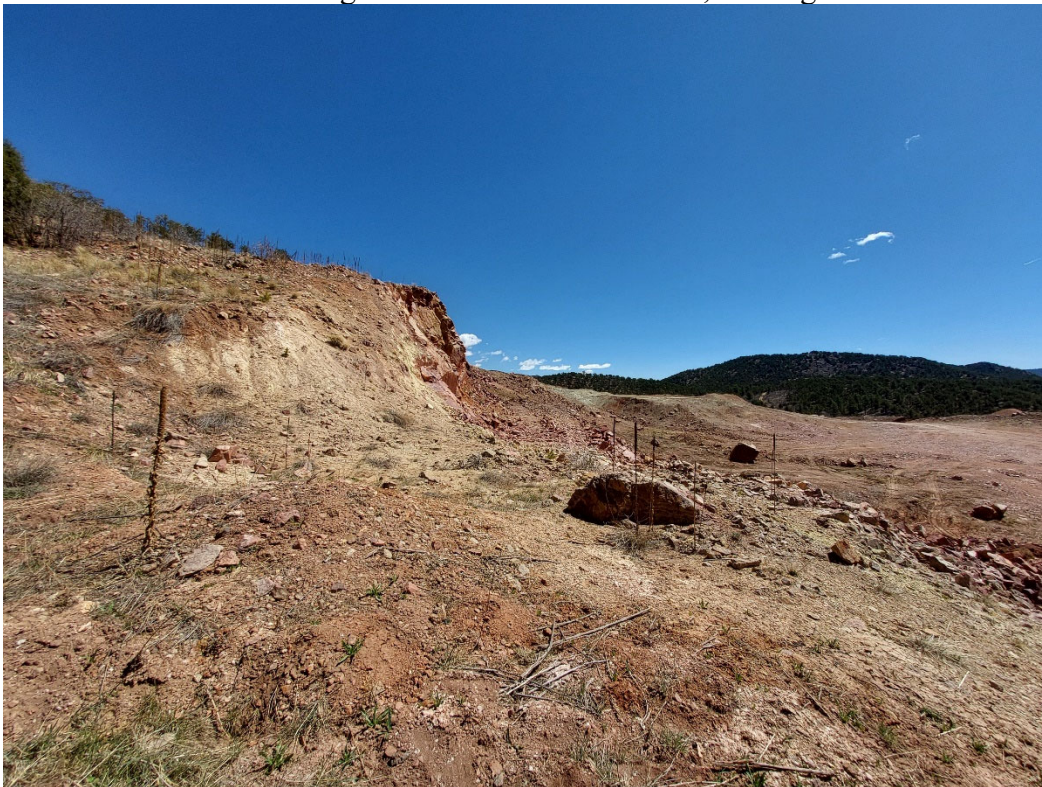
Common mullein, a List C noxious weed, was observed west of the highwall, the occurrence was sparse, and the operator was advised to reach out to Fremont County to inform them of the presence of the List C noxious weed.

Photo #16: Highwall viewed from the west, looking east. Common mullein can be seen in this photo.
