McClane Canyon Mine, C-1980-004, May 2024 Complete Inspection Report

PERMIT INFORMATION

Permit Number: C-1980-004 Mine Name: McClane Canyon Mine Operator: ARC McClane Canyon, LLC Operator Address: Joe Brinton 652 Peony Dr Grand Junction, CO 81507	County: Garfield Operation Type: Underground Permit Status: Temporary Cessation Ownership: Private
	Operator Representative Present: Chuck Silengo
Operator Representative Signature: (Field Issuance Only)

Inspection Start Date: May 16, 2024 Inspection Start Time: 09:00 Inspection End Date: May 16, 2024 Inspection End Time: 10:20		Inspection Type: Coal Complete Inspection Inspection Reason: Normal I&E Program Weather: Clear	
Joint Inspection Agency: None		Joint Inspection Contacts: None	
Post Inspection Agency: None		Post Inspection Contacts: None	
Inspector(s): Clayton Wein Travis Marshall		Inspector's Signature: <i>Clayton Wein</i> Signature Date: 5/28/2024

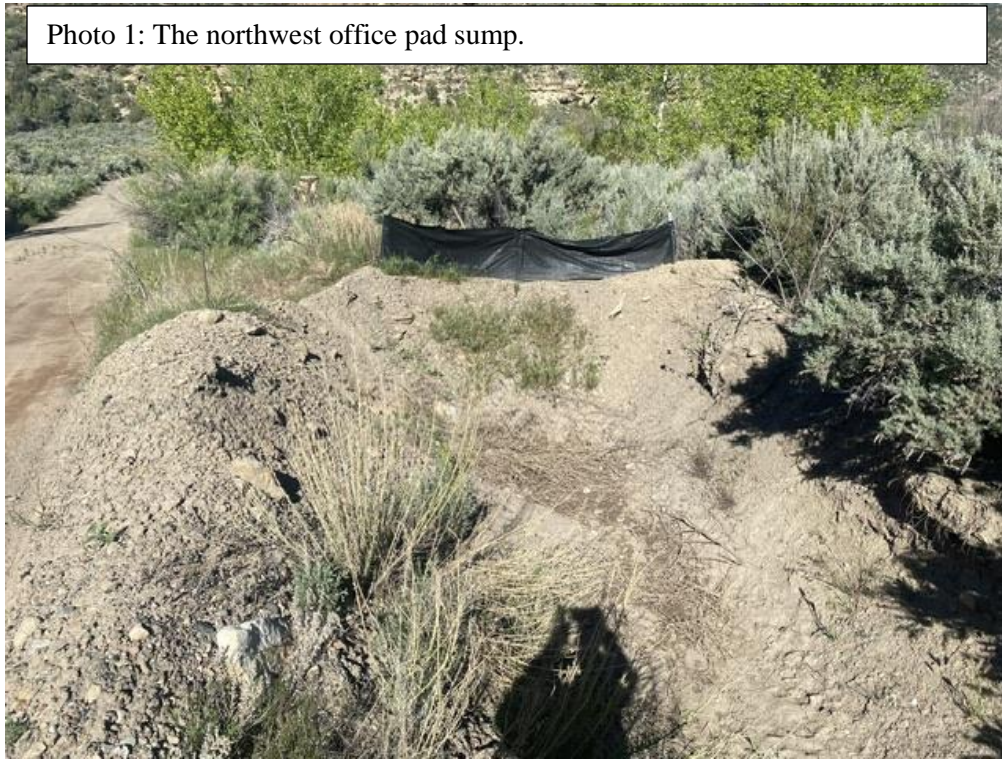
Two sumps are located on the west side of the mine office pad. One sump is located on the north side of the haul road and the other is located on the south side of the haul road. The north sump was dry at the time of the inspection (Photo 1). The silt fence at the outlet was in good shape and there were no erosional concerns. The sump was stable. The south sump was also dry. The sump was stable with no erosional features. **The silt fence for the sump's outlet had partially fallen down (Photo 2). Please repair the silt fence no later than June 6, 2024.**

Photo 1: The northwest office pad sump.

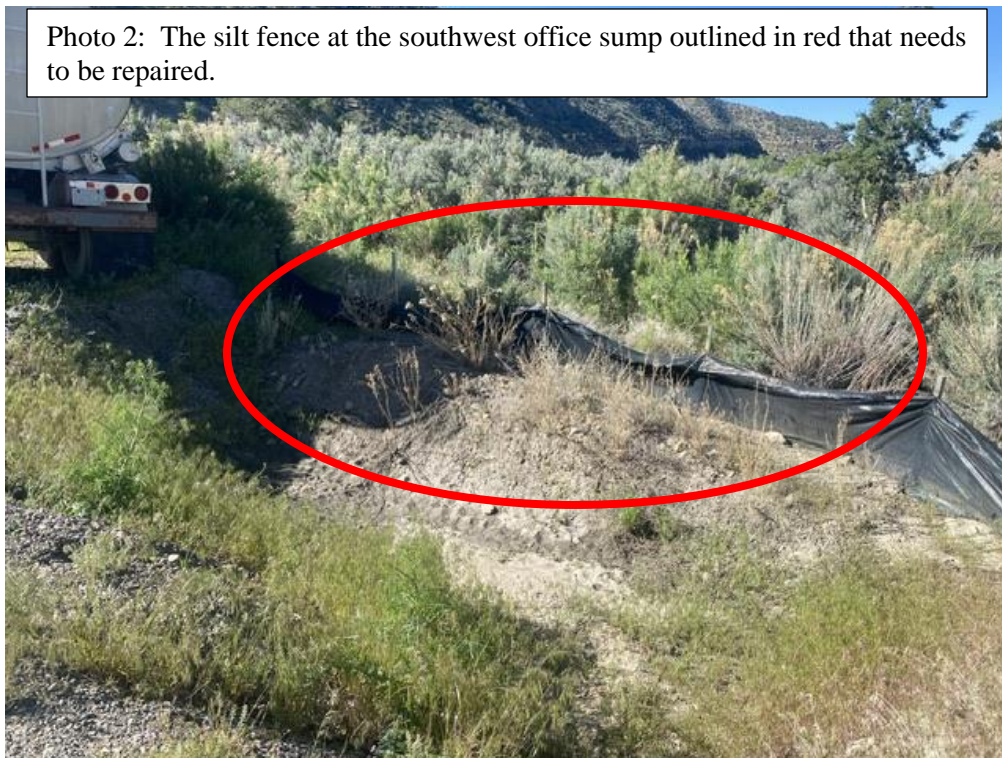
1. The Silt fence on the south office sump was partially fallen over. Please repair the silt fence.

Photo 2: The silt fence at the southwest office sump outlined in red that needs to be repaired.

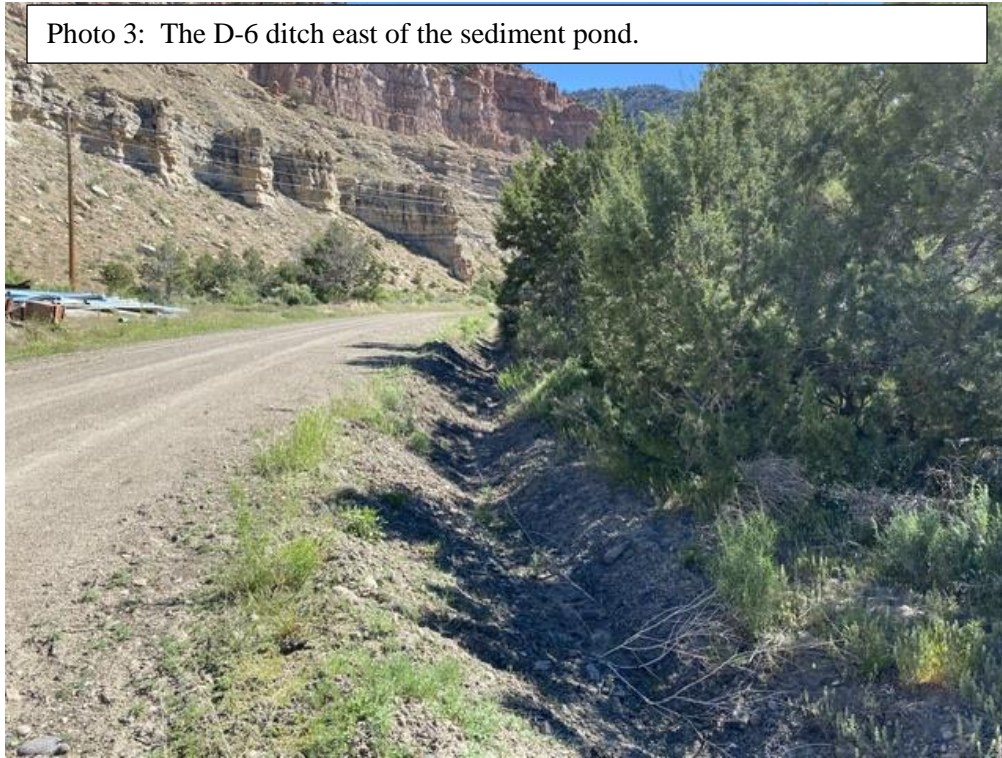
On the south side of the haul road, the D-6 Ditch transports runoff from Sump J to the sediment pond. The D-6 Ditch was unobstructed and stable (Photo 3). There were no erosional features.

Photo 3: The D-6 ditch east of the sediment pond.

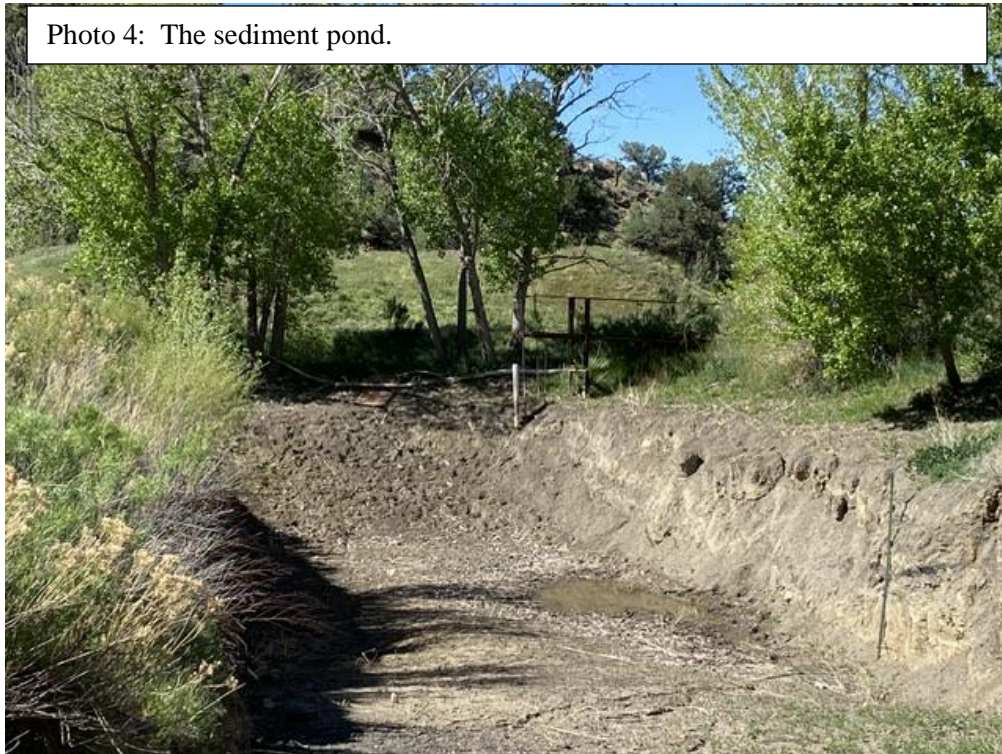
The sediment pond was impounding a small amount of water in the bottom. The level of water in the pond was well below the inlet of the primary discharge outlet (Photo 4). The riser pipe for the primary discharge point was clear and in good condition. The embankment for the pond was stable with vegetative cover. There were no erosional features observed. The sediment marker was seen in the pond. The level of sediment in the pond's bottom was well below the amount needed to require cleaning.

Photo 4: The sediment pond.

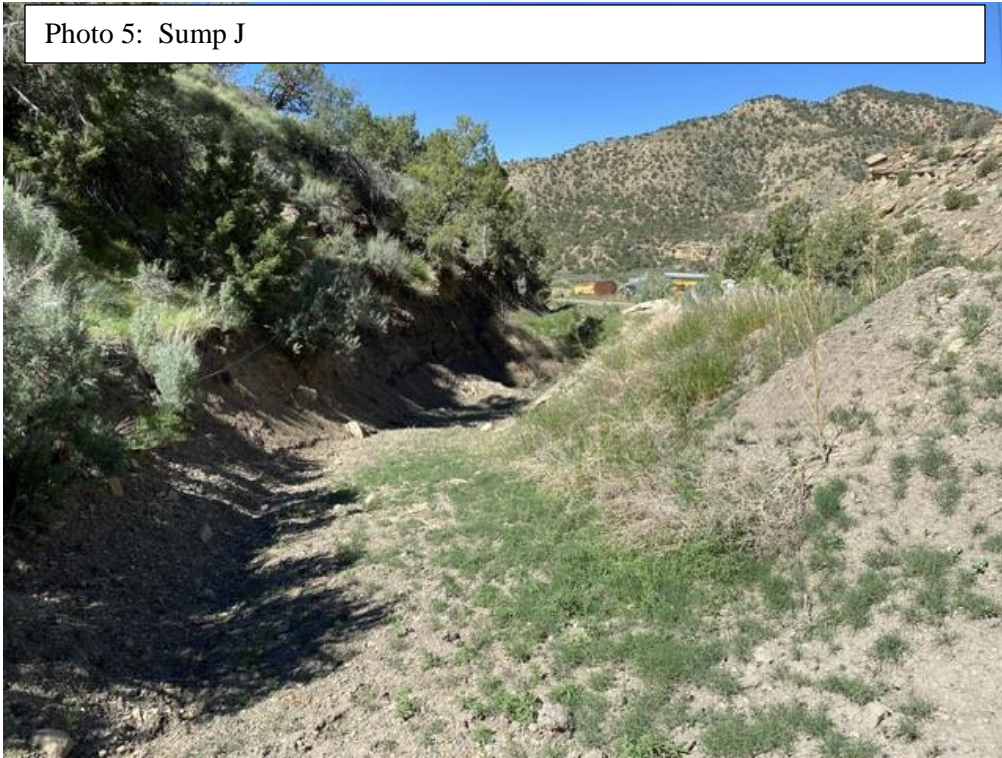
Sump J had no water in it during the inspection (Photo 5). The outlet for the sump is an open discharge outlet. The outlet was clear and there were no indications of instability or erosion.

Photo 5: Sump J

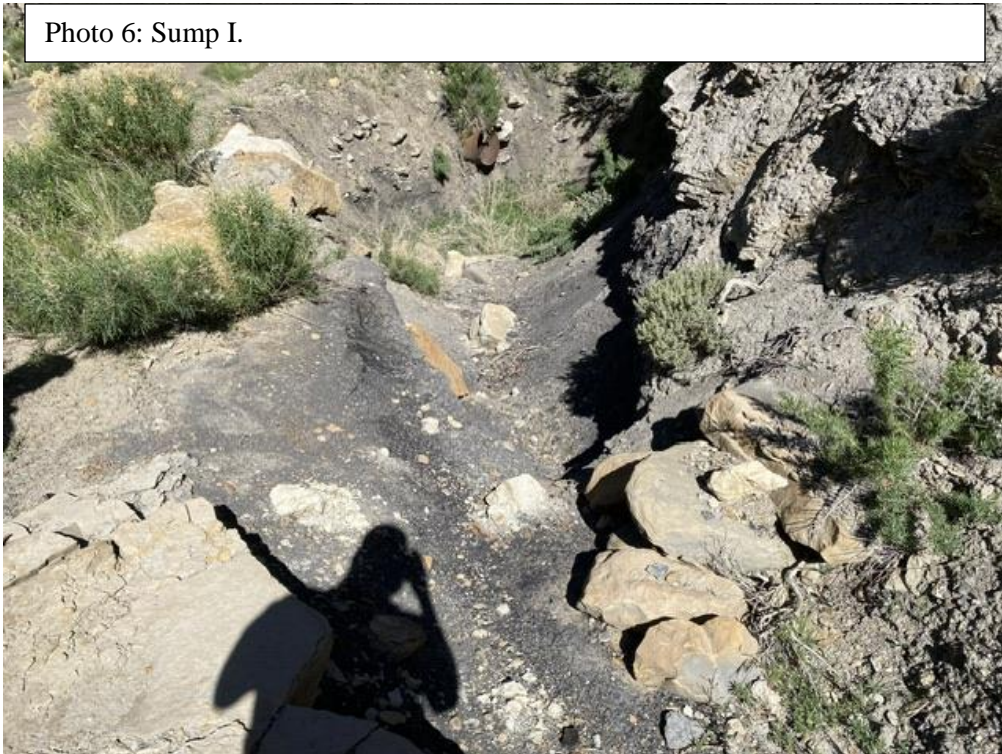
Sump I is located just west of the mine portals bench and then the north side of the haul road. The sump was dry during the inspection (Photo 6). There were no erosional features or indications of instability. The culvert outlet for the sump was clear of debris.

Photo 6: Sump I.

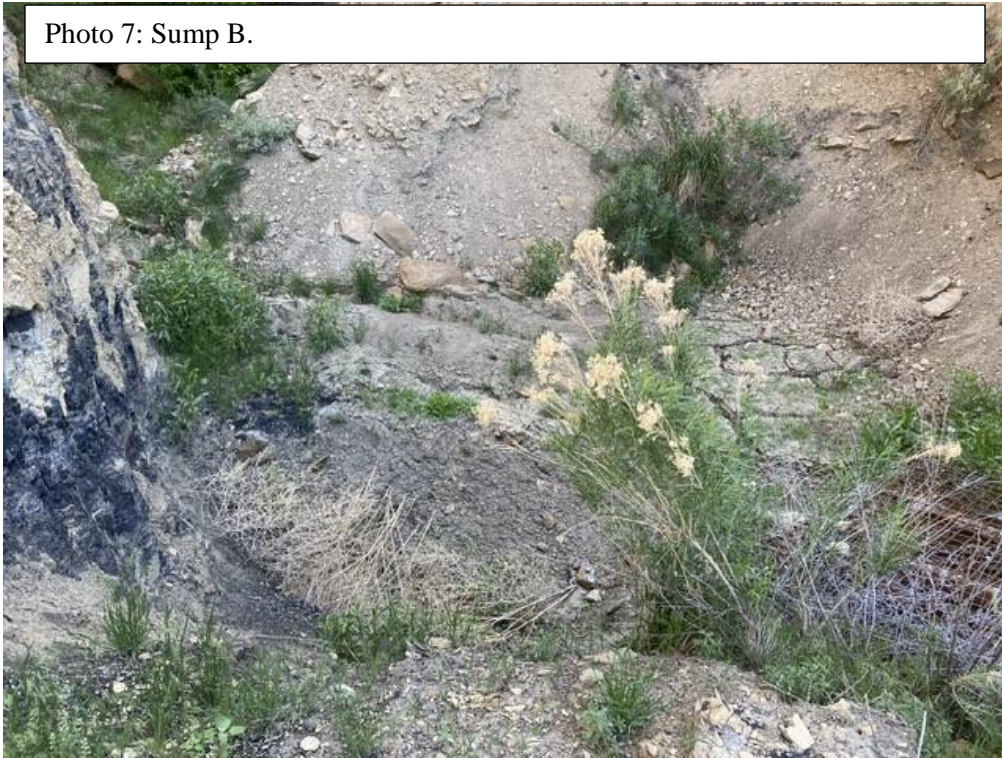
Sump A is located on the northern side of the portals bench (Photo 7). The sump was dry and stable. There were no erosional features observed. The trash rack covering the outlet was clear of debris.

Photo 7: Sump B.

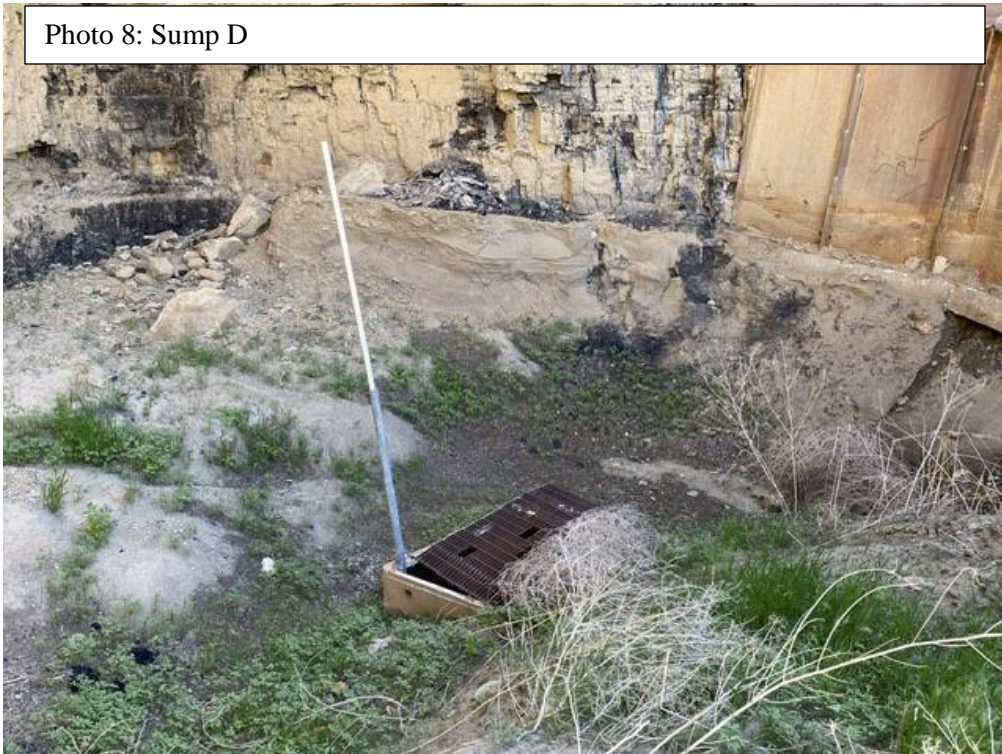
Sump D is located on the eastern portion of the portals bench (Photo 8). The sump was not holding any water during the inspection. The outlet for the sump was unobstructed. There were no erosional features or indications of erosion.

Photo 8: Sump D

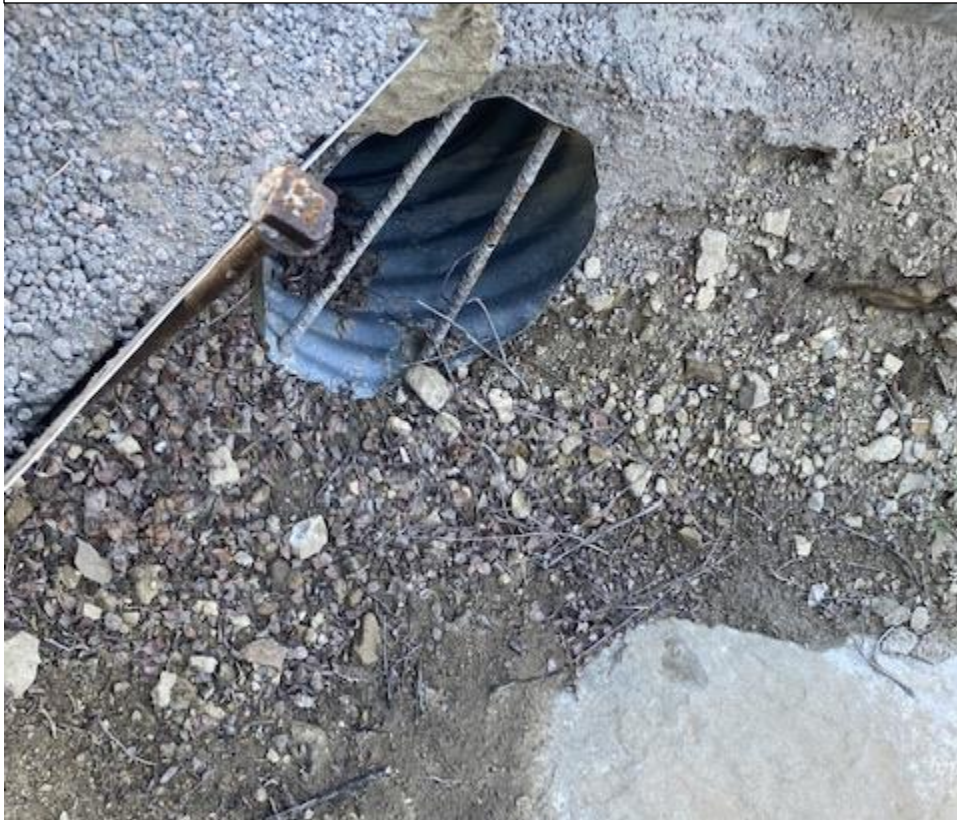
The clear water diversion sump E was dry and stable. The culvert outlet for the sump was clear of debris (photo 9). There were no erosional features or indications of instability observed.

Photo 9: The inlet to the Sump E culvert.

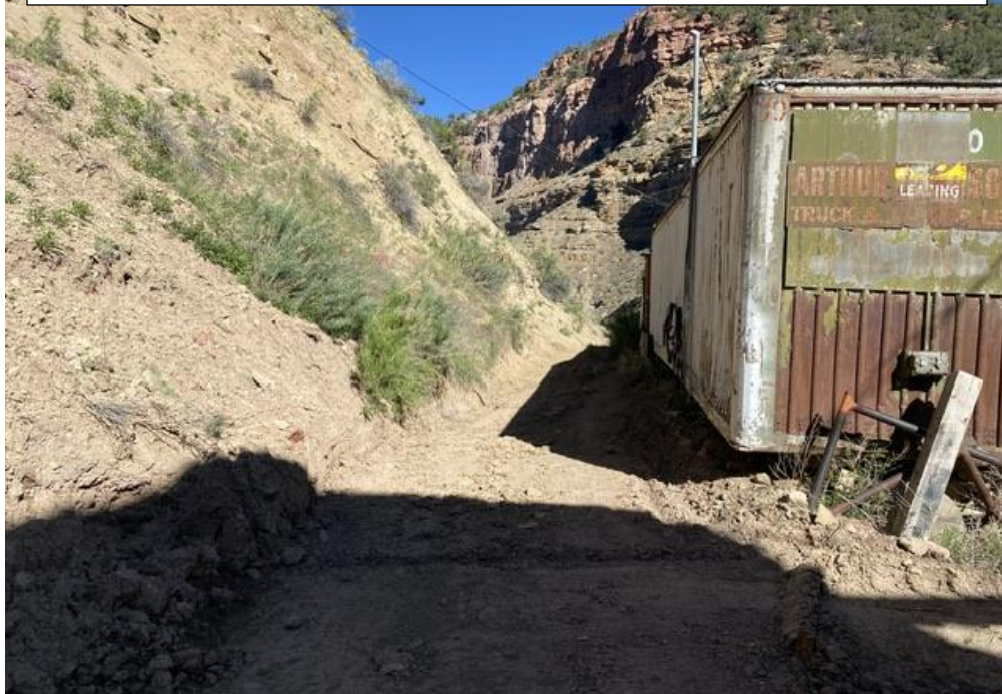
2. The D-2 Ditch was partially cleaned. The ground conditions were too soft to complete the ditch cleanout prior to May 16, 2024. Please clean the D-2 Ditch as soon as ground conditions allow but no later than June 6, 2024.

The D-2 ditch transports runoff behind the south side of the shop and into the D-3 ditch. The D-2 ditch was mostly dry (Photo 10). The remainder of the ditch that needs to be cleaned will be conducted soon according to Mr. Silengo. The ground conditions needed to be dry before the remainder of the ditch could be cleaned. **Please clean the D-2 Ditch as soon as ground conditions allow but no later than June 6, 2024.**

Photo 10: The D-2 ditch behind the shop.

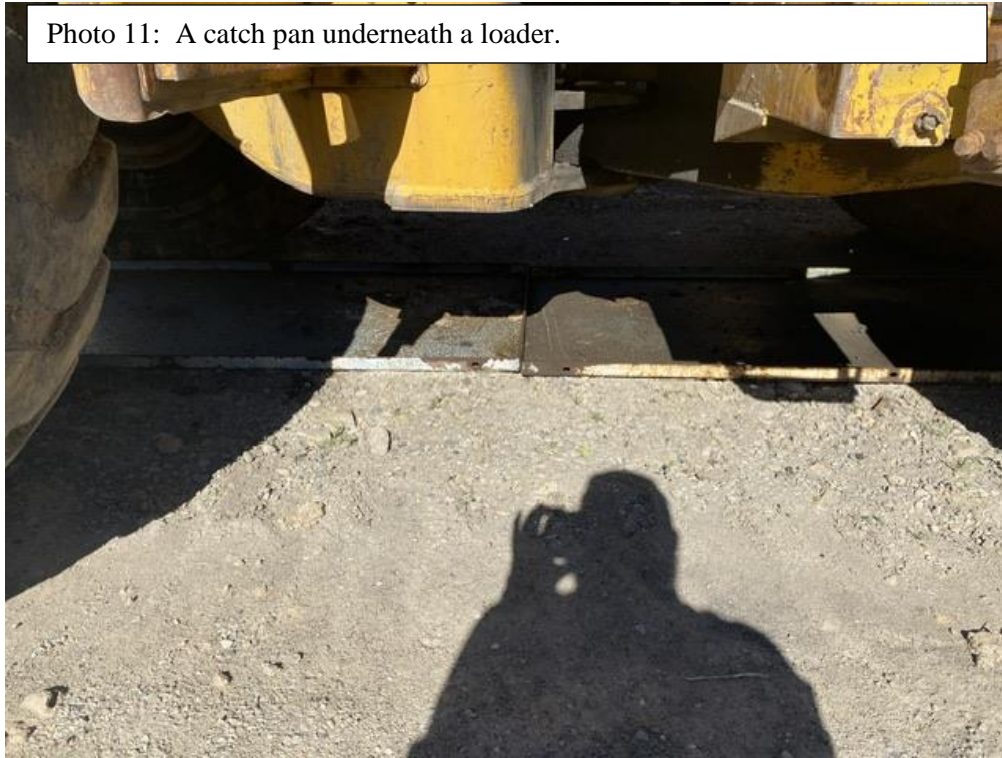
The Mine Office pad was well kept and stable. There were no erosional features identified. No fuel spills or contaminated soils were observed. Catch pans were observed to be placed under the equipment parked on the pad (Photo 11). All liquids were seen stored in a secondary containment structure.

Photo 11: A catch pan underneath a loader.

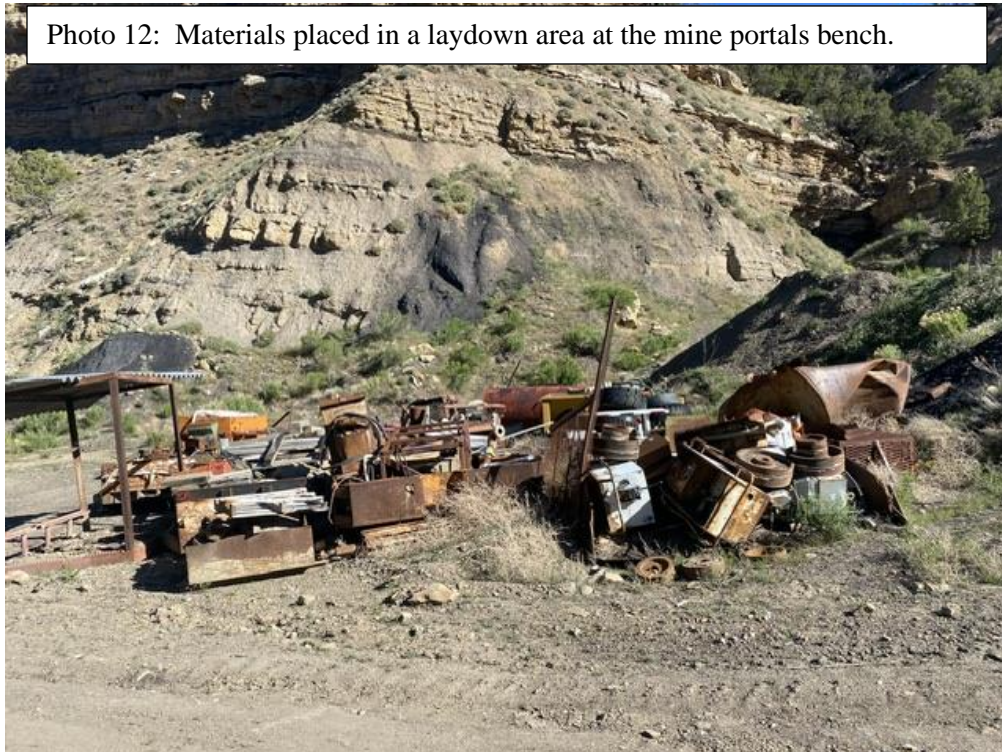
Equipment and materials are stored on the mine portals bench (Photo 12). The bench was stable and there were no erosional concerns. No fuels or hydrocarbons were observed outside of secondary containment structures.

Photo 12: Materials placed in a laydown area at the mine portals bench.

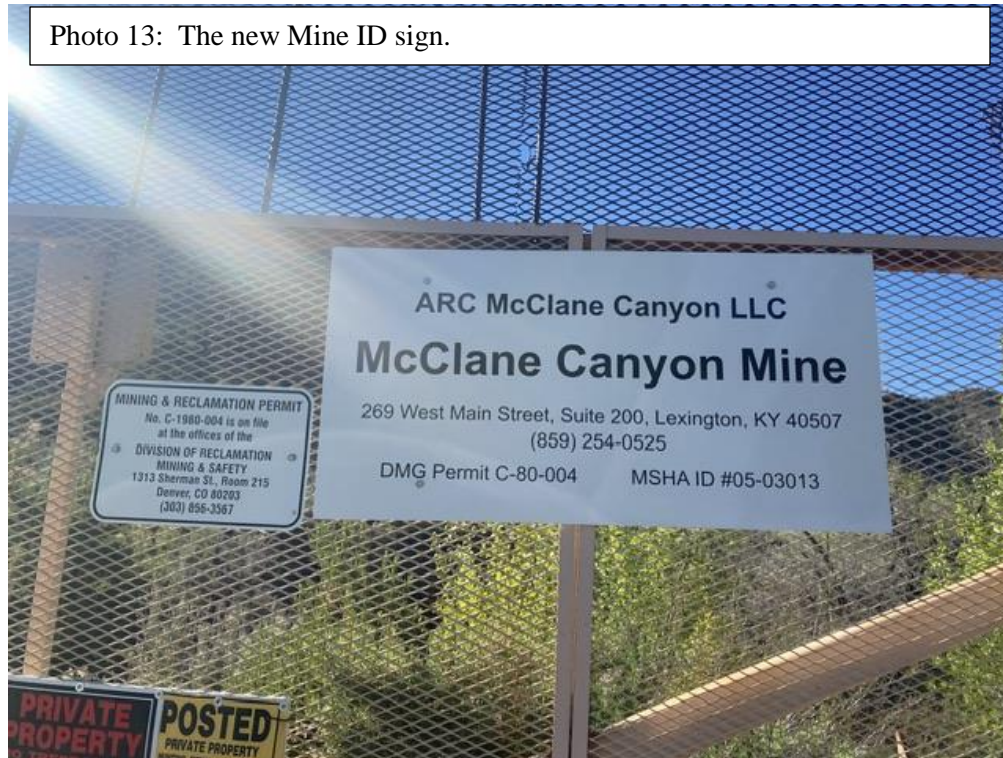
The updated mine identification sign was observed to be posted on the entrance gate over East Salt Greek (Photo 13). The sign displayed the current company name, permit number and contact information for both the Division and ARC McClane Canyon. The topsoil pile marker was seen on top of the topsoil stockpile to the southeast of the sediment pond. Stream buffer zone markers were also observed placed between the haul road and Upper McClane Creek in the areas that were closest to the creek.

Photo 13: The new Mine ID sign.

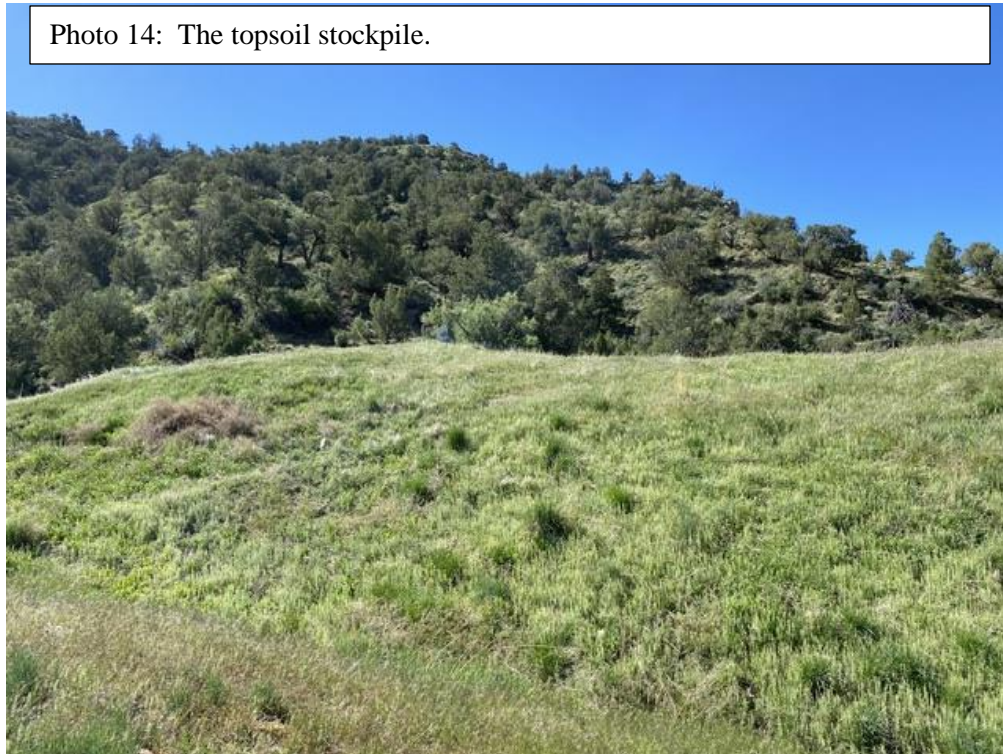
The topsoil pile was stable with vegetative cover (Photo 14). There were no signs of erosion. The perimeter ditch was stable with no debris. The topsoil pile marker was observed posted on top of the pile.

Photo 14: The topsoil stockpile.
