2024 May Inspections Yoast, Seneca IIW

PERMIT INFORMATION

Permit Number: C-1982-057 Mine Name: Seneca IIW Mine Operator: Seneca Property LLC Operator Address: Ms. Miranda Kawcak 29515 Routt County Road 27 Oak Creek, CO 80467	County: Routt Operation Type: Surface Permit Status: Permanent Cessation Ownership: Private
	Operator Representative Present: No, as this was an aerial inspection.
Operator Representative Signature: (Field Issuance Only) This report was issued electronically from the Divisions' Denver Office.

Inspection Start Date: 28 May 2024 Inspection Start Time: 11:00 a.m. Inspection End Date: 28 May 2024 Inspection End Time: 11:10 a.m.		Inspection Type: Aerial Inspection Inspection Reason: Normal I&E Program Weather: Clear	
Joint Inspection Agency: None		Joint Inspection Contacts:	
Post Inspection Agency: None		Post Inspection Contacts:	
Inspector(s): Robin Reilley, M.S. GISP Brock Bowles		Inspector's Signature:

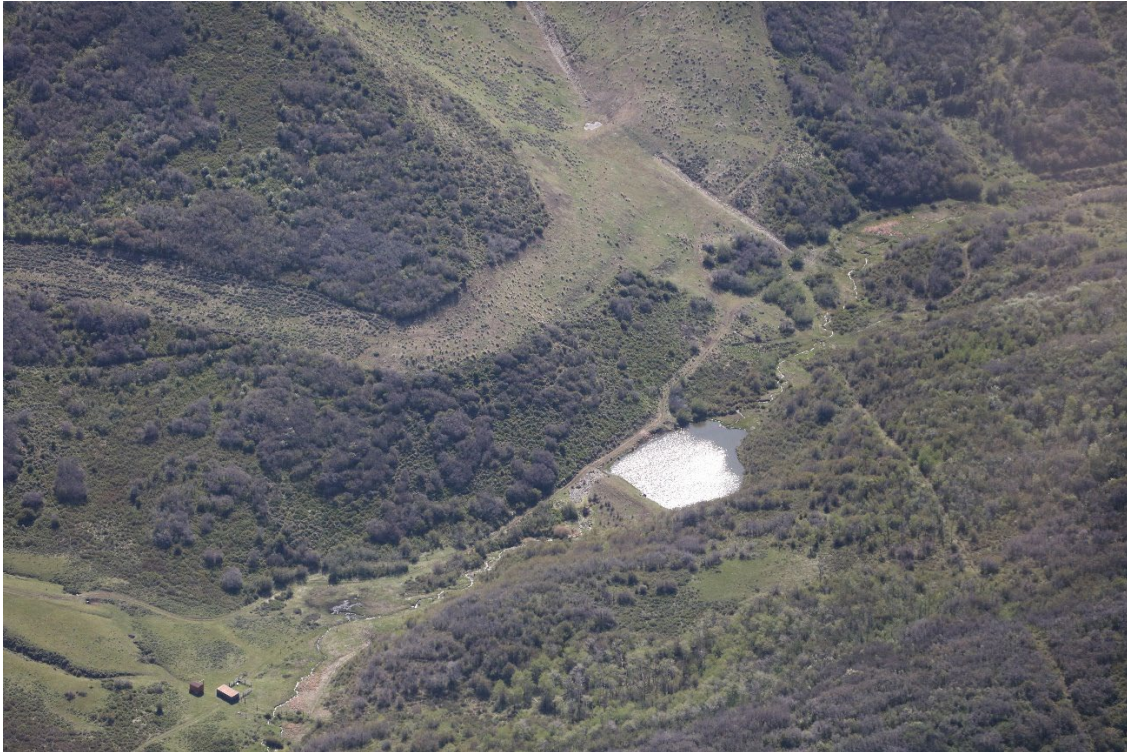
Photo 1: Pond 17 showing significant in and outflow.

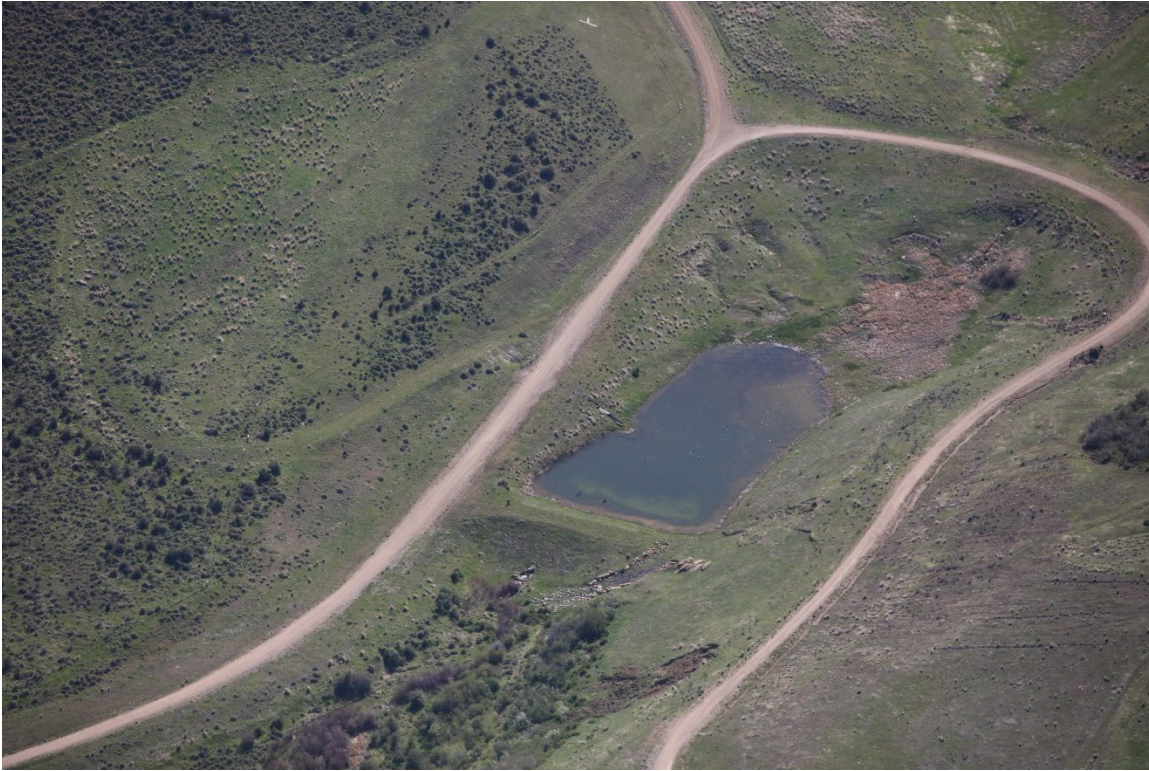
- Established slump at Pond 6 was noted.
- The new slide (spring 2023), downstream from the slump appears to encompass approximately 1/3 of an acre.
- A crack exists between the two areas.

Photo 2: Pond 6 looking toward slumped slopes.

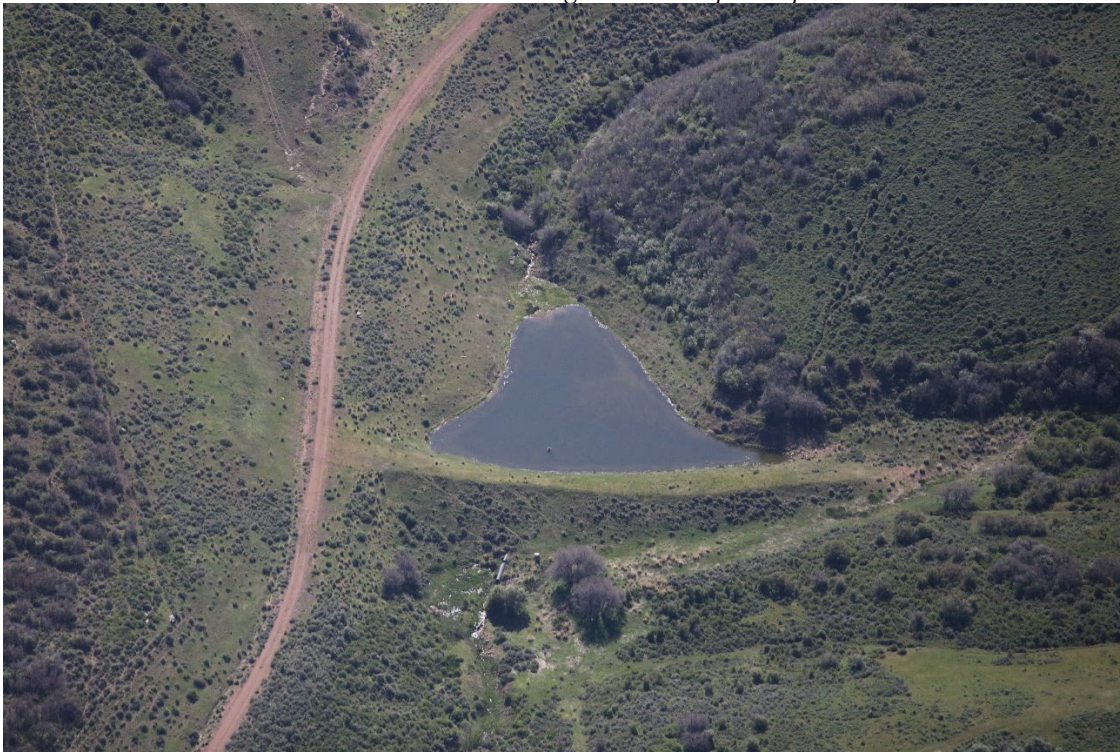
Photo 3: Pond 5 exhibiting inflow and outflow.

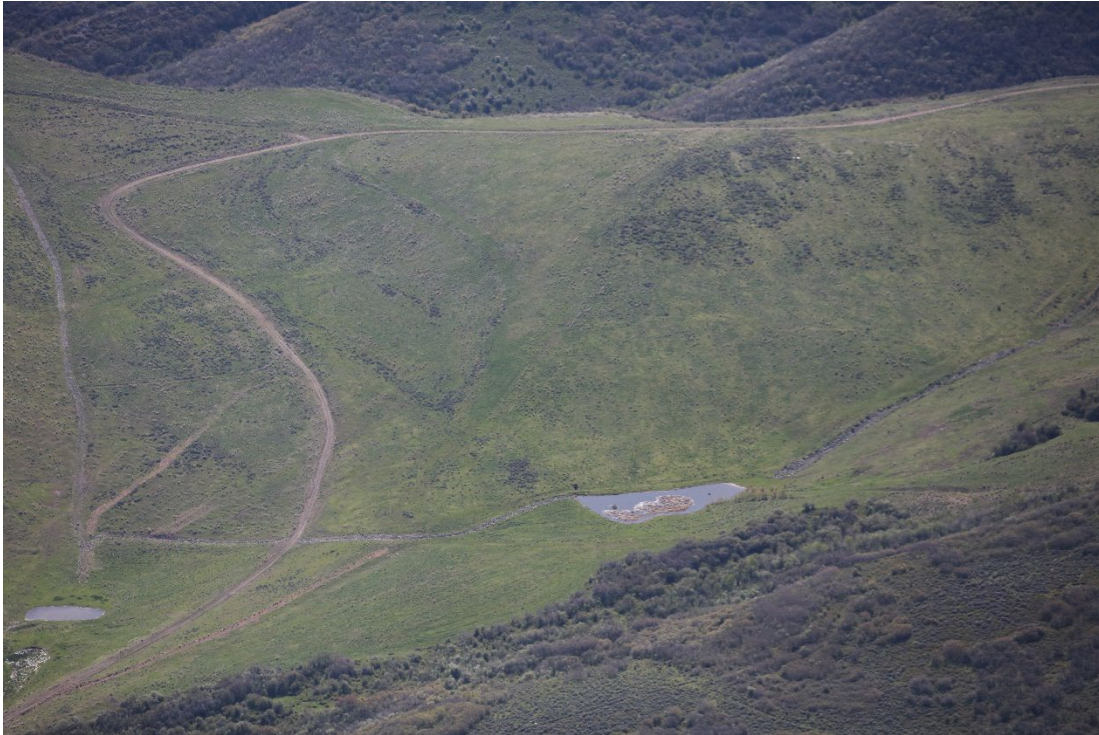
Photo 4: Stock Tank 18 full, not discharging, and associated reclamation.

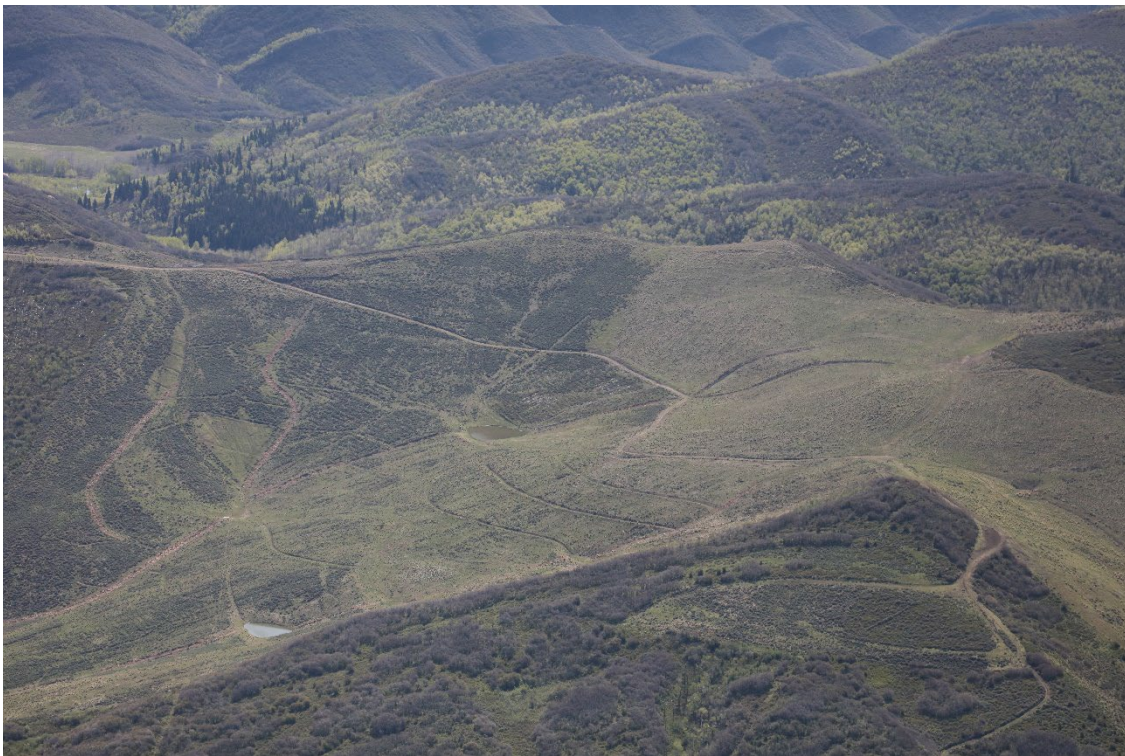
Photo 5: Overview of reclamation.
