COLORADO

Division of Reclamation,
Mining and Safety

PERMIT INFORMATION

Permit Number: C-1981-012 Mine Name: New Elk Mine Operator: New Elk Coal Company, LLC Operator Address: Mr. John Terry 12250 Highway 12 Weston, CO 81091	County: Las Animas Operation Type: Underground Permit Status: Active Ownership: Private
	Operator Representative Present: John Terry
Operator Representative Signature: (Field Issuance Only)

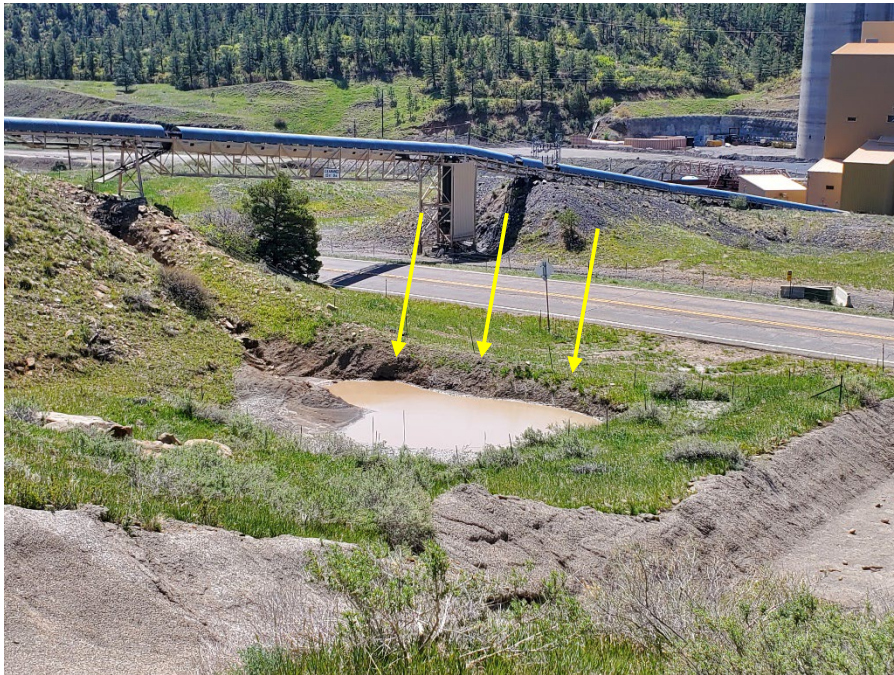
- During the previous inspection, Containment #5 was observed. At that time, the Division informed the Operator that Containment #5 would require some maintenance, such as cleaning some of the sediment accumulation, before operations begin. The Operator stated during the April 2024 inspection that Containment Area #5 was expected to be cleaned within the following week. During the May 2024

inspection, the Division observed that Containment Area #5 had been cleaned and appears to have an increased holding capacity as a result. Containment #5 held water at the time of the inspection (Photo 1).

Photo 1: Containment #5. Arrow points to area where an excavator was recently used to remove sediment from the pond.

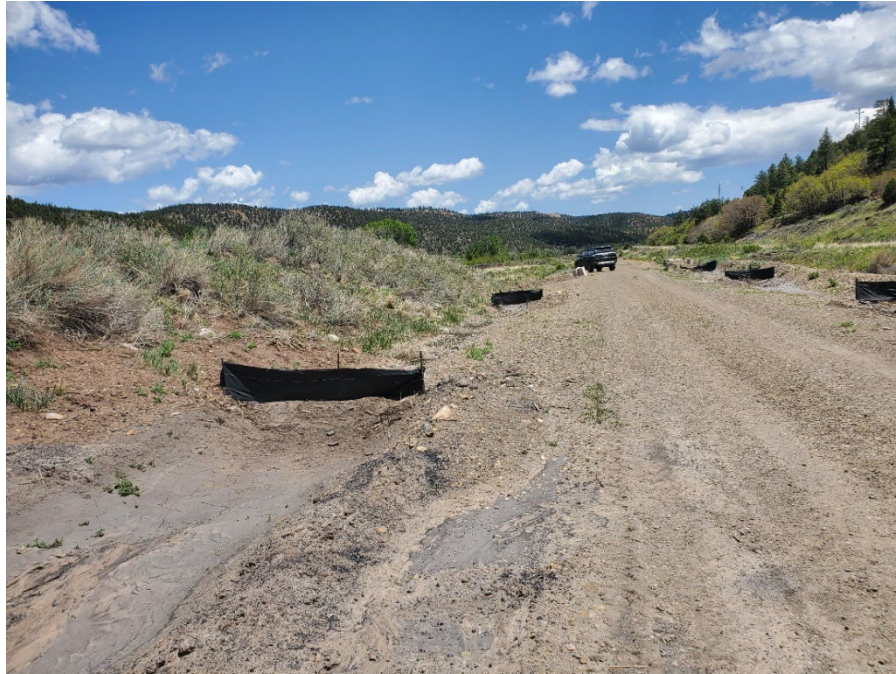
- **The silt fences along the SAE near Pond 007A that were damaged, mentioned in the January-April 2024 reports, still need to be repaired.** The majority of the silt fences along the road in the SAE do appear to be functioning appropriately, and seem to have contained the sediment and run-off generated by the recent rainstorm (Photo 2). Also, the silt fences along the eastern side of the SAE at the south side of the permit **still need to be repaired**. During the April inspection, the Operator located some silt fencing that they will use to make these repairs. The Operator had not made the repairs by the time of the May inspection, but stated that they will likely do the repairs in the following week.

Photo 2: Some of the silt fences at the SAE south of Pond 007A.

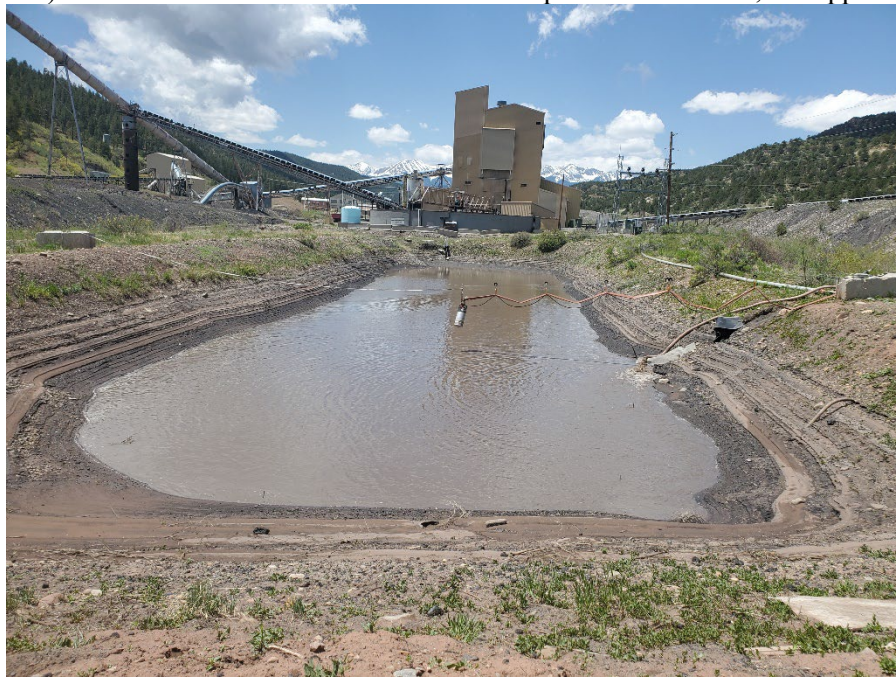
- Pond 006A contained water during the inspection. Water from Pond 007A was being pumped into Pond 006A (Photo 3). The banks around Pond 006A were damp from recent rain, but appeared to be stable.

Photo 3: Pond 006a

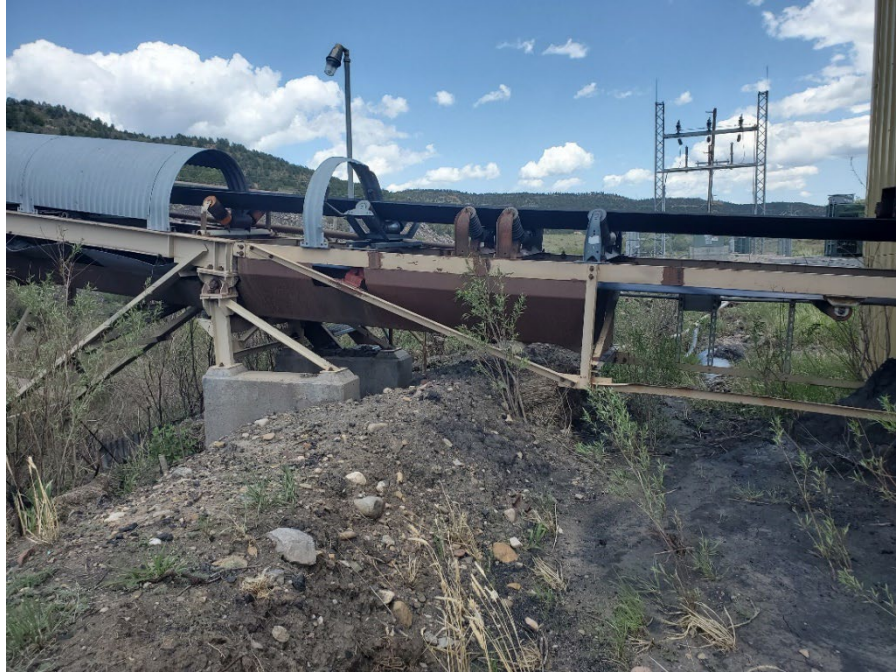
- The berm running under the refuse conveyor belt, south of the river, appears to be stable and functional (Photo 4).

Photo 4: Berm under the refuse conveyor belt.

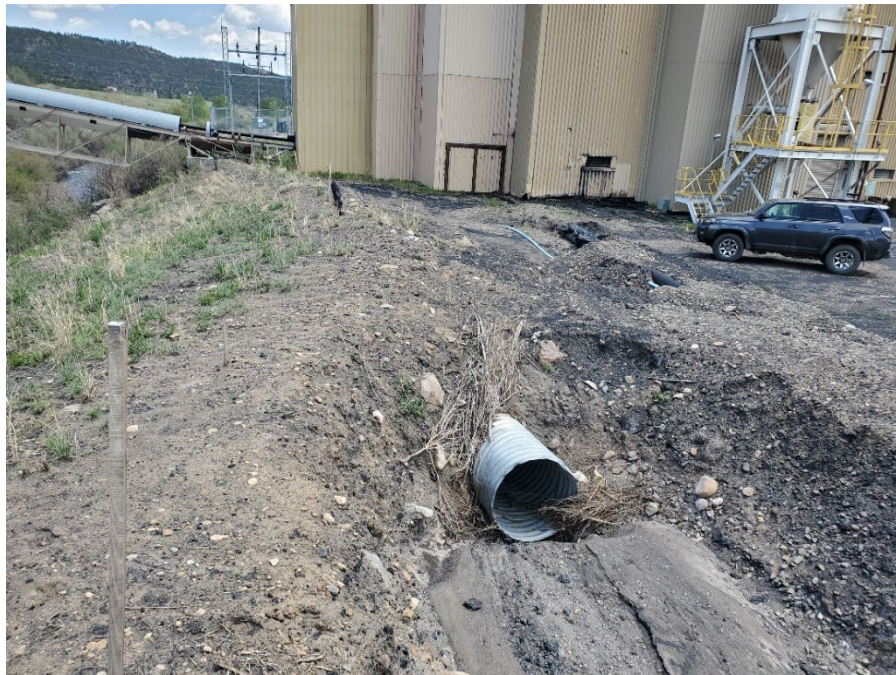
- Ditch D32 and Culvert C64 were observed during the inspection. They appear to be functional and no significant sediment accumulation due to recent rainfall was observed. Culvert C64 was clean at the time of the inspection (Photo 5).

Photo 5: Looking east from Ditch D32 at culvert C64.

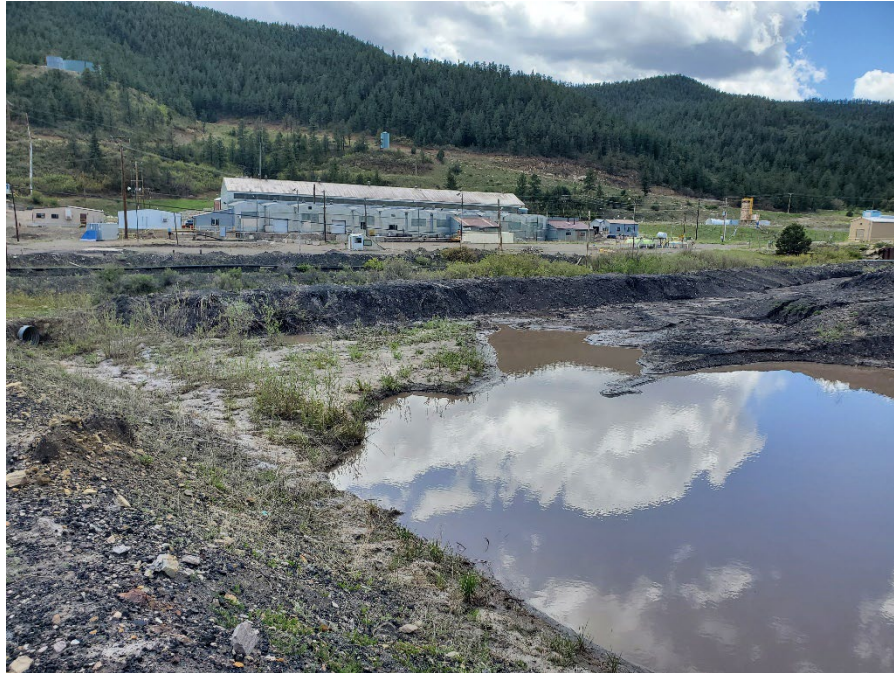
- The sediment containment sump at the east side of DWDA #2 contained water. The check dams appeared functional and the berm along the south side of the pile, north of the river, appeared stable (Photo 6). Culvert C13 also appeared clear and functional at the time of the inspection.

Photo 6: Water held within the sump area to the east of DWDA #2. Culvert C13 pictured in the left side of the photo.

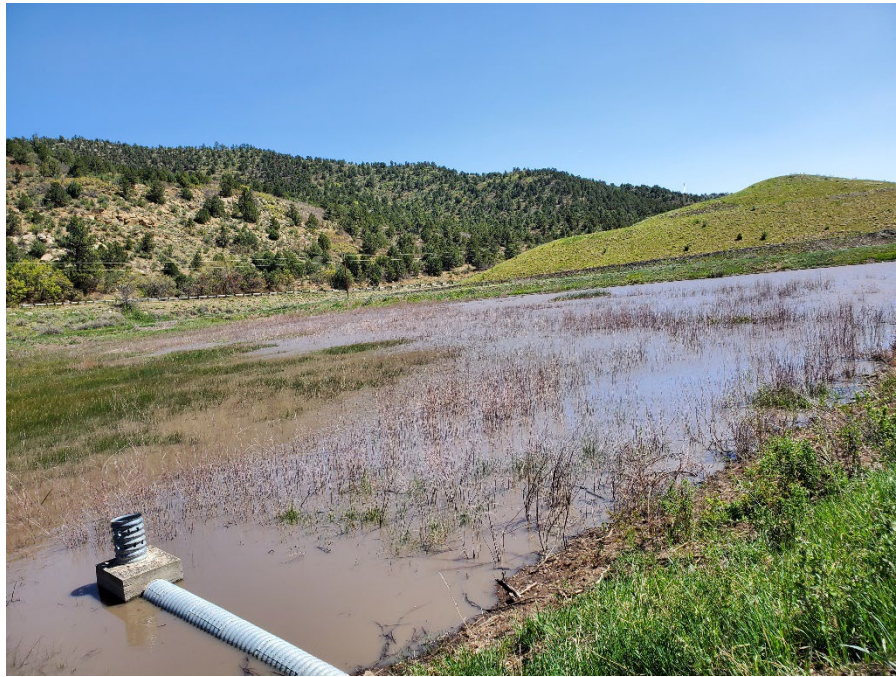
- Pond 004A contained some water, primarily from the water that had been pumped from Pond 007A and was being pumped from Pond 006A (Photo 7). Ditch D2 is used to pump water from Pond 006A that had been pumped from Ponds 007A and 08. Ditch D2 contained water that had recently been pumped from Pond 006A. Pond 004A was not discharging. Some mullein was observed along the south bank of Pond 004A. The Operator stated that mullein had been sprayed around the site, but this area will either be sprayed if it hasn't or a shovel will be used to manually remove the weed.

Photo 7: Pond 004A

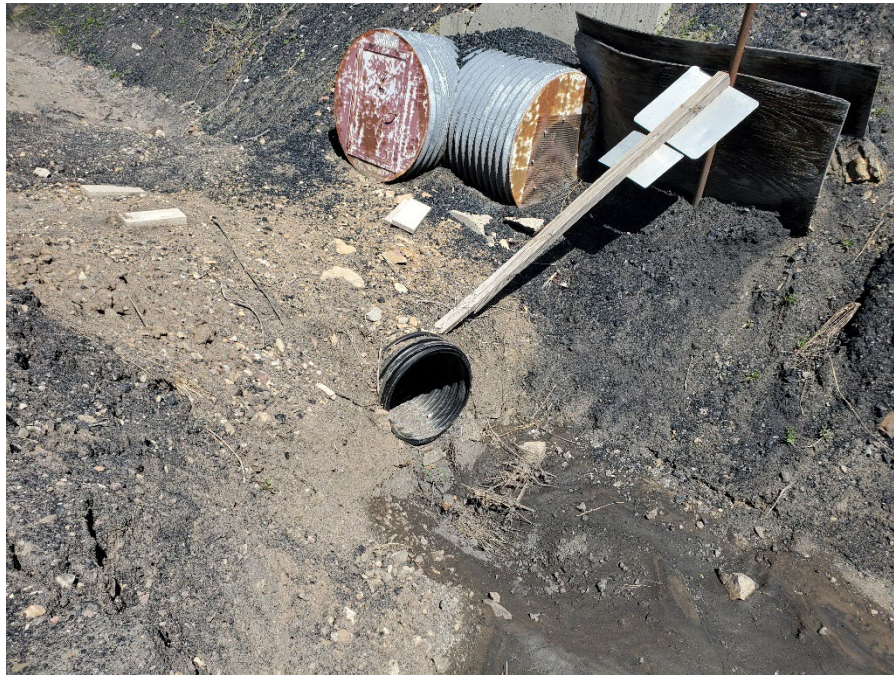
- Pond 08 contained water at the time of the inspection, but was not discharging. The banks appeared stable and the emergency and principle spillways were unobstructed. The Operator stated that Pond 08 would be pumped to Pond 006A within the next few days following the inspection.
- During the previous inspection, Culvert C17A contained an accumulation of sediment. The Operator has since cleaned the culvert and removed the sediment (Photo 8). Culvert C17A appears to be able to function properly.

Photo 8: East side of C17A. The Division observed that both sides had been cleaned out.

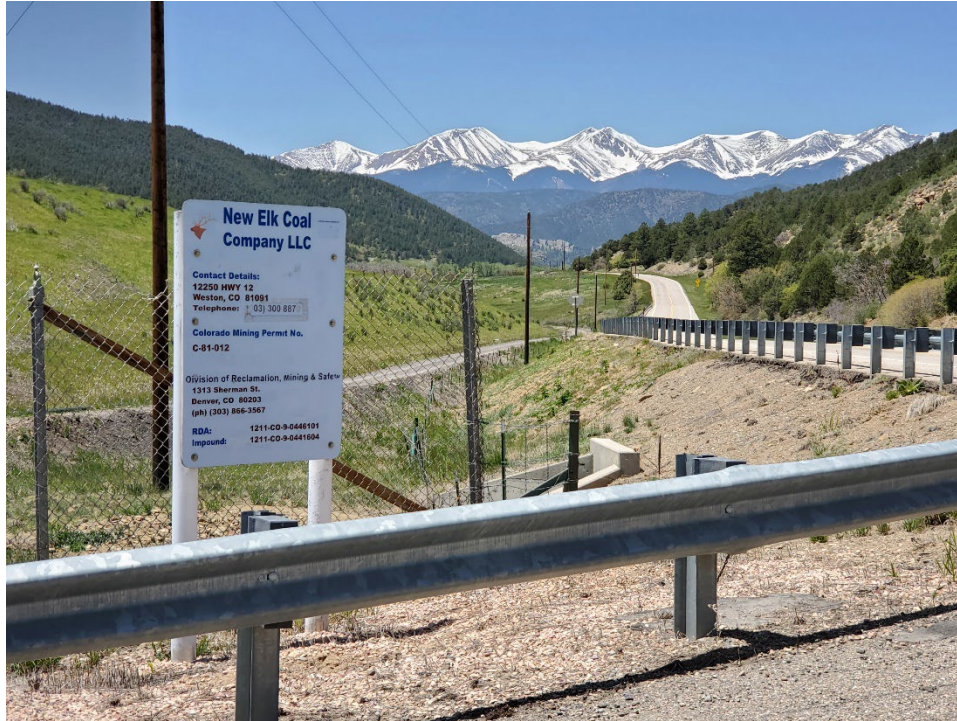
- A mine sign was posted at the main entrance in compliance with Rule 4.02 (Photo 9).

Photo 9: Mine sign posted at the entrance to the site.

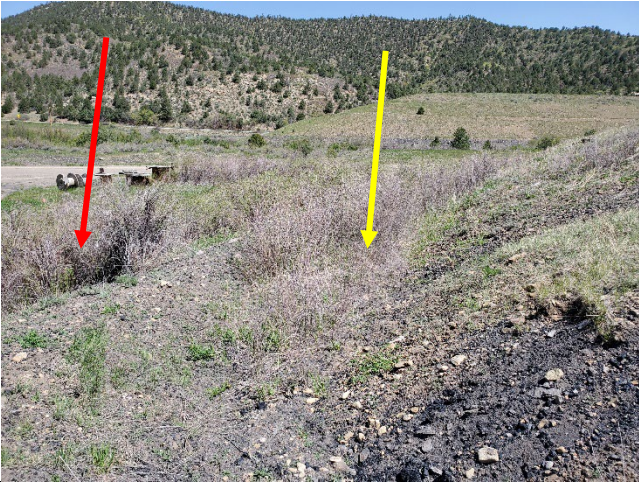
The red arrow points to D7, and the yellow arrow points to the unnamed/unnumbered ditch (see Figure 1).
9	2.5 x 13.8	V	3.33 x 14.5	V, Trap. in some areas

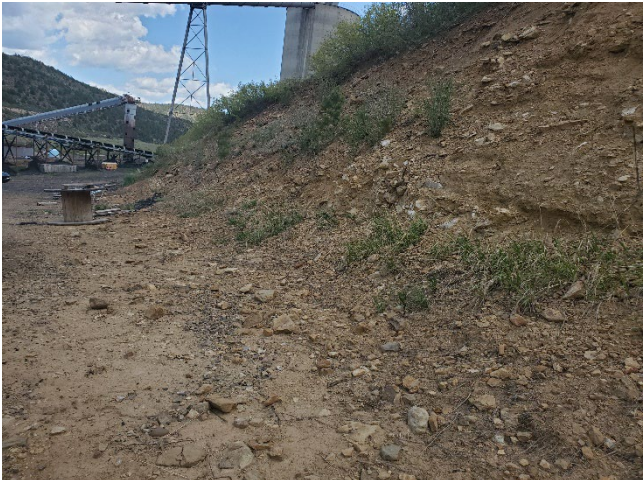
<p>D25A doesn't exist as depicted on Map 13.</p> <p>Pictured is the south side of the road where D25A is depicted on Map 13. The road slopes to the north, and water instead runs along the north side (see image below).</p>

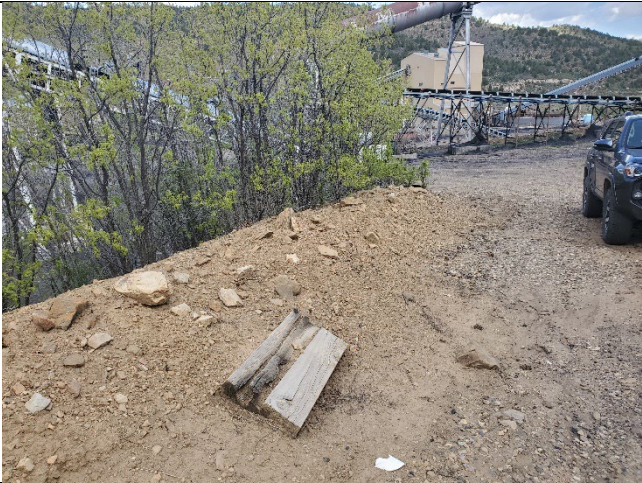
North side of road where water runs along the south side of the berm.
27	0.8 x 3.3	V	1.17 x 10.83	V

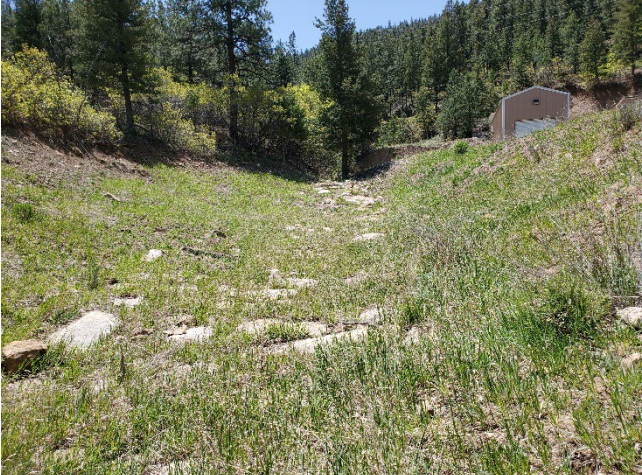
*Section of ditch not numbered on Map 14 (see Figure 2). Appears to be part of a clean water diversion ditch. Channel is rock lined.

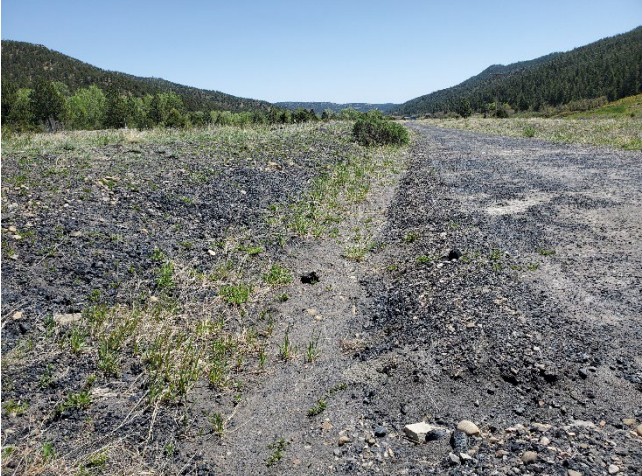
D34A is shown as being the ditch on both the north and south side of the road, but this measurement was taken on the north side, since D34A on the south side is also abled as D34B further to the east on Map 14.

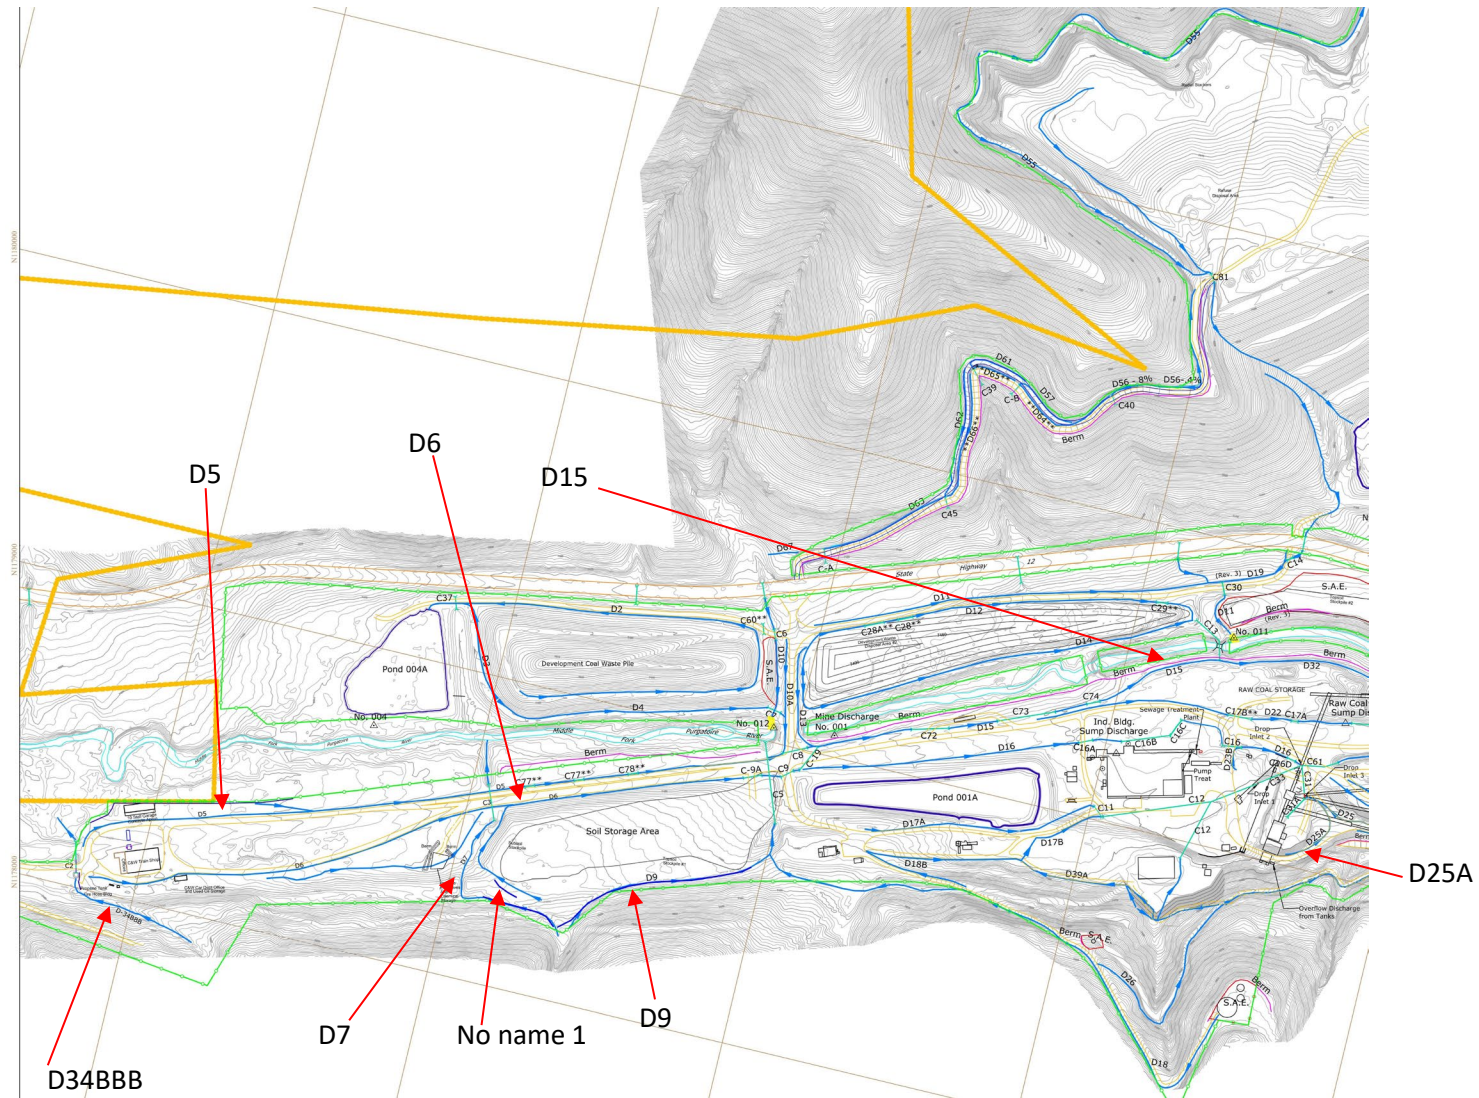
Figure 1: Figure indicating the approximate locations where photos and measurements were taken for each ditch in Table 1 (continued), overlain onto the *Map 13: East Portal Sediment and Surface Water Control Plan* map from the PAP. *There is some error in the photo locations in relation to the locations indicated on the map.

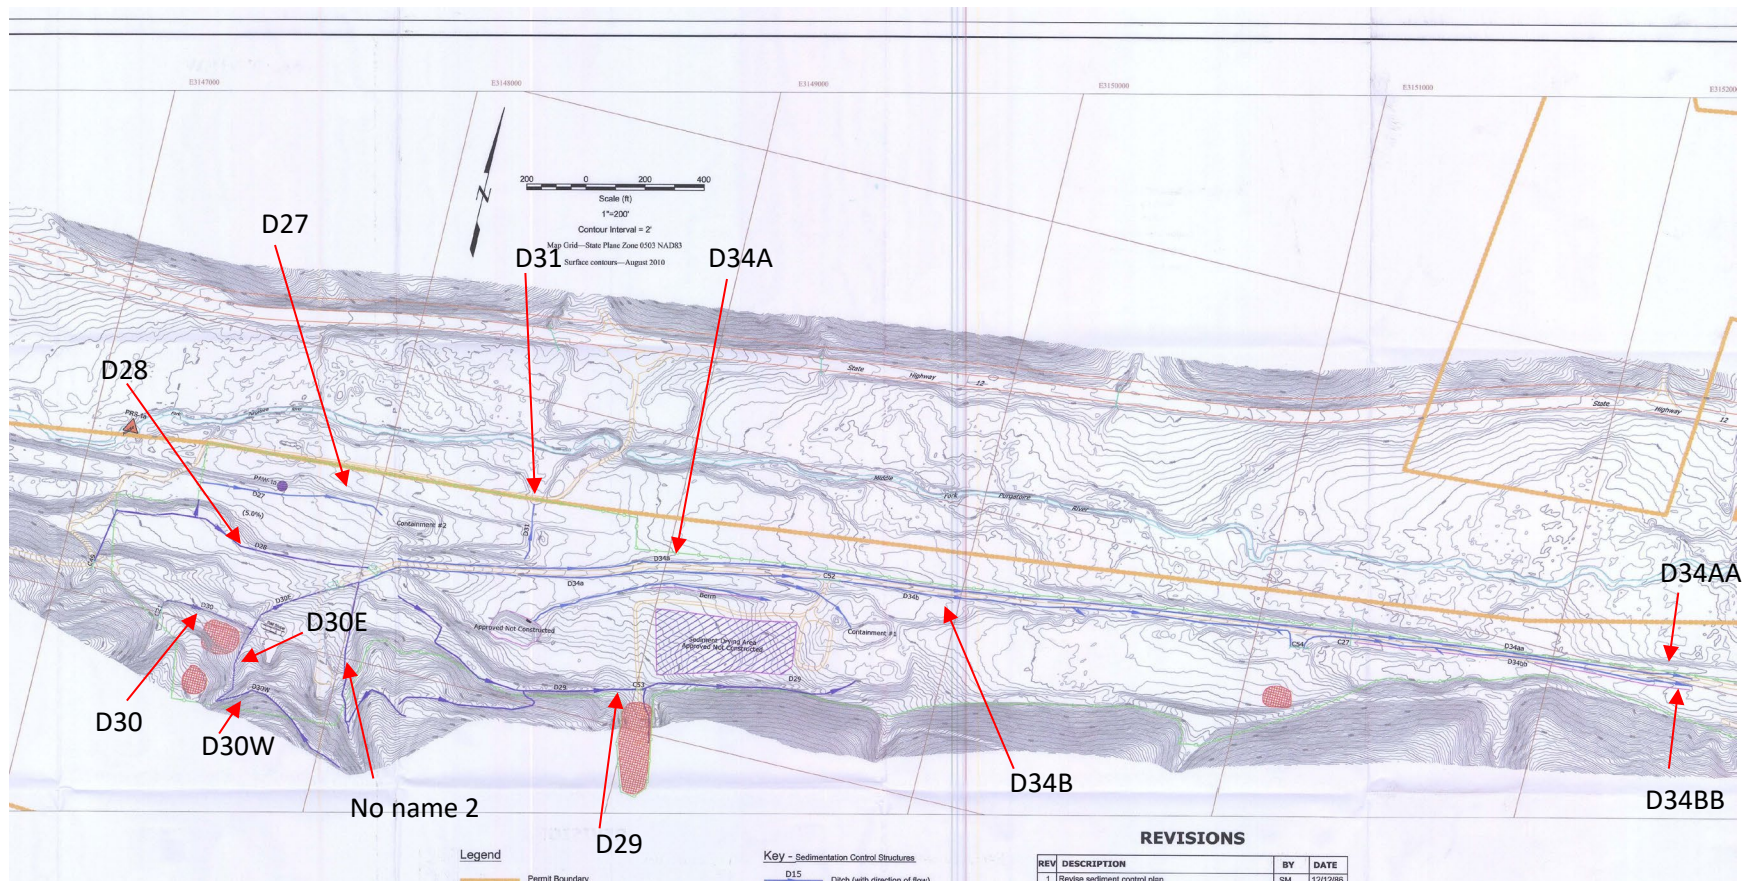
Figure 2: Figure indicating the approximate locations where photos and measurements were taken for each ditch in Table 1 (continued), overlain onto the Map 14: WEstPortal Sediment and Surface Water Control Plan map from the PAP. *There is some error in the photo locations in relation to the locations indicated on the map.
