Division of Reclamation,
Mining and Safety

MINERALS PROGRAM INSPECTION REPORT

MINE NAME: Mica Lode	MINE/PROSPECTING ID#: M-1977-144	MINERAL: Quartz (quartzite/qua sandstone)	COUNTY: Fremont
INSPECTION TYPE: Monitoring	WEATHER: Clear	INSP. DATE: April 29, 2024	INSP. TIME: 12:00
OPERATOR: Colorado Quarries Inc	OPERATOR REPRESENTATIVE: Aaron Tezak	TYPE OF OPERATION: 112c - Construction Regular Operation

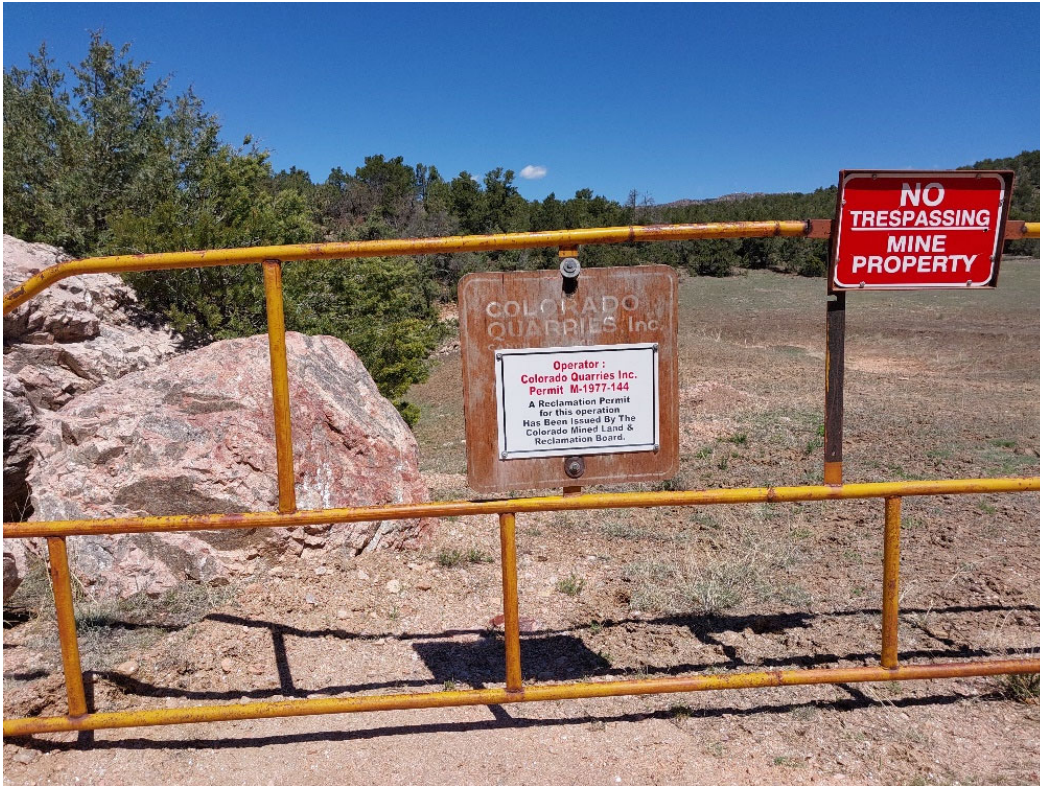
The required posted sign was observed at the mine entrance, see Photo #1. The permit boundary markers were not verified during this inspection.

Photo #1: Mine sign at entrance of site on County Road 383B.

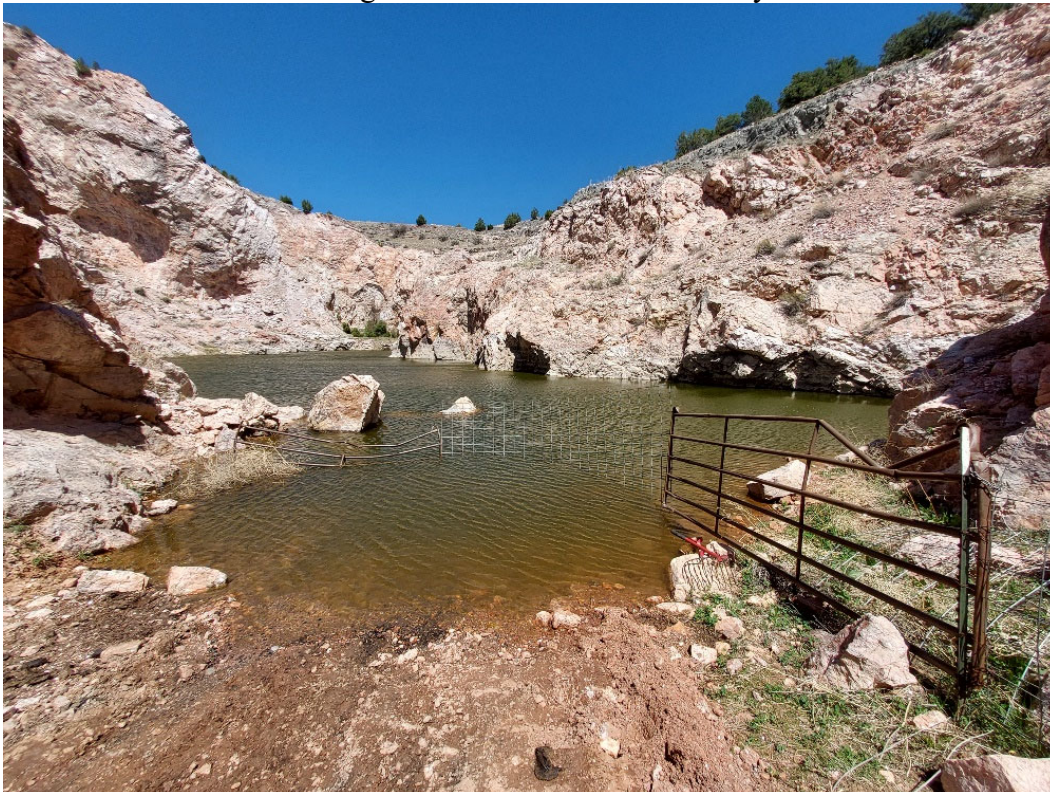
There is exposed water in the Mica/Rosa Pit, the exposure predates 1981 and does not require an augmentation plan. See Photo #2. There are no other indications of the hydrologic balance being negatively affected by the operation.

A pair of large predatory birds (hawks or eagles) were viewed to be nesting in the highwalls above the Mica/Rosa Pit pond area. There did not appear to be a negative impact on the wildlife because of mining activities in the area.

Photo #2: Exposed water in Mica/Rosa Pit, predatory large birds' nest is located near the tree on the cliff seen in the left of the photo.

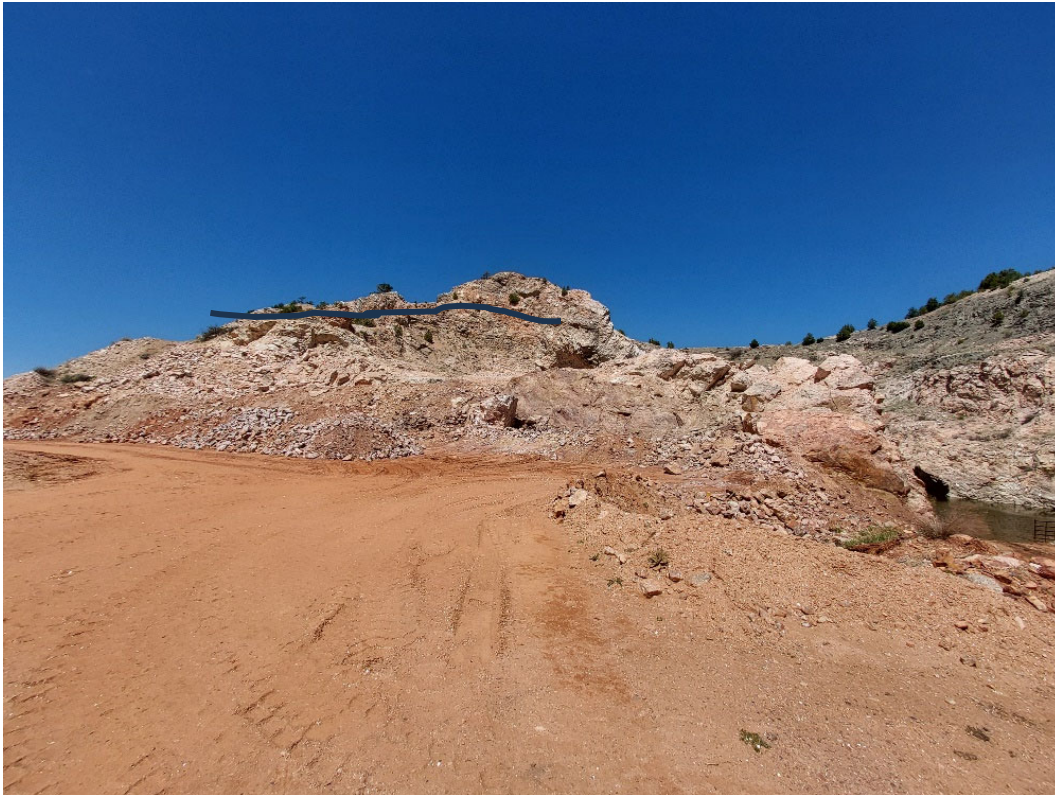
Photo #3: In area labeled MQHW-1, the line shows the top of a bench that will be removed; work has begun on the process. Taken from the south of MQHW-1, looking north.

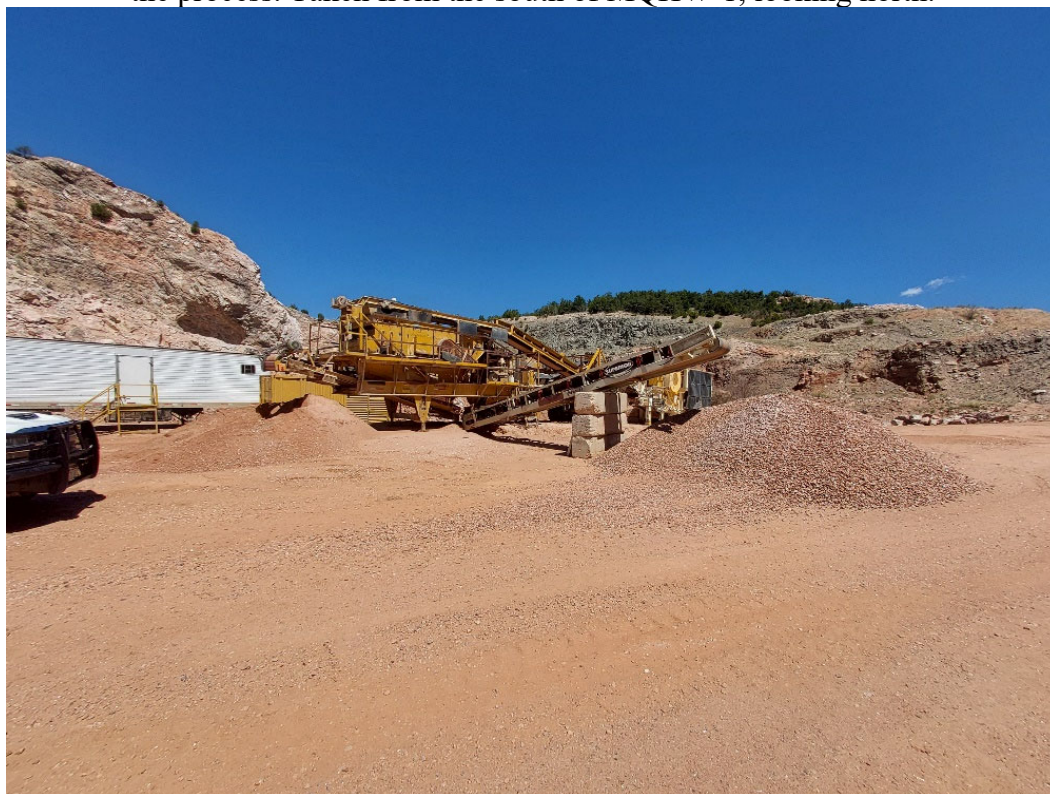
A crusher was observed on site and Mr. Tezak confirmed that blasting had recently occurred. There was not a large volume of processed material observed at the time of inspection. Two stockpiles were observed, one near the crusher located south of the Mica/Rosa Pit (see Photo #4) and large boulders located in the Ruby Pit (see Photo #7) where blasting occurred. The stockpiles were stable with no erosion issues.

A crusher was viewed on site, but it is not a permanent structure; see Photo #4. There are no permanent structures on site.

Photo #4: Crusher setup in the MQD-1 Dump area, the small stockpile of processed material can be seen; looking northwest.

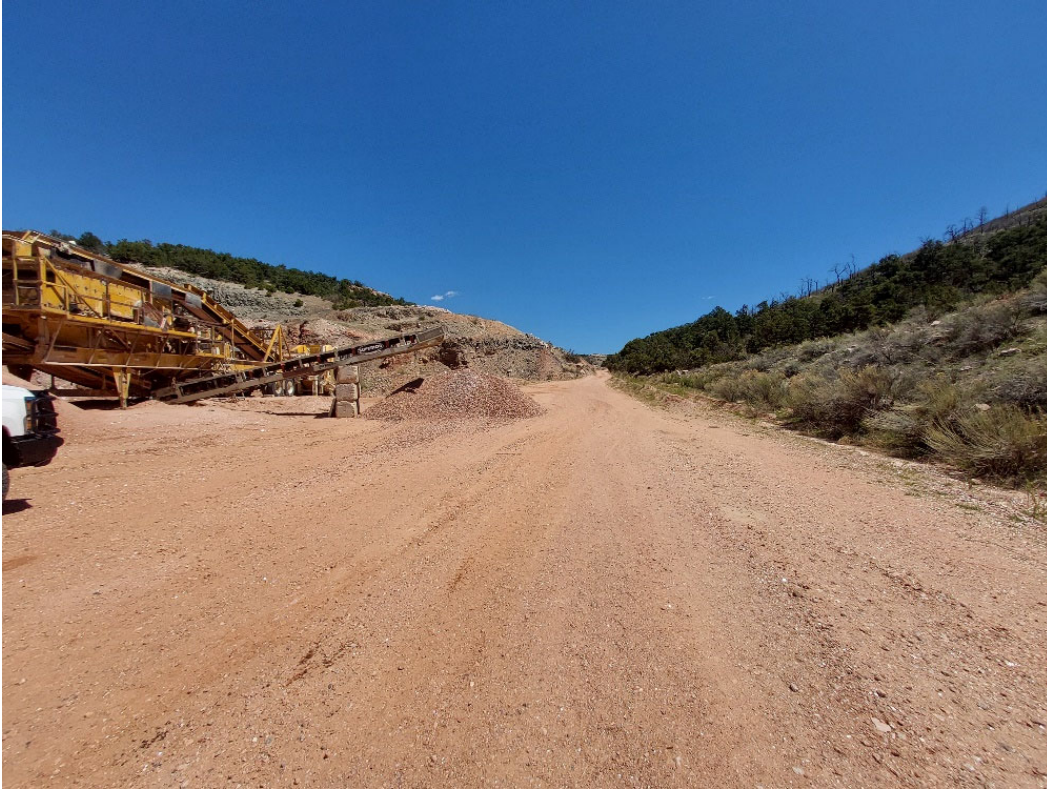
The permit site includes a section of Road 383B, this road is used as the primary site to travel between various areas of the mine. The road is located along the south permit boundary and travels generally north-south in the eastern portion of the permit area. There did not appear to be any damage to the road during the inspection; see Photo #5. Internal haul roads also appeared to be maintained and stable.

Photo #5: Road 383B along the south end of the permit area. Taken from the southeast end of MQD-1 Dump area, north of Area A, looking east northeast.

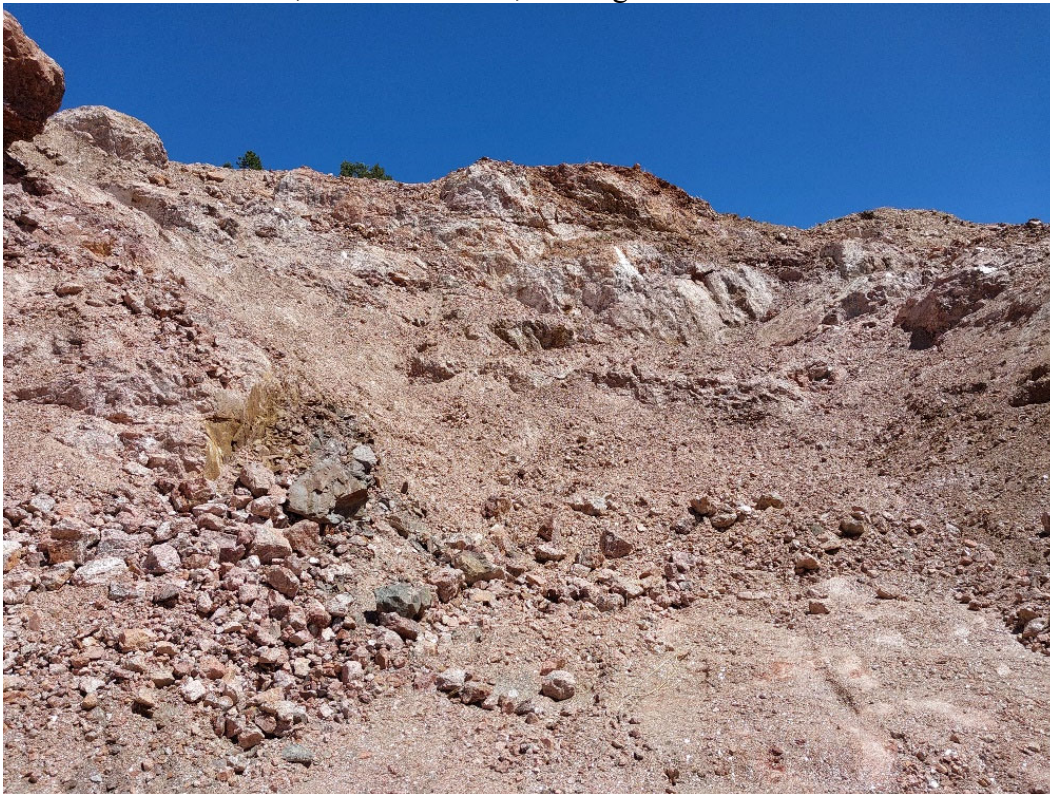
Blasting does occur at the mine site. The most recent blasting event occurred March of this year, according to Mr. Tezak; see Photo #6. No explosives are stored on site.

Phot #6: Recently blasted area on the east end of the Ruby Pit; looking east.

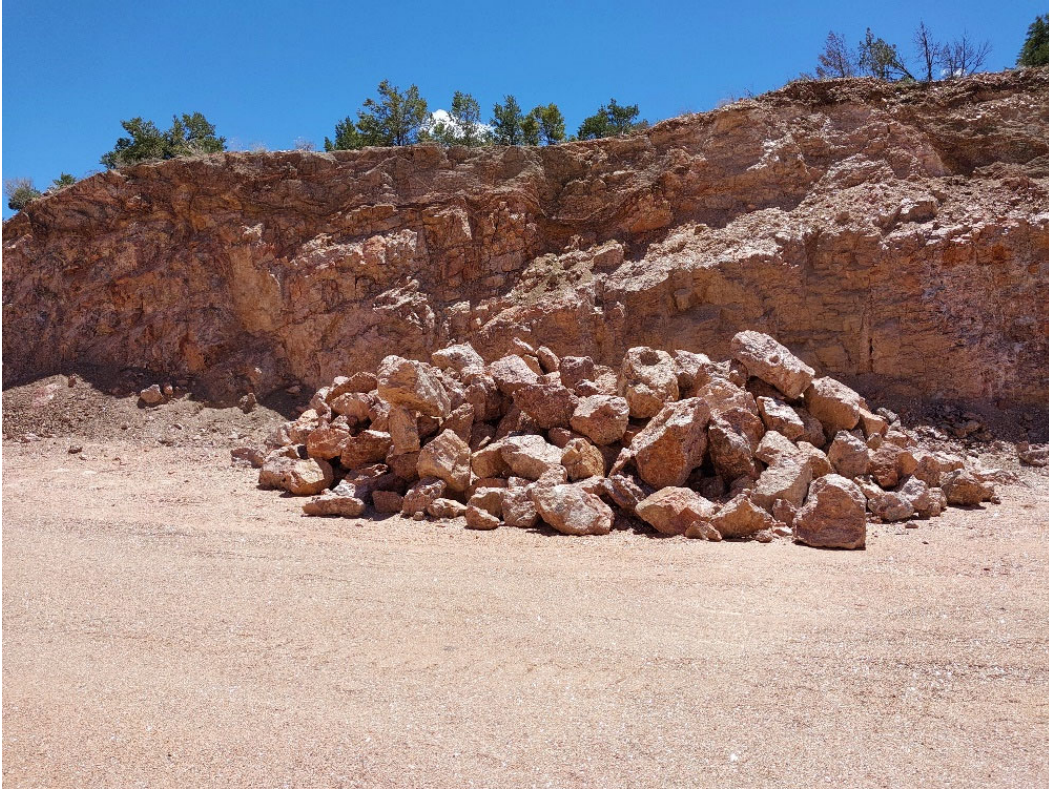
Photo #7: Boulder stockpile located in southwest area of the Ruby Pit; looking south.

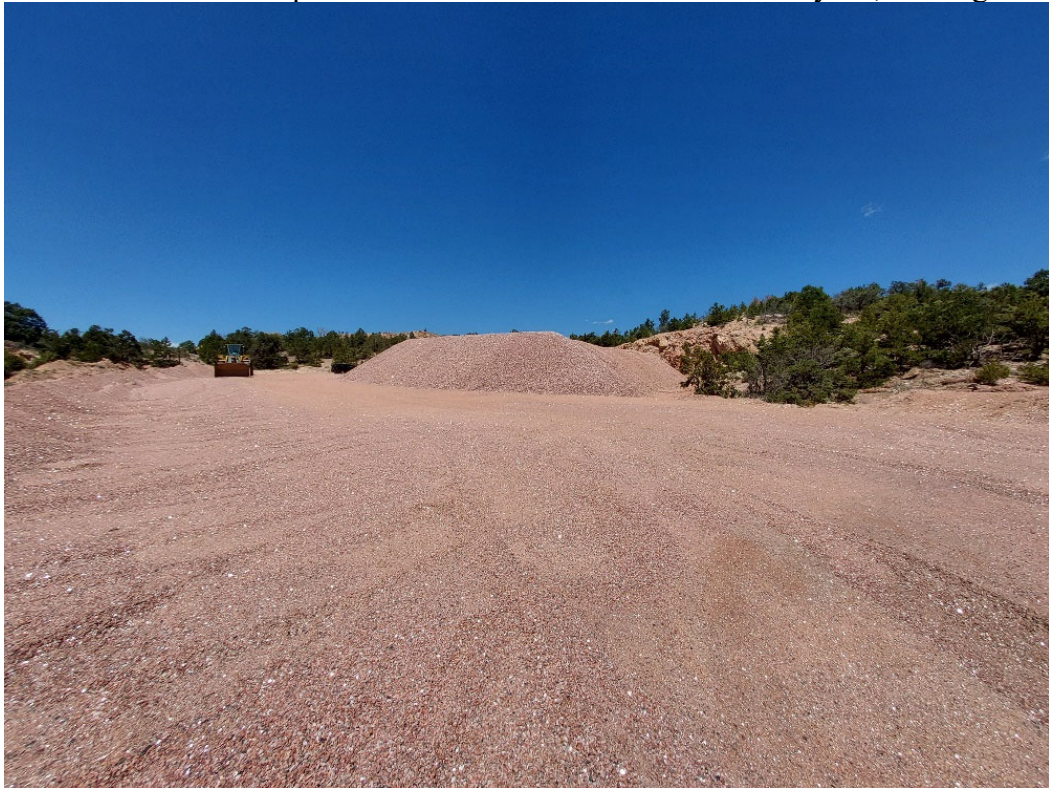
There is stockpile located south of the Ruby Pit, in area IMC-3 that appeared to be product material. The stockpile appeared to be stable with no erosion issues; see Photo #8. A product stockpile was also observed in the southwest portion of the area labeled MQD-1 Dump on the map below, see Photo #13.

Area IMC-3 is a pre-law pit that the operator has backfilled. The backfilling and grading in this area looks stable and is being used to stockpile product material, see Photo #8.

Photo #8: IMC-3 area, southeast of the Ruby Pit, looking north. The area is backfilled and graded; the stockpile of product material can be seen.

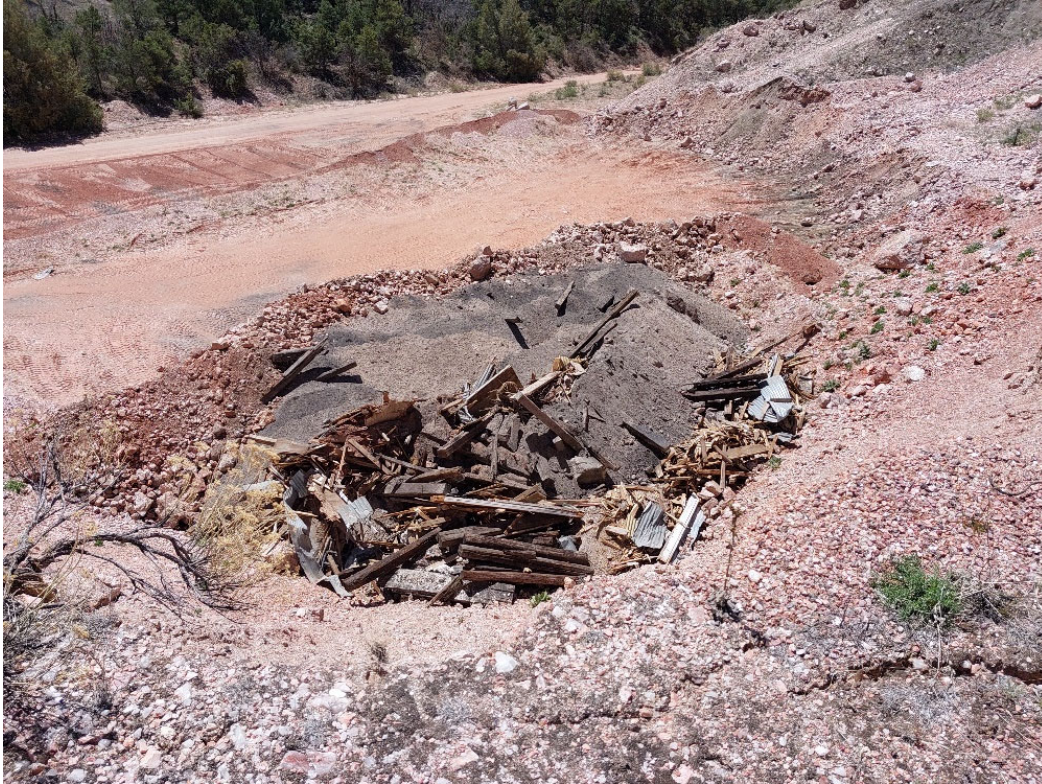
PROBLEM: Lumber was being used as backfill material. This is cited as a problem because wood material does not meet the definition of an inert material, per Rule 1.1(22). According to Rule 3.1.5(9), any material generated off-site that is intended to be used as backfill must be inert.

In the area labeled as MQED-4 on the map given below, there was some sheet metal and lumber observed in the backfilled area, see Photo #9. According to Mr. Tezak, there was a pre-law structure in the area that was demolished and disposed of in the dump area. This was cited as a problem as the wood material does not meet the definition of an inert material, per Rule 1.1(22). A review of the approved permit plan did not show indicate that this structure was going to be demolished and disposed of as backfill material. The corrective action is given above.

Photo #9: Sheet metal and lumber debris from an old pre-law structure that was demolished being used as backfill material. The lumber needs to be removed per the corrective action given at the beginning of this report.

CORRECTIVE ACTIONS: Remove the lumber from the backfill in area MQED-4 and provide photos to the Division of the cleaned up backfilled area.

CORRECTIVE ACTION DUE DATE: 6/28/24

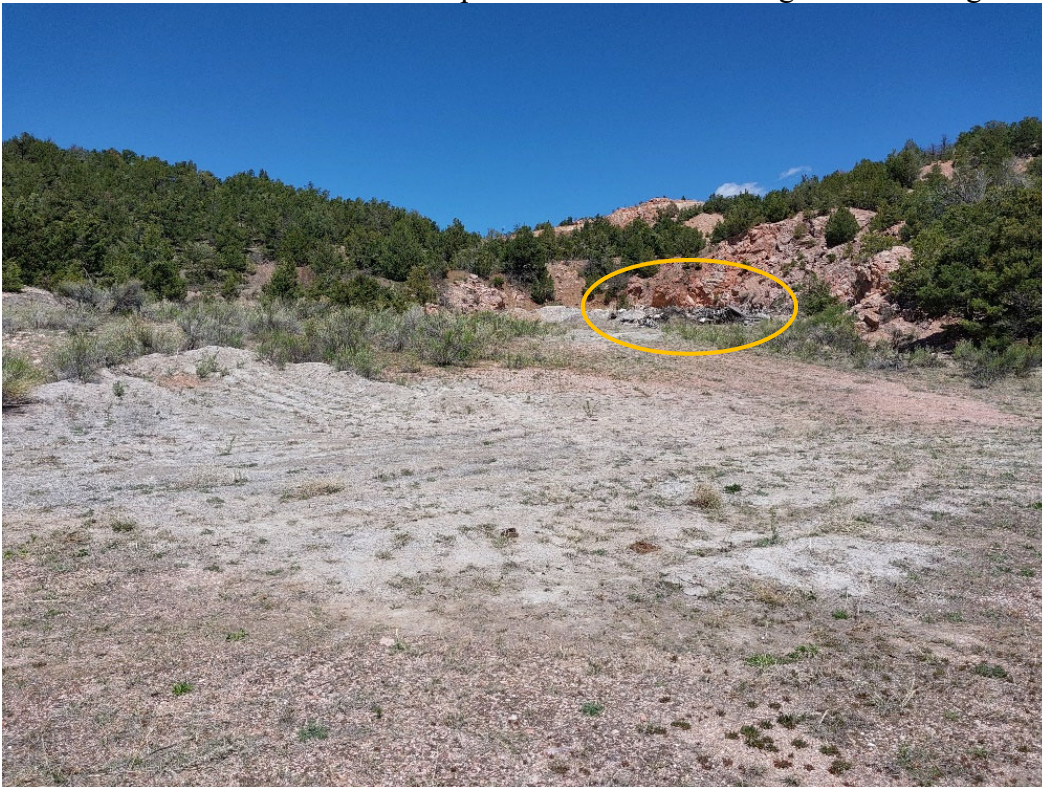
There appears to be discarded pallets at the south end of the IMC-1 area, just north of the MQED-4 region, see Photo #10. The IMC-1 area is designated as a pre-law pit that has been re-disturbed by the operation and is "limited to clean-up of certain dumped items" according to TR-1. There did not appear to be any hazardous materials and the situation is not high risk at this time. The Division will address this in more detail and reach out to the Operator if any action needs to be taken.

Photo #10: Discarded pallets located in the area labeled MQED-4, circled in orange; taken from the east central area looking north northeast.

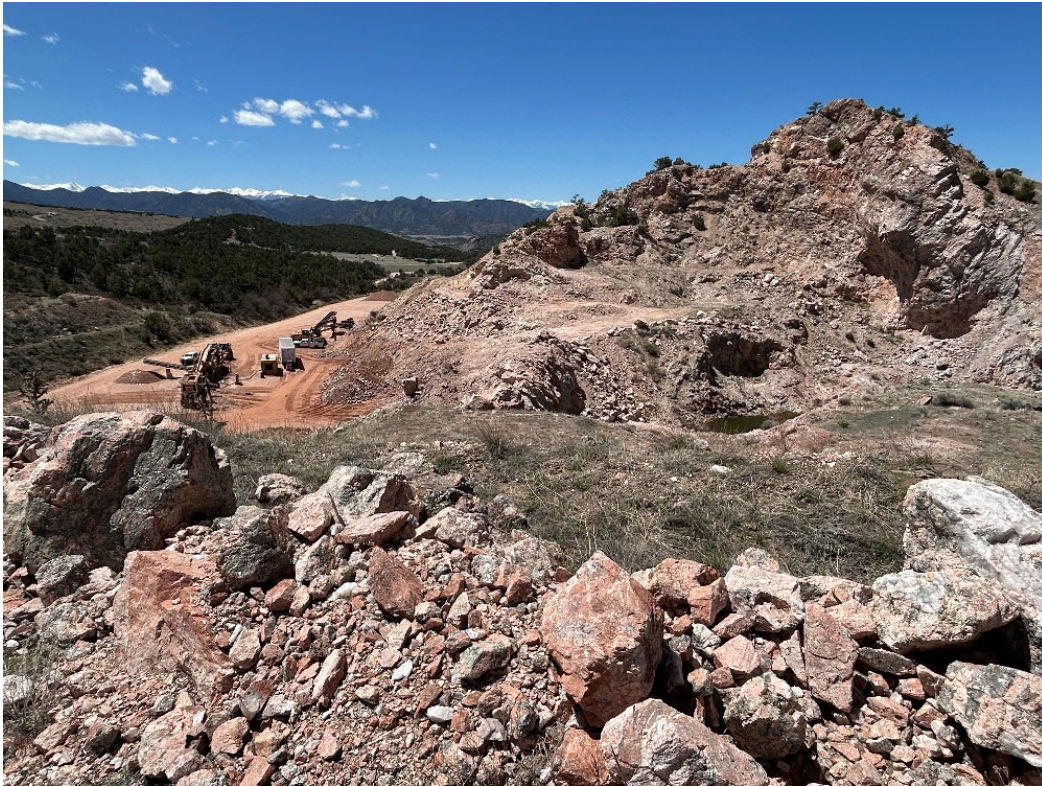
Photo #11, courtesy of Amy Eschberger: View of MQD-1 and processing area from the west end of MQED-4.

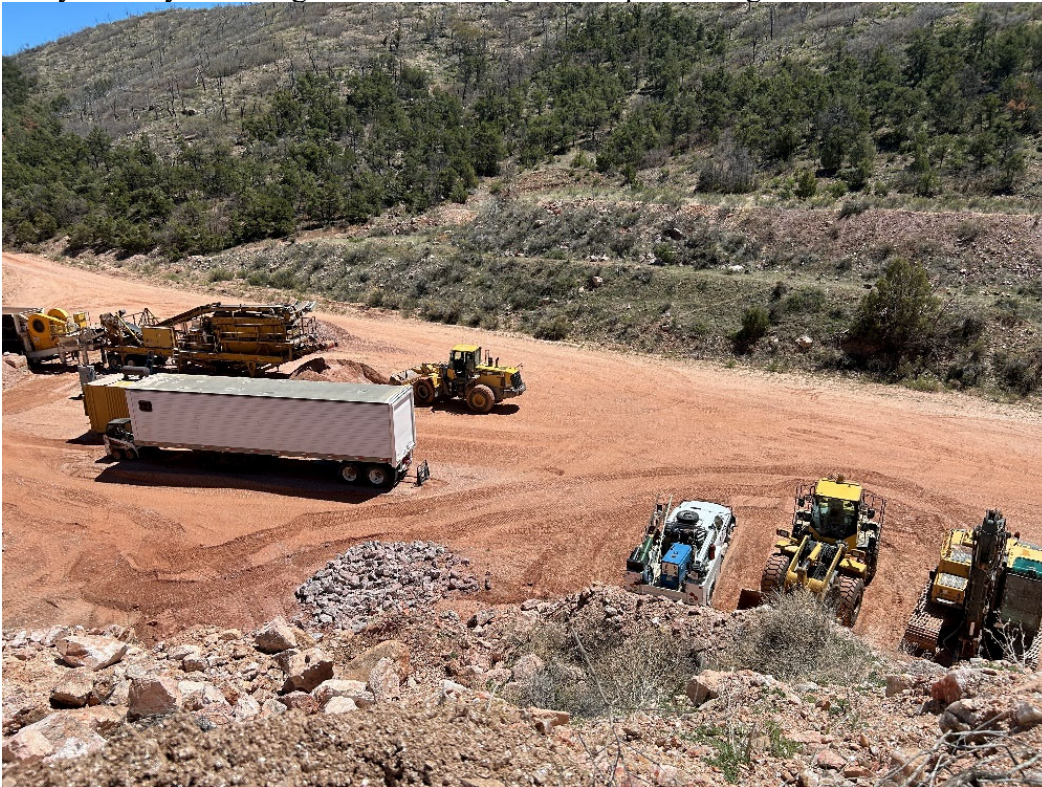
Photo #12, courtesy of Amy Eschberger: View of MQD-1 processing area from the upper bench area.

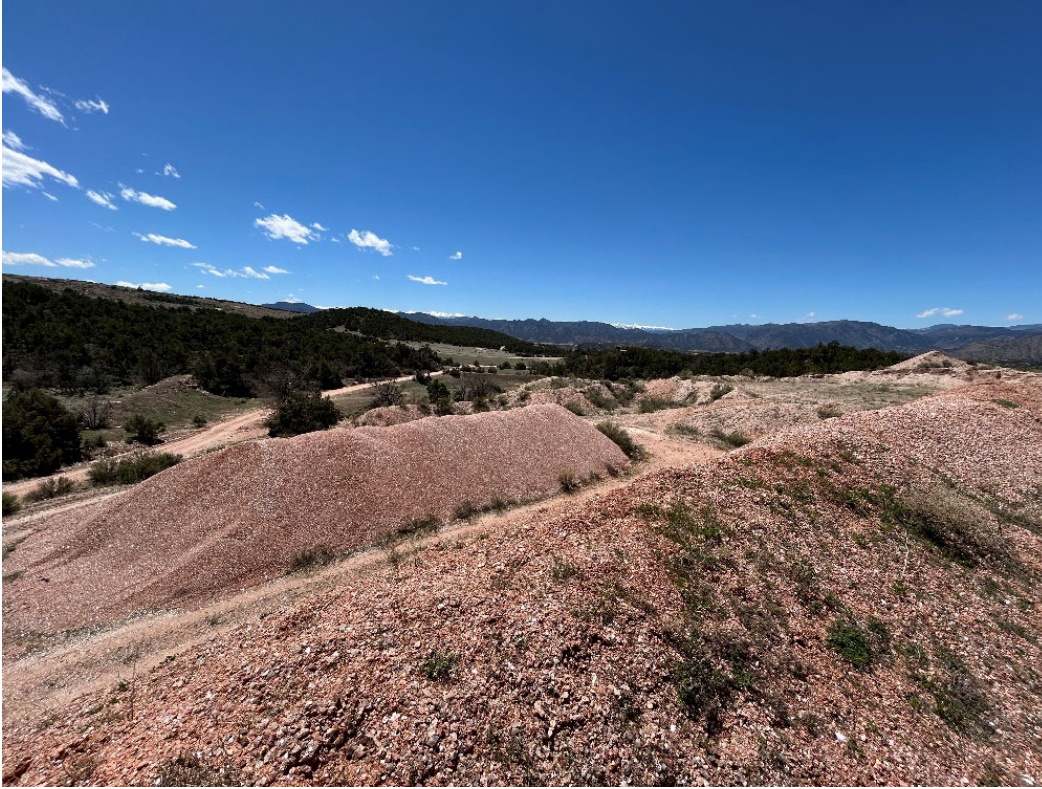
Photo #13, courtesy of Amy Eschberger: View of western end of MQD-1 Dump area looking southwest, a product stockpile can be seen with pre-law disturbance beyond. Road 383B can be seen in the background on the left side of photo.

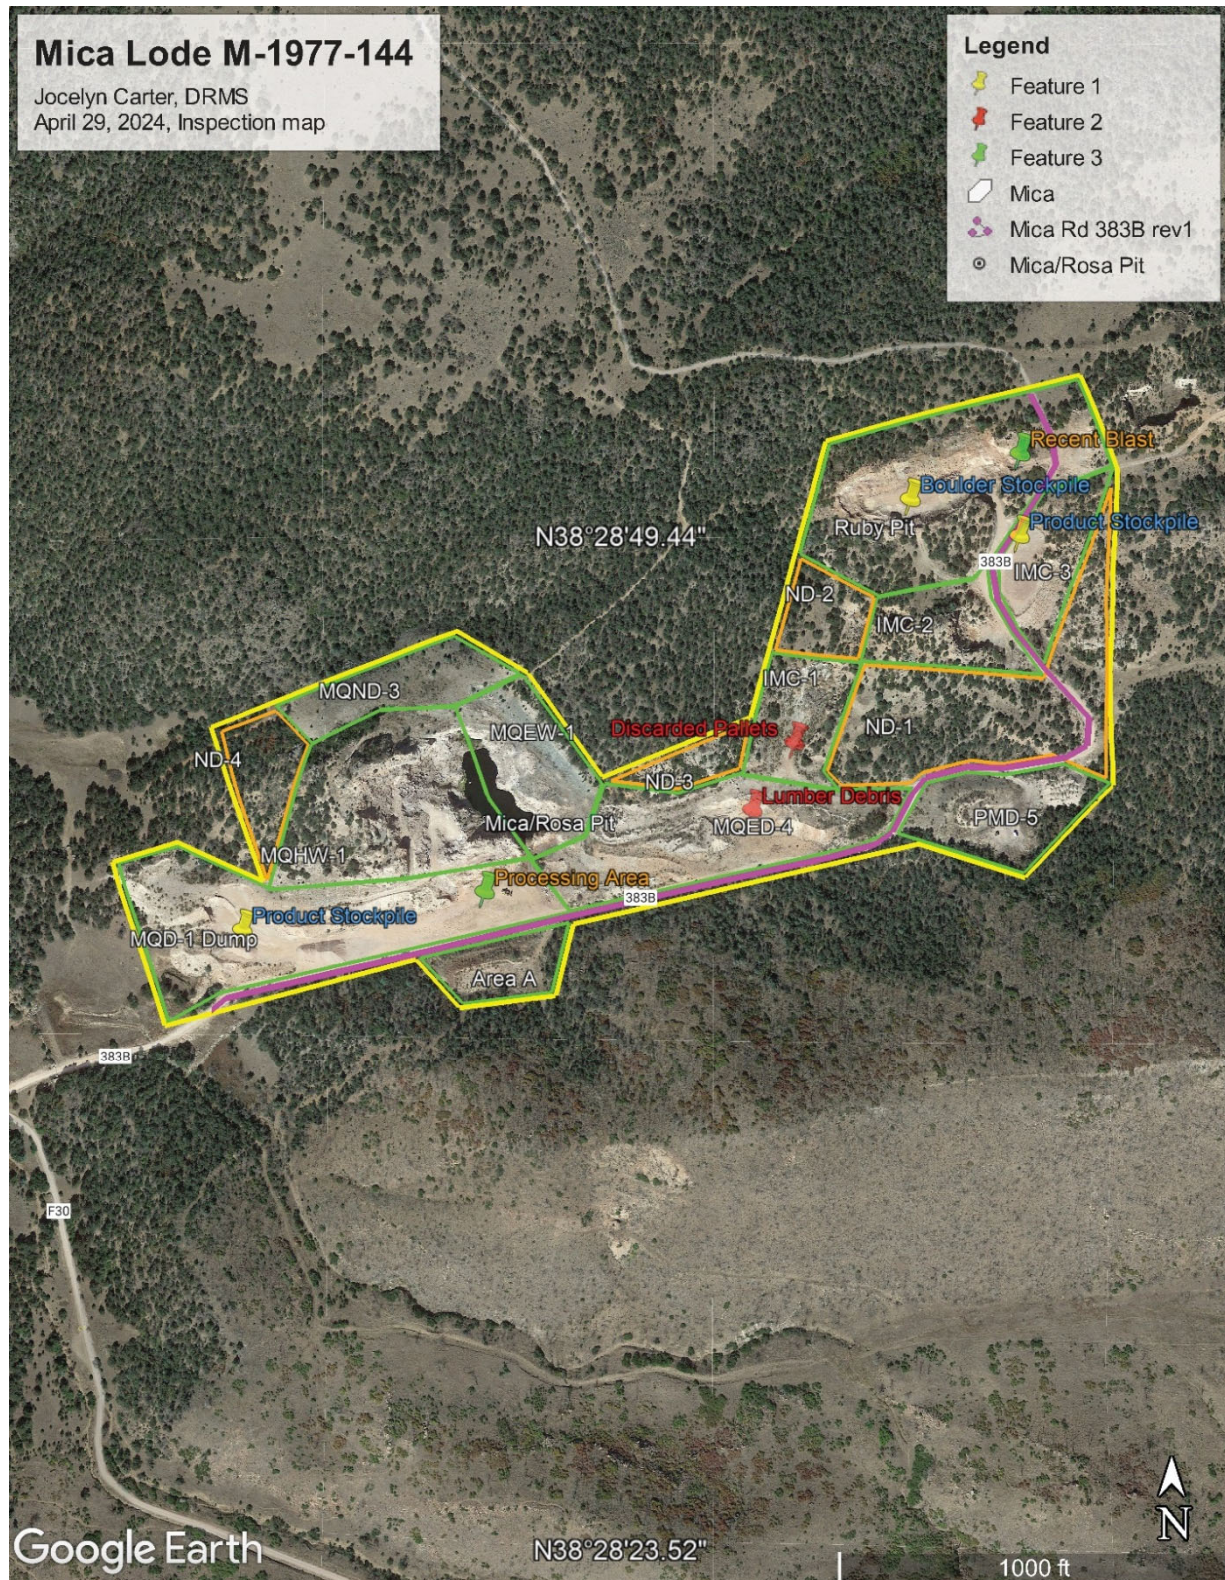
Map of April 29, 2024, inspection, and observations. Feature 1 items indicate stockpiles viewed during the inspection, Feature 2 items indicate the areas where problems were identified, and Feature 3 items indicate active areas.
