MINERALS PROGRAM INSPECTION REPORT
PHONE: (303) 866-3567

MINE NAME: Sunday Mine	MINE/PROSPECTING ID#: M-1977-285	MINERAL: Uranium and vanadium	COUNTY: San Miguel
INSPECTION TYPE: Monitoring	WEATHER: Clear	INSP. DATE: April 10, 2024	INSP. TIME: 10:00
OPERATOR: Pinon Ridge Mining LLC	OPERATOR REPRESENTATIVE: Micheal Rutter, Bruce Smith	TYPE OF OPERATION: 112d-2 - Designated Mining Operation	
REASON FOR INSPECTION: Normal I&E Program	BOND CALCULATION TYPE: Complete Bond	BOND AMOUNT: \$330,242.00	
DATE OF COMPLAINT: NA	POST INSP. CONTACTS: None	JOINT INSP. AGENCY: U.S.BLM	
INSPECTOR(S): Lucas West	INSPECTOR'S SIGNATURE:

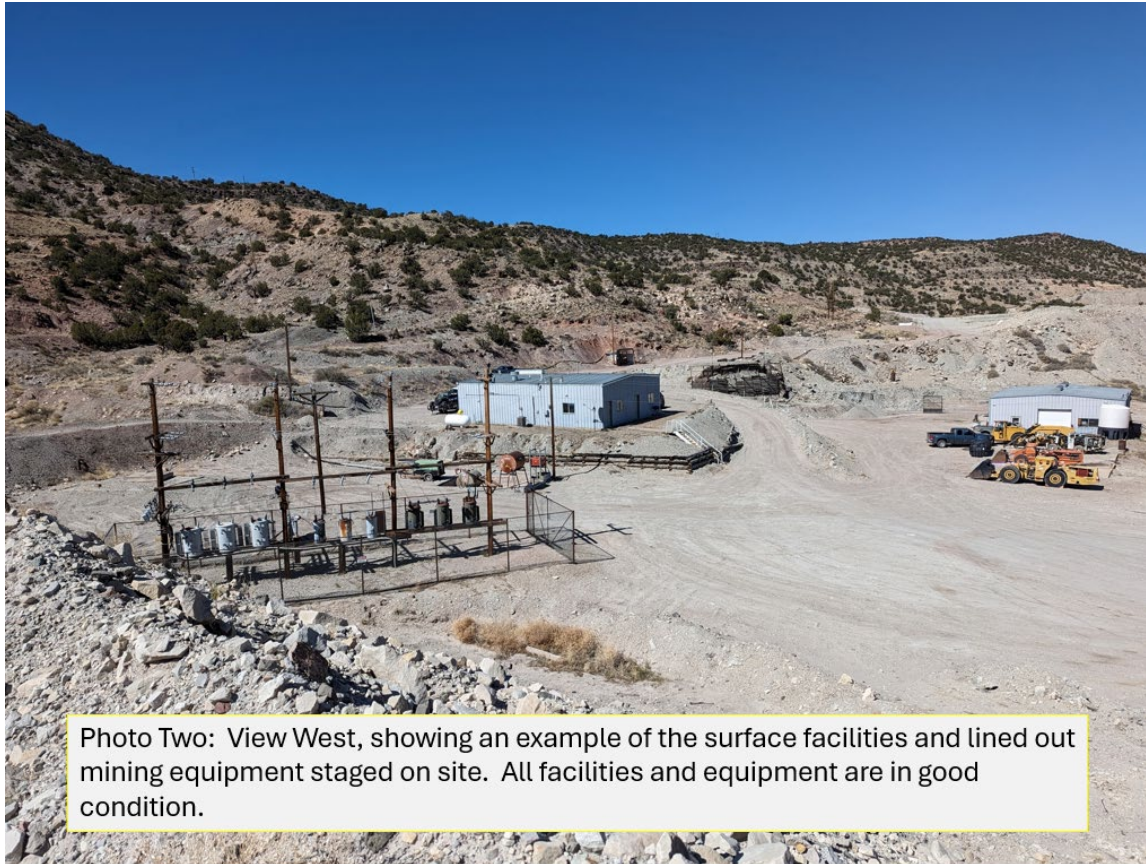
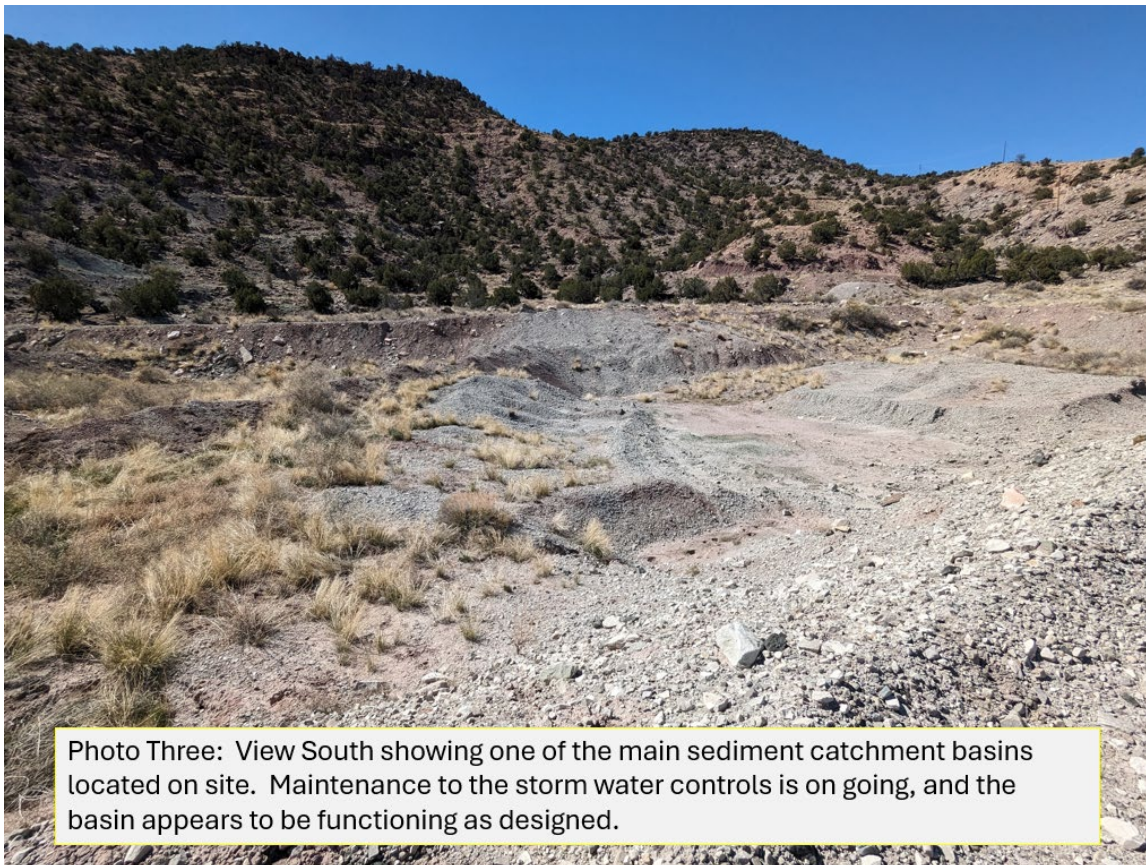
As stated previously, maintenance to the storm water control systems throughout the site is ongoing, and all observed storm water control ditches and basins are in excellent condition and appear to be functioning as designed. Photos Three and Four shows an example of the sediment catchment basins that are located on site as part of the storm water management plan. A considerable amount of time was spent at the south stockpile which consists primarily of capped low grade ore material. Discussions centered around possible blending operations, the details of which should be addressed through the Divisions Technical Revision process. The physical condition of the pad is good, with no signs of settling or slumping. The cap material is in good condition with no signs of significant wind erosion or material transport of any kind. The outslopes of the stockpile show no signs of instability and remain in the condition of previous inspections. Examples of the slopes as well as top of the stockpile can be seen in Photos Five and Six.

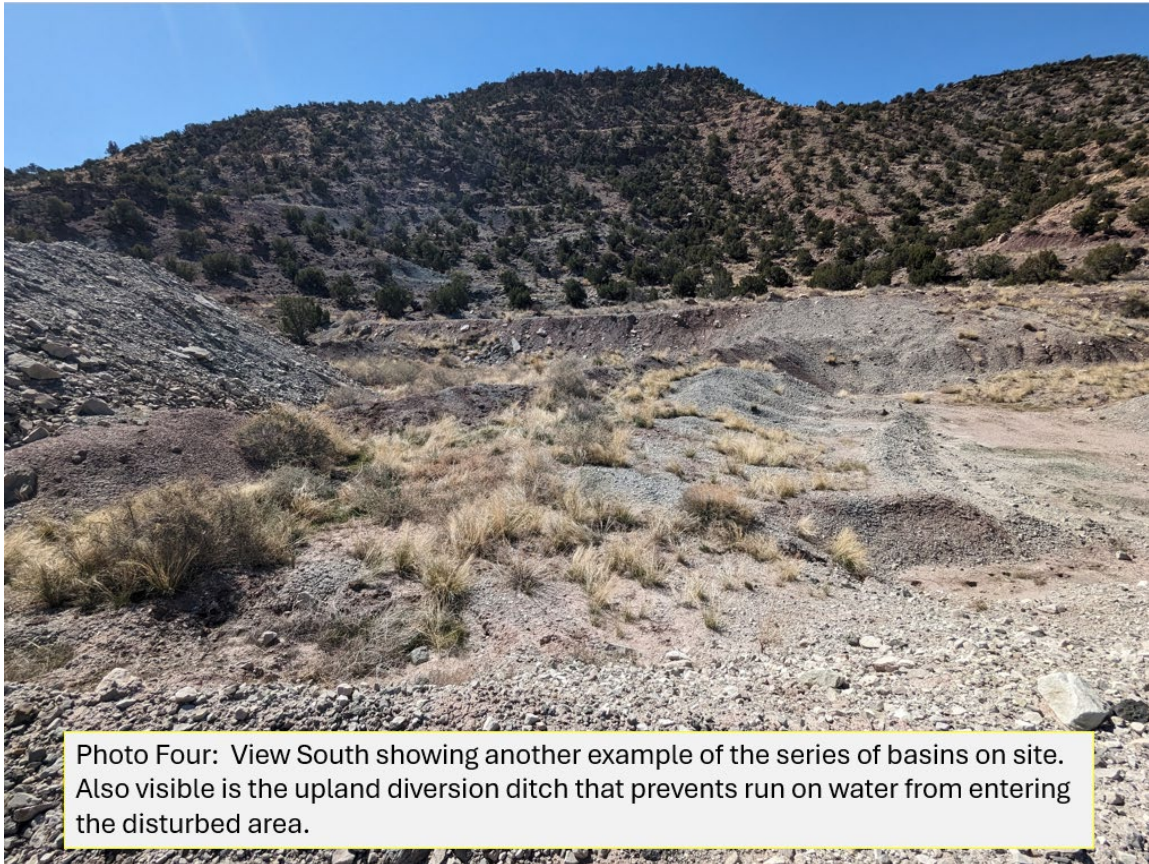
Photo Four: View South showing another example of the series of basins on site. Also visible is the upland diversion ditch that prevents run on water from entering the disturbed area.

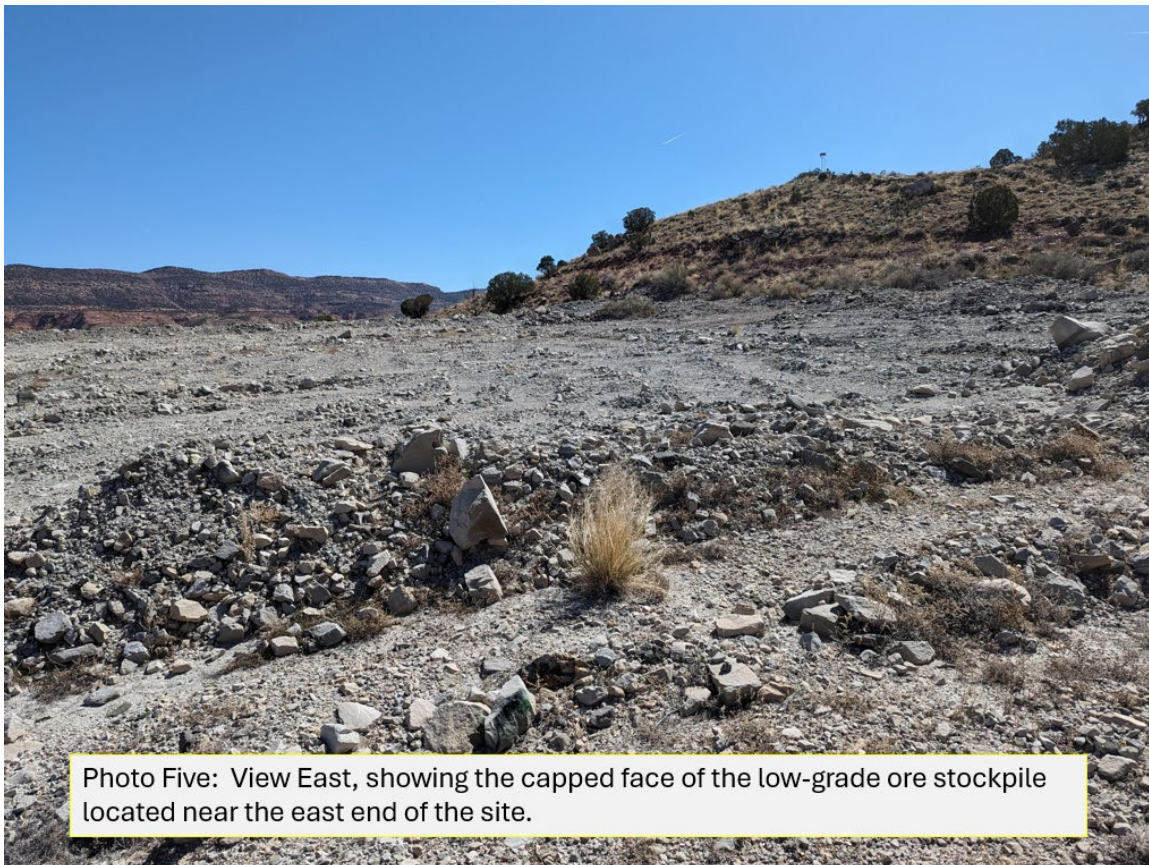
Photo Five: View East, showing the capped face of the low-grade ore stockpile located near the east end of the site.

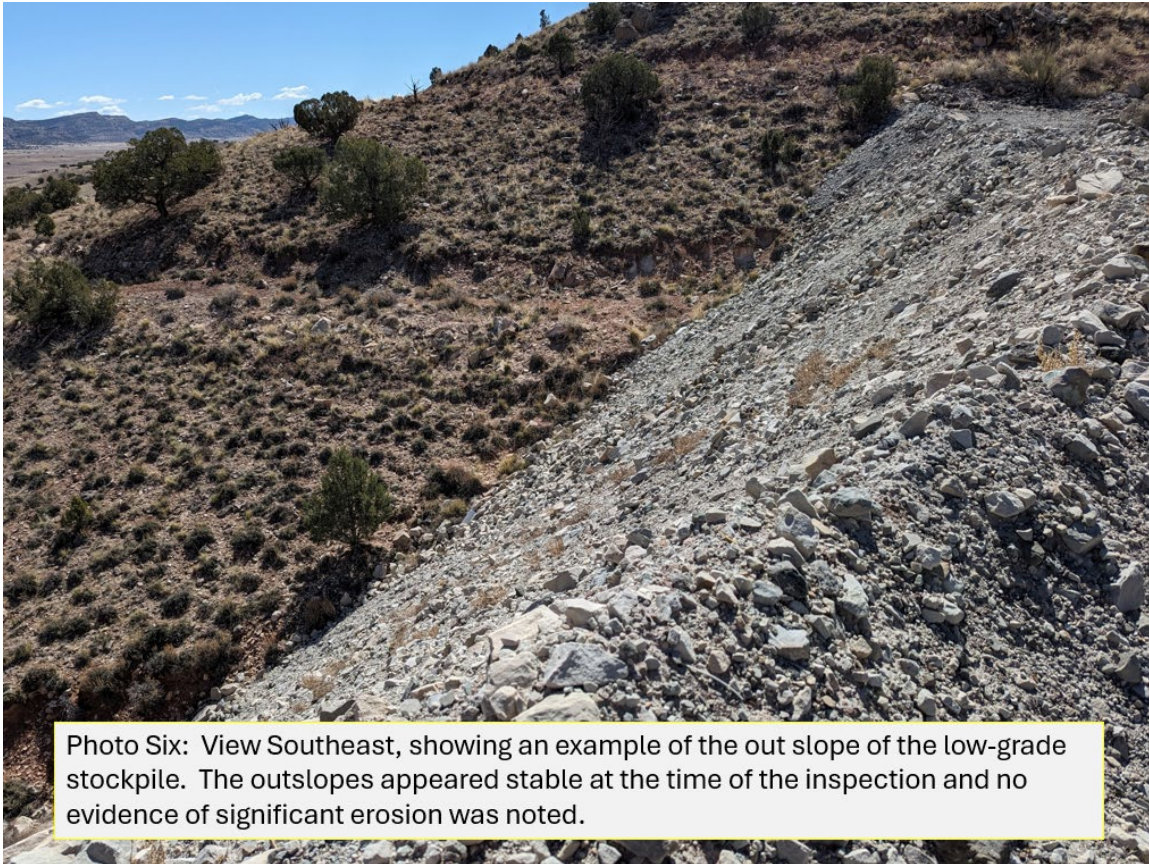
Photo Six: View Southeast, showing an example of the out slope of the low-grade stockpile. The outslopes appeared stable at the time of the inspection and no evidence of significant erosion was noted.

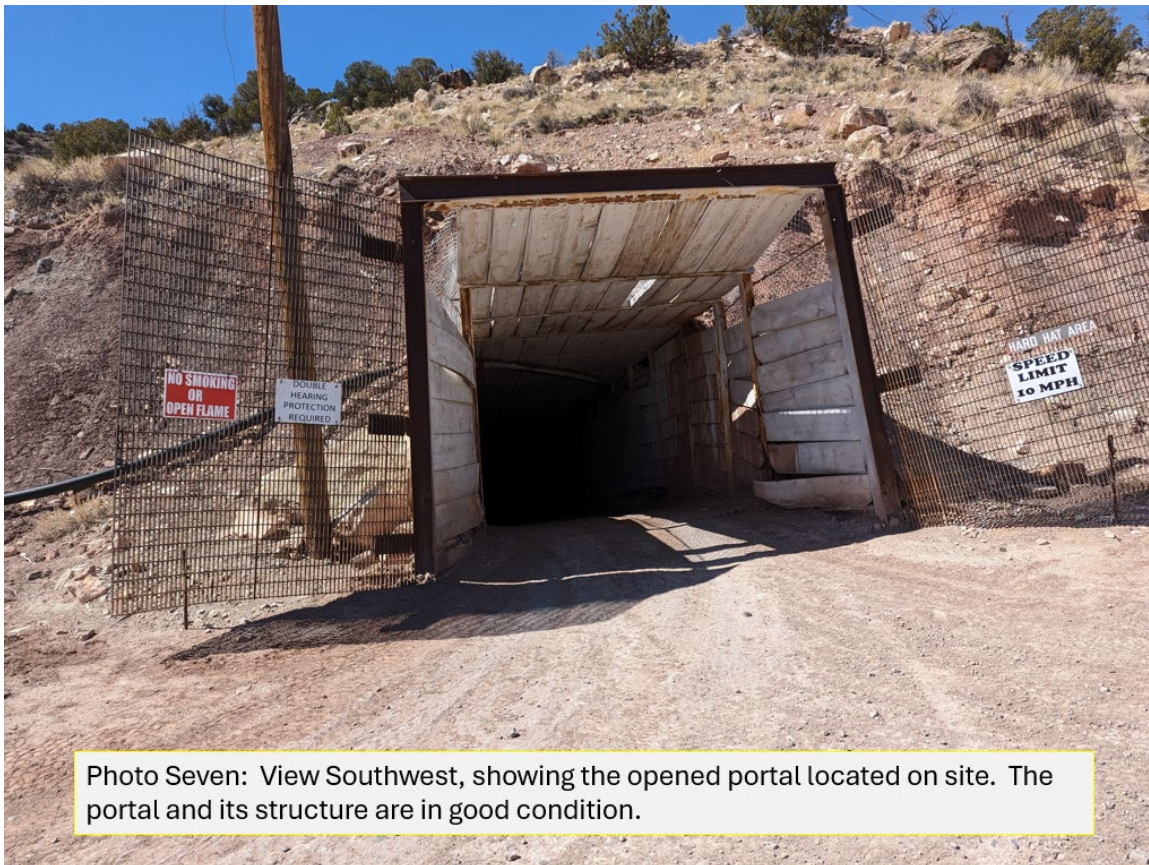
As the site is actively engaging in underground development and mining operations, the portal was open and in use at the time of the inspection. The portal structure is in good condition, with gates able to be locked when needed. The portal and its structure can be seen in Photo Seven. Vent shaft S-2, located to the Northwest of the shop facilities is covered with a steel grate and has been secured as shown in Photo Eight. All loadouts, roads and pad areas that exist on site were observed and in good condition. The lined Ore Pad was observed to be in good condition. The face of the pad shows no evidence of surface stockpiling and no observable impacts from precipitation was noted. The out slopes and berms of the pad appear stable. The pad can be seen in Photos Nine and Ten. To date, no ore material has been brought to the surface and stockpiled on the pad since it's construction, however the permitting has been conducted to allow those activities to take place whenever the Operator is ready.

Photo Seven: View Southwest, showing the opened portal located on site. The portal and its structure are in good condition.

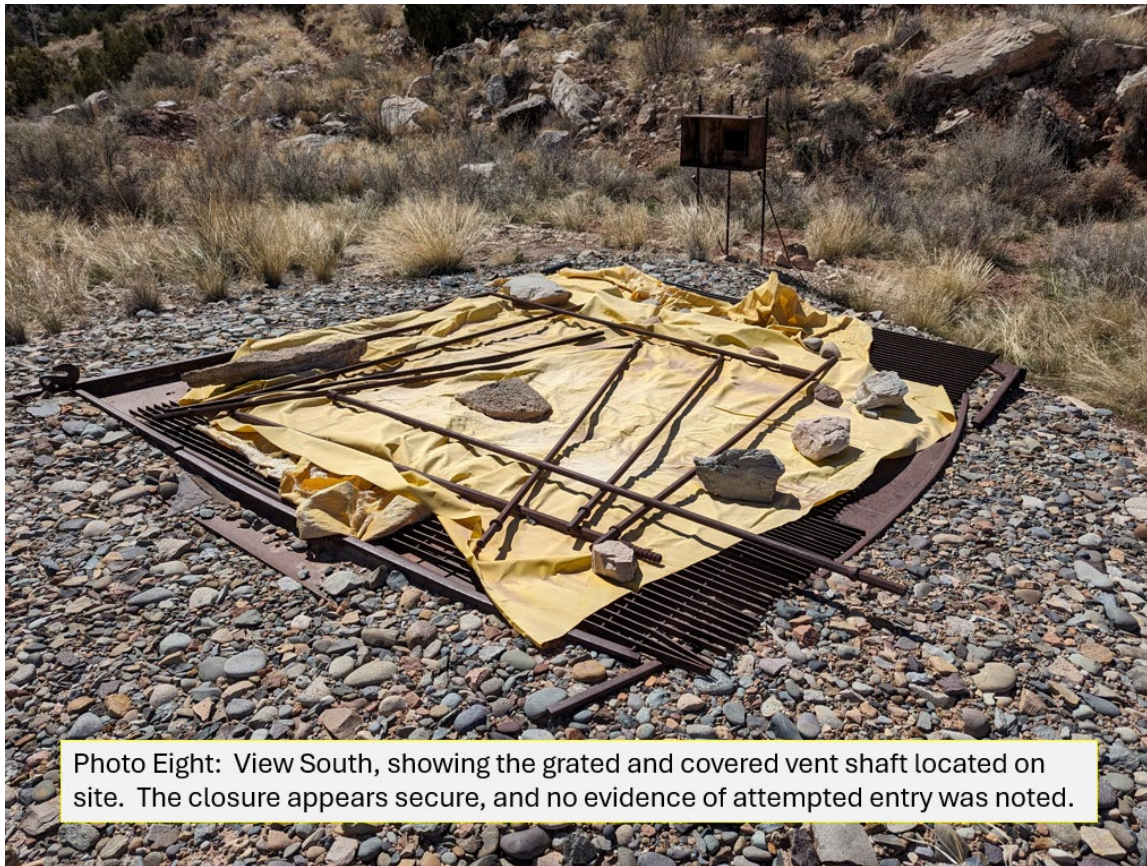
Photo Eight: View South, showing the grated and covered vent shaft located on site. The closure appears secure, and no evidence of attempted entry was noted.

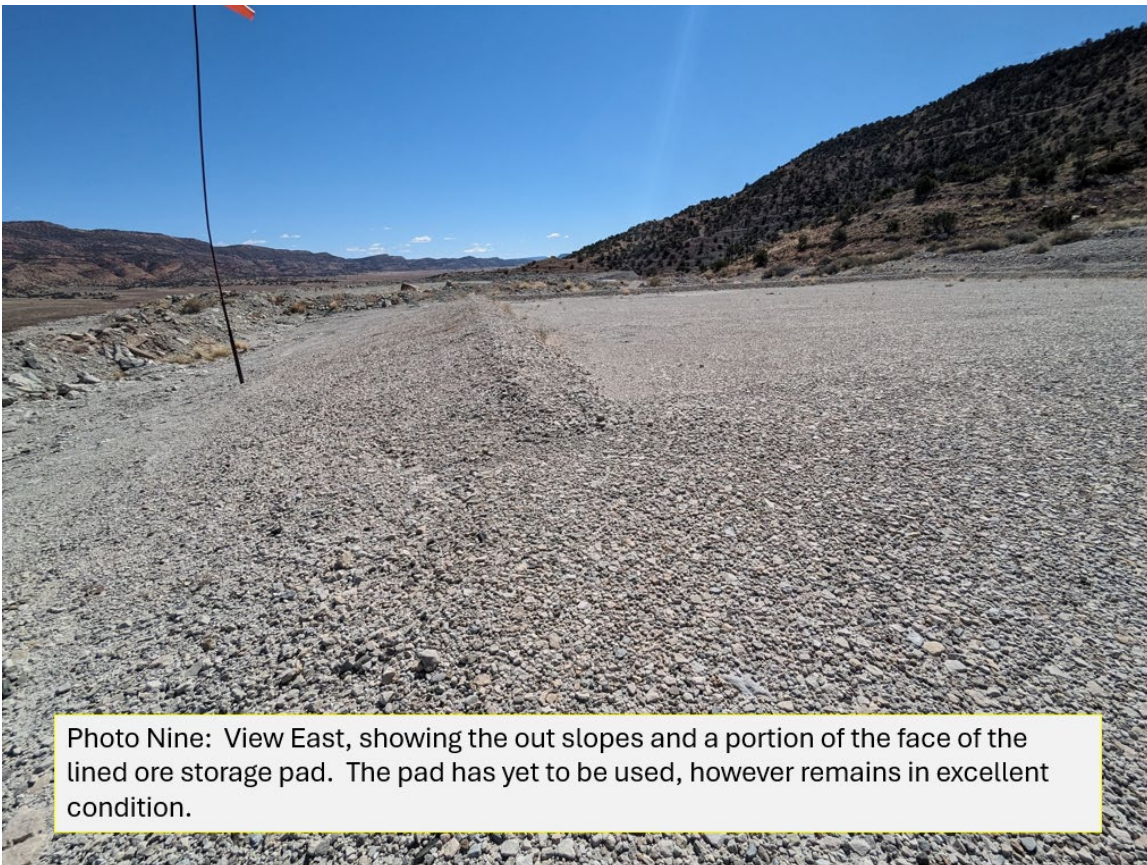
Photo Nine: View East, showing the out slopes and a portion of the face of the lined ore storage pad. The pad has yet to be used, however remains in excellent condition.
