C1983059, Terror Creek Loadout, April Inspection Report

Permit Number: C-1983-059 Mine Name: Terror Creek Loadout Operator: Oxbow Mining, LLC Operator Address: Mr Doug Smith PO Box 535 Paonia, CO 81434	County: Delta Operation Type: Loadout Permit Status: Active Ownership: Private
	Operator Representative Present: N/A
Operator Representative Signature: (Field Issuance Only)

Inspection Start Date: April 19, 2024 Inspection Start Time: 10:00 Inspection End Date: Inspection End Time:	Inspection Type: Coal Partial Inspection Inspection Reason: Normal I&E Program Weather: Cloudy
Joint Inspection Agency: None	Joint Inspection Contacts:
Post Inspection Agency: None	Post Inspection Contacts:
Inspector(s): Leigh Simmons	Inspector's Signature:

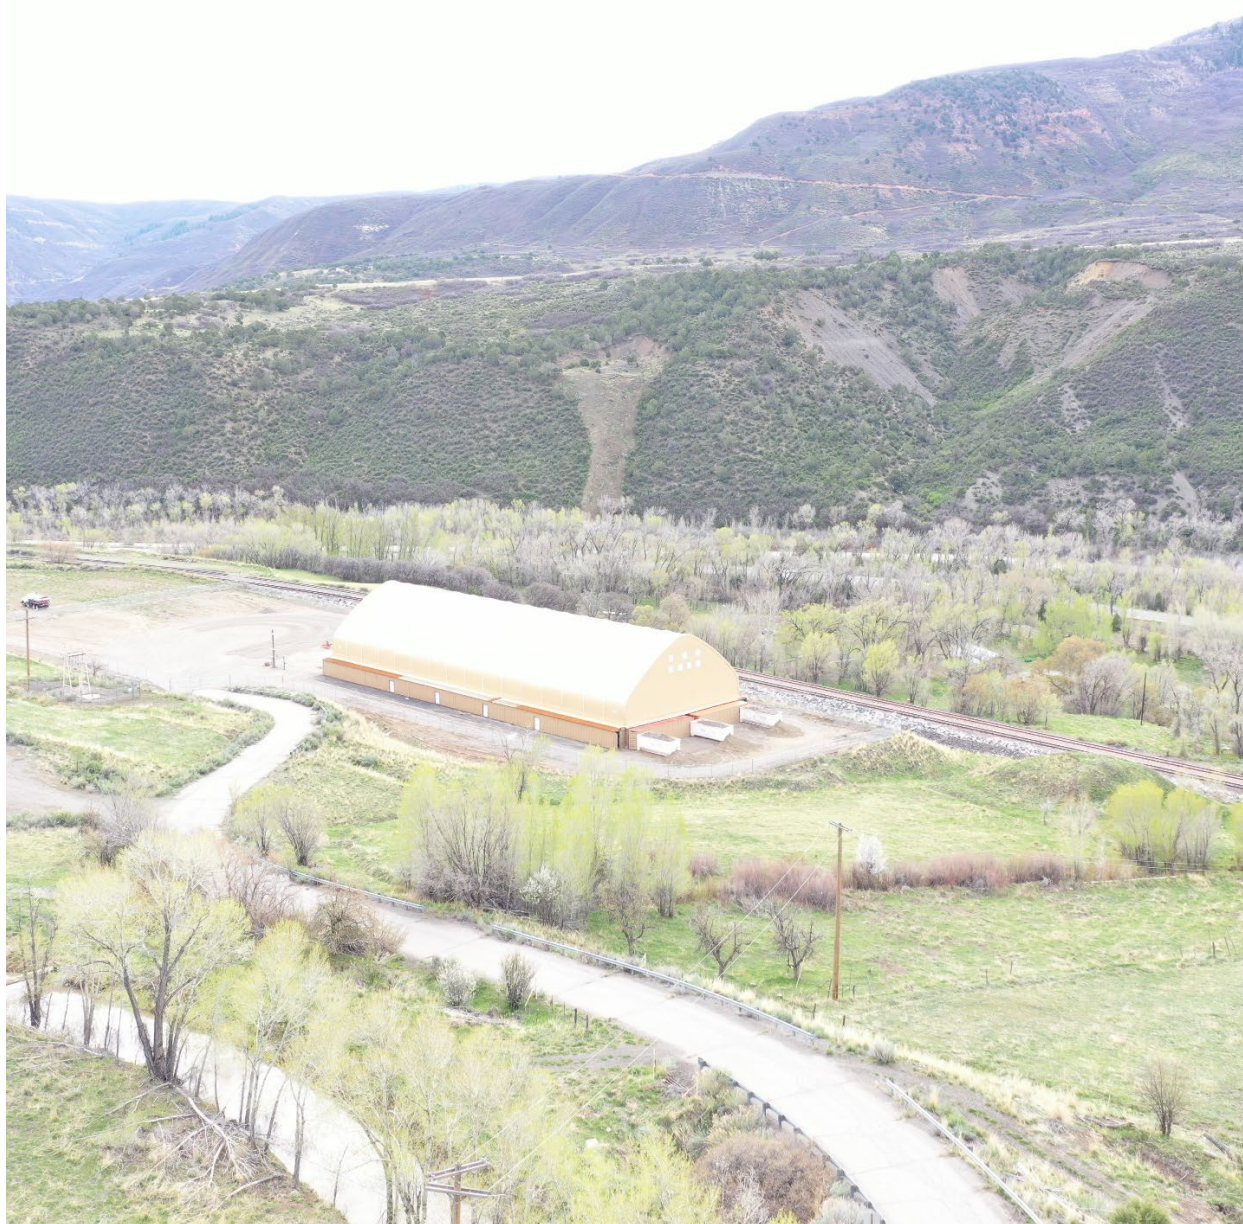
Figure 1: View of site from north west, showing temporary building

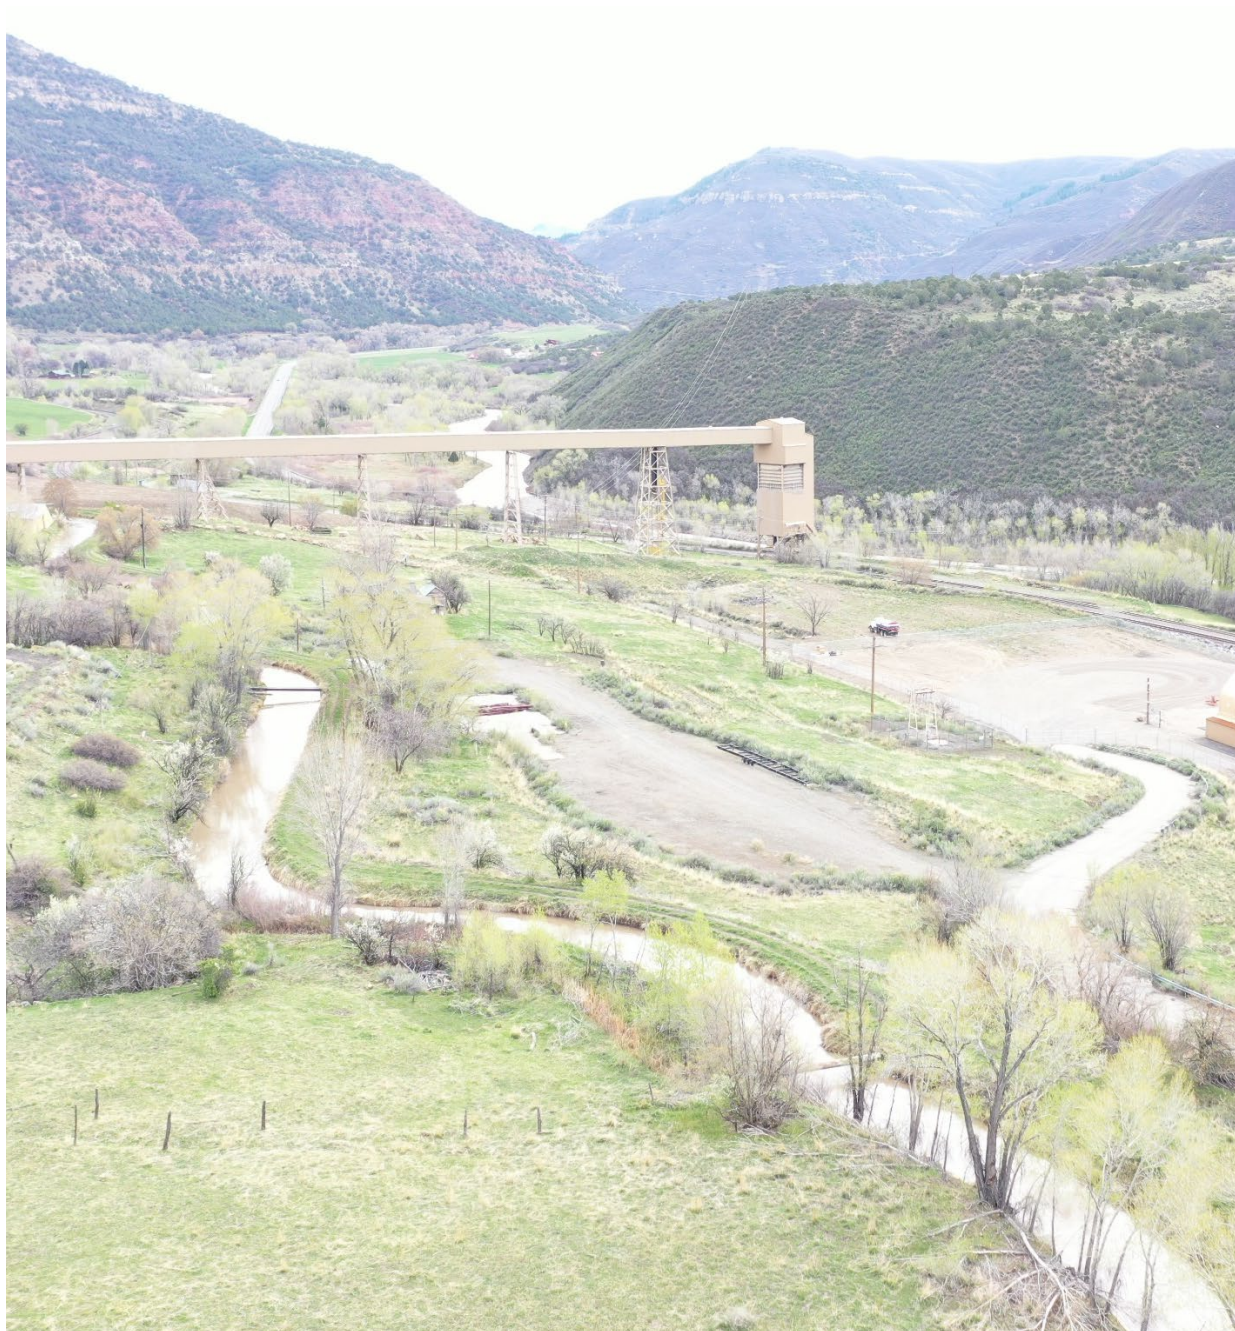
Figure 2: View of site from north west, showing upper pad and partially dismantled primary substation

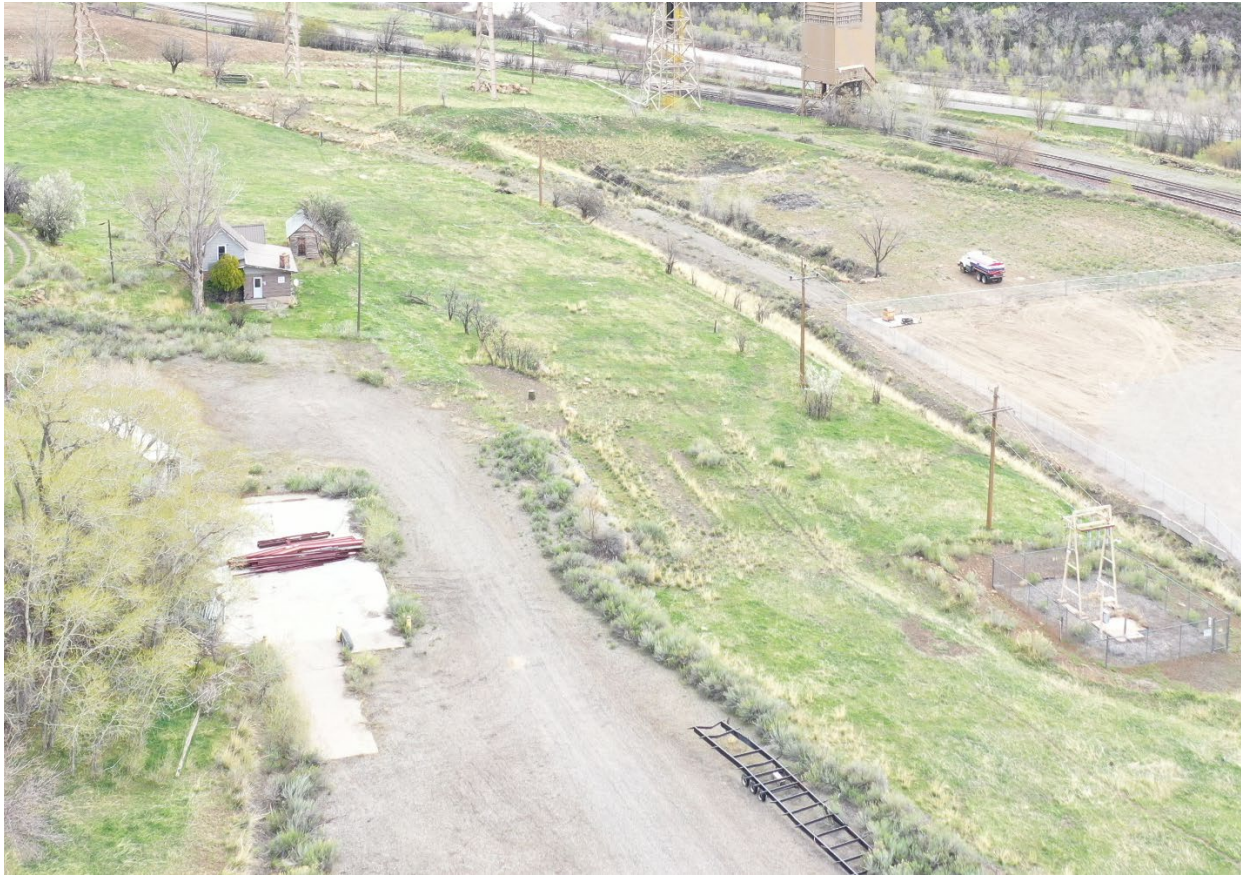
Figure 3: Garage/shop foundation, office, outbuilding, primary substation, power poles

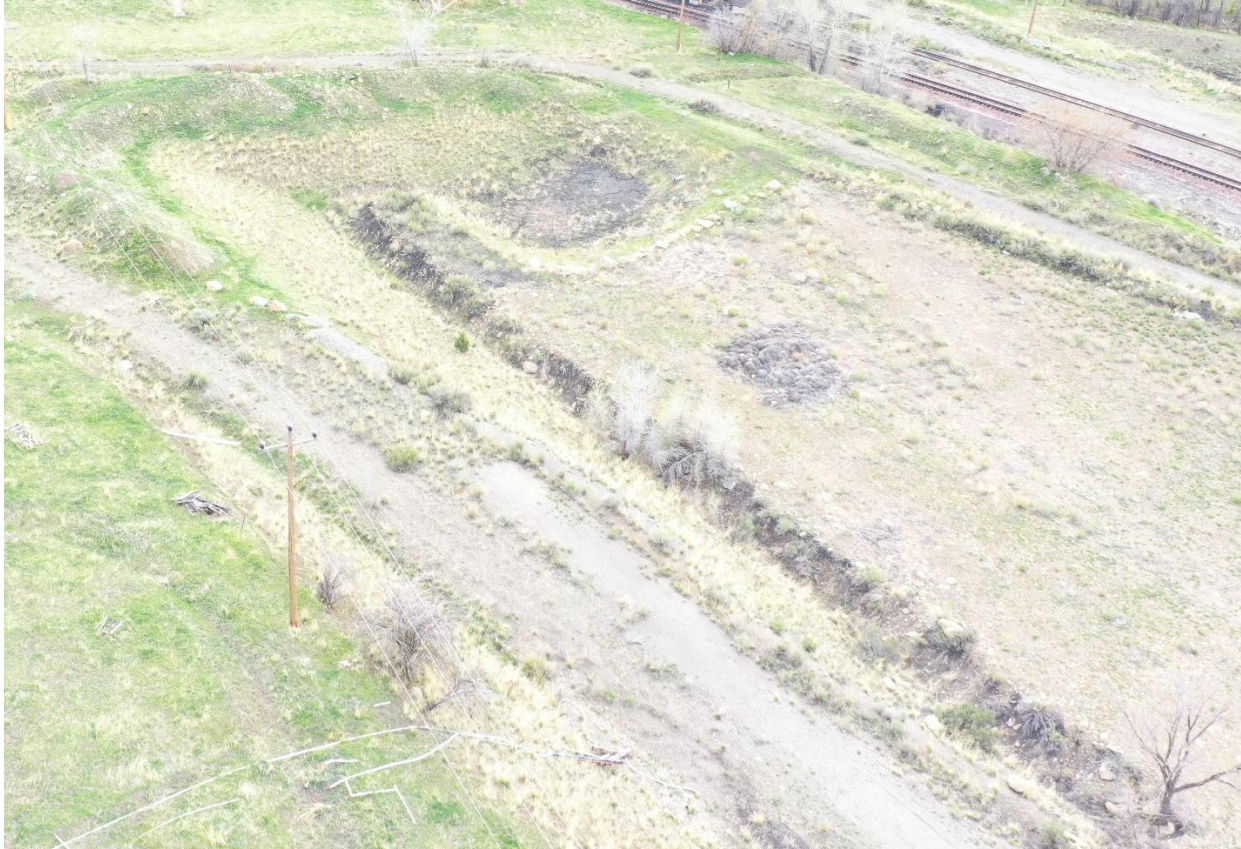
Figure 4: East end of lower pad and sediment pond

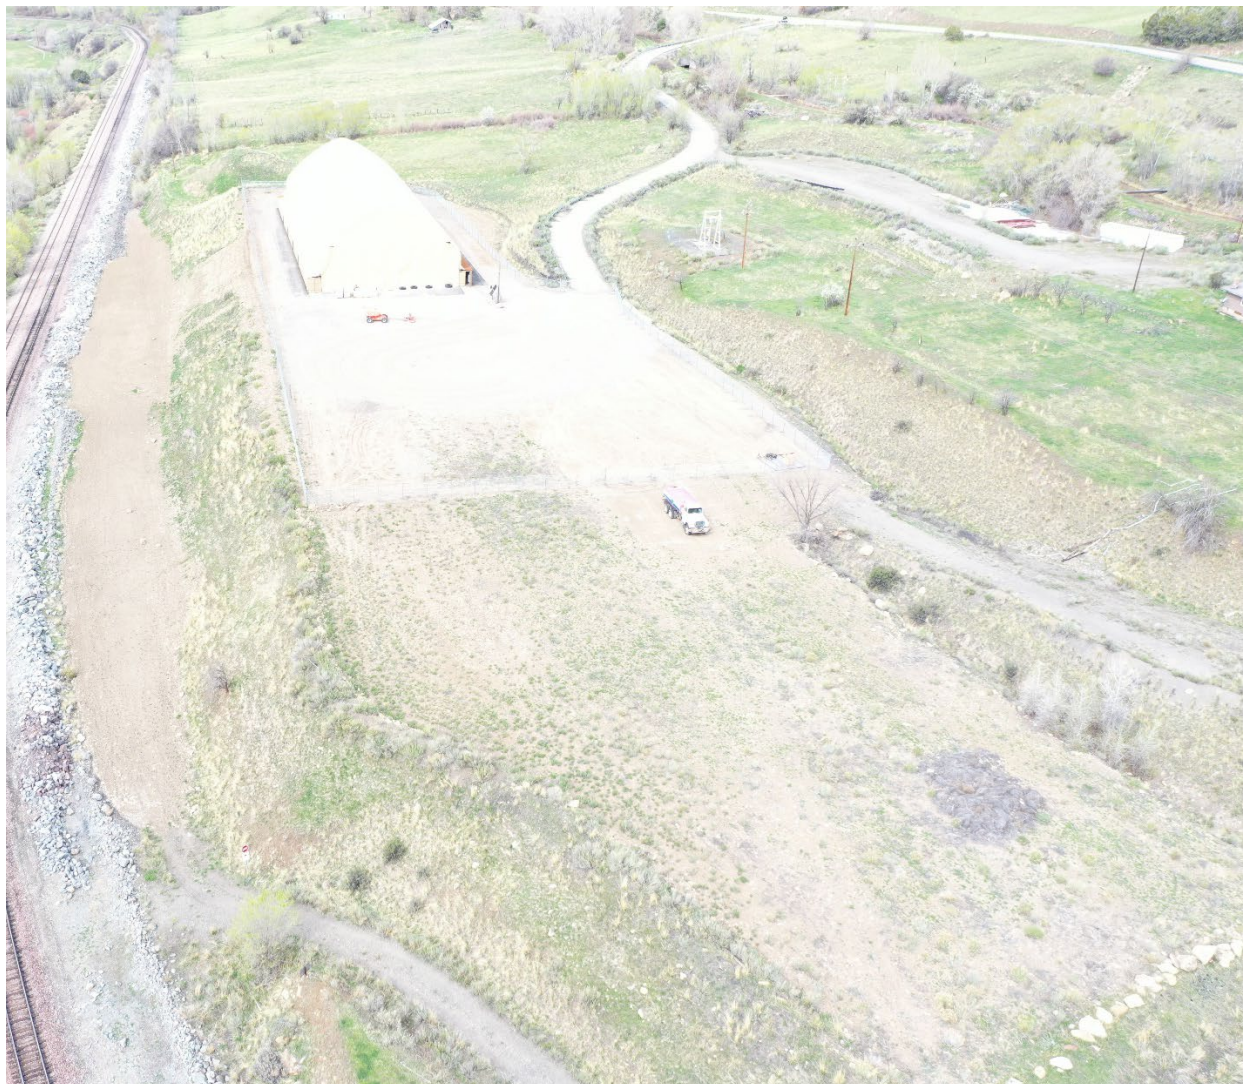
Figure 5: View of site from east, showing temporary building on lower pad, with upper pad in upper right of frame

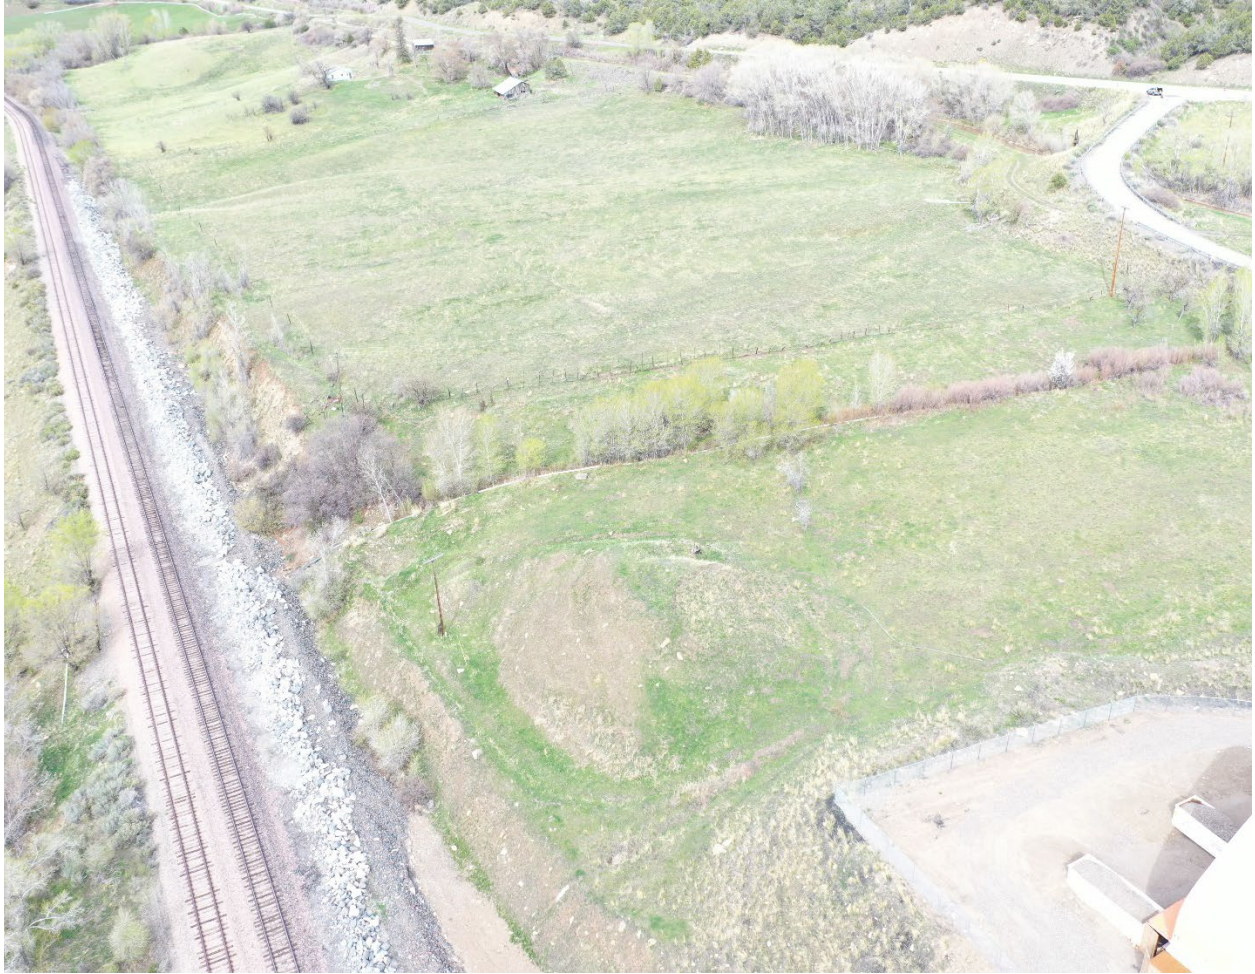
Figure 6: Topsoil stockpile and dugout pond

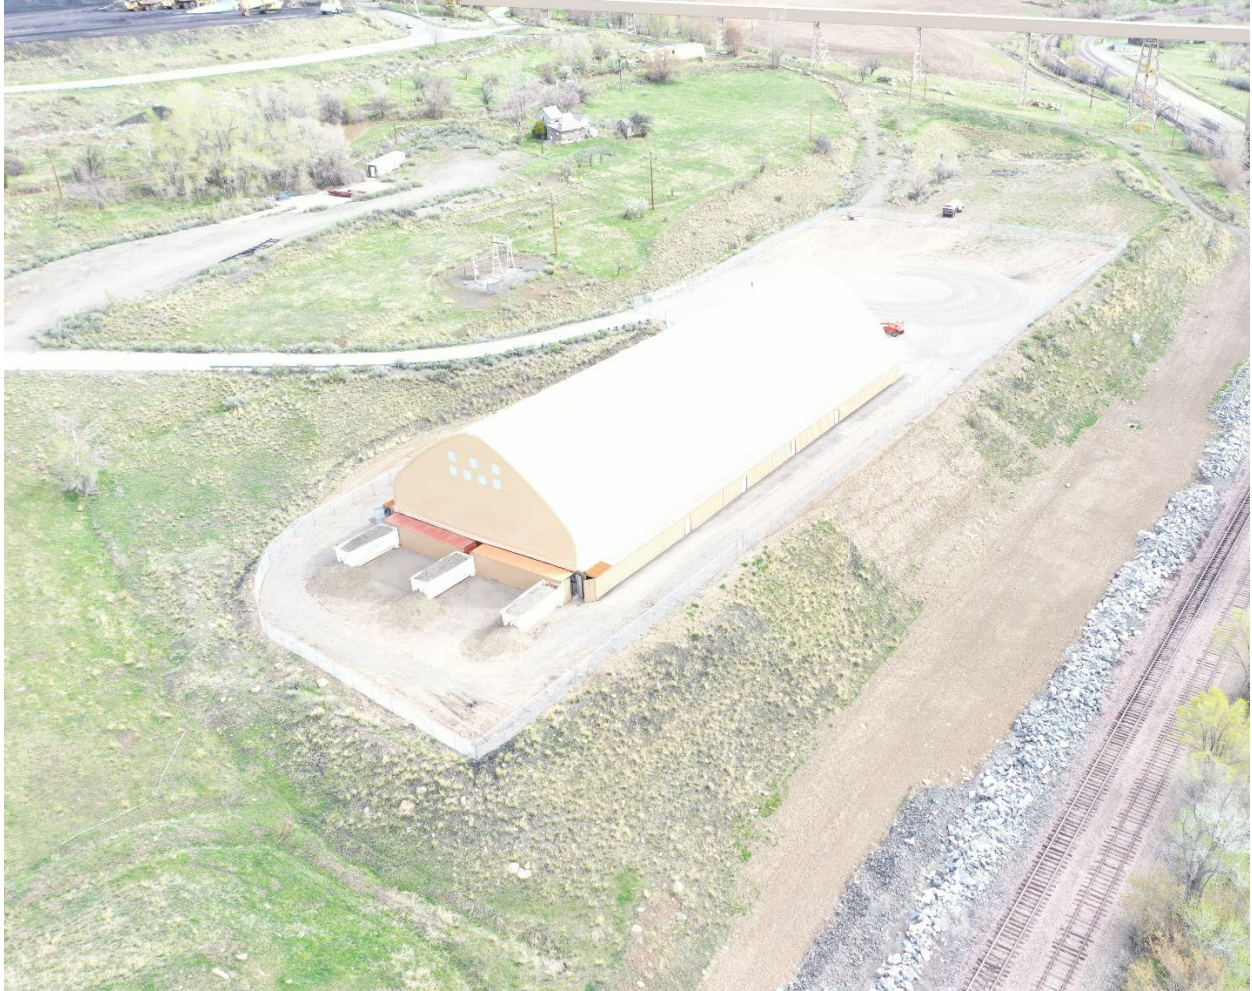
Figure 7: View of site from south west

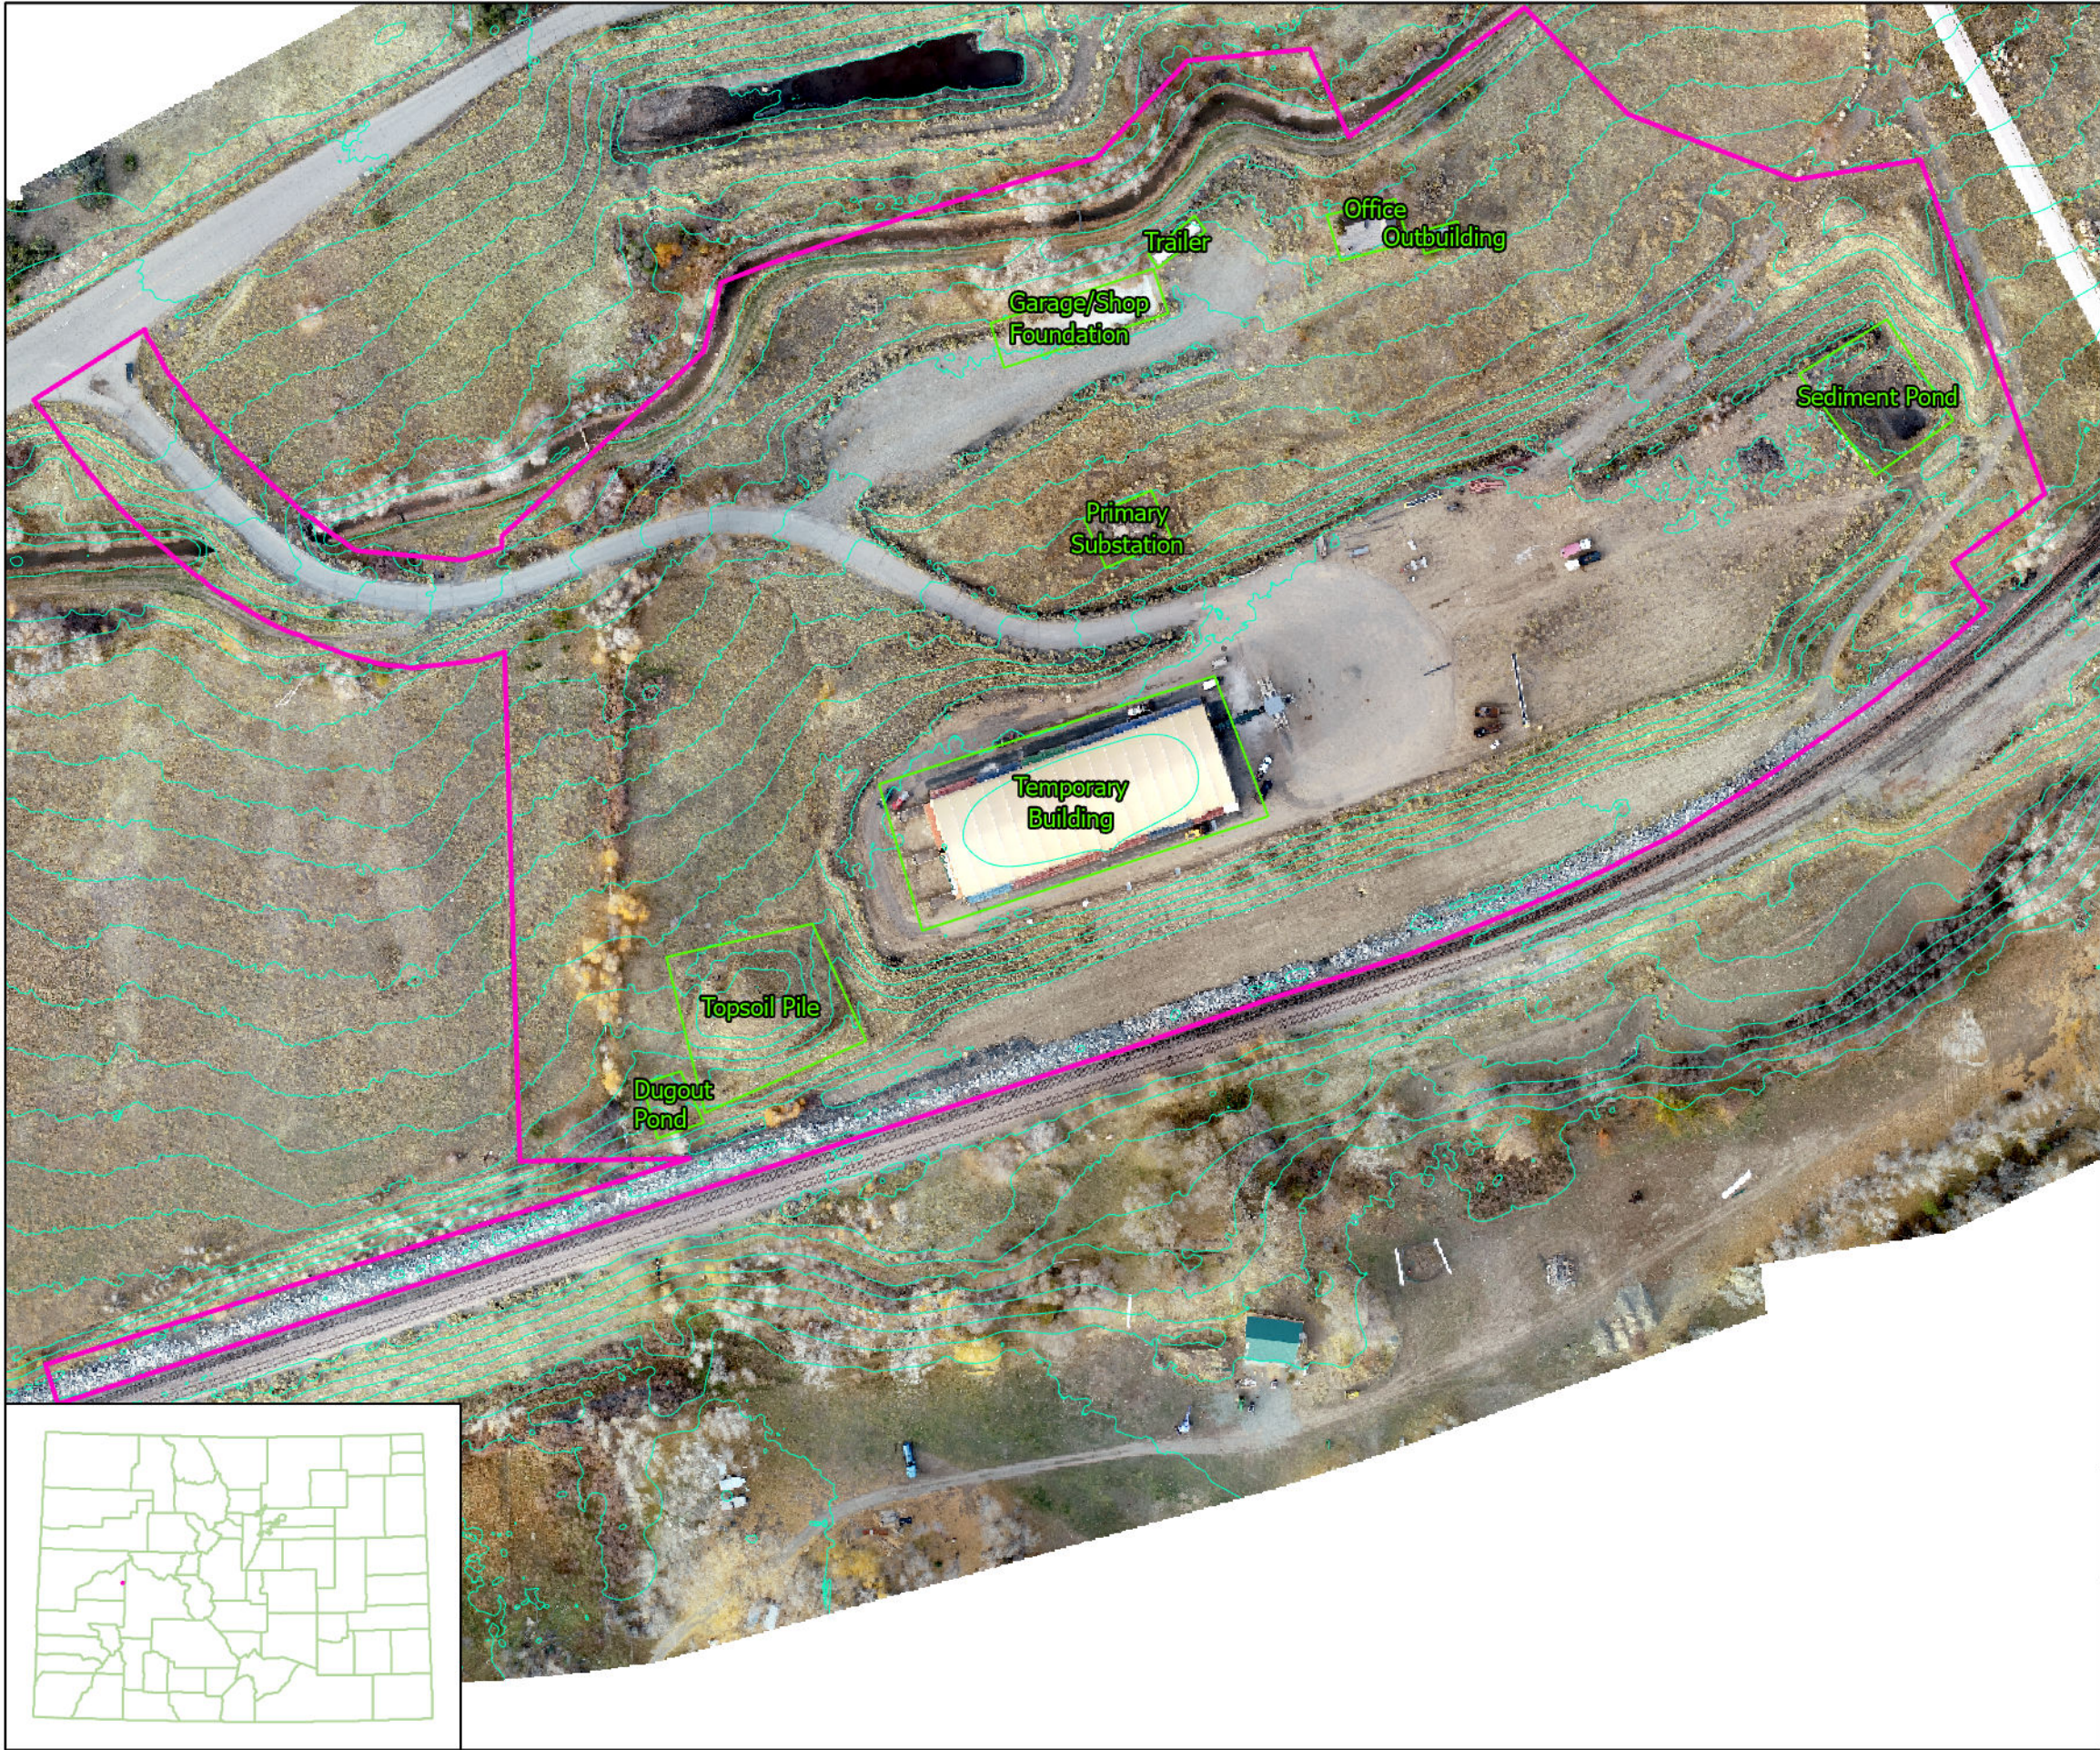
Bond Compliance Inspection

The DTM and Orthomosaic were imported into ArcPro for further analysis. Contour lines with a 5ft interval were generated from the DTM and overlain on the Orthomosaic. Existing mine features were identified on the orthomosaic. The data has been compiled on the appended map “Bond Compliance Inspection C1983059: Terror Creek Loadout”.

The contour lines shown on the inspection map were generated from the DTM and show the actual topography at the site. The contour interval on the inspection map is the same as that projected on Map 10, so a direct comparison can be made. The current topography is effectively the same as the approved post-mining topography, so no backfilling or grading is needed at the site.
