# **PERMIT INFORMATION**

Permit Number: C-1983-059	County: Delta	
Mine Name: Terror Creek Loadout	<b>Operation Type:</b> Loadout	
<b>Operator:</b> Oxbow Mining, LLC	Permit Status: Active	
Operator Address:	Ownership: Private	
Mr Doug Smith		
PO Box 535	<b>Operator Representative Present:</b>	
Paonia, CO 81434		
	N/A	
<b>Operator Representative Signature: (Field Issuance Only)</b>

## **INSPECTION INFORMATION**

Inspection Start Date: May 22, 2 Inspection Start Time: 14:00 Inspection End Date: Inspection End Time:	2024		<b>Inspection Type:</b> Coal Partial Inspection <b>Inspection Reason:</b> Normal I&E Program <b>Weather:</b> Clear	
Joint Inspection Agency:		Join	Inspection Contacts:	
None				
Post Inspection Agency: Post		Post	Post Inspection Contacts:	
None				
Inspector(s):	Inspector's Signature: Signature Date:			
Leigh Simmons	Ri	$\sim$	May 31, 2024

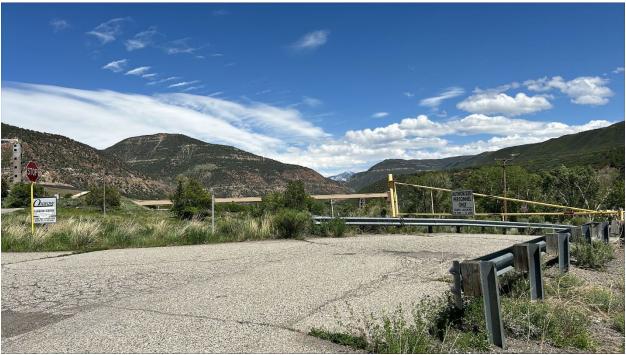
Figure 1: Gate locked, Mine ID sign in place

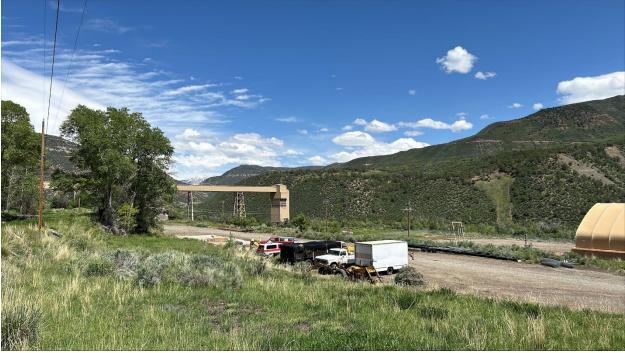
Oxbow had agreed a lease with a new tenant since the last inspection and some equipment had been moved to the upper pad. The tenant had also done some work to clean and rehabilitate the trailer.

Figure 2: Overview of upper pad

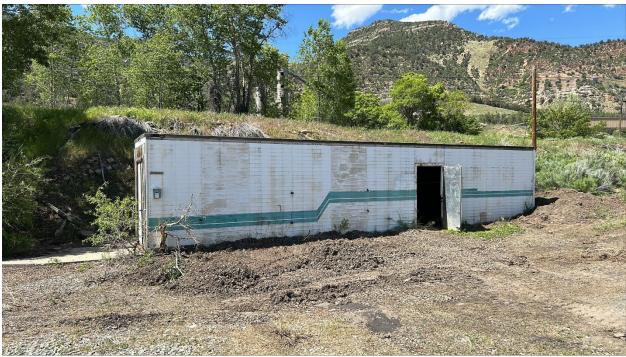
Figure 3: Trailer

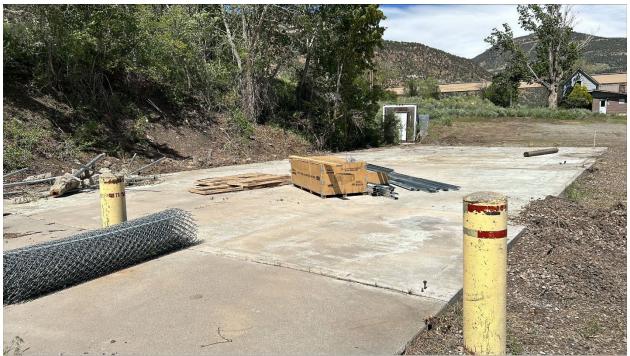
Figure 4: Garage/shop foundation pad

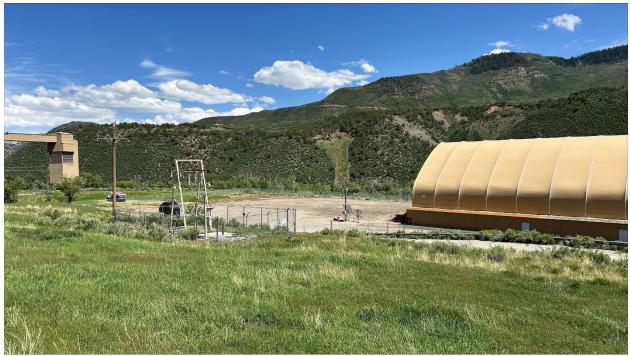
Figure 5: Lower pad and temporary building

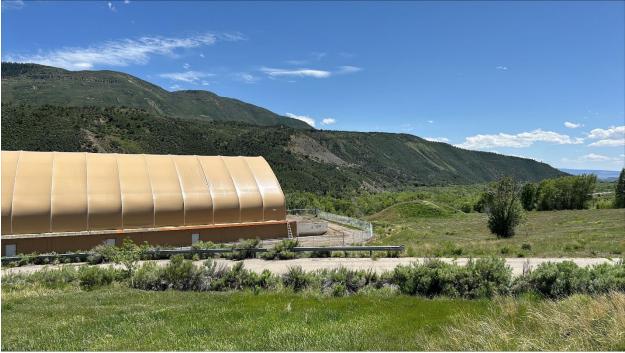
Figure 6: Western end of lower pad and temporary building
