## C1981022, Elk Creek Mine, May Inspection Report

**PERMIT INFORMATION**

<b>Permit Number:</b> C-1981-022 <b>Mine Name:</b> Elk Creek Mine <b>Operator:</b> Oxbow Mining, LLC <b>Operator Address:</b> Mr Doug Smith 3737 Hwy 133 P. O. Box 535 Somerset, CO 81434	<b>County:</b> Delta, Gunnison <b>Operation Type:</b> Underground <b>Permit Status:</b> Active <b>Ownership:</b> Private
	<b>Operator Representative Present:</b>  N/A
<b>Operator Representative Signature: (Field Issuance Only)</b>

<b>Inspection Start Date:</b> May 22, 2024 <b>Inspection Start Time:</b> 13:00 <b>Inspection End Date:</b> <b>Inspection End Time:</b>	<b>Inspection Type:</b> Coal Partial Inspection <b>Inspection Reason:</b> Normal I&E Program <b>Weather:</b> Clear
<b>Joint Inspection Agency:</b>  None	<b>Joint Inspection Contacts:</b>
<b>Post Inspection Agency:</b>  None	<b>Post Inspection Contacts:</b>
<b>Inspector(s):</b>  Leigh Simmons	<b>Inspector's Signature:</b>

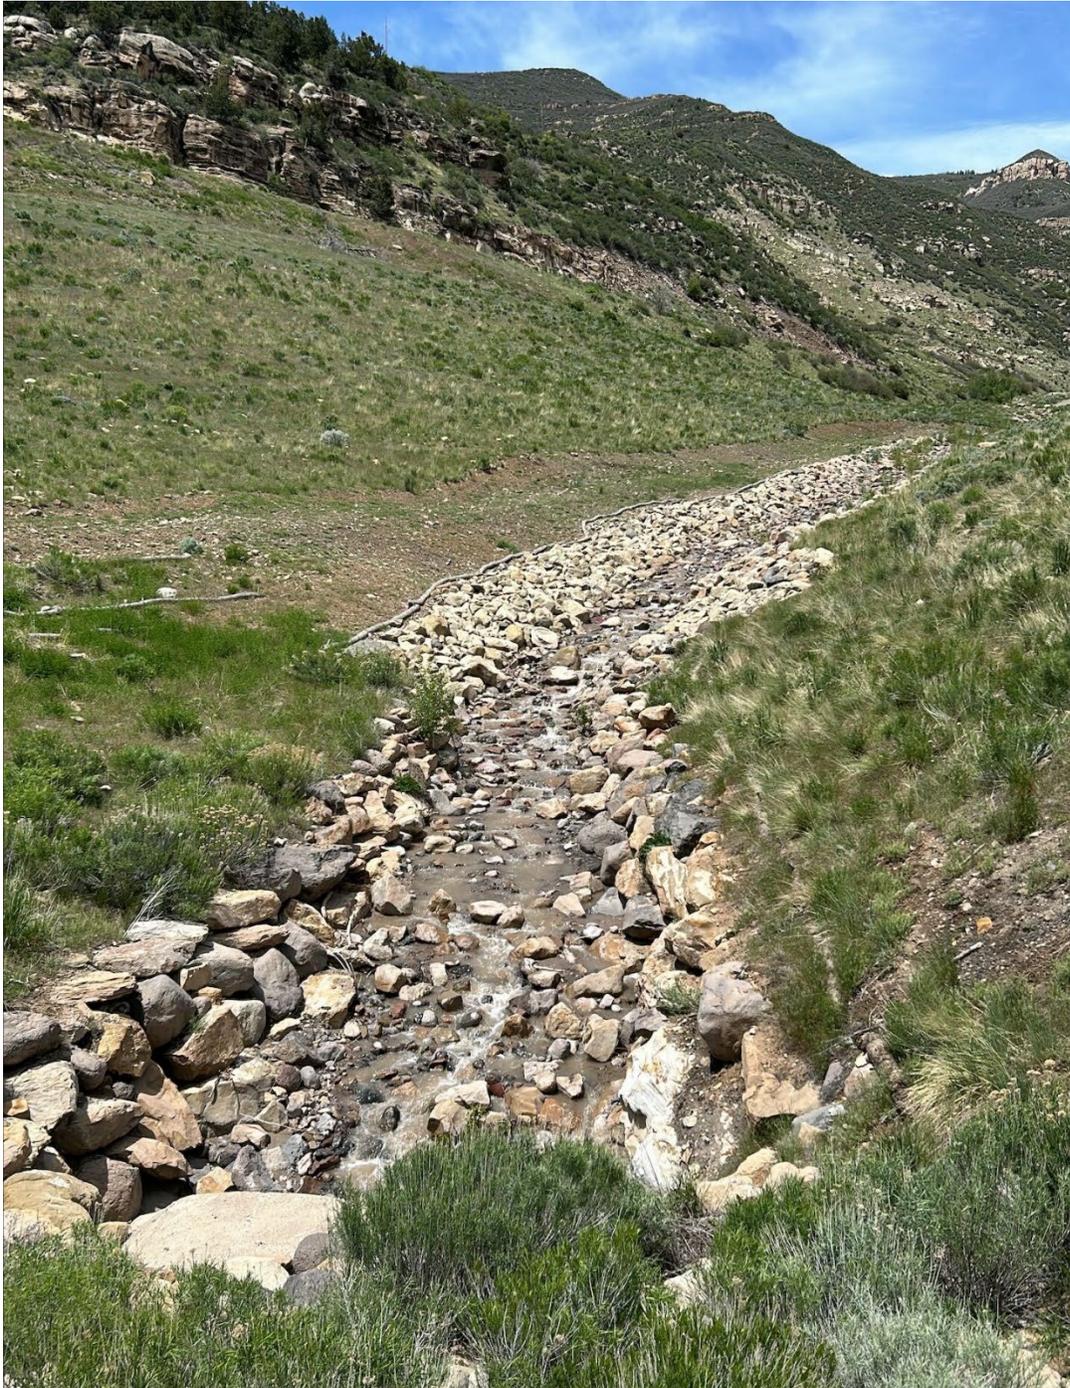
Elk Creek and Bear Creek continued to flow well below the flood levels seen in the spring of 2023. No damage to either channel was observed.

*Figure 1: Lower section of reclaimed Elk Creek channel*

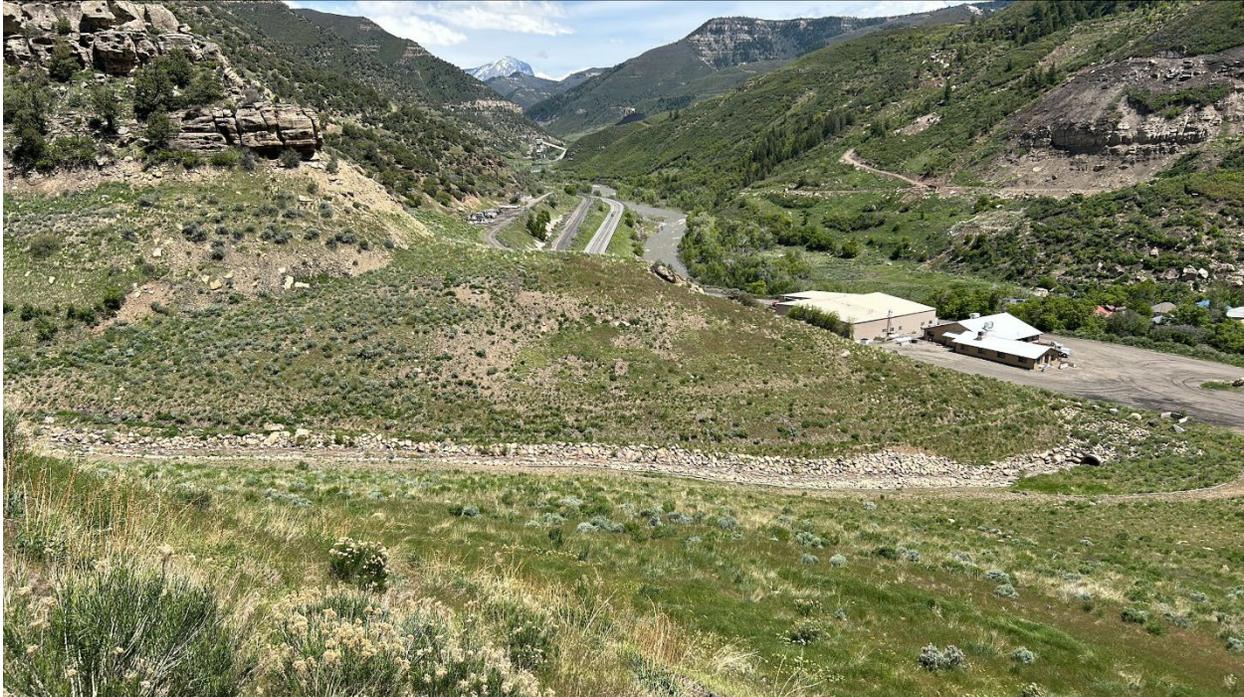
The reclaimed and repaired slopes of the Elk Creek channel were stable, with vegetation continuing to establish itself.

Figure 2: Reclaimed slopes of Elk Creek channel

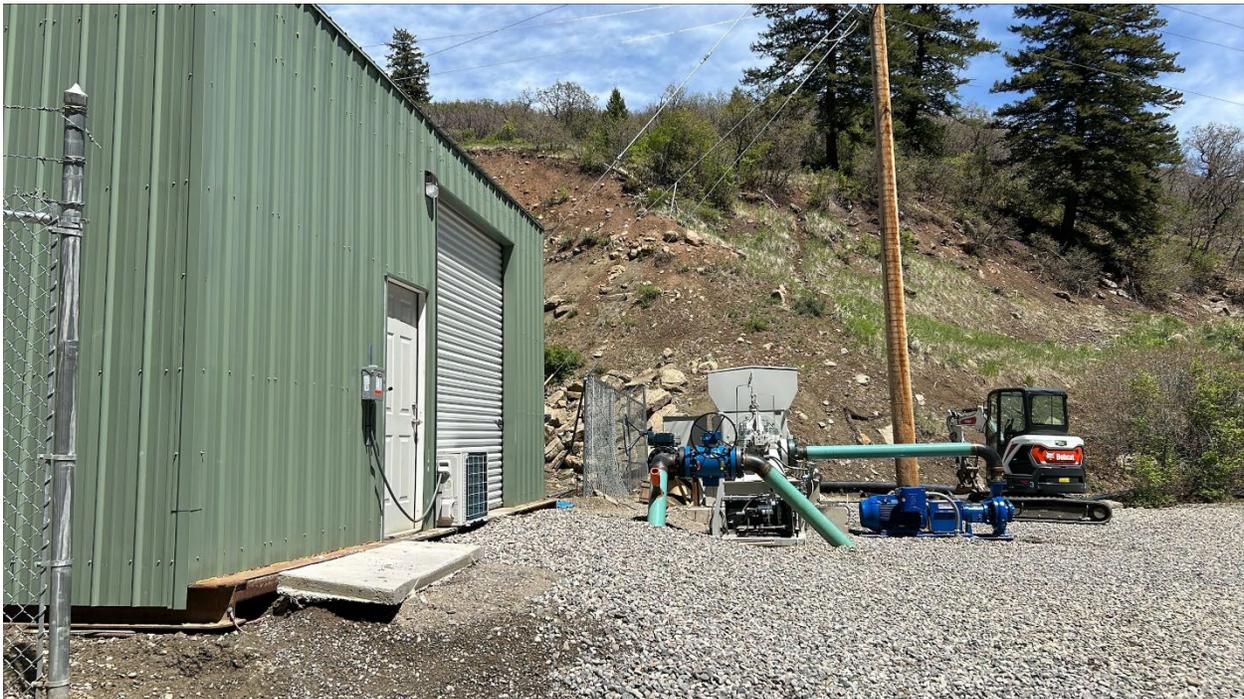
All four of the burners at the Bear Creek methane destruction facility were operating at the time of the inspection. Work had recently taken place at the facility but appeared to be complete for the time being. The fence around the facility had been temporarily removed but had not yet been replaced.

Figure 3: Recently installed equipment and broken fence at Bear Creek methane destruction facility

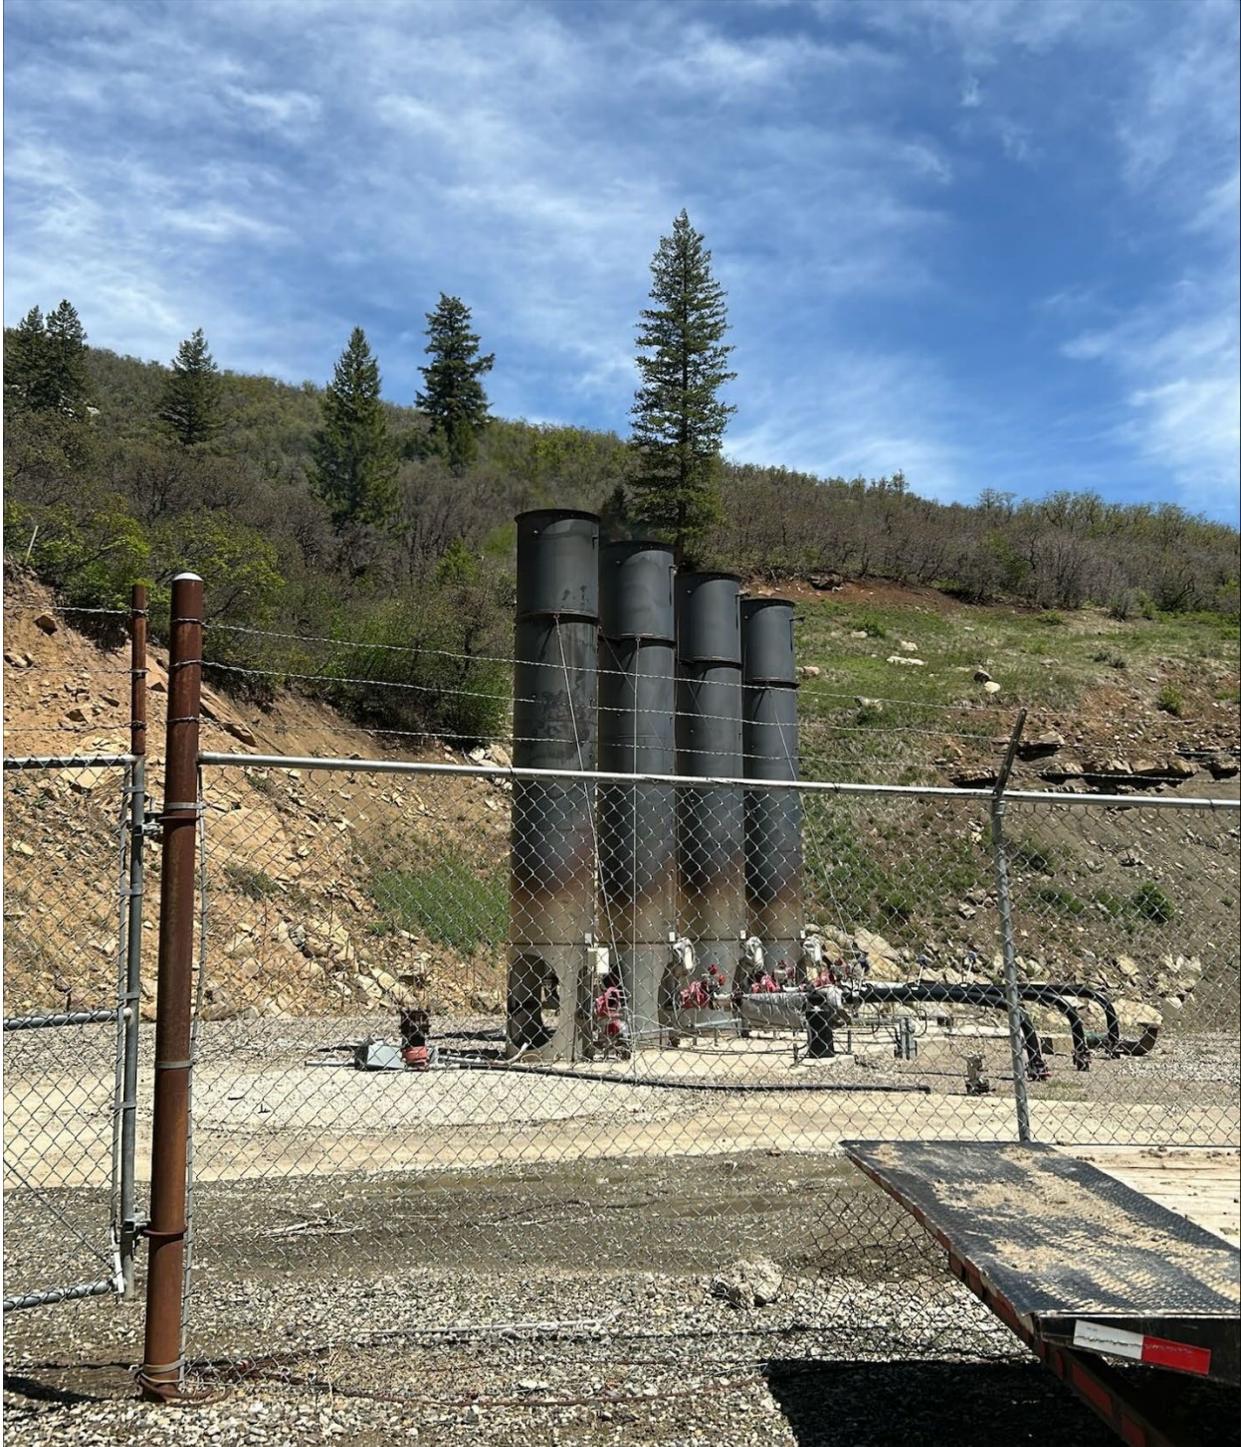
*Figure 4: All four burners at Bear Creek Methane Destruction Facility operating*
