MINERALS PROGRAM INSPECTION REPORT
PHONE: (303) 866-3567

MINE NAME: St Jude Mine	MINE/PROSPECTING ID#: M-1978-039-HR	MINERAL: Uranium and vanadium	COUNTY: San Miguel
INSPECTION TYPE: Monitoring	WEATHER: Clear	INSP. DATE: April 10, 2024	INSP. TIME: 12:00
OPERATOR: Pinon Ridge Mining LLC	OPERATOR REPRESENTATIVE: Micheal Rutter, Bruce Smith	TYPE OF OPERATION: 110d - Designated Limited Impact	
REASON FOR INSPECTION: Normal I&E Program	BOND CALCULATION TYPE: Complete Bond	BOND AMOUNT: \$69,828.00	
DATE OF COMPLAINT: NA	POST INSP. CONTACTS: None	JOINT INSP. AGENCY: U.S.BLM	
INSPECTOR(S): Lucas West	INSPECTOR'S SIGNATURE:

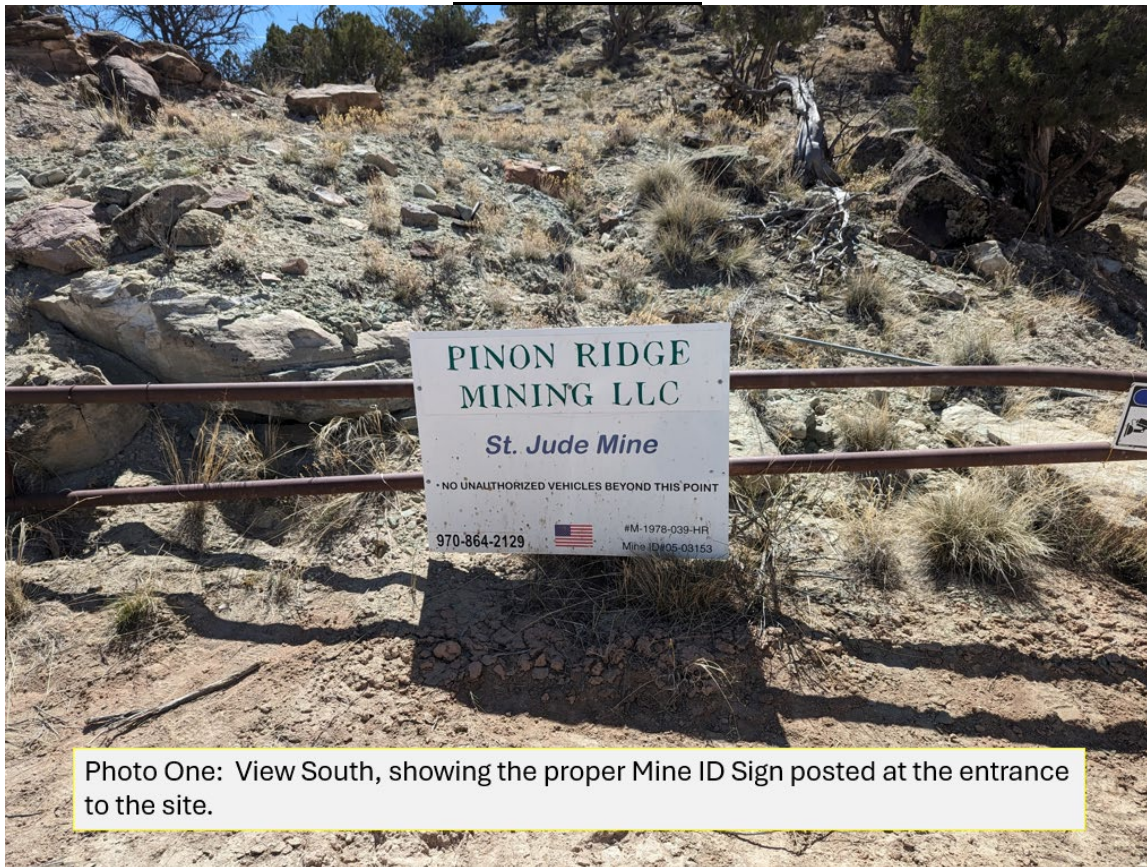
As seen in Photo One, the permit ID sign was observed at the entrance to the site. The permit boundary markers were also observed. All disturbances are contained within the permitted areas. The remote vent shaft sites were not inspected at this time. The diversion ditches and storm water control devices appear to be functioning as designed and no significant erosion was observed throughout the site. The main work area, adjacent to the portal and shops, appeared to be stable and in good condition. The portal was open and active at the time of the inspection. Four of the Five mines in the Sunday Complex connect underground and the portal is used as secondary egress and ventilation. The portal and it's structure are in excellent condition.

Photo One: View South, showing the proper Mine ID Sign posted at the entrance to the site.

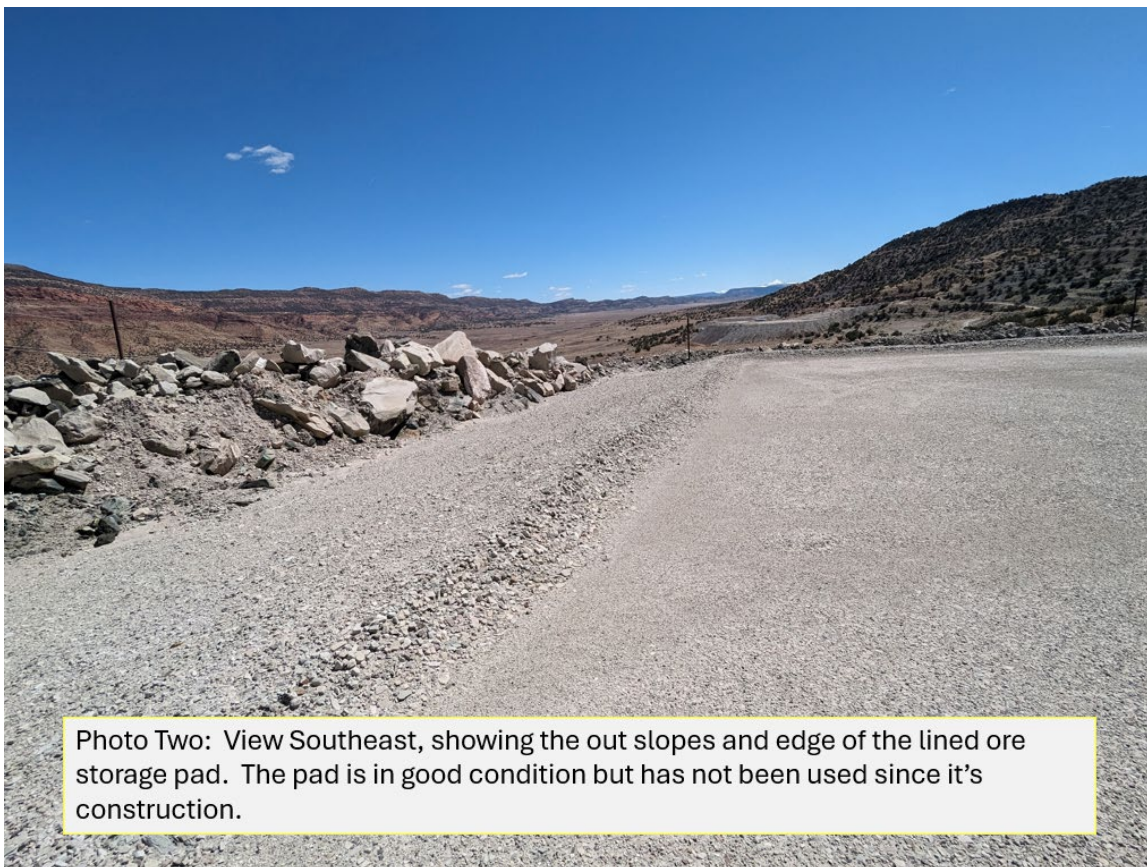
The lined Ore Pad was observed to be in good condition. The face of the pad shows no evidence of surface stockpiling and no observable impacts from precipitation was noted. The out slopes and berms of the pad appear stable. The pad can be seen in Photos Two and Three. All work and shop facilities onsite were secured and appeared to be in good condition as seen in Photo Four. One small above ground fuel tank is located on site to feed the air compressor, secondary containment of the tank was observed to have adequate volume to contain any spills. Various other items are observed on site however it was stored in an orderly fashion and was not a concern at this time. The waste rock dump storage area was observed and appears to be stable and in good condition. The out slopes show no signs of significant erosion. The waste rock stored in the area and it's outs slopes can be seen in Photos Five and Six.

Photo Two: View Southeast, showing the out slopes and edge of the lined ore storage pad. The pad is in good condition but has not been used since it's construction.

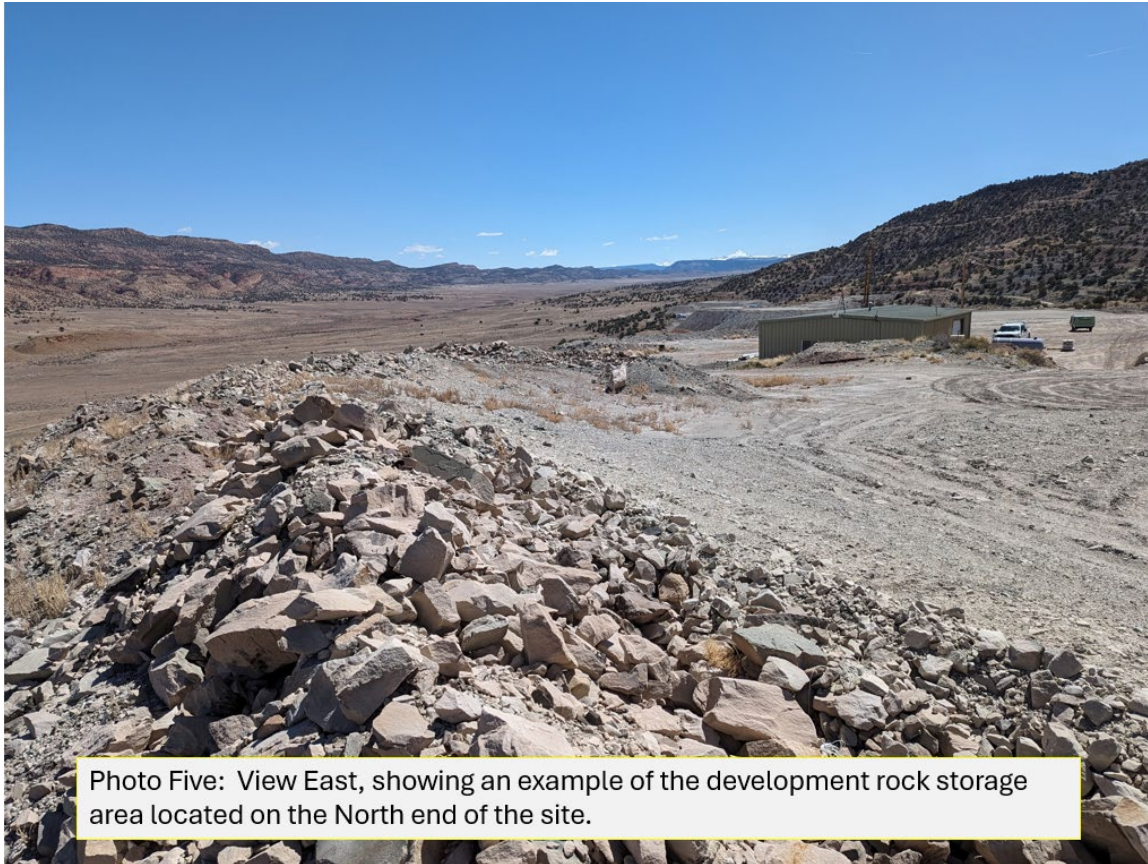
Photo Five: View East, showing an example of the development rock storage area located on the North end of the site.

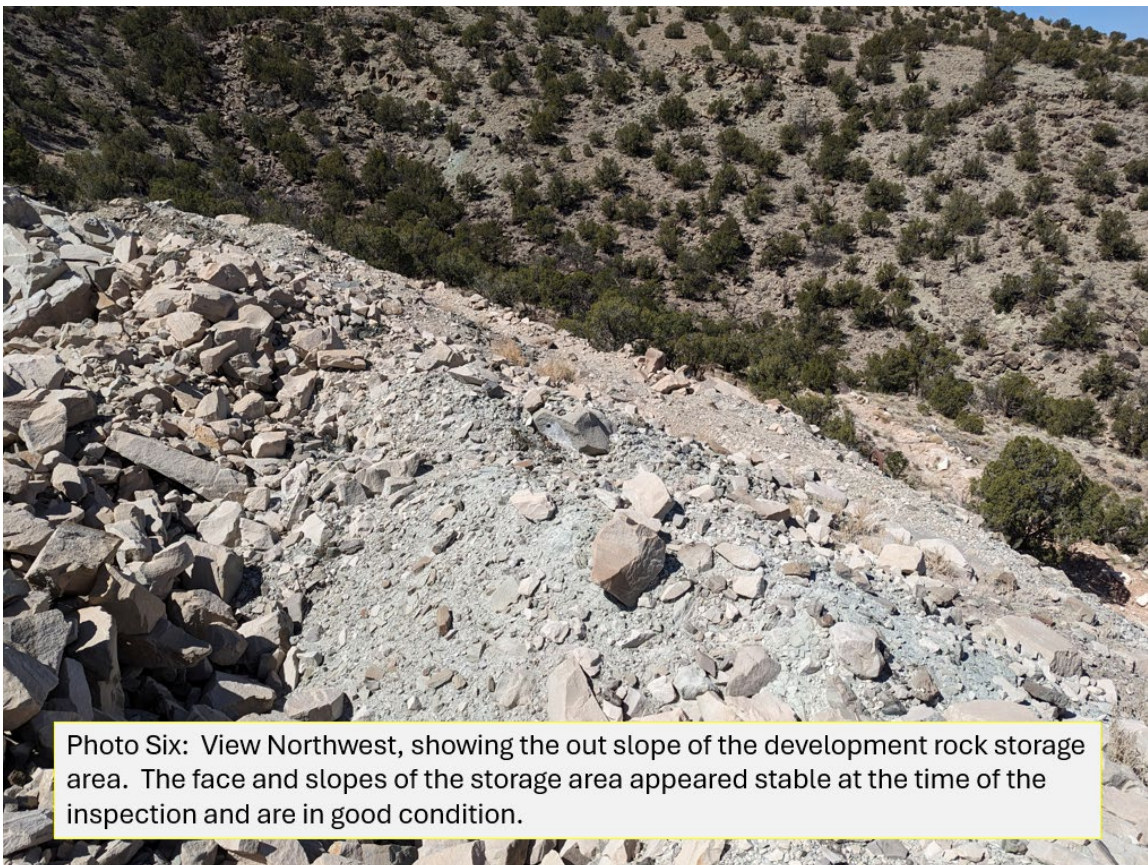
Photo Six: View Northwest, showing the out slope of the development rock storage area. The face and slopes of the storage area appeared stable at the time of the inspection and are in good condition.
