PERMIT INFORMATION

Permit Number: C1981033 Mine Name: Bear Mine Operator: N/A Operator Address: N/A	County: Gunnison Operation Type: Underground Permit Status: Revoked Ownership: Private
	Operator Representative Present: N/A
Operator Representative Signature: (Field Issuance Only)

INSPECTION INFORMATION

Inspection Start Date: May 22, 2024 Inspection Start Time: 13:00 Inspection End Date: Inspection End Time:	Inspection Type: Coal Complete Inspection Inspection Reason: Normal I&E Program Weather: Clear
Joint Inspection Agency: None	Joint Inspection Contacts:
Post Inspection Agency: None	Post Inspection Contacts:
Inspector(s): Leigh Simmons	Inspector's Signature:

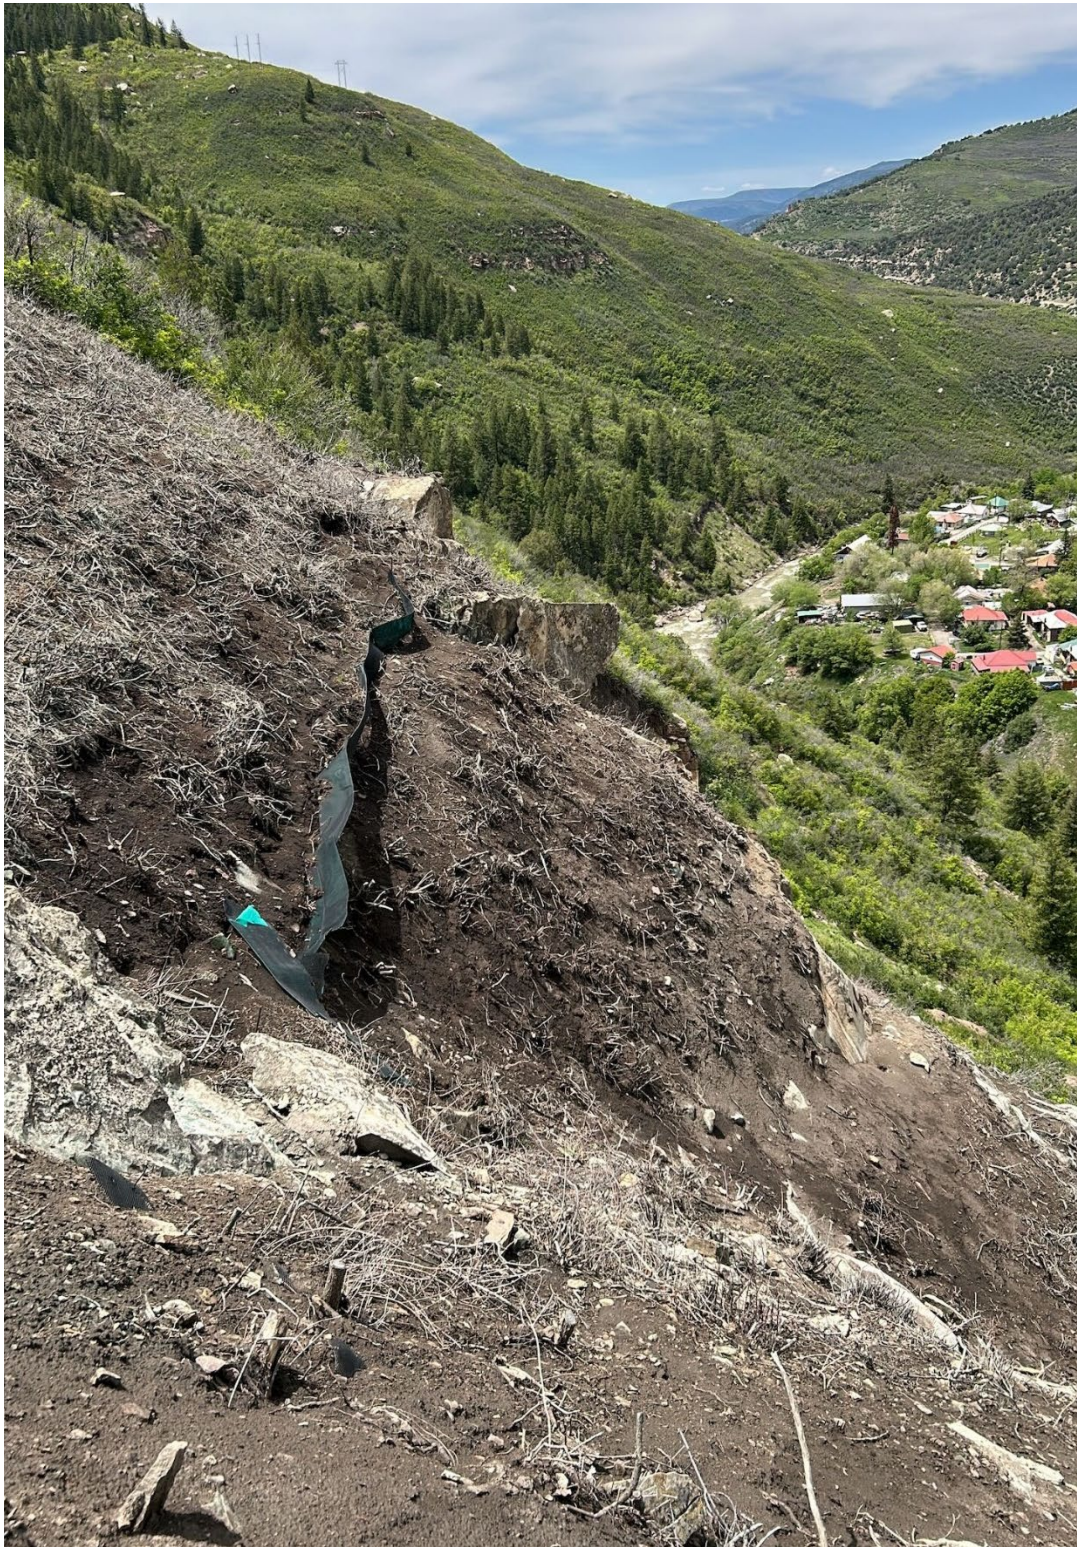
The bench itself appeared to be stable. The silt fence had done a good job of controlling surface run-off.

Figure 1: Silt fence below bench

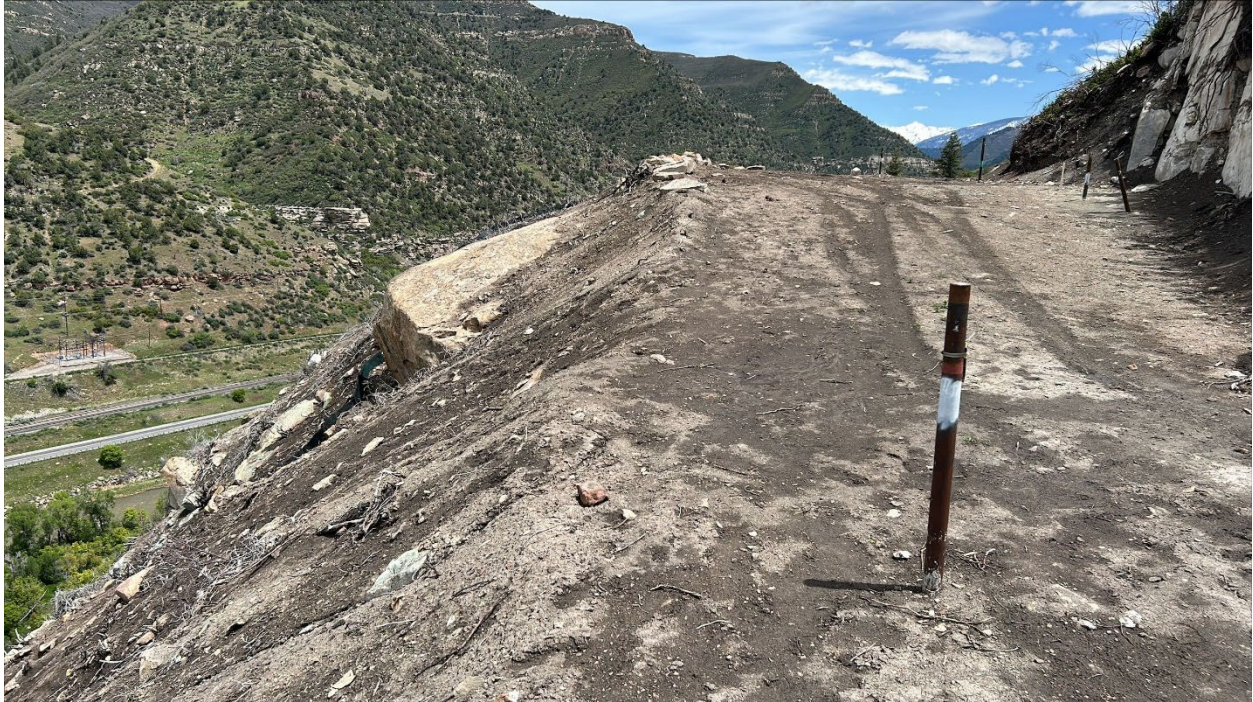
Figure 2: View along bench to the east

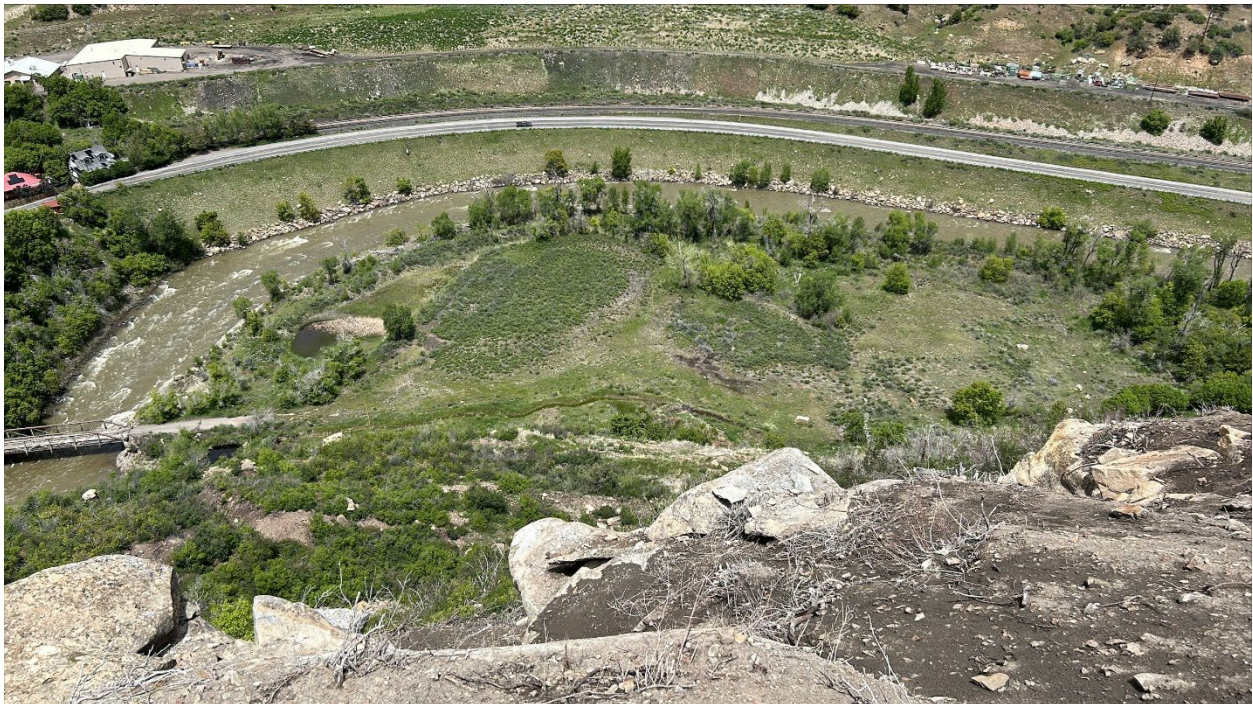
Figure 3: Overview of site

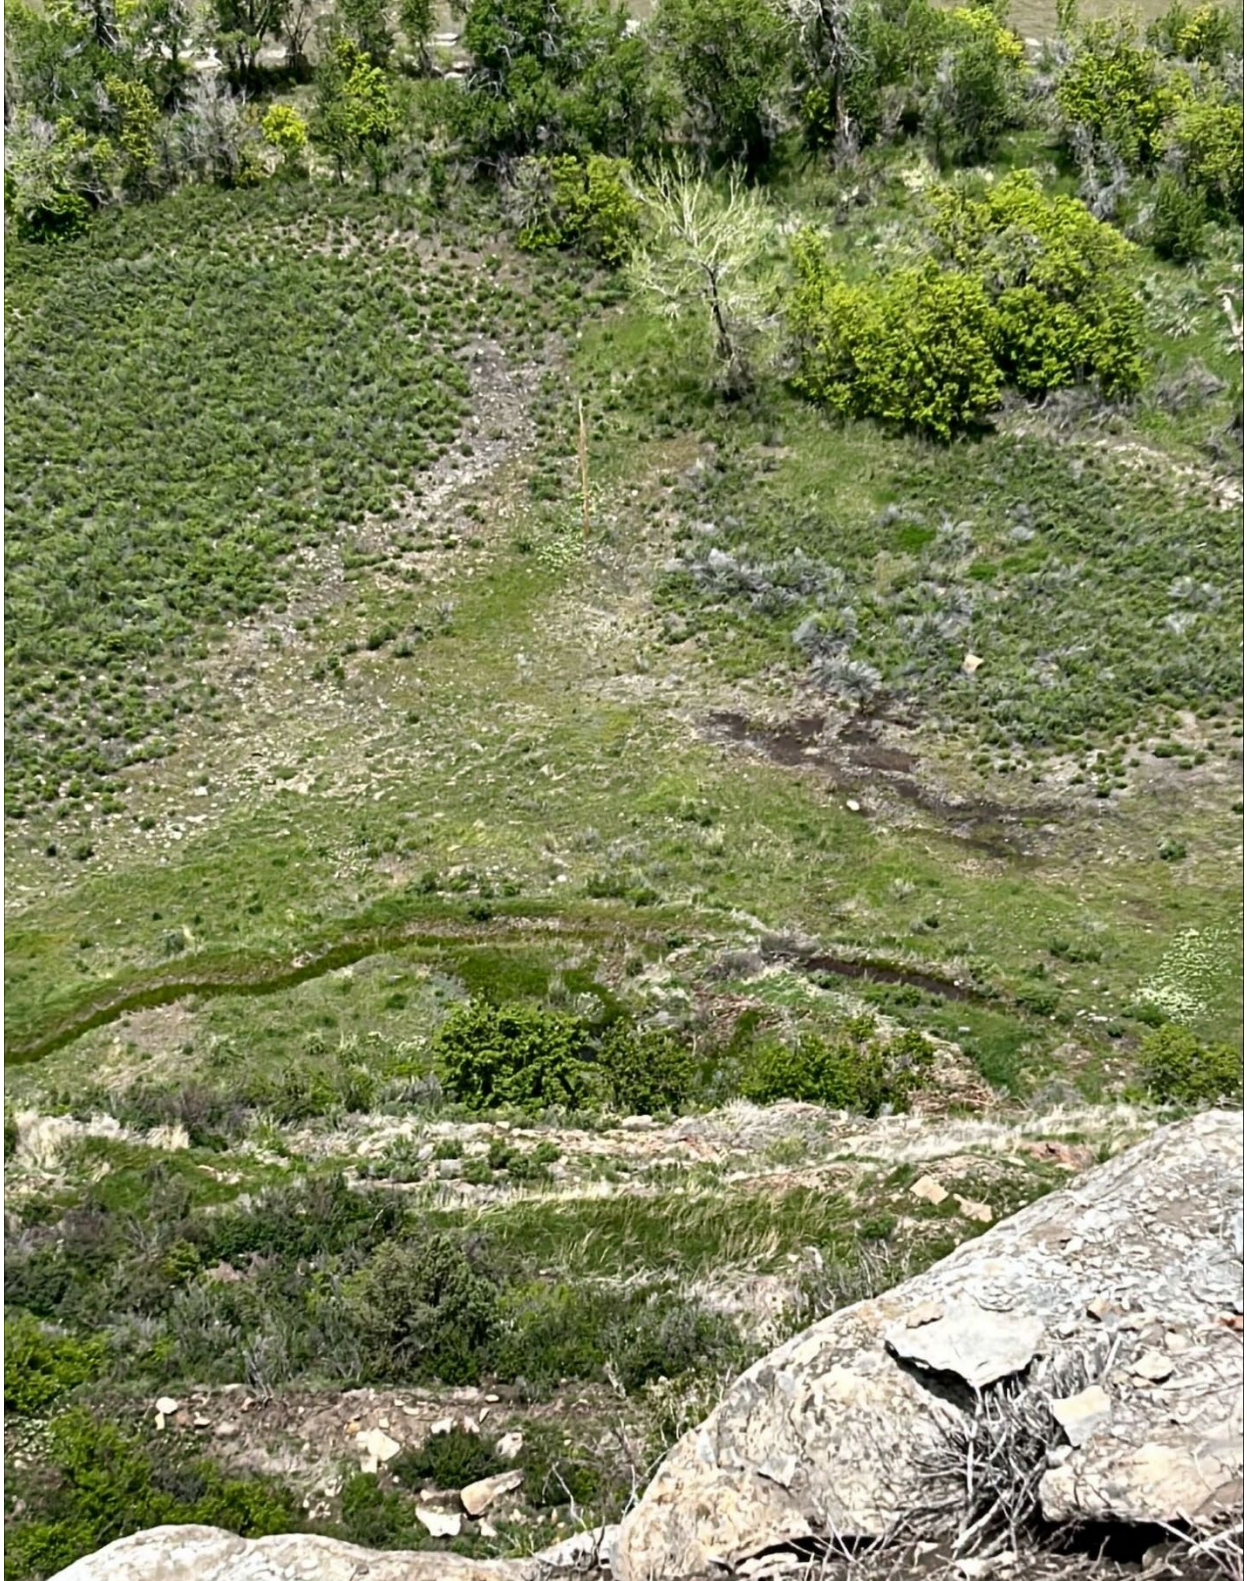
Figure 4: View of seep area from bench

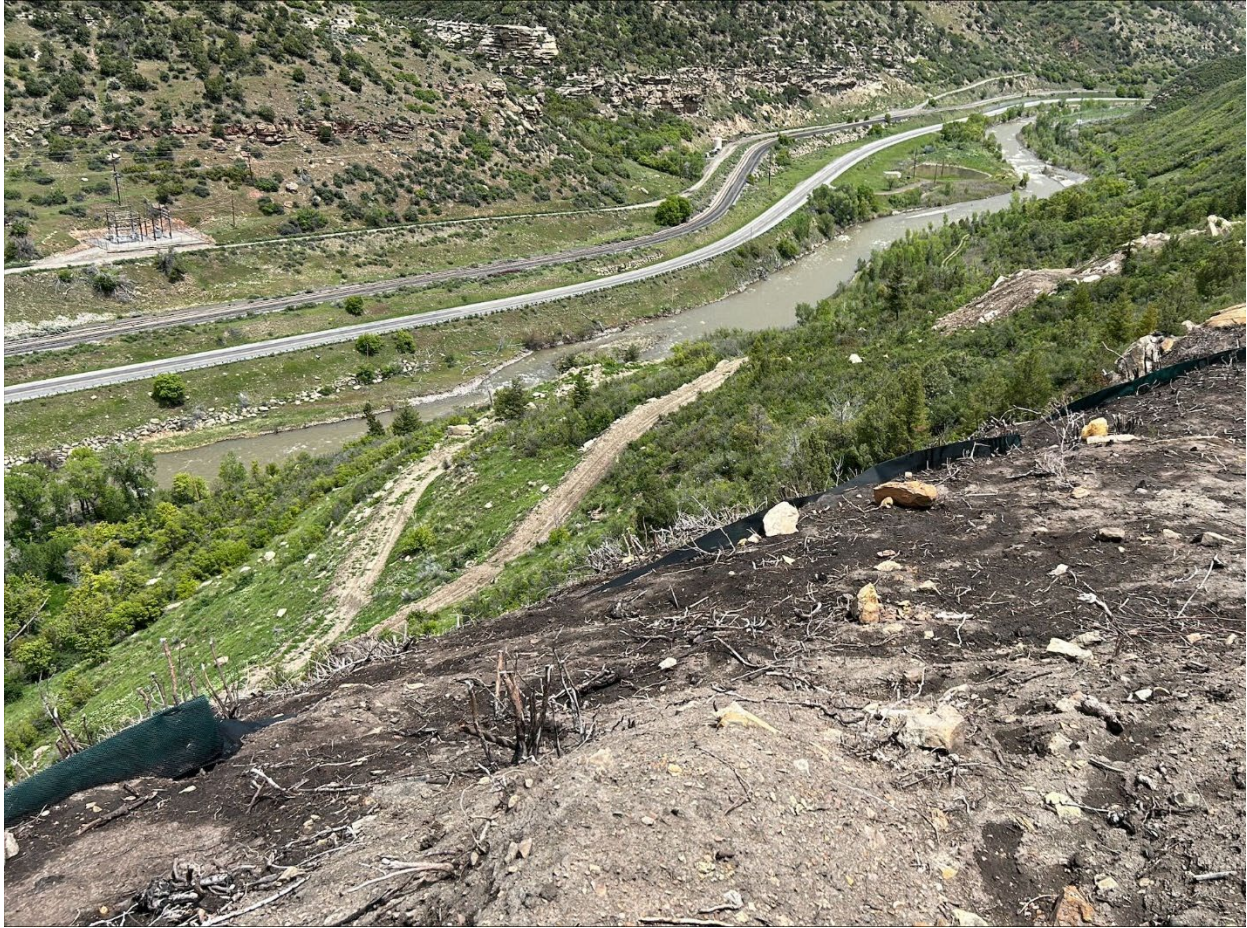
Figure 5: Silt fence sediment control
