MINERALS PROGRAM INSPECTION REPORT
PHONE: (303) 866-3567

MINE NAME: Topaz Mine	MINE/PROSPECTING ID#: M-1980-055-HR	MINERAL: Uranium and vanadium	COUNTY: San Miguel
INSPECTION TYPE: Monitoring	WEATHER: Clear	INSP. DATE: April 17, 2024	INSP. TIME: 12:35
OPERATOR: Pinon Ridge Mining LLC	OPERATOR REPRESENTATIVE: Mike Rutter, Bruce Smith	TYPE OF OPERATION: 112d-3 - Designated Mining Operation	
REASON FOR INSPECTION: Normal I&E Program	BOND CALCULATION TYPE: Complete Bond	BOND AMOUNT: \$99,893.00	
DATE OF COMPLAINT: NA	POST INSP. CONTACTS: None	JOINT INSP. AGENCY: U.S.BLM	
INSPECTOR(S): Lucas West	INSPECTOR'S SIGNATURE:

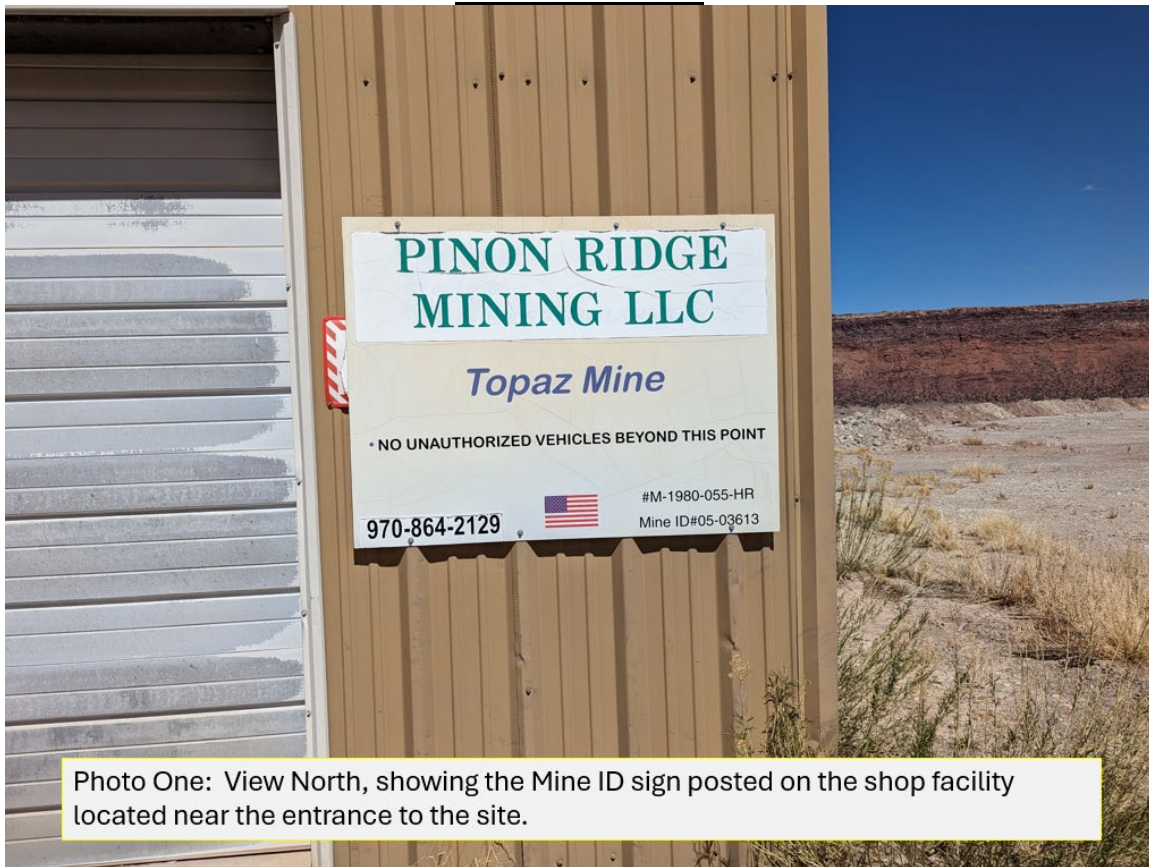
As seen in Photo One, the permit ID sign was observed posted on the shop facility near the entrance. The permit boundary markers were also observed. Evidence that the diversion ditches and storm water control devices are functioning as designed was noted and no significant erosion was observed throughout the site. Maintenance of the storm water control structures has not been needed and all structures were in good condition at the time of the inspection.

Photo One: View North, showing the Mine ID sign posted on the shop facility located near the entrance to the site.

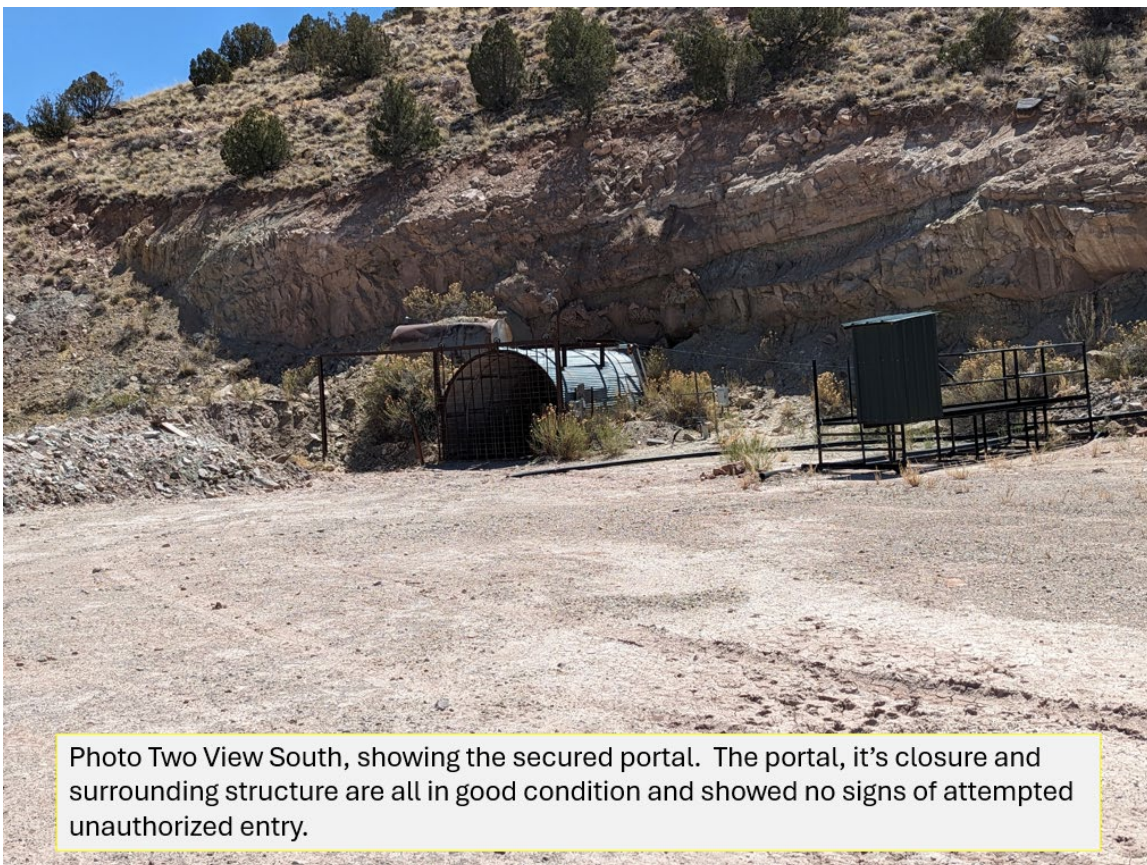
The shop facility located on site was observed to be secure and is in good working order. No damage or signs of vandalism was noted during the inspection. The portal located on site was also secured, it has been closed off with steel grates as well as encompassed by a small berm as seen in Photo Two. The previously stored items that had been on site for some time have been removed, and no trash or debris was noted. No fuel storage containers were observed on site.

Photo Two View South, showing the secured portal. The portal, it's closure and surrounding structure are all in good condition and showed no signs of attempted unauthorized entry.

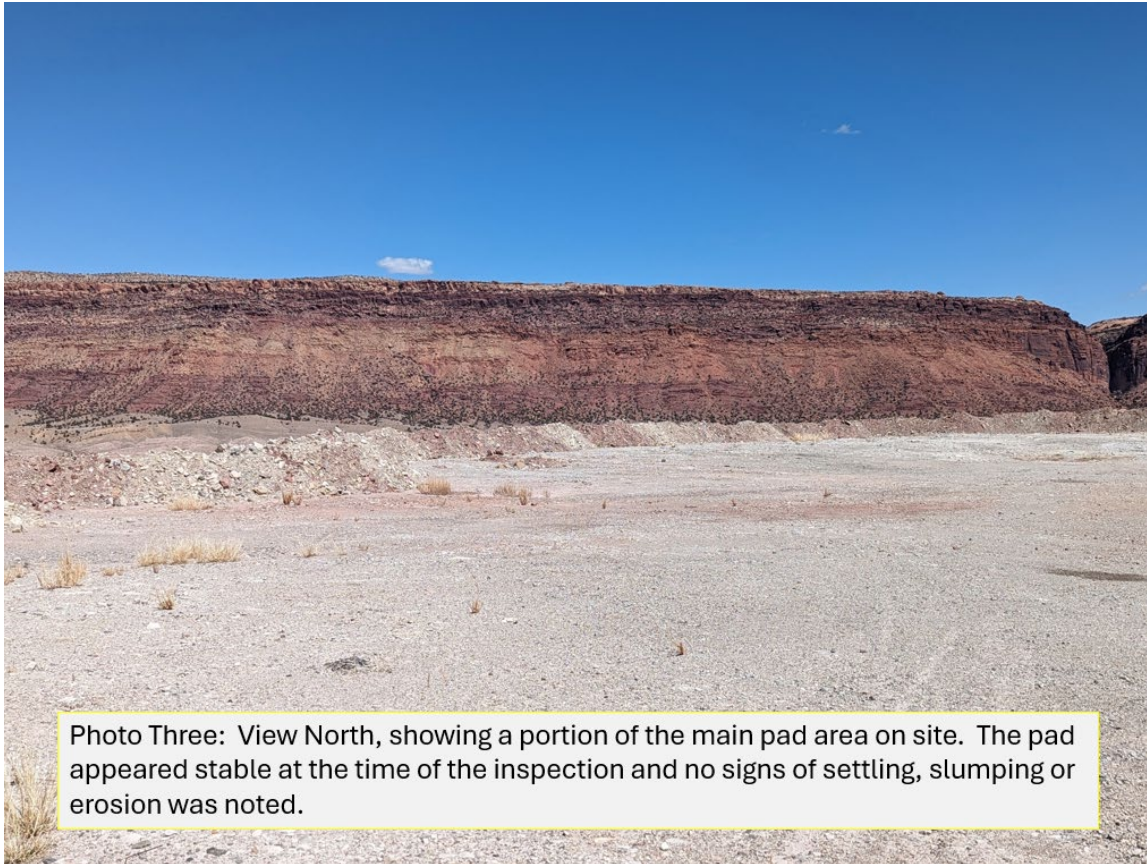
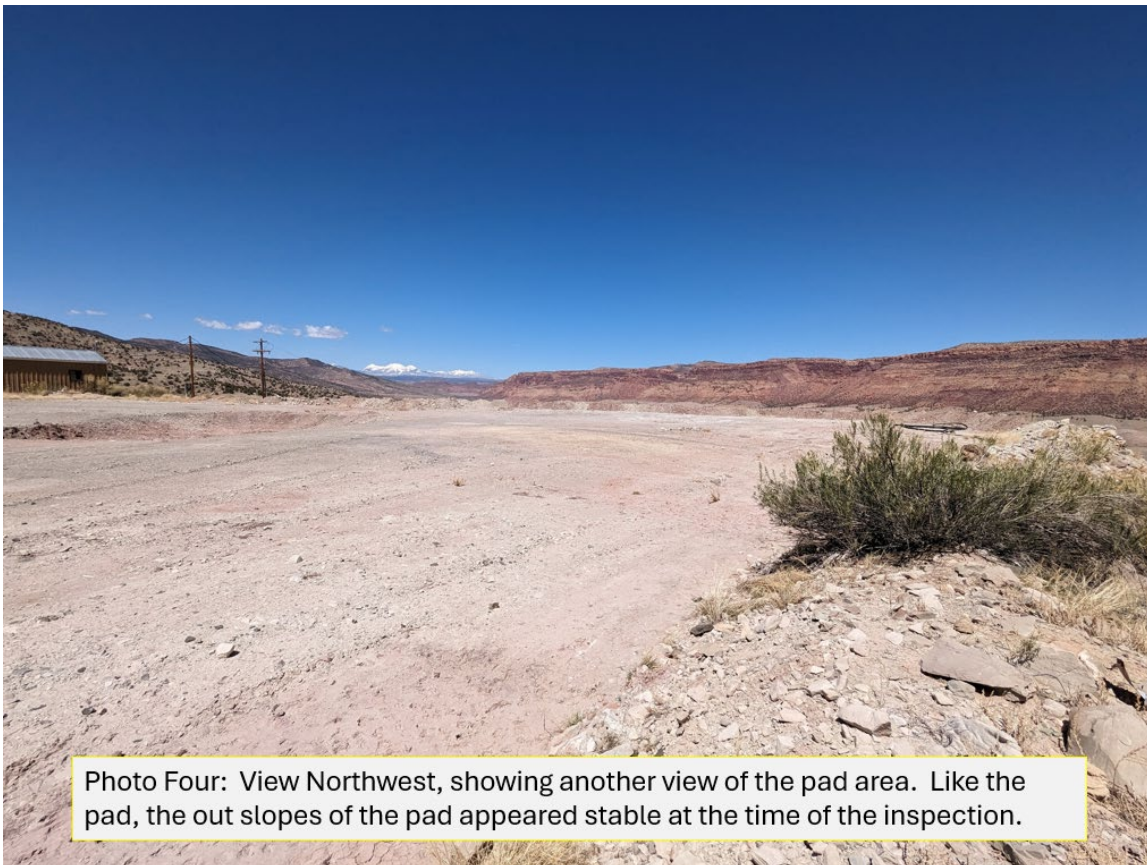
The main pad and work area was in good condition as seen in Photos Three and Four. A small depression was dug in the center of the pad. Evidence of weed management during the growing season was observed. Some areas around the perimeter of the pad area have begun to revegetate themselves with volunteer species. The whole site exhibits positive drainage, and no erosional issues were observed at this time.
