MINERALS PROGRAM INSPECTION REPORT
PHONE: (303) 866-3567

MINE NAME: Prince Albert Mine	MINE/PROSPECTING ID#: M-2011-040	MINERAL: Uranium and vanadium	COUNTY: Montrose
INSPECTION TYPE: Monitoring	WEATHER: Clear	INSP. DATE: April 30, 2024	INSP. TIME: 16:30
OPERATOR: Rimrock Exploration & Development, Inc.	OPERATOR REPRESENTATIVE: None	TYPE OF OPERATION: 110d - Designated Limited Impact	
REASON FOR INSPECTION: Normal I&E Program	BOND CALCULATION TYPE: Complete Bond	BOND AMOUNT: \$23,262.00	
DATE OF COMPLAINT: NA	POST INSP. CONTACTS: None	JOINT INSP. AGENCY: None	
INSPECTOR(S): Dustin Czapla	INSPECTOR'S SIGNATURE:

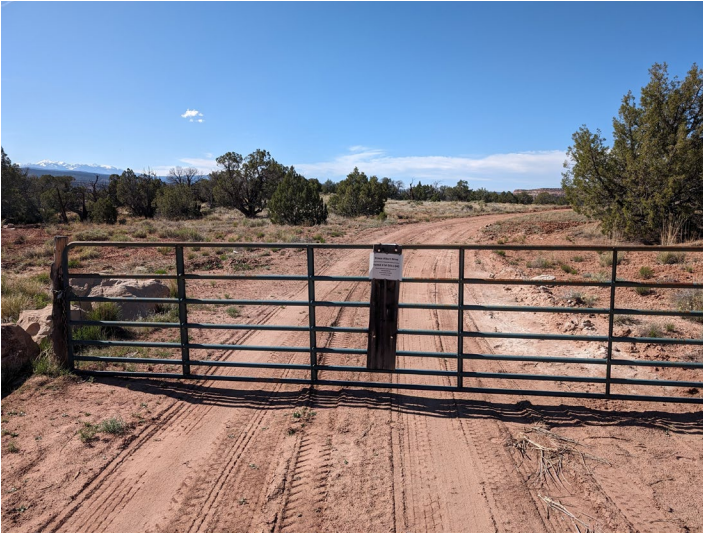
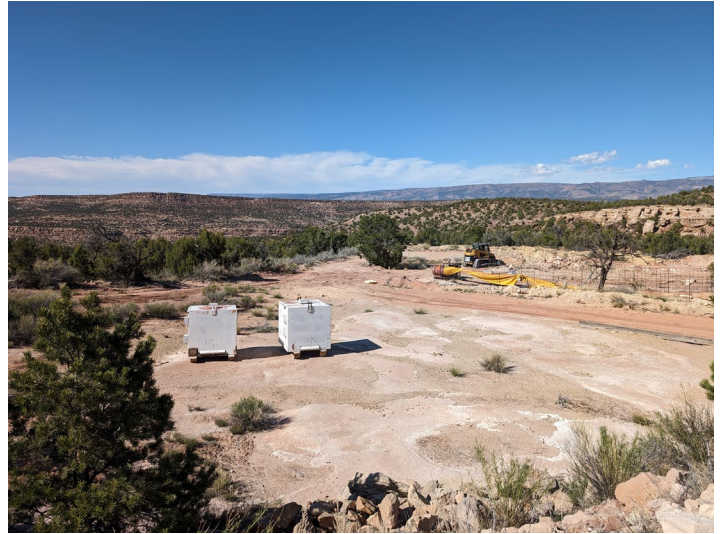
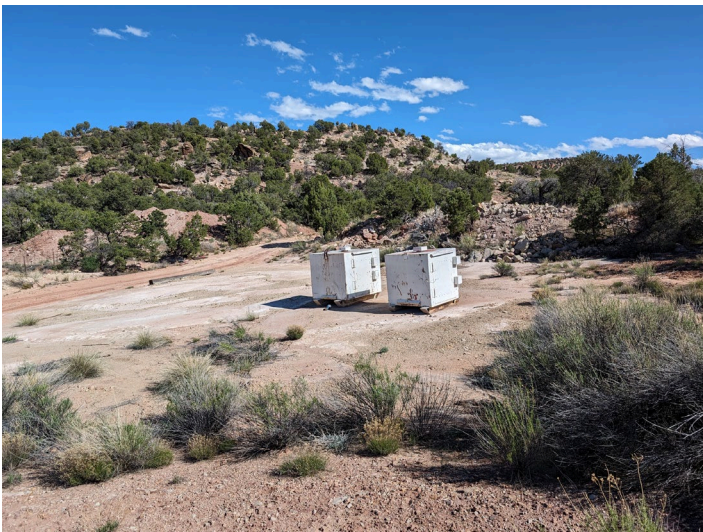
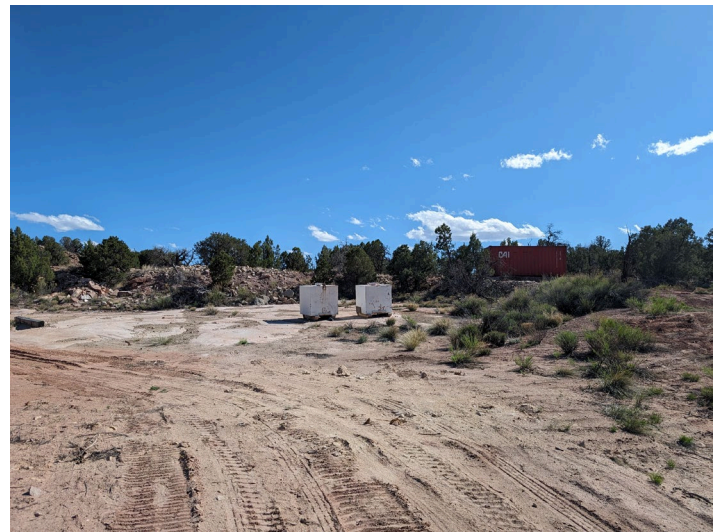
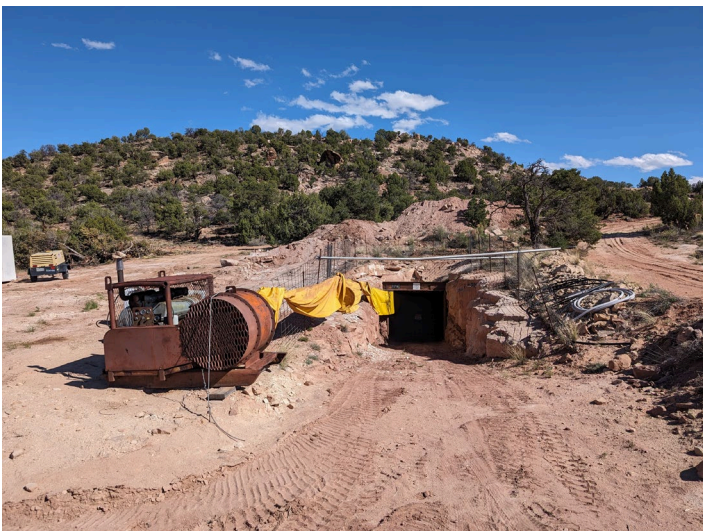
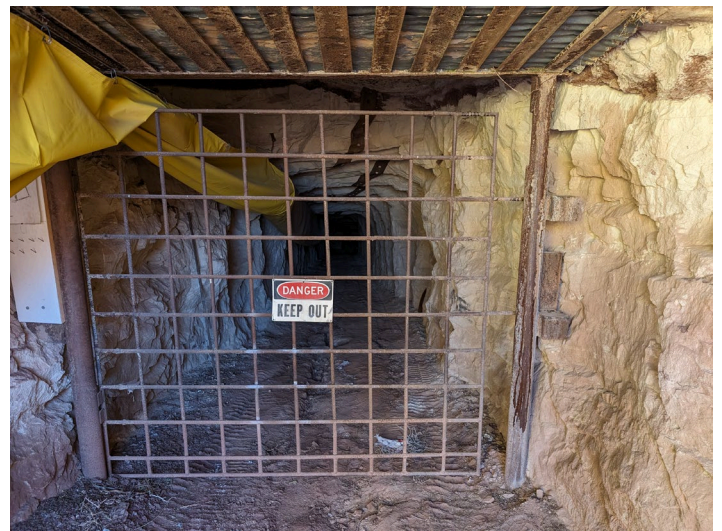
Operations appear to have resumed at the site. A skid steer was on site and work has occurred in the pond area and around the dump and portal. A ventilation system is in now installed at the portal. The portal was secured with a locked gate.
