PERMIT INFORMATION

Permit Number: C-1981-019 Mine Name: Colowyo Coal Mine Operator: Colowyo Coal Company L.P. Operator Address: Mr Tony Tennyson 5731 State Highway 13 Meeker, CO 81641	County: Moffat, Rio Blanco Operation Type: Surface Permit Status: Active Ownership: Private
	Operator Representative Present: None
Operator Representative Signature: (Field Issuance Only)

INSPECTION INFORMATION

Inspection Start Date: May 28, 2024 Inspection Start Time: 13:00 Inspection End Date: May 28, 2024 Inspection End Time: 13:30		Inspection Type: Aerial Inspection Inspection Reason: Normal I&E Program Weather: Clear	
Joint Inspection Agency: None		Joint Inspection Contacts: 	
Post Inspection Agency: None		Post Inspection Contacts: 	
Inspector(s): Hunter Ridley	Inspector's Signature: <i>Hunter Ridley</i>		Signature Date: May 31, 2024

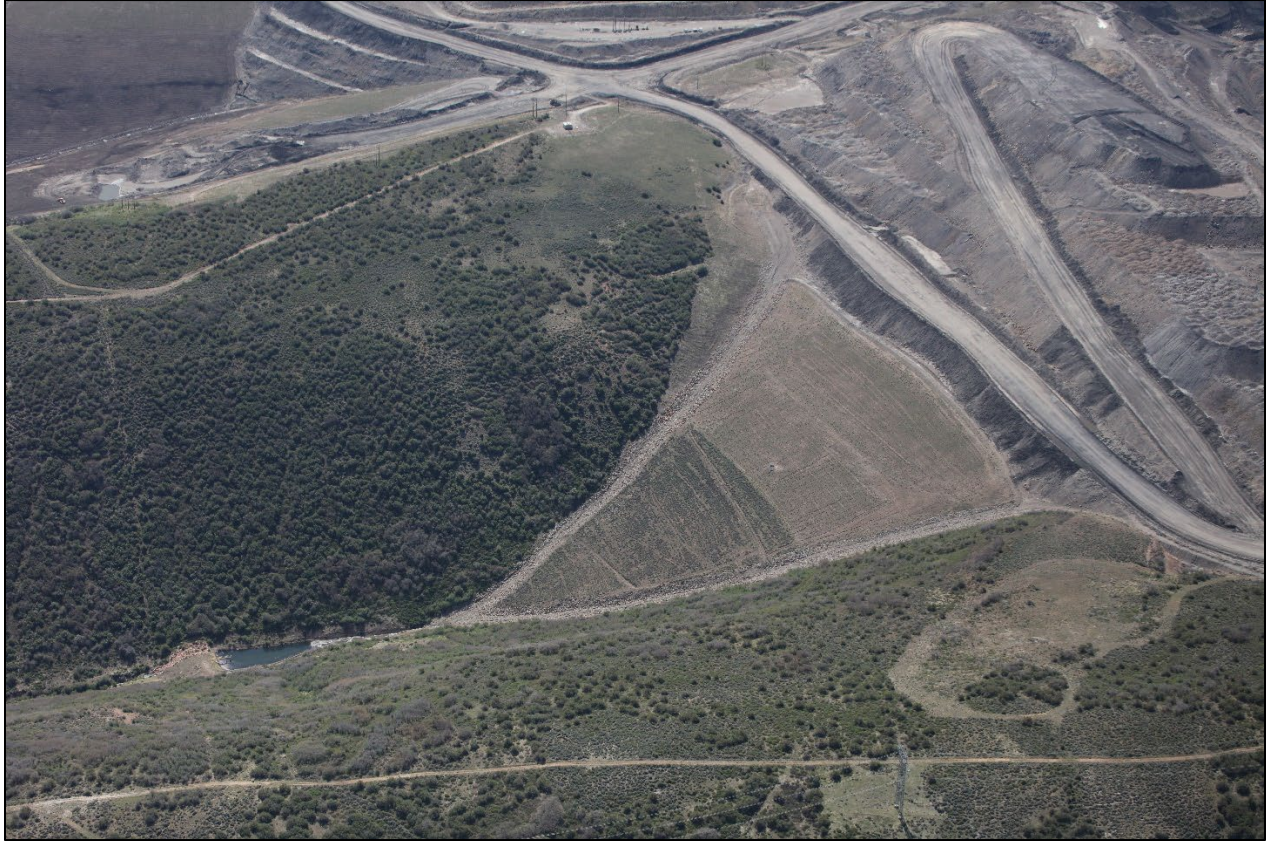
The West Taylor Valley Fill area looked to be vegetated and stable. Photographs showed signs of small rills along this fill slope (Photo 1). No BMPs are needed at this time. The West Taylor Pond was also visible in these photographs and appeared to be free of issues.

Photo 1: View easy of the West Taylor Pond & West Taylor valley fill area.

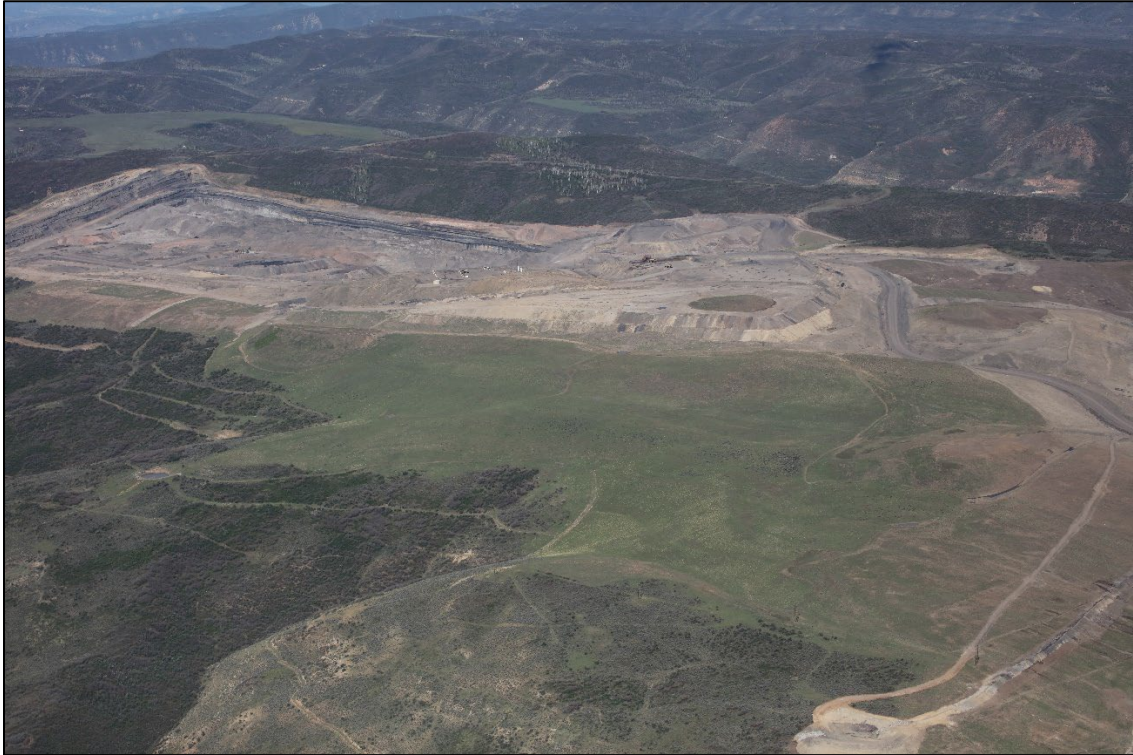
Backfill operations continue in the South Taylor Pit (Photo 2) and West Pit. A small highwall to the south of the West Pit and a highwall to the west of the South Taylor Pit remain to be backfilled. Material for this will be sourced from the South Taylor Pit's temporary spoil pile and from adjacent internal haul roads in final reclamation.

Photo 2: View west of the South Taylor pit.

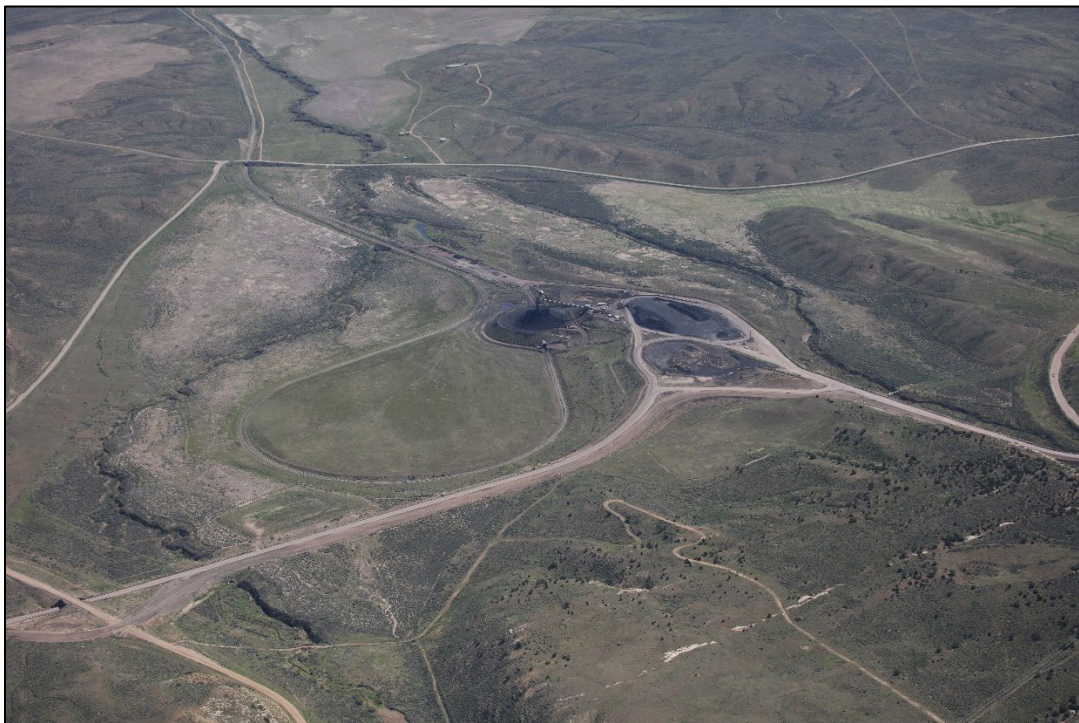
All three train loadout area ponds appeared to be holding water and free of observational issues (Photo 3). Main facilities ponds adjacent to the West Pit and north of the East Pit were holding water (Photo 4). Final East Pit ditch and the stock ponds located along its path (EP1, EP2, and EP3) looked to be free of issues with erosion or instability (Photo 8). In the West Pit, the Taylor Ditch showed no signs of erosion or instability. The East Taylor Pond was holding water (Photo 6). Section 25 and Section 26 Ponds in the Collom Pit were partially visible in aerial photographs (Photo 10). Both ponds looked to be holding water and the slump area at Section 26 Pond appeared to still be stable.

Photo 3: View of the train loadout area and Gossard pond, Stoker Siding pond, and Rail Loop pond.

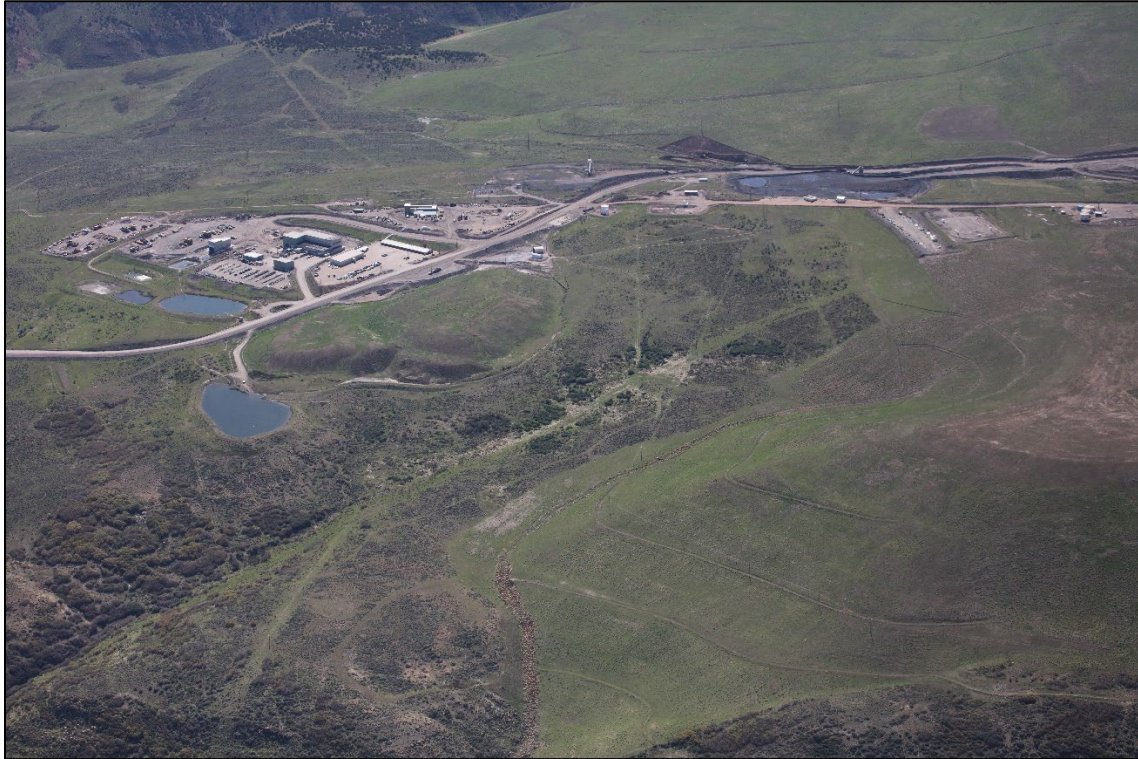
Water was observed to be impounded across several areas of the site (Photos 4 and 13). This is assumed to be a result of recent snowmelt. The Operator is reminded that Colorado statute requires all stormwater to continuously release or infiltrate within the 72 / 120 hour time limits, depending on the magnitude of the storm event.

Photographs show the continued growth of stable vegetation in the West Pit (Photo 4). There were no signs of erosion across this area. A reclamation parcel located on the eastern side of the South Taylor Pit, which was inaccessible at the last inspection, was noted to be continuing to support vegetation (Photo 9).

Photo 4: View southeast of the main facilities area and associated ponds.

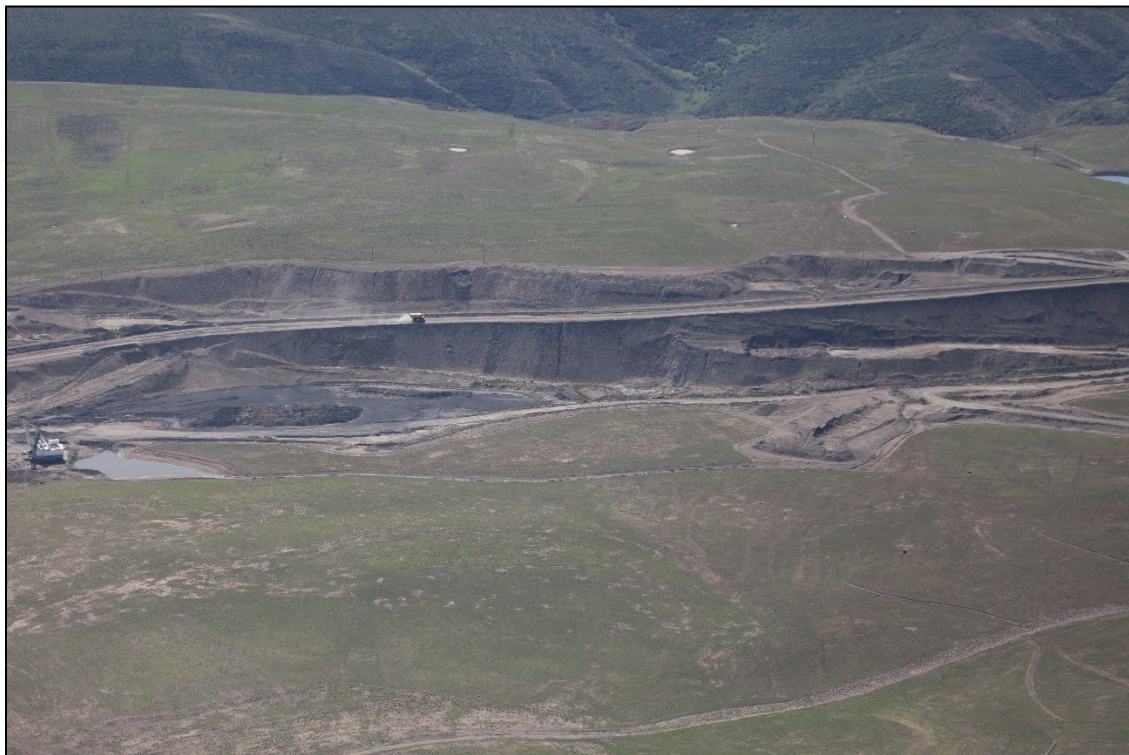
Several aerial photographs captured internal haul roads throughout the site. These roads looked well maintained and dry. A water truck was noted to be active on the haul road between East and West Pit (Photo 5).

Photo 5: View east of an internal haul road, water truck active in the area.

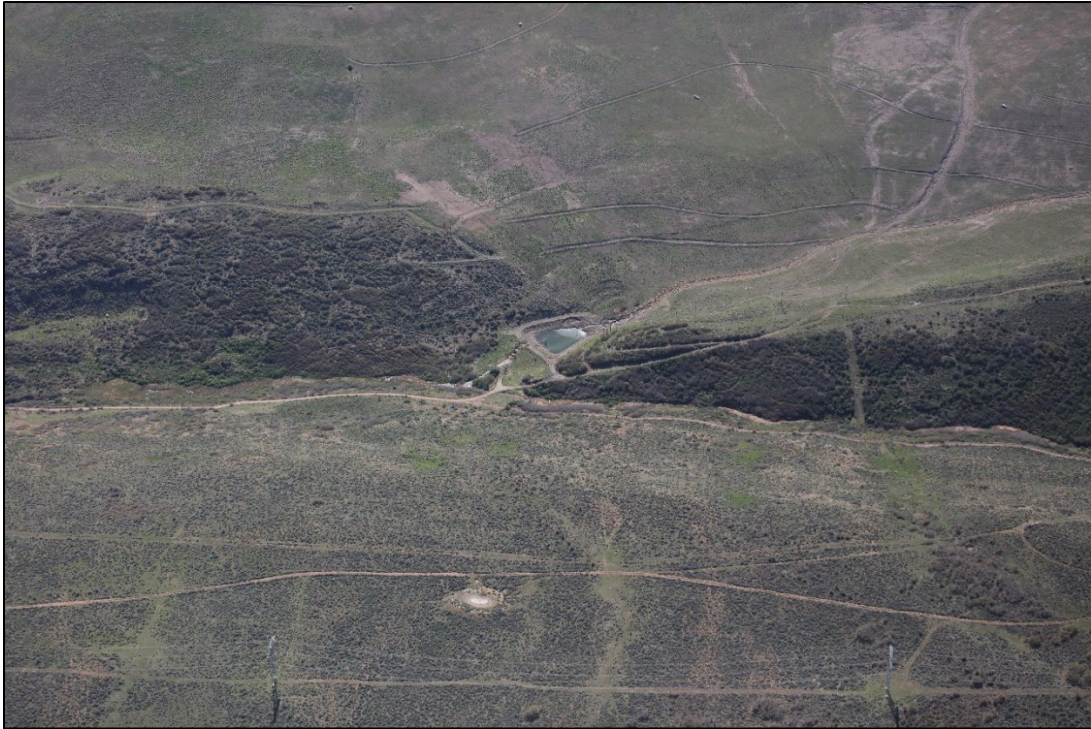
Photo 6: View of the Taylor Ditch and East Taylor Pond.

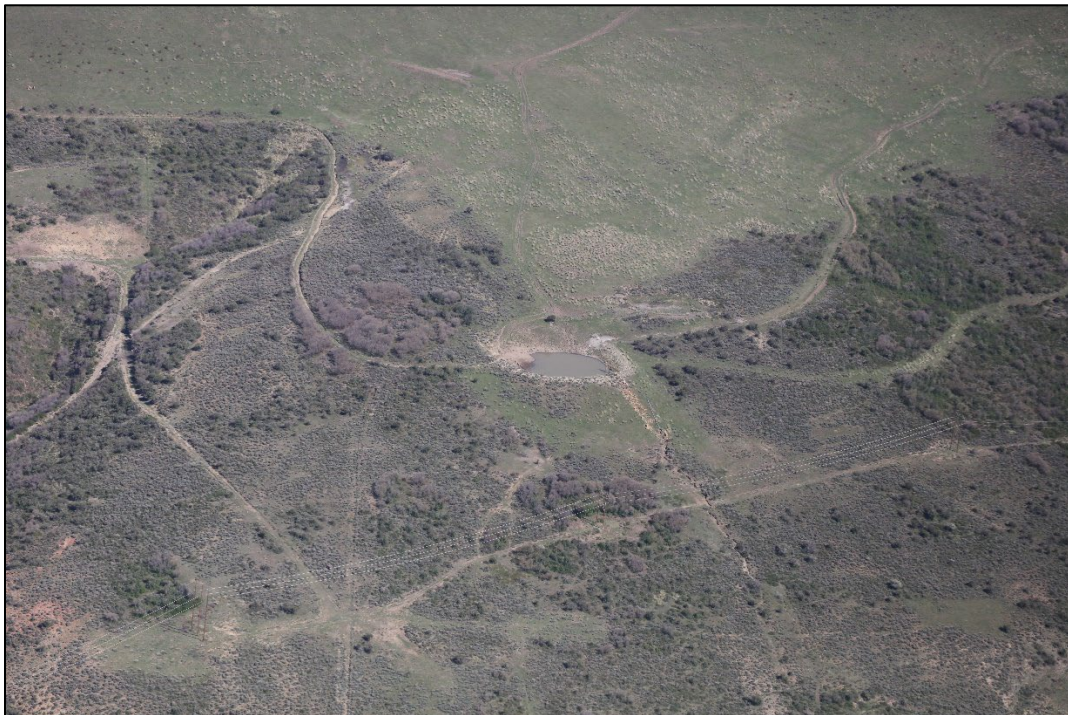
This aerial inspection allowed for observation of several ponds and ditches which were inaccessible during the Division's last inspection. This includes Section 16 Pond, Section 28 Pond, and Section 15 Pond. All ponds appeared to be stable. Section 15 and Section 28 Ponds were dry (Photo 8 and Photo 13). Section 16 Pond was holding water and appeared stable (Photo 7).

Photo 7: View of Section 16 pond.

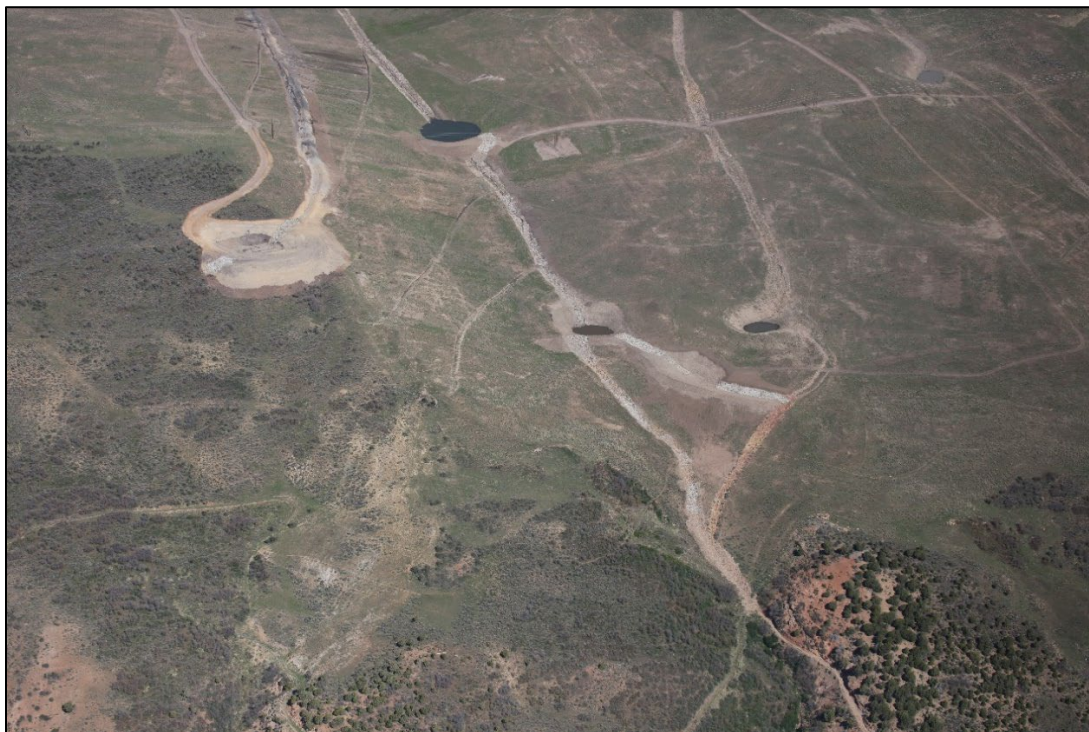
Photo 8: View of Section 15 Pond and the final East Pit ditch and its associated stock ponds: EP1, EP2, and EP3.

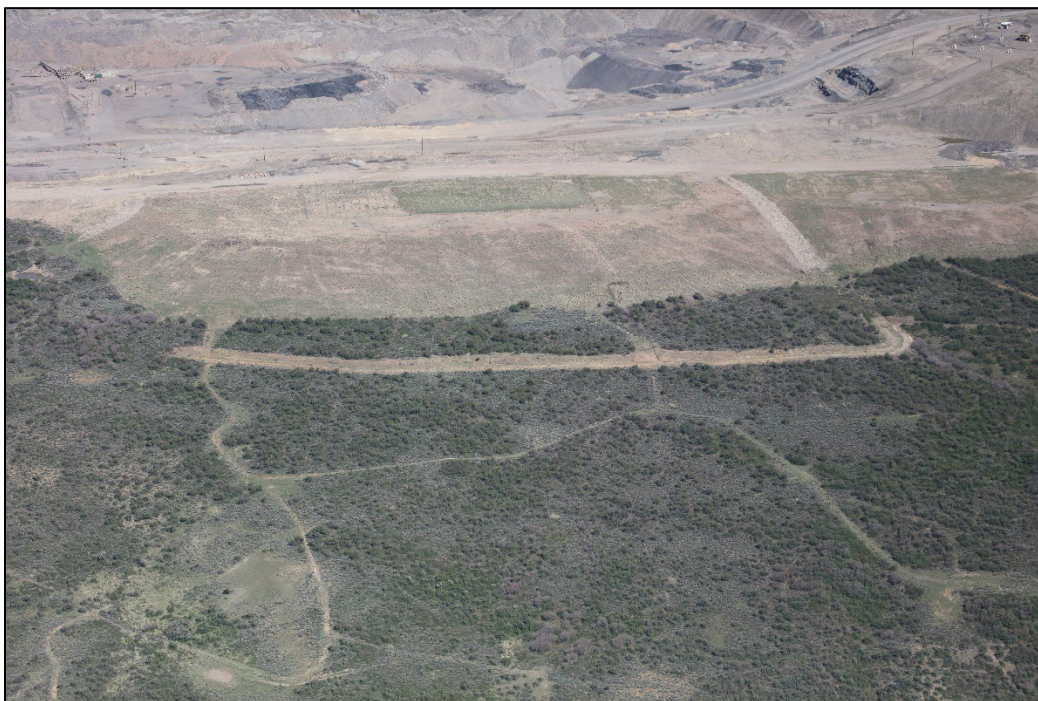
Photo 9: Reclamation parcel located east of the South Taylor pit; the West Section 16 ditch is also visible.

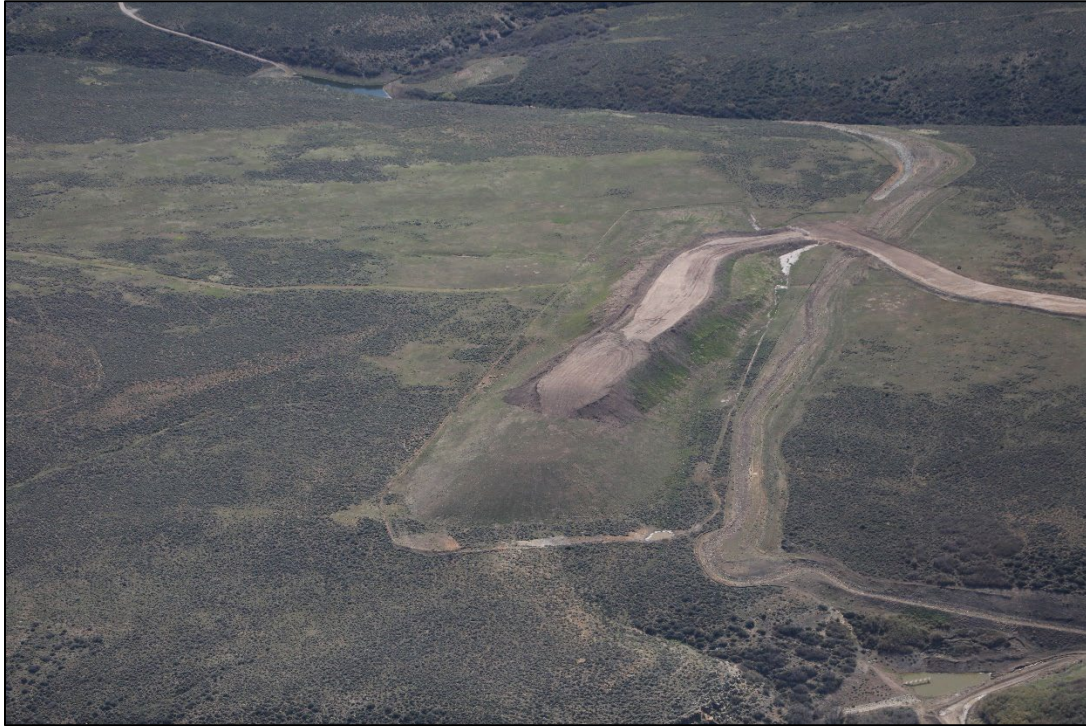
The topsoil pile located in the northernmost section of Collom Pit was photographed. It appears that material may have been recently added to the pile (Photo 10). This topsoil pile will need to be graded and seeded as soon as hauling to this area is complete.

Photo 10: View east of a large topsoil pile located in Collom Pit, view of Section 25 (east) and Section 26 (west) ponds.

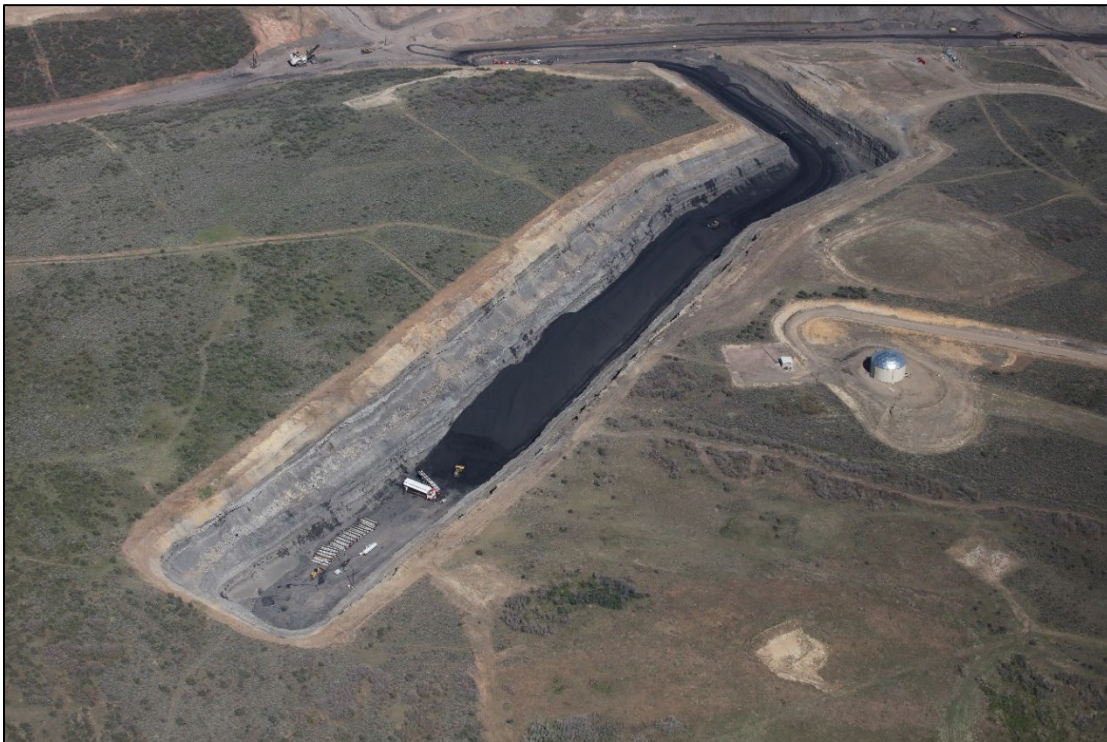
Photo 11: Active highwall mining area on the eastern side of Collom Pit.

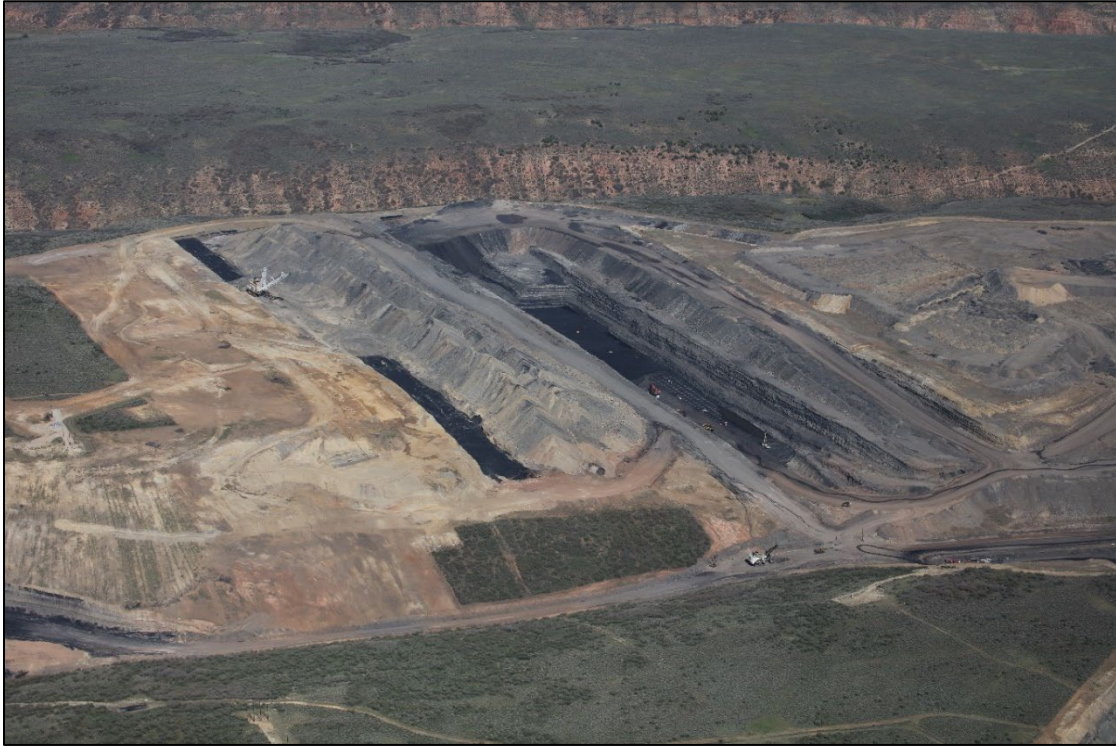
The active truck and load section of the Collom Pit showed signs of prepping for additional blasts (Photo 12).

Photo 12: View west of the active Collom Pit, evidence of prepping for blasts, dragline is visible.

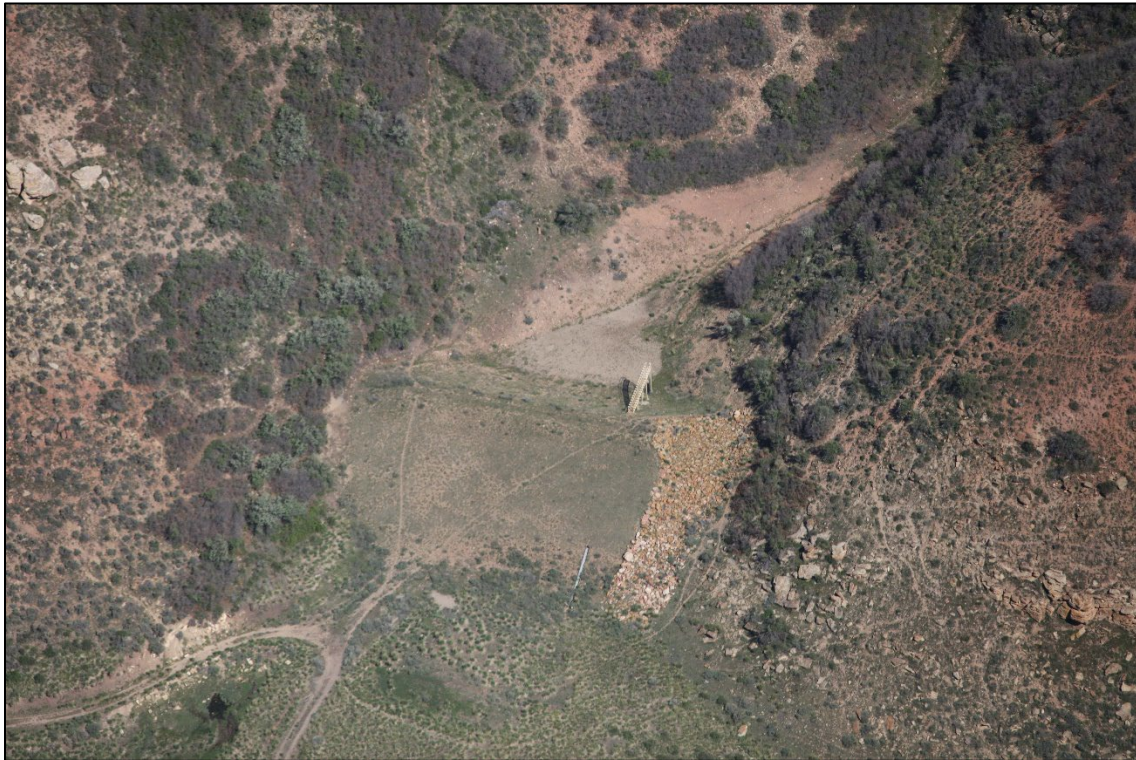
Photo 13: Section 28 Pond.

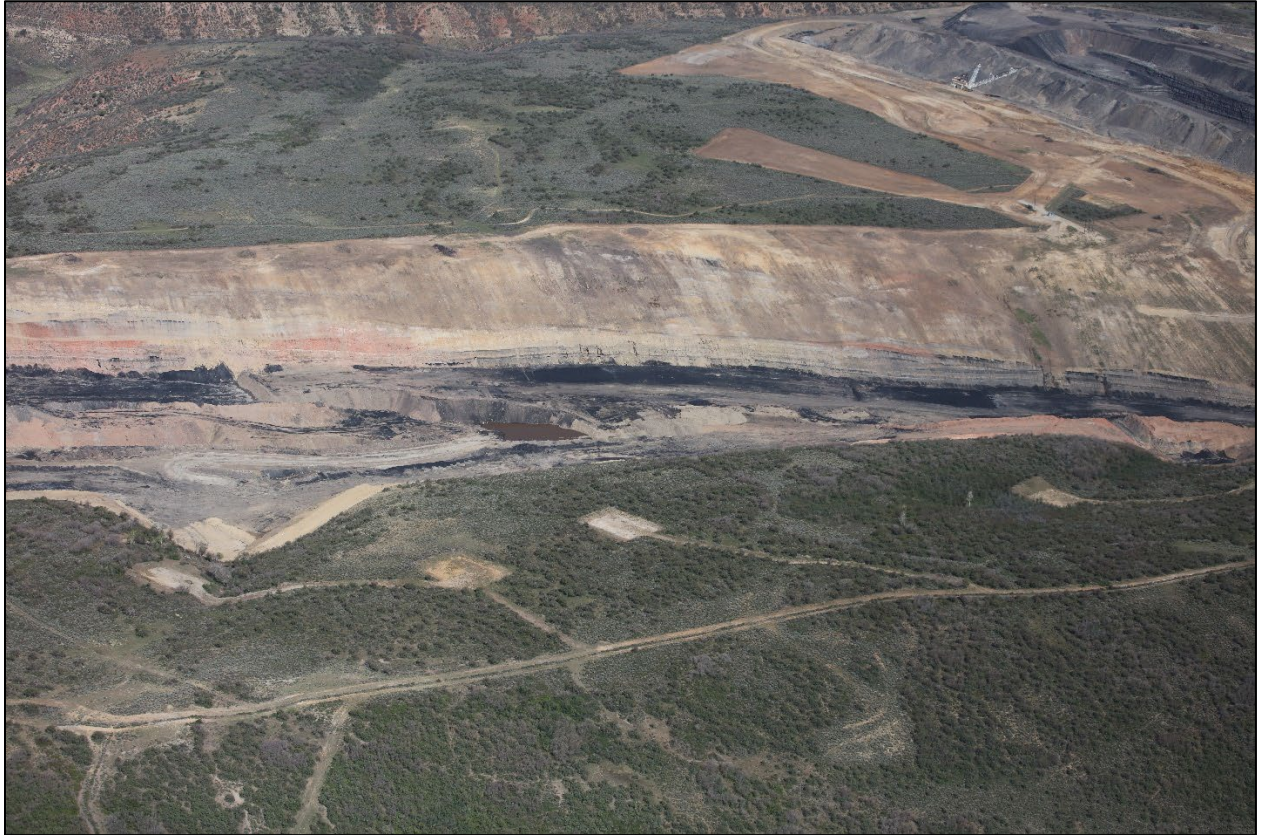
Figure 14: View west of the south end of the Collom Pit, stormwater appears to be ponding in one area.
