File: April 2024 Monitoring Summary

Reference: April 2024 Geotechnical Monitoring Summary Pikeview Quarry

Client/Project
CASTLE AGGREGATE
PIKEVIEW QUARRY SLOPE
MONITORING
Project No.
2057288200

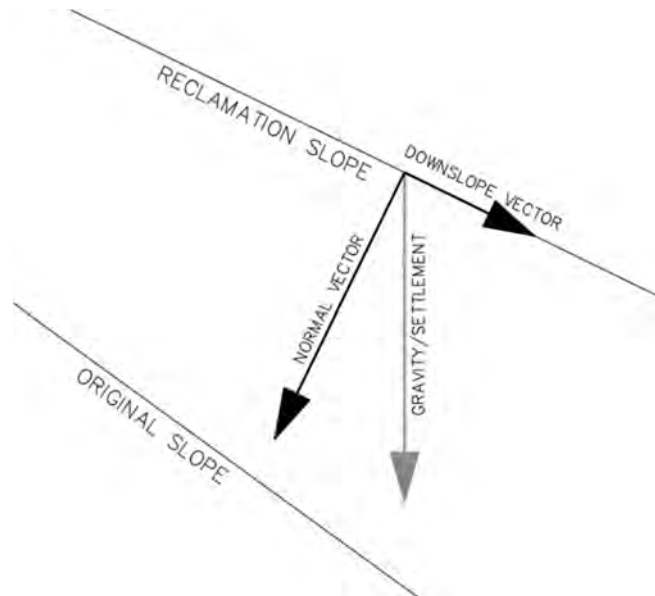
- Cracking was observed on the graded slopes near the upper extents of the fill slope. These tension cracks were observed to be approximately 100 feet long and 2 inches wide. The nature and location of these cracks suggests ongoing settlement of the buttress fill as the likely cause of the cracking. The settlement of the fill on a sloping foundation results in a downslope vector that is causing the cracking. The location near the upper extent of the fill is expected considering the in-situ material further uphill would not experience the settlement that occurs in the fill. Stantec has observed similar cracks on mine slope regrades including sites that did not have a landslide component. The cracks at the other regrade projects also occurred at the upper extent of the fill slope. The vector diagram below shows the settlement due to gravity and the resulting movements normal and parallel to the slope.

- Restricted access to the ungraded landslide slopes should continue.
- All monitoring should continue at current frequencies.
- All alerts shall continue to be taken seriously even if data errors are suspected.
- The upper fill slope should continue to be monitored for signs of increased or ongoing cracking. The area where cracking was observed will be covered with topsoil and erosion control matting in the near future, and the cracking will no longer be visible.
- Areas where cracking has been observed should be graded and compacted to prevent infiltration of runoff through the cracks.

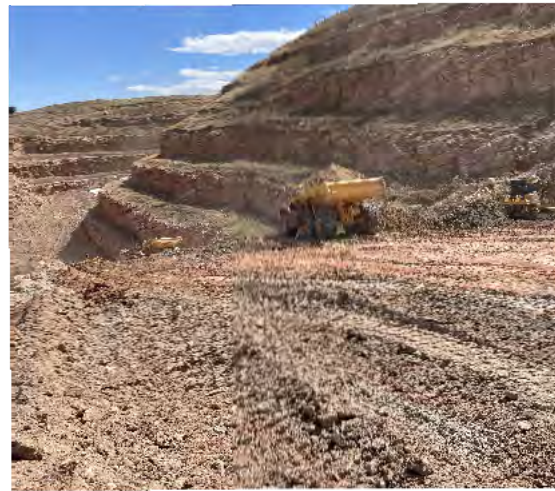
6. PLACING COMPACTED FILL ON BUTTRESS.

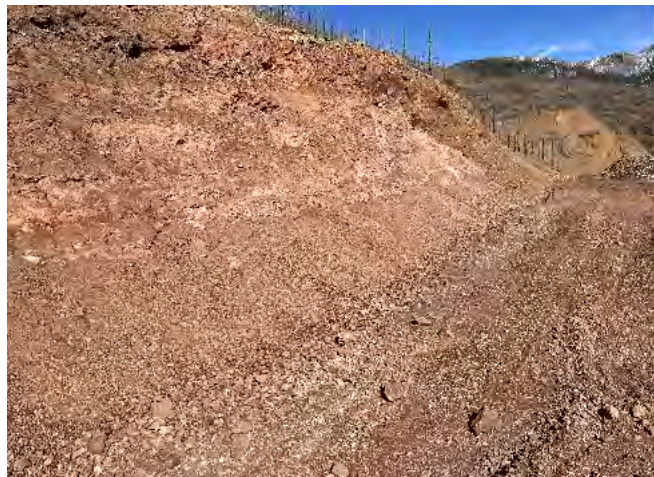
5. BENCHING ON SOUTH PEAK.

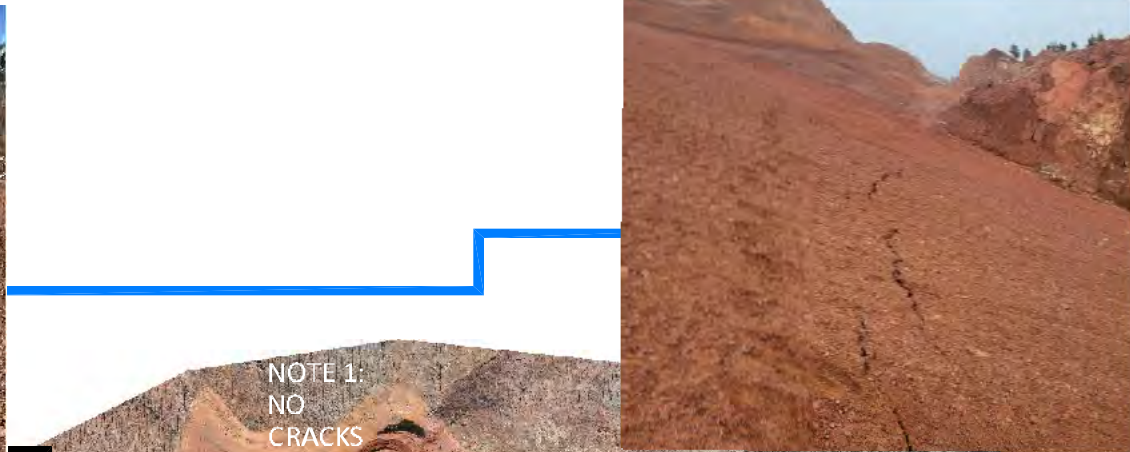
4. CRACKING ON UPPER FILL SLOPE.

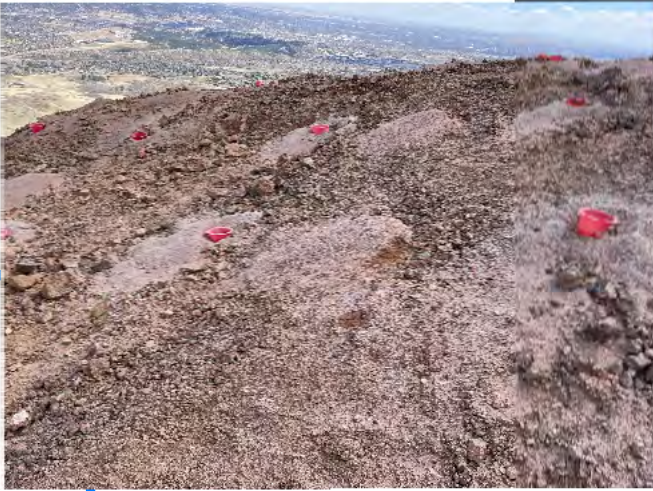
3. BLASTING PREPARATION ON SOUTH PEAK.

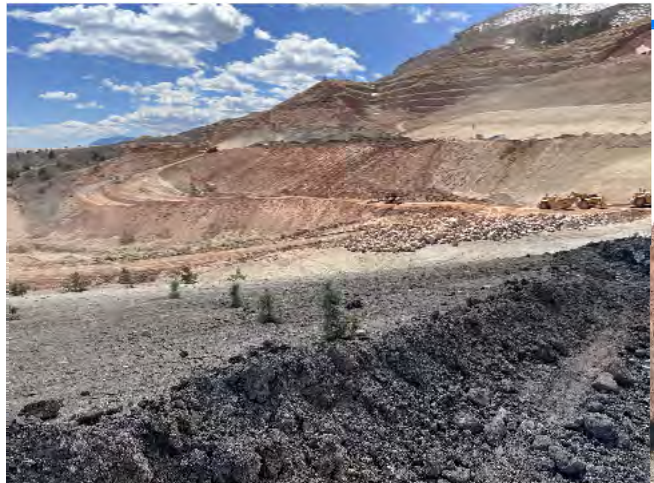
7. VIEW SOUTHWEST OF RECLAMATION.

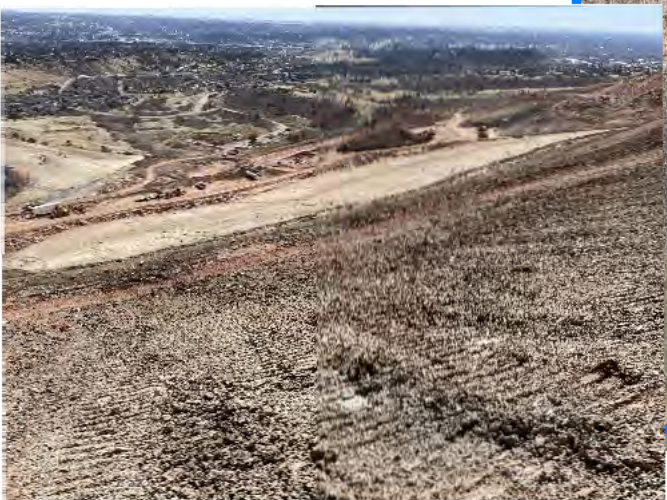
8. SLOPE BELOW CRACKING AREA. NO SIGNS OF MOVEMENT.

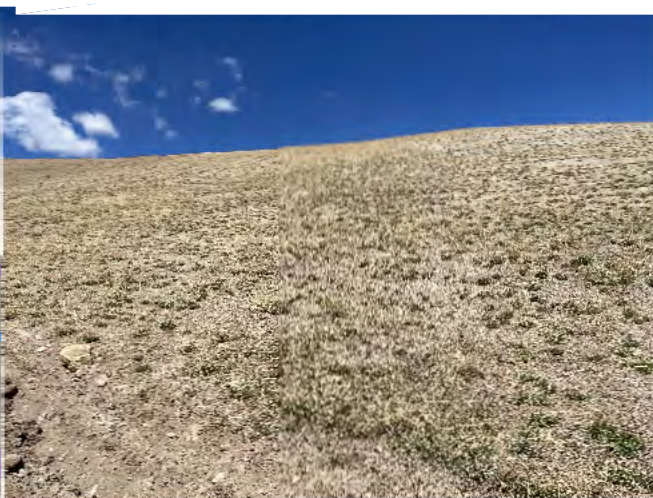
2. GROWTH MEDIUM WITH GRASS ON NORTH SLOPE.

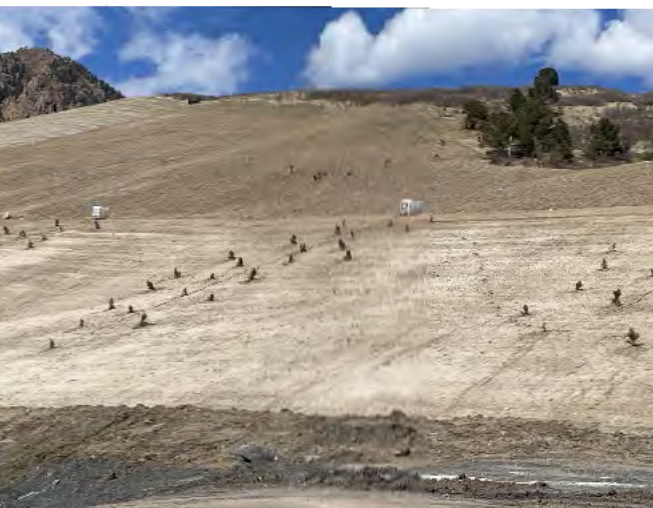
1. GROWTH MEDIUM WITH TREES ON NORTH SLOPE.

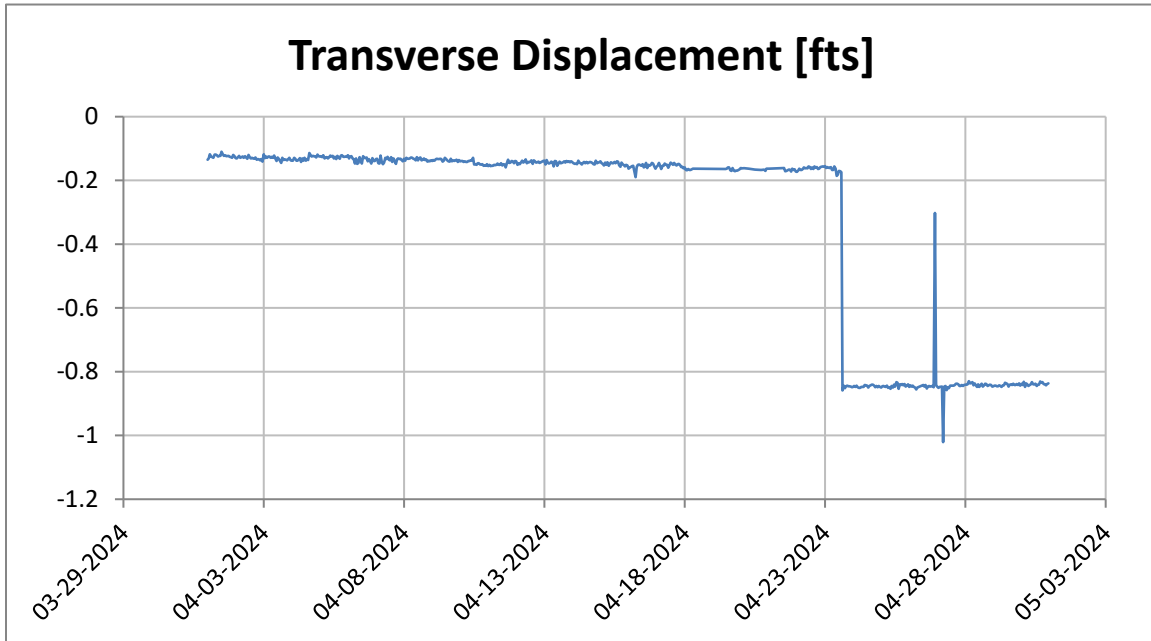
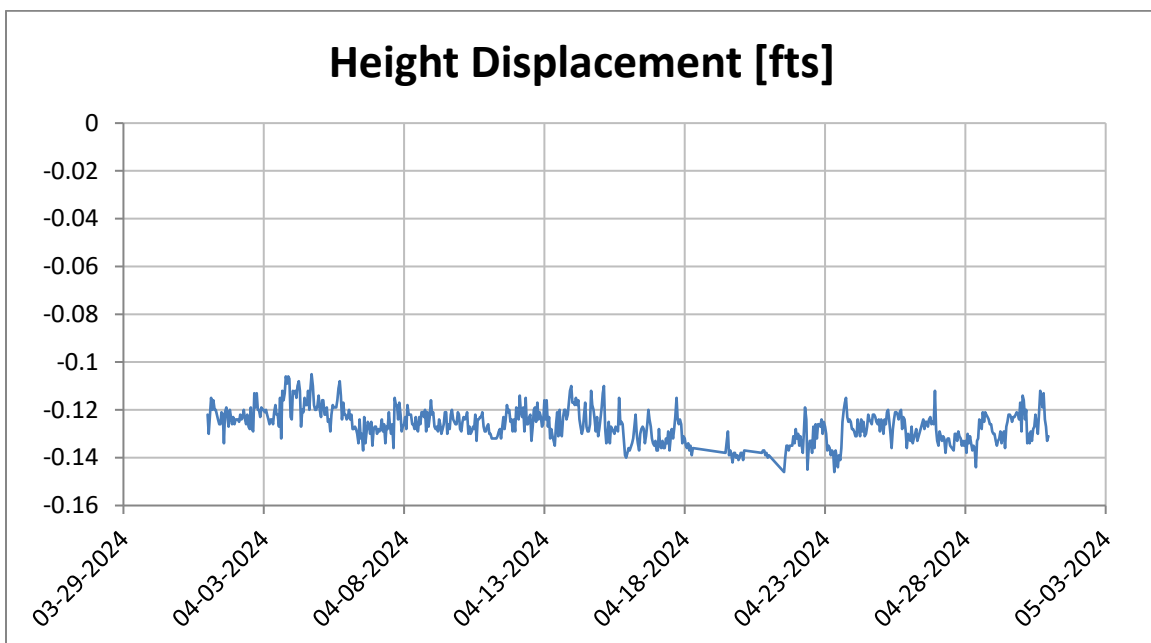
Prism B7300-0

The data show stable conditions with no or very small settlement movements at 21 of 24 prisms. Prisms B7300-0, B7400-1, and B7400-5 recorded movements in April, and these were likely caused by the revegetation crews that were operating in those areas at those time periods. The prisms are believed to have been bumped or impacted by the hydroseeding and/or erosion control matting operations. Prisms on the buttress slope continued to record slow and decreasing gradual movement as the fill consolidates along the benches. The fill is likely consolidating under its own weight and by the placement of topsoil. A small amount of settlement is common for newly placed compacted fill, and this is being recorded by the prisms, which were installed as the buttress was constructed. The previous prism installations were

1. Survey accuracy is +/-0.016 feet.
2. Alert threshold is +/-0.35 feet.
3. Transverse displacement is in the horizontal direction. Positive direction means closer to the robotic total station.
4. Height displacement is in the vertical direction. Positive direction means higher in elevation.
5. Data shift believed to be caused by revegetation operations impacting the prism.

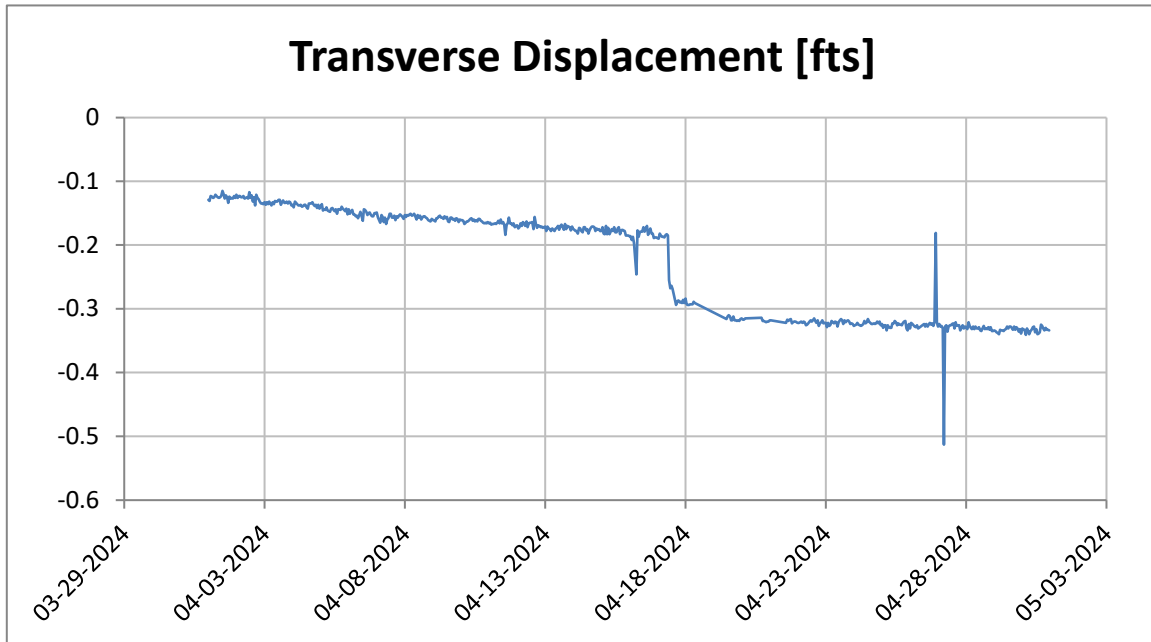
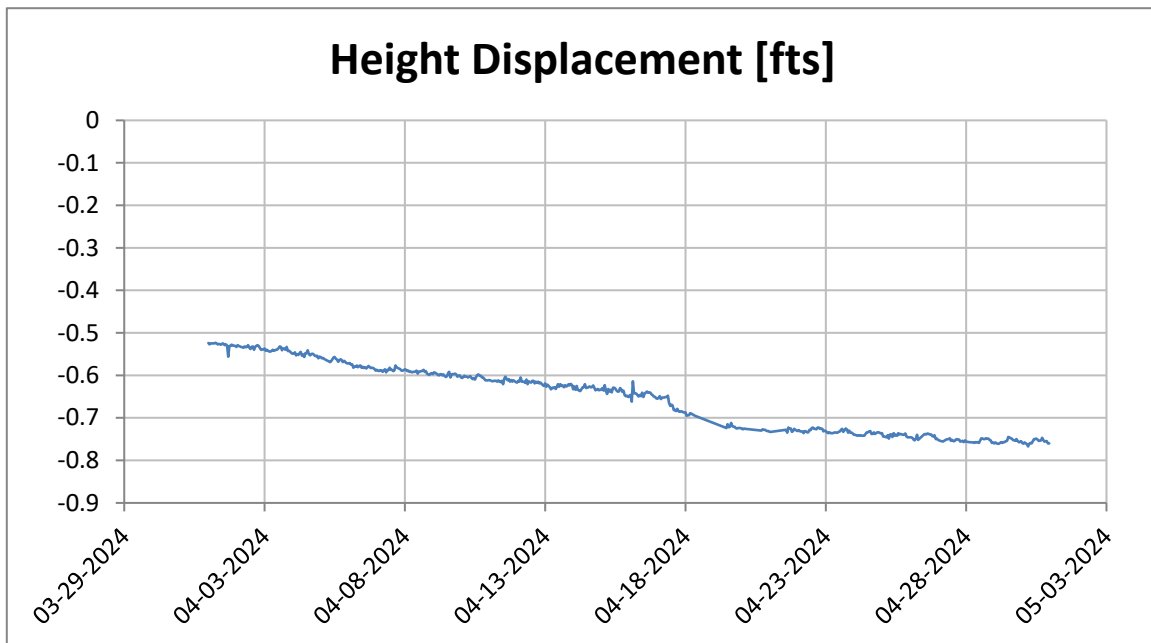
Prism B7400-1

1. Survey accuracy is +/-0.016 feet.
2. Alert threshold is +/-0.35 feet.
3. Transverse displacement is in the horizontal direction. Positive direction means closer to the robotic total station.
4. Height displacement is in the vertical direction. Positive direction means higher in elevation.
5. Movement believed to be settlement of the compacted fill.
6. Data shift believed to be caused by revegetation operations impacting the prism

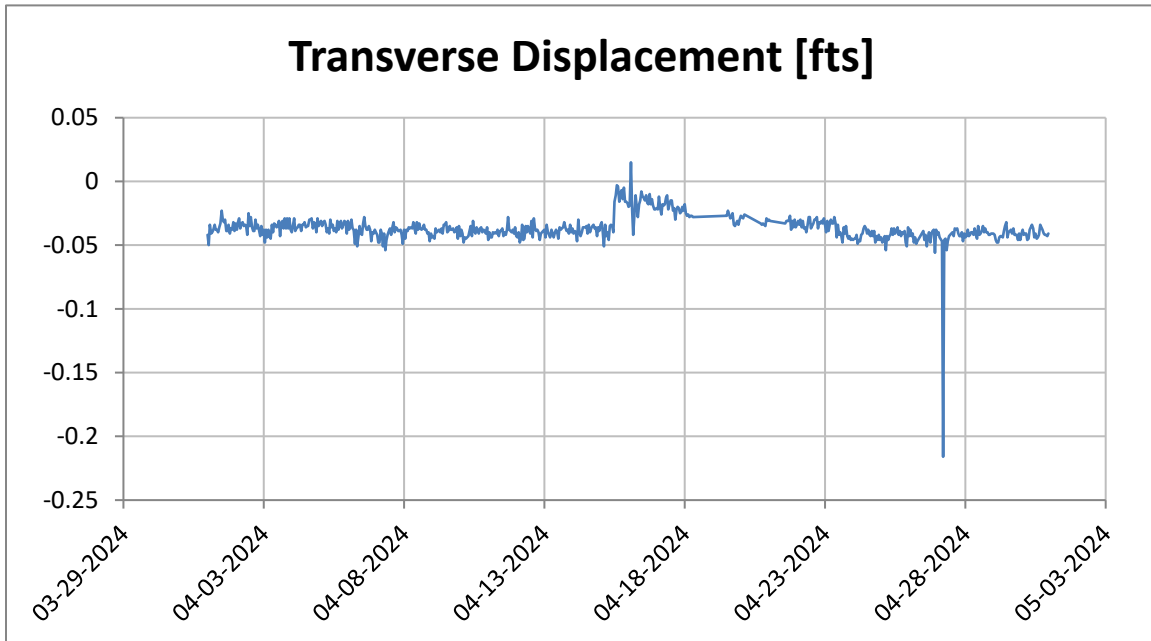
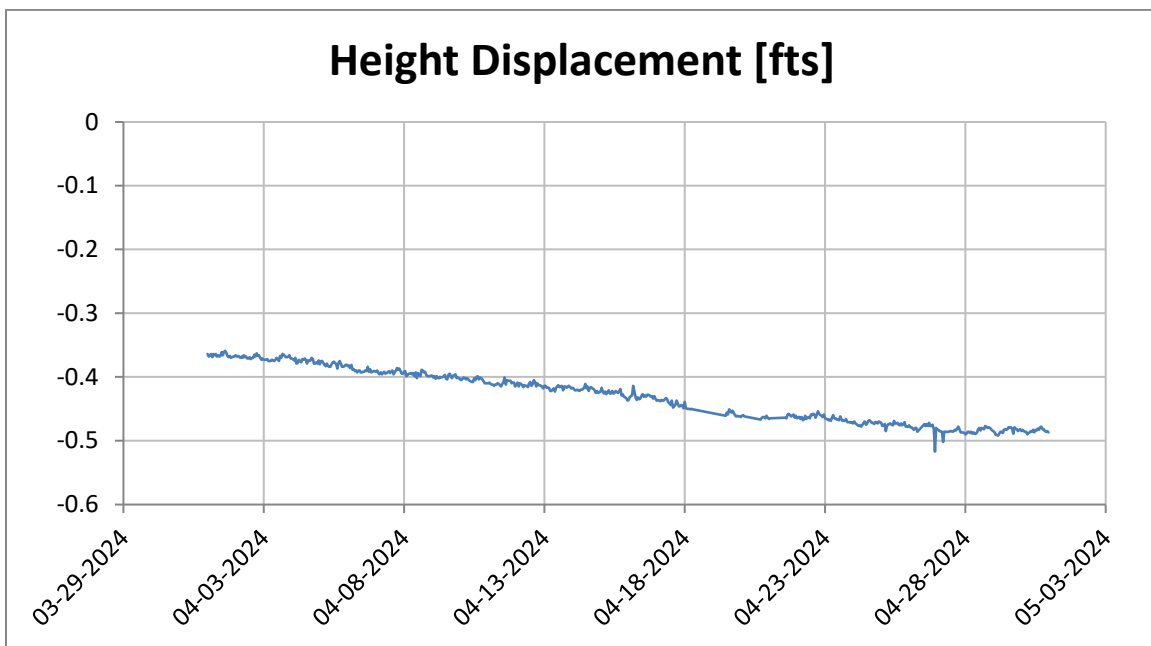
Prism B7400-2

B7400-2	-0.041	-0.487	0.5864	1.0206	Slope creep
B7400-3	0.124	-0.352	0.0726	0.4739	Slope creep
B7400-4	0.530	-0.307	0.0743	0.7094	Slope creep
B7400-5	0.698	-0.127	0.6256	0.7672	Data jump on 4-26. No movement before or after offset.

1. Survey accuracy is +/-0.016 feet.
2. Alert threshold is +/-0.35 feet.
3. Transverse displacement is in the horizontal direction. Positive direction means closer to the robotic total station.
4. Height displacement is in the vertical direction. Positive direction means higher in elevation.
5. Movement believed to be settlement of the compacted fill.

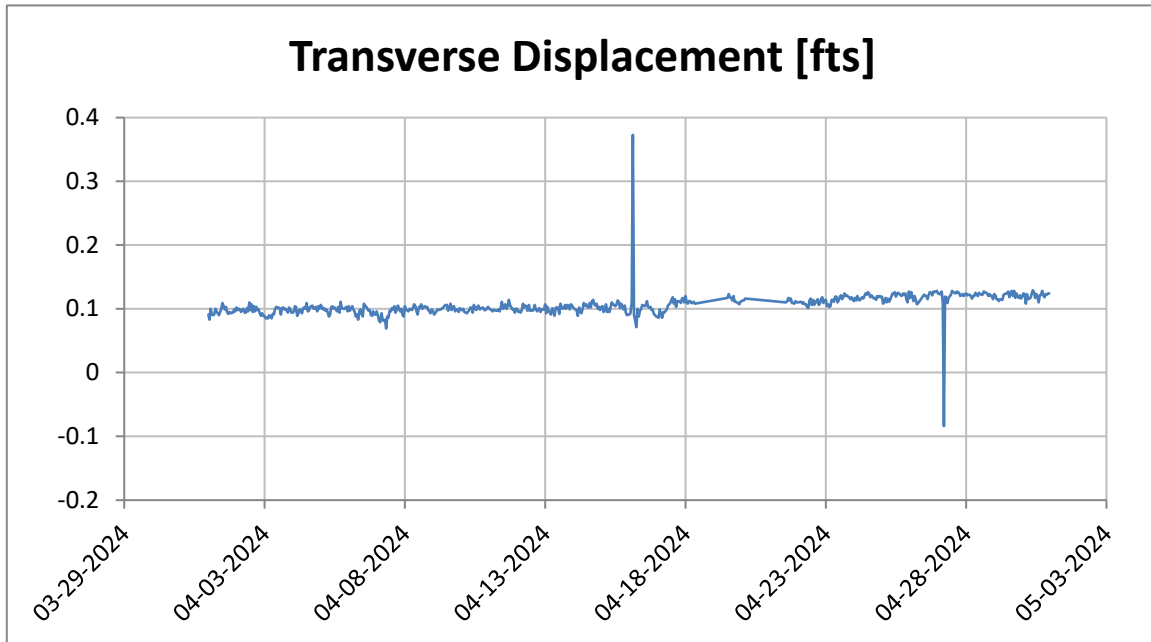
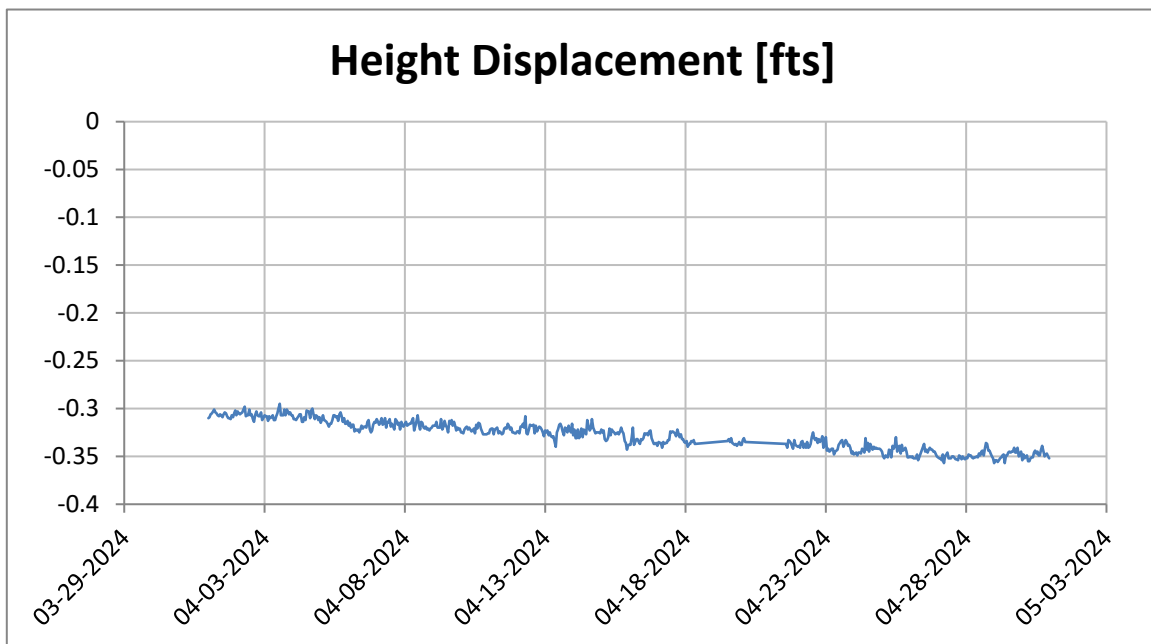
Prism B7400-3

1. Survey accuracy is ± 0.016 feet.
2. Alert threshold is ± 0.35 feet.
3. Transverse displacement is in the horizontal direction. Positive direction means closer to the robotic total station.
4. Height displacement is in the vertical direction. Positive direction means higher in elevation.
5. Movement believed to be settlement of the compacted fill.

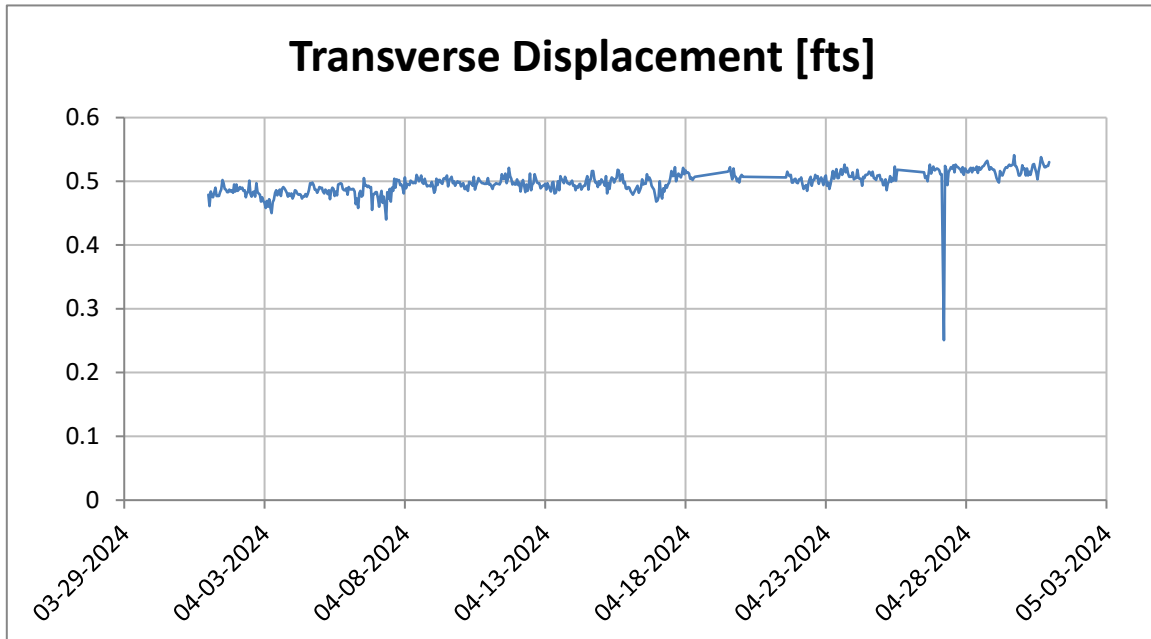
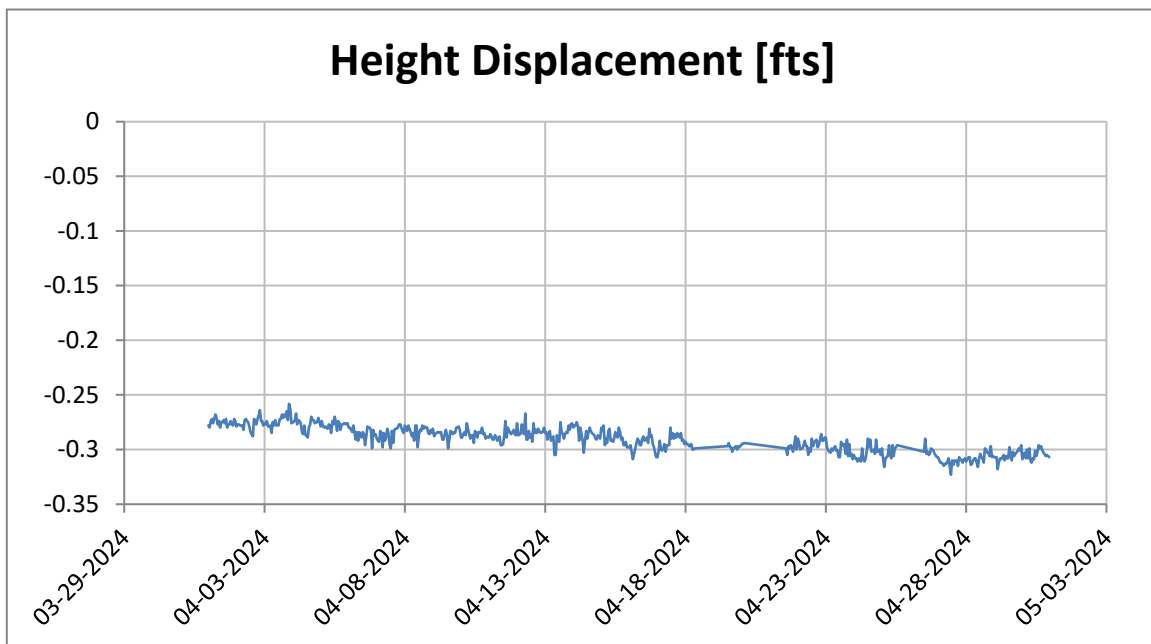
Prism B7400-4

1. Survey accuracy is +/-0.016 feet.
2. Alert threshold is +/-0.35 feet.
3. Transverse displacement is in the horizontal direction. Positive direction means closer to the robotic total station.
4. Height displacement is in the vertical direction. Positive direction means higher in elevation.
5. Movement believed to be settlement of the compacted fill.

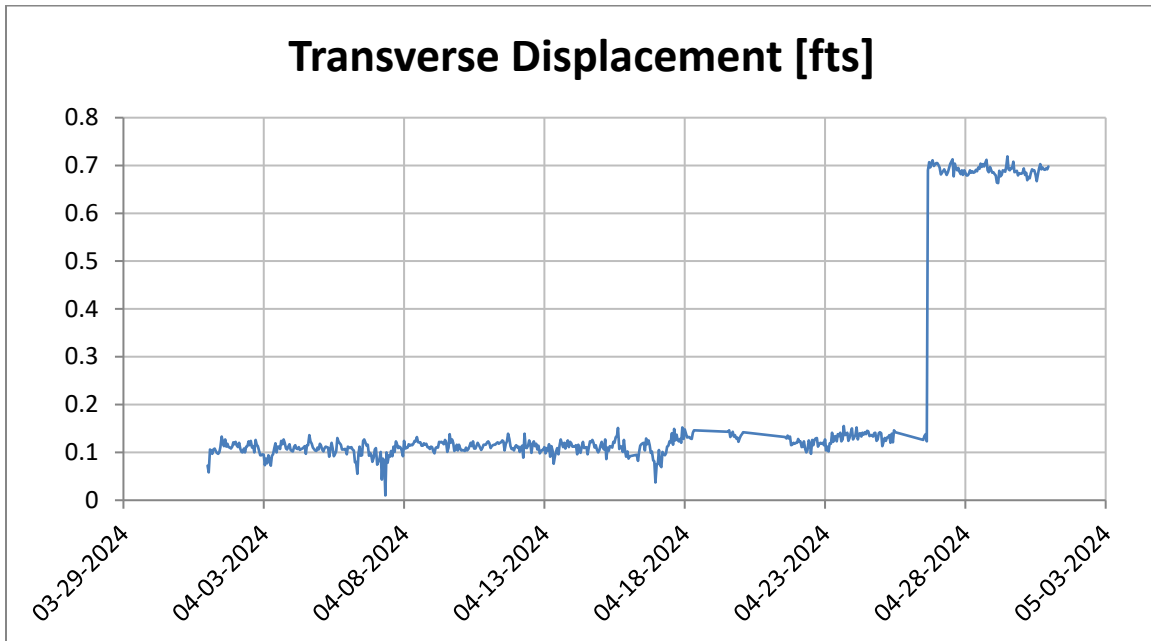
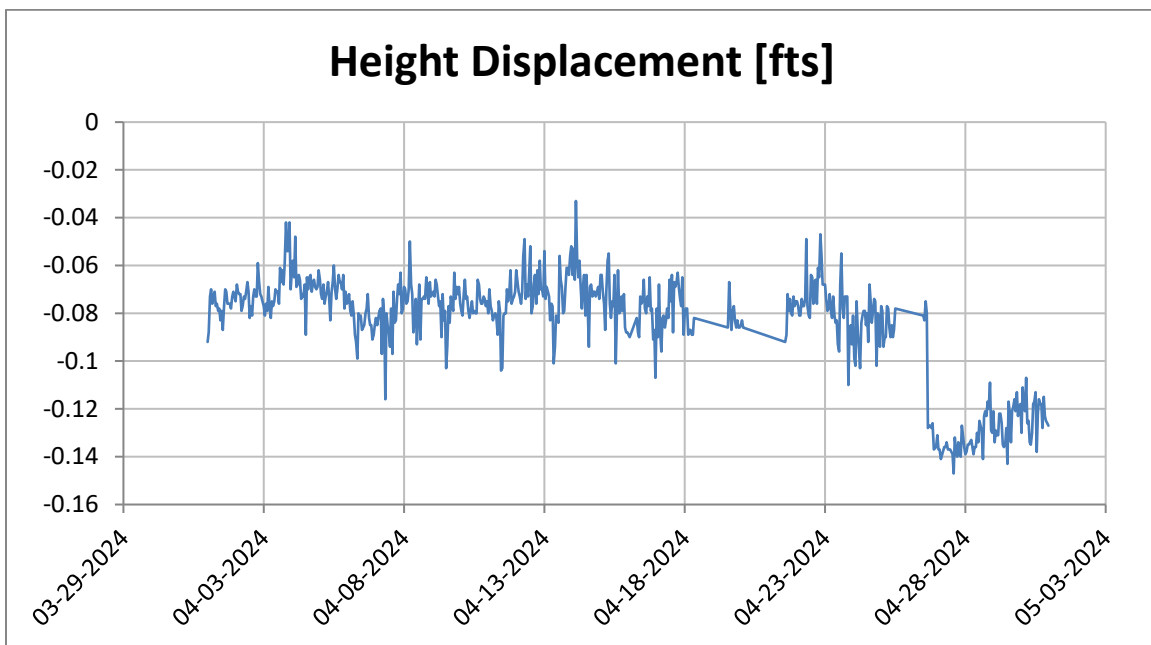
Prism B7400-5

1. Survey accuracy is ± 0.016 feet.
2. Alert threshold is ± 0.35 feet.
3. Transverse displacement is in the horizontal direction. Positive direction means closer to the robotic total station.
4. Height displacement is in the vertical direction. Positive direction means higher in elevation.
5. Data shift believed to be caused by revegetation operations impacting the prism.
