## C1980007, West Elk Mine, May Inspection Report (OSMRE oversight)

**PERMIT INFORMATION**

<b>Permit Number:</b> C-1980-007 <b>Mine Name:</b> West Elk Mine <b>Operator:</b> Mountain Coal Company, LLC <b>Operator Address:</b> Jessica Wilczek 5174 Highway 133 Somerset, CO 81434	<b>County:</b> Delta, Gunnison <b>Operation Type:</b> Underground <b>Permit Status:</b> Active <b>Ownership:</b> Private
	<b>Operator Representative Present:</b>  Garren Atchley
<b>Operator Representative Signature: (Field Issuance Only)</b>

<b>Inspection Start Date:</b> May 22, 2024 <b>Inspection Start Time:</b> 09:00 <b>Inspection End Date:</b> <b>Inspection End Time:</b>	<b>Inspection Type:</b> Coal Partial Inspection <b>Inspection Reason:</b> OSM Oversight Inspection <b>Weather:</b> Clear
<b>Joint Inspection Agency:</b>  None	<b>Joint Inspection Contacts:</b>  
<b>Post Inspection Agency:</b>  None	<b>Post Inspection Contacts:</b>  
<b>Inspector(s):</b>  Leigh Simmons	<b>Inspector's Signature:</b>

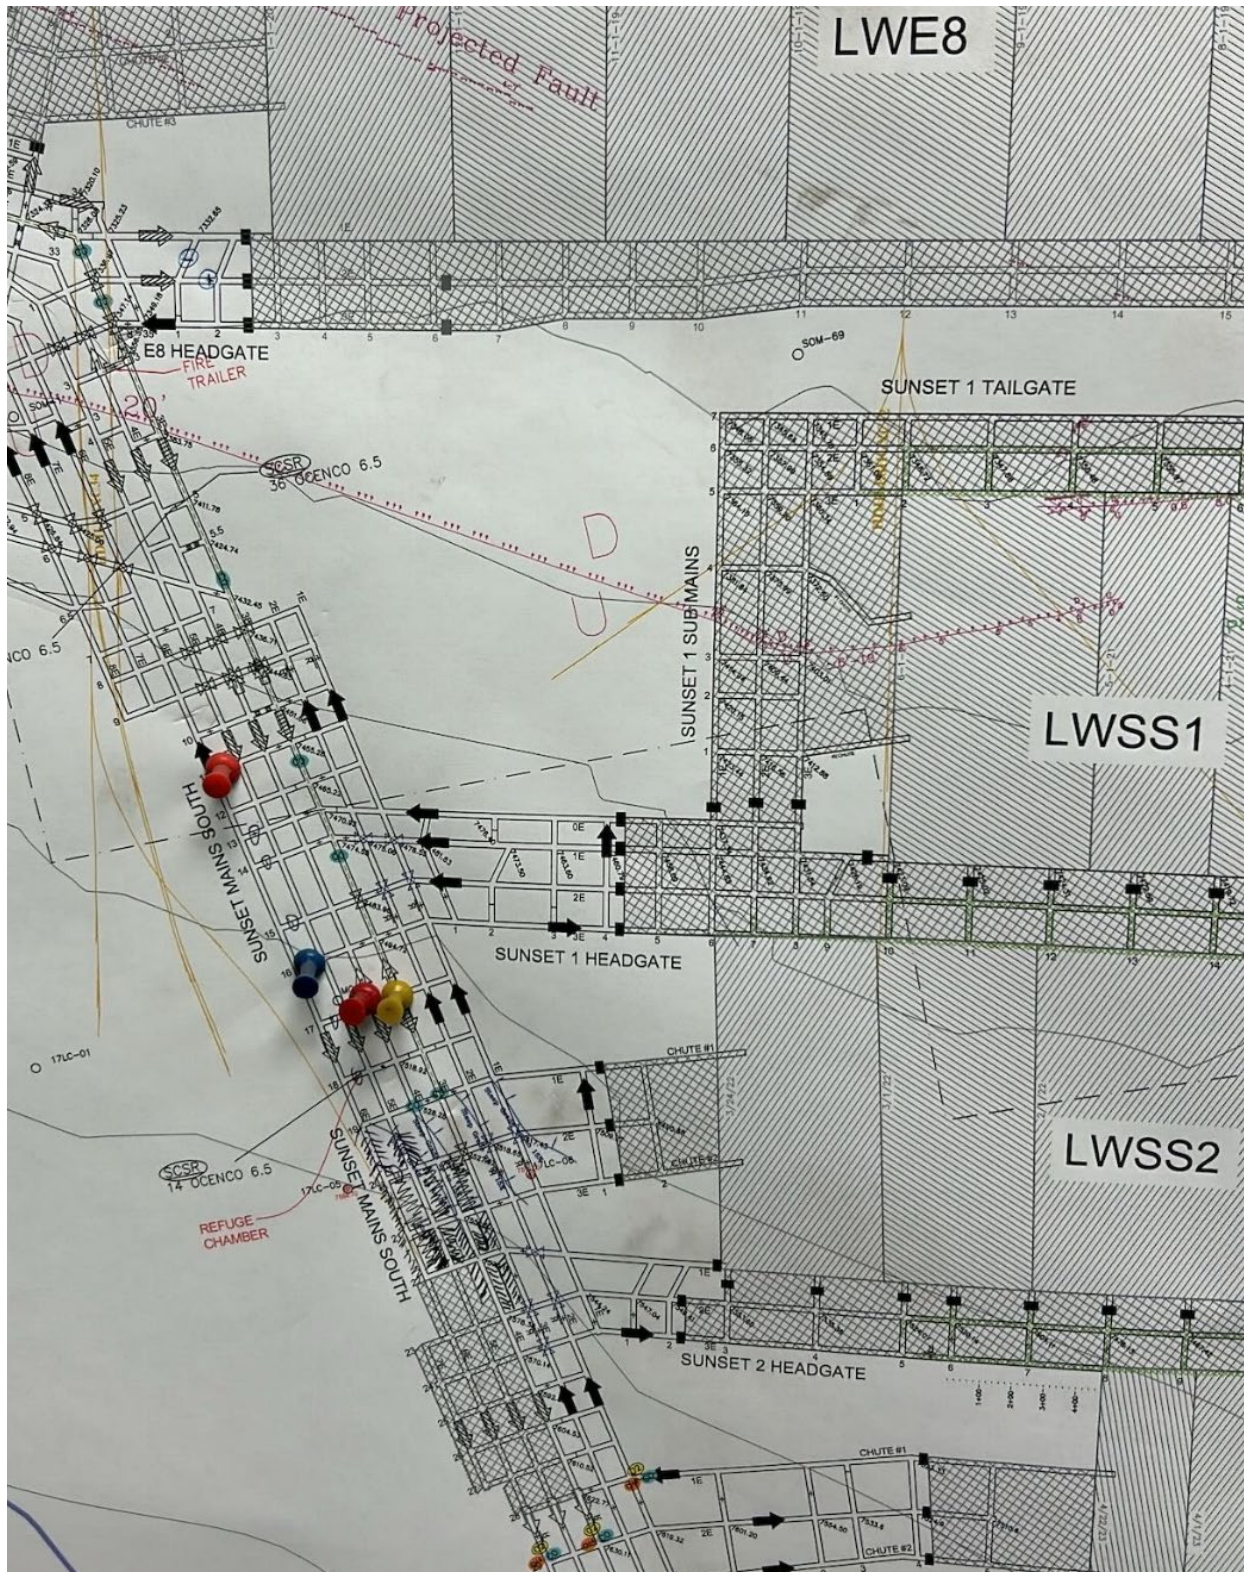
Pillaring of the Sunset Mains South was in progress, at around crosscut 19. The work was being done by contractors with Phoenix Mining.

Figure 3: Mine map showing pillaring progress in Sunset Mains South

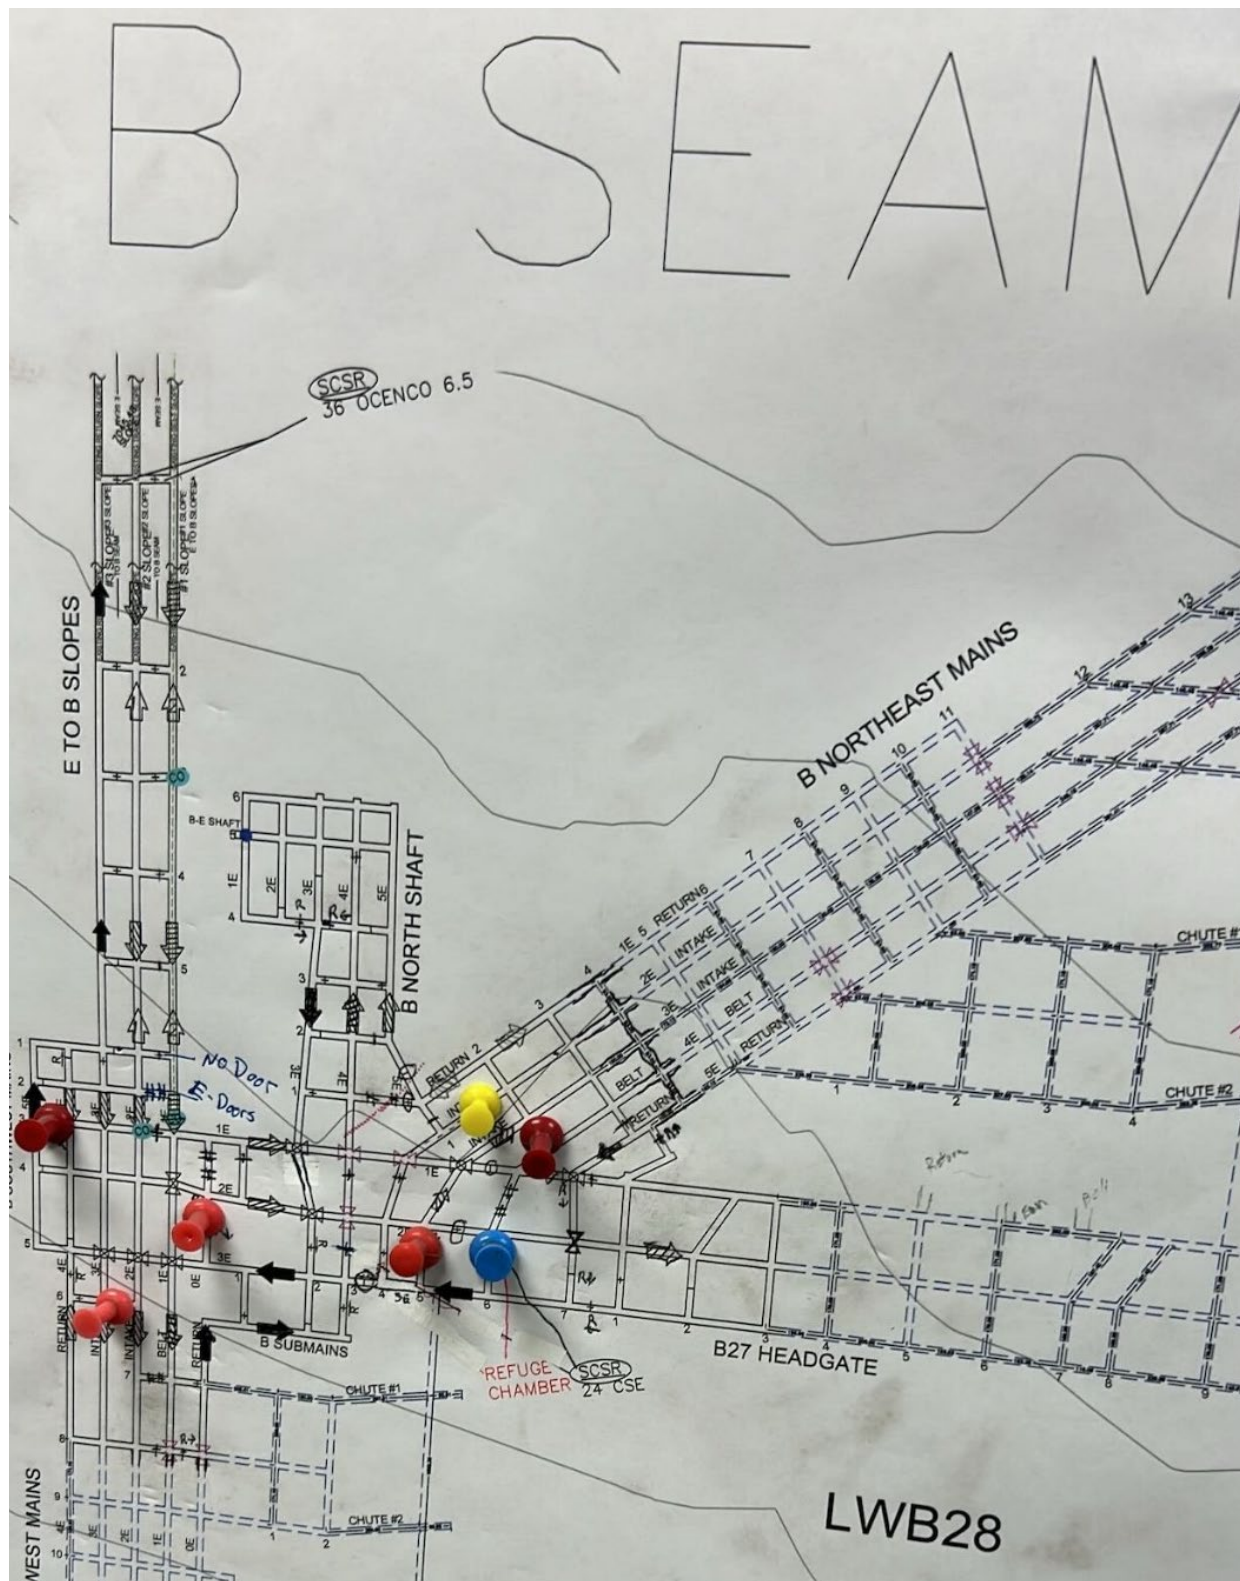
Two crews were also working in the B-seam mains; a Phoenix Mining crew shoring up development work, and a MCC crew preparing the beltline.

Figure 4: Mine map showing development progress in B-Seam

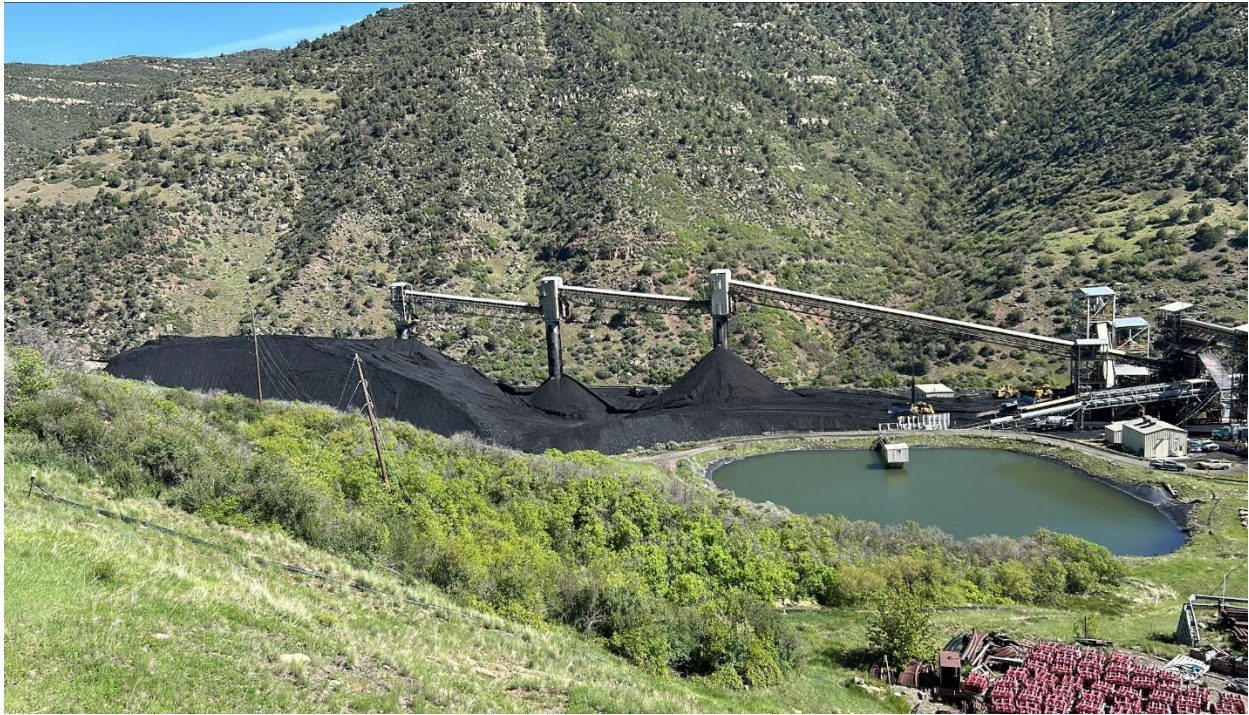
*Figure 5: Run-of-Mine coal stockpile*

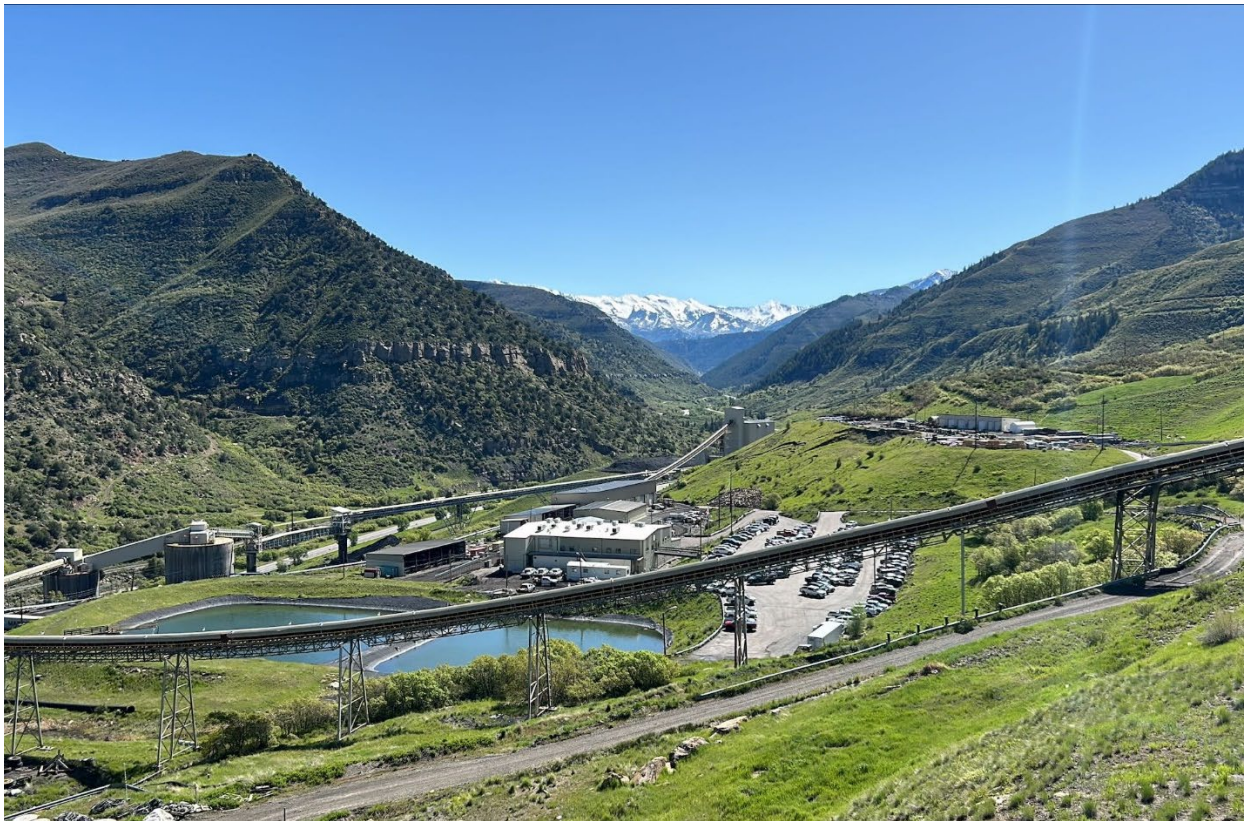
The slide on the out-slope of the Material Storage Bench (MSB) was inspected and discussed. There was no evidence of any recent movement. MCC continued to operate on the reduced surface of the bench with no issues and did not have any immediate plans to repair the bench.

*Figure 6: Overview of facilities area, with Material Storage Bench center right*

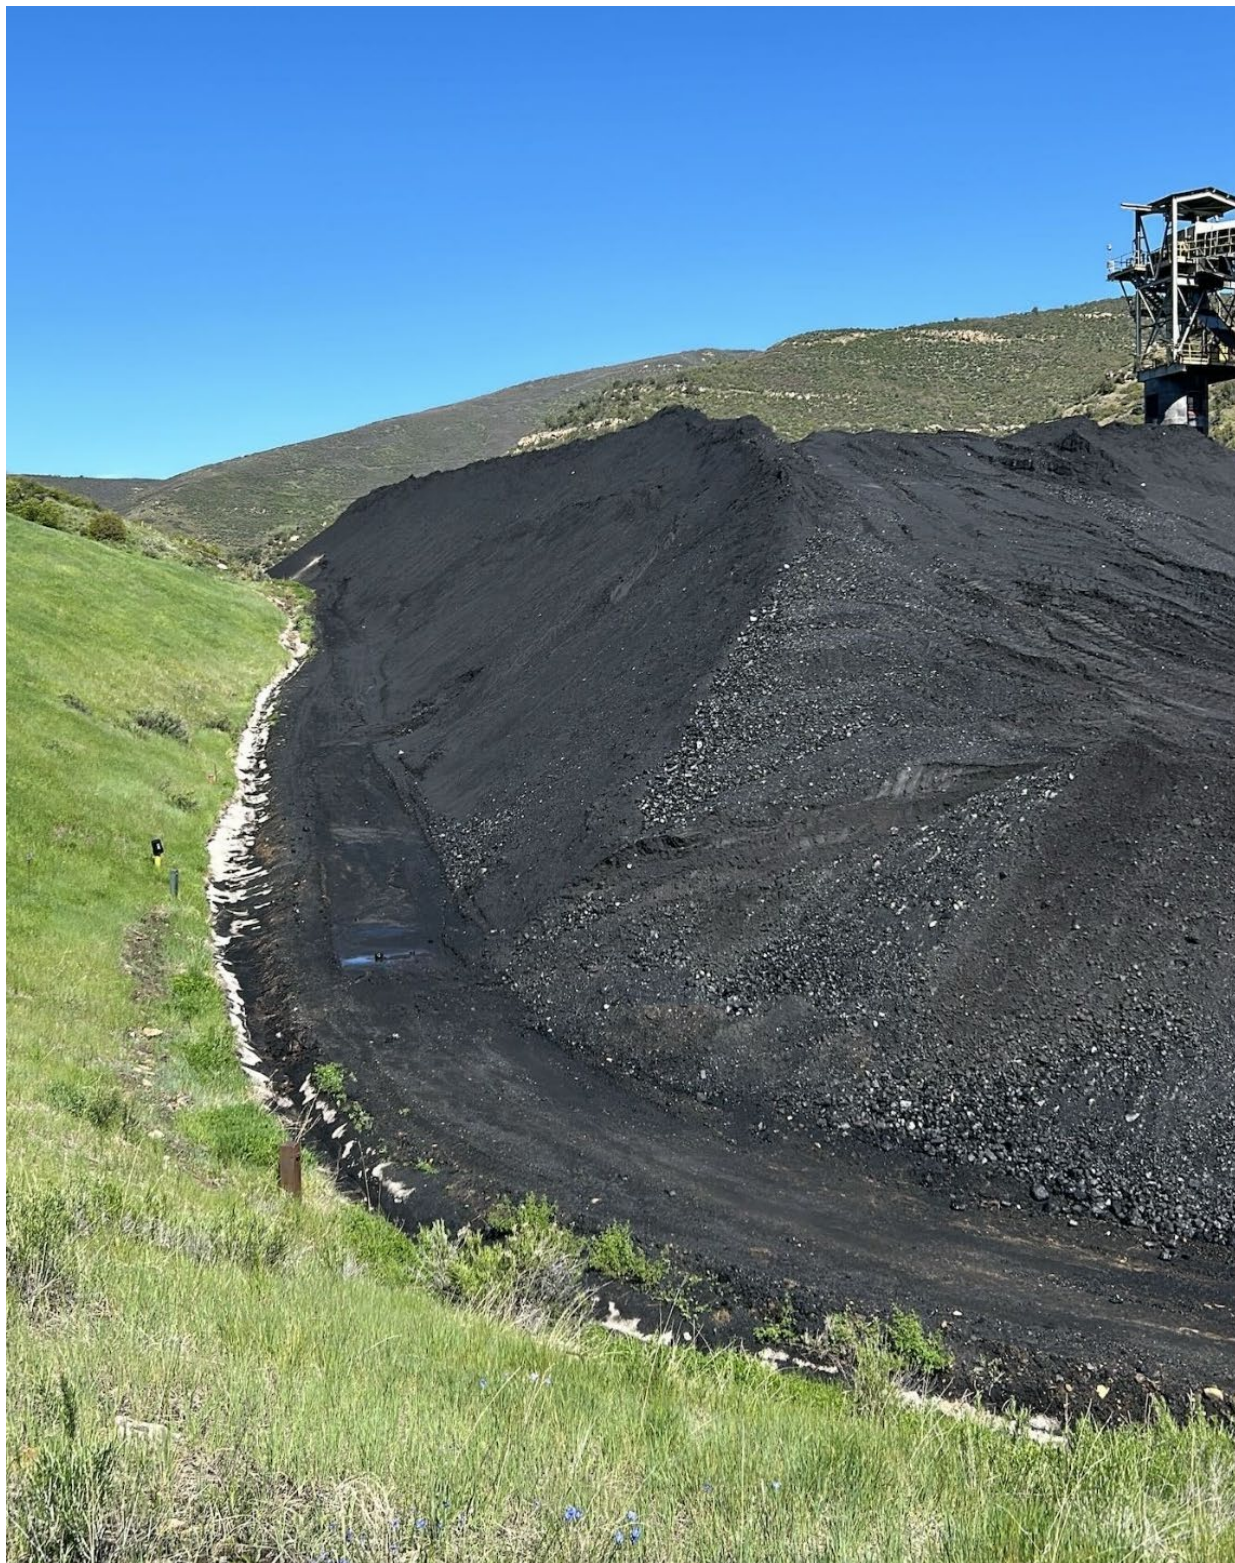
*Figure 7: Run-of-Mine Coal Stockpile, within boundary of stockpile footprint*

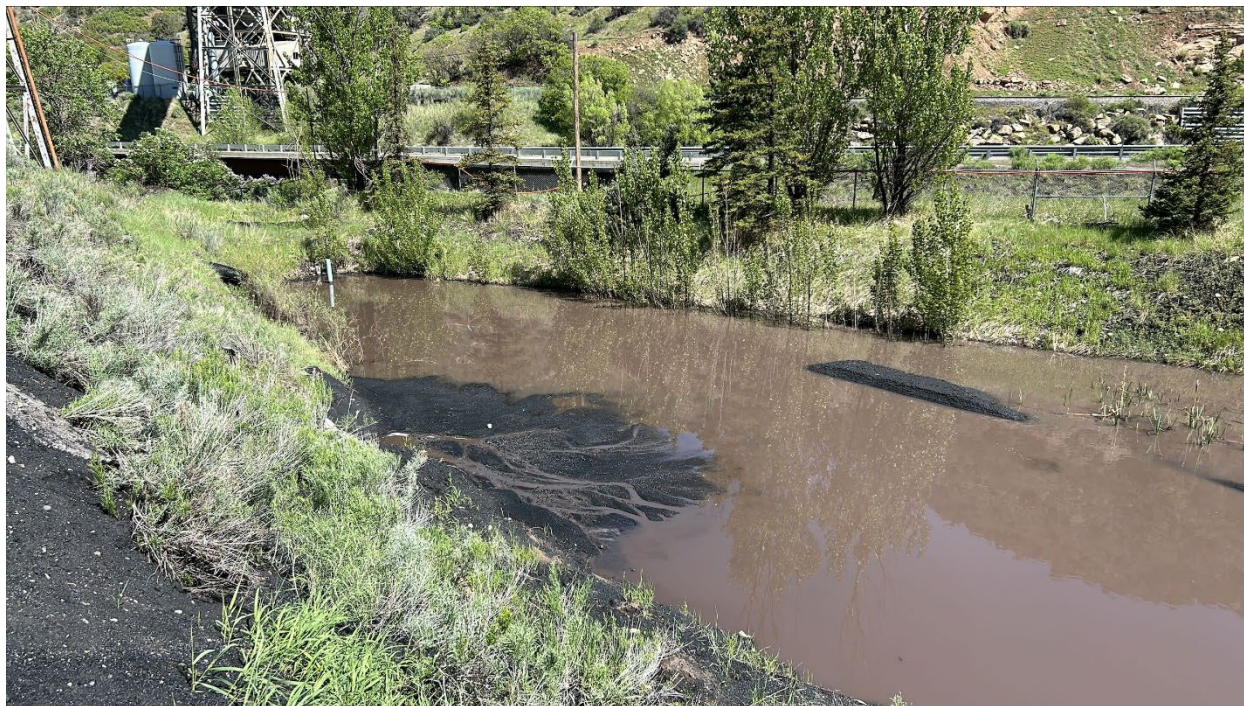
Ditches and culverts around the facilities area were in good order, with no evidence of disruptions to the designed surface water treatment system despite recent wet weather. The RPE, MB3, MB5E and SG1 ponds were inspected. None of the ponds were discharging, or close to the discharge level. Pond embankments and spillways were in good order. Pond cleaning and surveying was scheduled for the summer of 2024, probably in August.

*Figure 8: MB3 pond*

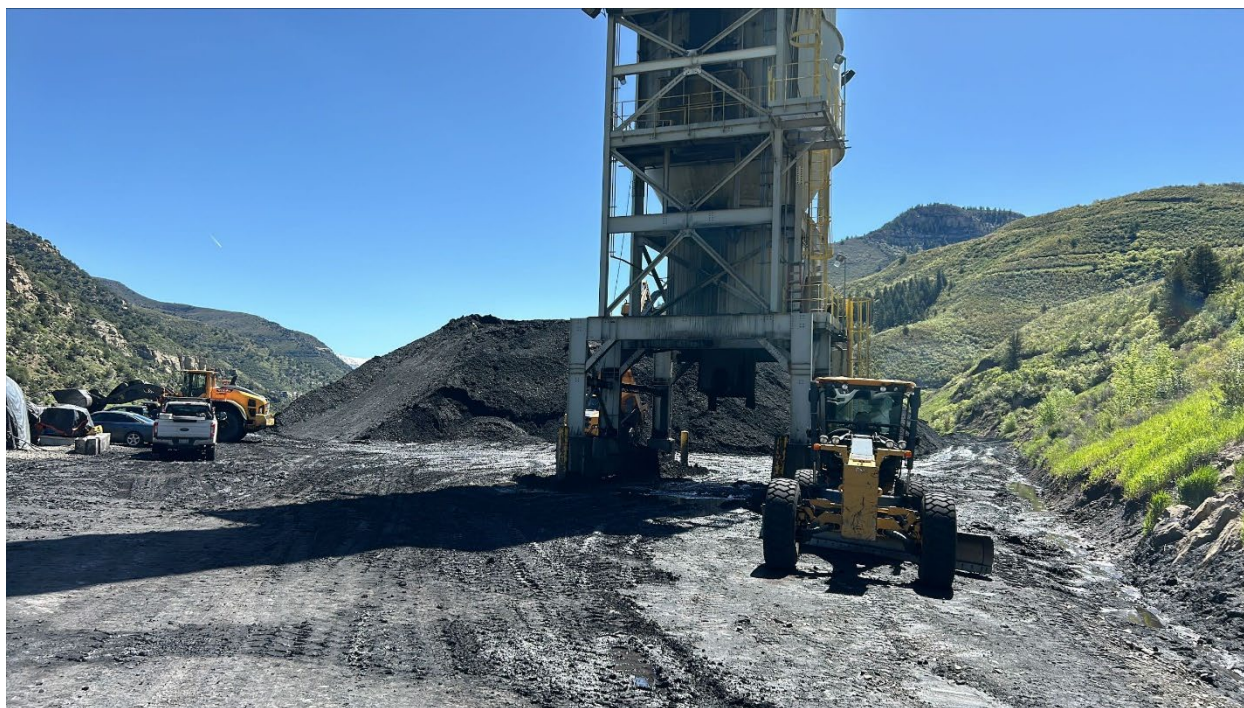
Refuse was being generated at the time of the inspection. Given the damp surface of the RPEE haul road following recent wet weather, no attempt was being made to haul the material to the RPEE (and no attempt was made to inspect the RPEE). The refuse was being temporarily stockpiled on the RPE.

*Figure 9: Temporary refuse pile on surface of RPE*

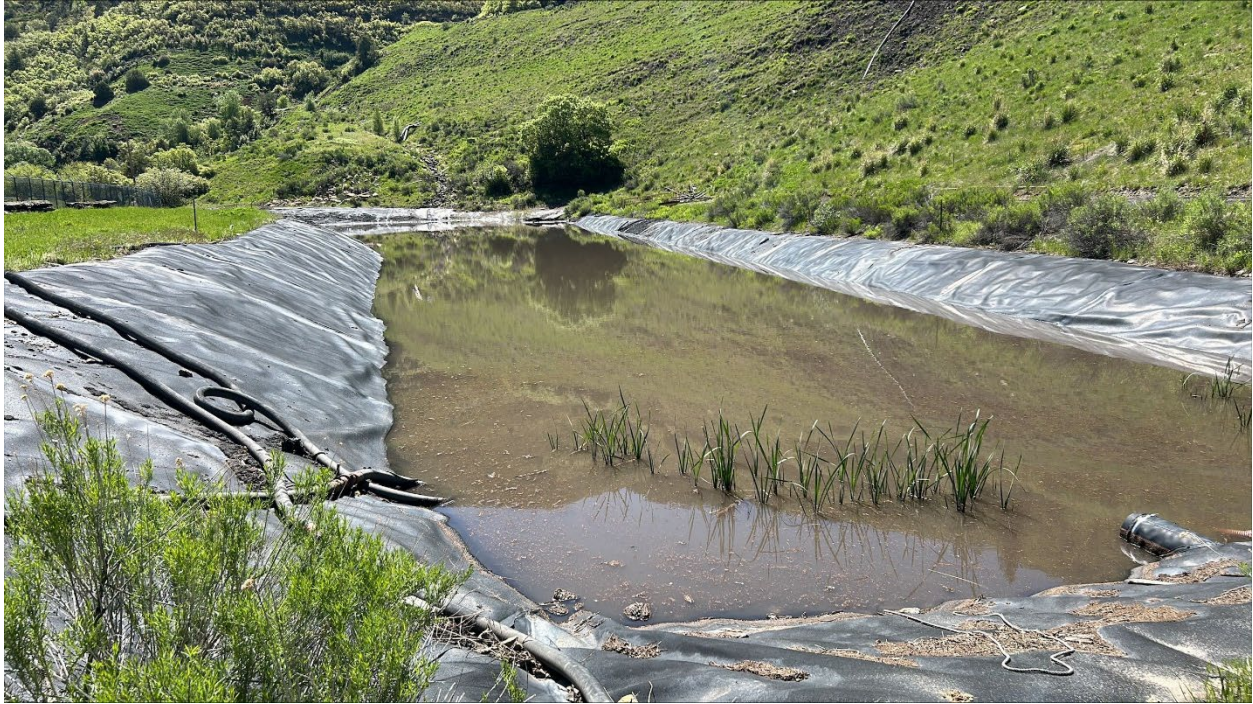
Figure 10: RPE pond, east cell

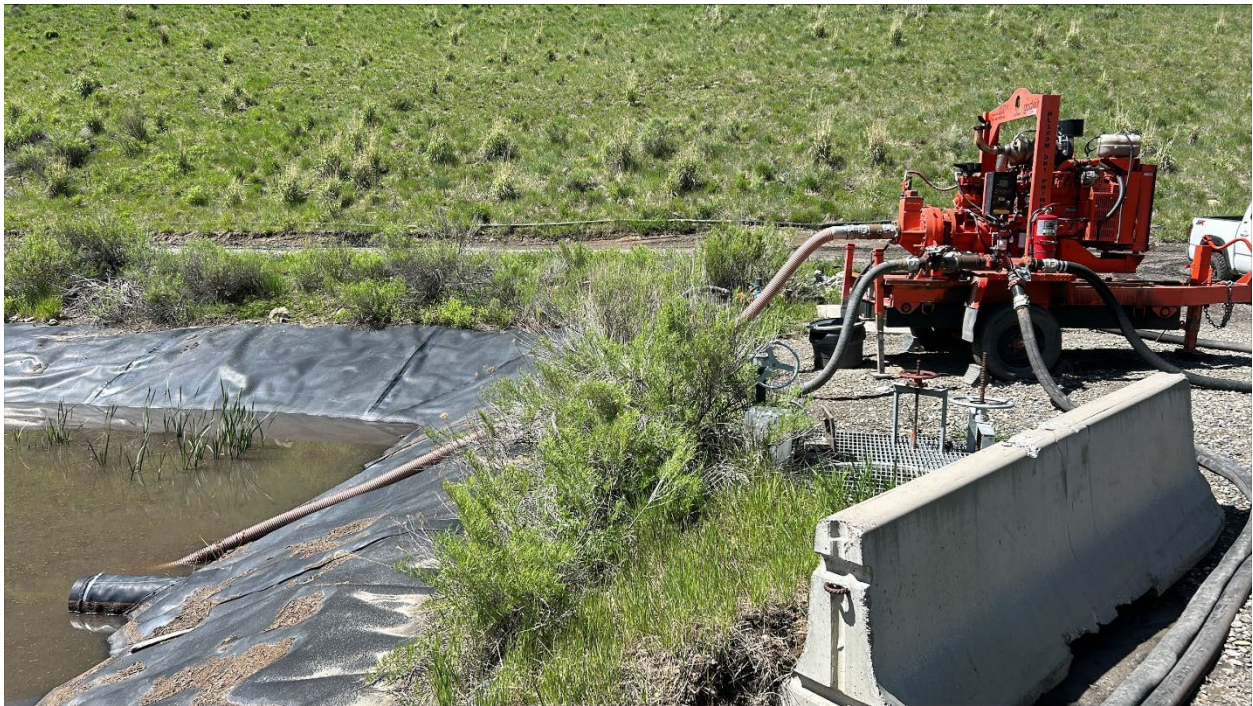
Figure 11: Pump at RPE pond

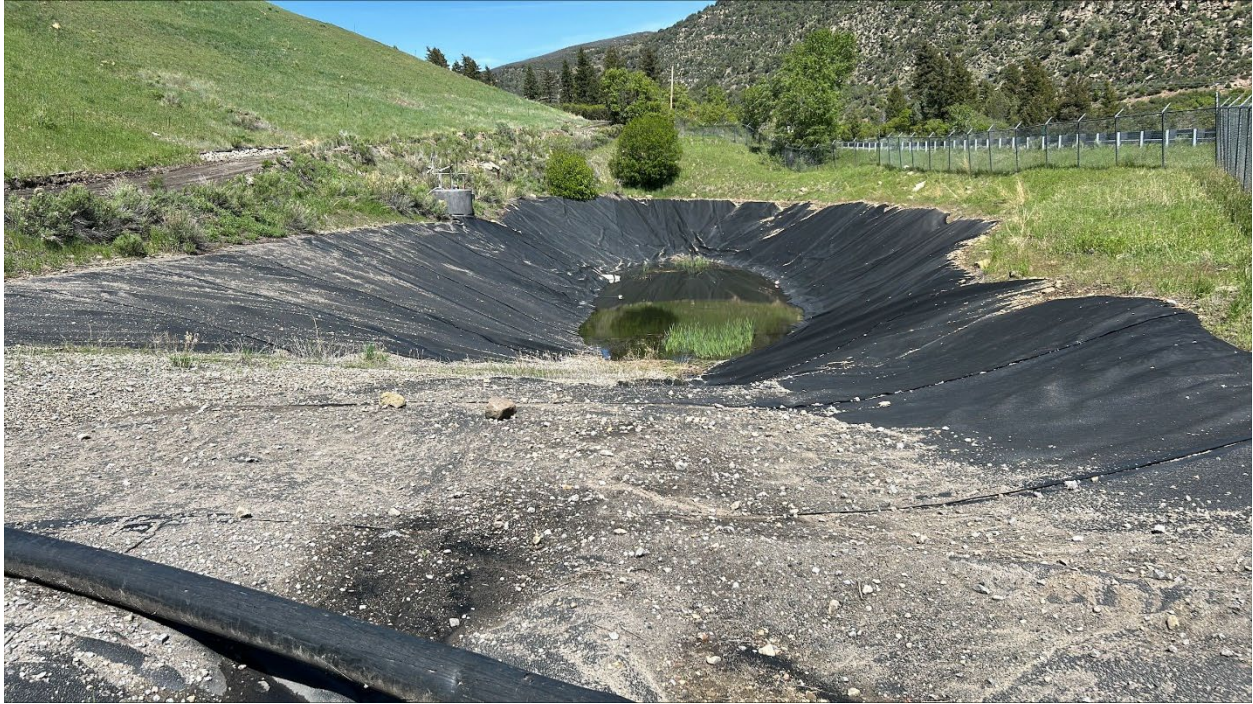
Figure 12: RPE pond, west cell

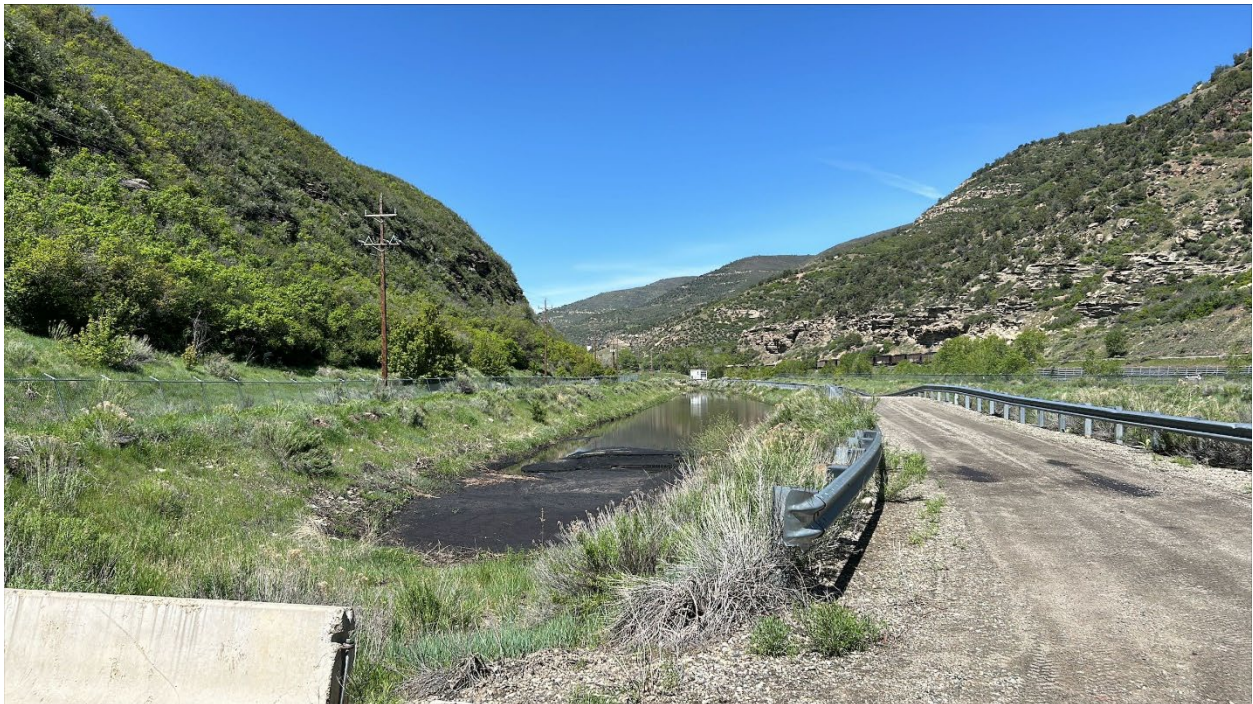
Figure 13: MB5E pond, south cell

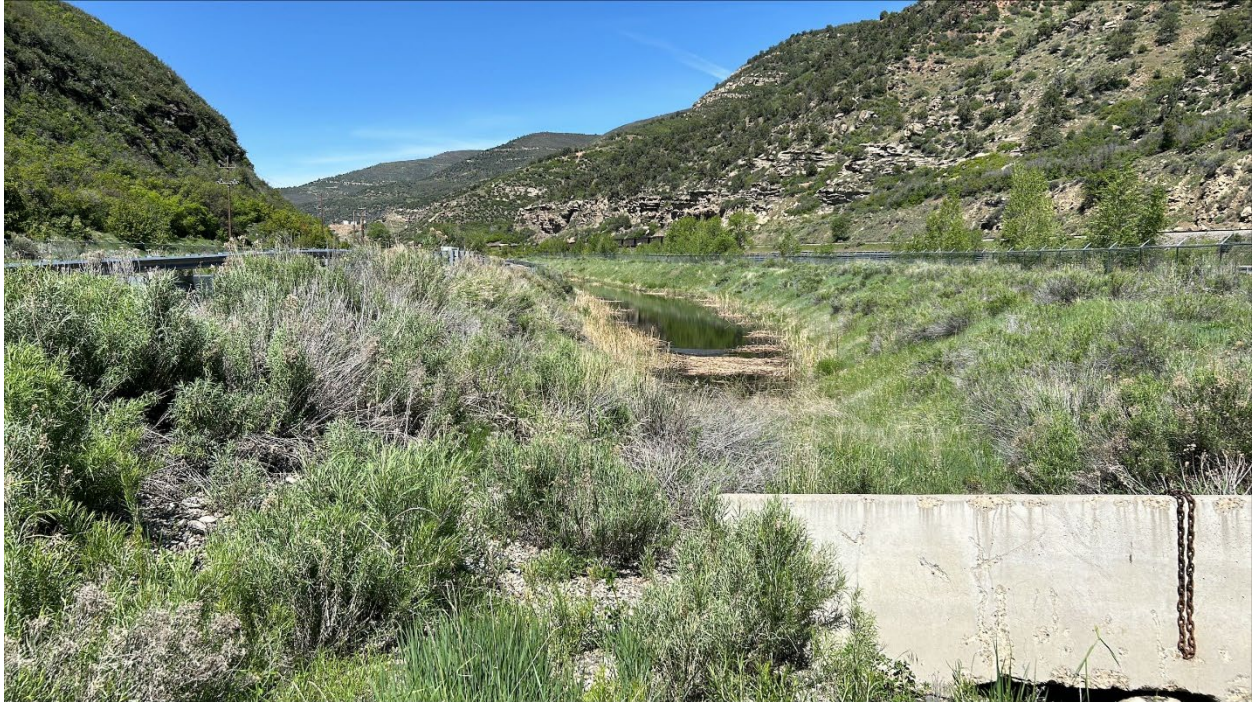
Figure 14: MB5E pond, north cell

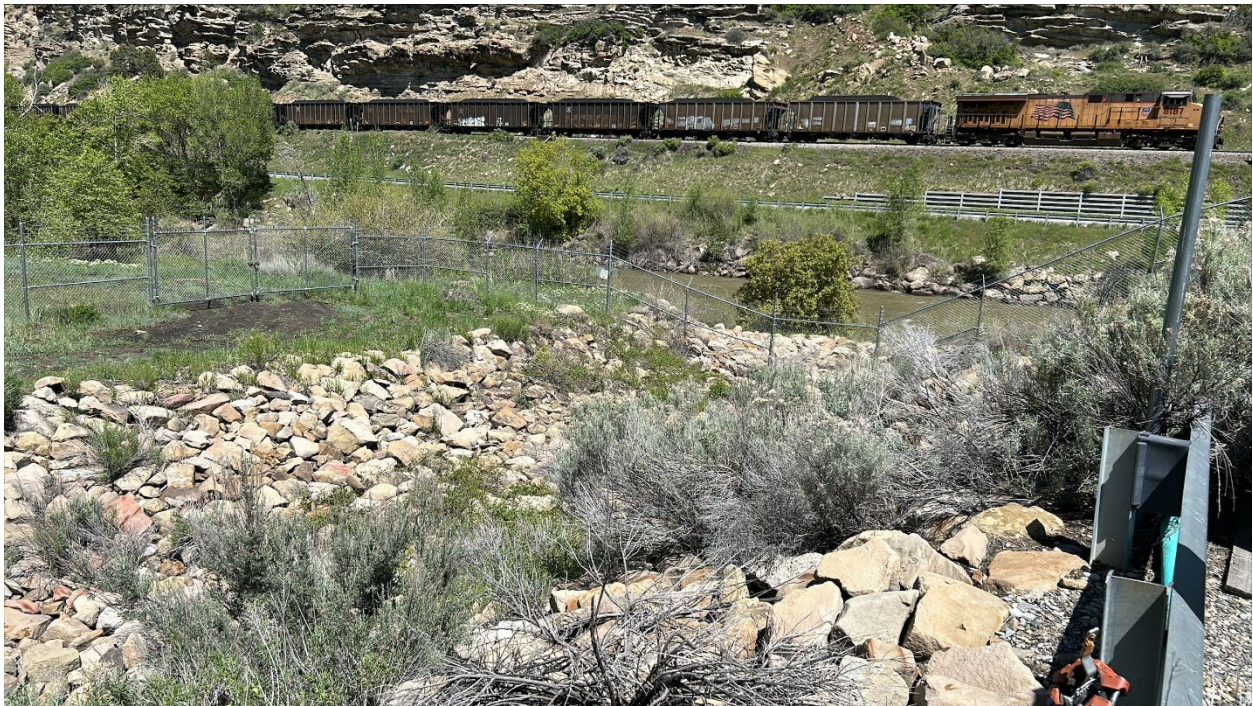
Figure 15: MB5E pond emergency spillway

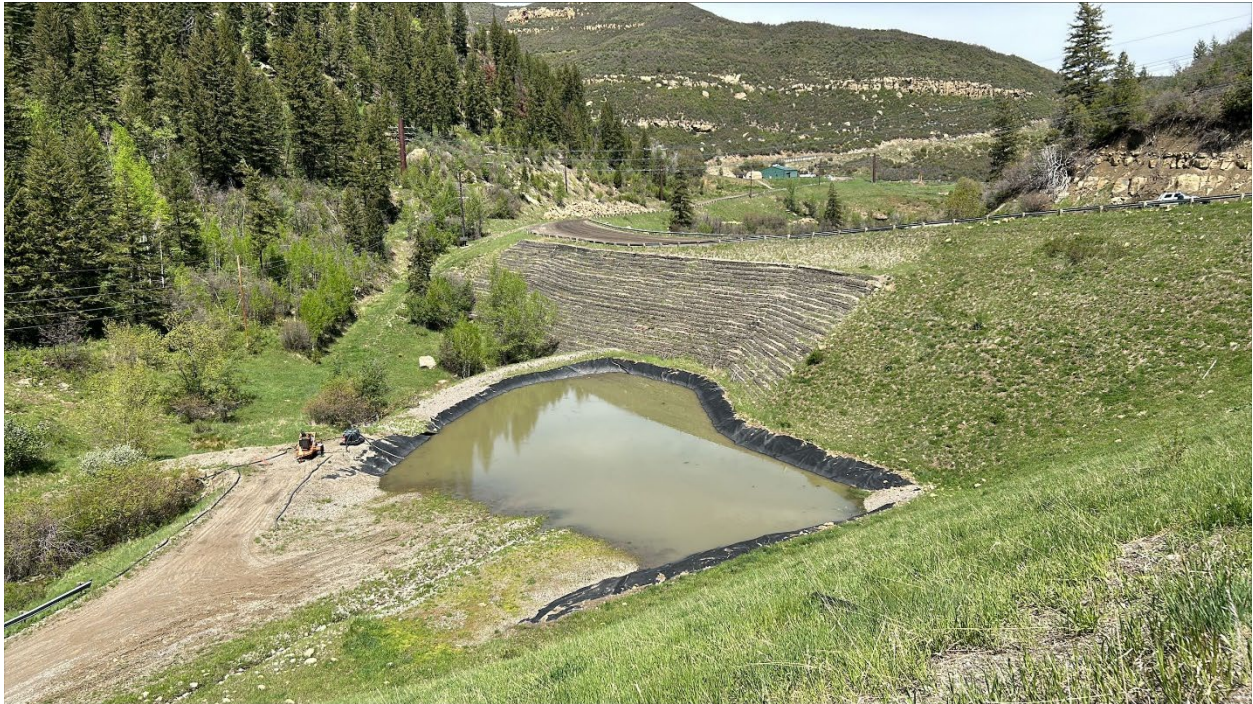
Figure 16: SG1 pond

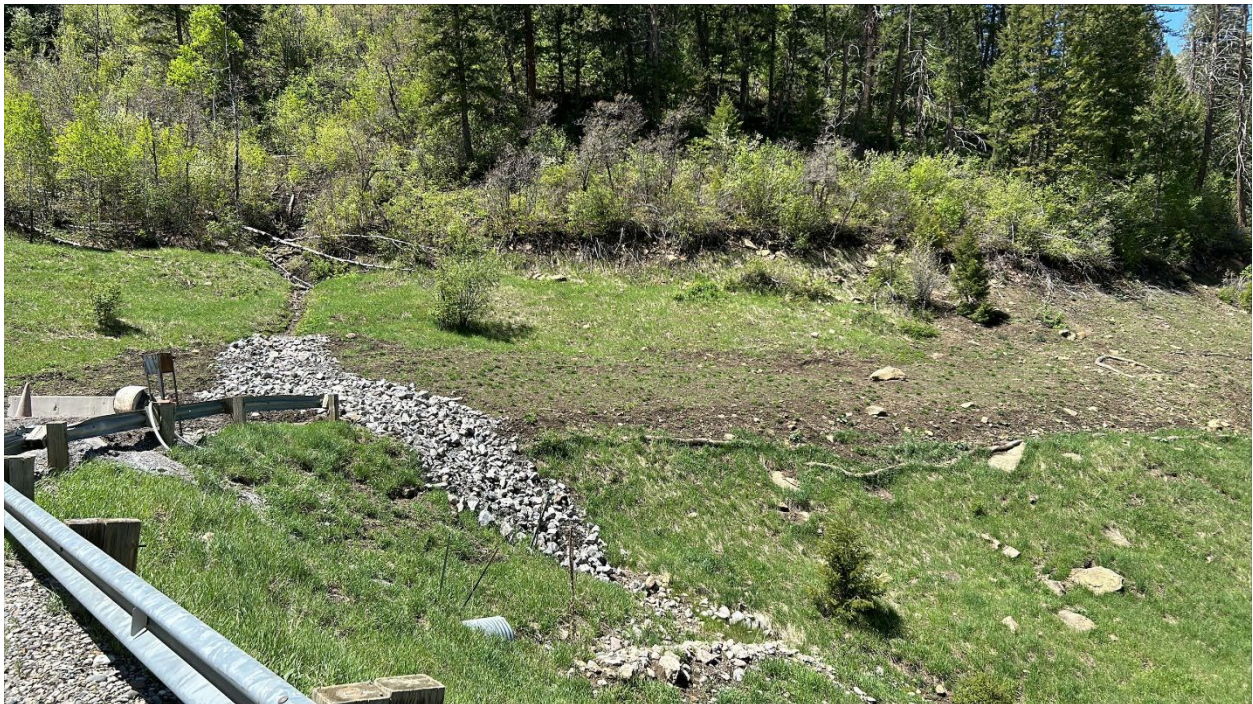
A gully eroded by a small spring that had emerged above the reclaimed area near Shaft 3 had been repaired with riprap. The reclaimed area appeared stable, with vegetation becoming established.

Figure 17: Repaired erosion on reclaimed area at Shaft 3
