MINERALS PROGRAM INSPECTION REPORT
PHONE: (303) 866-3567

MINE NAME: Mid-Continent LST	MINE/PROSPECTING ID#: M-1982-121	MINERAL: Limestone (general)	COUNTY: Garfield
INSPECTION TYPE: Multi Person Inspection	WEATHER: Clear	INSP. DATE: May 28, 2024	INSP. TIME: 13:40
OPERATOR: RMR Aggregates, Inc.	OPERATOR REPRESENTATIVE: Justin Olin	TYPE OF OPERATION: 112c - Construction Regular Operation	
REASON FOR INSPECTION: Normal I&E Program	BOND CALCULATION TYPE: None	BOND AMOUNT: \$366,179.00	
DATE OF COMPLAINT: NA	POST INSP. CONTACTS: None	JOINT INSP. AGENCY: None	
INSPECTOR(S): Amy Yeldell Todd Jesse	INSPECTOR'S SIGNATURE:

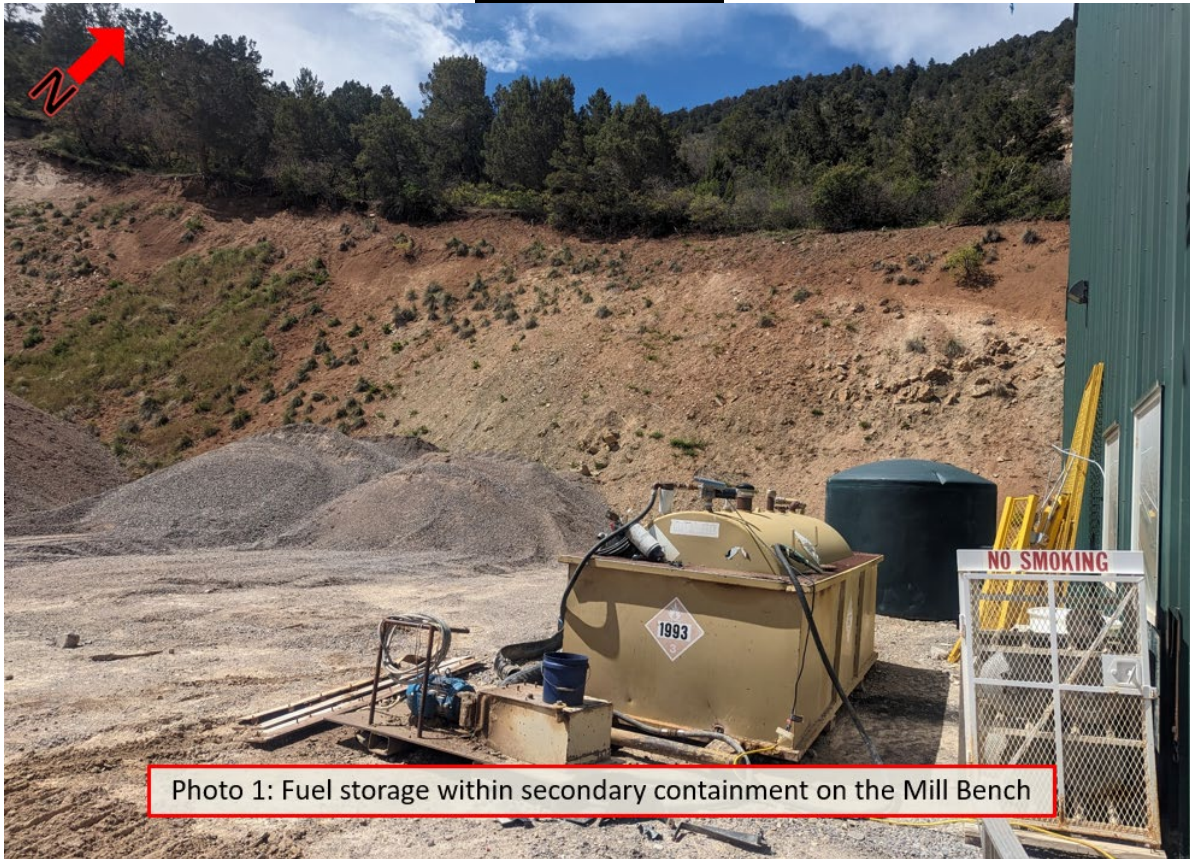
All fuel is stored within secondary containment located on the Mill Bench (Photo One). Additional hydrocarbons are stored within the Mill Building on a spill pallet (Photo Two).

Photo 1: Fuel storage within secondary containment on the Mill Bench

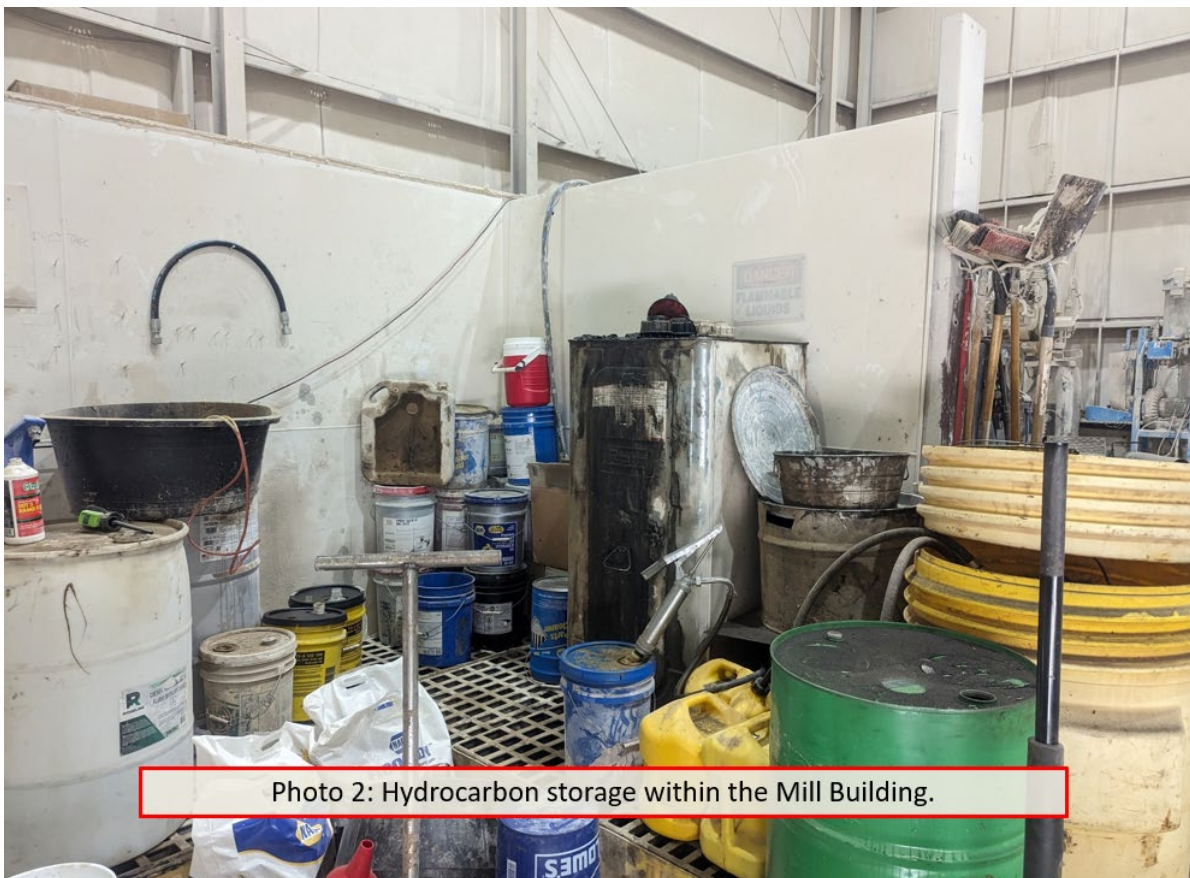
Photo 2: Hydrocarbon storage within the Mill Building.

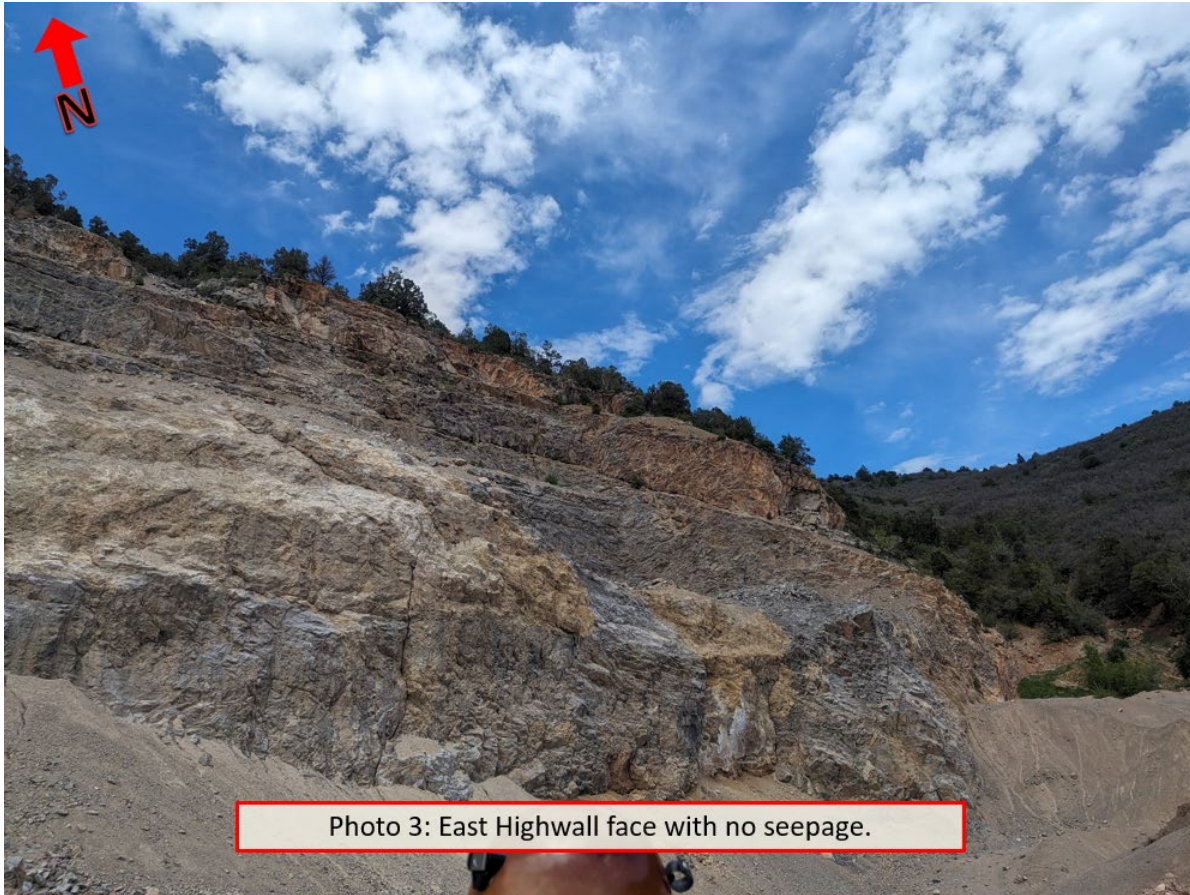
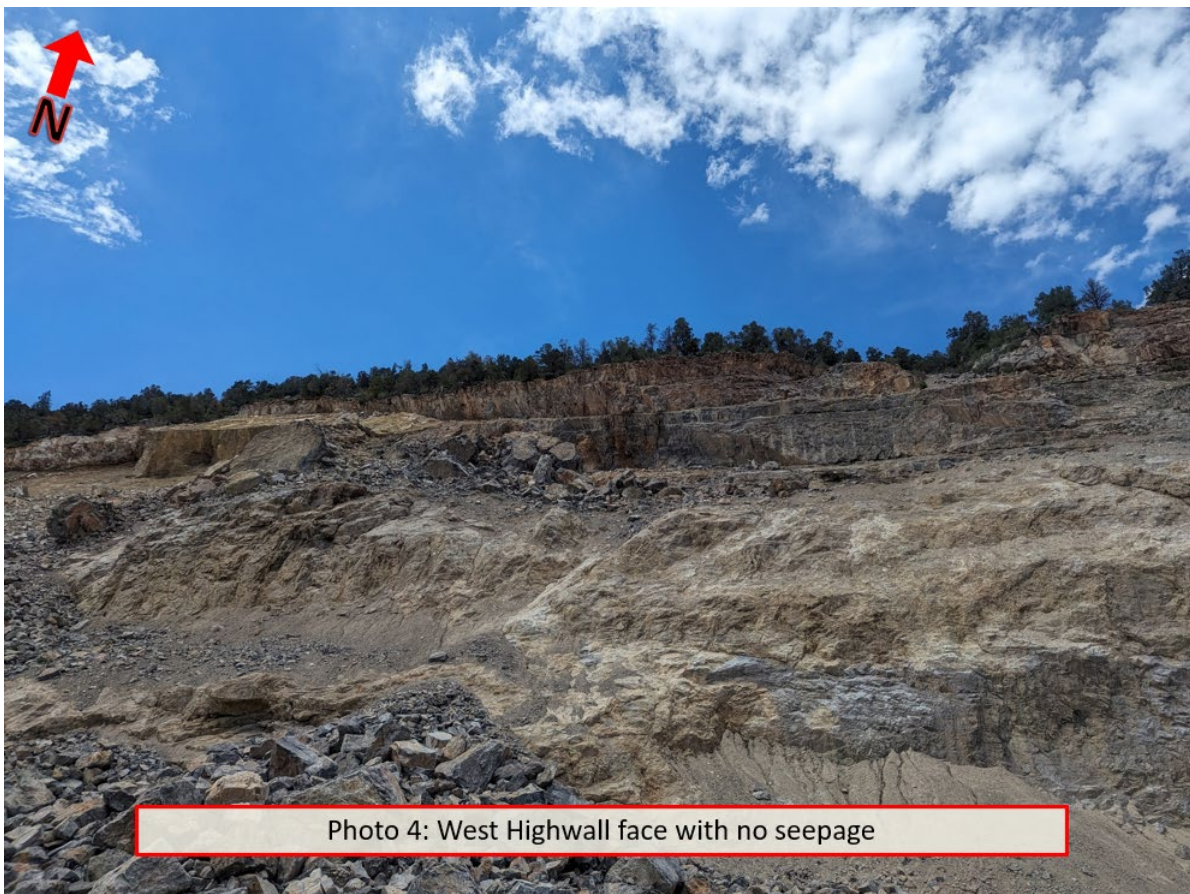
No exposed ground water was observed. Some pooling of water was still present from the heavy rains over the weekend. No seepage was observed between the contact points on the highwall face (Photos Three and Four).

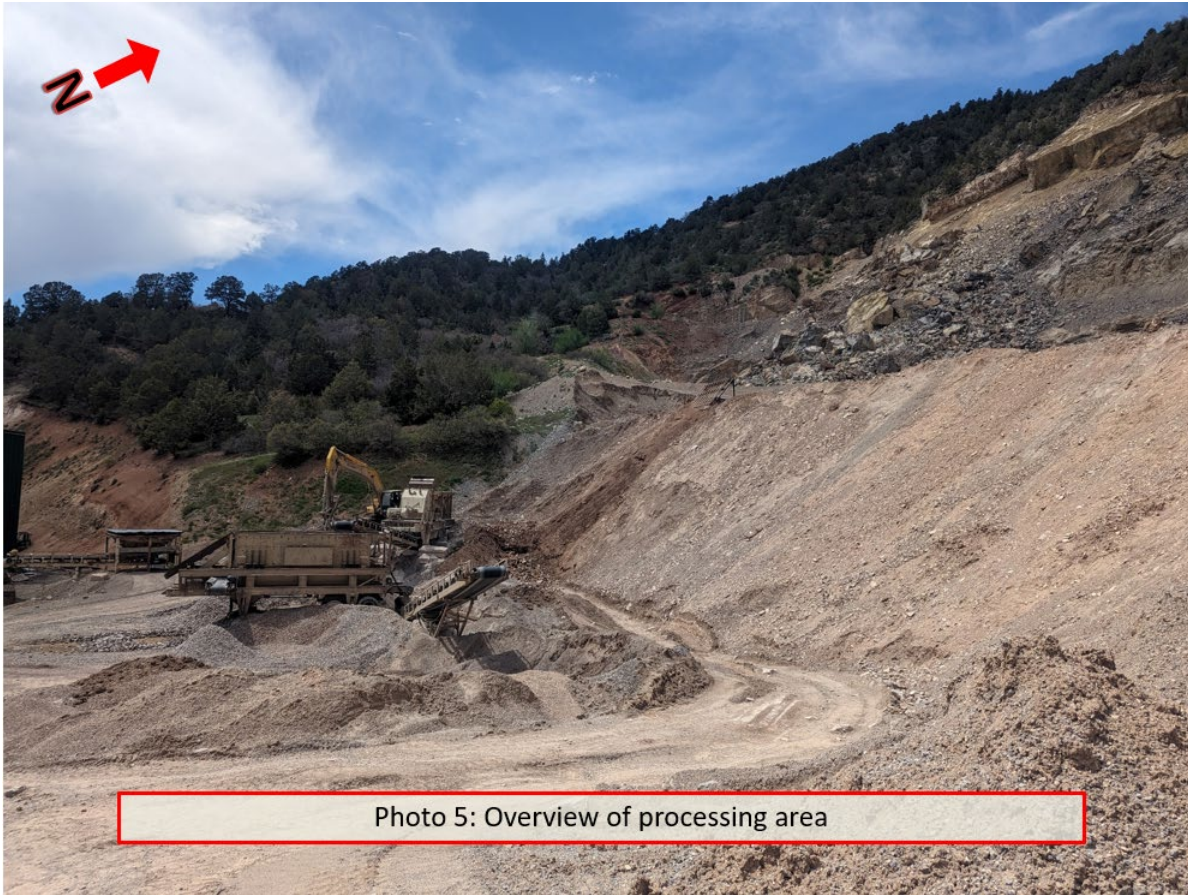
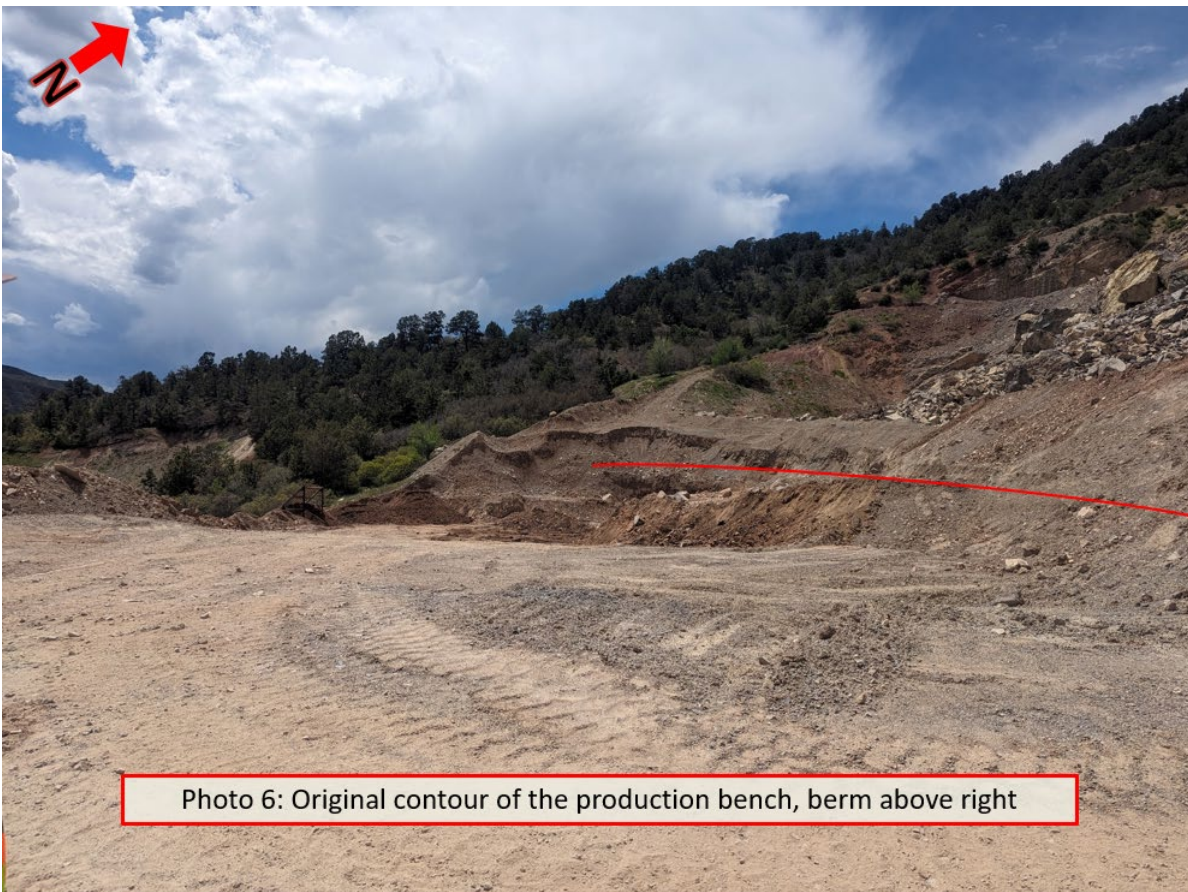
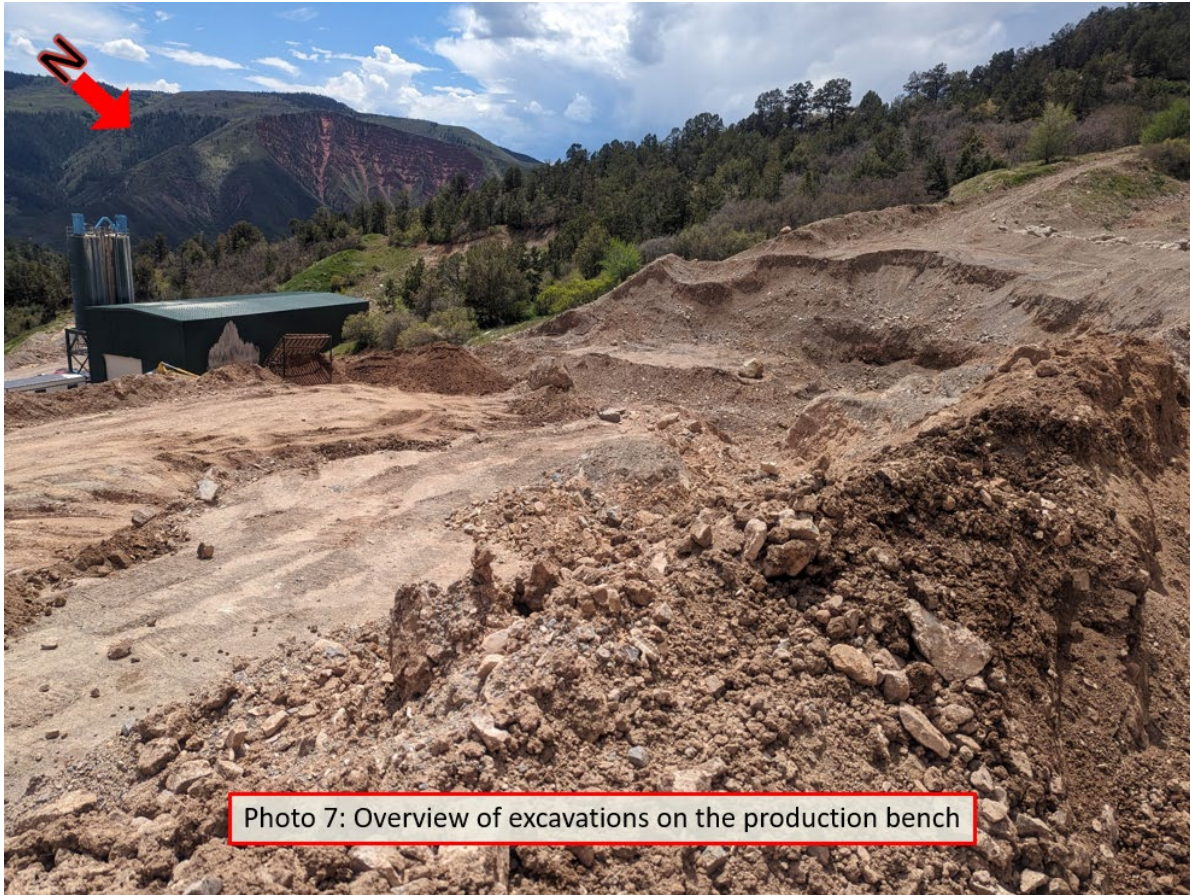
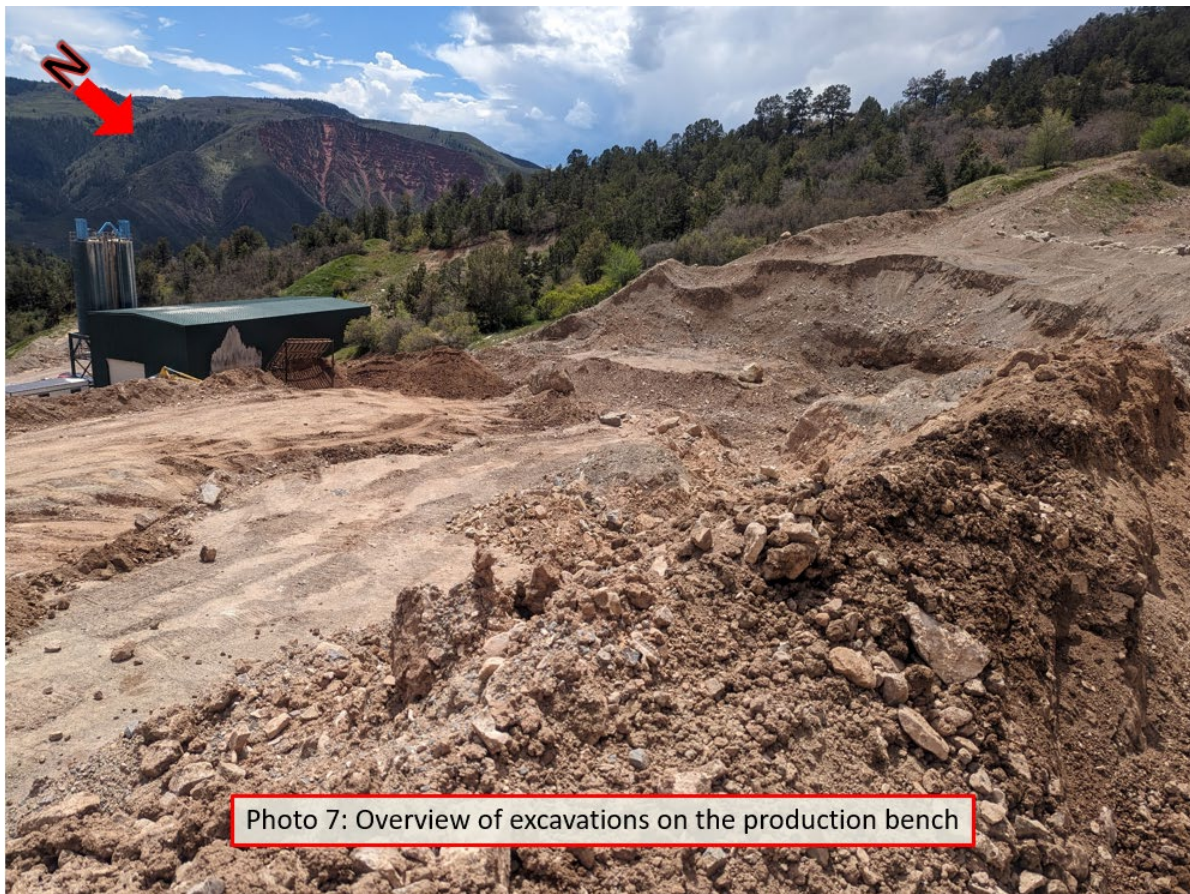
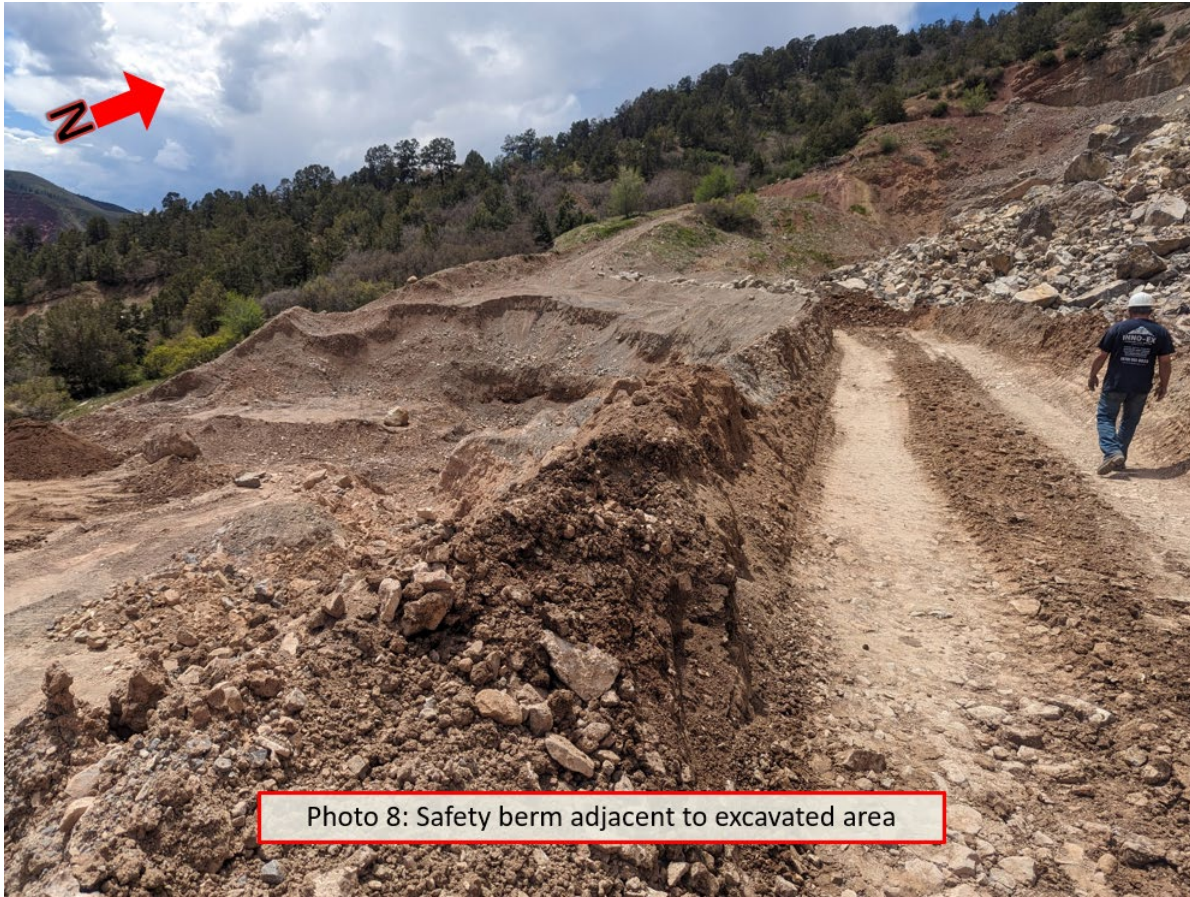
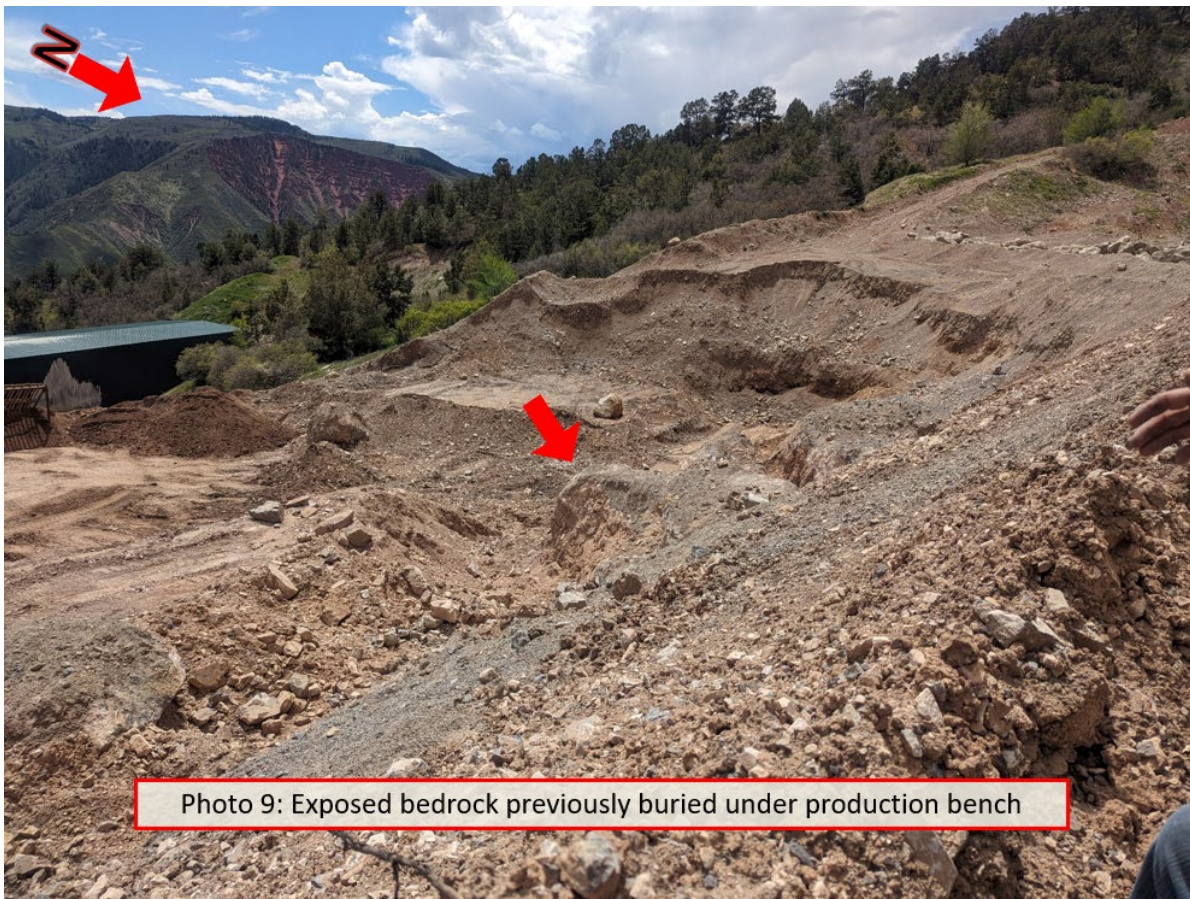
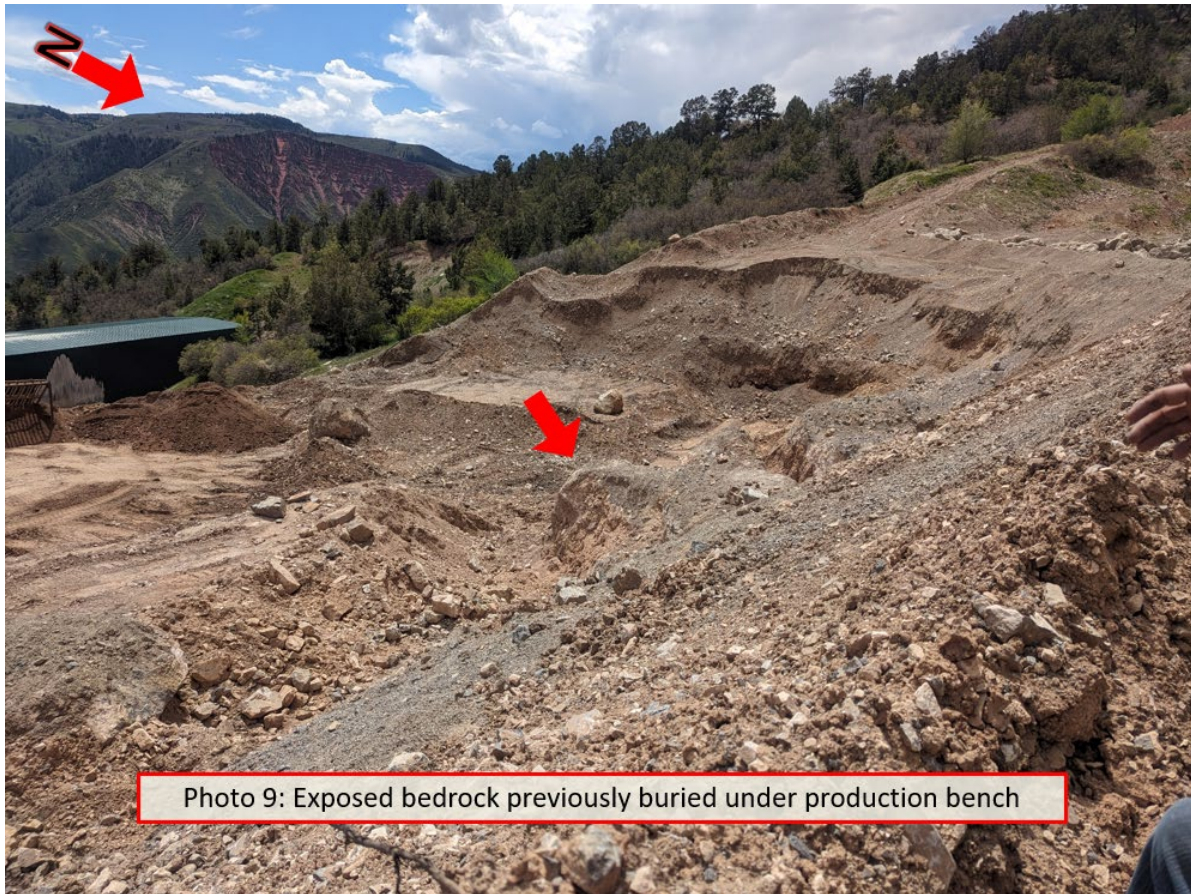
The site was active at the time of the inspection. There were two personnel working on site. Maintenance was being conducted. Overburden material was being excavated from the Production Bench and screened down the slope to the Mill Bench. To date the Production Bench has been excavated down approximately 20 feet. This practice will continue until only bedrock remains and all overburden is removed. Currently there is a distinction between the crest of the excavated production bench slope and the foot of the safety berm (Photos Five – Eleven).

Excavation of the Production Bench is twofold. It provides material to construct the safety berm. As well as it exposes previously buried parent material that is not covered under the C&D that resulted from the January 2023 rock fall event. Construction of the safety berm is expected to be completed by the end of May. The berm construction will need to be approved by MSHA. Once the berm is approved, if the blasting plan is accepted by MSHA, RMR intends to blast the newly exposed bedrock.

Construction of the Safety Berm was not authorized under TR-6. TR-6 only approved the Geotechnical Engineering Report. In the approval letter it expressly stated that:

The safety berm is a safeguarding feature which is not a part of the currently approved Mine Plan. Therefore, this is cited as a maintenance item (problem). RMR shall revise their Mine Plan to include the construction the of safety berm. Including but not limited to providing all MSHA certifications of construction. Furthermore, though the site is approved for blasting the Division does not have a blasting plan or any such details of how blasting will occur on site. Given the nature of the site, this is a problem, additional assurances regarding blasting must be provided. Please submit to the Division a copy of the blasting plan as approved by MSHA. Both the revised mine plan to incorporate the safety berm and the blasting plan shall be submitted in the form of a technical revision with the required revision fee. The berm revision must be submitted within 30 days of this report. The Blasting plan must be submitted within 30 days of MSHA acceptance.

CORRECTIVE ACTIONS: Both the revised Mine Plan to incorporate the safety berm and the Blasting Plan shall be submitted in the form of a technical revision with the required revision fee. The berm revision must be submitted within 30 days of this report. The Blasting plan must be submitted within 30 days of MSHA acceptance.

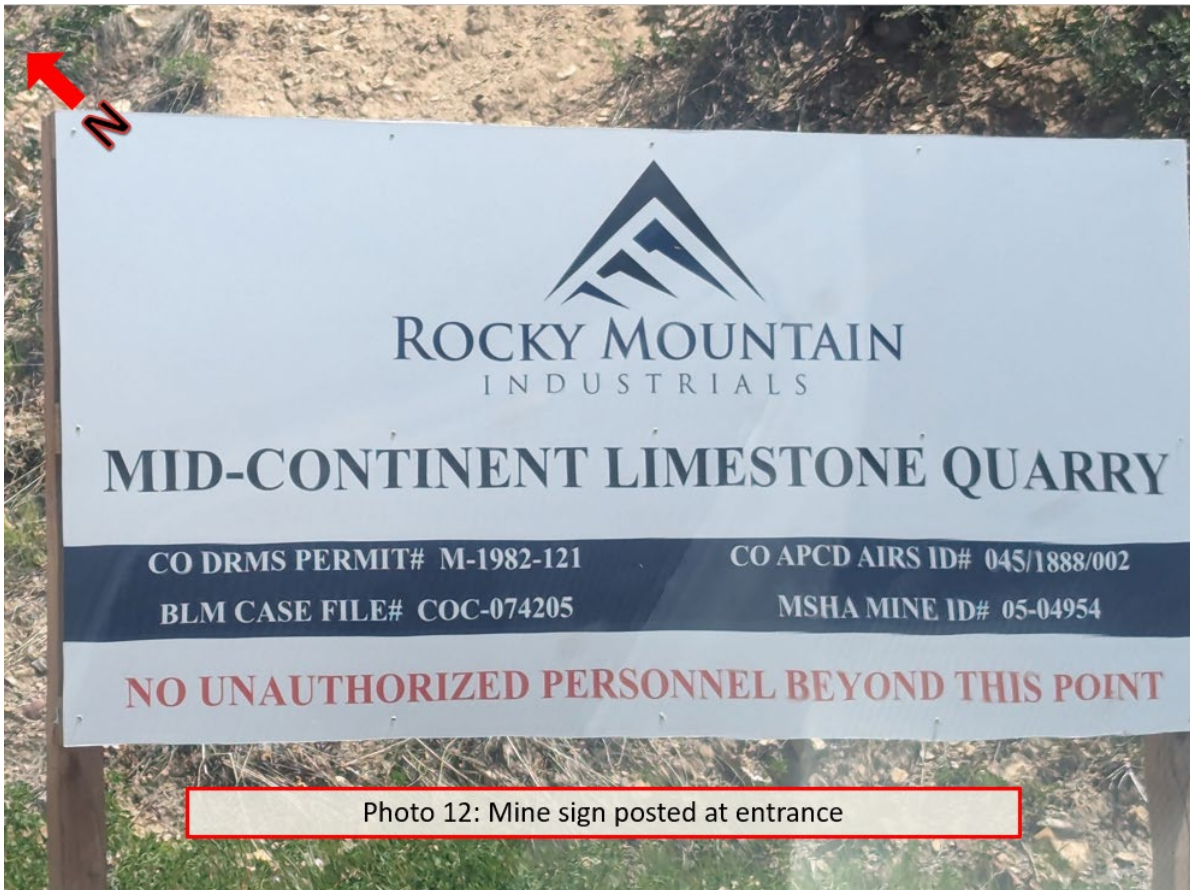
A mine sign was posted at the entrance to the mine site as required by Rule 3.1.12(1). The information depicted was correct/ up to date and the sign was of sufficient size (Photo Twelve). The permit boundary of the affected land was clearly delineated primarily by a wire fence pursuant to Rule 3.1.12(2).
