**MINERALS PROGRAM INSPECTION REPORT**  
**PHONE: (303) 866-3567**

<b>MINE NAME:</b> Turnpike Mining Resource	<b>MINE/PROSPECTING ID#:</b> M-2004-009	<b>MINERAL:</b> Sand and gravel	<b>COUNTY:</b> Weld
<b>INSPECTION TYPE:</b> Monitoring	<b>WEATHER:</b> Clear	<b>INSP. DATE:</b> May 10, 2024	<b>INSP. TIME:</b> 10:00
<b>OPERATOR:</b> Asphalt Specialties Co., Inc.	<b>OPERATOR REPRESENTATIVE:</b> Greg Geras and Cody Hunt	<b>TYPE OF OPERATION:</b> 112c - Construction Regular Operation	
<b>REASON FOR INSPECTION:</b> Citizen Complaint	<b>BOND CALCULATION TYPE:</b> None	<b>BOND AMOUNT:</b> \$1,114,000.00	
<b>DATE OF COMPLAINT:</b> NA	<b>POST INSP. CONTACTS:</b> None	<b>JOINT INSP. AGENCY:</b> None	
<b>INSPECTOR(S):</b> Nikie Gagnon Jared Ebert	<b>INSPECTOR'S SIGNATURE:</b>

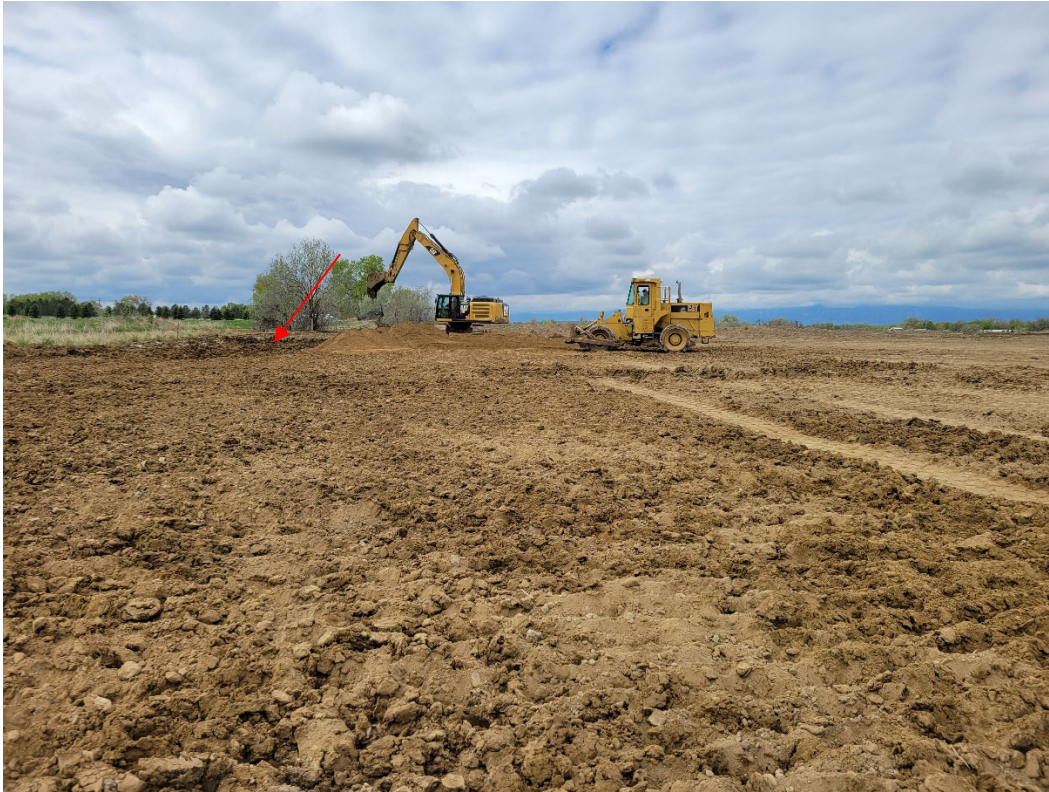
**PROBLEM/POSSIBLE VIOLATION:** Problem: Operator backfilled a pond on the eastern side of the permit area. Material was pushed into a drainage ditch that runs along the property boundary, blocking the natural flow of water. Material from the backfilling operation migrated into a small area offsite on the east side of the drainage and filled a culvert draining the adjacent property. Rule 3.16 states "Disturbances to the prevailing hydrologic balance of the affected land and of the surrounding area and to the quantity or quality of water in surface and groundwater systems both during and after the mining operation and during reclamation shall be minimized."

Photo 1: Looking south across backfilled area on eastern side of permit area.  
Backfilled drainage marked by arrow.

1. Contact the adjacent landowner and obtain permission to clean out the culvert. Ensure the work is done to the landowner's satisfaction.
2. Clean out the material that was placed into the ditch to restore flow.
3. Grade the slope to 3H:1V and blend with the contours of the natural drainage.
4. Seed the repaired slope to reestablish vegetation.
5. The Operator shall work with the adjacent landowner to obtain access permission for the repair work outside the permit area and minimize additional disturbance to the adjacent land.
6. The Operator shall provide proof to the Division that this work has been done by the corrective action date.

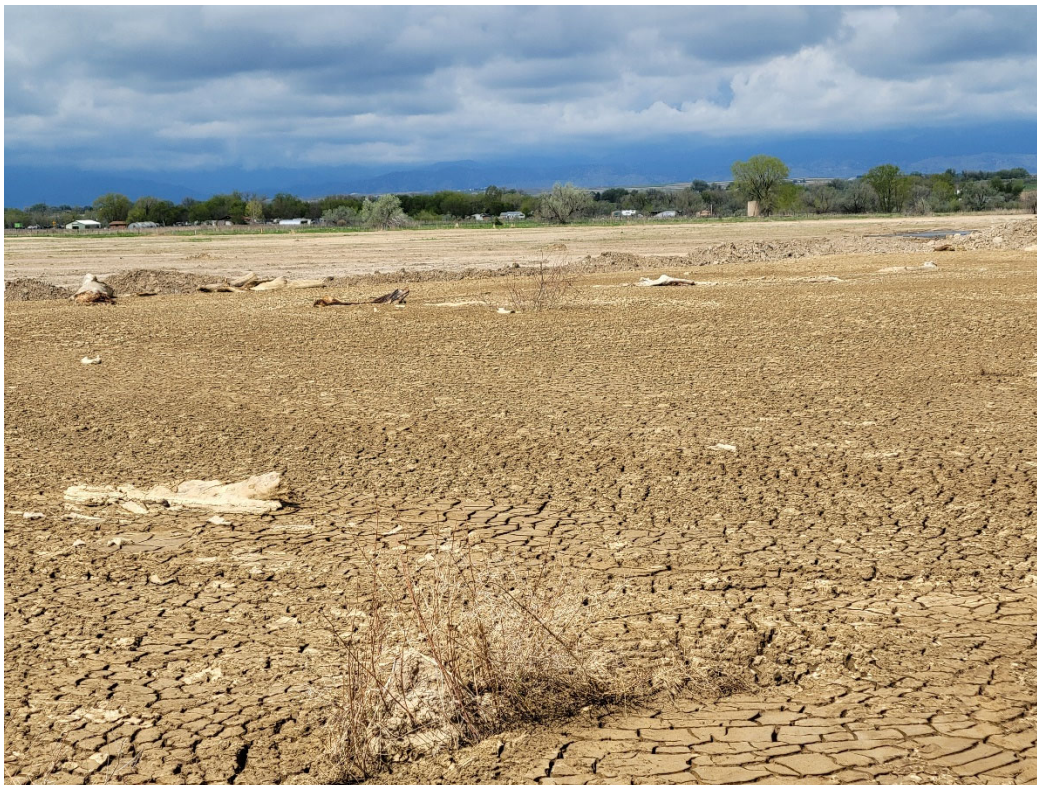
Photo 2: Looking west across the recently backfilled pond area.

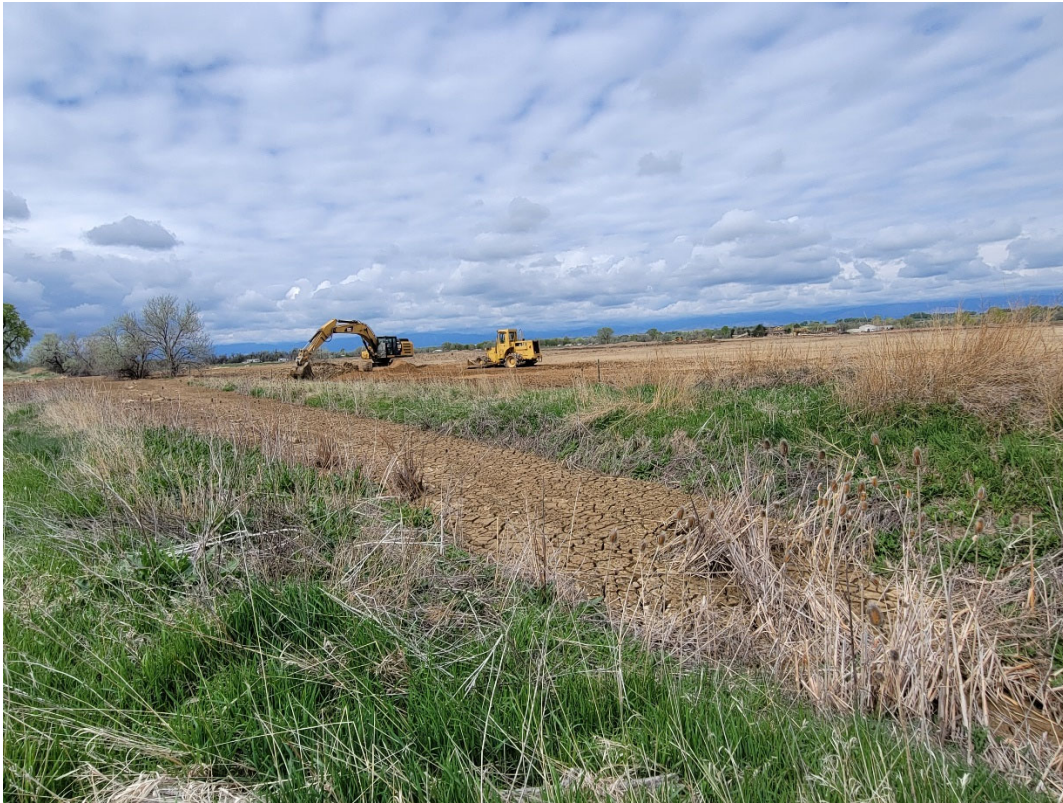
During the inspection, the Division observed an excavator on the west side of the drainage removing material. The Operator stated they were cleaning out the material to restore water flow. The impacted culvert cannot be reached from the mine side of the drainage and the Operator will need to obtain permission from Mr. Schell to clean out the culvert and restore it to his satisfaction.

Photo 3: Looking south down the backfilled drainage. The excavator is working from within the permit boundary to open the drainage channel.

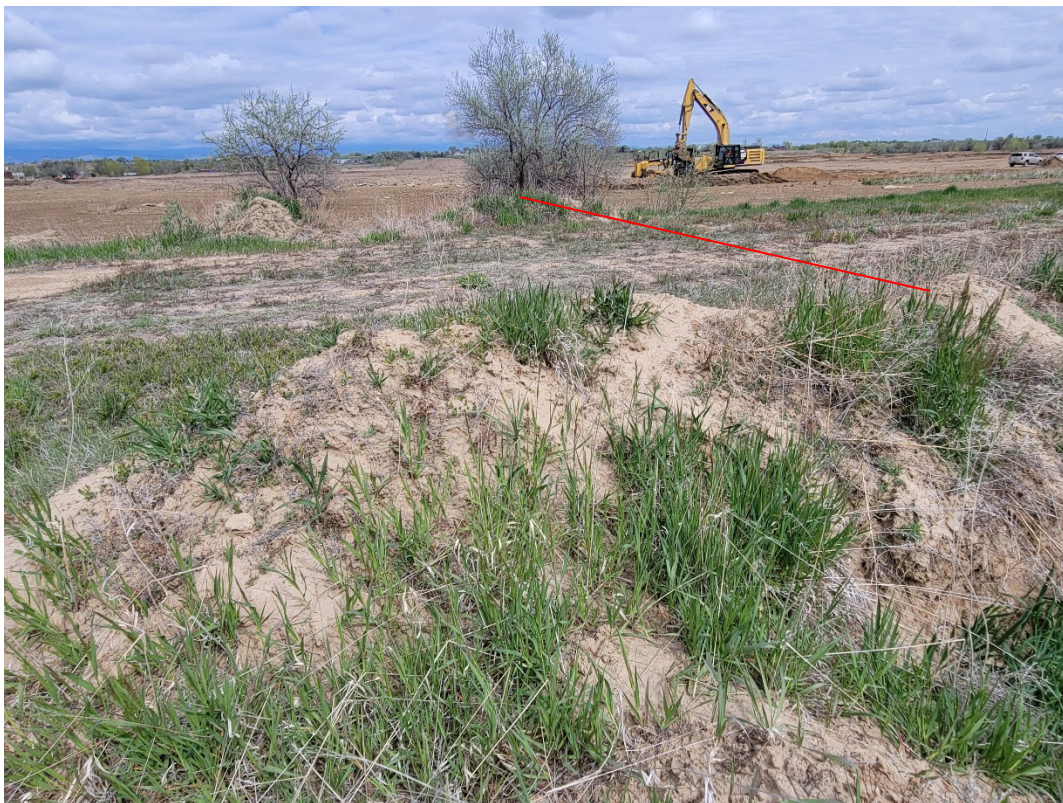
Photo 4: Looking west from the adjacent property. Red line depicts the approximate location of the culvert installed under the berm to the drainage.

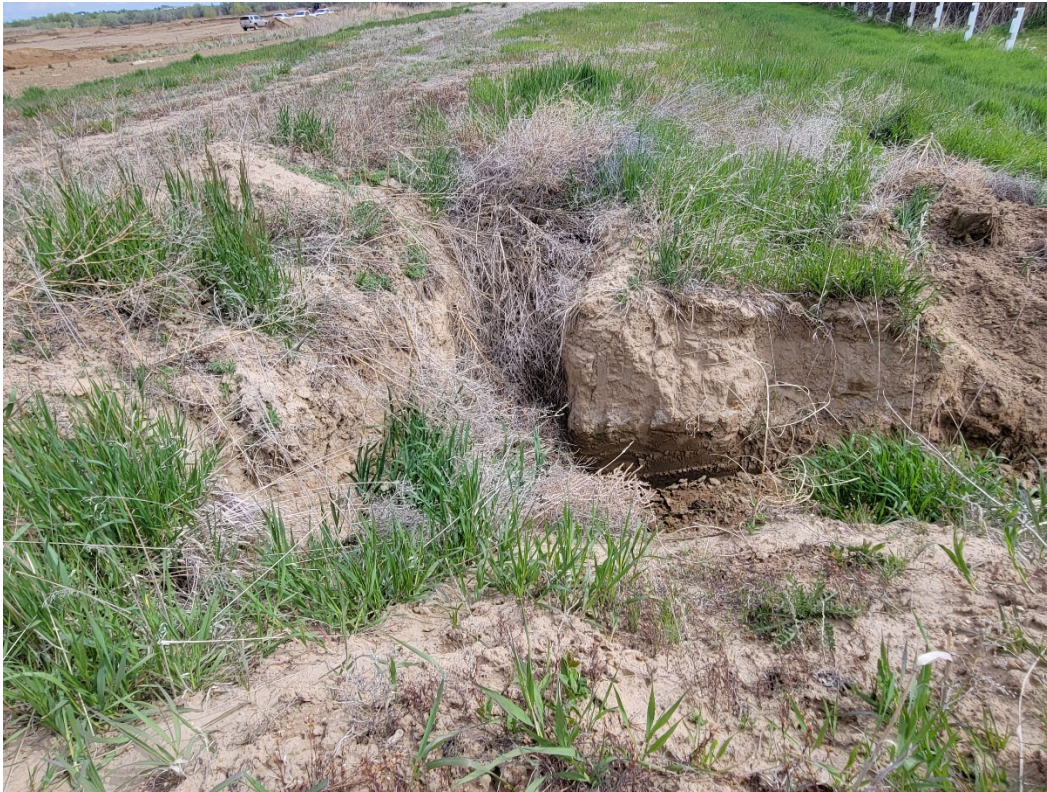
Photo 4: Culvert inlet on Mr. Schell's property.

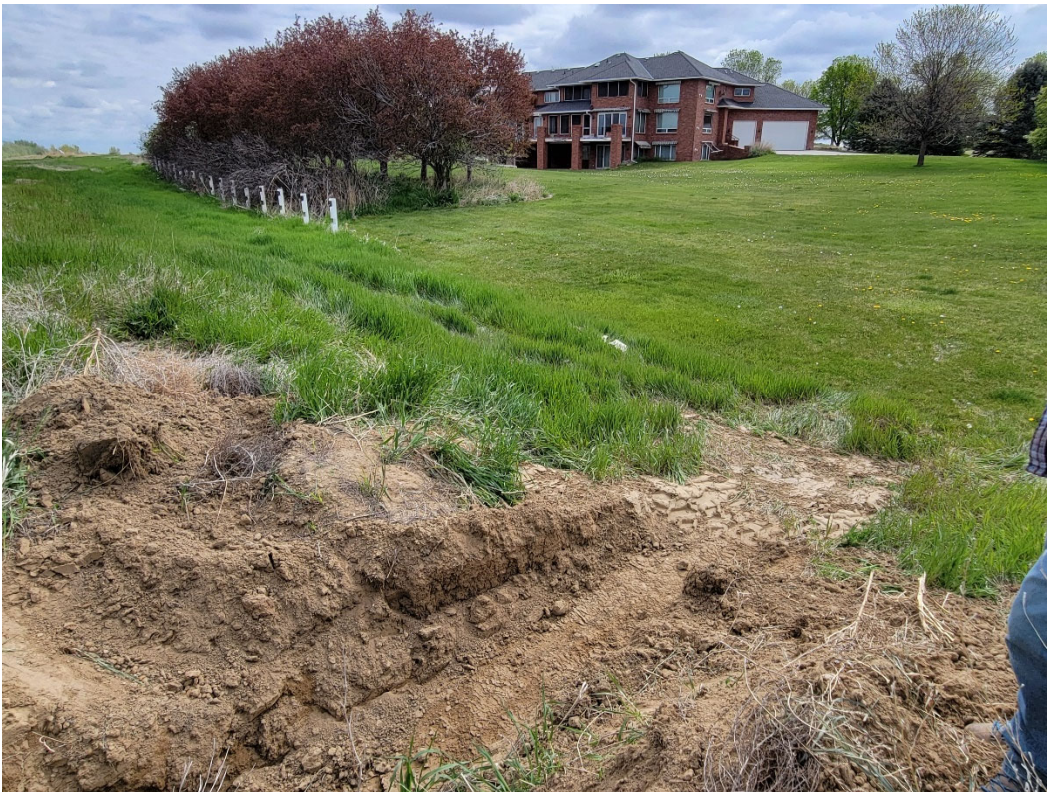
Photo 4: Channel to inlet of culvert on Mr. Schell's property.

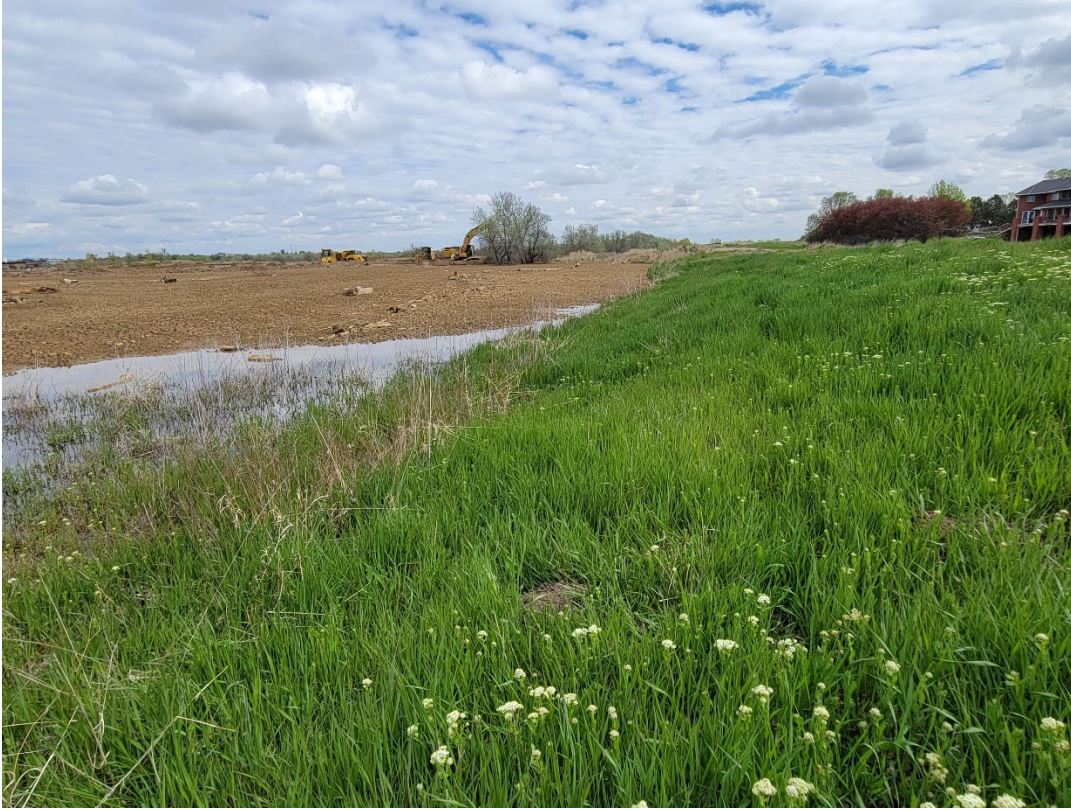
Photo 4: Looking north down the backfilled area at the base of the old railbed.

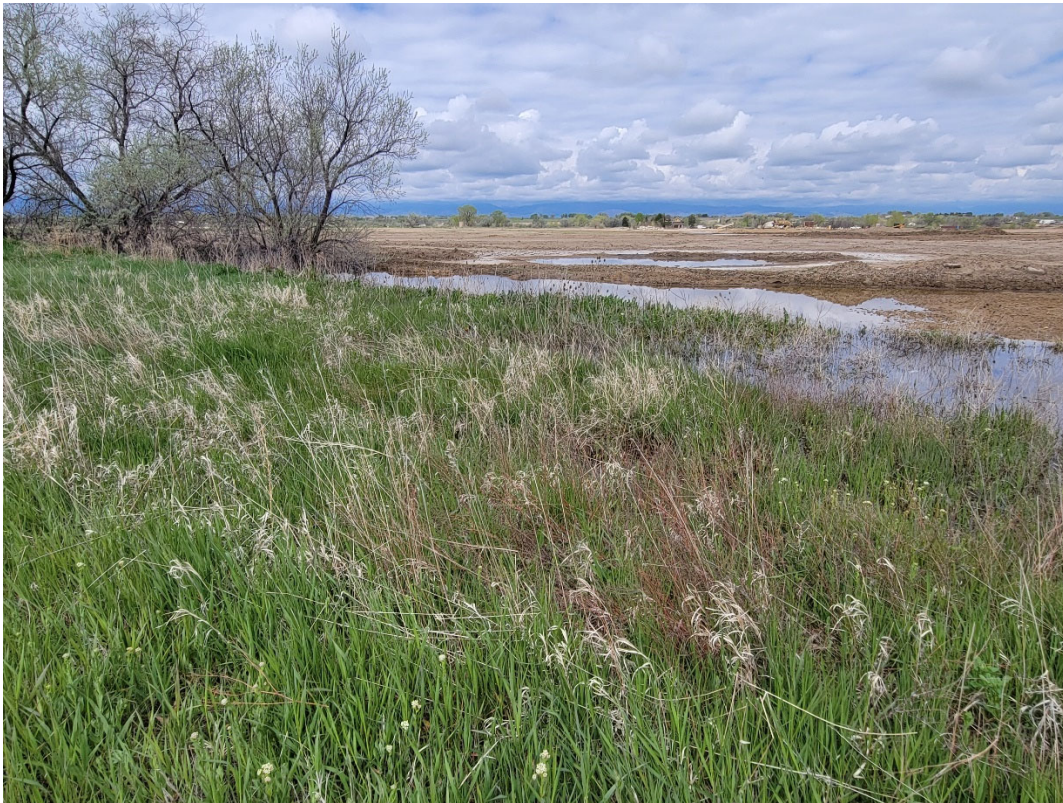
Photo 4: Looking northwest at the backfilled drainage area. Water ponding upstream from backfilled channel.

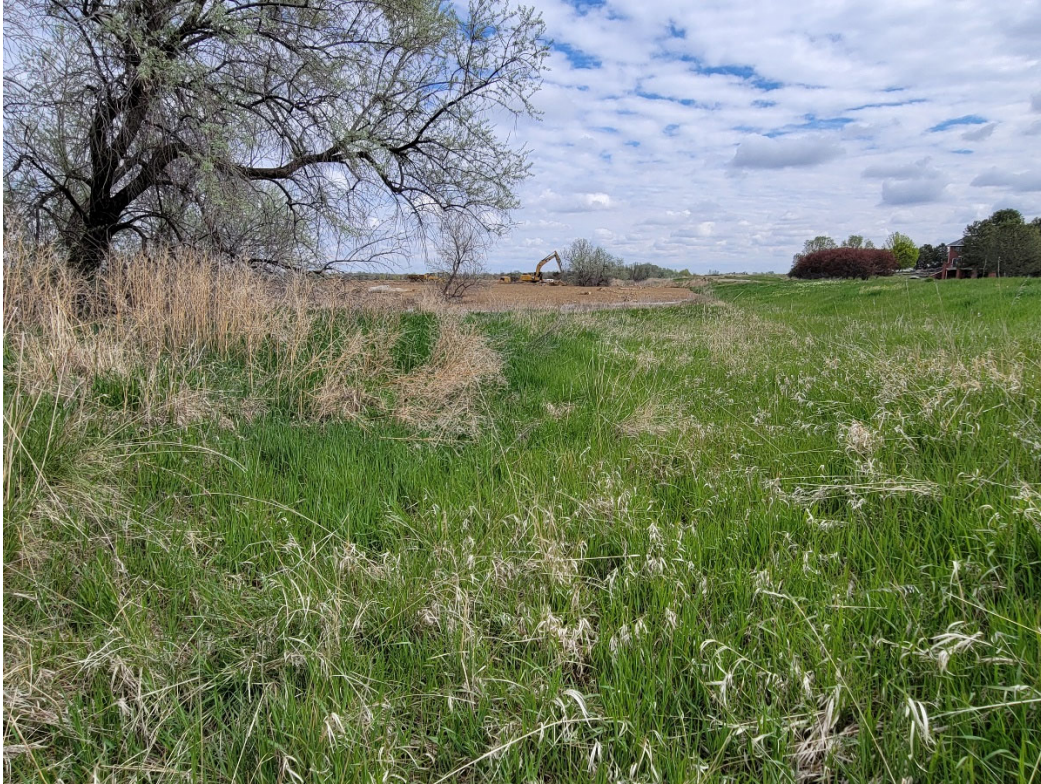
Photo 4: Standing upstream looking north down the drainage between the properties.

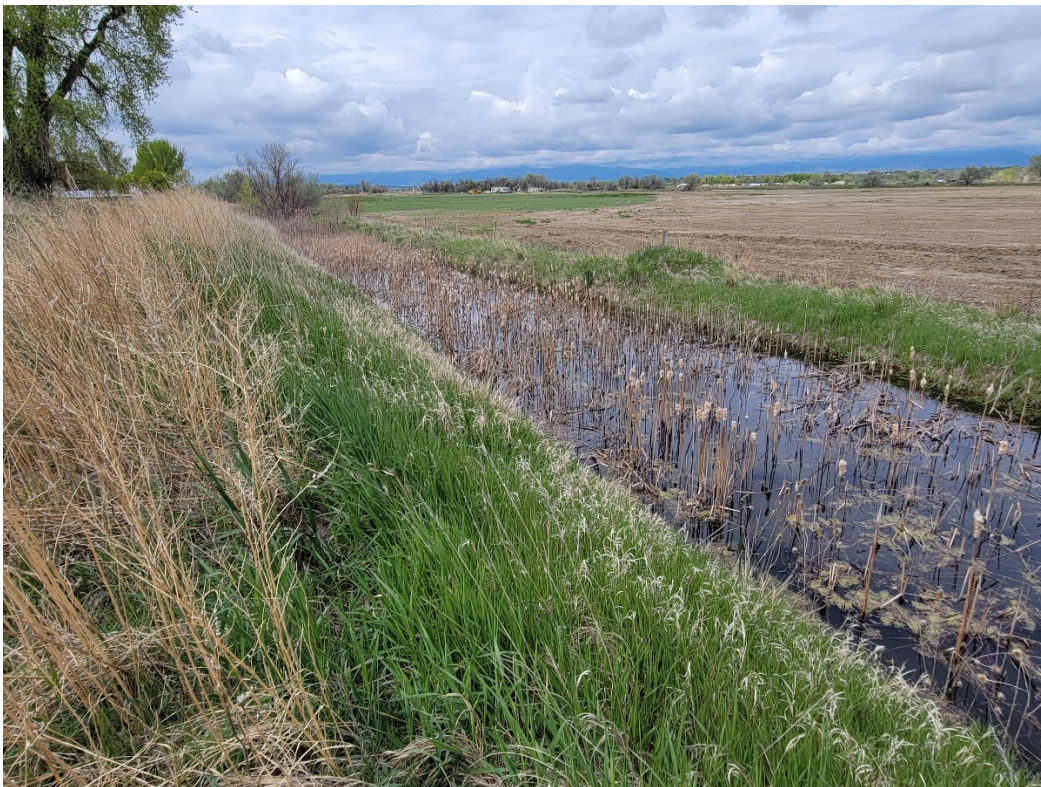
Photo 4: Looking south/upstream at water ponded above the backfilled channel.

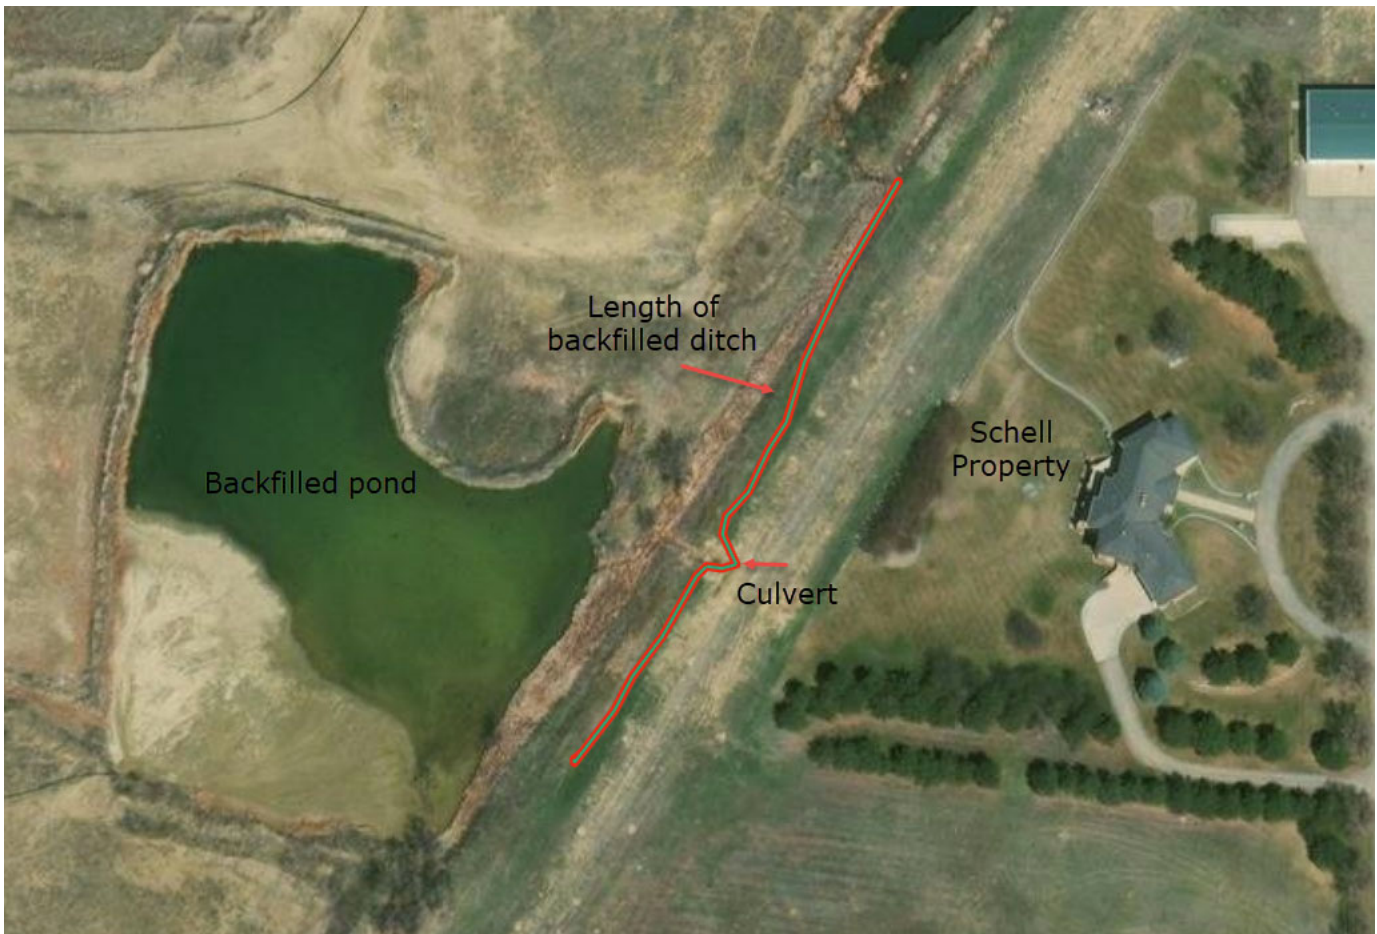
Figure 1: Image of backfilled area on the eastern edge of the permit area and adjacent land owned by Mr. Schell. Google Earth image dated 09/2023.

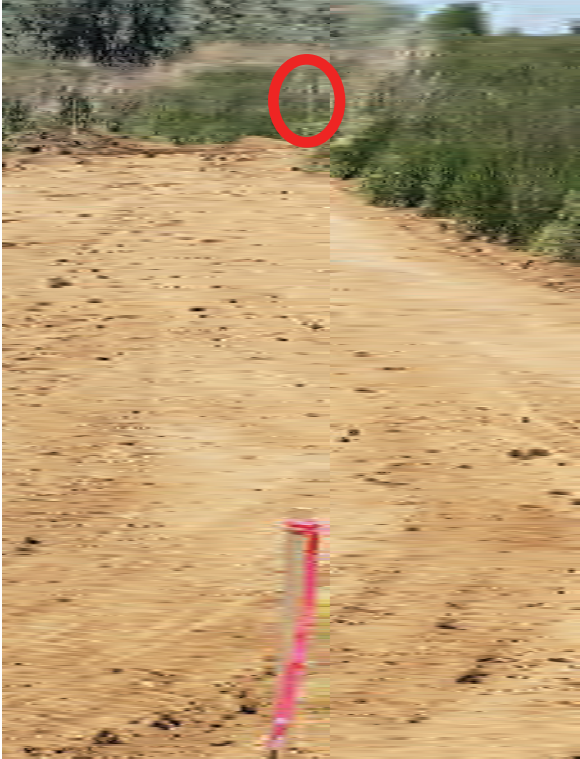
<b>Direction Photo Taken:</b>  North			
<b>Description:</b>  Staked property line by culvert

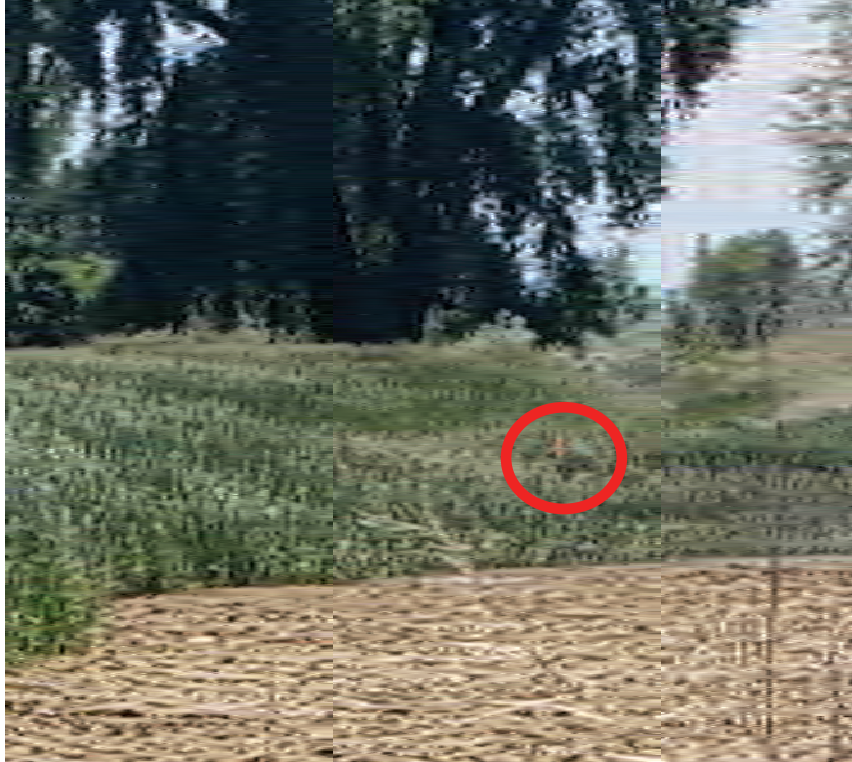
**3**

Zoom in on stake south of mud flow.

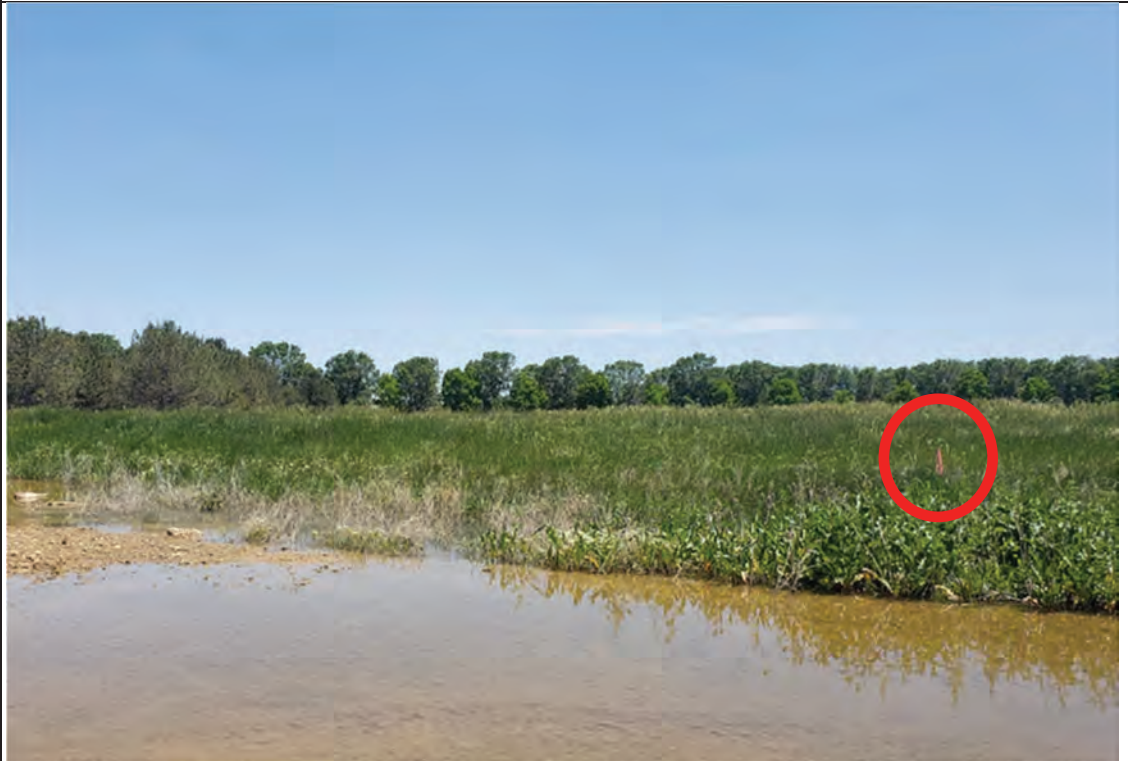
**4**

Stake south of mud flow.

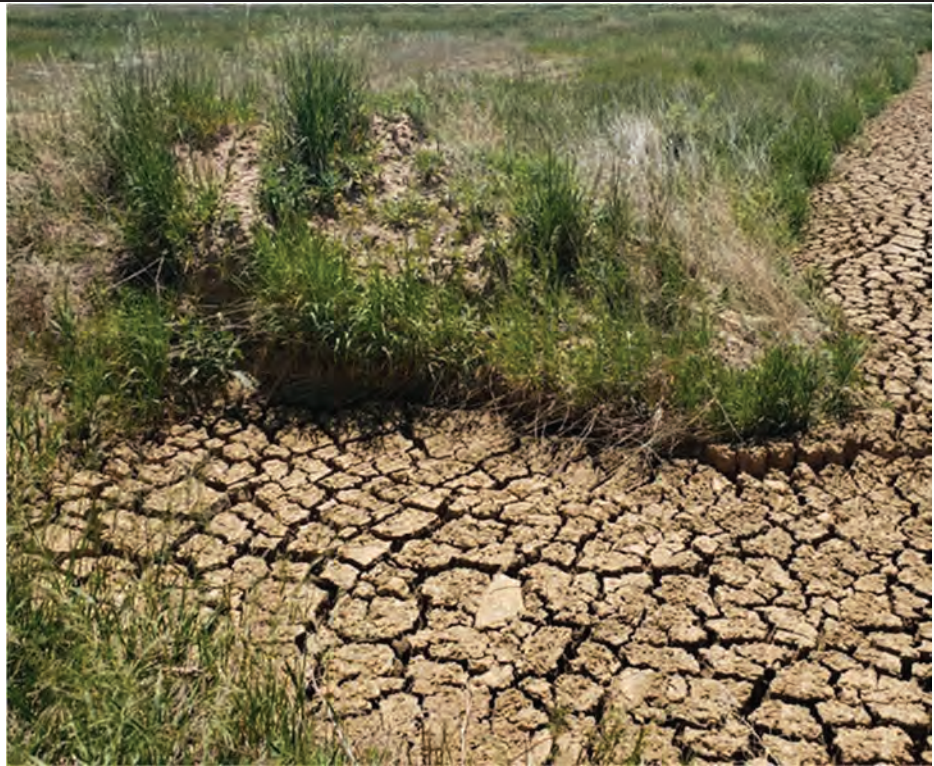
**5**

View of Schell culvert

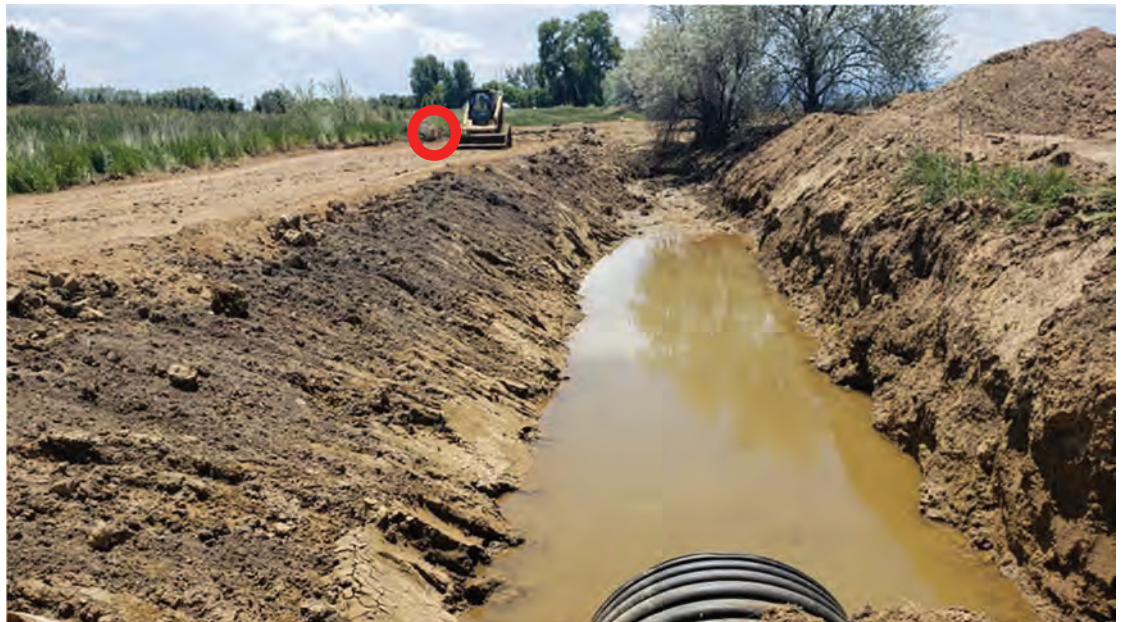
**6**

Culvert installed on ASCI property to facilitate drainage.

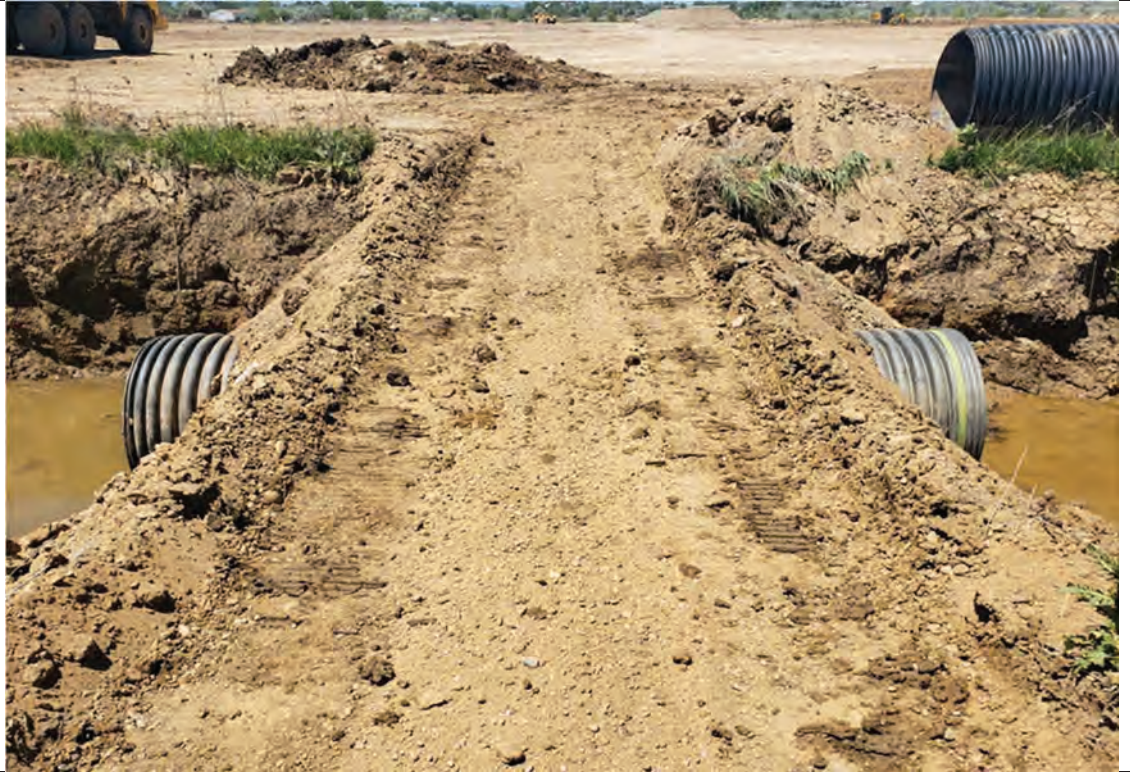
**7**

Culvert installed on ASCI property to facilitate drainage.

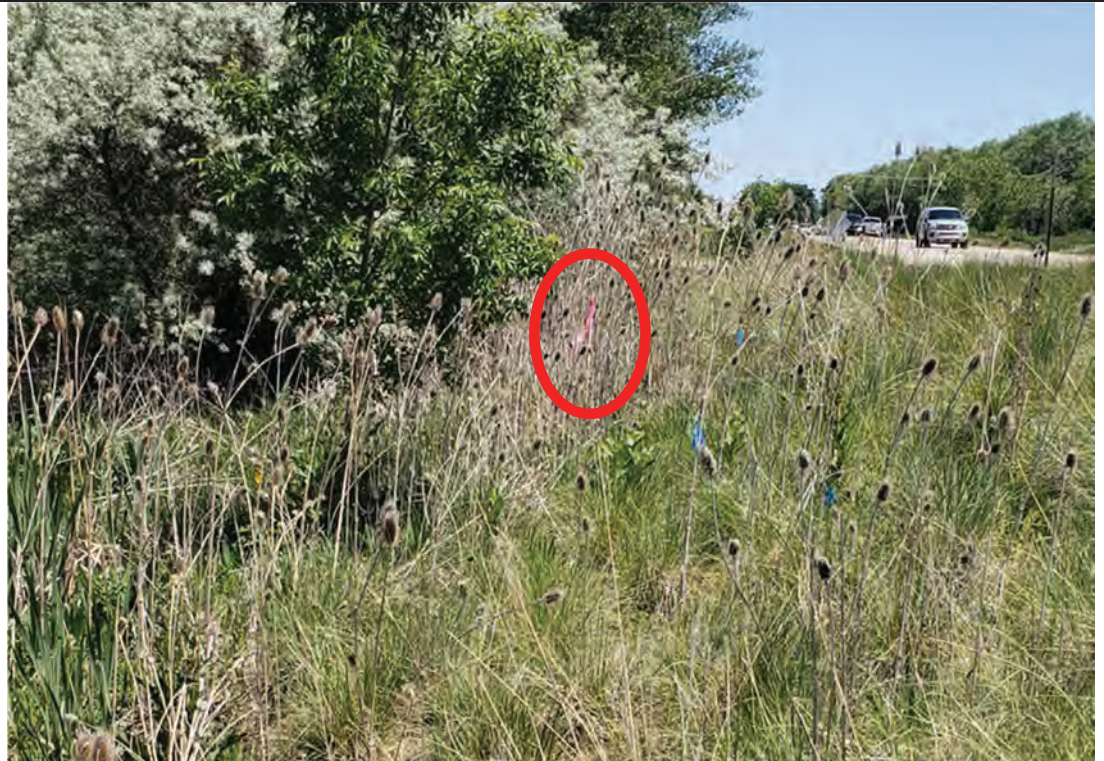
**8**

SE Property boundary marker along HWY 52.
