Bowie #2 inspection report

Permit Number: C-1996-083 Mine Name: Bowie No. 2 Mine Operator: Bowie Resources, LLC Operator Address: Mr. Basil Bear P.O. Box 1488 Paonia, CO 81428	County: Delta Operation Type: Underground Permit Status: Active Ownership: Private
	Operator Representative Present: Basil Bear
Operator Representative Signature: (Field Issuance Only)

Inspection Start Date: June 4, 2024 Inspection Start Time: 07:15 Inspection End Date: June 4, 2024 Inspection End Time: 15:30	Inspection Type: Coal Partial Inspection Inspection Reason: Normal I&E Program Weather: Clear
Joint Inspection Agency: None	Joint Inspection Contacts:
Post Inspection Agency: None	Post Inspection Contacts:
Inspector(s): Robert Zuber, P.E.	Inspector's Signature:

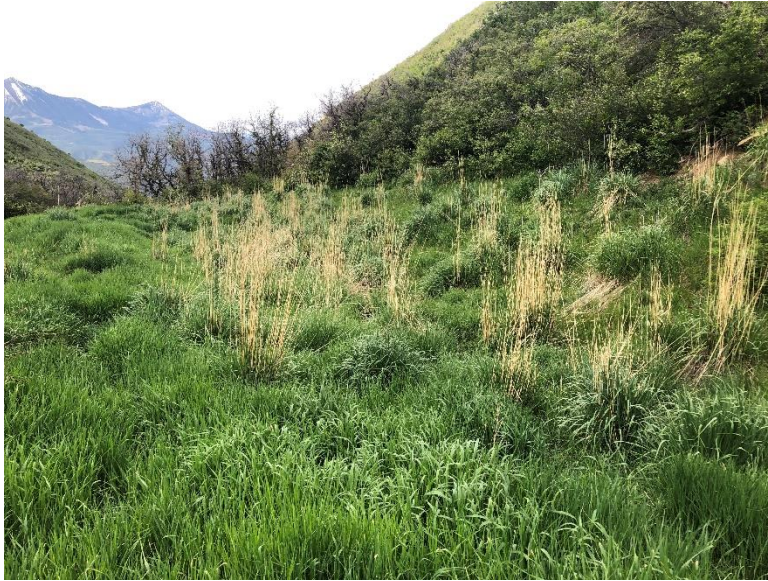
Several pads and roads for GVBs were inspected. The vegetation cover on nearly all of them was good to excellent, and many shrubs were growing, in addition to desirable grasses. Exceptions include bare spots on the roads to GVB-4A and GVB-B3-A1.

Typical vegetation on reclaimed GVB pad

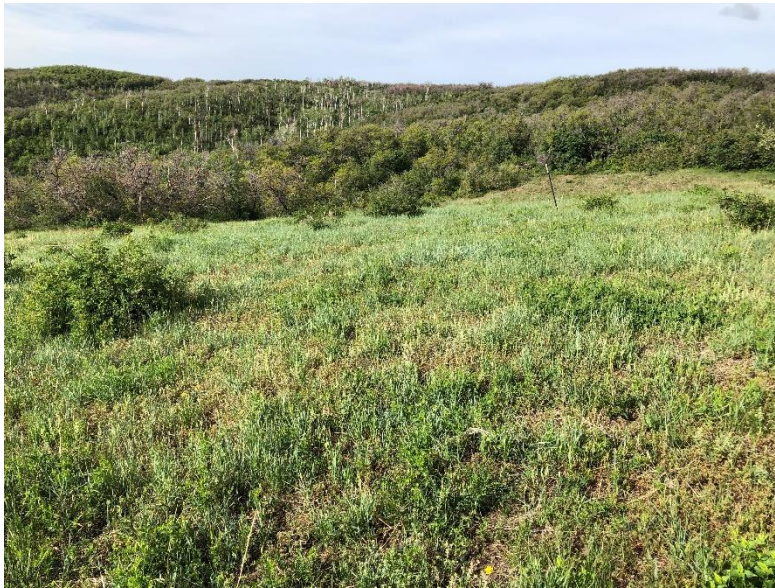
GV B-6E

The table shows that the sizes of pads and roads in the PAP are larger than (or equal to) the estimates from the field observations, with only one exception: the actual pad for GVB-6E appears to be larger than in the PAP. However, in general, the sizes of roads and pads are conservatively estimated in the PAP. Also, it should be noted that the total areas in the PAP table (approximately 85 acres for the pads and 69 acres for roads if the values on pages 45i to 45x are summed) compare closely to the acreages in the Reclamation Cost Estimate for the Bowie #2 Mine (Tasks 151 and 152).

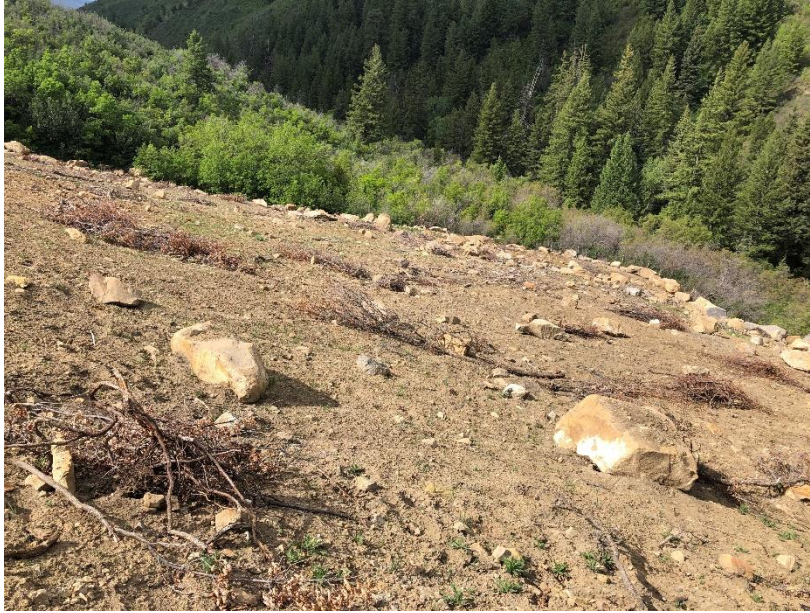
The reclaimed Terror Creek vent shaft pad was inspected. A slide occurred in 2023 and afterwards the structure was demolished, the area was re-graded and hydro mulched, and branches and rocks were used to prevent erosion. During the inspection, no erosion was seen, and a small amount of vegetation has emerged.

Reclaimed Terror Creek vent shaft pad, upper portion

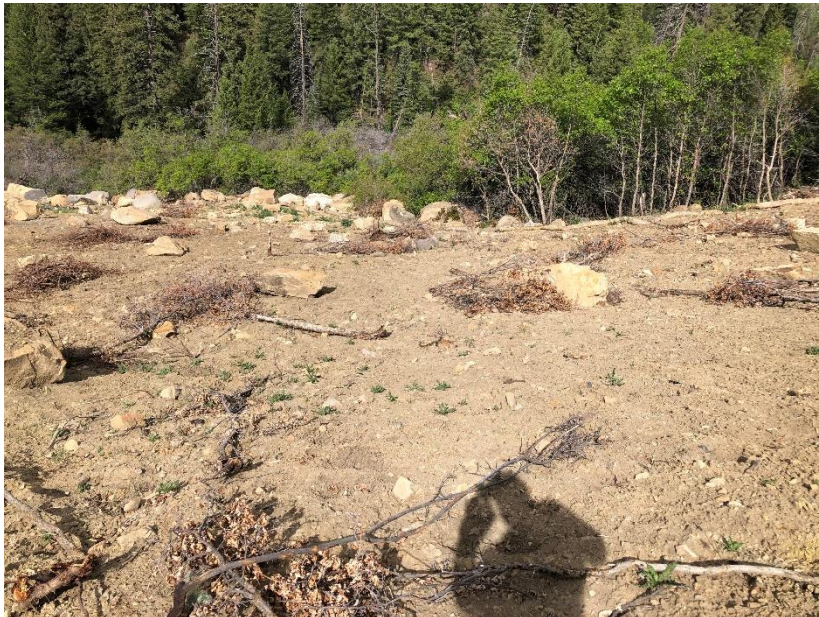
Reclaimed Terror Creek vent shaft pad, lower portion

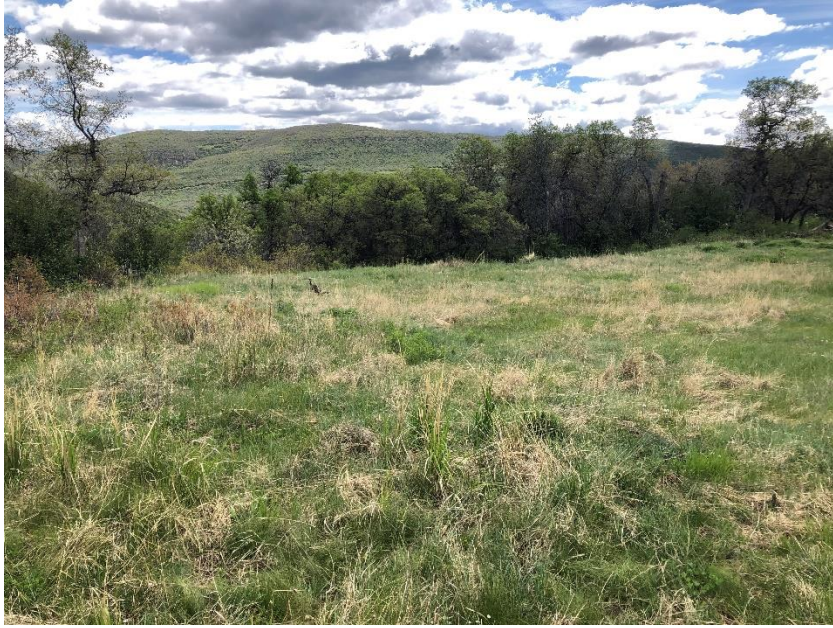
At the GVB-B12E pad, a turkey and a moose were seen. Bear scat was seen in many locations while inspecting the GVBs.

GVB-B12-E (turkey left of center)

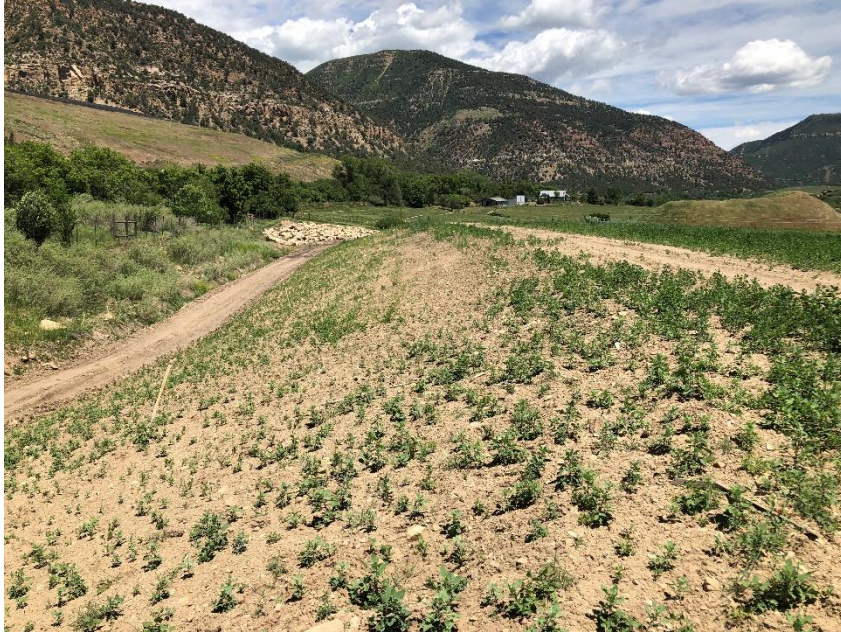
The sides of Gob Pile #3 were stable. The drain on the east side of this pile has been diverted to flow to the area between the soil piles. This will be a point of discussion to determine the long-term plan for this diversion.

North slope, Gob Pile #3

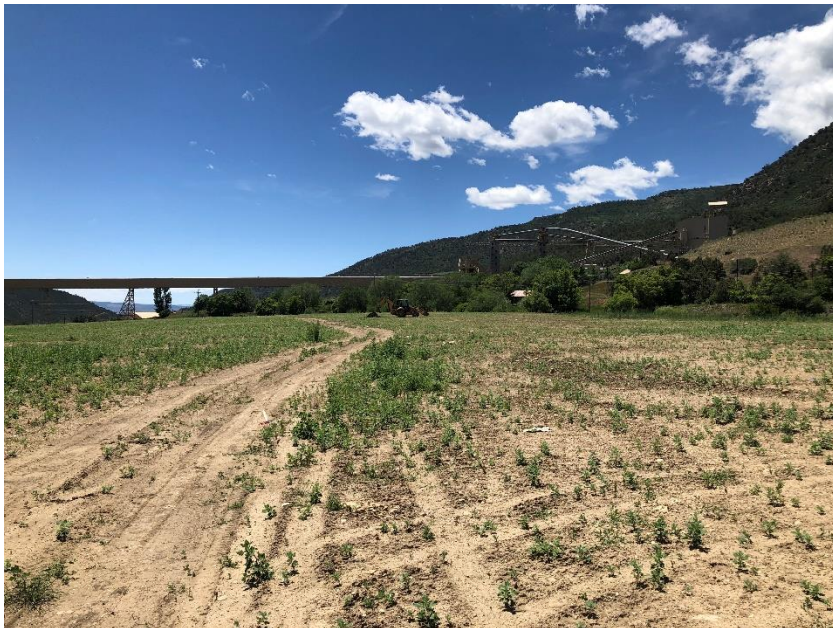
The depths of coverfill on Gob Pile #3 were checked at four locations on the east side of the pile. All of the depths were three feet or more, ranging from 3'0" to 3'10".

Gob Pile #3, looking west at Ken Pitt digging hole to check depth of coverfill material

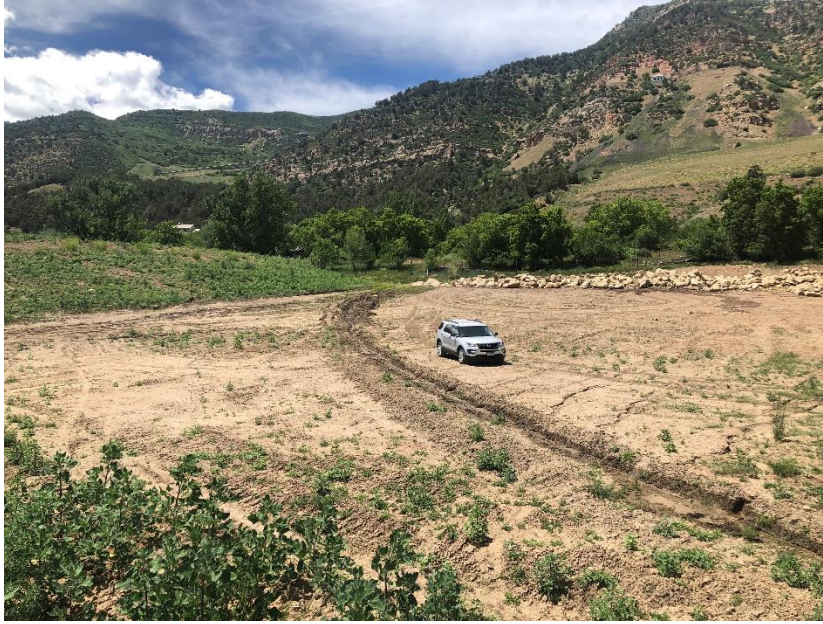
Water diversion at east side of Gob Pile #3

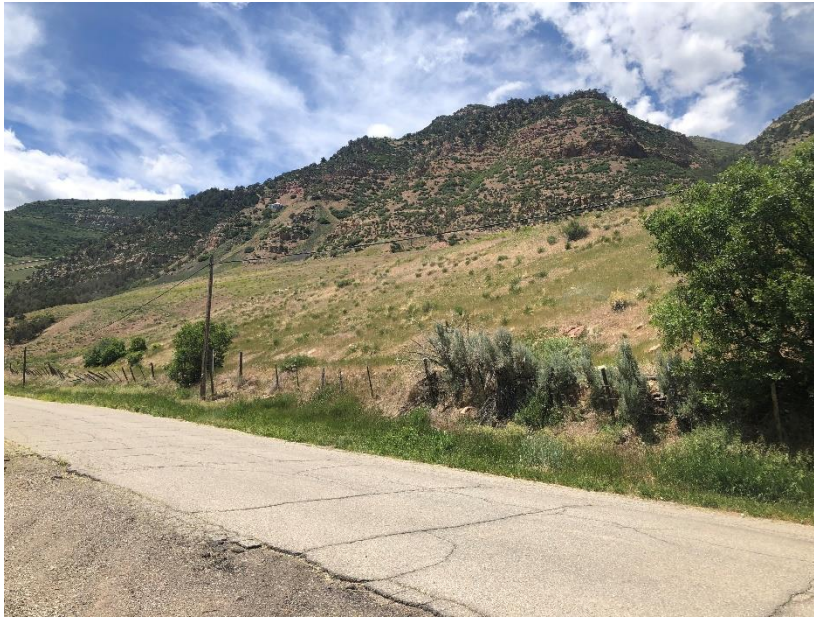
Thistle plants, houndstongue, and/or mullein were seen in many locations, including:

- The road to GVB-B1-A1
- The Terror Creek vent shaft pad
- The slope above the old highway, below Gob Piles 1,2, and 4.

Slope below Gob Piles 1, 2, and 4

Mr. Bear indicated that he and his staff will be spraying weeds in these areas and other areas soon. Signs of past spraying were seen in some locations such as the hill above Pond F.

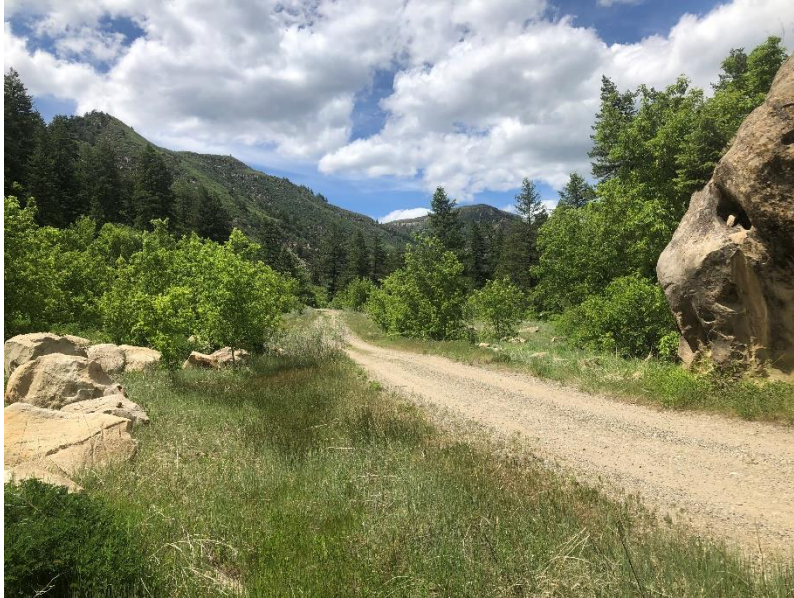
The areas along Hubbard Creek were observed and no problems were seen.

Reclaimed vent shaft area along Hubbard Creek Road

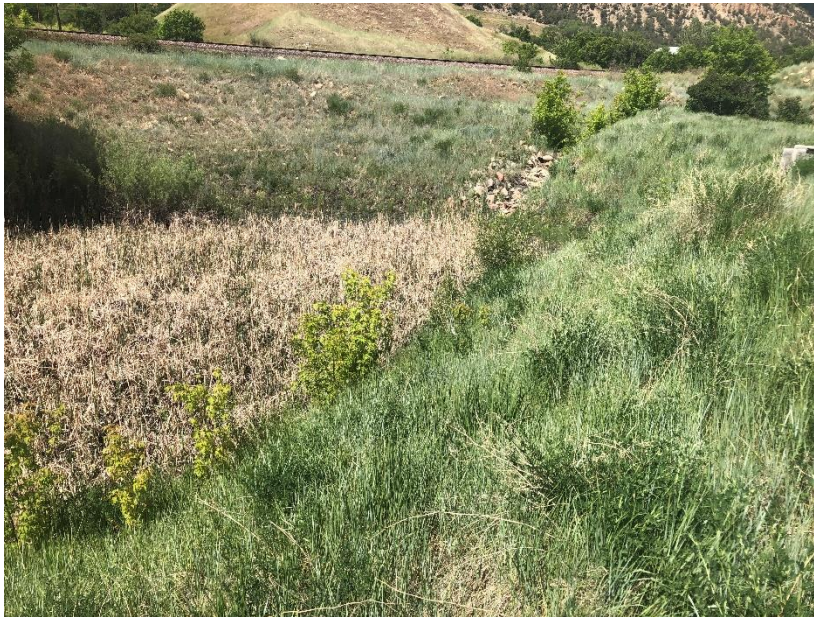
Three sediment ponds were inspected: F, J, and K. None of the ponds were close to discharging. Pond F contained a small amount of water. The bottom of Pond J is obscured by cattails, and no water was seen. Pond K was dry. No significant problems were identified with embankments, spillways, inlet channels, or other features of the ponds.

Pond J (note small trees and willows on embankment)

The Division recommends that willows and small trees be removed or killed on the pond side of Pond J.
