Inspection report for Bowie #1

Permit Number: C-1981-038 Mine Name: Bowie No. 1 Mine Operator: Bowie Resources, LLC Operator Address: Mr. Basil R Bear	County: Delta Operation Type: Underground Permit Status: Active Ownership: Private		
P.O. Box 1488	Operator Representative Present:		
11012011100	Sperator Representative Present.		
Paonia, CO 81428	None		
Operator Representative Signature: (Field Issuance Only)

Inspection Start Date: June 4, 2024 Inspection Start Time: 15:35 Inspection End Date: June 4, 2024 Inspection End Time: 16:20			Inspection Type: Coal Partial Inspection Inspection Reason: Normal I&E Program Weather: Clear	
Joint Inspection Agency:		Joint Inspection Contacts:		
None				
Post Inspection Agency:		Post Inspection Contacts:		
None				
Inspector(s):	Inspector's Signature: Signature Da		re Date:	
Robert Zuber, P.E.	Phot D. The			
			6/7/20	024

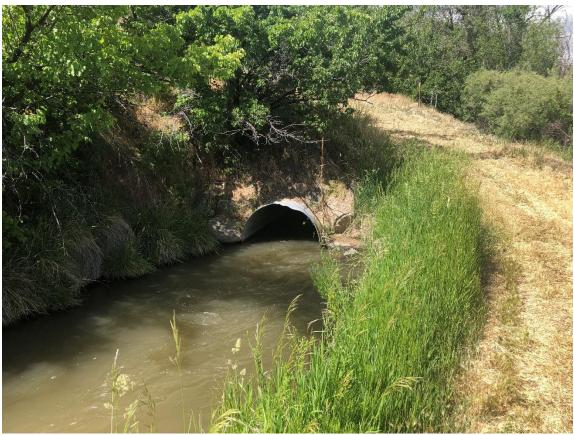
The irrigation ditch that flows under the loadout (the Farmers Ditch) was flowing full. No problems were identified with the large culvert that contains this ditch.

Water in Farmers Ditch at outlet of long culvert at loadout

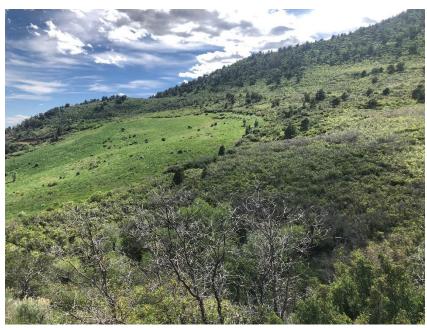
No erosion was seen at the West Mine, including the reclaimed road. Cattle were grazing in this area. The Division recommends that this practice be limited to achieve good vegetation for final bond release.

West Mine reclaimed road

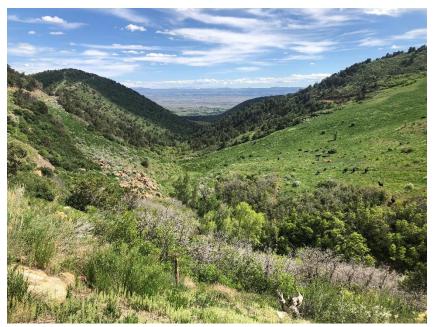
The ponds at the loadout, the Coal Storage Area (near Black Bridge Road), and the West Mine contained little to no water, and no problems were identified with these ponds.

Ponds at West Mine
