MINERALS PROGRAM INSPECTION REPORT
PHONE: (303) 866-3567

MINE NAME: Bootleg Quarry	MINE/PROSPECTING ID#: M-2015-022	MINERAL: Sand and overburden	COUNTY: Adams
INSPECTION TYPE: Monitoring	WEATHER: Windy	INSP. DATE: April 10, 2024	INSP. TIME: 13:30
OPERATOR: Lazy H Inc	OPERATOR REPRESENTATIVE: Bill Havengar	TYPE OF OPERATION: 111 - Construction by Government Agency	
REASON FOR INSPECTION: Normal I&E Program	BOND CALCULATION TYPE:	BOND AMOUNT: \$34,000.00	
DATE OF COMPLAINT: NA	POST INSP. CONTACTS: None	JOINT INSP. AGENCY: None	
INSPECTOR(S): Nikie Gagnon	INSPECTOR'S SIGNATURE:

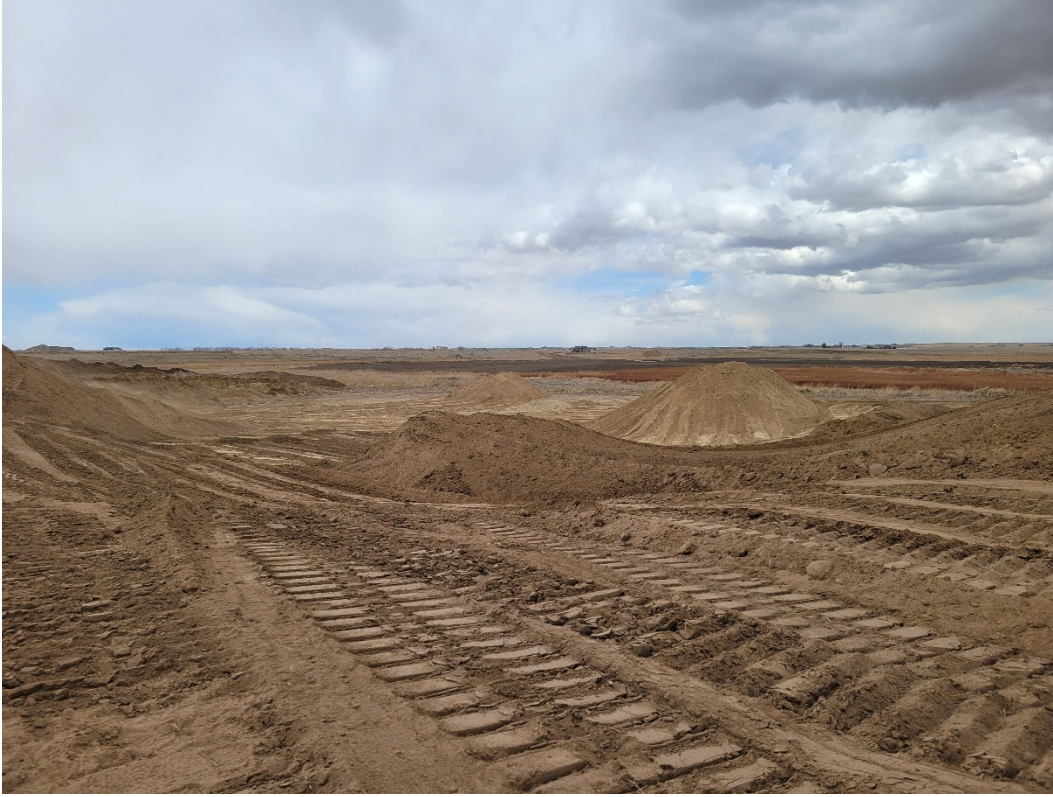
Photo 1: Looking east across the pit area on the western edge of Boot Lake Reservoir.

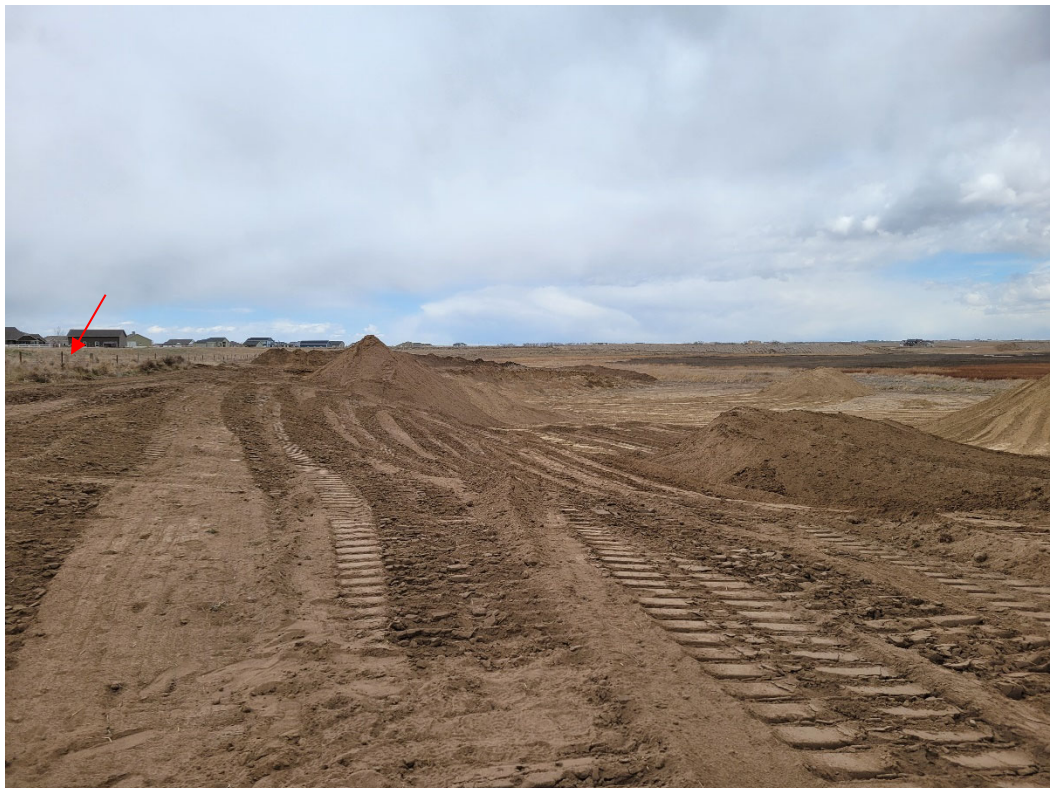
Photo 2: Looking north across the recently graded western highwall of the pit. A barbed wire fence runs along the western edge (red arrow).

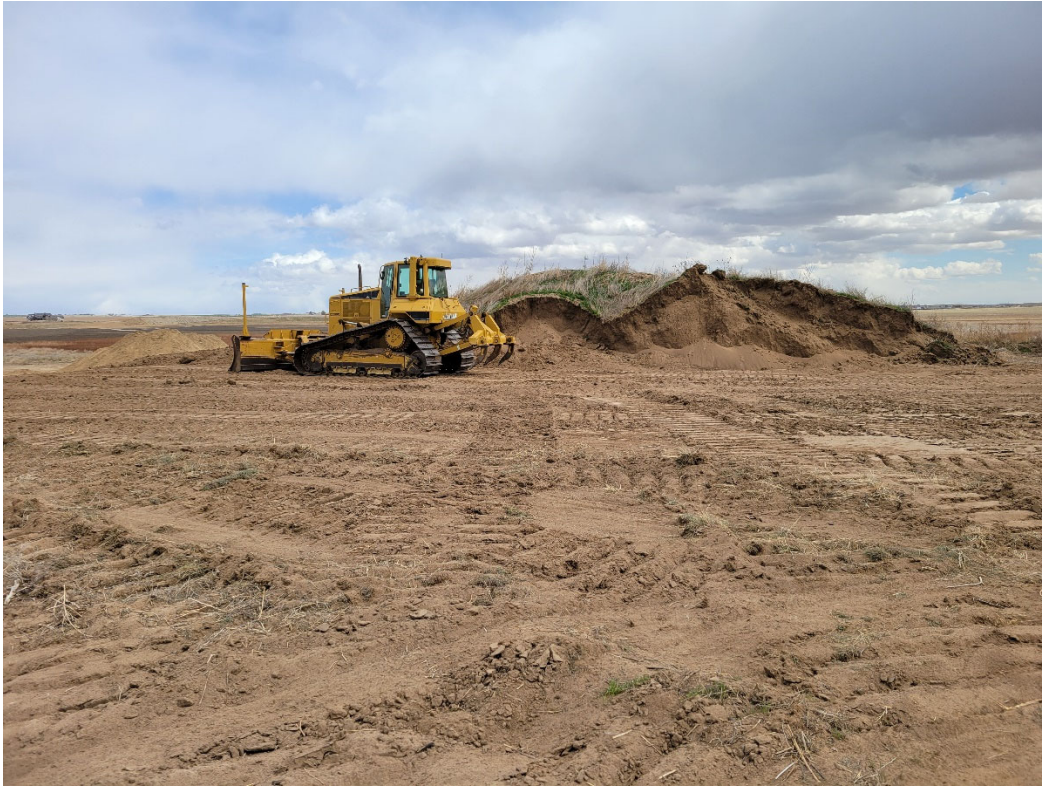
Topsoil is stockpiled above the southern and northern highwalls. During the inspection, these piles appeared stable and vegetated. The Operator was working on grading and topsoiling the upper pit slope and moving some of the topsoil down to the bottom of the pit to a new storage location for future reclamation.

Photo 3: Dozer moving topsoil from top of pit to reclaimed slopes and relocated storage location at the bottom of pit.

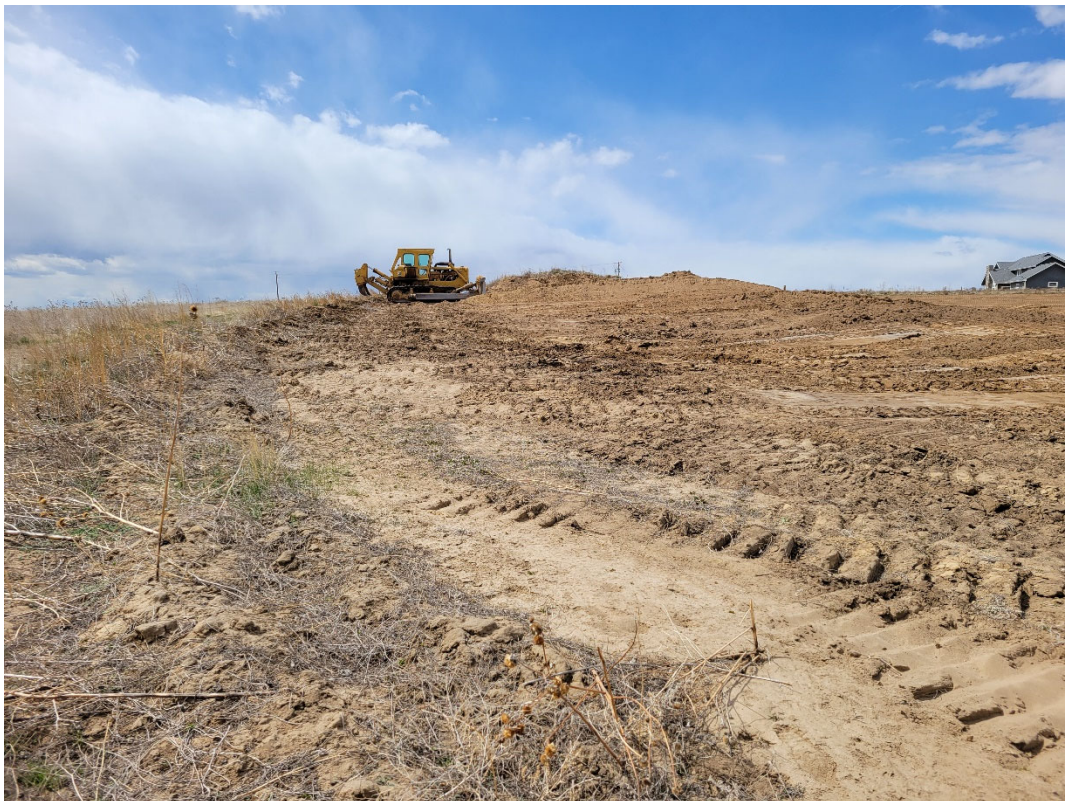
Photo 4: Looking west along the southern disturbance boundary. A barbed wire fence runs the length of the parcel on this side.

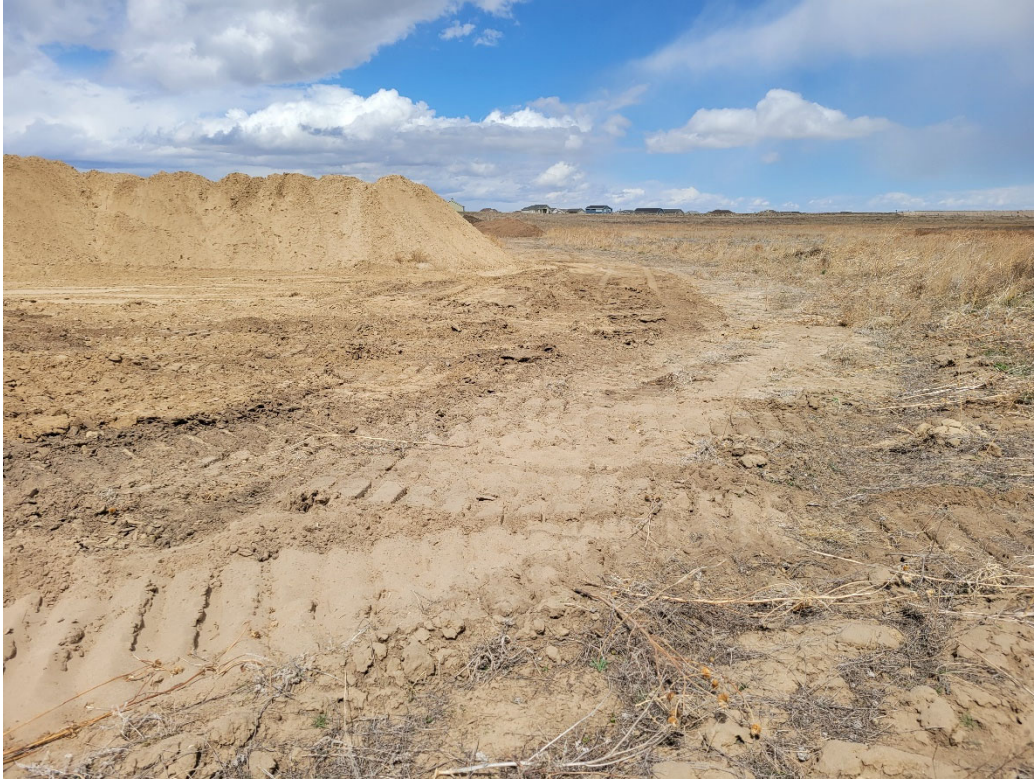
Photo 5: Looking north along the eastern edge of the pit disturbance.

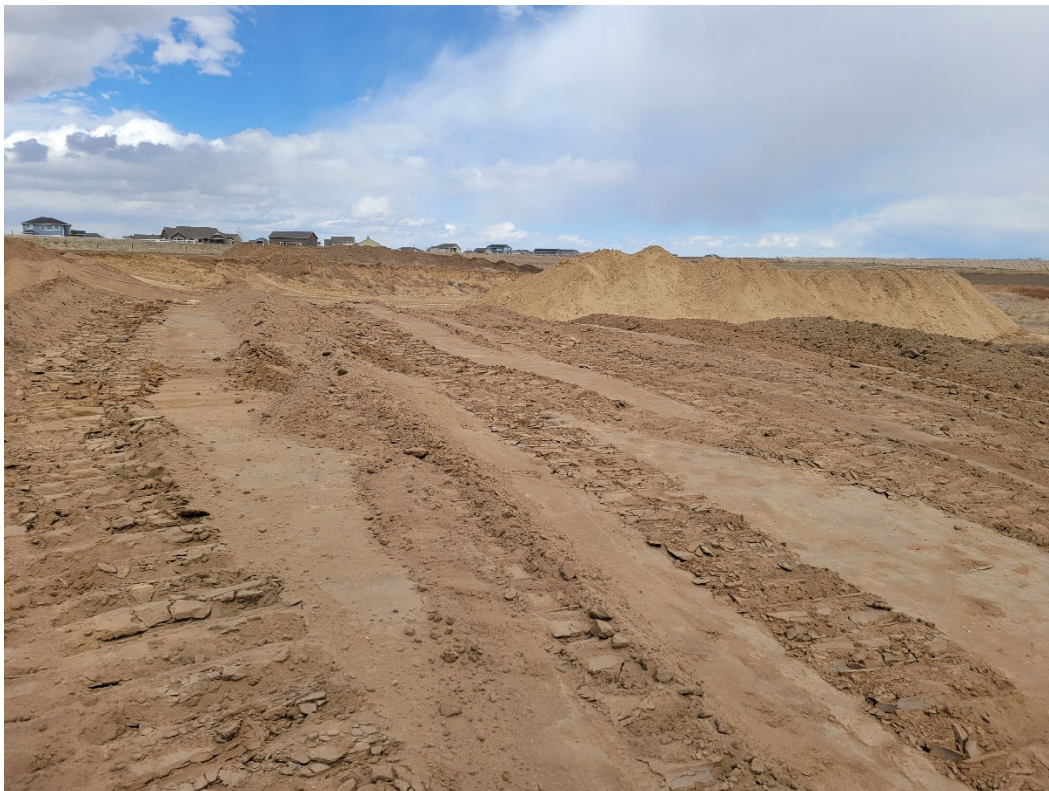
Photo 6: Looking across the graded slopes on the southern end. Stockpile of material sits in the bottom of the pit.

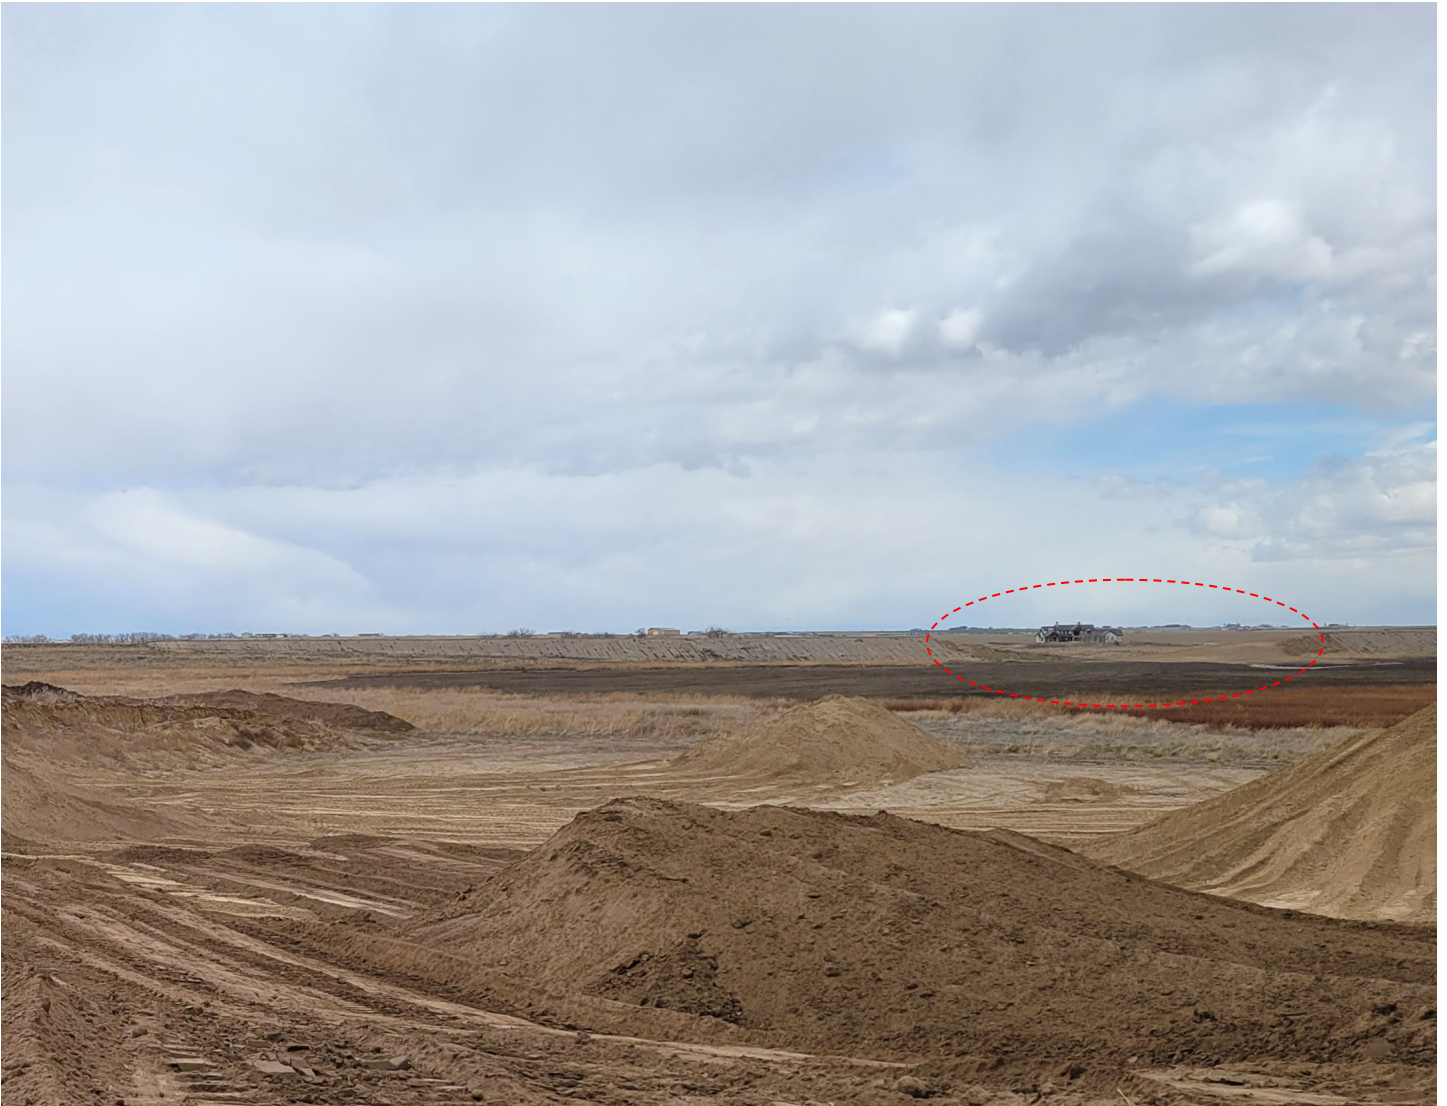
The pit sits along the western boundary of the Boot Lake Reservoir. The Boot Lake Reservoir is no longer used for water storage and has been taken out of service. A dam runs along the north end of the reservoir, outside the permit area. The Operator pointed out damage to the historic dam caused by recent flooding of Box Elder Creek in 2023 and indicated material from the mine is used for repairs to the dam and the Denver-Hudson irrigation canal.

Photo 7: Looking east from the pit into the historic reservoir. Damaged section of dam in the background marked by red circle.

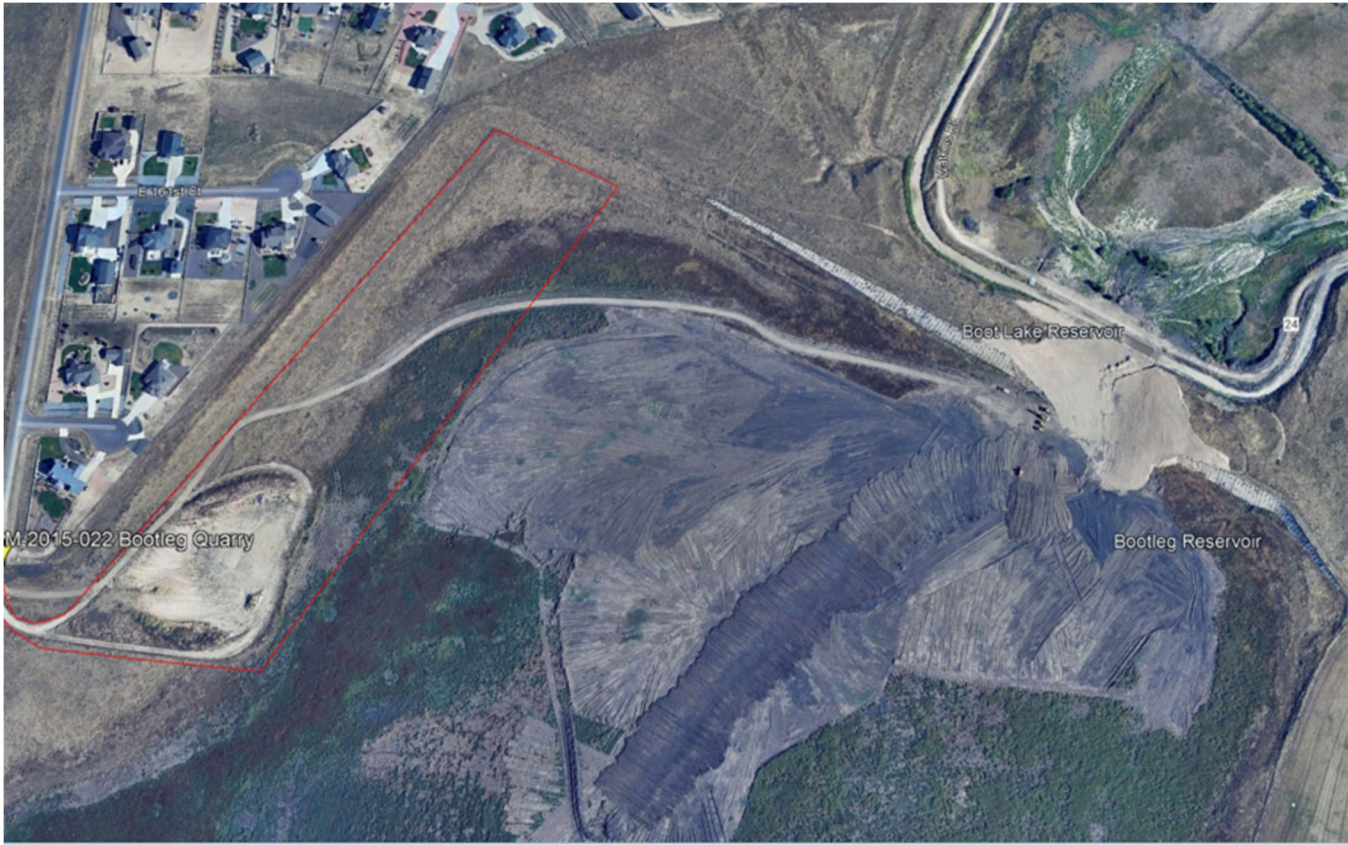
Figure 1: Permit area shown by red outline along the western edge of the reservoir. Google Image from 9/4/24 shows repair work on Box Elder creek and the dam after 2023 flooding.
