**MINERALS PROGRAM INSPECTION REPORT**  
**PHONE: (303) 866-3567**

<b>MINE NAME:</b> Ackerman Pit	<b>MINE/PROSPECTING ID#:</b> M-2019-037	<b>MINERAL:</b> Sand and gravel	<b>COUNTY:</b> Cheyenne
<b>INSPECTION TYPE:</b> Monitoring	<b>WEATHER:</b> Clear	<b>INSP. DATE:</b> April 23, 2024	<b>INSP. TIME:</b> 10:00
<b>OPERATOR:</b> Cheyenne County	<b>OPERATOR REPRESENTATIVE:</b> Jim Brown	<b>TYPE OF OPERATION:</b> 110c - Construction Limited Impact	
<b>REASON FOR INSPECTION:</b> Normal I&E Program	<b>BOND CALCULATION TYPE:</b> N/A County Operation	<b>BOND AMOUNT:</b> N/A County Operation	
<b>DATE OF COMPLAINT:</b> NA	<b>POST INSP. CONTACTS:</b> None	<b>JOINT INSP. AGENCY:</b> None	
<b>INSPECTOR(S):</b> Nikie Gagnon	<b>INSPECTOR'S SIGNATURE:</b>

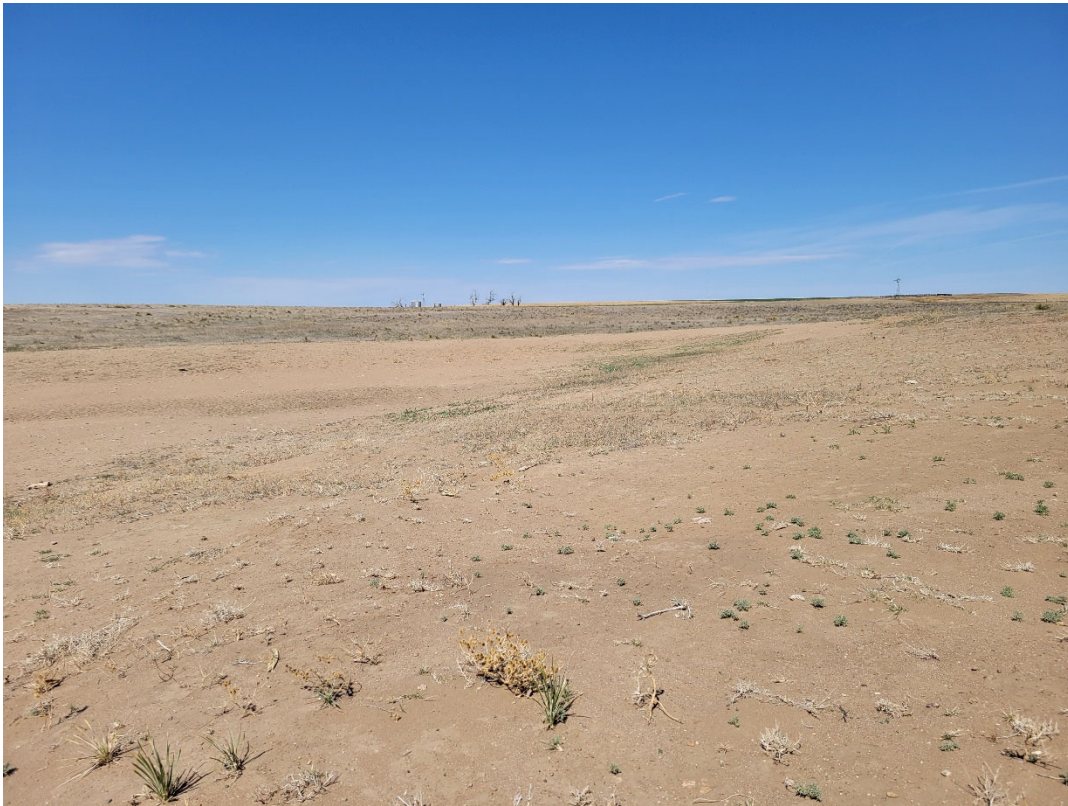
Sparse vegetation was observed in the western mined area. The Operator will need to scarify the pit before spreading topsoil. The approved plan calls for applying fertilizer or manure prior to seeding. Drill seeding and mulch shall be applied in accordance with the approved reclamation plan. Any soils that have been compacted by equipment should be tilled to break up restrictive layers.

Photo 1: View looking northwest across the sloped pit. Little vegetation observed.

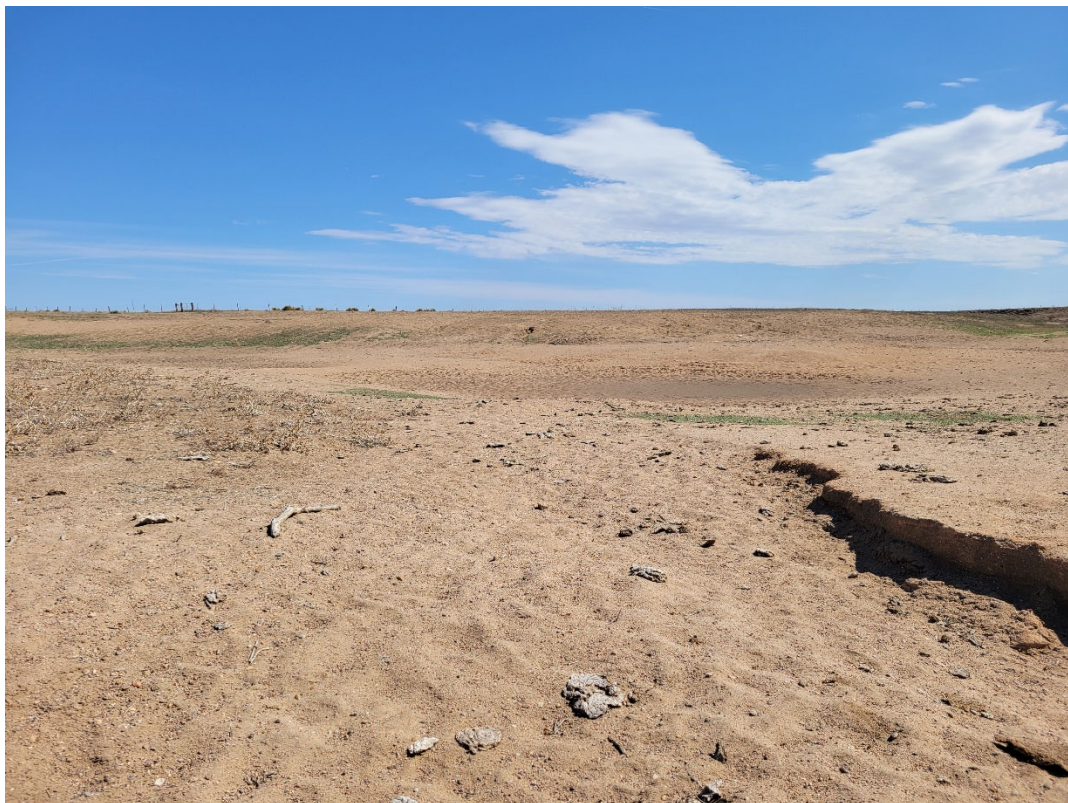
The operation consists of a circular mined pit on the western end of the permit area. The slopes have been graded to 3H:1V in this area. Small topsoil/overburden berms were observed pushed along the edge of the disturbance area. The eastern side of the permit area remains undisturbed except for a haul road. No equipment was observed on-site. The Operator indicated that they will reclaim the western side and may mine the eastern side of the permit area in the future.

Photo 2: View looking northeast from the entrance to the pit. Slopes are graded 3H1:1V or shallower around the pit.

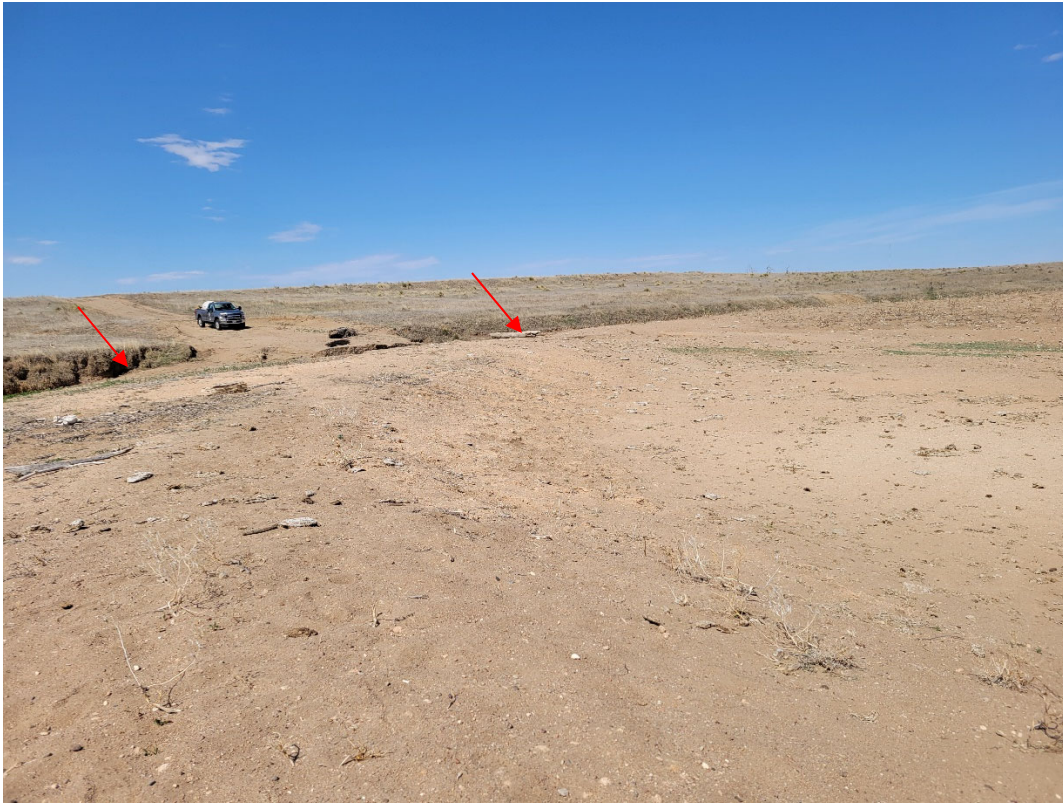
Photo 3: Entrance to the pit. The dry creek that runs around the south and west sides of the pit is marked by the arrow.

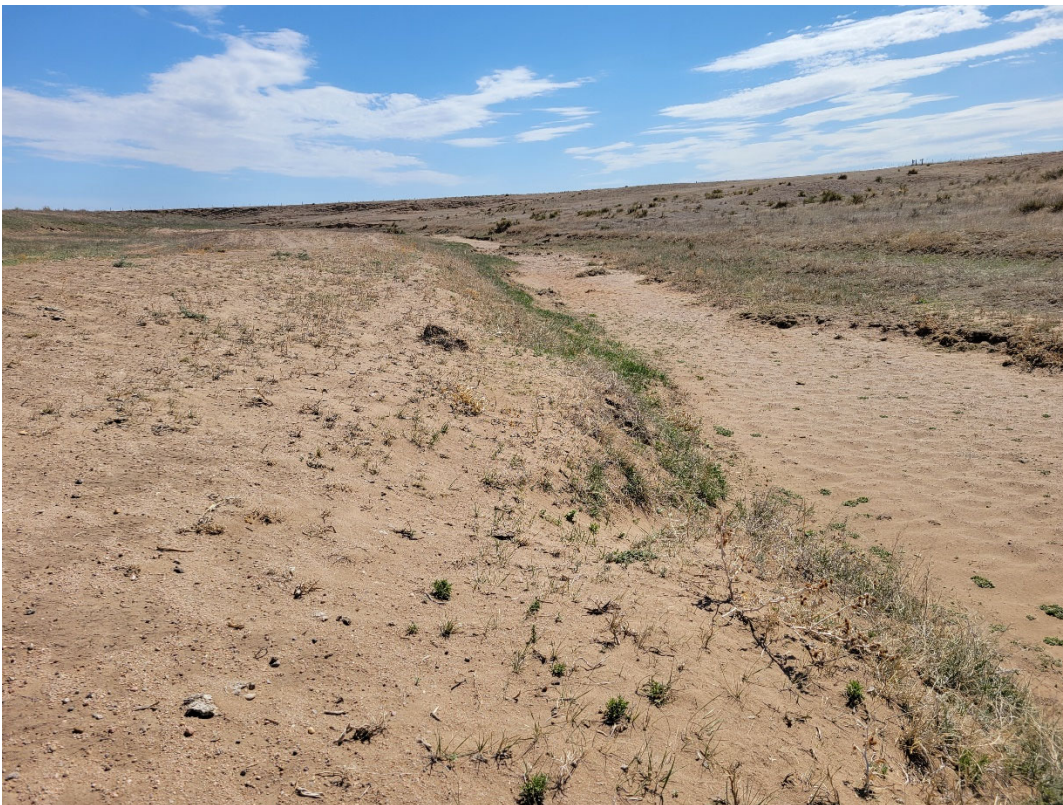
Photo 4: View looking down the dry creek bed on the western side of the pit.

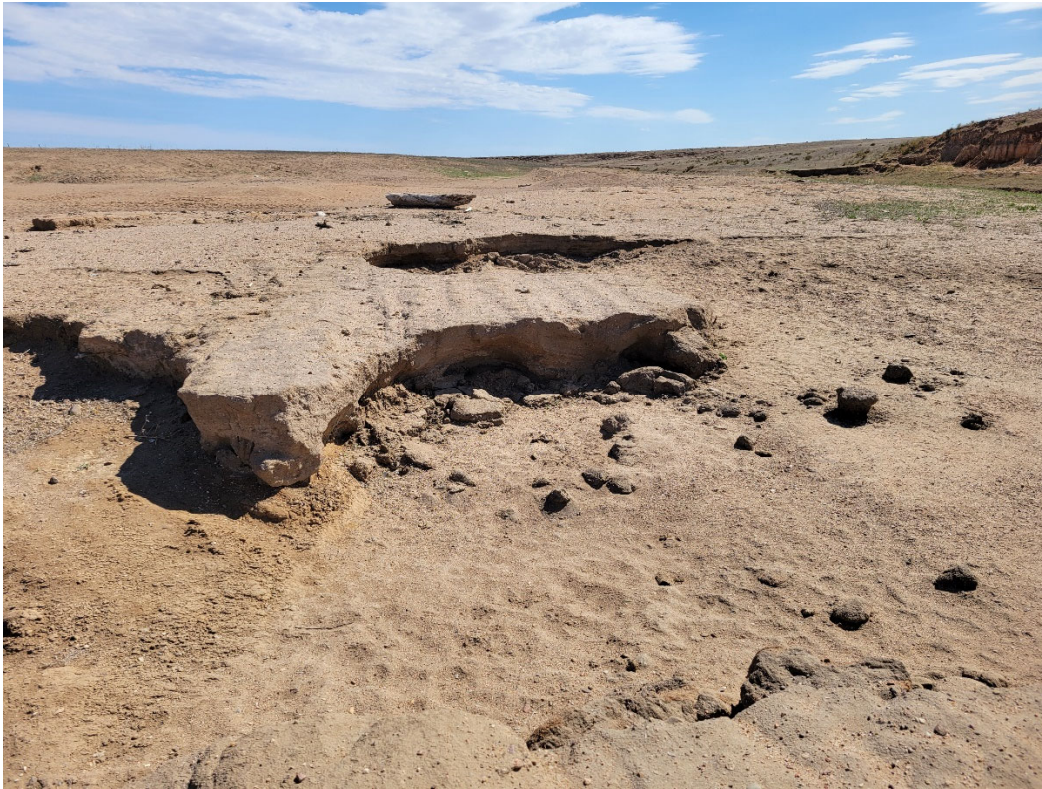
No standing water was observed in the pit. A dry creek bed, the Smoky Hill River, runs along the south and west sides of the mining area. No water was observed during the inspection. The Operator indicated the creek was flowing for the first time in years last spring and eroded the crossing at the entrance to the pit. The Operator will need to regrade the entrance to allow mining and reclamation equipment to enter the site.

Photo 5: Entrance to the pit where the creek eroded the haul road.

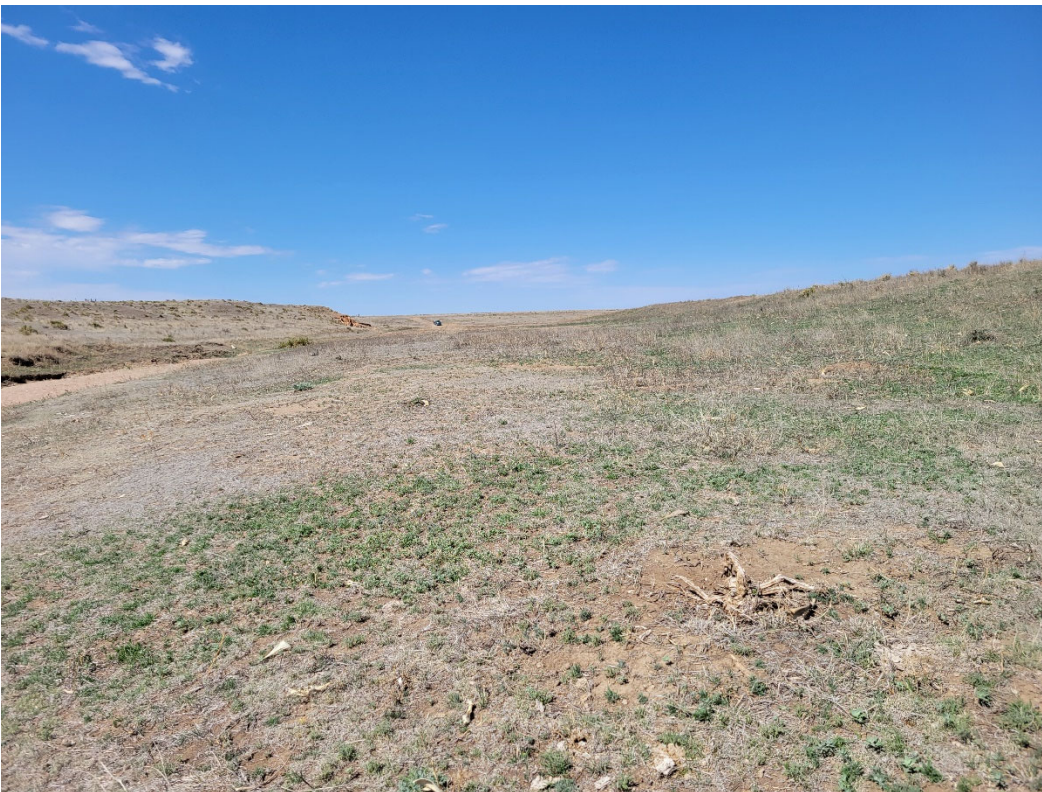
Photo 6: Eastern unmined section of the permit area.

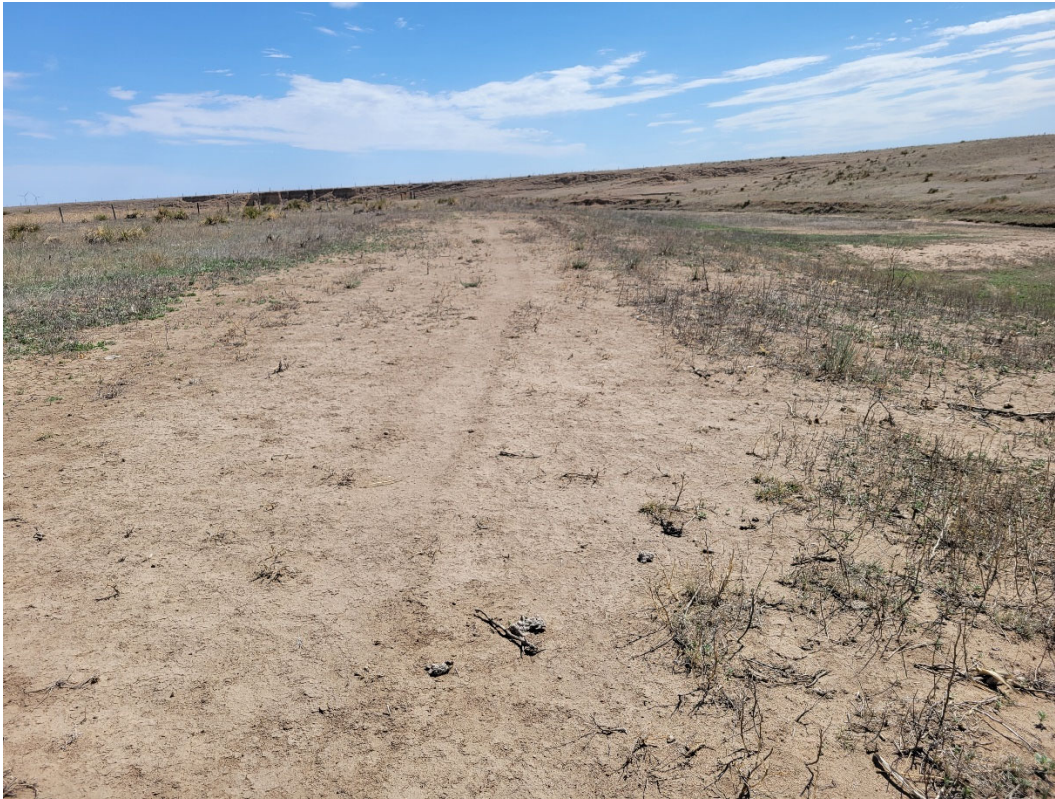
Photo 7: Looking east down the haul road that leads to the eastern unmined section of the permit area.
