MINERALS PROGRAM INSPECTION REPORT
PHONE: (303) 866-3567

MINE NAME: Knodel Pit	MINE/PROSPECTING ID#: M-2011-042	MINERAL: Gravel and Sand	COUNTY: Yuma
INSPECTION TYPE: Monitoring	WEATHER: Clear and Windy	INSP. DATE: April 24, 2024	INSP. TIME: 10:00
OPERATOR: Yuma County	OPERATOR REPRESENTATIVE: Tom Andersen	TYPE OF OPERATION: 112c - Construction Regular Operation	
REASON FOR INSPECTION: Normal I&E Program	BOND CALCULATION TYPE: N/A County Operator	BOND AMOUNT: N/A County Operator	
DATE OF COMPLAINT: NA	POST INSP. CONTACTS: None	JOINT INSP. AGENCY: None	
INSPECTOR(S): Nikie Gagnon	INSPECTOR'S SIGNATURE:

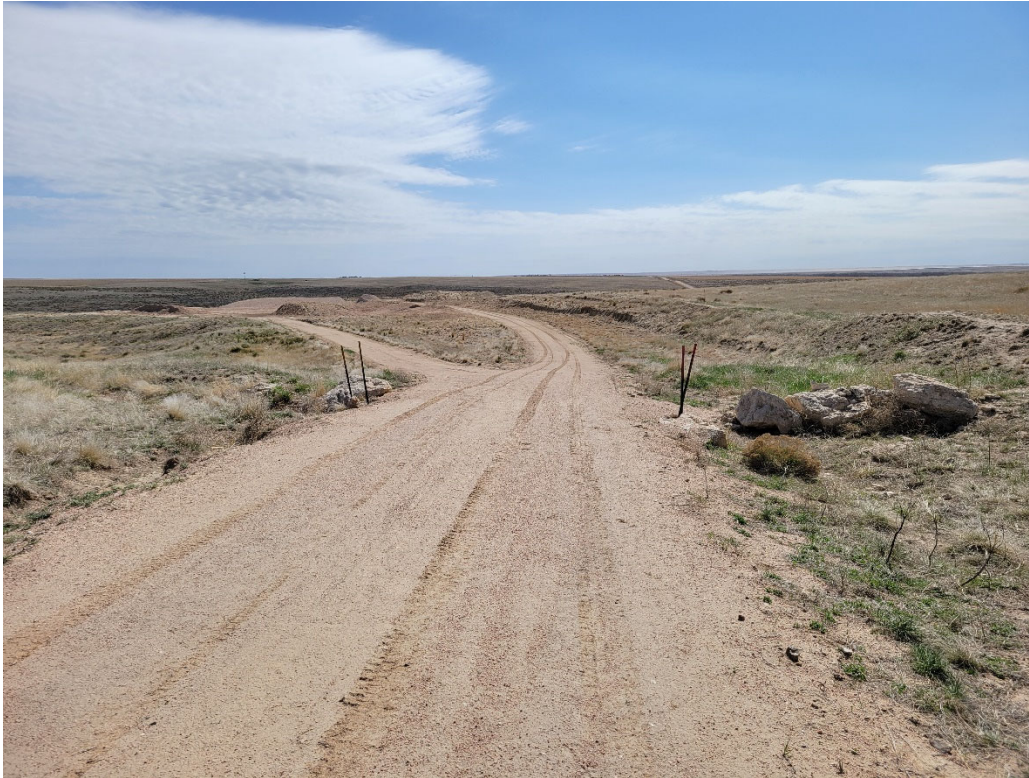
Photo 1: Looking east down access road at entrance to site.

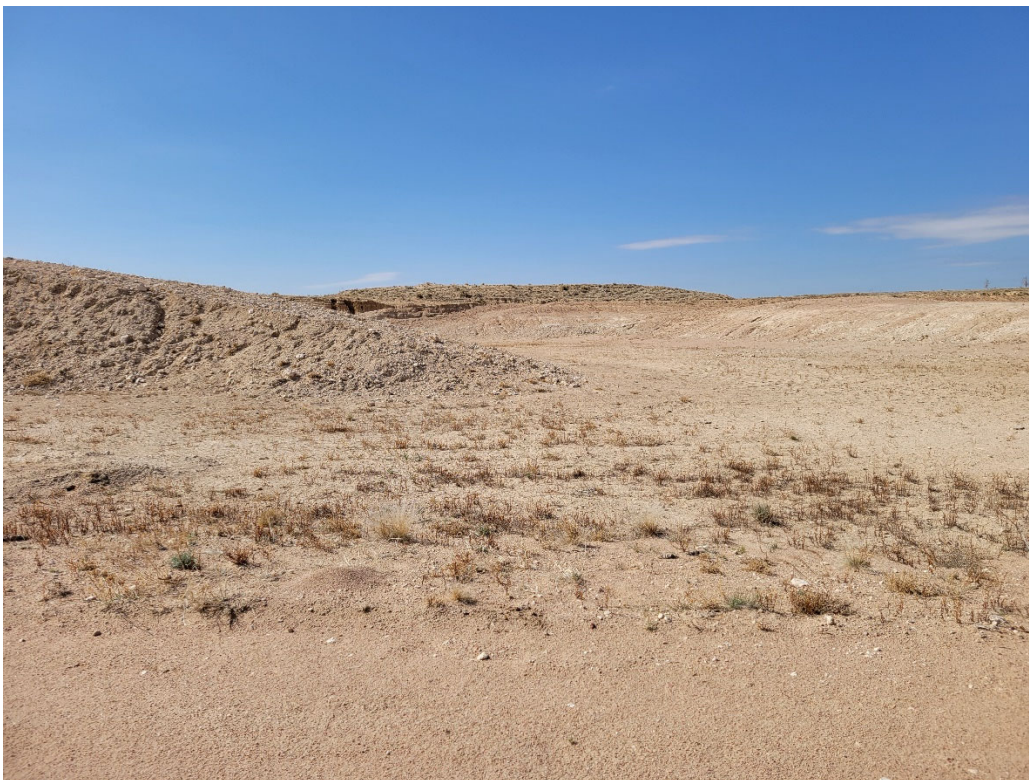
Photo 2: Looking southeast across the pit area in the southern section of the permit area.

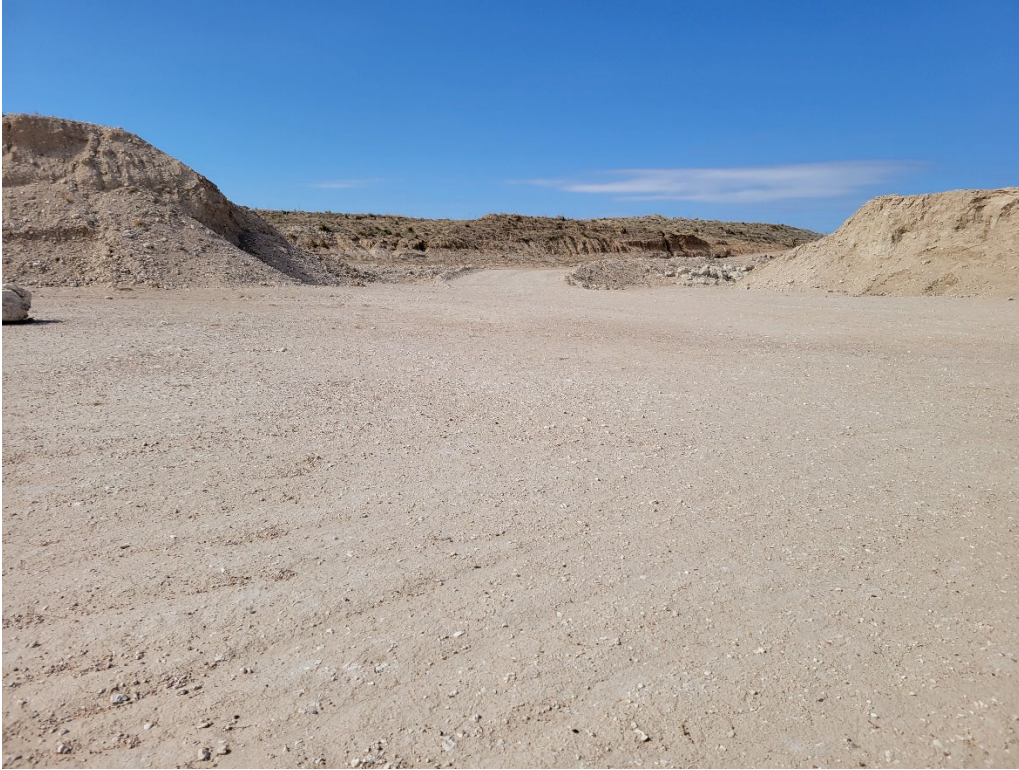
Photo 3: Looking southwest across the pit floor.

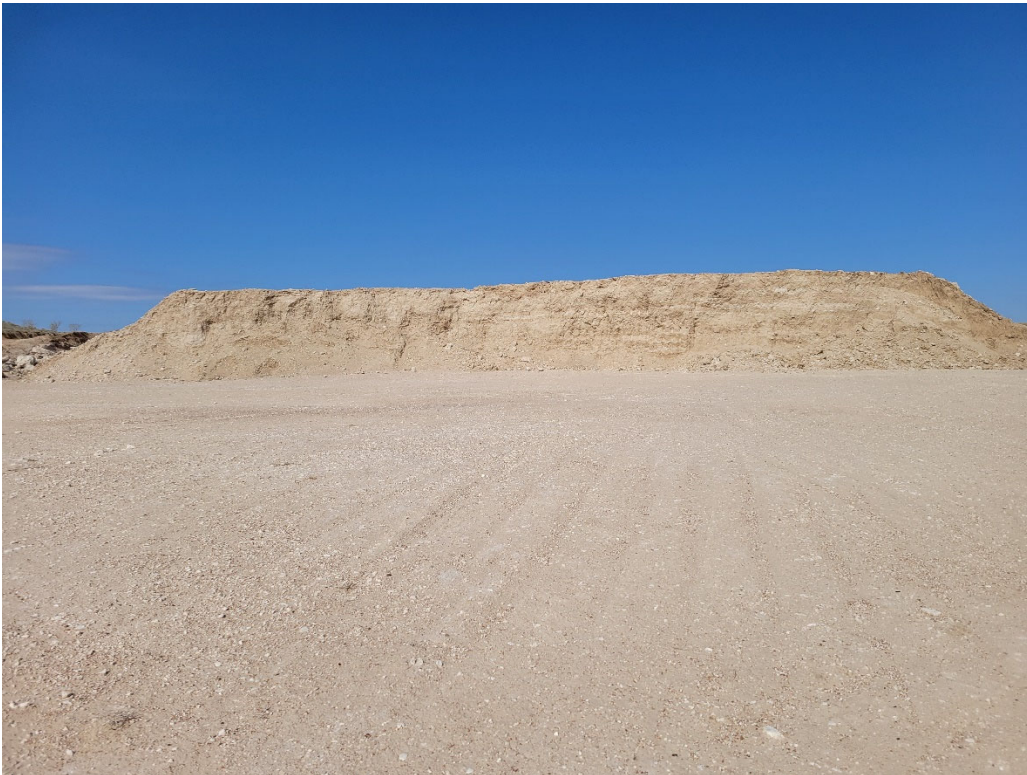
Photo 4: Looking west across the pit floor at the mining face.

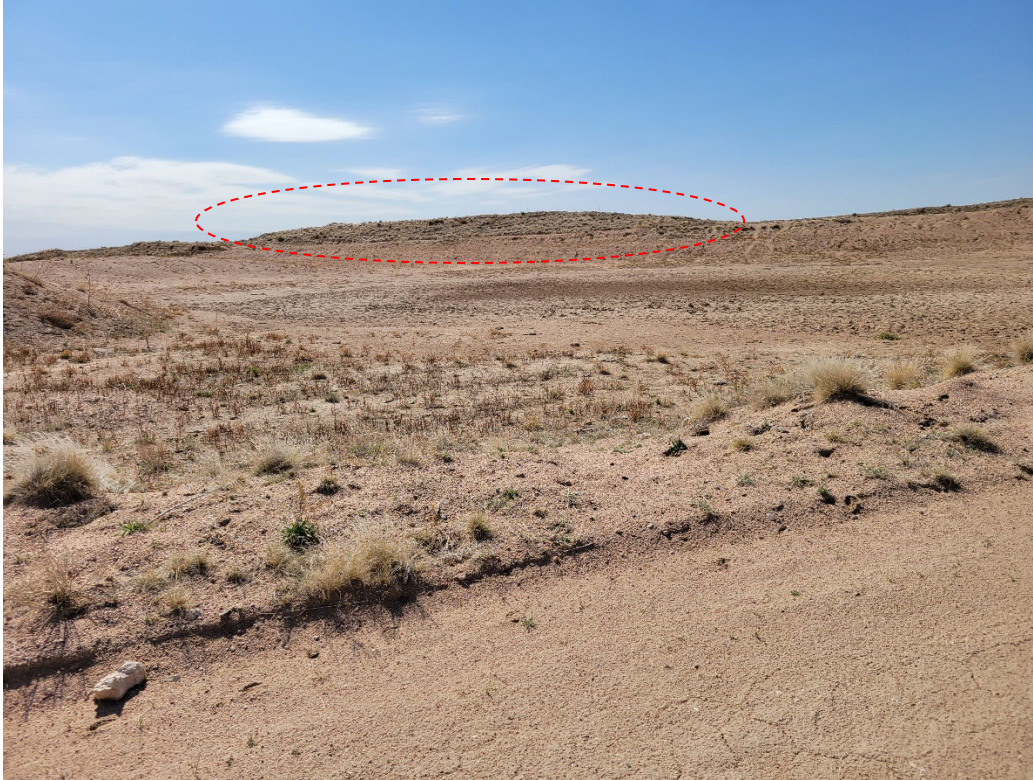
Topsoil is shallow in this area. The salvaged topsoil was observed stockpiled in berms above the southern highwall.

Photo 5: Looking south at highwall. Topsoil stored above the highwall along the southern boundary (circled).

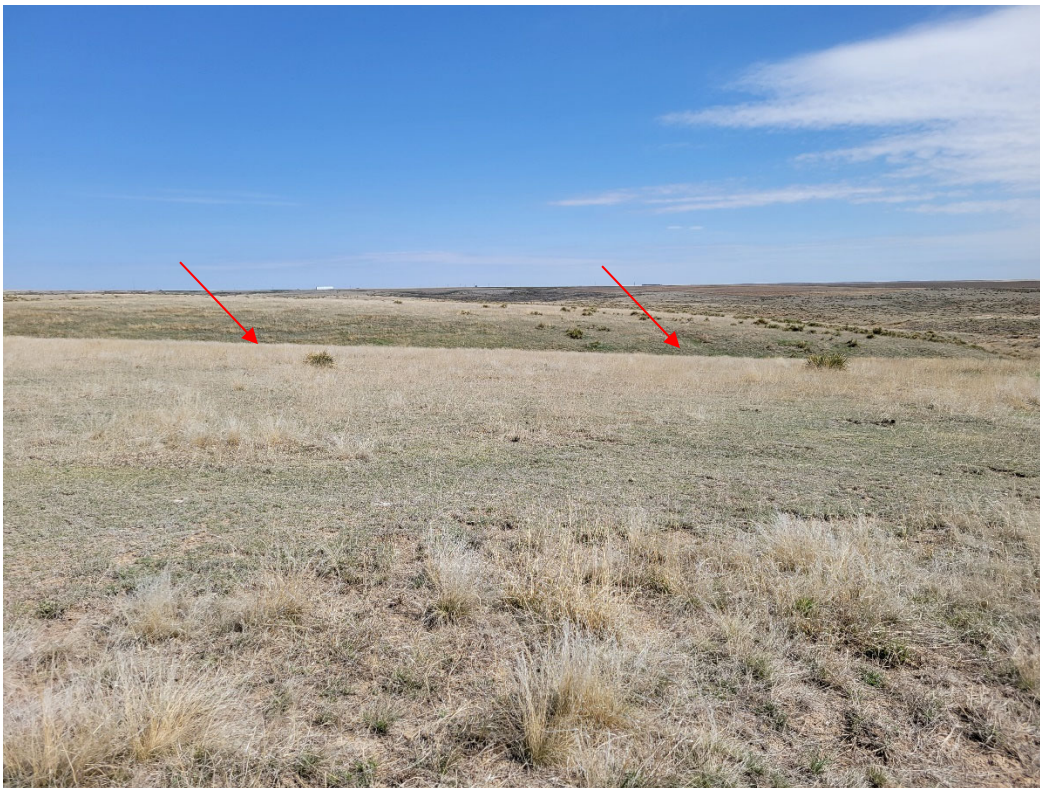
A dry drainage runs through the center of the permit area. Drainage from the site eventually flows to the South Fork of the Republican River. No evidence of sedimentation or stormwater runoff outside the permit boundary was noted. A low spot in the center of the pit showed evidence of standing water, however water likely infiltrates quickly.

Photo 6: Looking north across unmined area northwest of the active mining disturbance. Dry drainage runs through the center of the permit area (red arrows).

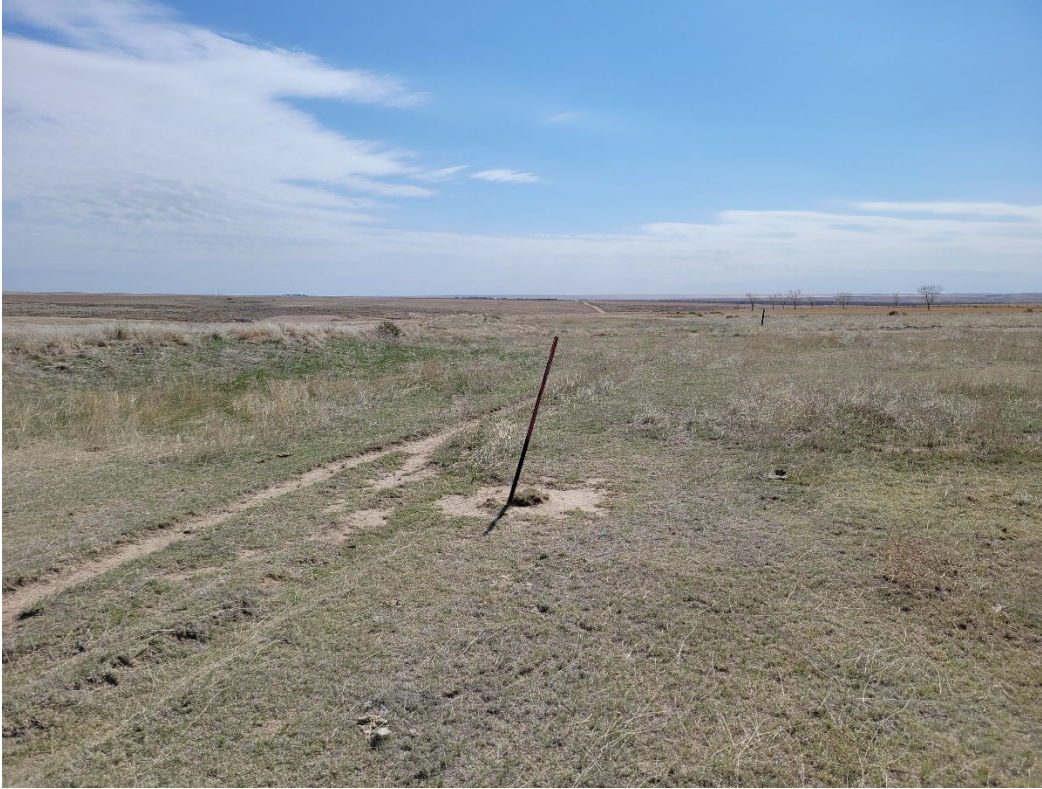
The Knodel Pit is an open pit mine utilized intermittently for sand, gravel and borrow material. The site was not active at the time of inspection and no equipment was on-site. Stockpiled material was observed in the pit and equipment and vehicle tracks were noted. Mr. Andersen indicated the County utilizes stockpiled material as needed to maintain roads. The current disturbance is approximately 20-acres in the south end of the permit area, which hasn't expanded in recent years. The mine plan calls for mining to approximately 25 feet deep. The highwalls surrounding the pit area are approximately 15 feet high. The operator opened a smaller area on the northwest side of the permit area a few years ago and this area has been fully reclaimed with grasses. No evidence of off-site damage was observed. The majority of the permit area remains undisturbed. The mine plan calls for a 25-foot setback around the edges of the mining boundary. This setback was observed on the eastern and southern boundaries of the current mining disturbance area.

Photo 7: Looking down the southern boundary line, above the highwall in the active mining area.

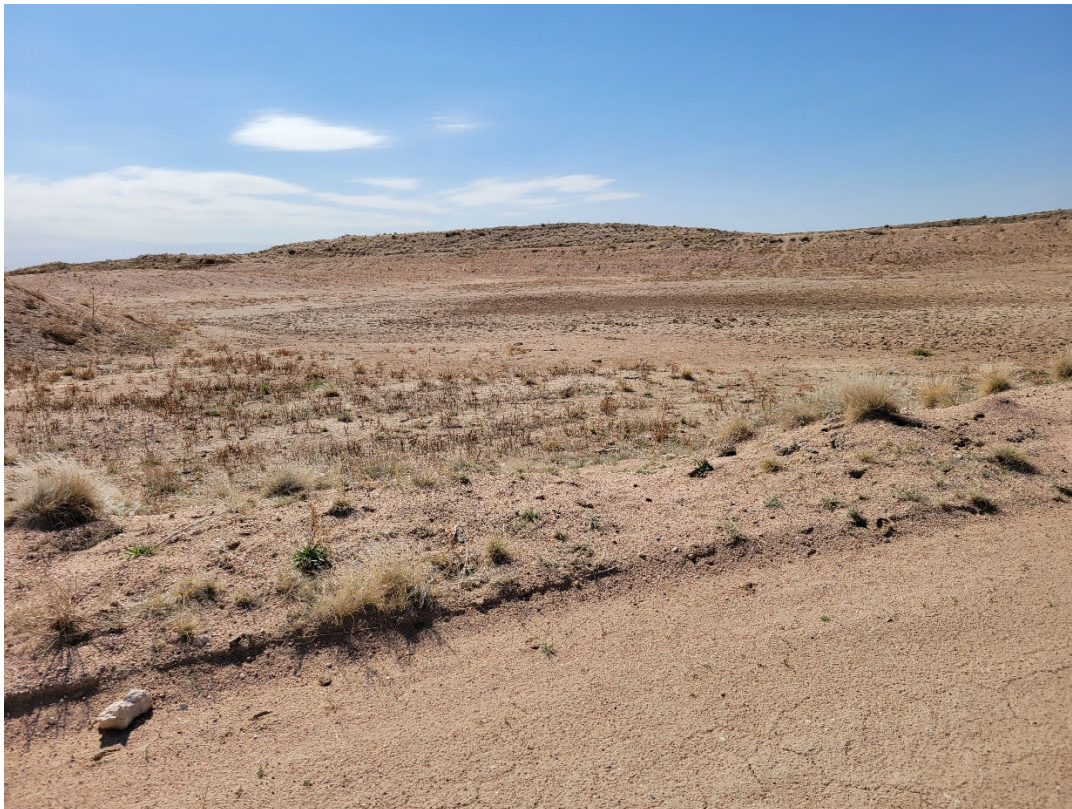
Photo 8: Evidence of previous standing water noted in a low spot in the active mining area. This area was dry during the inspection.
