**MINERALS PROGRAM INSPECTION REPORT**  
**PHONE: (303) 866-3567**

<b>MINE NAME:</b> Homm Pit	<b>MINE/PROSPECTING ID#:</b> M-2015-049	<b>MINERAL:</b> Sand, gravel & clay	<b>COUNTY:</b> Yuma
<b>INSPECTION TYPE:</b> Monitoring	<b>WEATHER:</b> Clear and Windy	<b>INSP. DATE:</b> April 24, 2024	<b>INSP. TIME:</b> 11:00
<b>OPERATOR:</b> Yuma County	<b>OPERATOR REPRESENTATIVE:</b> Tom Andersen	<b>TYPE OF OPERATION:</b> 112c - Construction Regular Operation	
<b>REASON FOR INSPECTION:</b> Normal I&E Program	<b>BOND CALCULATION TYPE:</b> N/A County Government	<b>BOND AMOUNT:</b> N/A County Government	
<b>DATE OF COMPLAINT:</b> NA	<b>POST INSP. CONTACTS:</b> None	<b>JOINT INSP. AGENCY:</b> None	
<b>INSPECTOR(S):</b> Nikie Gagnon	<b>INSPECTOR'S SIGNATURE:</b>

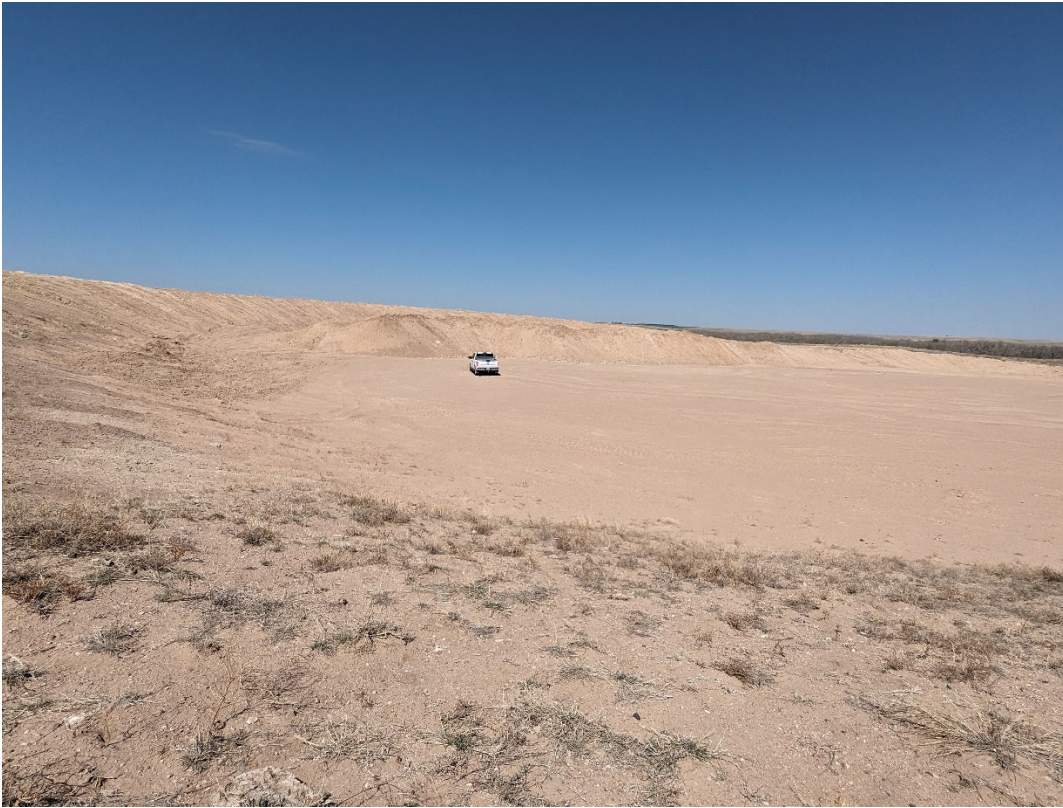
Photo 1: Looking west across the Phase 1 mining area.

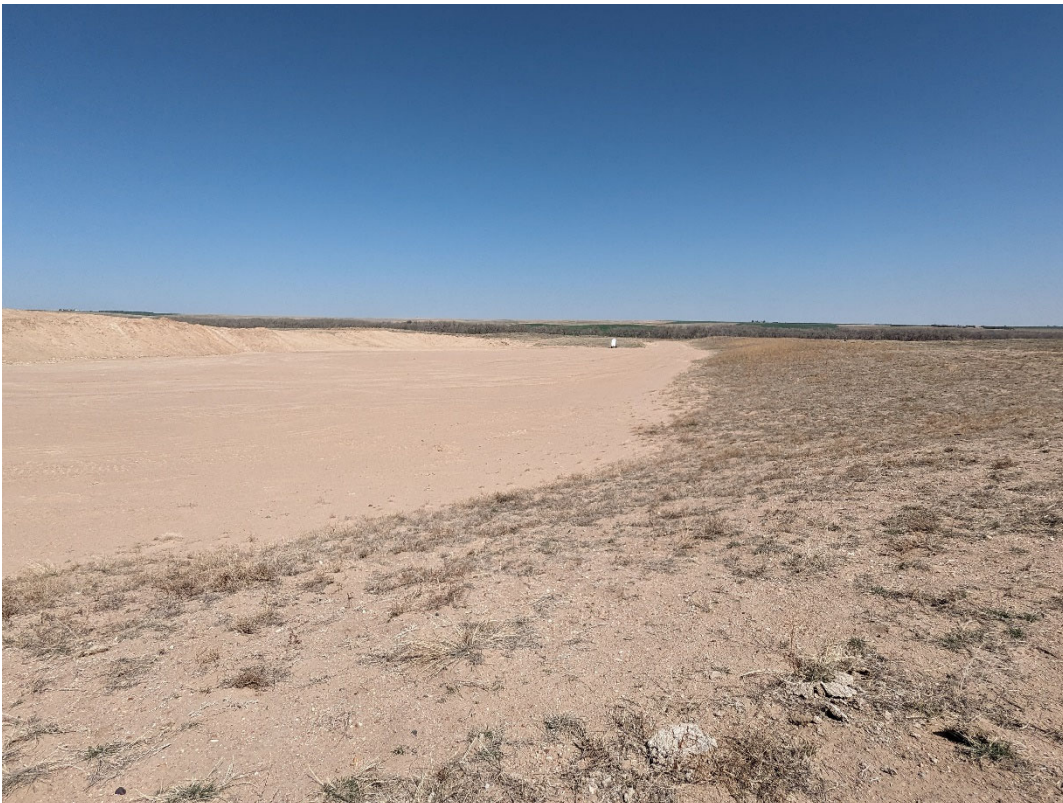
Photo 2: Looking north across the Phase 1 mining area towards the entrance.

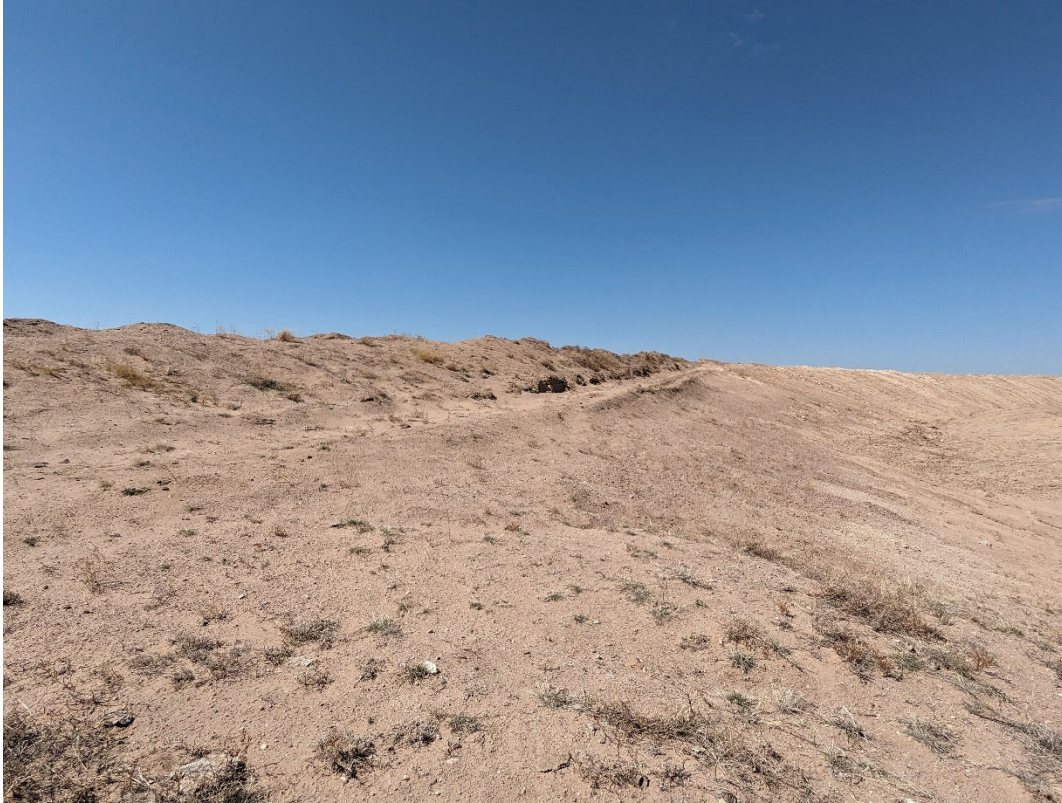
The mine plan calls for stockpiling overburden and topsoil in a dike around the active mining area to stop stormwater from entering the mining area and flowing south. During this inspection, topsoil was observed stockpiled above the eastern highwall and the overburden was stockpiled above the southern highwall.

Photo 3: Overburden stored above the highwall on the south end of the Phase 1 mining area.

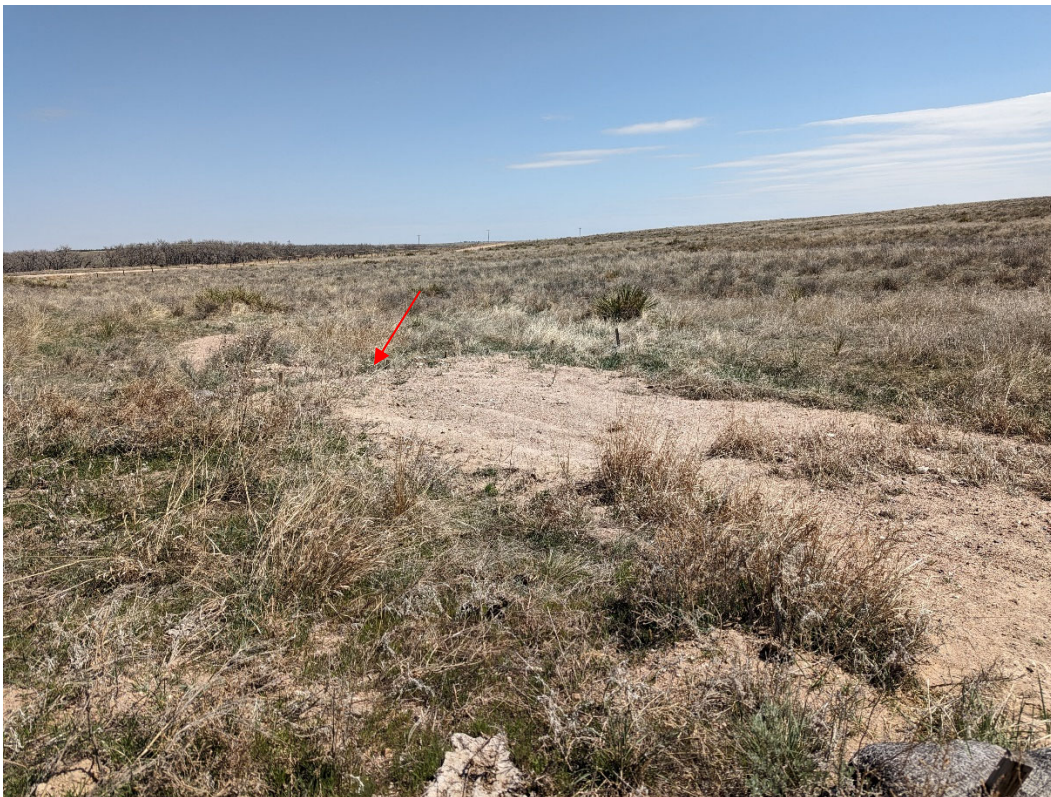
The pit is a dry pit. The Republican River flows approximately 600 feet north of the entrance to the mine. Stormwater from the permit area flows north towards the river. The Operator installed sediment control straw wattles north of the pit to capture sediment and prevent runoff from leaving the active mining area. The Division observed several installed sediment control structures that are adequately collecting sediment. The Division recommends regular inspection and maintenance of the straw wattles. Additionally, the County should install a berm and additional straw wattles along a runoff channel that is developing in the northwestern corner of the pit to prevent runoff and sediment from flowing into the pasture within the permit area during rain events.

Photo 4: Straw bales installed adjacent to the access road north of the mining area to capture sediment and slow runoff into the pasture within the permit area.

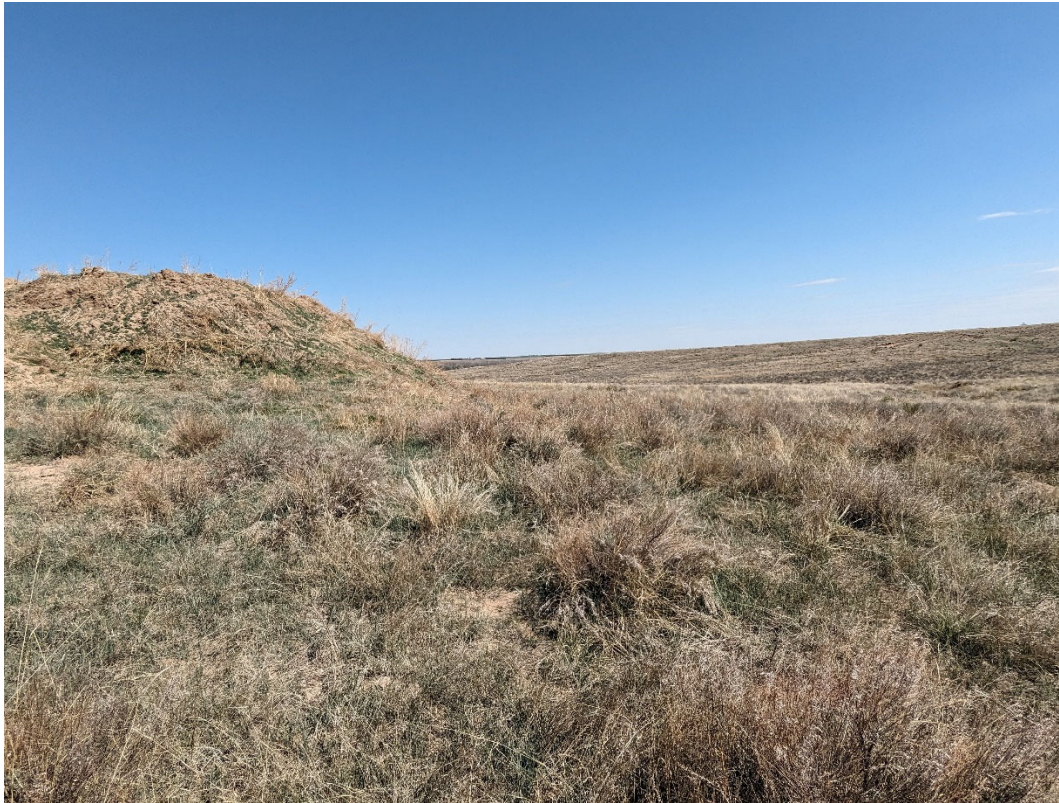
Photo 4: Topsoil pile sitting above the eastern highwall in the Phase1 mining area.

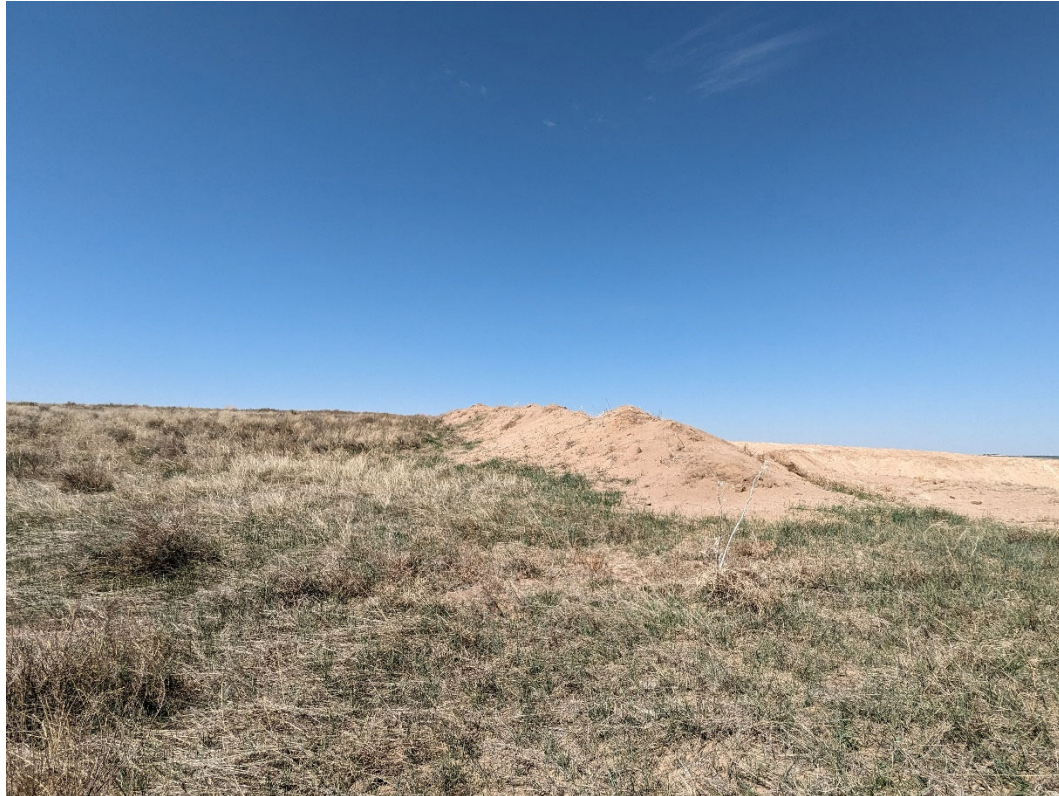
Photo 5: Overburden stored above the southern highwall to prevent water from flowing down into the pit.

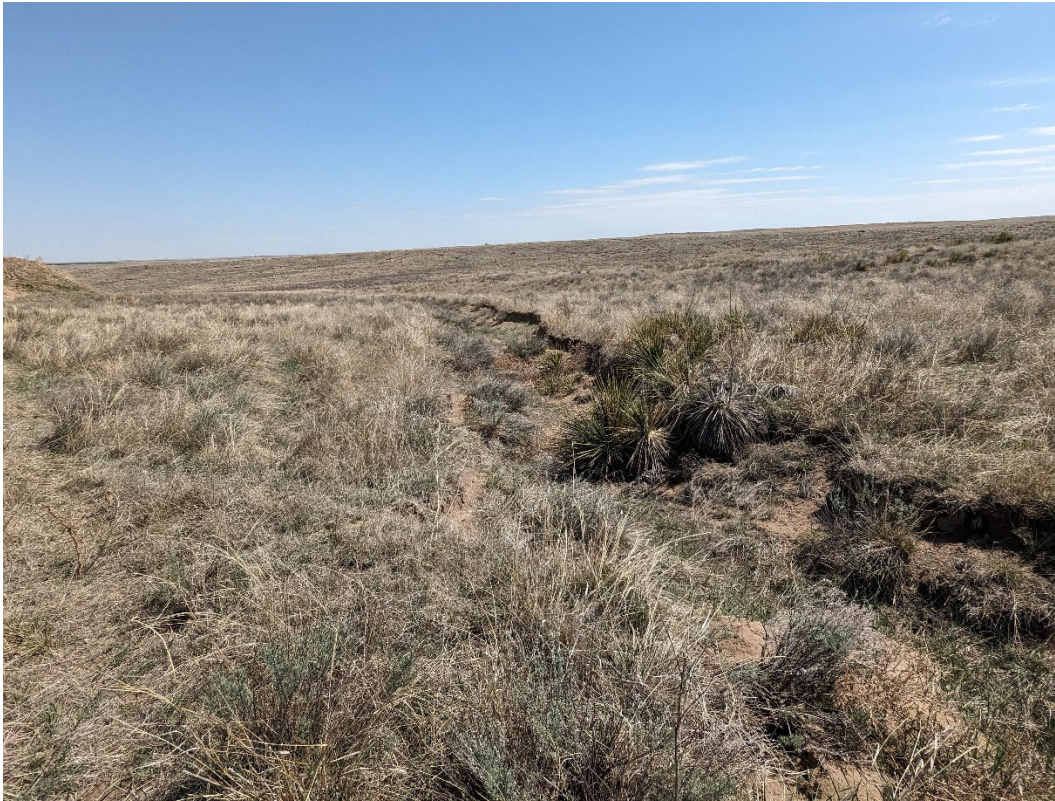
Photo 6: Vegetated channel above the Phase 1 mining area directing runoff around the pit.

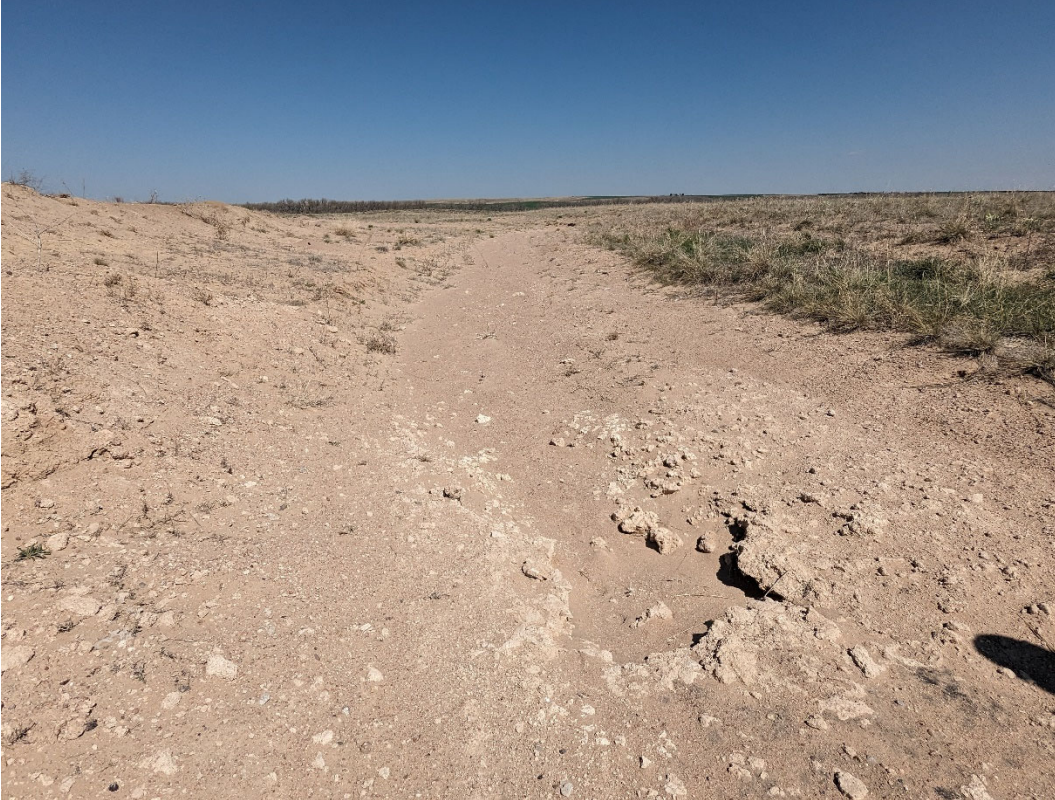
Photo 7: Runoff channel developing in the northwestern corner of the pit area. The Operator should install a berm and straw bales in this area to prevent sediment from leaving the pit during rain events.

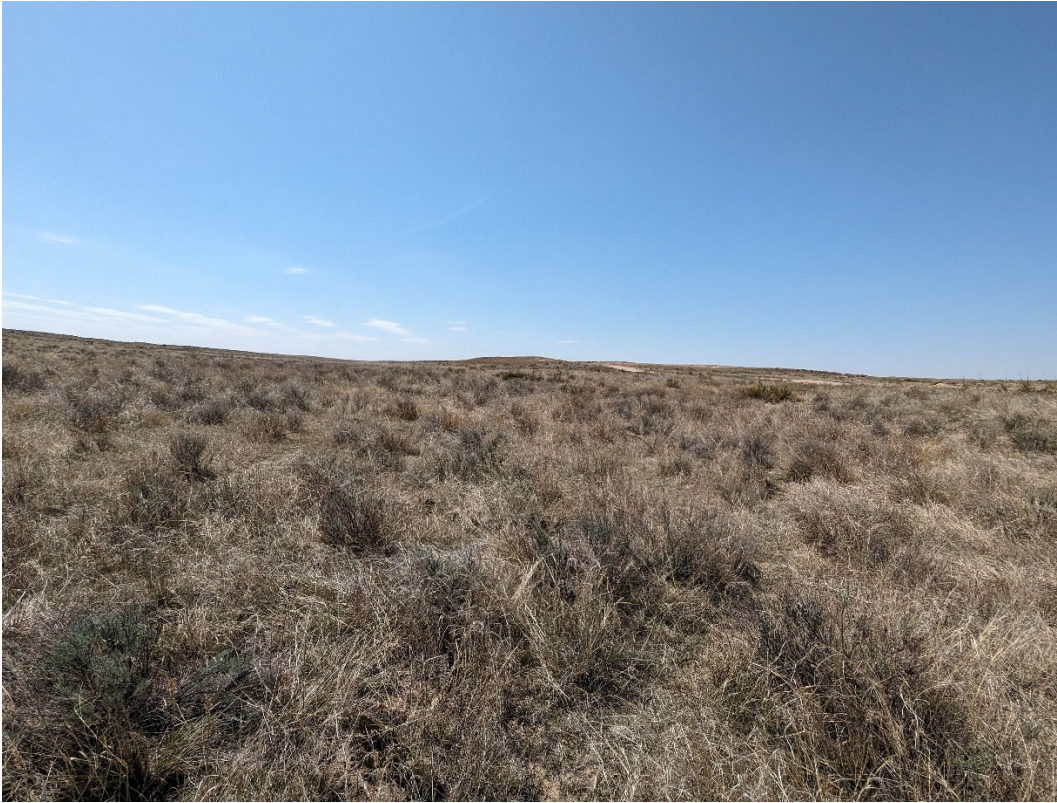
Photo 8: Looking south towards the mining area from the undisturbed area near the entrance.

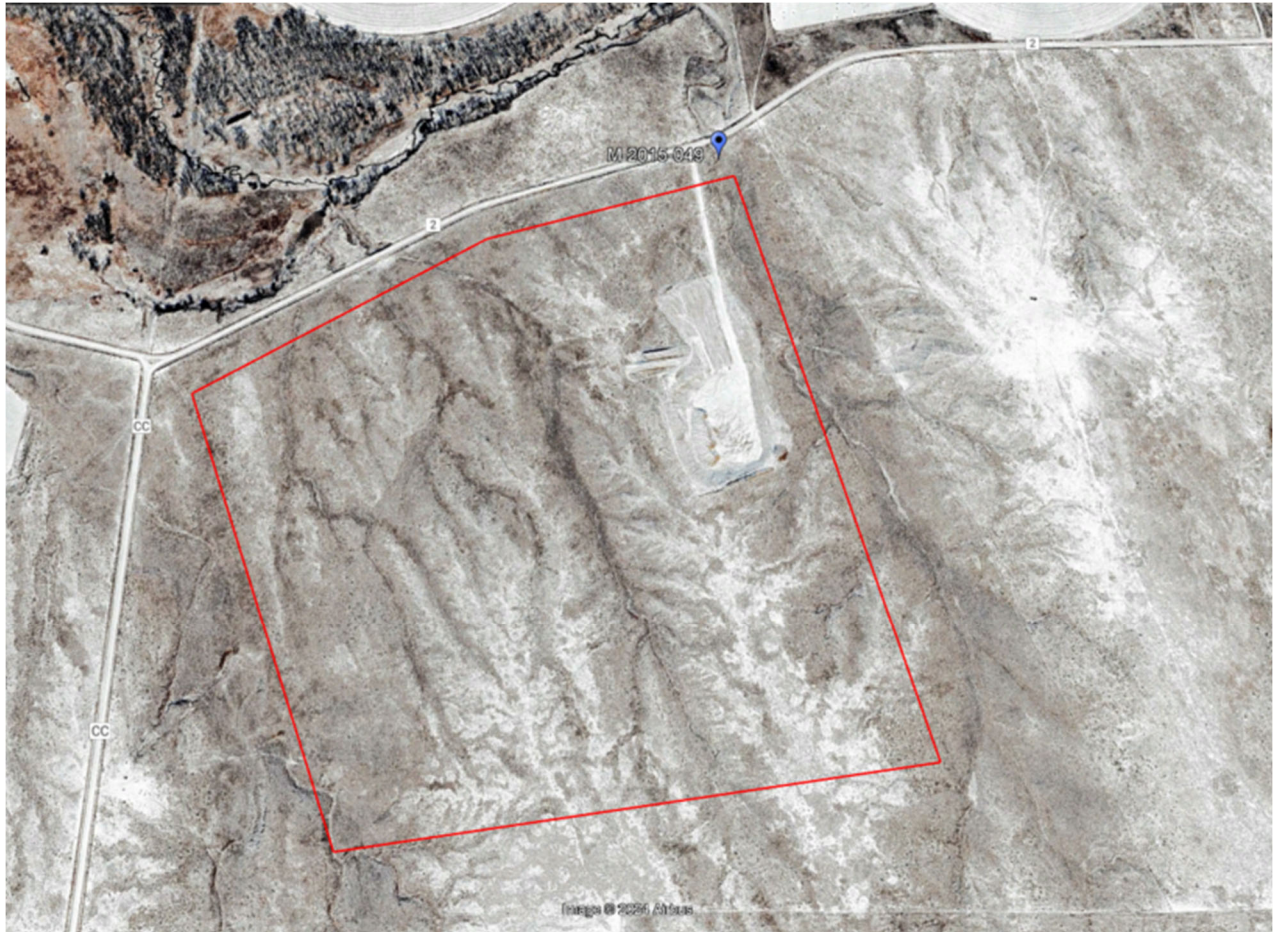
Figure 1: Permit boundary marked by red outline. Google Earth imagery dated 12/16/2024.
