MINERALS PROGRAM INSPECTION REPORT
PHONE: (303) 866-3567

MINE NAME: Diehl Borrow Pit	MINE/PROSPECTING ID#: M-2018-054	MINERAL: Borrow material for	COUNTY: Larimer
INSPECTION TYPE: Monitoring	WEATHER: Clear	INSP. DATE: April 9, 2024	INSP. TIME: 13:00
OPERATOR: SEMA Construction, Inc.	OPERATOR REPRESENTATIVE: Misty Gothard	TYPE OF OPERATION: 111 - Construction by Government Agency	
REASON FOR INSPECTION: Normal I&E Program	BOND CALCULATION TYPE: None	BOND AMOUNT: \$88,112.00	
DATE OF COMPLAINT: NA	POST INSP. CONTACTS: None	JOINT INSP. AGENCY: None	
INSPECTOR(S): Nikie Gagnon	INSPECTOR'S SIGNATURE:

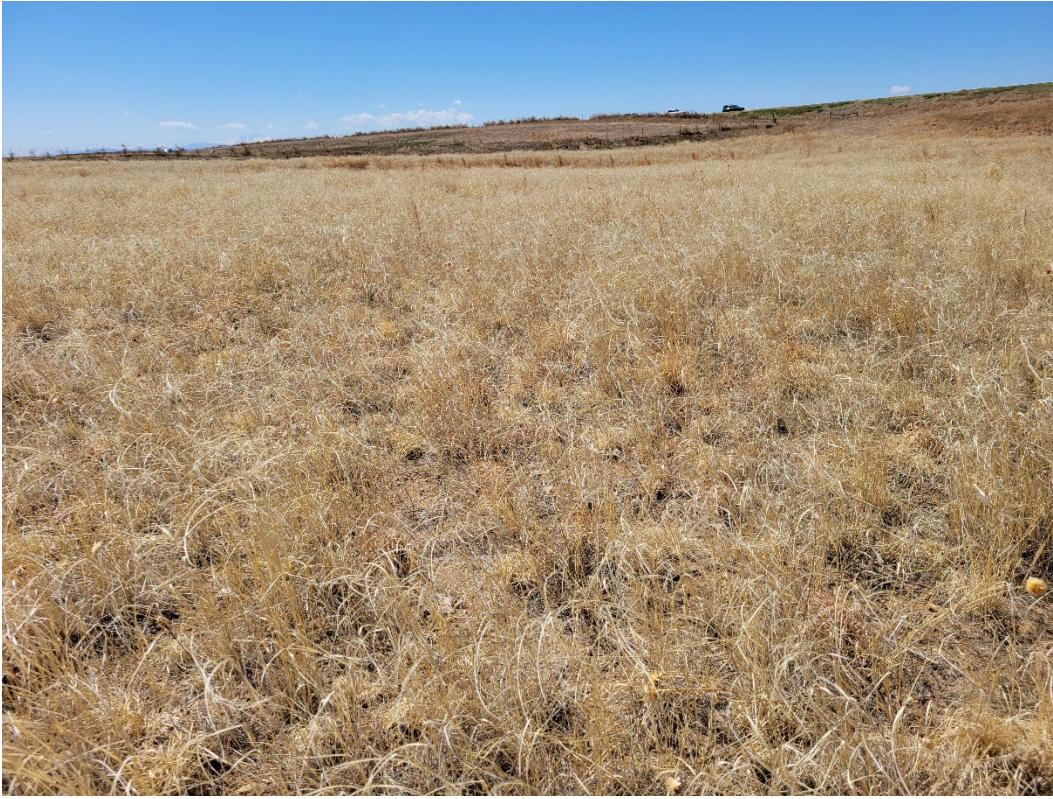
Photo 1: Looking southeast across the reclaimed pit on the south side of the permit area.

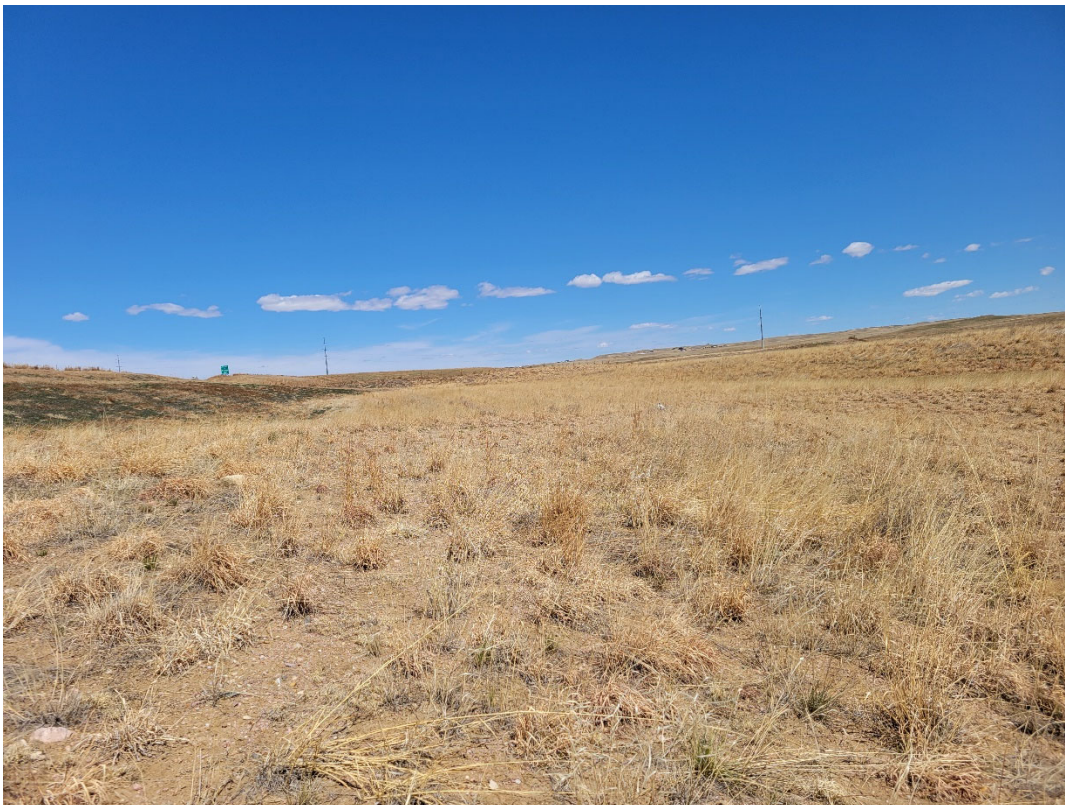
Photo 2: Looking north from the entrance across the reclaimed pit on the south side.

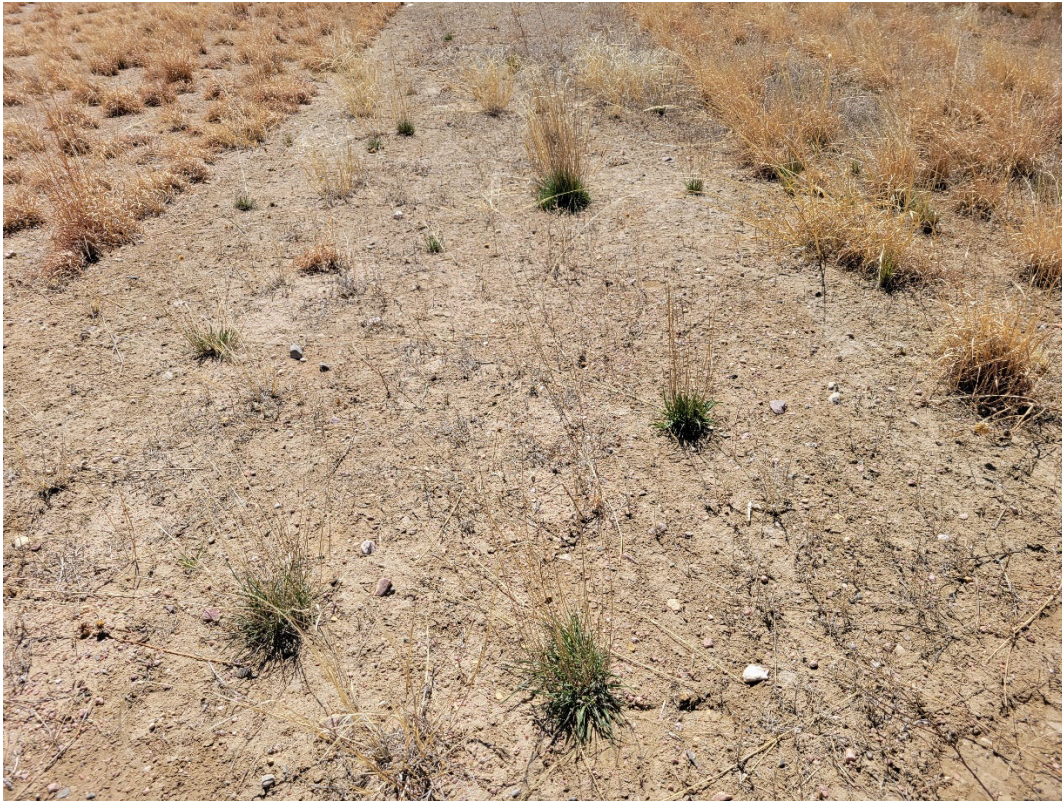
This site was last inspected in May 2023. At that time, native grasses were established across the pit floor and slopes on the south side of the permit area. The Division noted a bare strip of land above the pit that appeared to be a compacted haul road and recommended reworking and reseeding the road. During this inspection, the Operator stated they reworked the bare areas in the fall of 2023. The strip of haul road is still evident, however, bunch grass was noted sprouting in a few spots. The Division observed straw mulch in the reseeded area. It appears wind may have blown away some of the seed and mulch, but it is too early in the season to determine the success of the reseeding. The Operator should monitor the revegetated strip later in the growing season and determine if more work should be done.

Photo 3: Strip of bare and patchy revegetation above the pit in the southern side of the permit area.

As of the date of this inspection, the site is not ready for release. The Operator should continue to monitor revegetation success across the entire site and reseed and mulch areas as necessary. Additionally, the Operator will need to keep up with weed management and erosion control at the site until disturbed areas are stabilized with the desired vegetation.

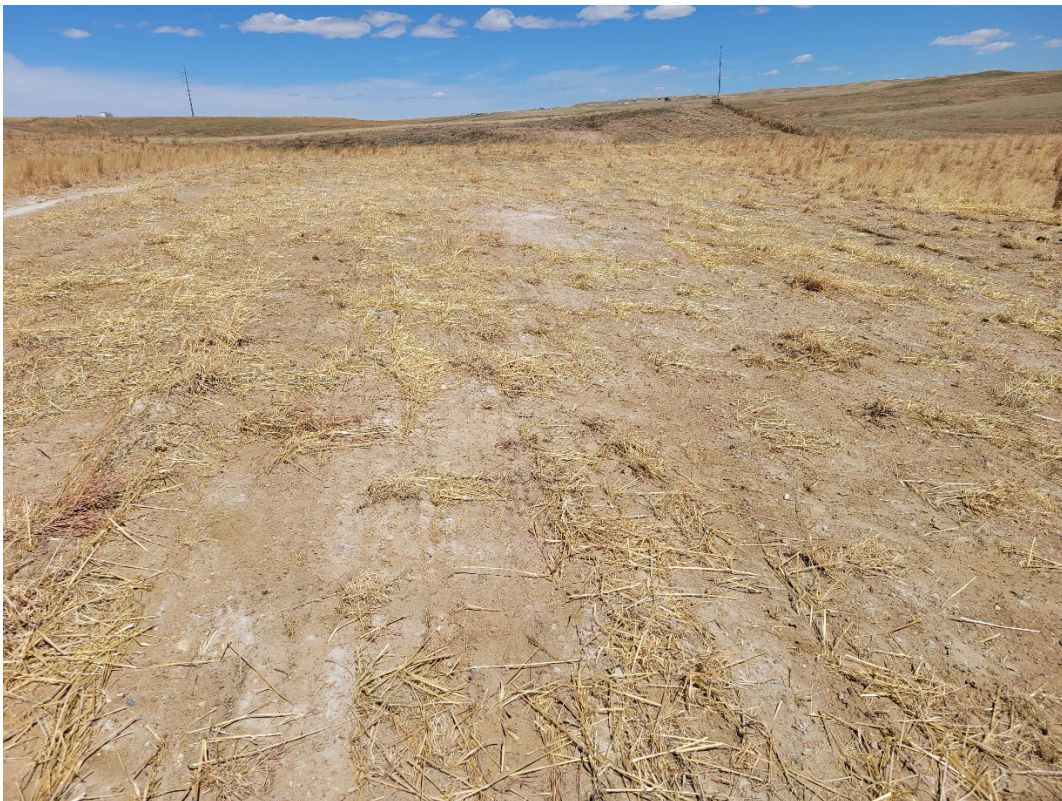
Photo 4: Strip of land on the southern side of the permit recently reseeded and mulched.

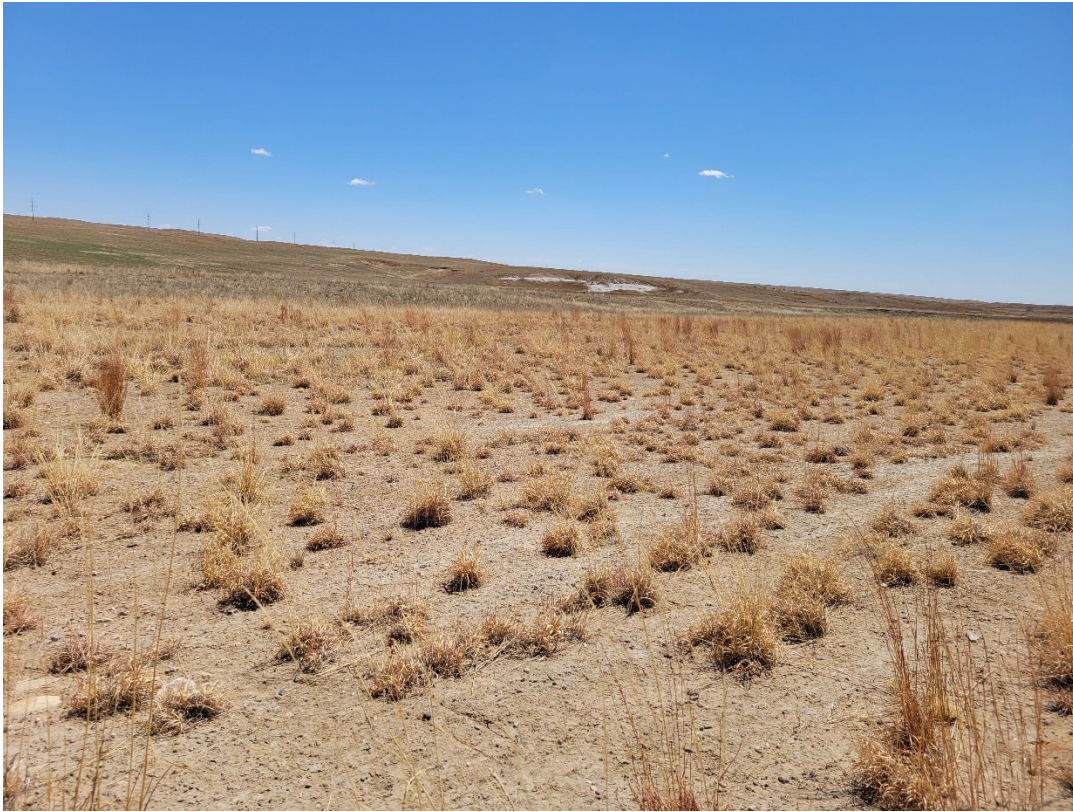
Photo 5: Looking southeast at stalks of native grasses from previous growing season observed in the southern permit area, above the pit.

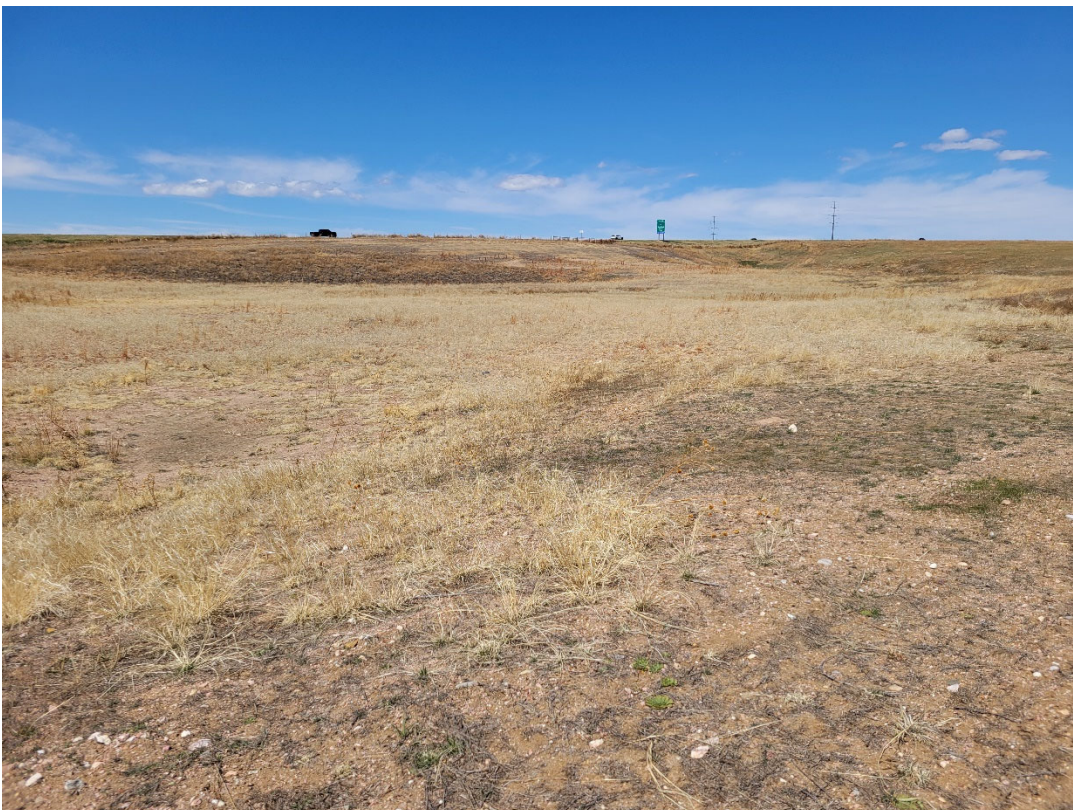
In 2023, the Division noted downy brome and kochia as the dominant species on the northern side of the permit area and recommended that the Operator conduct weed control and reseed the pit. During this inspection, stalks of wheatgrass, switchgrass, and little bluestem from the previous growing season were observed in the floor of the pit. The eastern pit slopes are still patchy and bare, and the soil was observed to contain more gravel. The Operator will need to monitor the northern side later in the growing season and determine if more work should be done to ensure the greatest possibility of success in plant establishment.

Photo 6: Looking north across the northern permit area. Vegetation is patchy on the eastern slope.

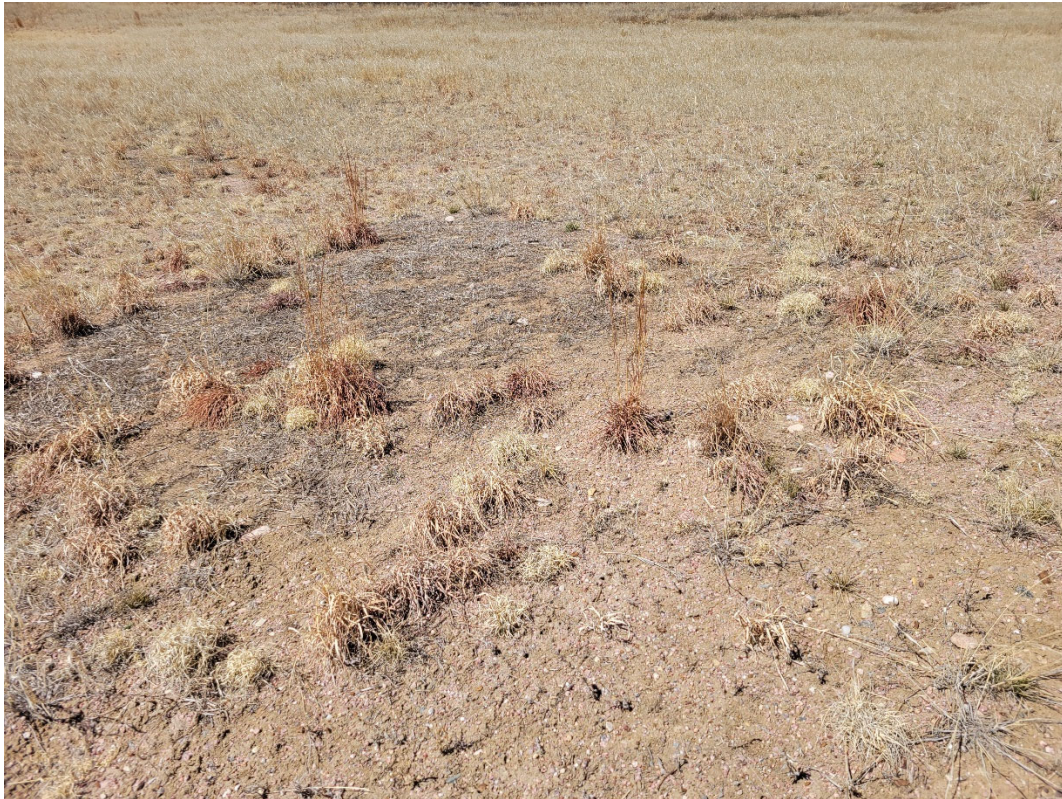
Photo 7: Little bluestem and western wheatgrass from the previous season noted on the floor of the pit on the north side of the permit area.

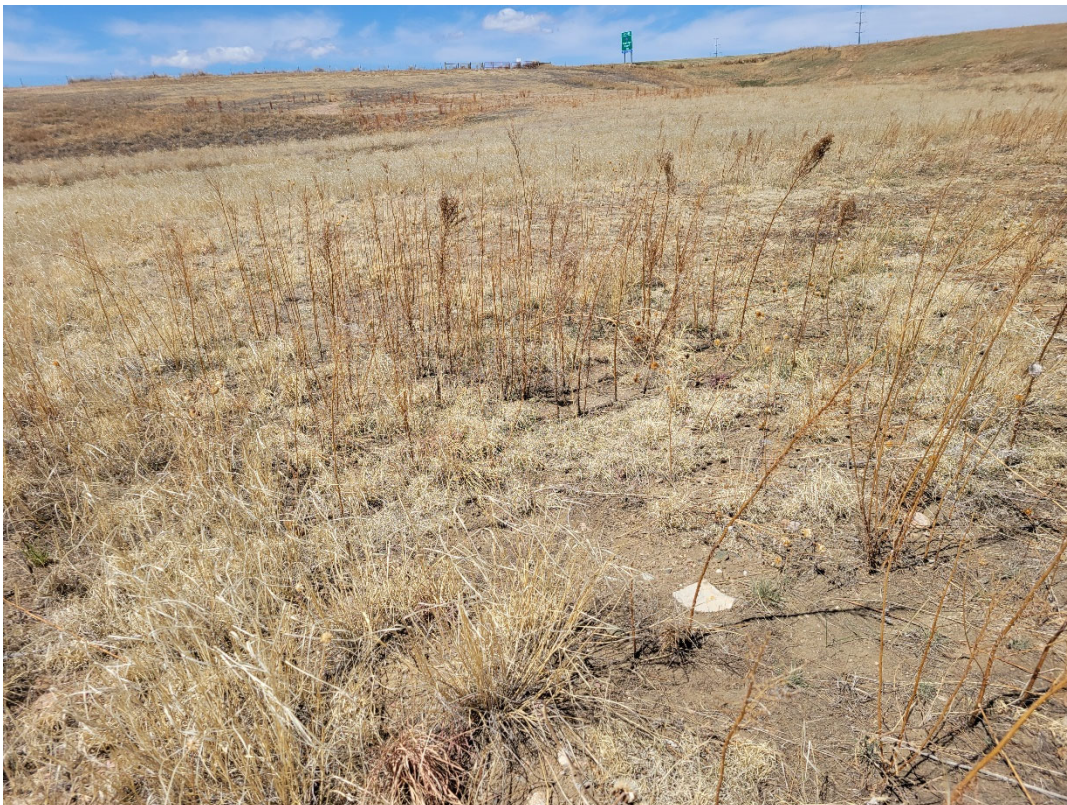
Photo 8: Vegetation in a low spot on the floor of the pit on the north side of the permit area.

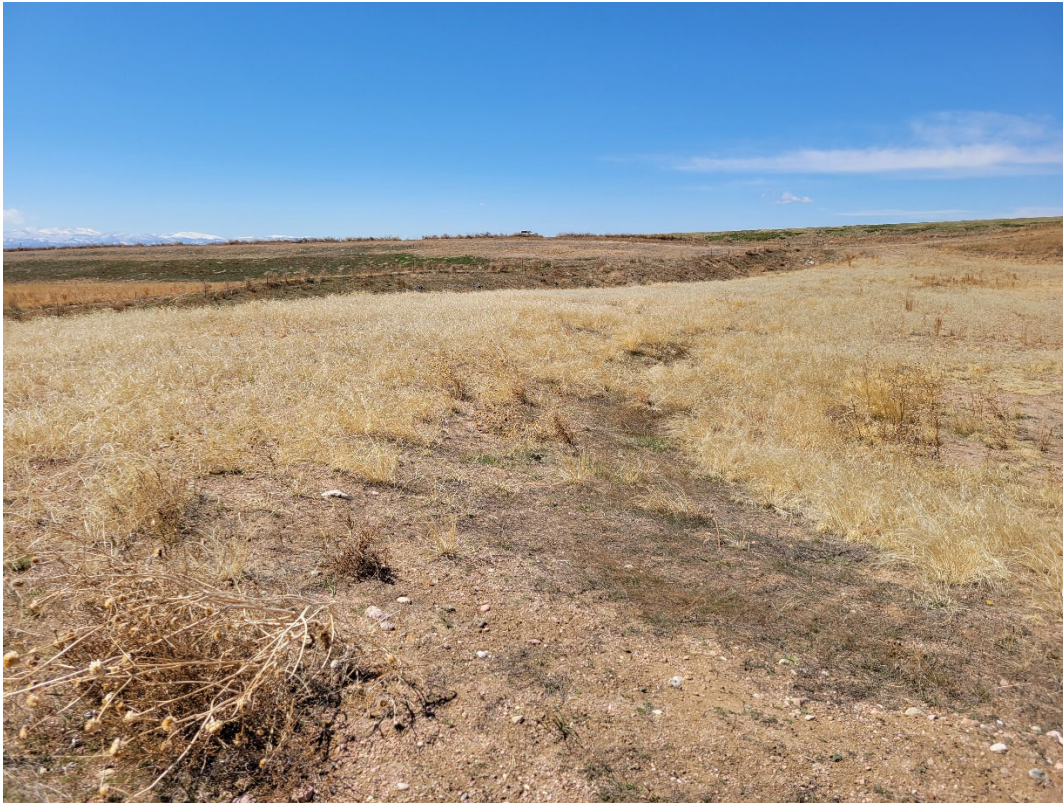
Photo 9: Looking down the southern edge of the northern mining area where a haul road led to the pit. Vegetation is patchy and the soil is more gravelly here.
