MINERALS PROGRAM INSPECTION REPORT
PHONE: (303) 866-3567

MINE NAME: Willow Bend	MINE/PROSPECTING ID#: M-1986-165	MINERAL: Sand and gravel	COUNTY: La Plata
INSPECTION TYPE: Monitoring	WEATHER: Clear	INSP. DATE: May 8, 2024	INSP. TIME: 10:20
OPERATOR: Elam Construction, Inc. dba Sandco, Inc.	OPERATOR REPRESENTATIVE: Chuck Foutz	TYPE OF OPERATION: 110c - Construction Limited Impact	
REASON FOR INSPECTION: Normal I&E Program	BOND CALCULATION TYPE: Complete Bond	BOND AMOUNT: \$6,647.21	
DATE OF COMPLAINT: NA	POST INSP. CONTACTS: None	JOINT INSP. AGENCY: None	
INSPECTOR(S): Dustin Czapla	INSPECTOR'S SIGNATURE:

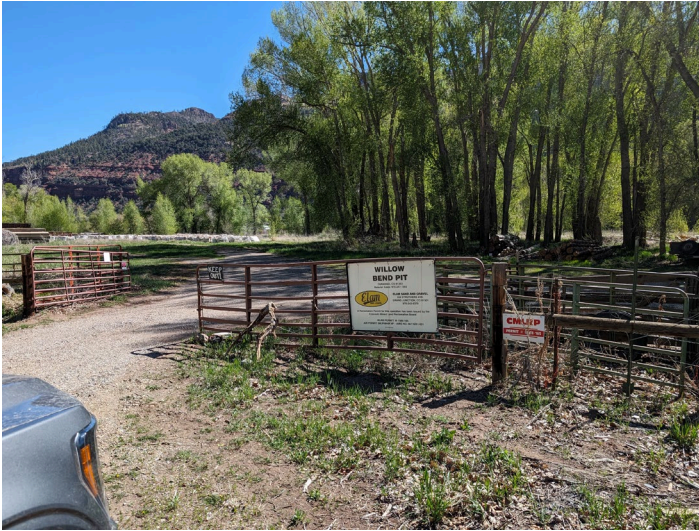
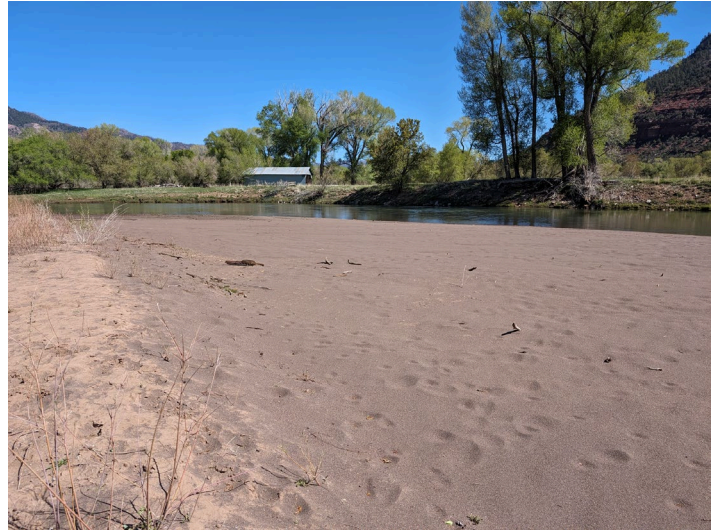
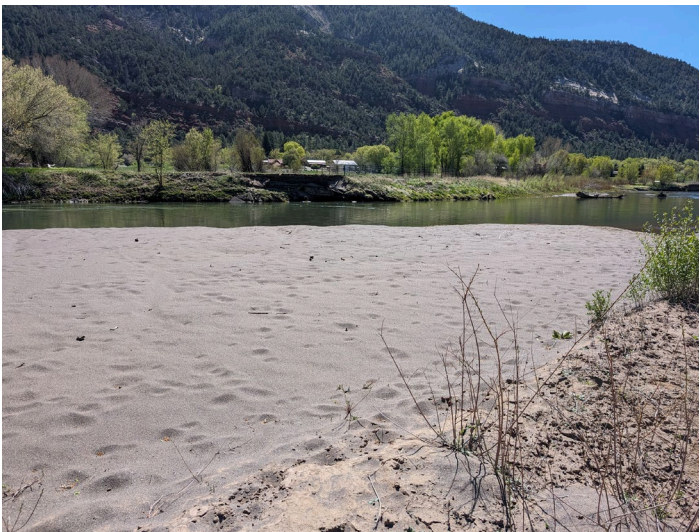
Adequate mine identification signage was noted at the entrance to the site.

The affected area was marked by fencing adequate to delineate the affected area boundary.

Sand extraction takes place from a point bar on the west side of the Animas River. Extraction occurs during winter when the river level is low. No noticeable disturbance was observed during this inspection. The sand bar regenerates as new material is deposited by the river.
