MINERALS PROGRAM INSPECTION REPORT
PHONE: (303) 866-3567

MINE NAME: Taylor Pit	MINE/PROSPECTING ID#: M-2013-006	MINERAL: Limestone (general)	COUNTY: Moffat
INSPECTION TYPE: Surety-Related Inspection	WEATHER: Clear	INSP. DATE: June 6, 2024	INSP. TIME: 9:30
OPERATOR: Bower Brothers Construction, Inc.	OPERATOR REPRESENTATIVE: Bud Bower	TYPE OF OPERATION: 110c - Construction Limited Impact	
REASON FOR INSPECTION: Surety Release Requested	BOND CALCULATION TYPE: None	BOND AMOUNT: \$33,279.00	
DATE OF COMPLAINT: NA	POST INSP. CONTACTS: None	JOINT INSP. AGENCY: None	
INSPECTOR(S): Hunter Ridley	INSPECTOR'S SIGNATURE:

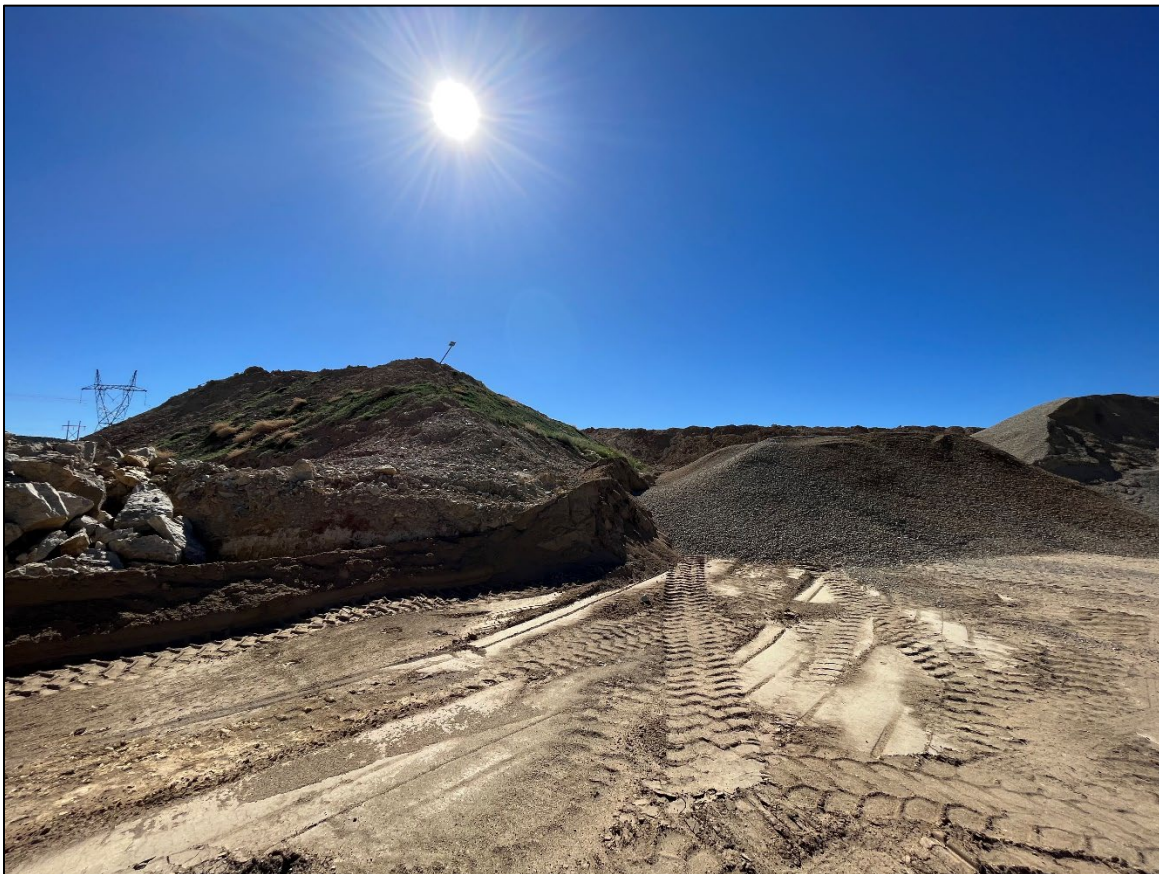
Topsoil: Two topsoil piles are located on site at in the Taylor Pit area (Photo 1). These are both vegetated and marked pursuant to Rule 3.1.19.

Photo 1: Topsoil pile and stockpiles located to the northeast.

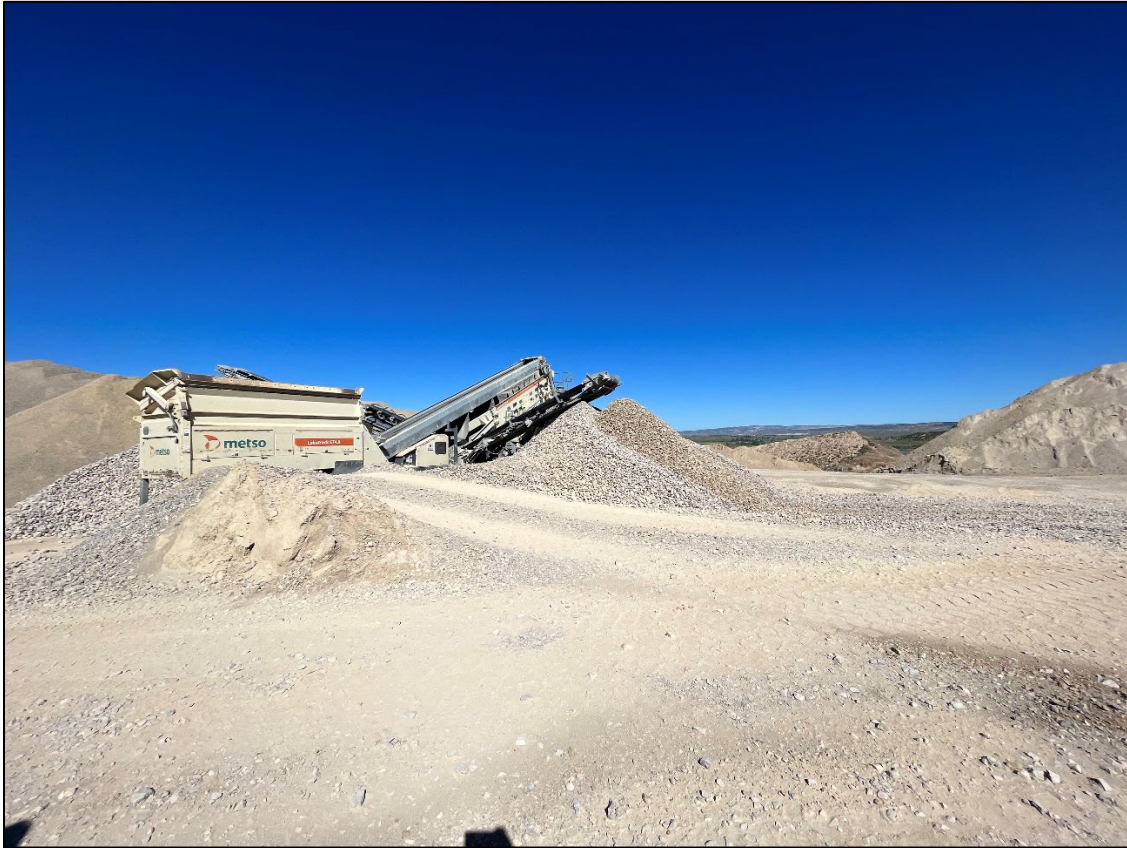
Support Facilities On-site: A truck scale and scale house are on site and located in the northern Hertzog Pit area. A crusher is located in the Taylor Pit area (Photo 2).

Photo 2: A crusher is located on the northern staging area of the Taylor Pit.

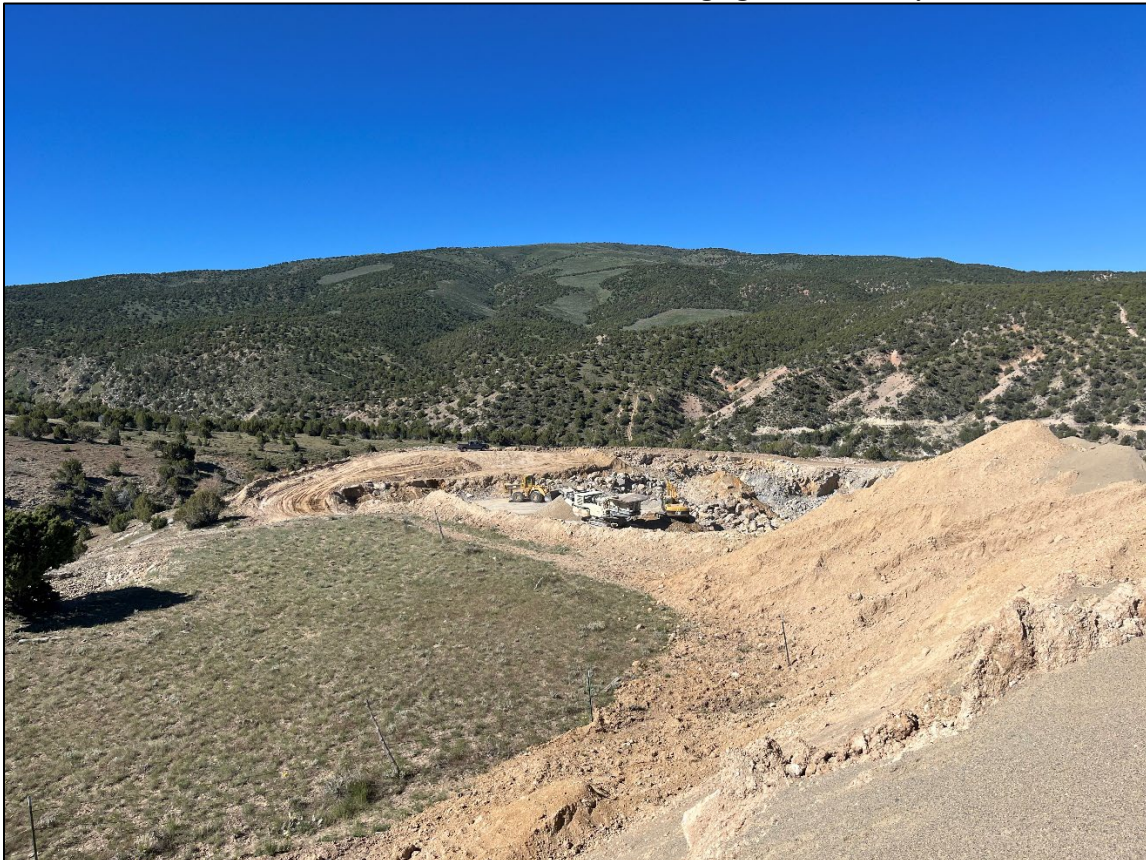
The Taylor Pit was inspected by Hunter Ridley with the Division of Reclamation, Mining and Safety (Division) in response to Surety Release Request 2 (SL2) submitted to the Division on April 8, 2024. The required notices were sent out on April 11, 2024. To-date, no objections to the release have been received. Taylor Pit is 110c site permitted for 9.98 acres. This site is located approximately four miles southeast of Maybell, Colorado. Bud Bower, the Operator, was present during the inspection. The approved post mining land use at the site is rangeland. The Taylor Pit area was active at the time of inspection (Photos 3 and 5).

Photo 3: View southwest of the active pit at the southern end of Taylor Pit.

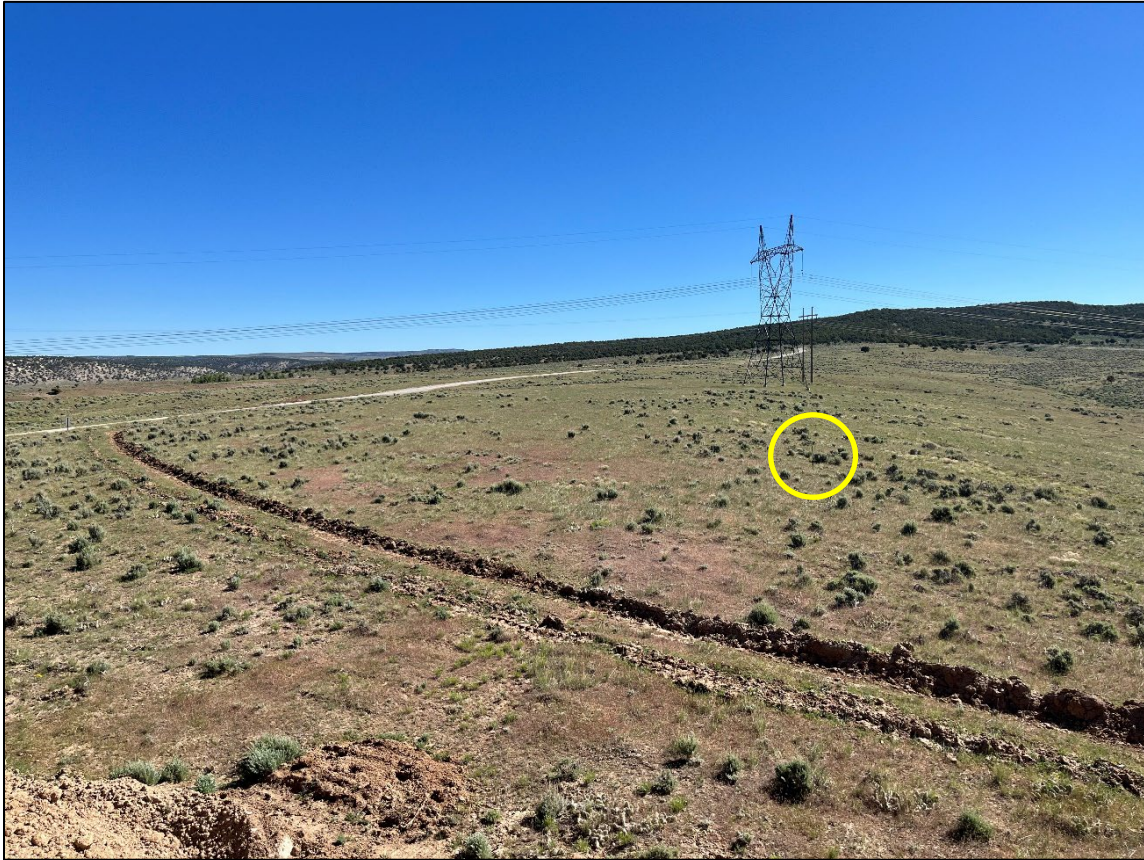
Signs and Markers: The permit sign was posted at the access road entrance to the Hertzog Pit area. Boundary markers in the form of green top stakes were also in place throughout the Taylor Pit and Hertzog Pit areas (Photo 4). A fence delineated the property boundary.

Photo 4: A permit boundary marker is visible.

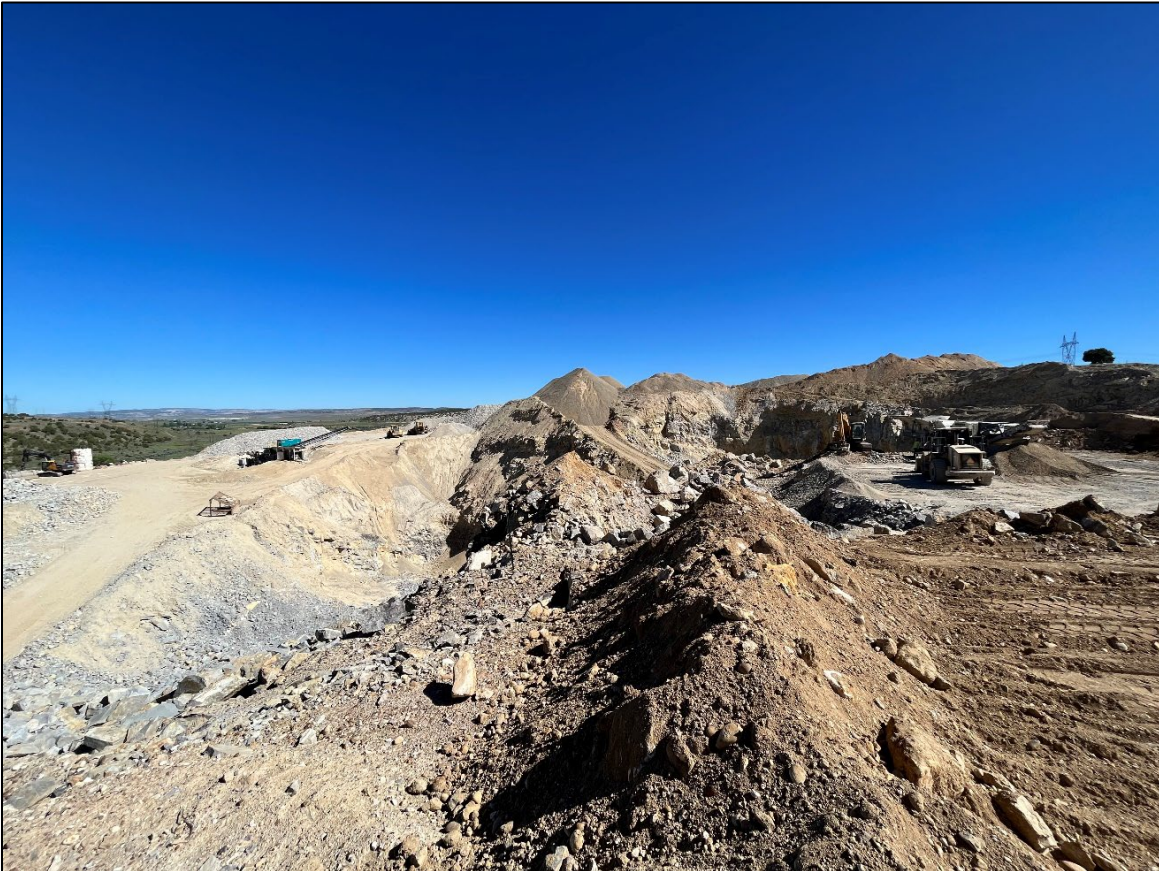
Photo 5: View north of the active pit area.

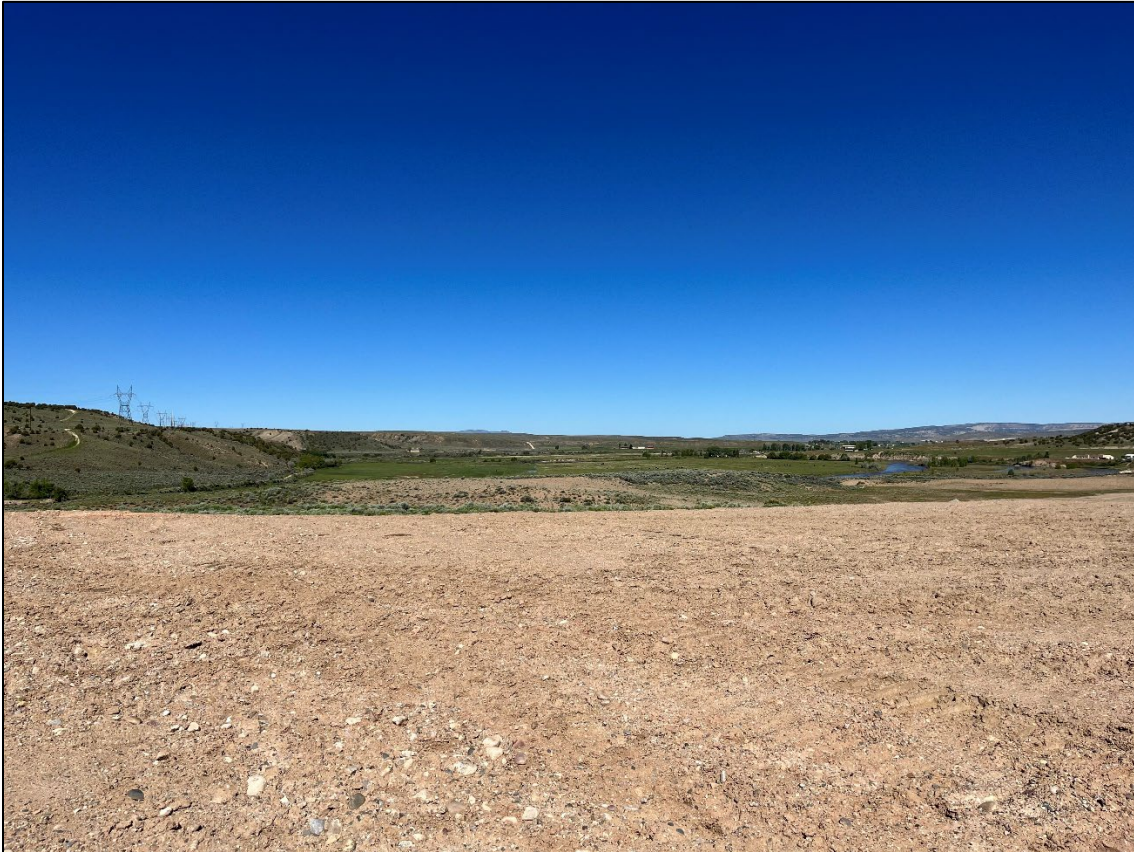
Reclamation Success: Final reclamation has not yet begun in the Taylor Pit area of the permit. Minimal grading and some reclamation work has begun in the western portion of the upper Hertzog Pit area (Photo 6).

Photo 6: A small amount of grading and revegetation work has been completed in the upper Hertzog Pit.

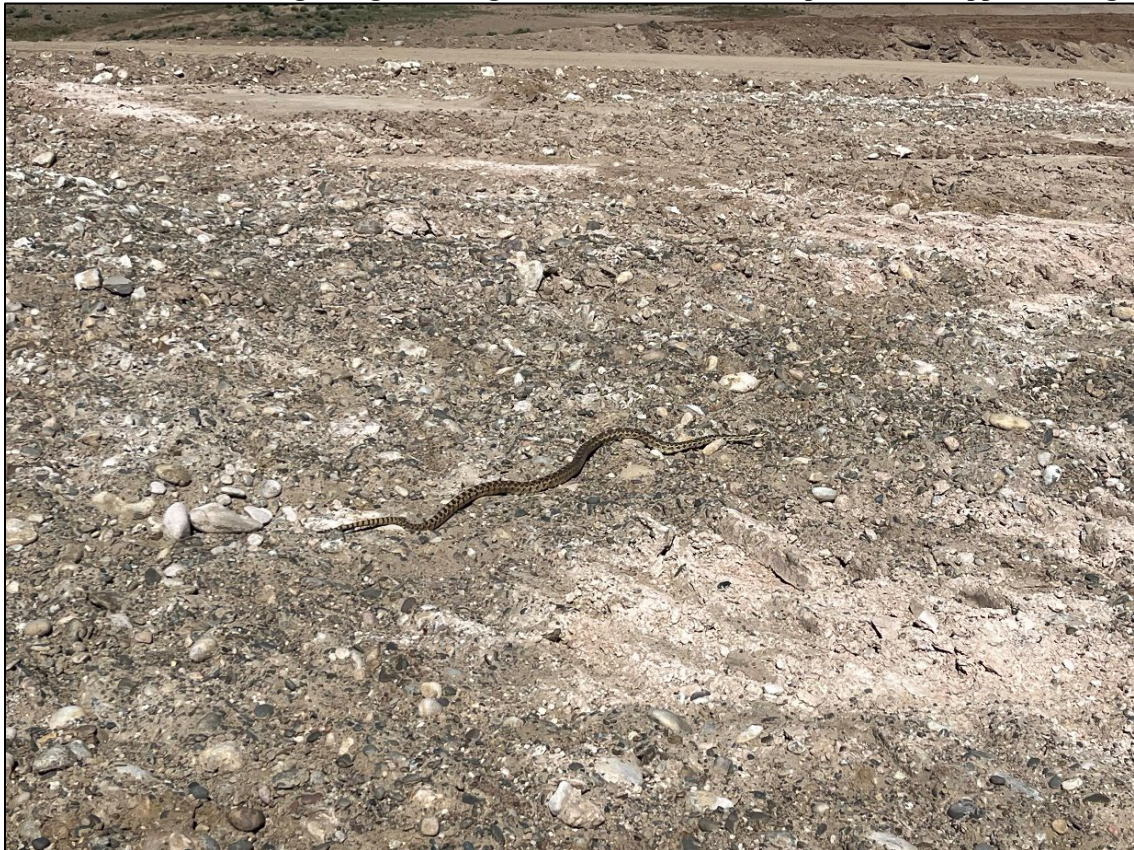
Fish and Wildlife: No impact to wildlife was observed. A bull snake was observed onsite in the northern pit (Photo 7).

Photo 7: A Bull snake was observed in the northern Hertzog Pit area.
