Roadside Mine, C-1981-041, May 2024 Complete Inspection Report

PERMIT INFORMATION

Permit Number: C-1981-041 Mine Name: Roadside Portals Operator: Snowcap Coal Company, Inc. Operator Address: Ms Tonya Hammond 743 Horizon Court, Suite 334 Grand Junction, CO 81506	County: Mesa Operation Type: Underground Permit Status: Active Ownership: Private
	Operator Representative Present: Tonya Hammond
Operator Representative Signature: (Field Issuance Only)

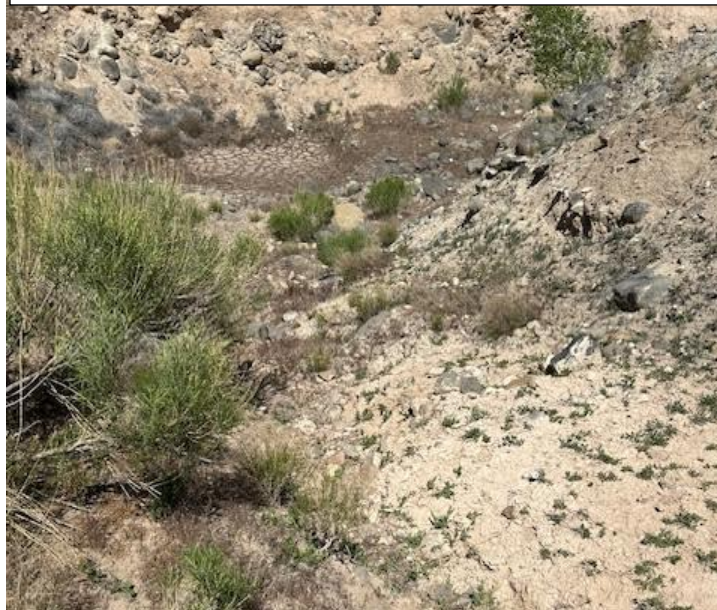
The Carey pit is located in the southwest corner of the permit area. The pit was not constructed by or used by SCC. The pit was observed to be dry during the inspection (Photo 1). There was no indication of recent water application by the landowner. The landowner's trenches on the northern and eastern portions of Tract 71 were also observed to be dry (Photo 2). There was no evidence of recent flows in the trenches. Likewise the irrigation system on the landowner's middle field had no evidence of recent water application (Photo 3). During the inspection the landowner's riser pipes on top of the Tract 70 mesa were inactive (Photo 4). There was no indication that water had been applied from the riser pipes into the trenches.

Photo 1: The Carey Pit.

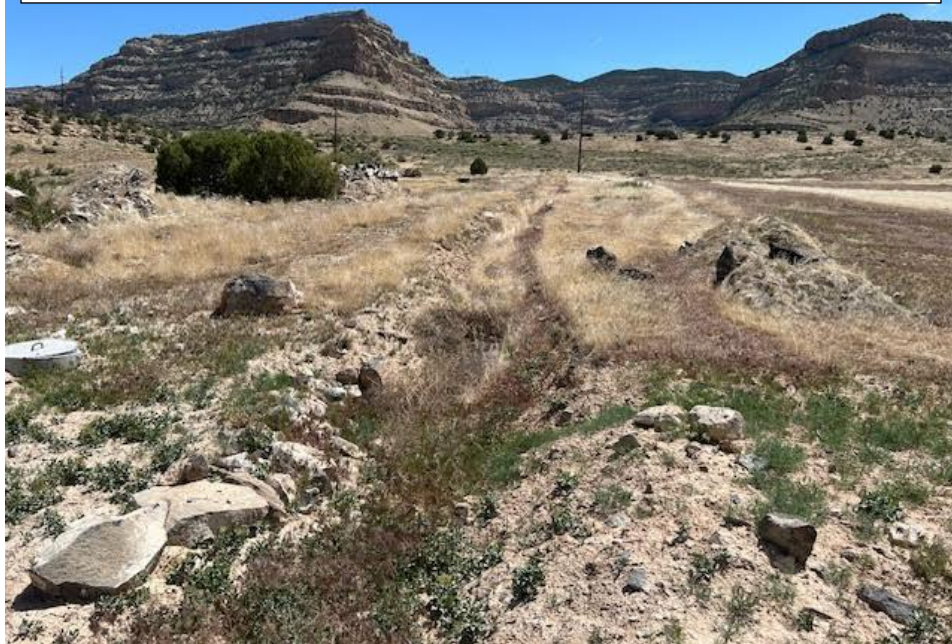
Photo 2: The landowner's northern Tract 71 trench.

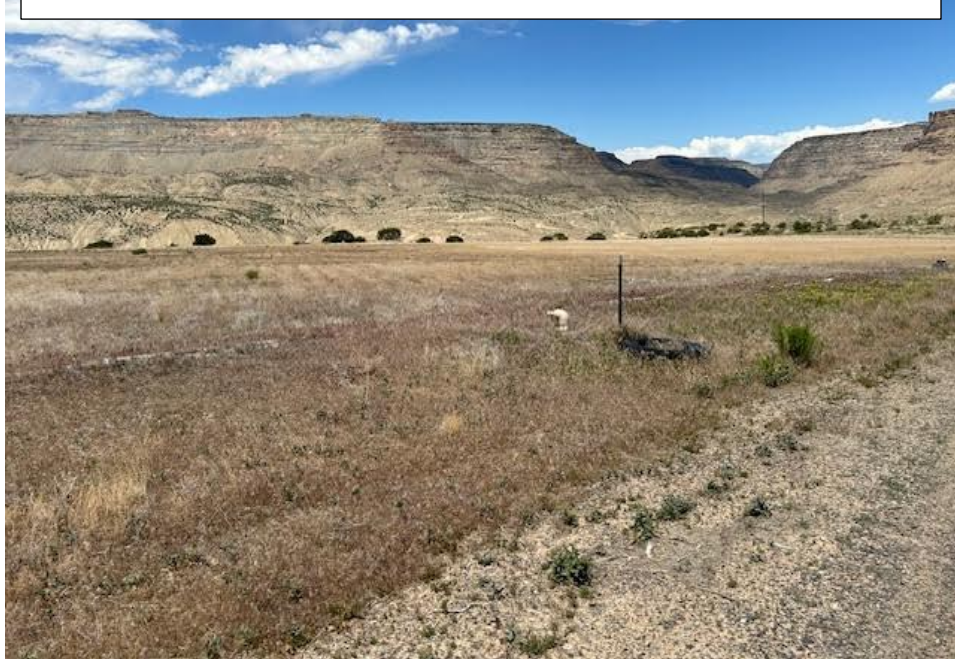
Photo 3: The landowner's middle field.

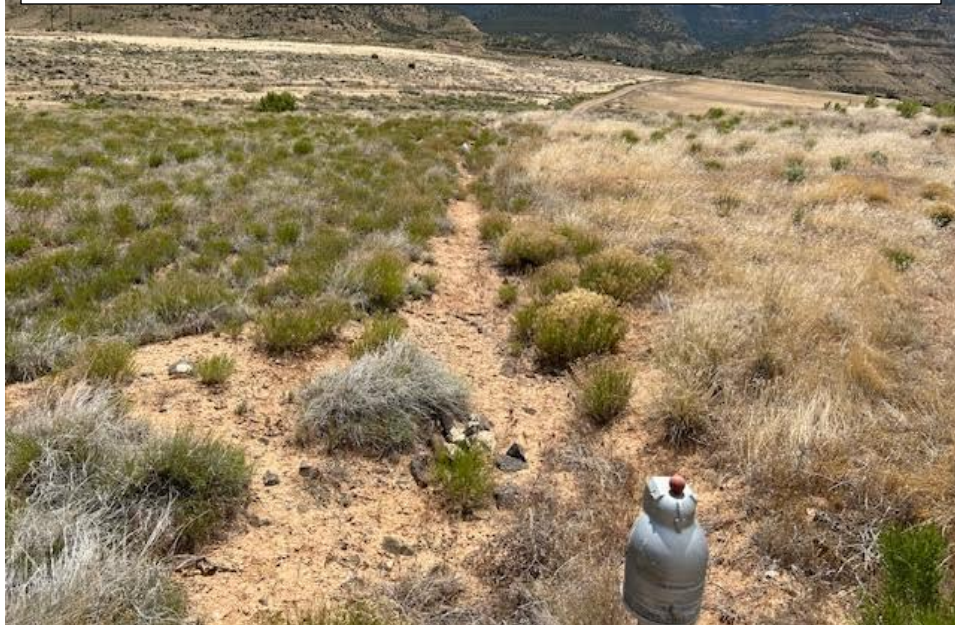
Photo 4: One of the Landowner's riser pipes and trenches on top of the Tract 70 Mesa.

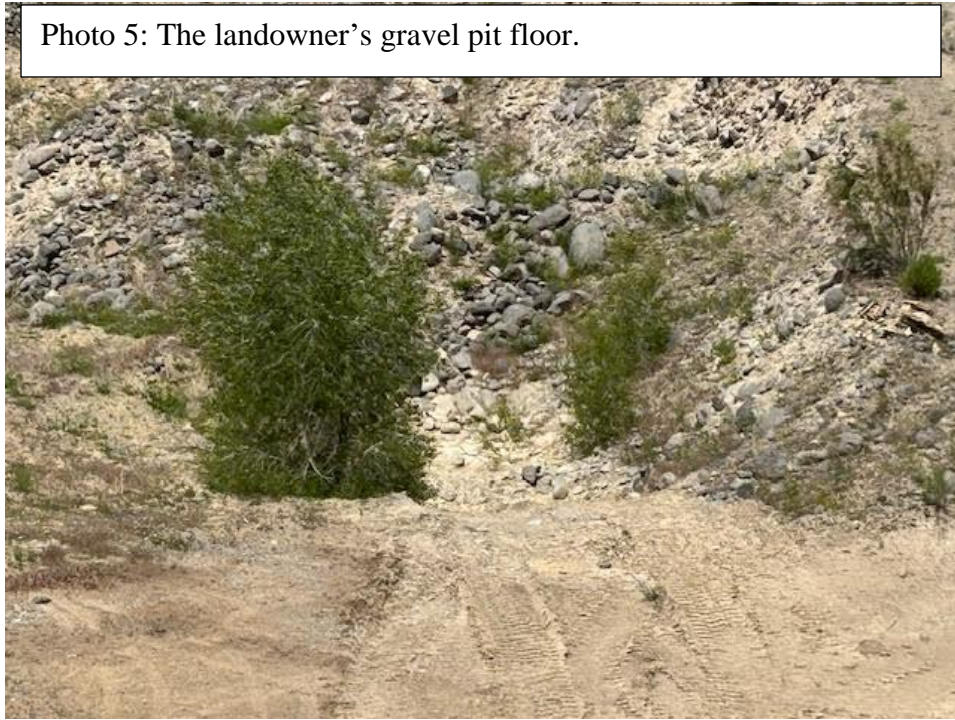
The permit boundary for Western Slope Flagstone Quarry No. 2, Permit No. M-1996-076, and C-1981-041 overlap each other in the southeastern corner of the permit area of C-41's permit. The Division observed water flowing from the landowner and permittee's buried pipeline into the main pit within the M-076 permit. The water was quickly shut off. The Division observed no indications of recent flow from the pipeline. The pit floor was observed to be dry during the inspection (Photo 5).

Photo 5: The landowner's gravel pit floor.

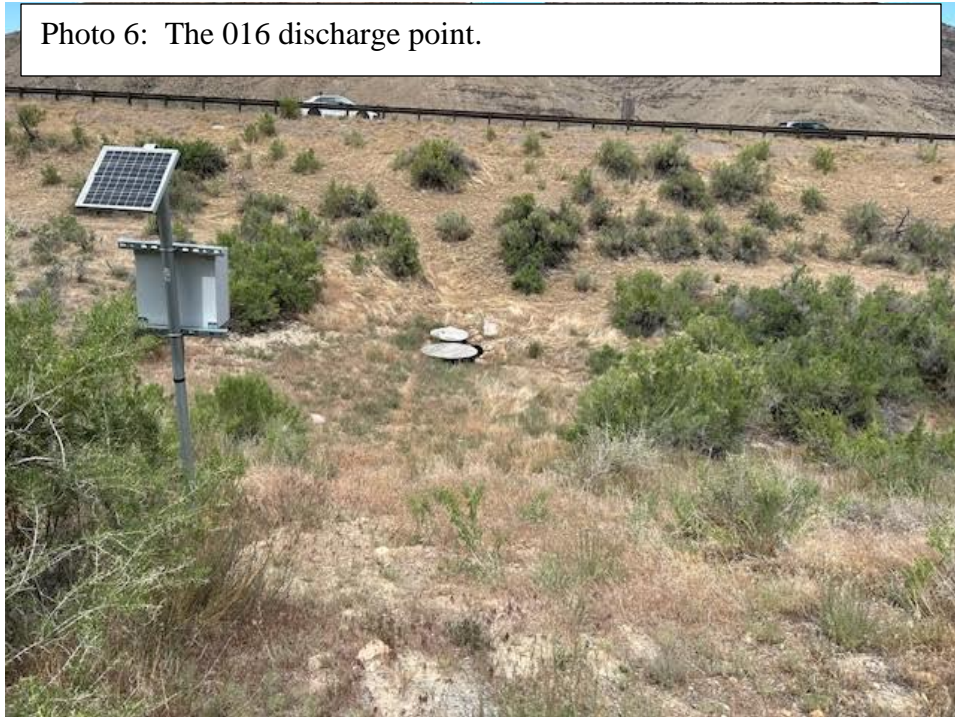
The Discharge Point 016 is located in the northeastern portion of the permit boundary (Photo 6). There was flow observed coming out of the discharge point. The operator's gauge was recording an average discharge of 110 gallons per minute. This rate of flow is consistent with recorded seasonal values at that spot.

Photo 6: The 016 discharge point.

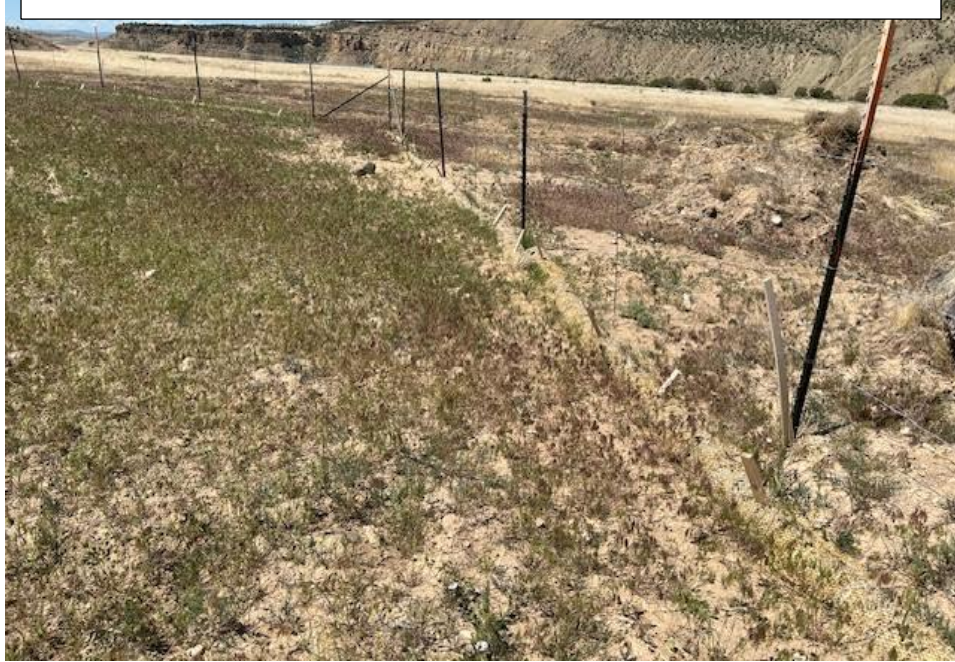
The remaining reclamation permitted on a disturbed area is approximately 0.4 acres located in the northern portion of Tract 71. The reclamation is related to the work permitted under Technical Revision No. 69. The reclamation at the site was conducted in the fall of 2019. In the fall of 2023, the reclamation was disturbed by the landowner and was repaired and reseeded. During this inspection, the site was stable with no erosional features identified. The straw waddles located at the down-gradient portions of the repair area were in good condition (Photo 7). No off site impacts were observed. Vegetation seeded last fall was beginning to fill in. The vegetation was helping stabilize the area (Photo 8). No noxious weeds were identified other than cheatgrass. Cheatgrass completely surrounds the 0.4 acres and is impossible to keep out of the reclaimed area.

Photo 7: The TR-69 Repair Area with straw waddles.

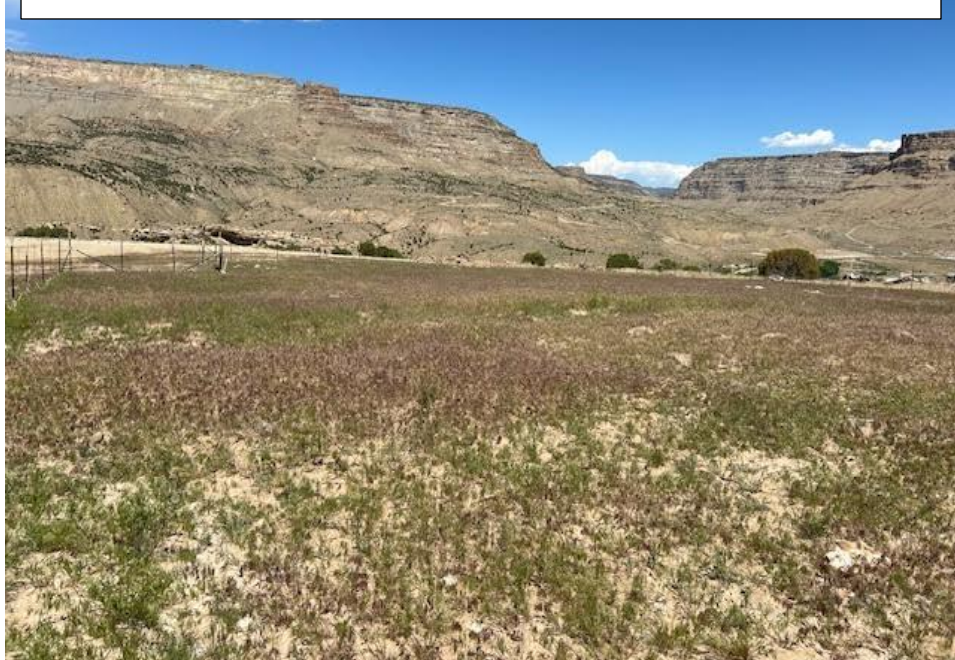
Photo 8: New vegetation on the TR-69 Repair Area.

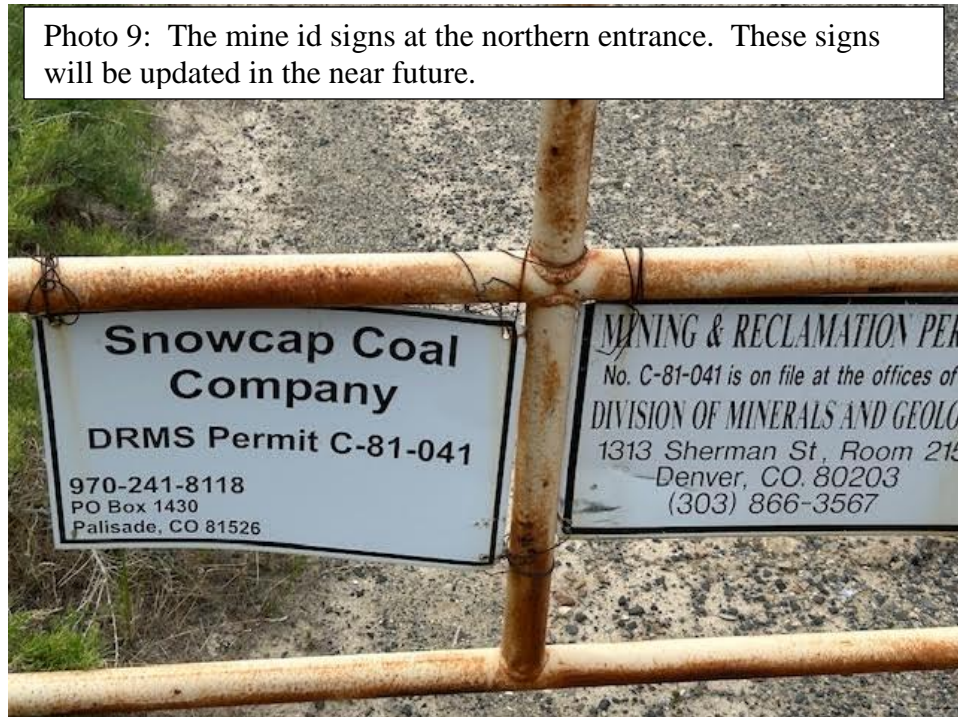
Mine permit boundary markers were observed posted at the entrances to the mine site. The signs included two signs with some current and some outdated information on them (Photo 9). The operator's representative stated that they will get new signs to replace the old ones so that the outdated information is no longer displayed. Between the two signs posted currently, the required information about the permit, the permittee and the Division was displayed. The perimeter fence delineating the 0.4 acres of the TR-69 repair area was intact. The fence also displayed a mine id sign on one of the southern facing posts.

Photo 9: The mine id signs at the northern entrance. These signs will be updated in the near future.
