Inspection Sage Creek 2024 Q2

Please find the June 2024 complete inspection for the Peabody Sage Creek site.

Permit Number: C2009087 Mine Name: Sage Creek Operator Address: Seneca Property LLC Ms. Miranda Kawcak 29515 Routt County Road No. 27 Oak Creek, CO 80467	County: Routt Operation Type: Surface Permit Status: Permanent Cessation Ownership: Private Operator Representative Present: Michael Howard
Operator Representative Signature: (Field Issuance Only) This report was issued electronically from the Divisions' Denver Office.

Inspection Start Date: 4 June 2024 Inspection Start Time: 8:30 a.m. Inspection End Date: 4 June 2024 Inspection End Time: 15:00 p.m.	Inspection Type: Coal Complete Inspection Inspection Reason: Normal I&E Program Weather: Cloudy
Joint Inspection Agency: None	Joint Inspection Contacts:
Post Inspection Agency: None	Post Inspection Contacts:
Inspector(s): Robin Reilley, M.S. GISP	Inspector's Signature:

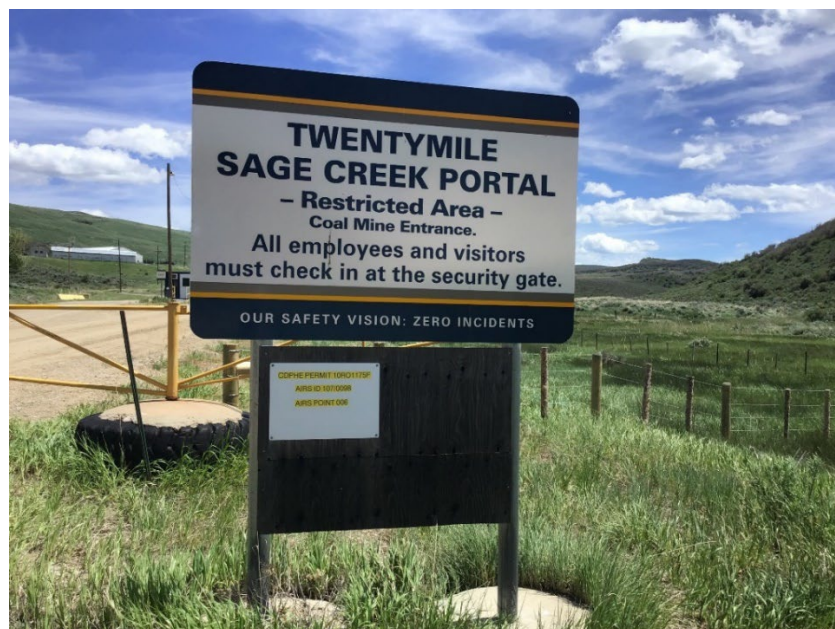
- The mine identification signs were in place at the site entrance The sign was intact, displaying all required information: mine name, operator name, address, phone number, DRMS permit number and contact information.
- The sign appeared very faded and difficult to read, requiring replacement.

Photo 1: Signage at entry to the site.

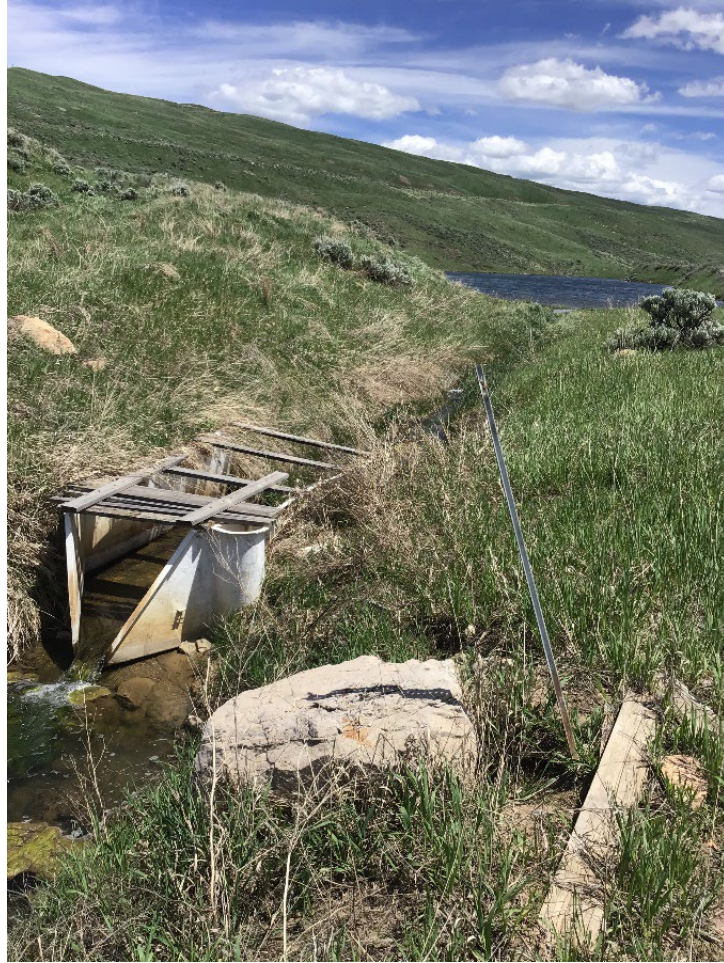
- Sage Creek Pond 2 was holding water at the time of inspection. Water appeared to be discharging out of the bottom of flume.
- The flume appears defective and requires replacing. The operator has a replacement flume and will be executing the replacement in the near future.
- ***Last photo pond 3***

Photo 2: Flume at Pone 2, requiring replacement.

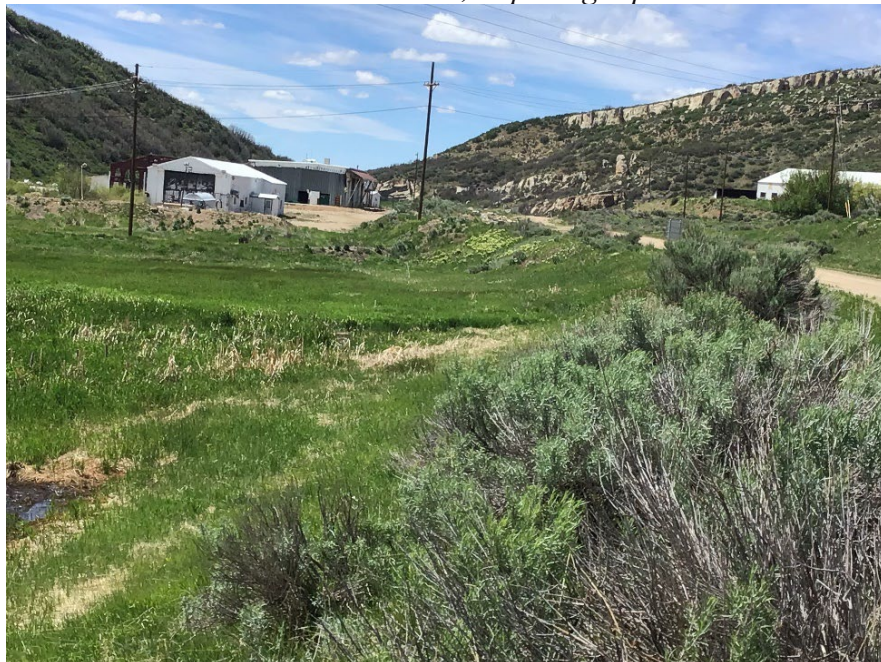
Photo 3: Structures and facilities.

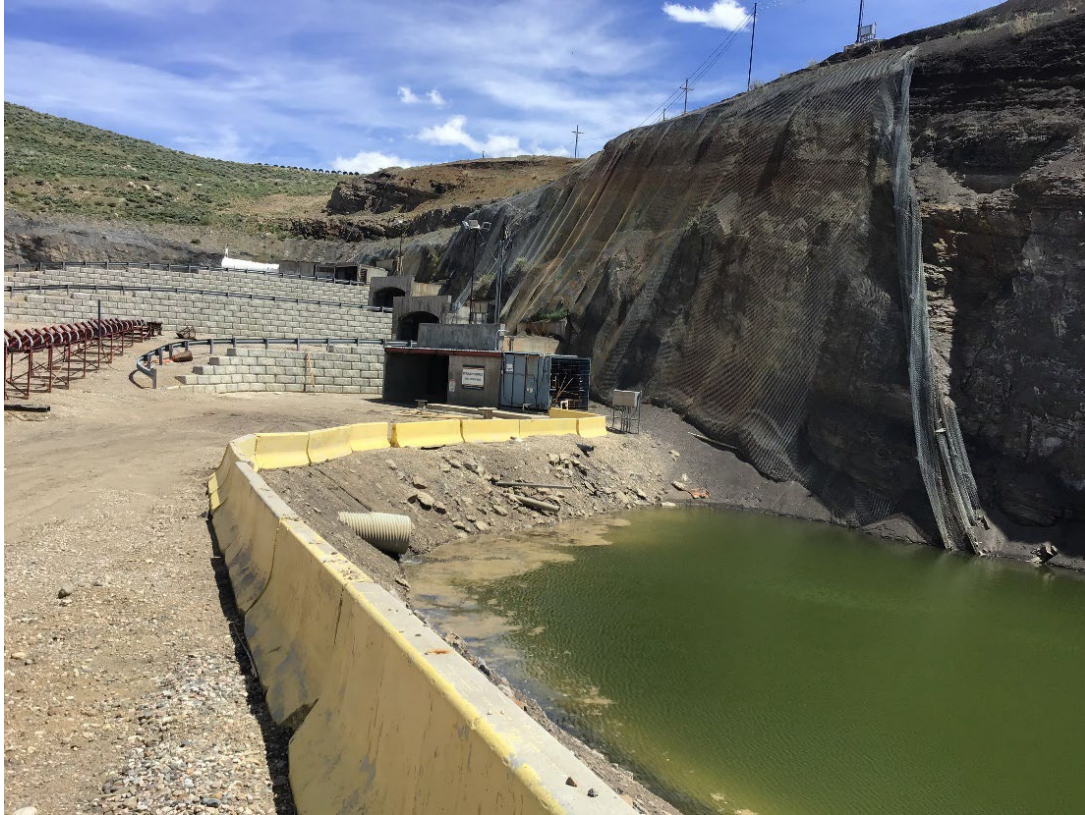
Photo 4: Sealed portals in background and settling pond in foreground.

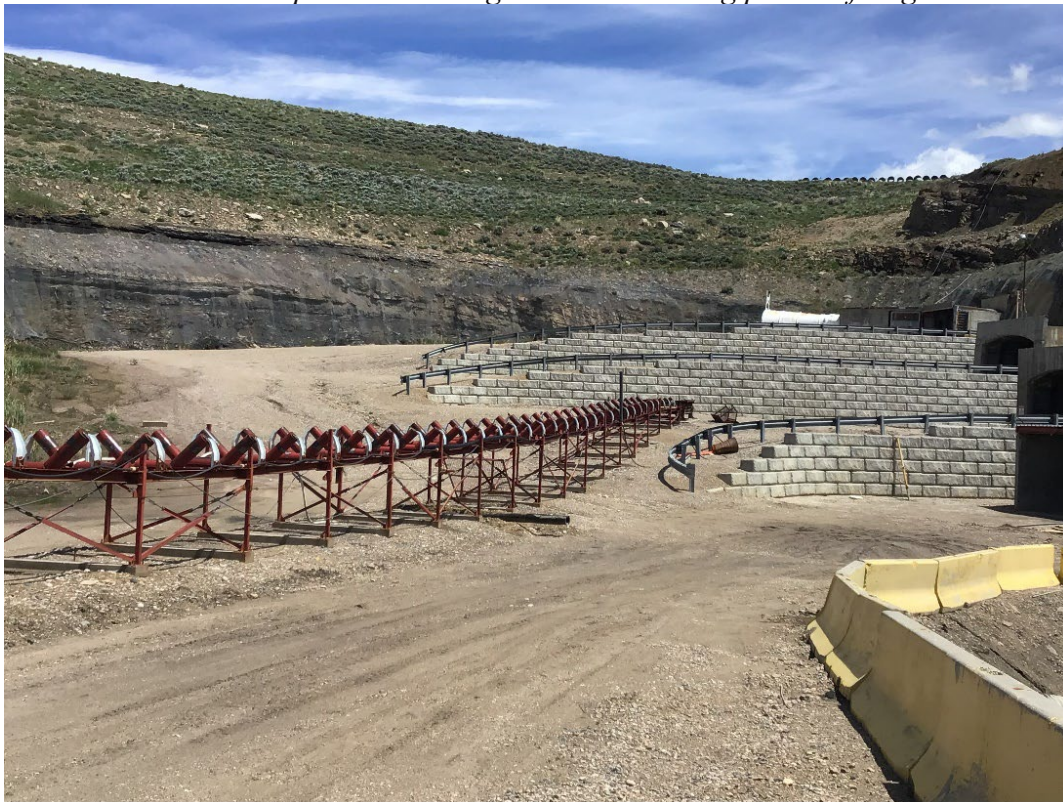
Photo 5: Sealed portals in background and conveyor.

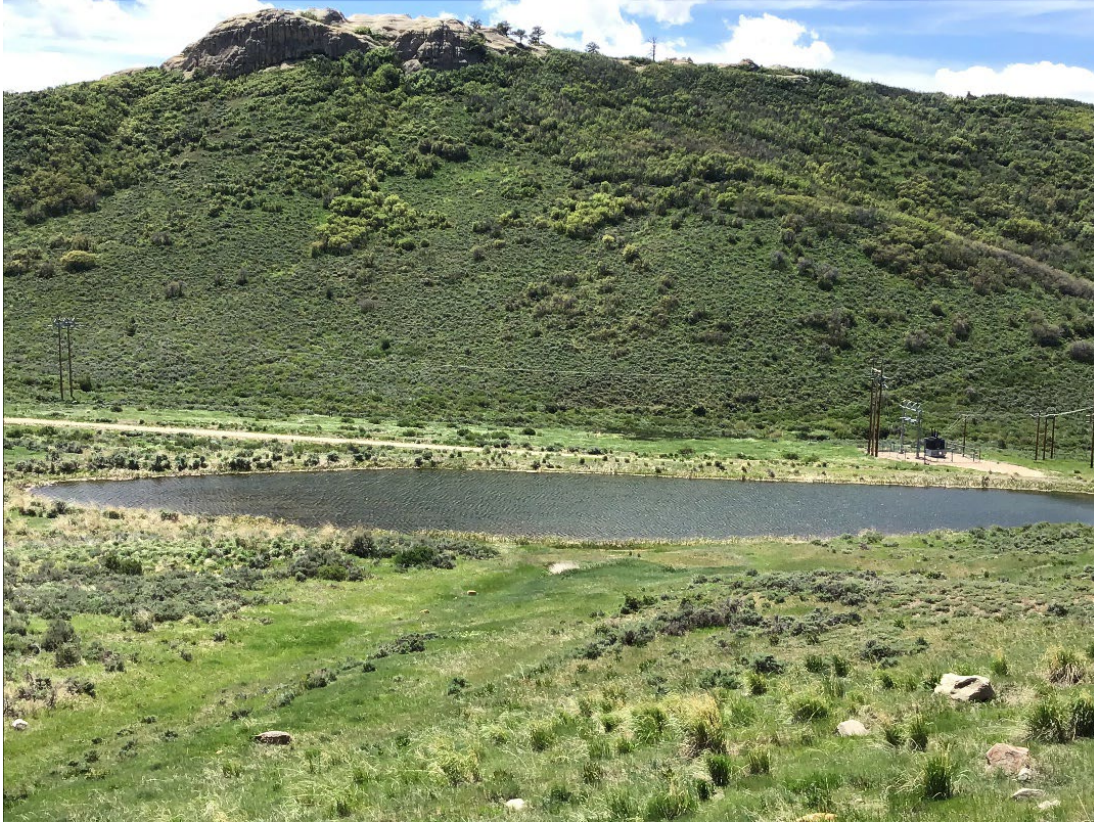
Photo 6: Pond 4 from above.

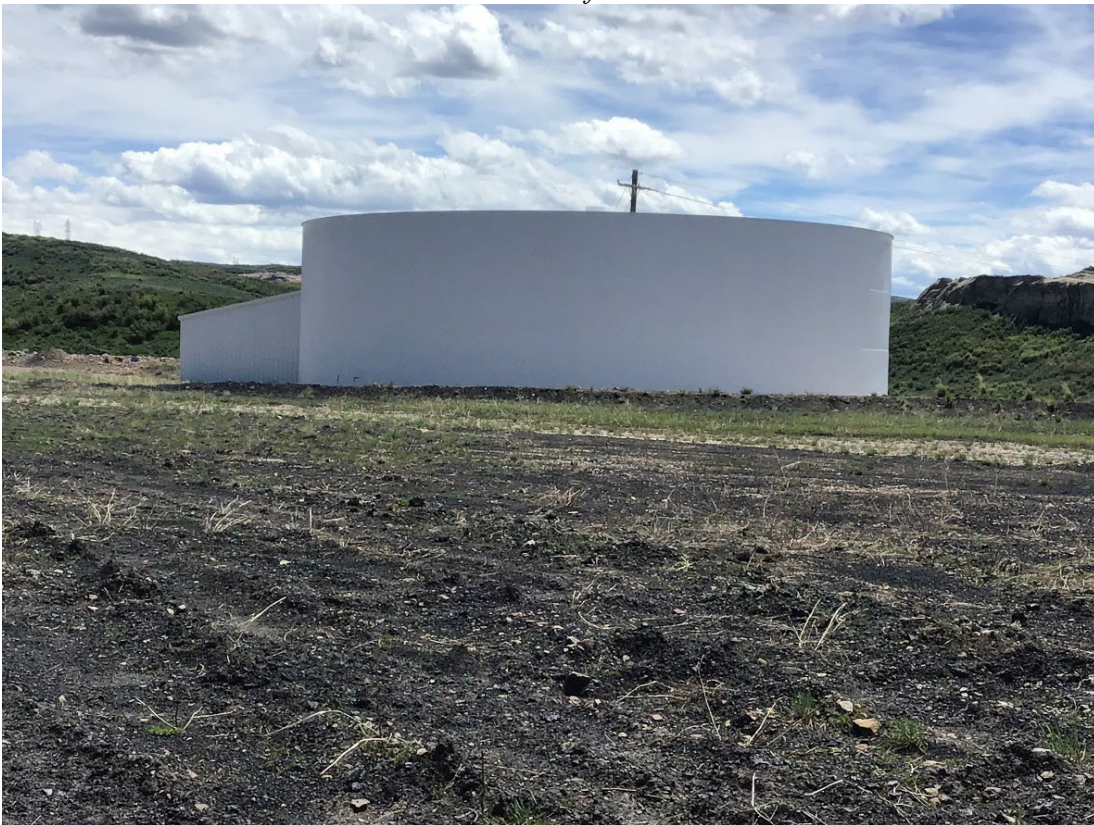
Photo 7: Empty water tanks.

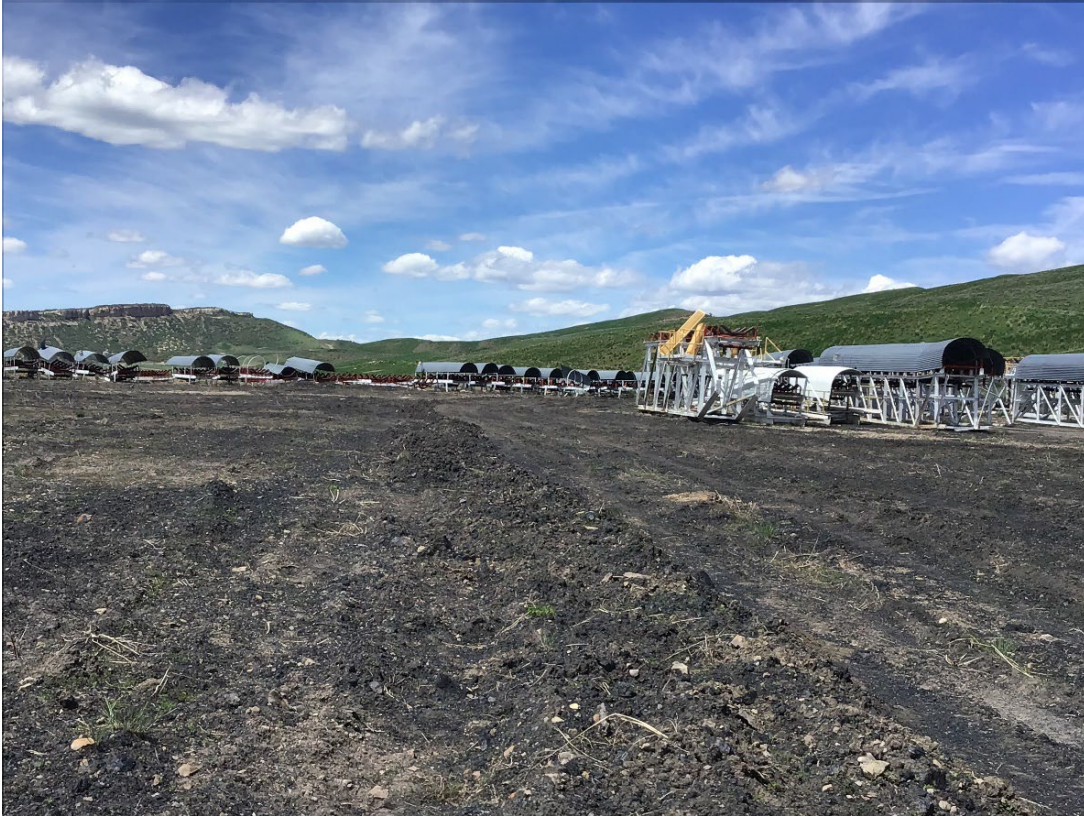
Photo 8: Stockpiled equipment.

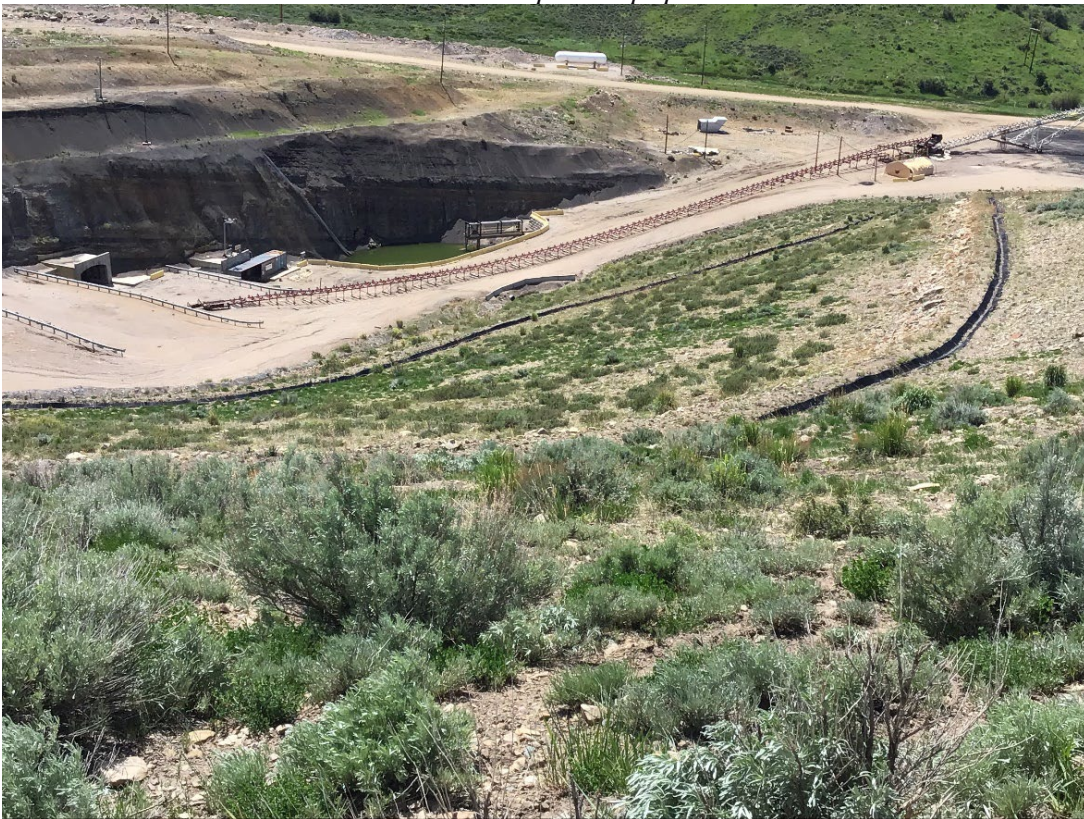
Photo 9: Overview of portal area.

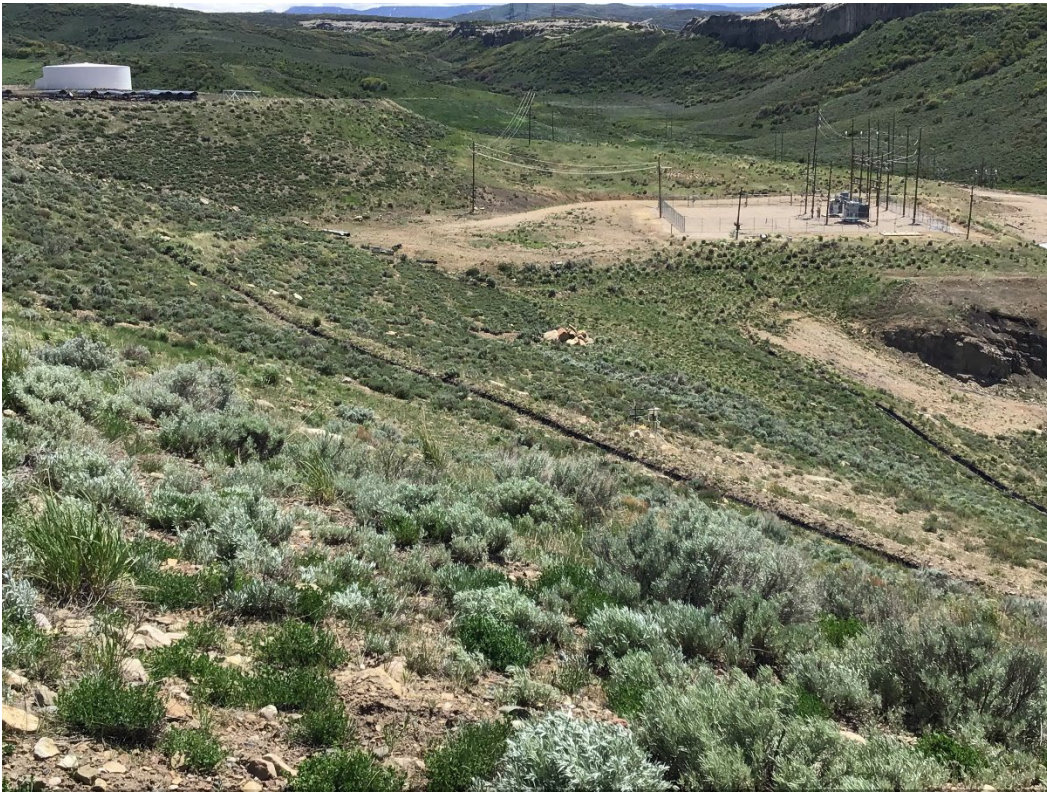
***Photo 10:** Transformers and water tanks.*

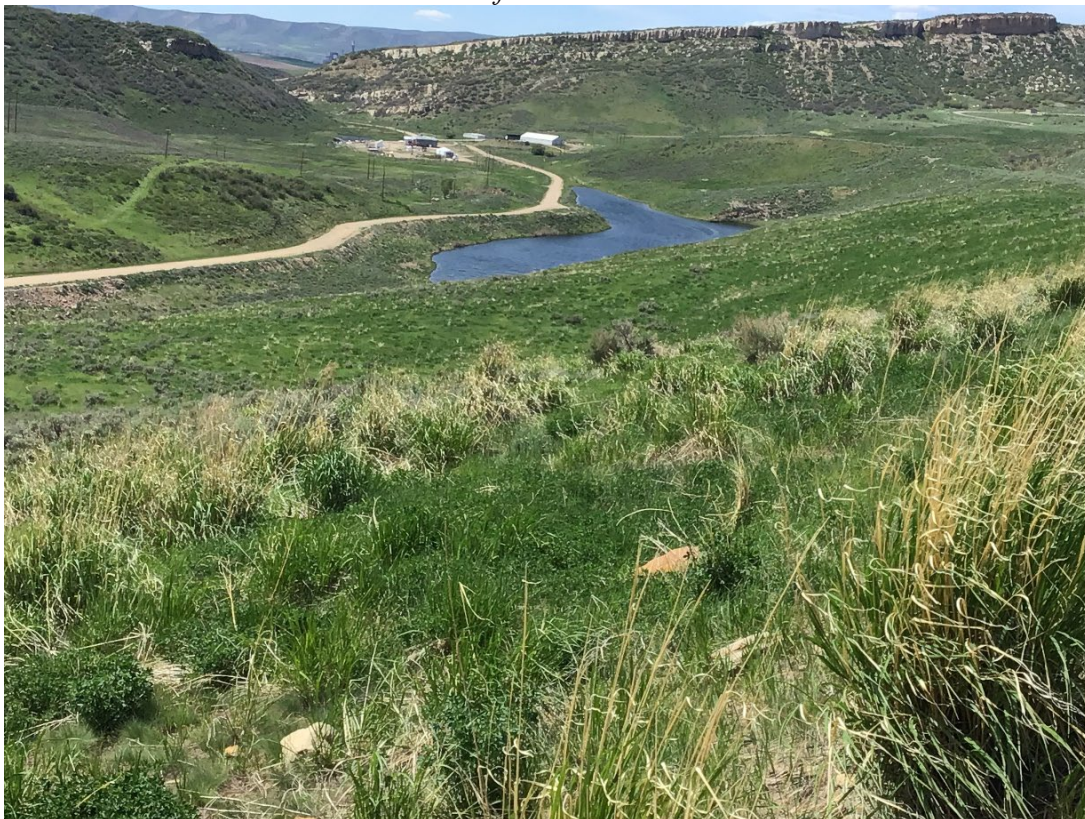
***Photo 11:** Pond 2 from above.*

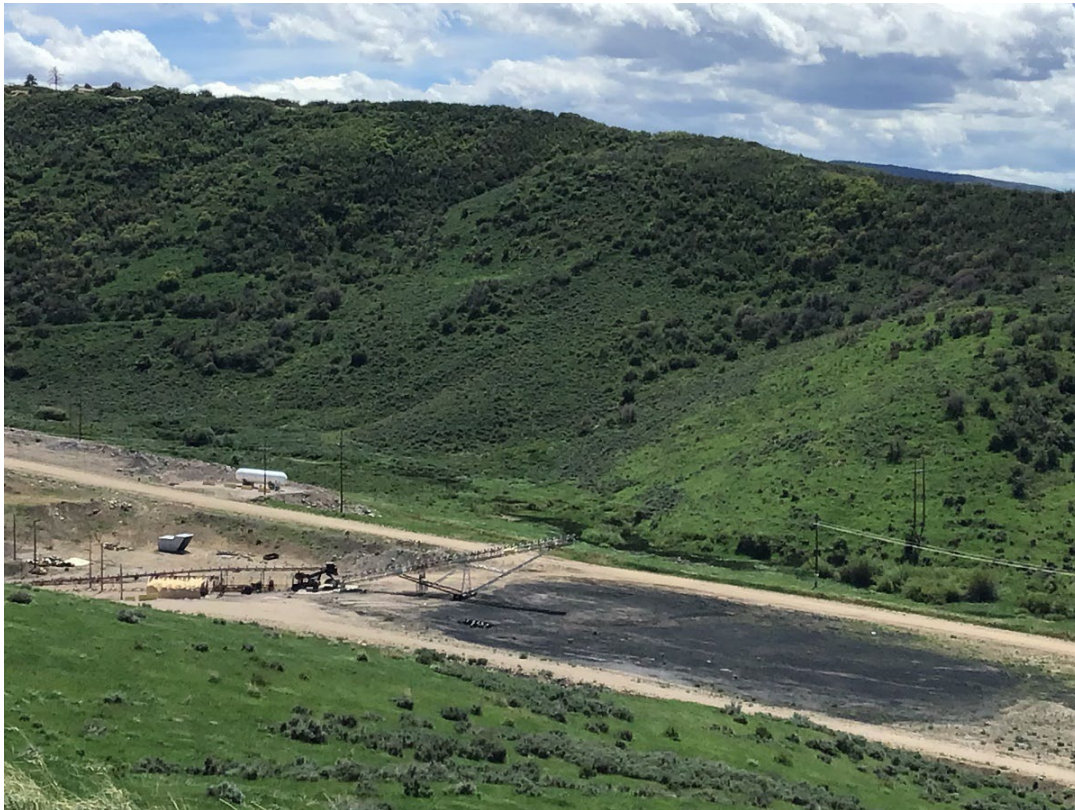
Photo 12: Former site of the coal stockpile.

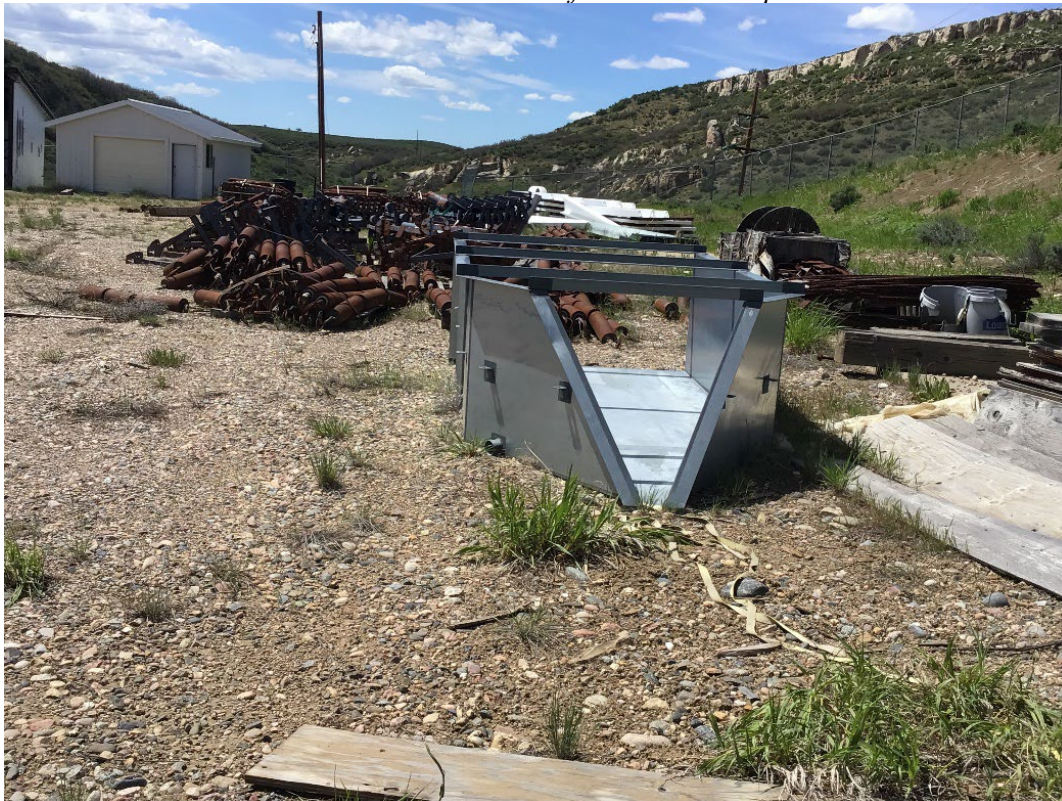
Photo 13: Replacement flume for Pond 2 in foreground of stockpiled materials.

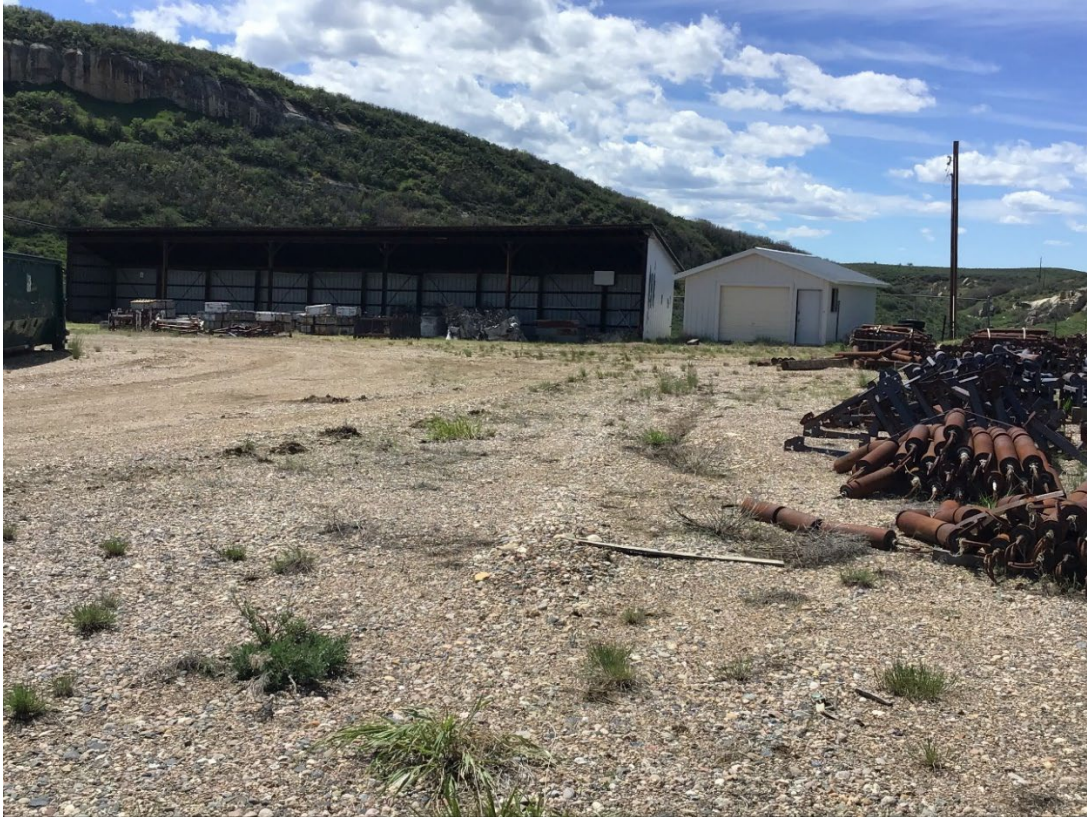
Photo 14: Structures and stockpiled materials.

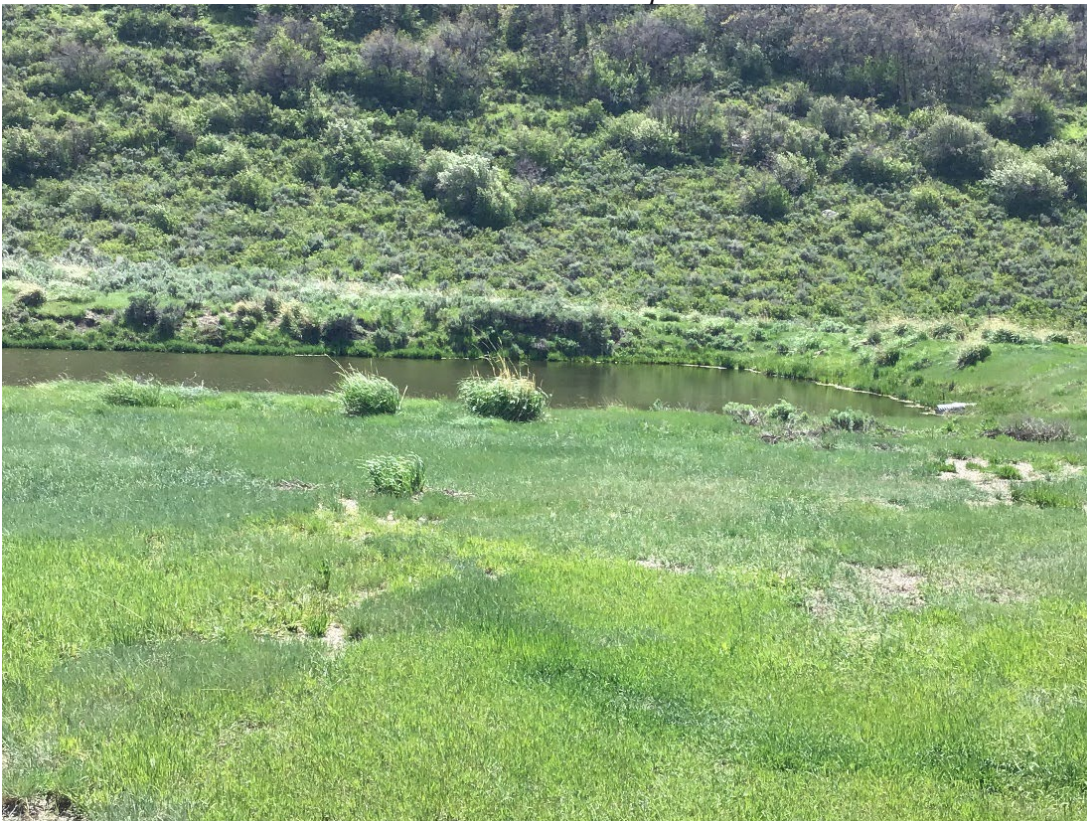
Photo 15: Pond 3.
