New Horizon Mine, C-1981-008, May Complete Inspection Report

PERMIT INFORMATION

Permit Number: C-1981-008 Mine Name: New Horizon Mine Operator: Elk Ridge Mining and Reclamation, LLC Operator Address: Mr. Tony Tennyson P.O. Box 628 27646 West 5th Avenue Nucla, CO 81424	County: Montrose Operation Type: Surface Permit Status: Active Ownership: Private
	Operator Representative Present: Jason Carver
Operator Representative Signature: (Field Issuance Only)

INSPECTION INFORMATION

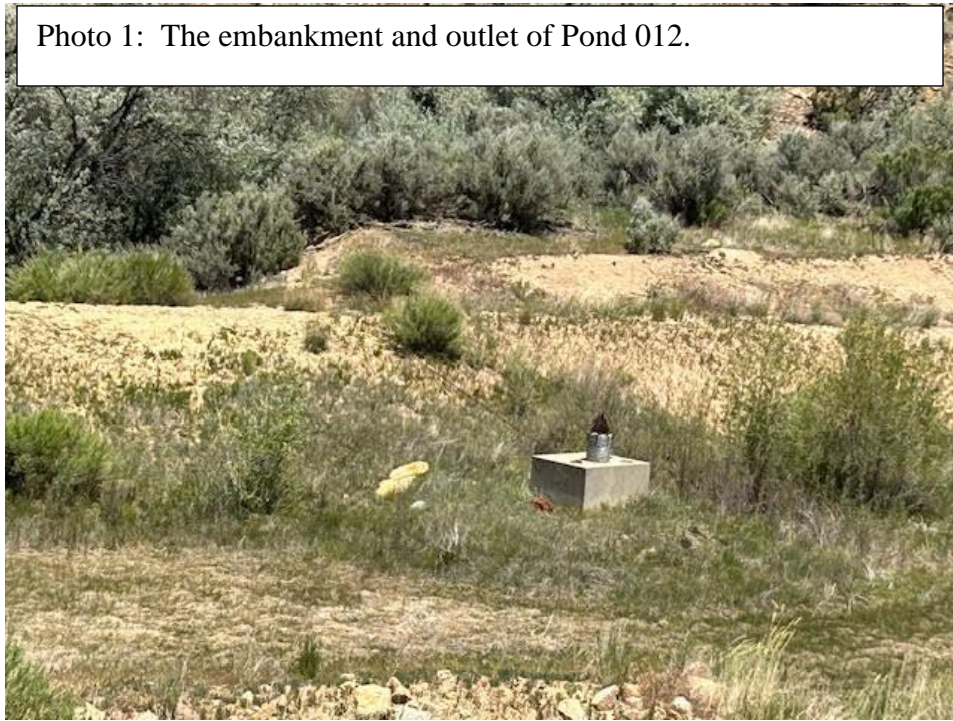
During the inspection, Pond 012 was dry. The embankment was stable with vegetative cover (Photo 1). The outlet for the pond was unobstructed. There were no indications of erosional features.

Photo 1: The embankment and outlet of Pond 012.

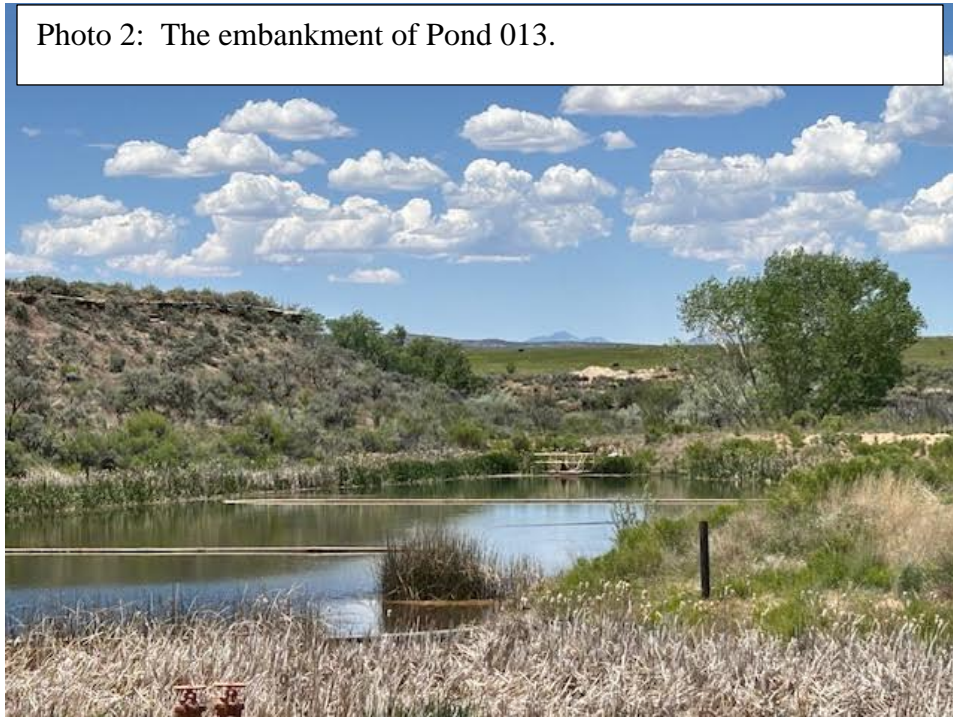
Pond 013 was receiving water from both the inlet from the French drain and the irrigation runoff. The pond was observed to be discharging through the primary outlet. The outlet was clear of blockages. The embankment for the pond was covered with vegetation and stable (Photo 2). No erosional concerns were identified.

Photo 2: The embankment of Pond 013.

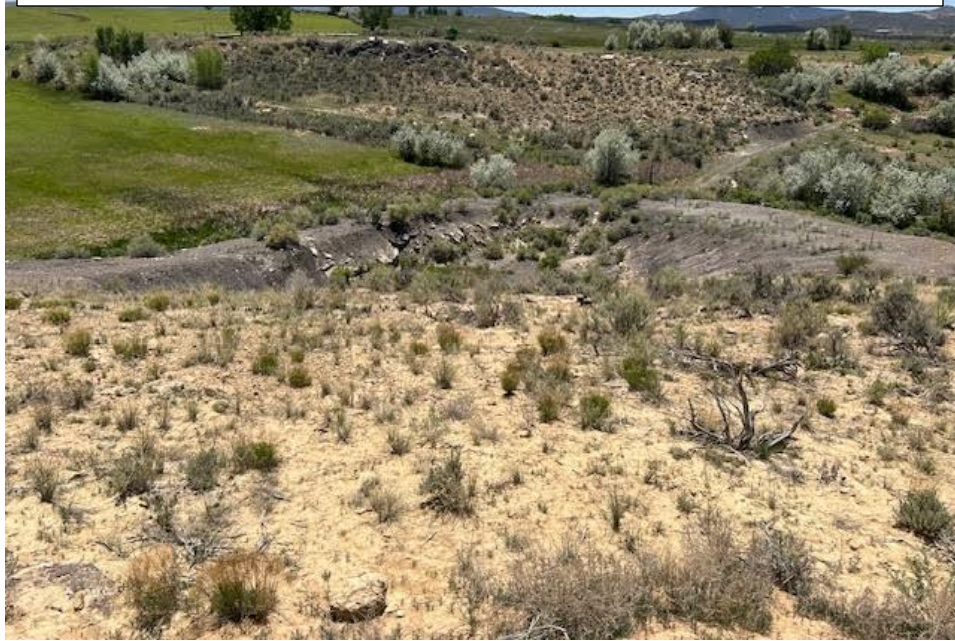
Pond 015 was also dry at the time of the inspection (Photo 3). The embankments were in similar condition to the previous complete inspection that was conducted. Minor rills remain on the interior of the embankment. The rills have been noted in previous Division inspection reports. The rills have not impacted the stability of the pond. The outlet was clear and no new erosional concerns were observed.

Photo 3: Pond 015.

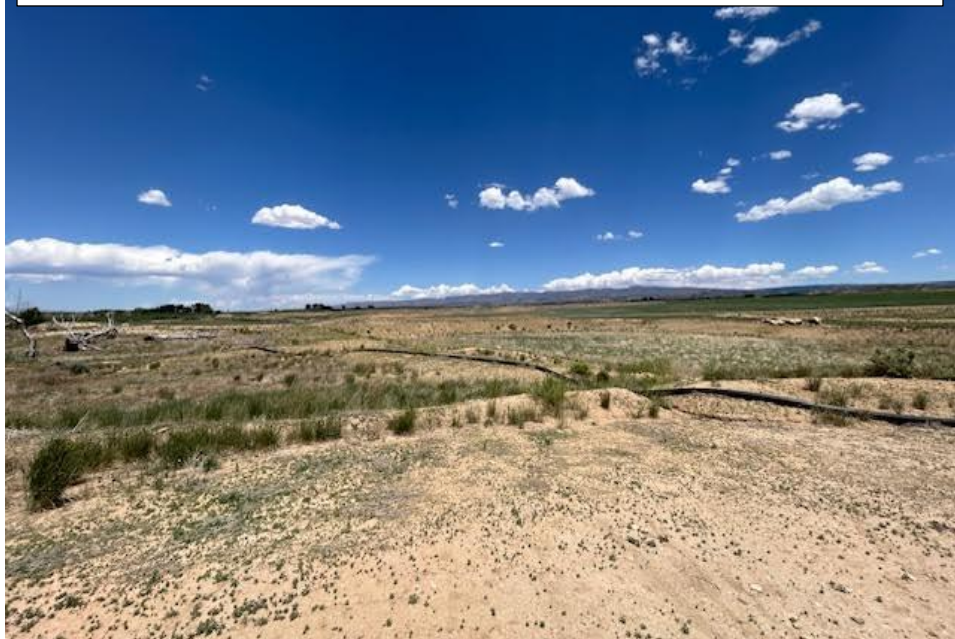
Pond 016 was dry (Photo 4). The pond's embankment was stable with vegetative cover. There were no indications of erosion. The outlet for the pond was observed to be clear of debris.

Photo 4: Pond 016.

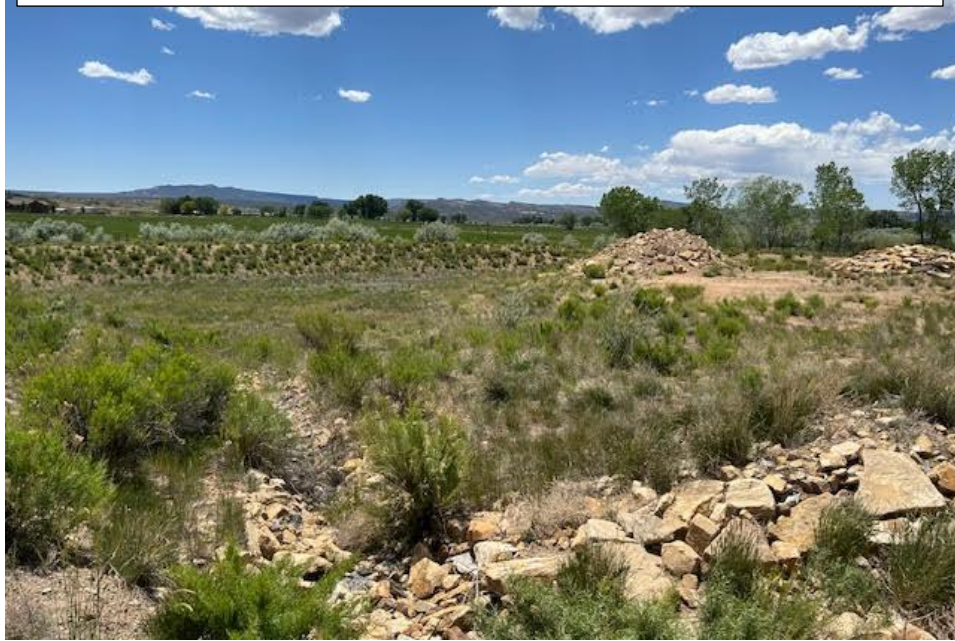
Pond 18 is located to the south of the mine office. The pond was dry. The embankment for the pond was covered with vegetation (Photo 5). There were no erosional features or indications of instability. The outlet for the pond was observed to be unobstructed.

Photo 5: Pond 018.

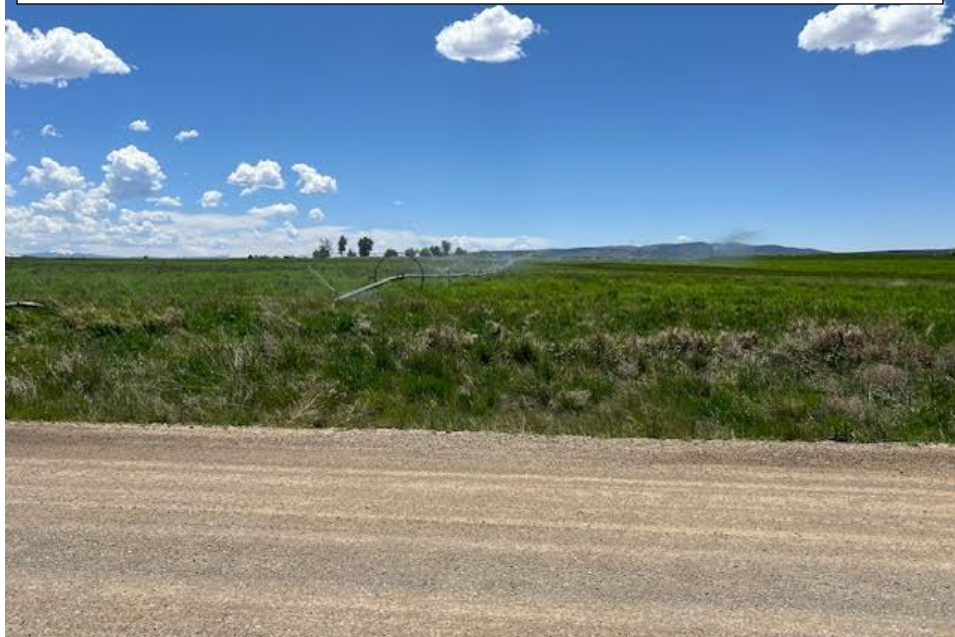
During the inspection Irrigated Cropland IC-1 was actively being irrigated (Photo 6). The field's vegetation was green and had grown noticeably since the March and April 2024 Inspections. The field was stable with no erosional concerns.

Photo 6: Irrigated Cropland IC-1 south of BB Road.

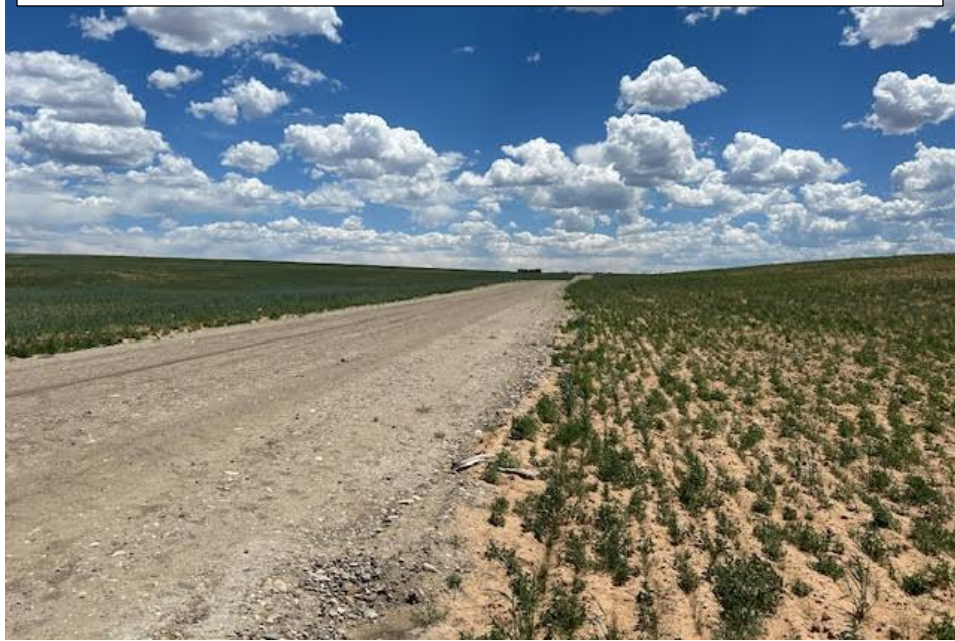
The Johnson Access road is located in section 36, bisecting Dryland pastures DP-20 and DP-21. The road was stable with no erosional concerns (Photo 7). The culverts underneath the access road were observed to be unobstructed (Photo 8). The inlets and outlets of the culverts are lined with riprap. The inlets and outlets were all stable with no erosion.

Photo 7: The Johnson Access Road looking to the southeast.

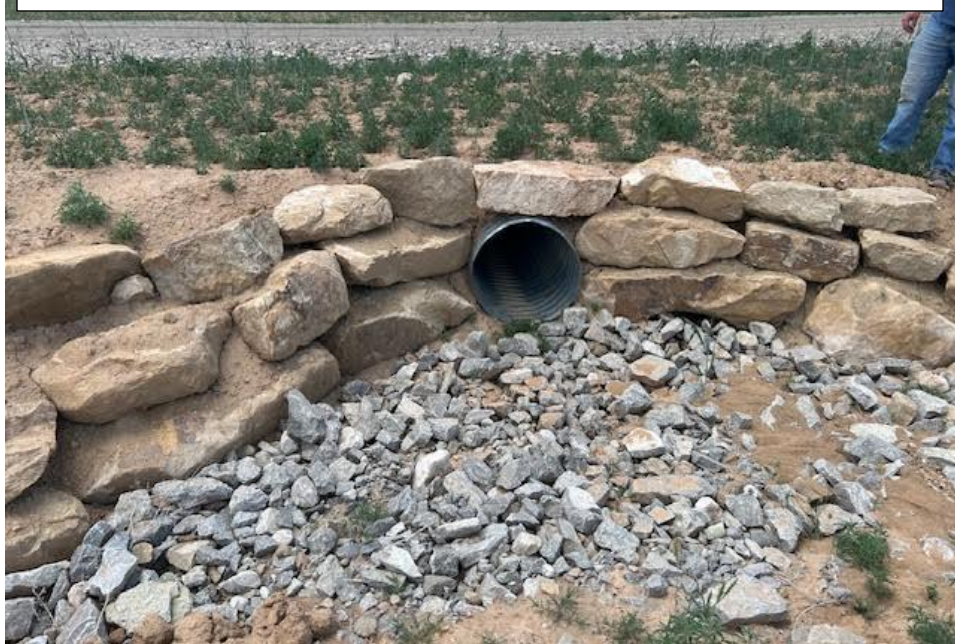
Photo 8: The northern culvert inlet under the Johnson Access Road.

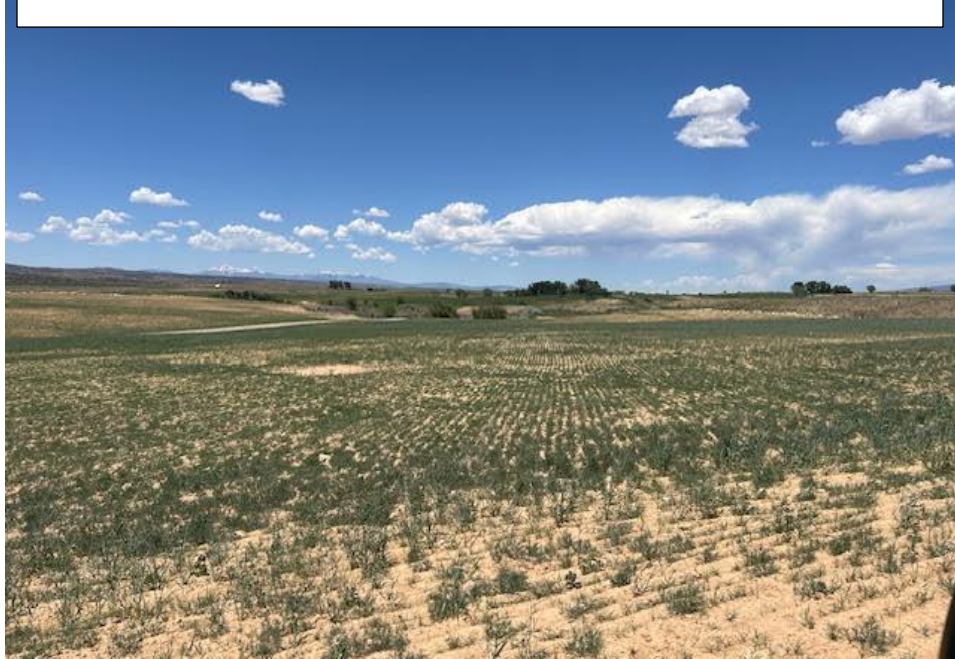
The vegetation seeded in the fall of 2023 on DP-20 (Photo 9), DP-21 (Photo 10), Prime Farmland PF-1 and Irrigated Pasture IP-12 was growing in well this spring. The vegetation was beginning to cover most of the reclaimed areas and less barren ground was exposed. The reclamation was stable and no erosional features were observed.

Photo 9: Dryland Pasture DP-20 looking west.

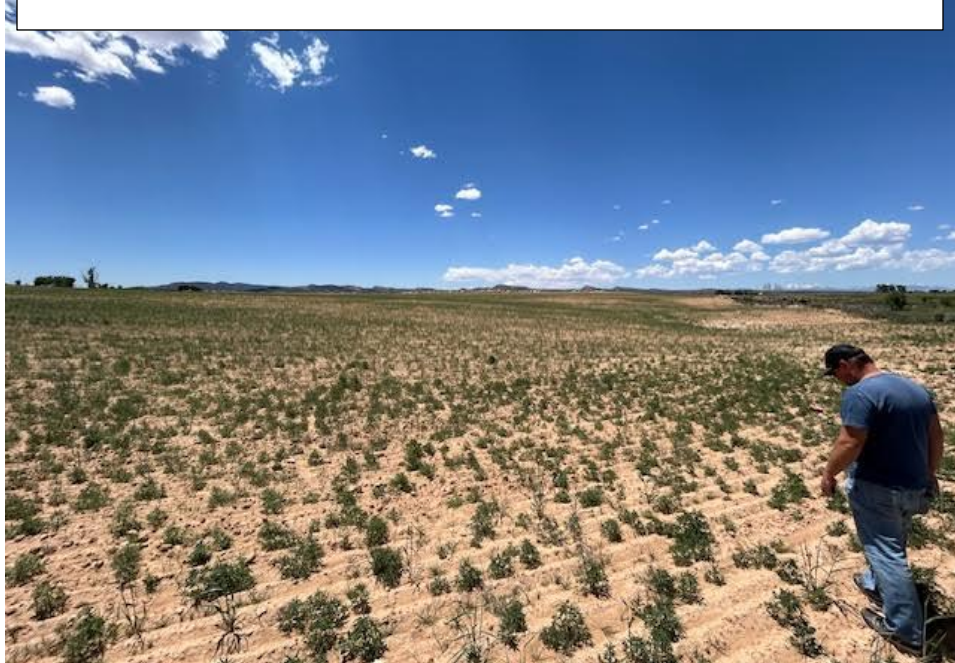
Photo 10: Dryland Pasture DP-21 looking west.

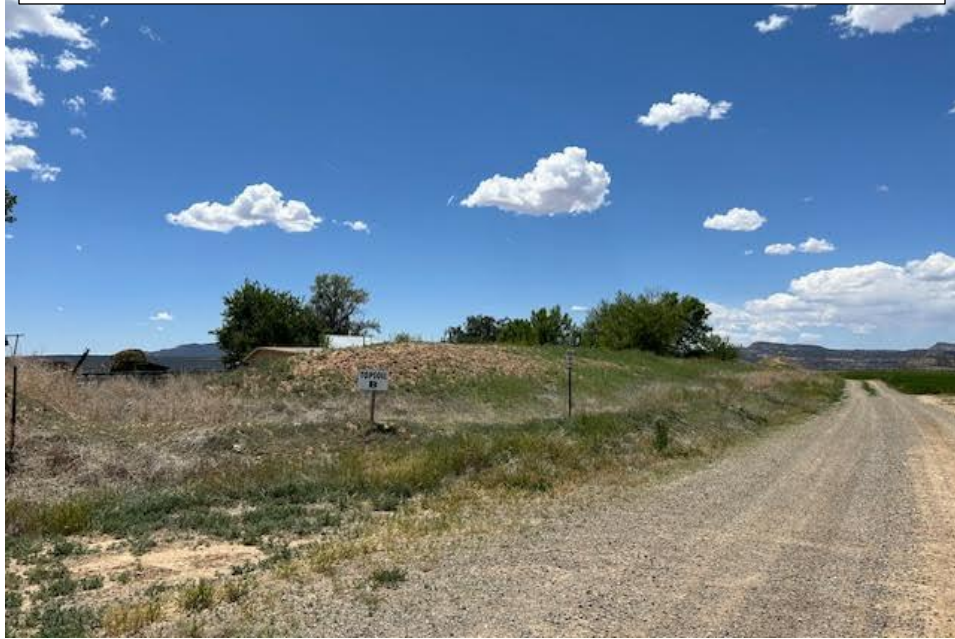
Topsoil piles 11A and 11B (Photo 11) are located on the South side of IC-1. The piles were stable with

vegetative cover. There were no erosional features observed. The perimeter ditches for the piles were clear of debris and stable.

Photo 11: Topsoil Stockpile 11B.
