## Hayden Gulch LO May inspection

### PERMIT INFORMATION

<b>Permit Number:</b> C-1992-081 <b>Mine Name:</b> Hayden Gulch Loadout <b>Operator:</b> Hayden Gulch Terminal, LLC <b>Operator Address:</b> Ms. Miranda Kawcak 29515 Routt County Road 27 Oak Creek, CO 80467	<b>County:</b> Routt <b>Operation Type:</b> Loadout <b>Permit Status:</b> Active <b>Ownership:</b> Private
	<b>Operator Representative Present:</b>  N/a
<b>Operator Representative Signature: (Field Issuance Only)</b>

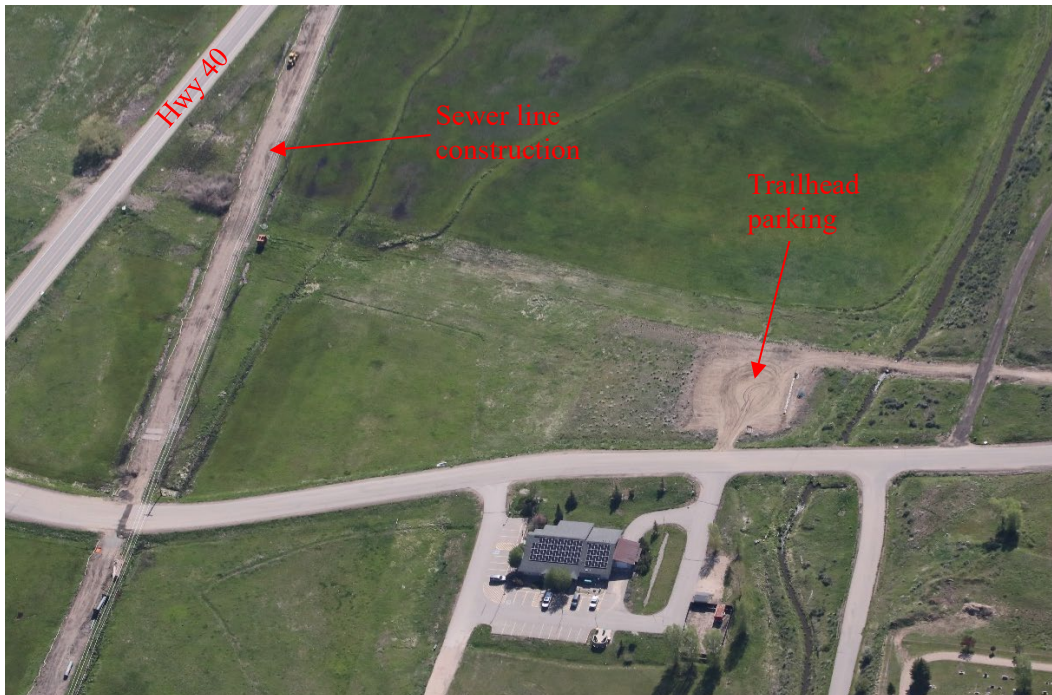
The area between the trailhead parking lot and highway 40 is starting to sprout for the season (photo 1). The grass appears to be less well developed on the east side of the reclaimed area but overall looks good. A sewer line is being installed immediately north and parallel to the powerlines. The sewer line construction crosses the reclamation in this area. The sewer line is a project of the Town of Hayden and is not mine related.

Photo 1 – The area between the trailhead parking lot and Hwy 40

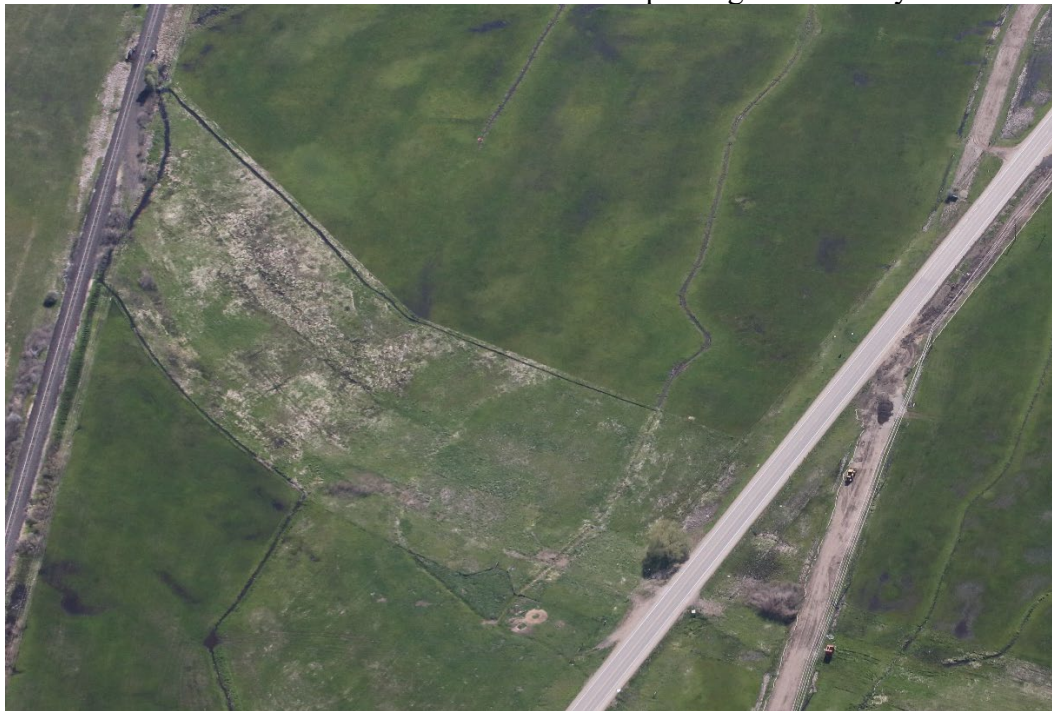
The area between Hwy 40 and the railroad is also starting to sprout (photo 2). The vegetation appears to be more well developed on the southern portion of the reclamation.

Photo 2 – The area between Hwy 40 and the railroad
