Please find the 2024 May DRMS inspection report for Trapper Miine. This was an aerial inspection

28 May 2024

Permit Number: C1981010 Mine Name: Trapper Mine Operator: Trapper Mining, Inc. Operator Address: Mr. Graham Roberts P.O. Box 187 Craig, CO 81626	County: Moffat Operation Type: Surface Permit Status: Active Ownership: Federal
	Operator Representative Present: No, as this was an aerial inspection.
This report was issued electronically from the Divisions' Denver Office.

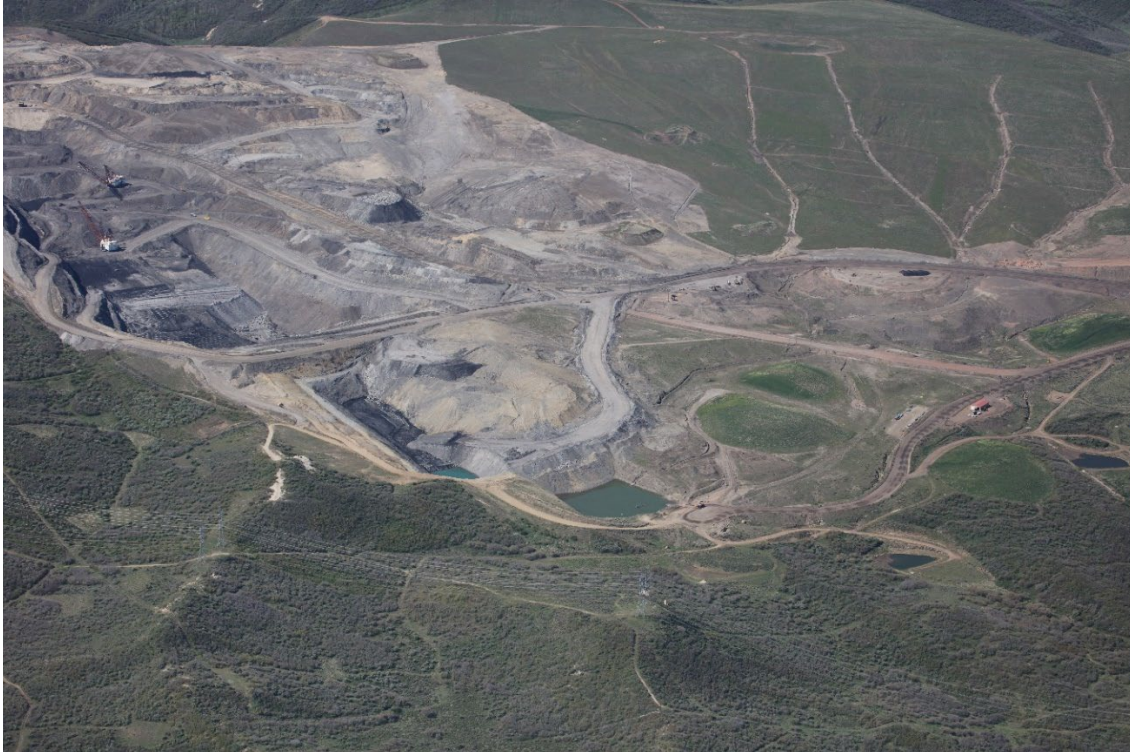
Photo 2: L Pit overview looking southwest with constructed drainages in Phase II LAB parcels.

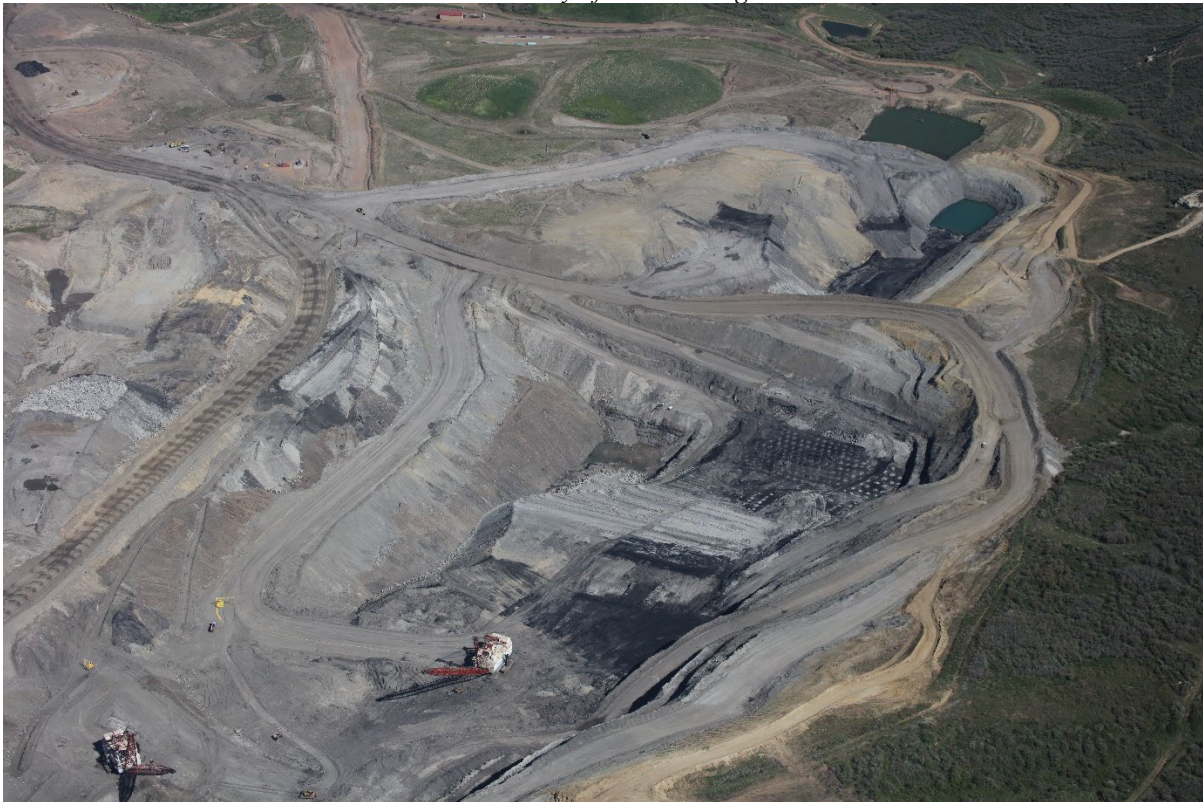
- A blast appeared to be set up between J Pits East and West and in L Pit. (photos 4 and 13).
- Blasting explosive permit has been extended and documentation placed in records.

Photo 4: A blast set up in L Pit, looking north.

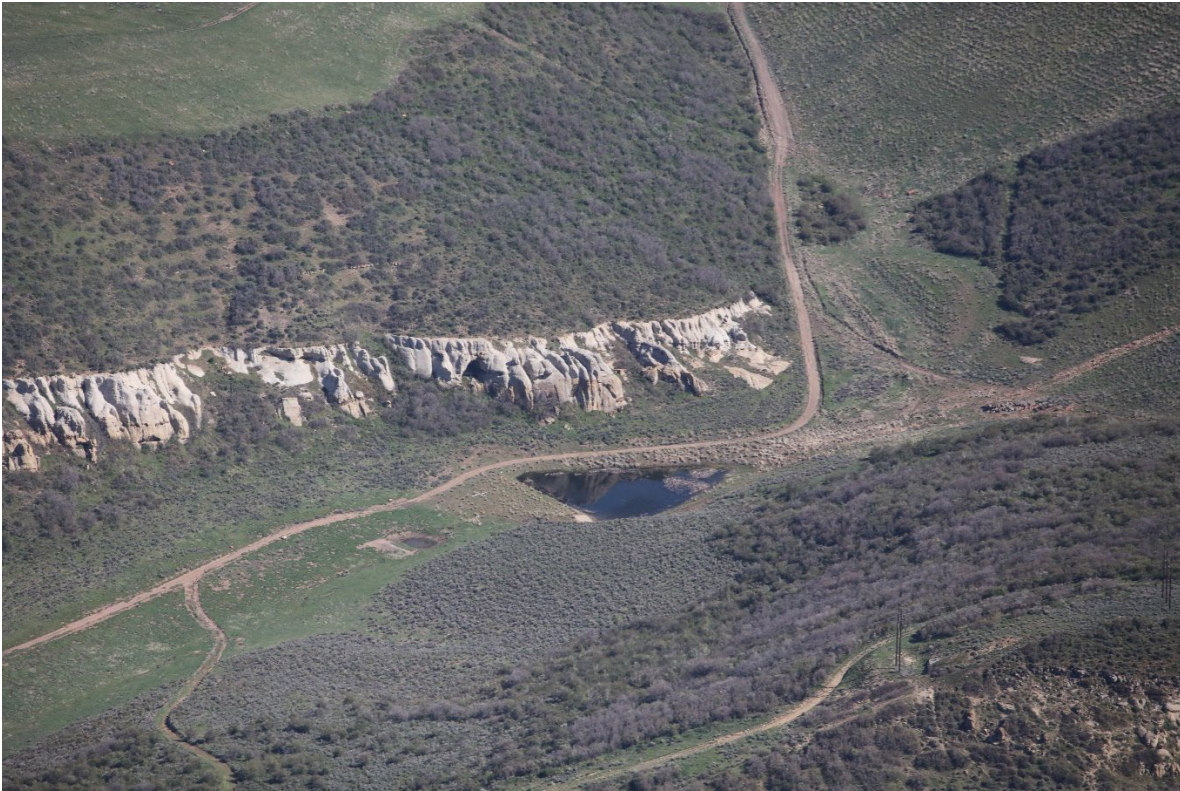
Photo 5: Horse Pond holding water.

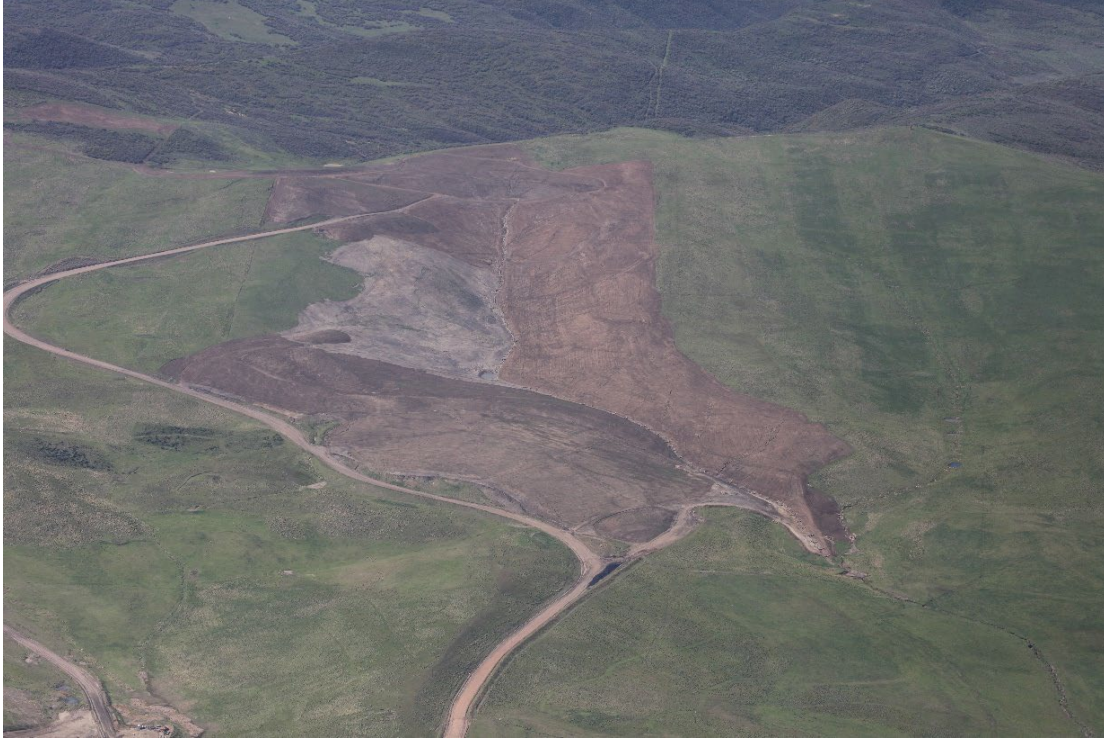
- Reclamation consists of benched overburden in L Pit awaiting grading, an ongoing activity at Trapper Mine.
- A small waterbody is situated in the center of D Pit between check dams, most likely the result of snowmelt.

Photo 9: D Pit and it's constructed drainage with small body of water in the center of the photo.

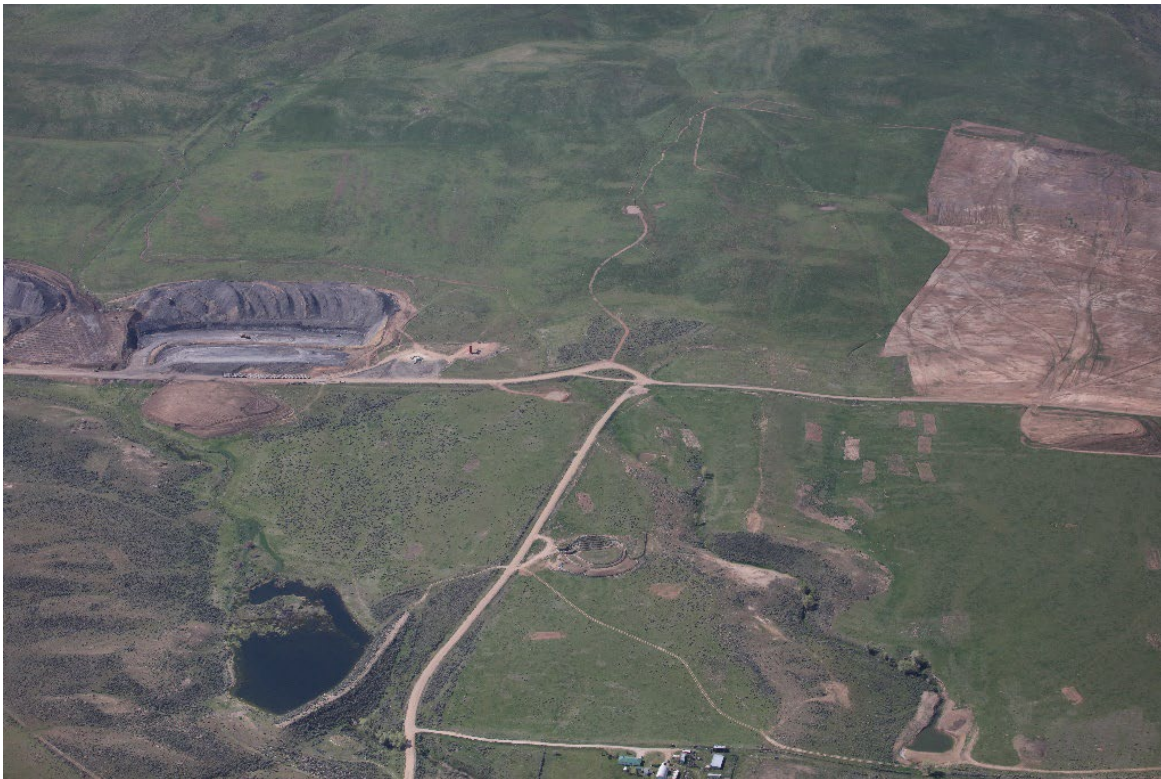
Photo 10: Coyote Pond and I Pit Middle on left, stripped area of C Pit on right of photo, looking south.

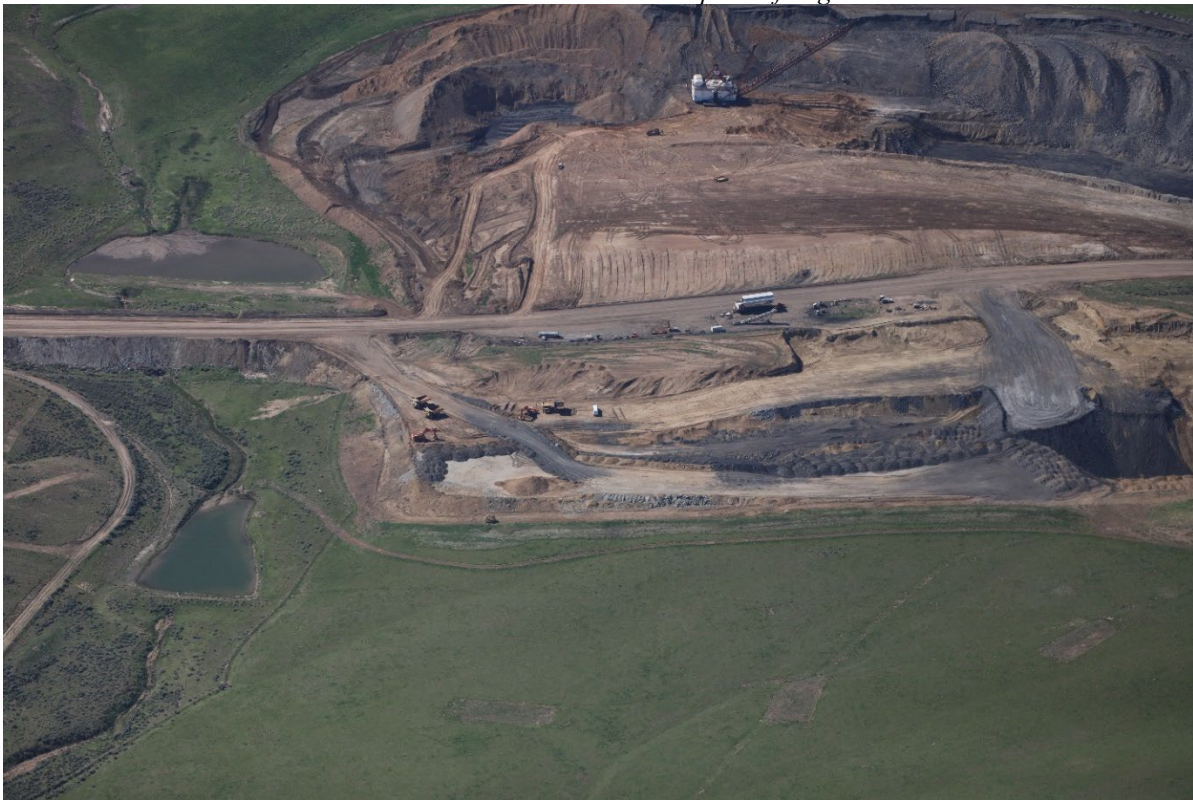
- No Name Pond #2 exhibited a substantial sediment fan. (Photo 12)
- West Pyeatt #1 held a small amount of water.
- West Pyeatt #2 appeared to be holding water at the time of inspection.
- East Pyeatt system held water in all three ponds, and it did not appear from the imagery that East Pyeatt #3 was discharging at the time of inspection.
- East Middle Flume held showed inflow and exhibited a substantial sediment fan. (Photo 19)
- Middle Flume#3 showed a sediment fan. (Photo 17)

Photo 12: I Pit Middle and J Pit West mining activities, looking south, No Name Pond #4 in foreground.

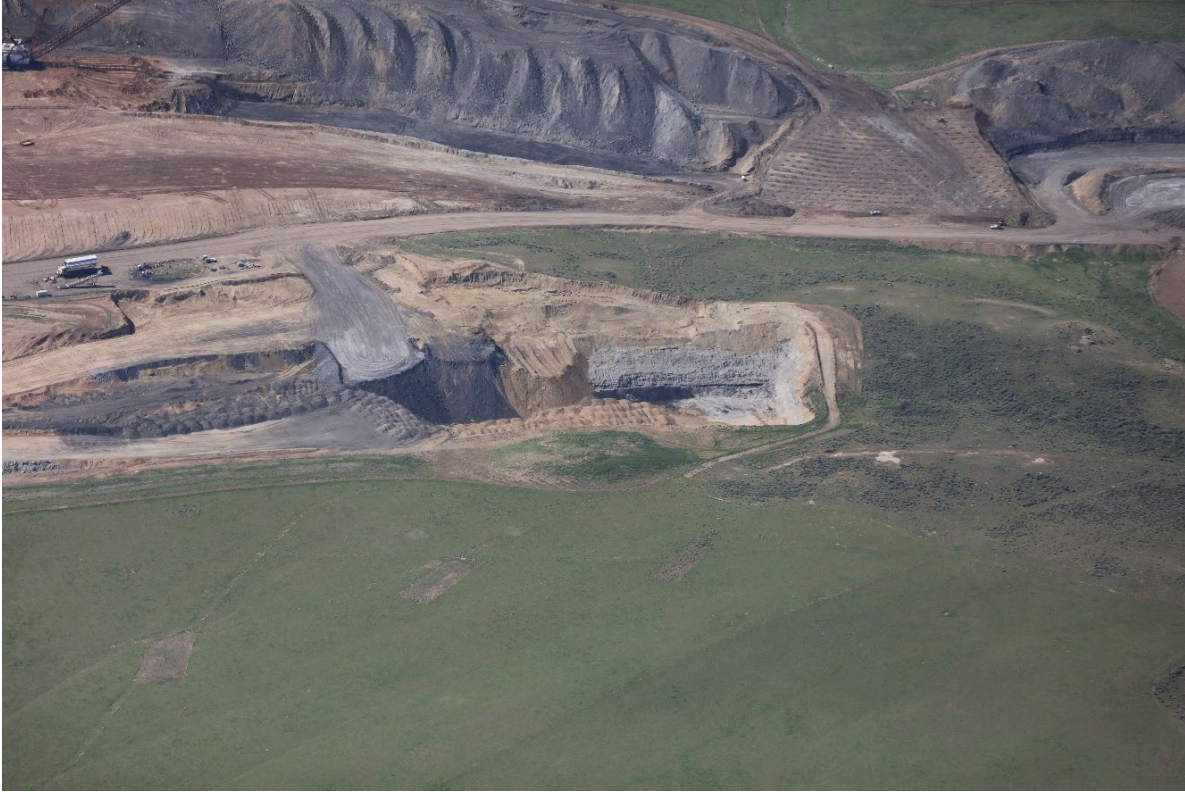
Photo 13: Overview of west panel Pit activities, with slope to be blasted.

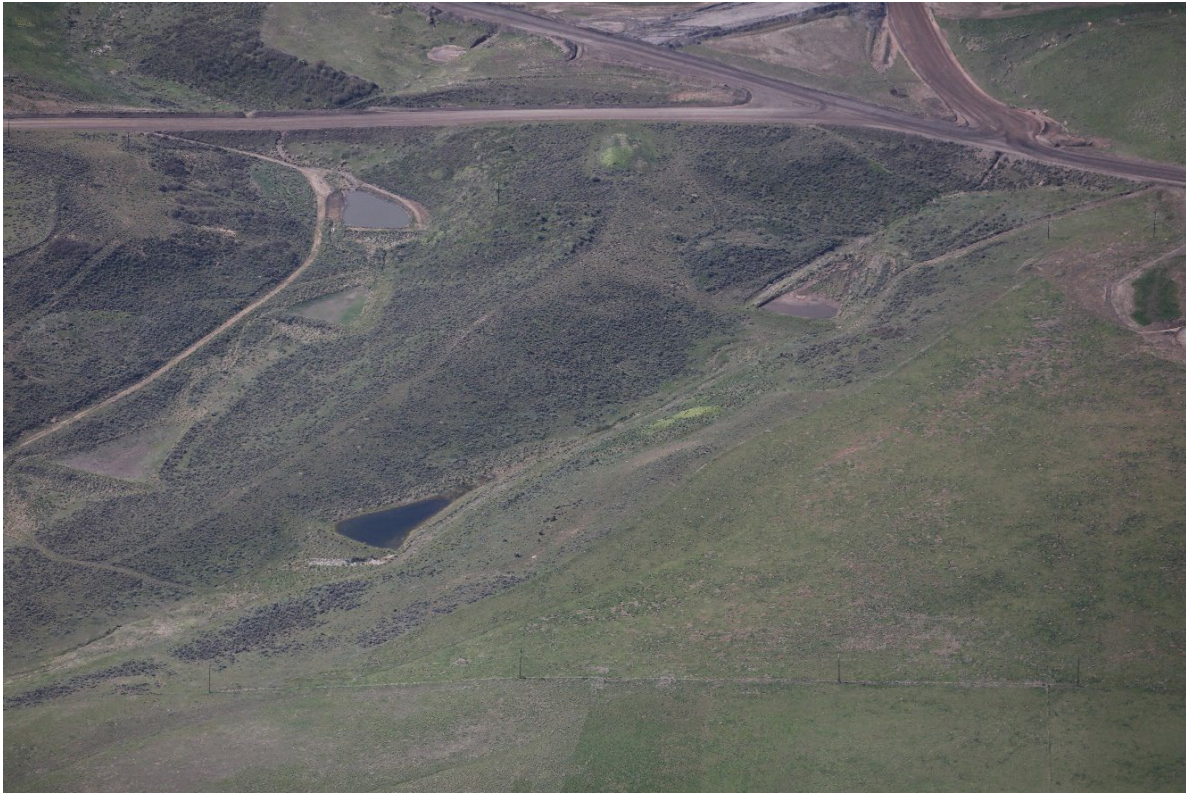
Photo 15: Middle (left) and West(right), Pyeatt Ponds.

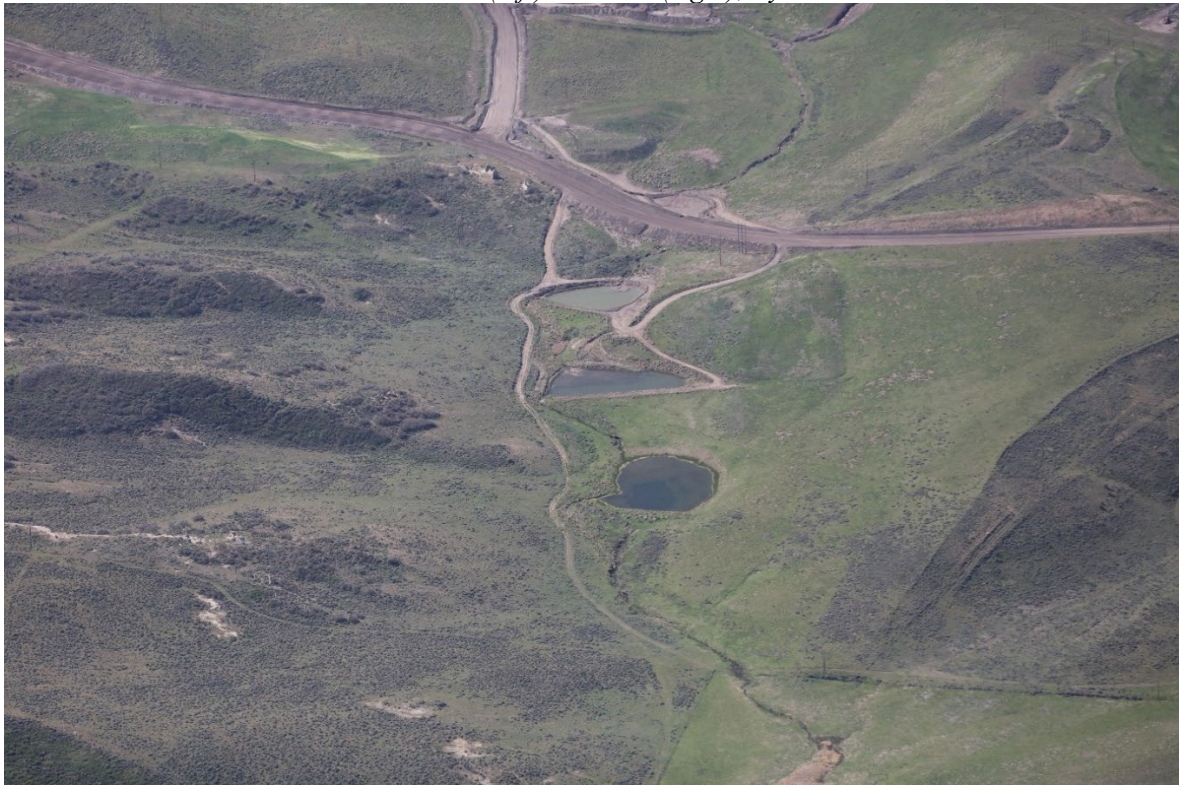
Photo 16: East Pyeatt System

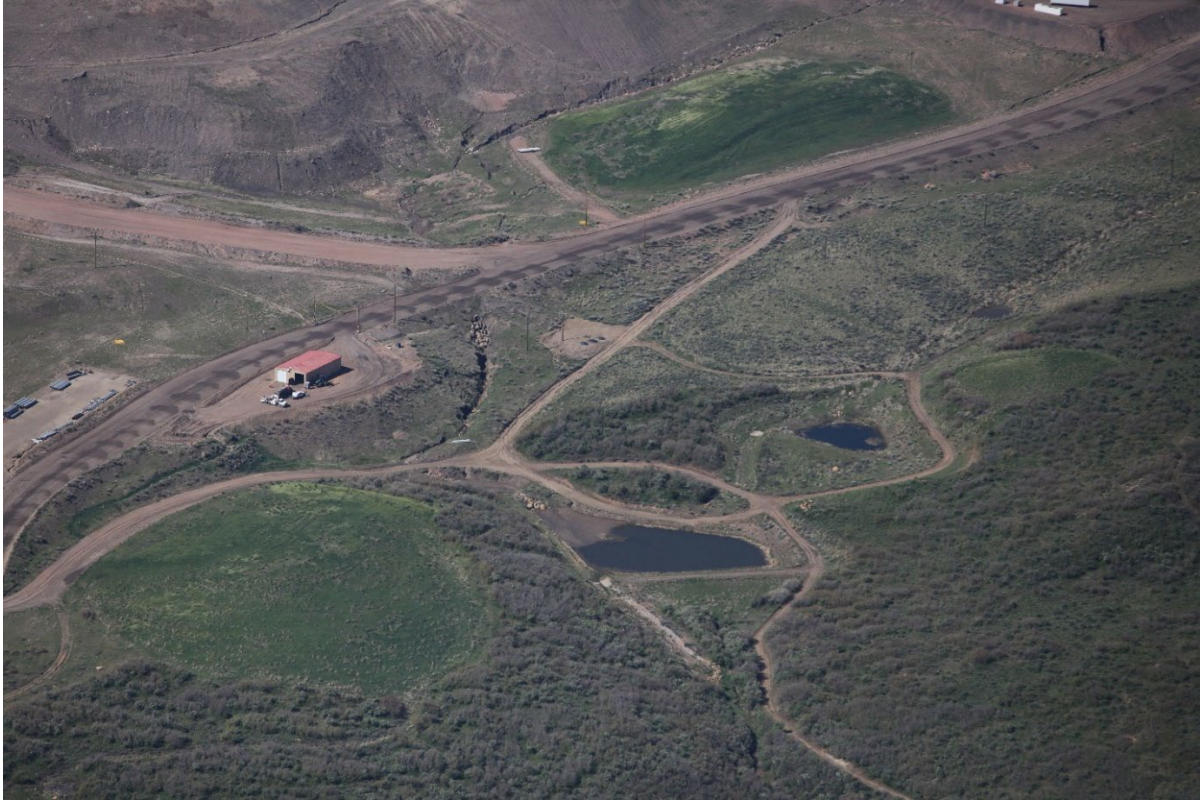
Photo 17: Middle Flume #3(foreground), showing a sediment delta and Middle Flume #1.

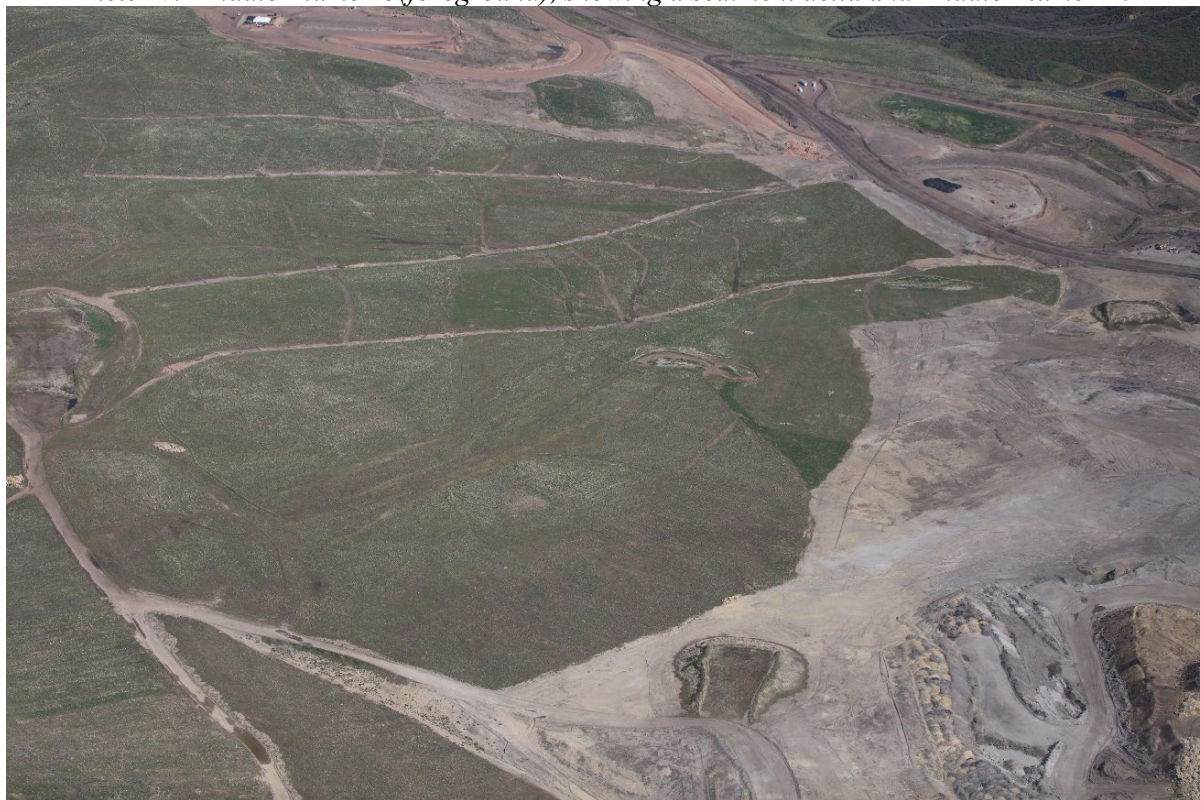
Photo 18: Constructed drainages in Z, LAB and K Parcels draining to the Flume System.

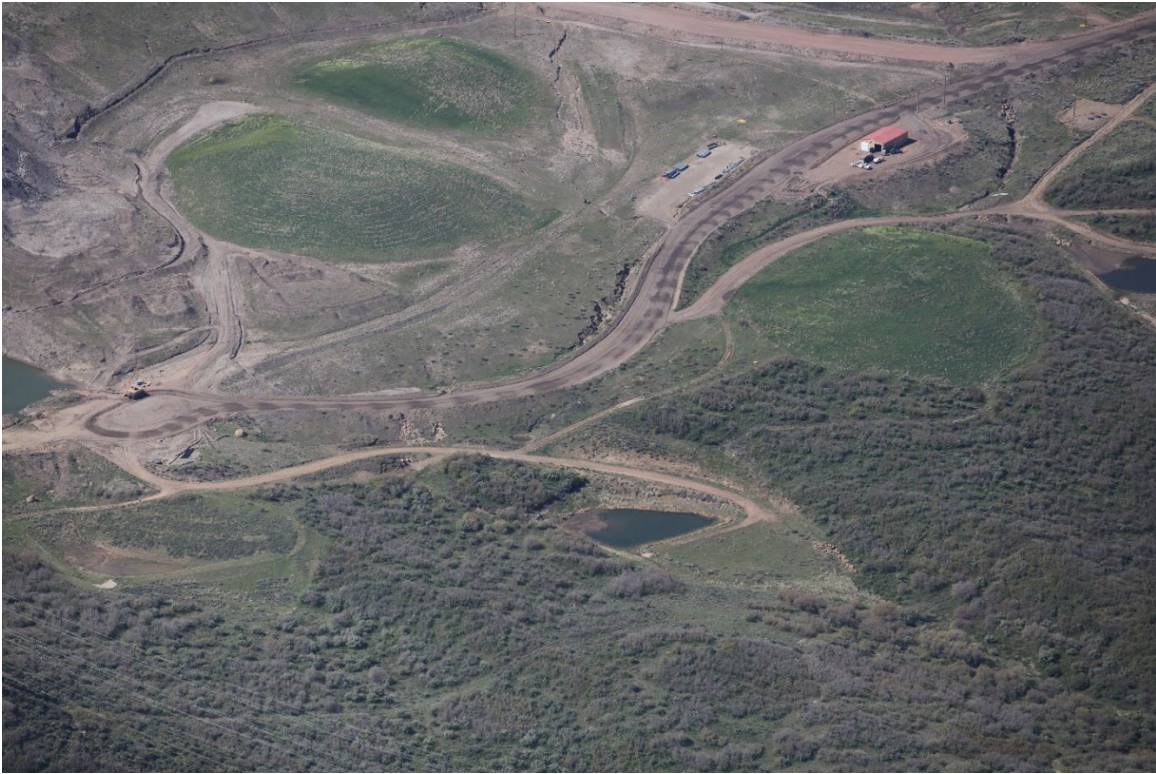
Photo 19: East Middle Flume

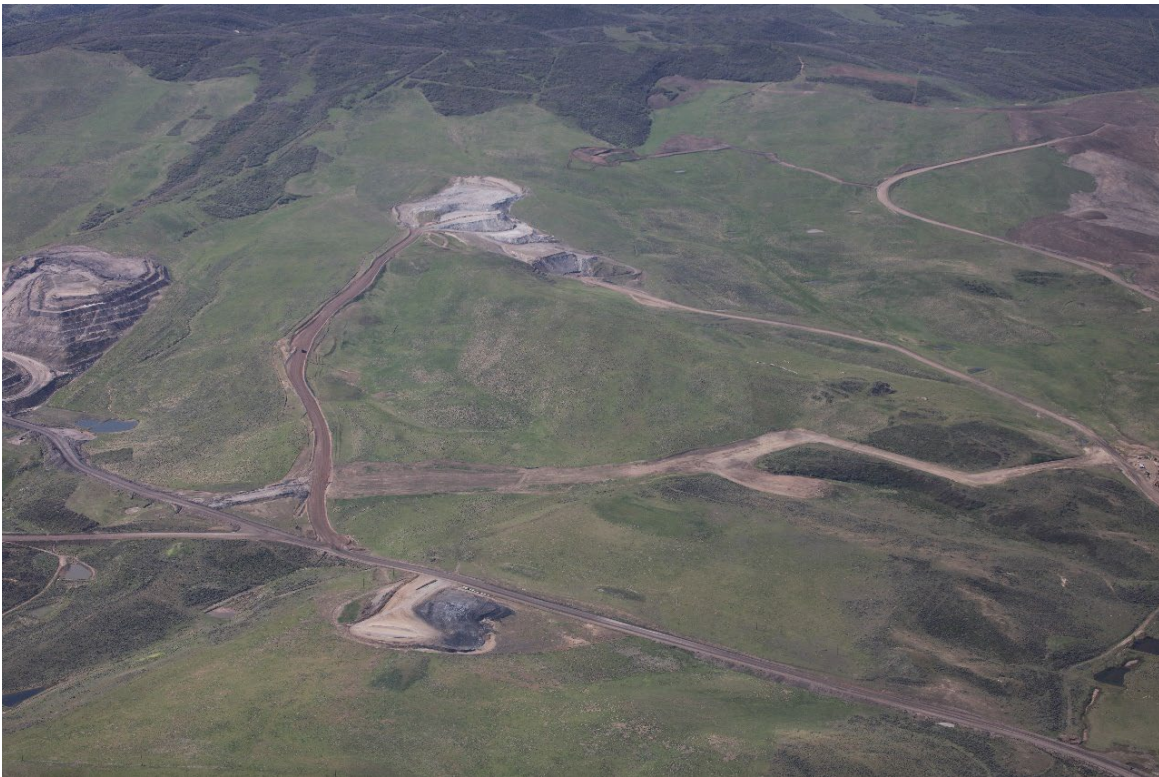
Photo 20: Ash Pit in center of photo with N Pit overburden stockpile on left edge, and dozer basin below.
