King Mine, C-1981-035, May Complete Inspection Report

PERMIT INFORMATION

INSPECTION INFORMATION

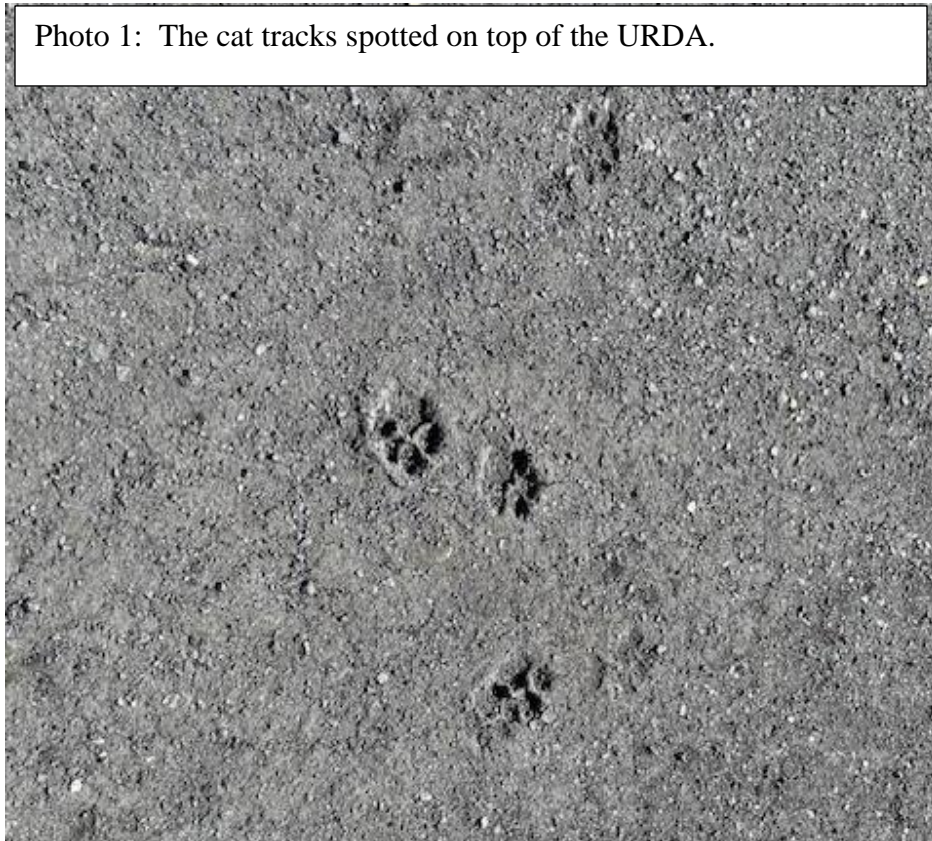
During the inspection of the King I area, a couple sets of large cat tracks were observed traversing the upper refuse disposal area (Photo 1). The tracks were likely from a bobcat or a young mountain lion. Also seen on the edge of the King I west pond was a mother bear and her two cubs.

Photo 1: The cat tracks spotted on top of the URDA.

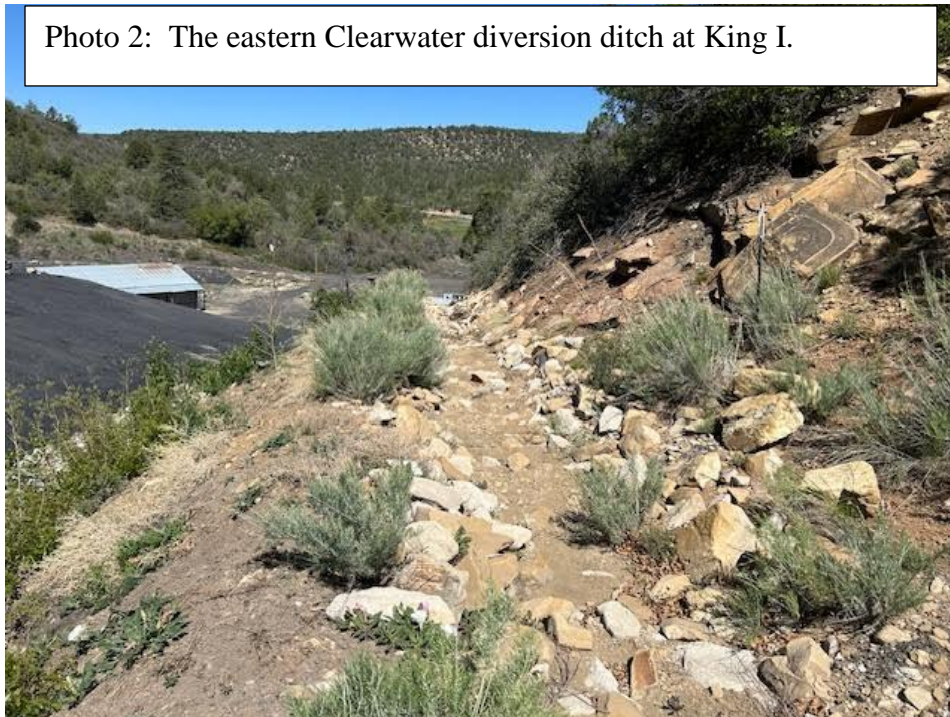
There are two clear water diversion ditches at the King I area. Both ditches transport up gradient runoff from undisturbed areas around the refuse disposal piles. The east (Photo 2) and west ditch were dry during the inspection. The ditches were clear of debris and no erosional concerns were identified.

Photo 2: The eastern Clearwater diversion ditch at King I.

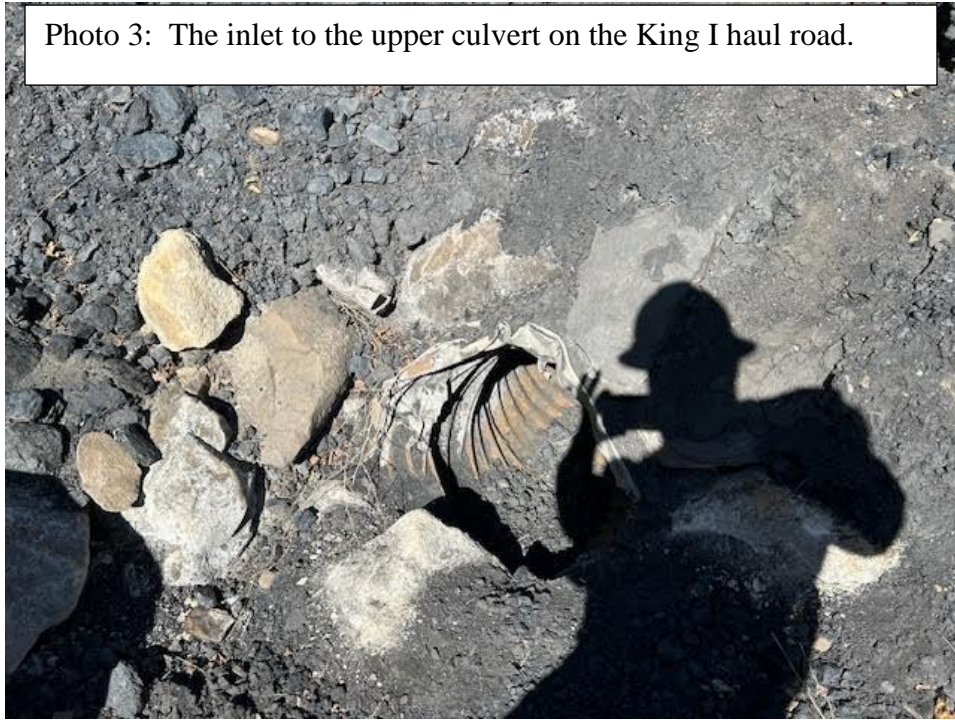
Culverts along the haul road from the lower refuse disposal area (LRDA) and the upper refuse disposal area (URDA) were observed to be clear of debris and stable (Photo 3 and 4). The ditches connecting the culverts were dry and stable. No obstructions or erosional features were identified.

Photo 3: The inlet to the upper culvert on the King I haul road.

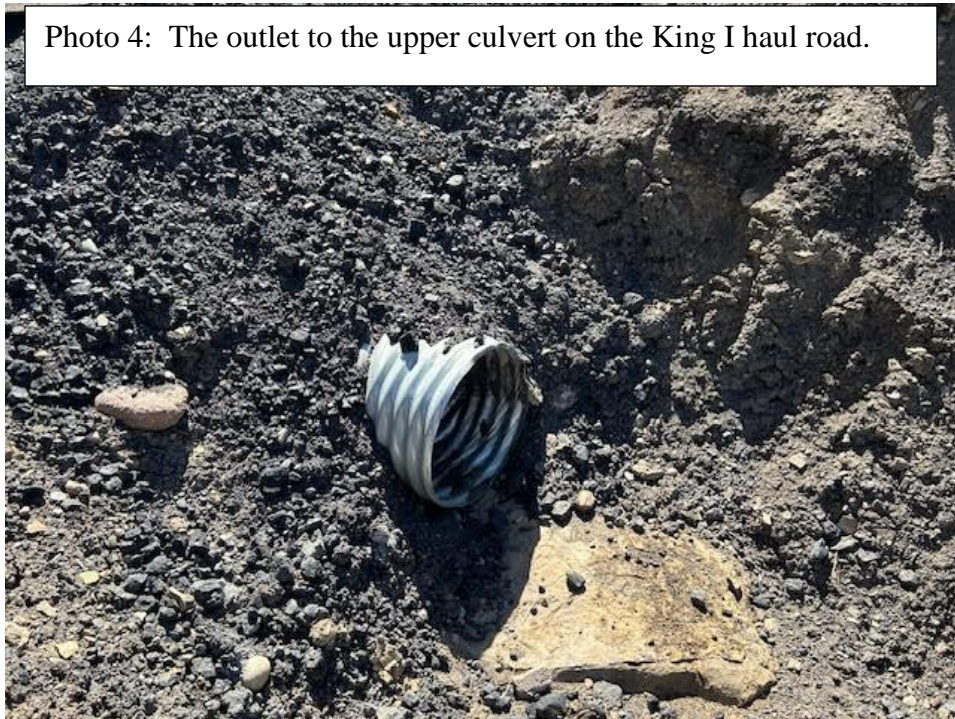
Photo 4: The outlet to the upper culvert on the King I haul road.

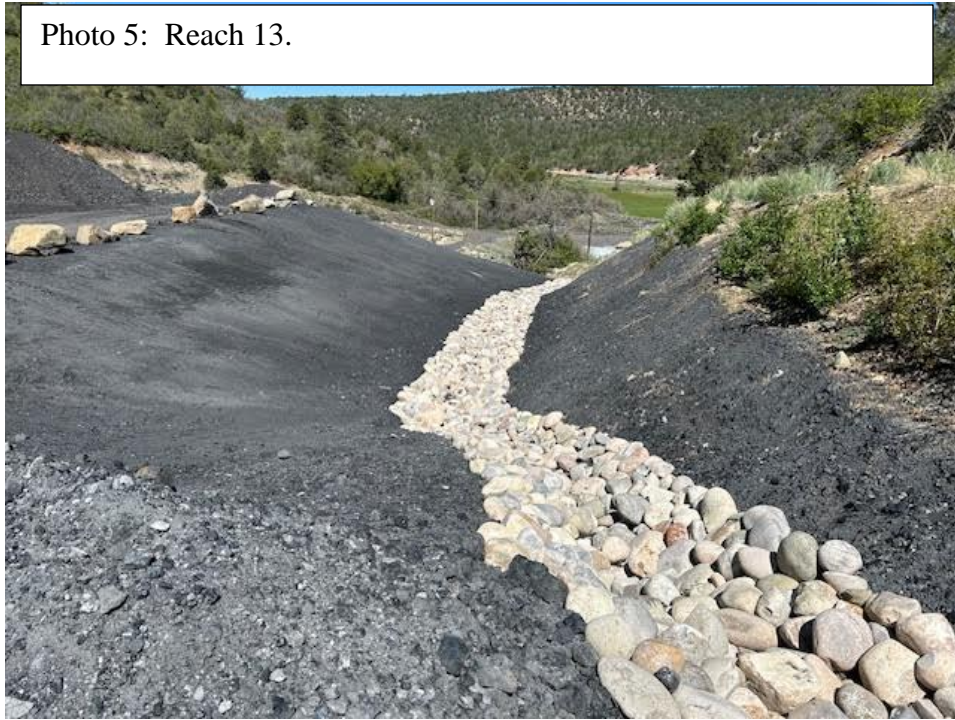
Photo 5: Reach 13.

Reach 13 transports runoff down the east side of the refuse disposal area from above the LRDA down to be collected in the sediment ponds. Reach 13 was dry and stable. The riprap section along the slope adjacent to the LRDA was in good condition (Photo 5). No blockages or erosional concerns were observed.

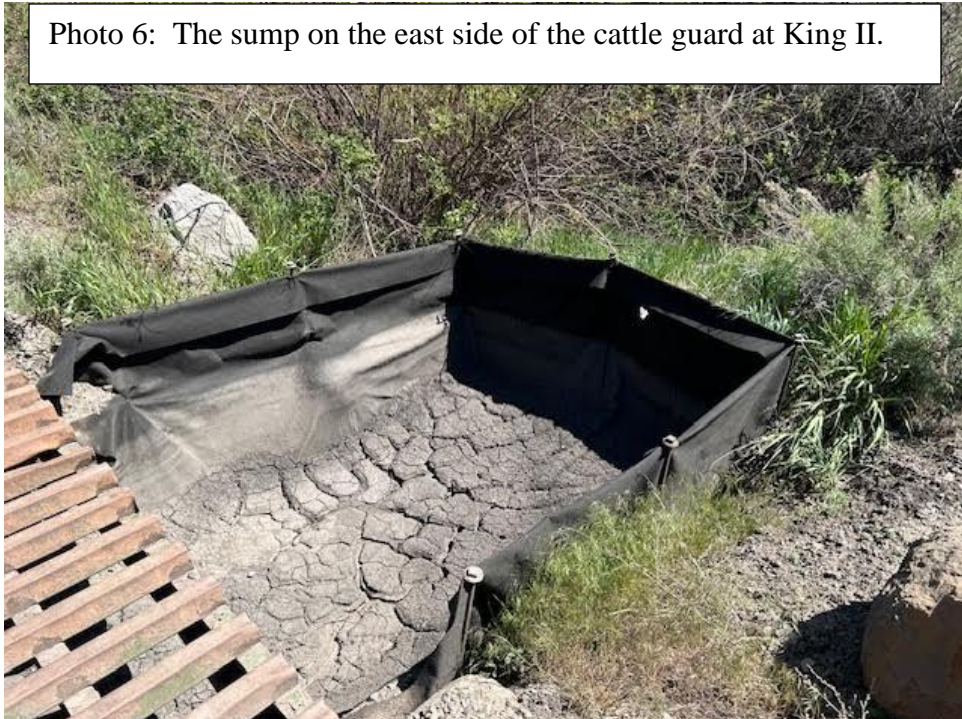
At the entrance to the King II Mine there is a sump on the east side of the cattle guard (Photo 6). The sump was dry during the inspection. The silt fence was in good condition and no off site impacts were observed. The ditch paralleling the haul road was clear of debris and stable. There were no erosional features observed.

Photo 6: The sump on the east side of the cattle guard at King II.

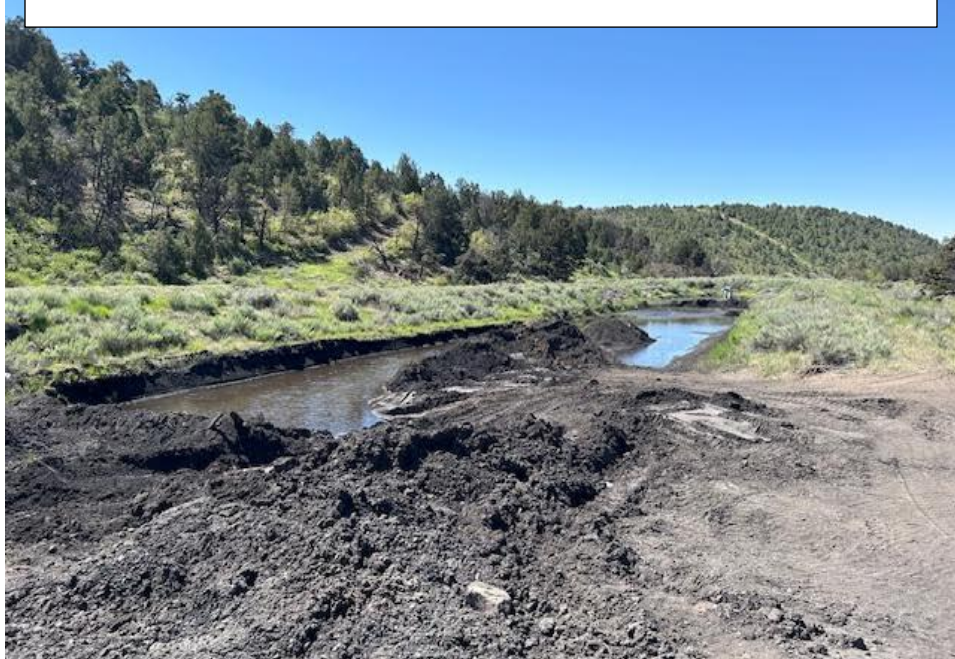
The sediment pond for the King II mine was receiving a small amount of water during the inspection (Photo 7). The Pond was impounding water below the level of the discharge outlet. The outlet was observed to be unobstructed. The pond's embankments were stable with vegetative cover. There were no erosional concerns identified. Material within the pond is organized to be cleaned when conditions allow. Currently the bottom of the pond is too soft for equipment to access the material. At the inlet to the pond, a couple of large pieces of sheet metal had fallen off the bench into the ditch (Photo 8). The operator sent the Division photos of the material removed from the ditch before the end of the day on May 30th (Photo 9).

Photo 7: The sediment pond at King II.

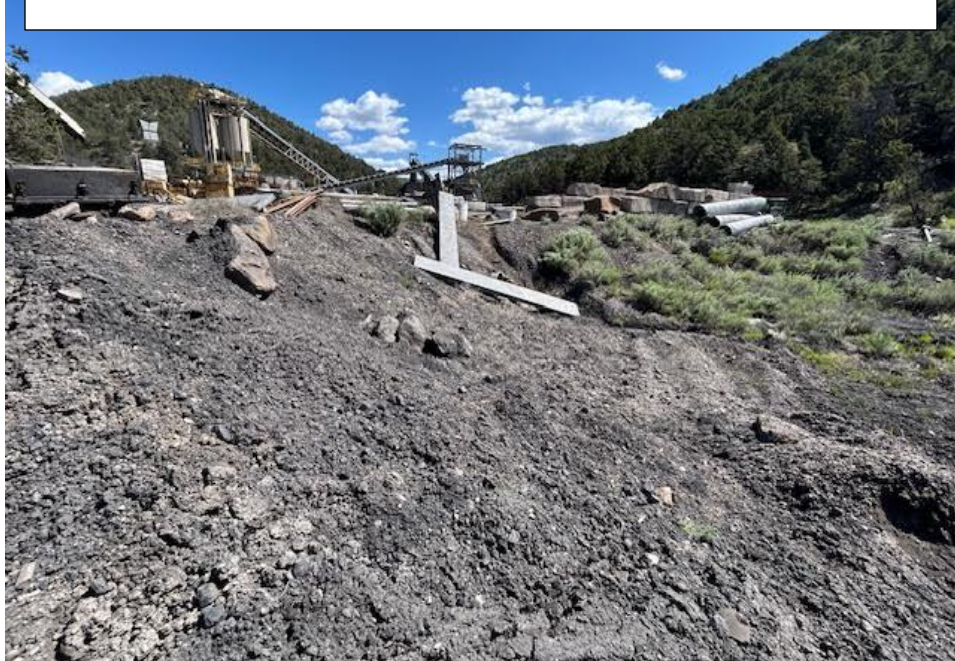
Photo 8: The sheet metal observed in the sediment pond's inlet.

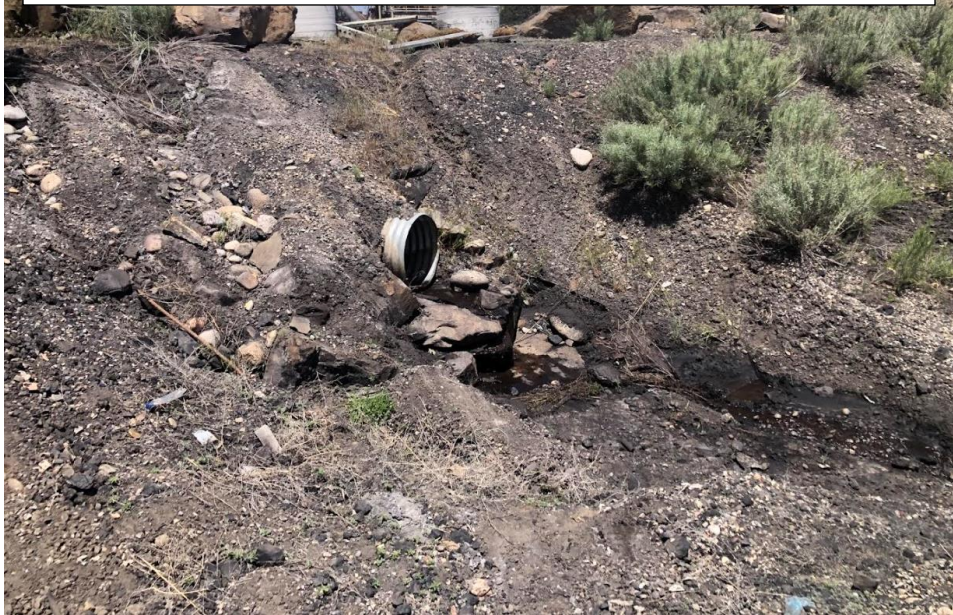
Photo 9: The cleaned inlet to the sediment pond (operator Provided Photo).

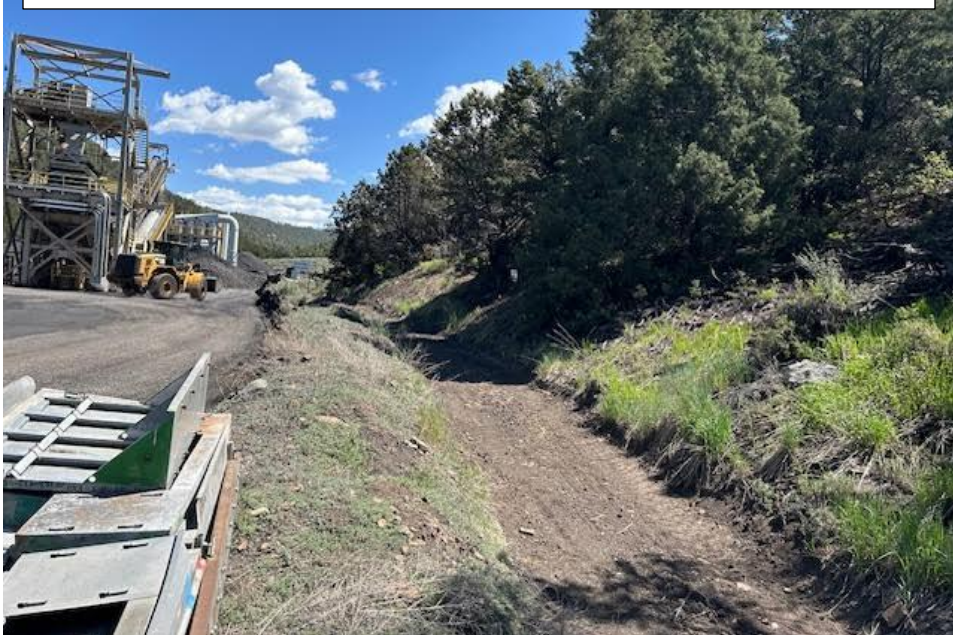
The eastern (Photo 10) and western clearwater diversion ditches were dry. The ditches were stable with no erosion.

Photo 10: The eastern Clearwater ditch at King II.

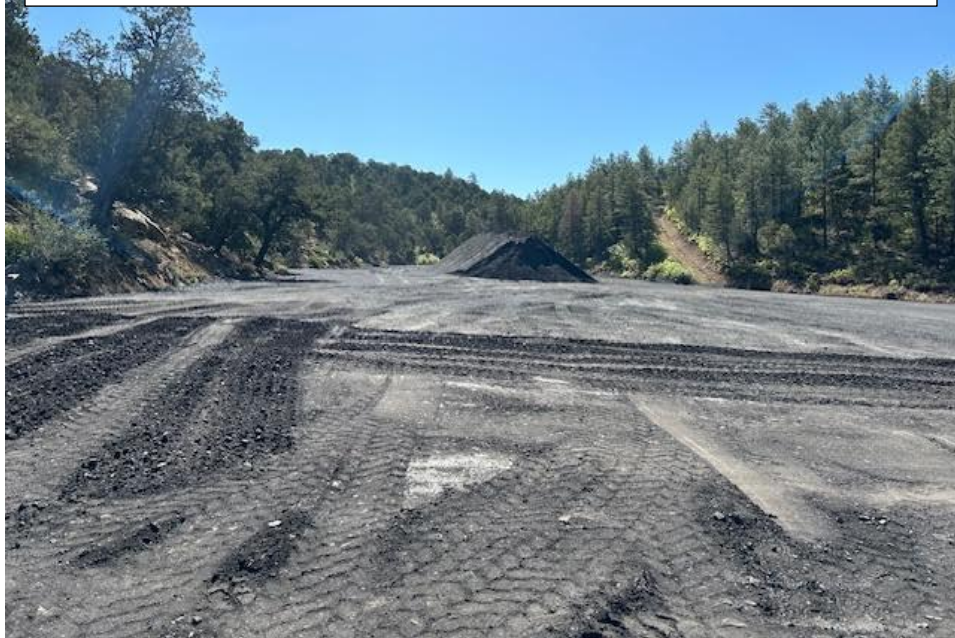
The refuse from the King II Mine is hauled to the King I Mine where an upper and lower refuse disposal area are used to store the material. The URDA was stable with no erosional features observed. A stockpile of refuse material was placed towards the southern end of the pile (Photo 11). Material had been spread and compacted at the north end of the pile. The operator will continue to take refuse material from this stockpile and spread and compact it on the URDA. The face of the URDA was stable with no erosional features.

Photo 11: The top of the URDA.

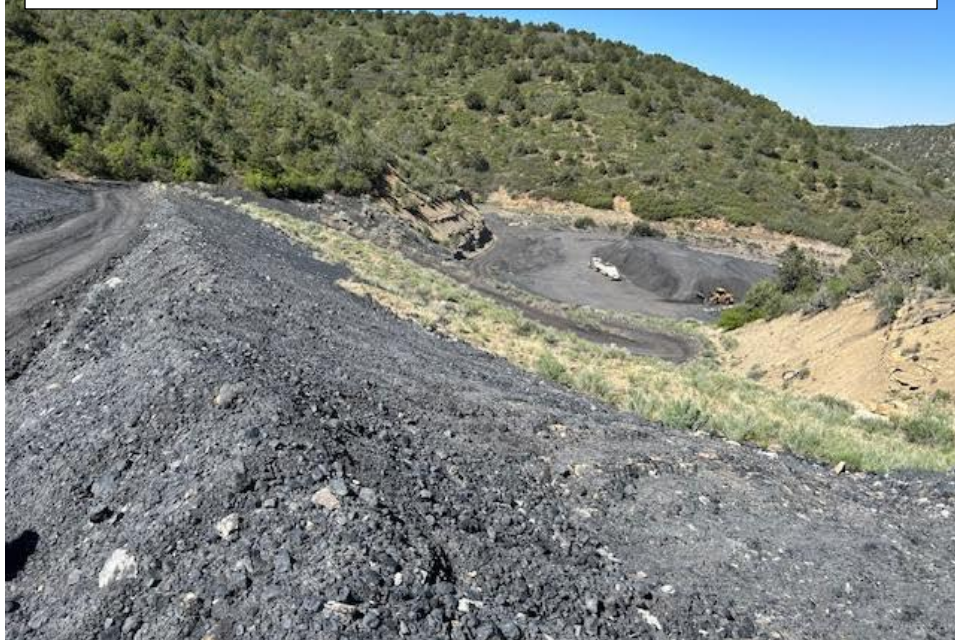
The LRDA was being used at the time of the inspection to stockpile refuse material (Photo 12). The top of the pile was stable and had no erosional features. The face of the refuse pile was observed to be stable. There were no erosional features identified.

Photo 12: Looking down at the LRDA from the URDA.

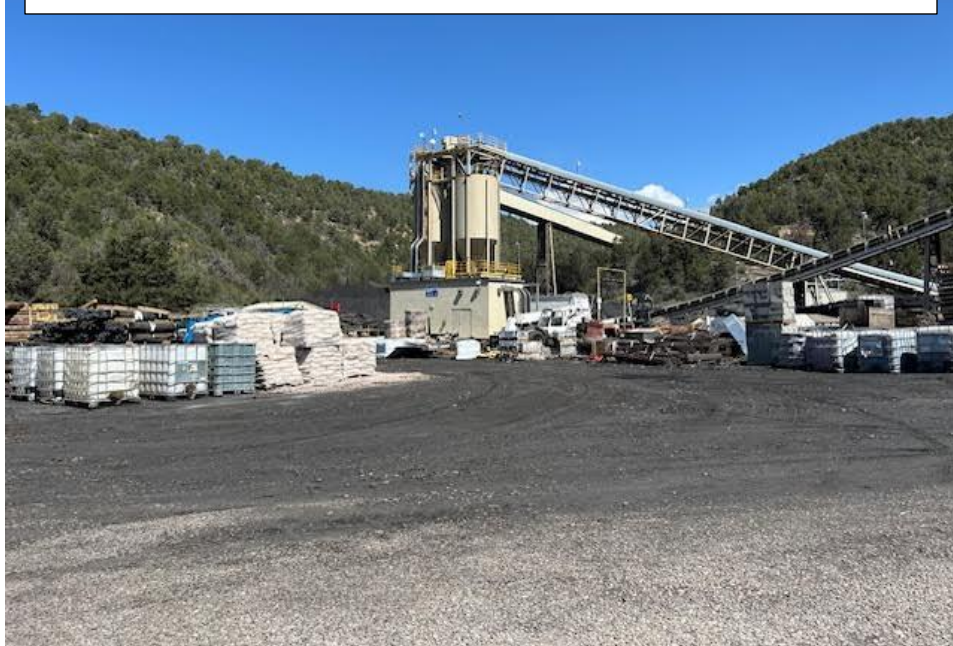
The Material laydown area at the King II Mine was well kept. Materials were contained within the bench and there were no identified off site impacts (Photo 13). Coal stockpiles throughout the facilities area were contained to their respective pads. No off site impacts were observed.

Photo 13: Materials laydown area at King II.

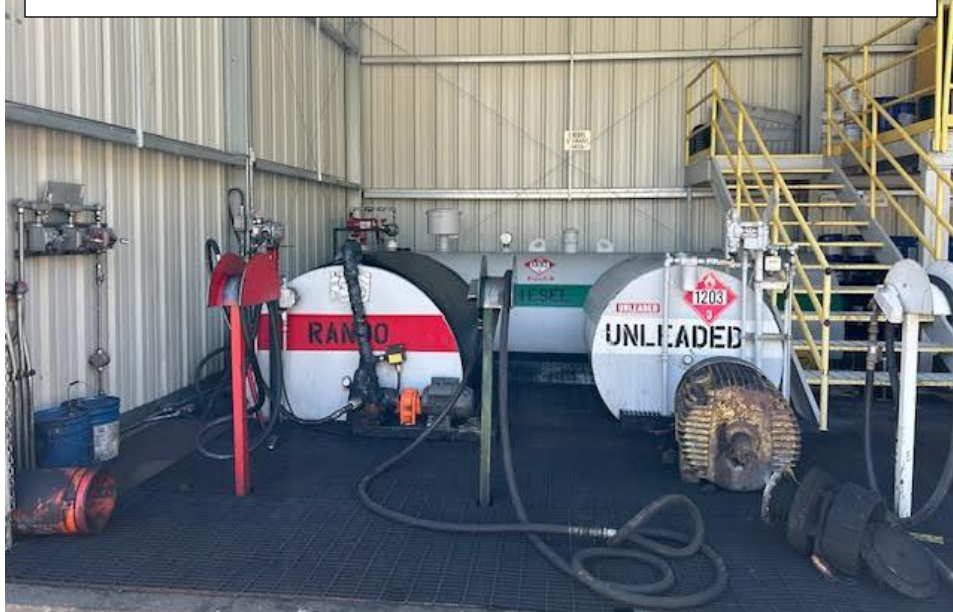
The hydrocarbons were all stored in the shed and placed within the secondary containment structure (Photo 14). There were no spills or liquids stored improperly.

Photo 14: Fuel tanks stored within the hydrocarbons secondary containment structure.

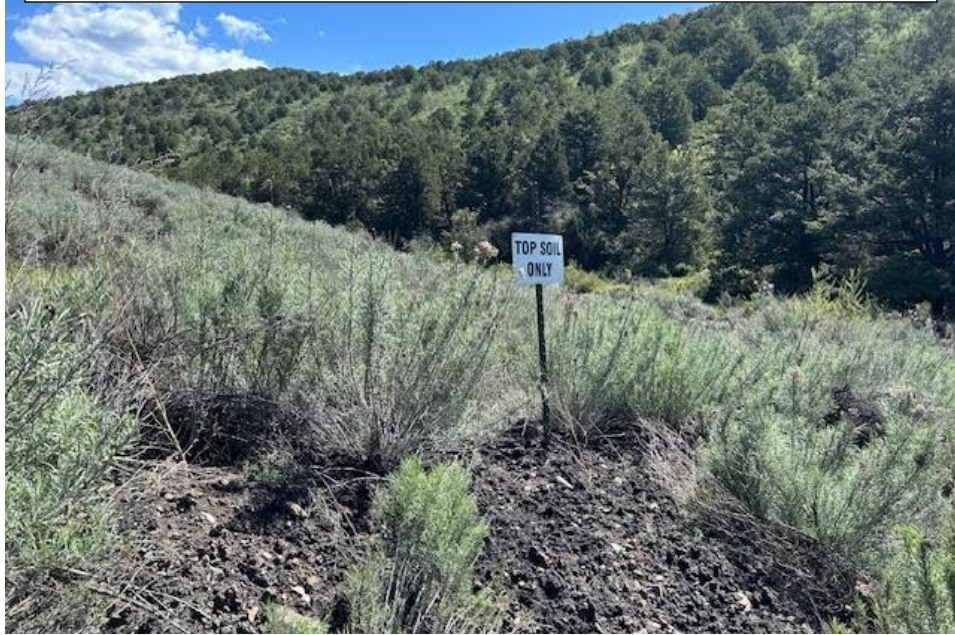
Topsoil pile markers were observed to be posted on all topsoil stockpiles at the King I and King II mines (Photo 15). The stockpiles were stable and covered with vegetation. There were no erosional features observed. Perimeter ditches for the stockpiles were stable and unobstructed. There were no erosional concerns identified. No loss of topsoil resource was observed.

Photo 15: The main topsoil pile marker at King II.
