## Inspection Report, Colowyo, C-1981-019

<b>Permit Number:</b> C-1981-019 <b>Mine Name:</b> Colowyo Coal Mine <b>Operator:</b> Colowyo Coal Company L.P. <b>Operator Address:</b> Mr Tony Tennyson 5731 State Highway 13 Meeker, CO 81641	<b>County:</b> Moffat, Rio Blanco <b>Operation Type:</b> Surface <b>Permit Status:</b> Active <b>Ownership:</b> Private
	<b>Operator Representative Present:</b>  Tony Tennyson / Tom Fry
<b>Operator Representative Signature: (Field Issuance Only)</b>

<b>Inspection Start Date:</b> June 4, 2024 <b>Inspection Start Time:</b> 11:00 <b>Inspection End Date:</b> June 5, 2024 <b>Inspection End Time:</b> 13:30		<b>Inspection Type:</b> Coal Complete Inspection <b>Inspection Reason:</b> Normal I&E Program <b>Weather:</b> Clear	
<b>Joint Inspection Agency:</b>  None		<b>Joint Inspection Contacts:</b>  	
<b>Post Inspection Agency:</b>  None		<b>Post Inspection Contacts:</b>  	
<b>Inspector(s):</b>  Hunter Ridley	<b>Inspector's Signature:</b>  <i>Hunter Ridley</i>		<b>Signature Date:</b>  June 13, 2024

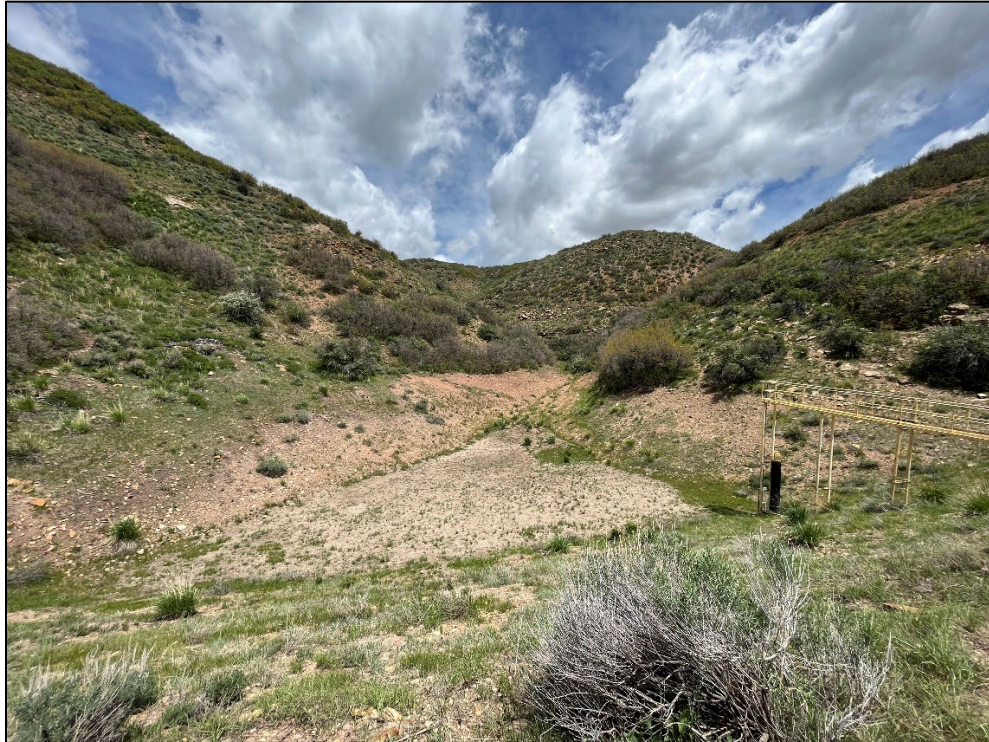
The Streeter Pond, Section 28 Pond, and Prospect Pond, accessible via Hwy 13, were inspected. Streeter and Prospect ponds held water at the time of inspection and all embankments appeared to be stable and vegetated. Section 28 Pond was dry (Photo 1). Streeter and Prospect Ponds are routinely cleaned, the most recent maintenance occurring last year. Section 16 Pond was inspected. No issues were reported.

*Photo 1: View north of Section 28 pond.*

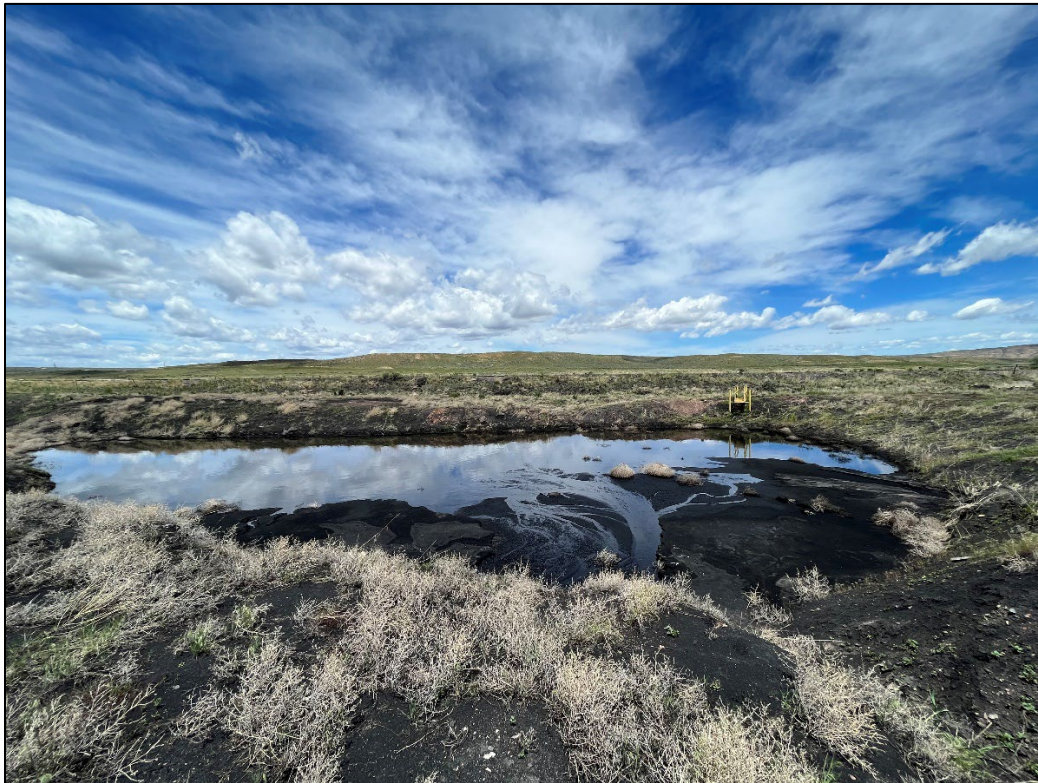
The following Ponds in the Loadout Area were inspection this month: Gossard Pond, Rail Loop Pond, Stoker Siding Pond. No problems or erosional concerns were noted. All ponds were noted to be holding water.

*Photo 2: View north of the Rail Loop Pond.*

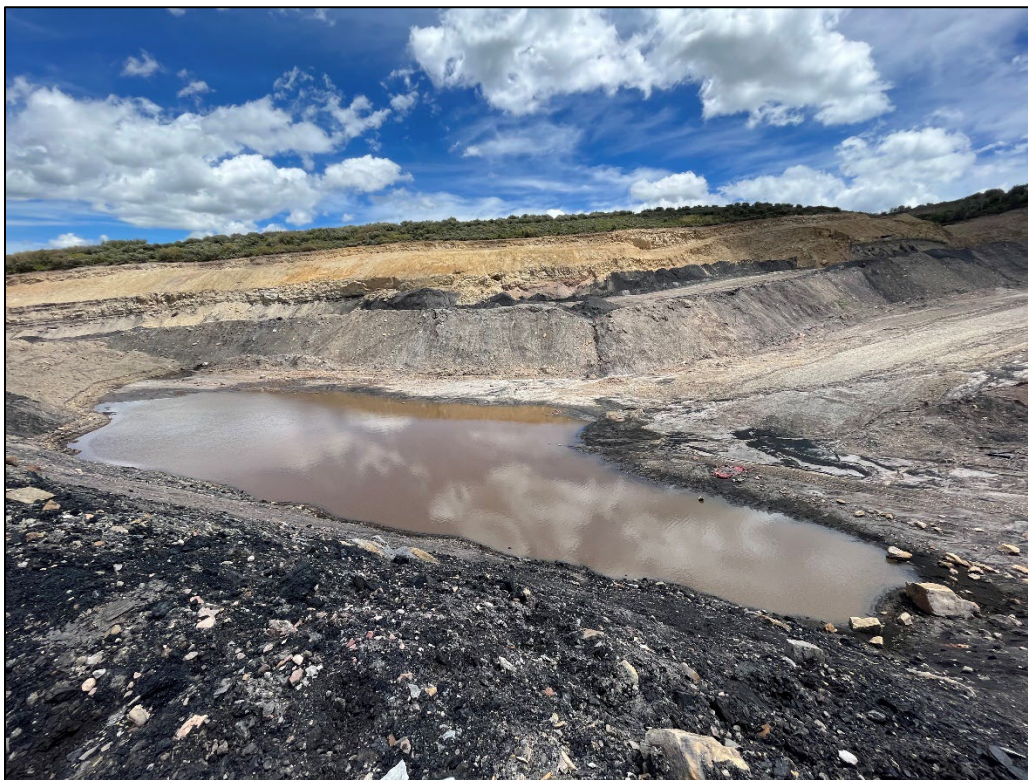
A small area of ponded water was observed during the Division's aerial inspection in May of 2024. The Division observed this area in person during this inspection and confirmed that stormwater water was present in the southern portion of the Collom Pit (Photo 3). However, water levels had reduced since the aerial inspection and was activity infiltrating the ground surface.

*Photo 3: View east on the ponding observed in the southern portion of Collom Pit.*

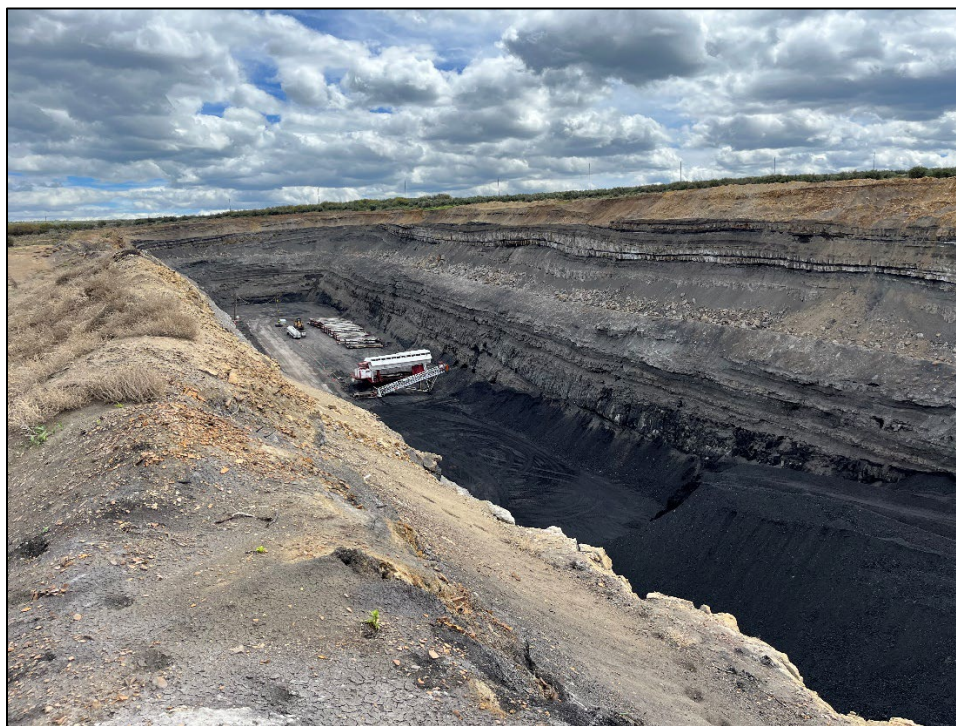
Backfilling has continued in the eastern portion of the Collom Pit to support highwall mining operations (Photo 4). Backfill is used create benches and allow access to upper seams located along the highwall.

*Photo 4: Highwall mining operations have progressed in the east Collom Pit, but were not active at the time of inspection.*

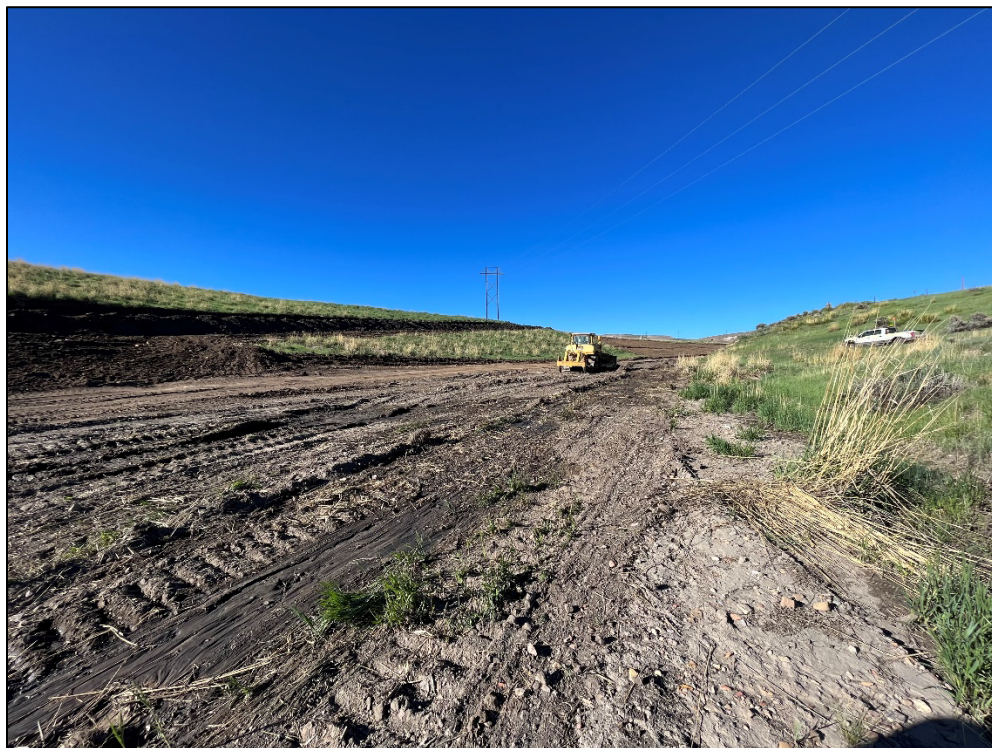
Topsoil stripping work had begun to the north of the Phase III release East Pit area for construction of the Upper and Lower Section 3 Ponds (Photo 5). These ponds were approved in TR-155 and are located within Streeter Ditch directly below the primary crushing facility at Colowyo. The sediment ponds will be used in series with the Lower Section 3 Pond being a non-discharging structure.

*Photo 5: Topsoil stripping has begun for Upper and Lower Section 3 Ponds.*

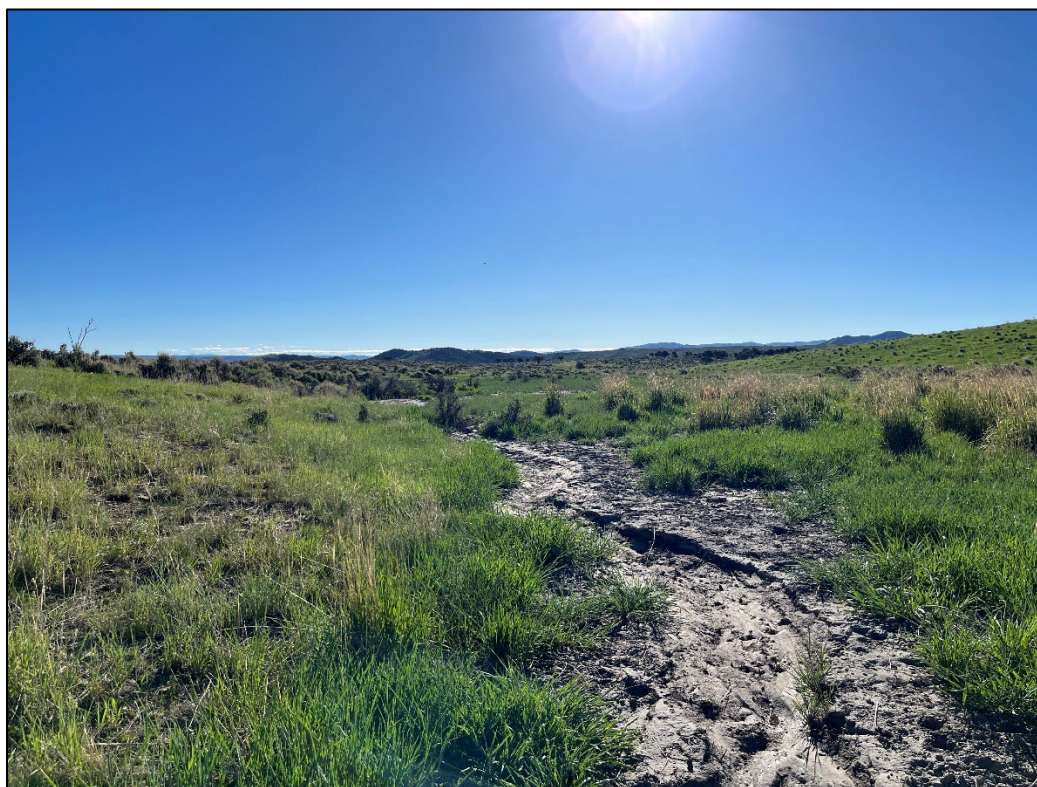
The following ditches in the East Pit were observed during the inspection: Streeter Ditch (Photo 6), Section 15 Ditch, and the Final East Pit Ditch. Streeter Ditch was walked nearly in its entirety, the steep, easternmost portion being observed from above (Photo 13). The ditch was mostly dry and showed no issues. South Side Ditch was also observed from Streeter Ditch and had no issues.

*Photo 6: View east of the top of Streeter Ditch.*

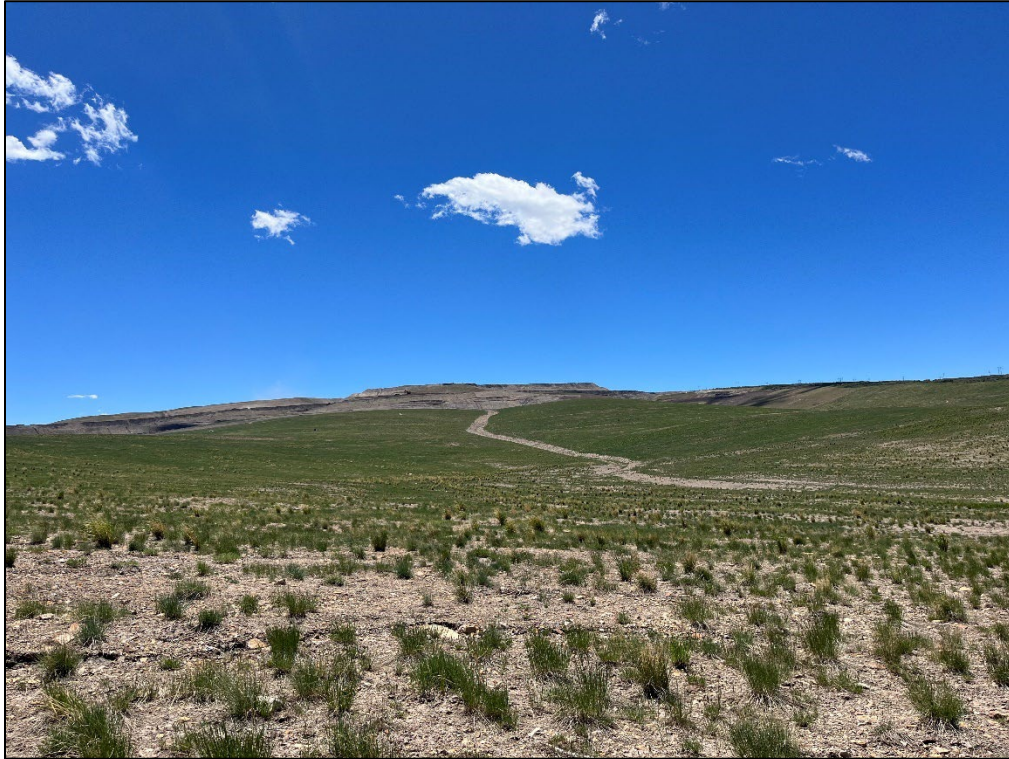
Additional backfill work in the West Pit has been minimal, though the pit is near completion in terms of backfill operations. Final reclamation of this area will be some of the last reclamation done on site at Colowyo. Other areas of the West Pit have been both backfilled and reclaimed. The Division inspected these areas and found vegetation to be mature and stable (Photos 7 and 8).

*Photo 7: View southwest of West Pit reclamation and the Taylor Ditch.*

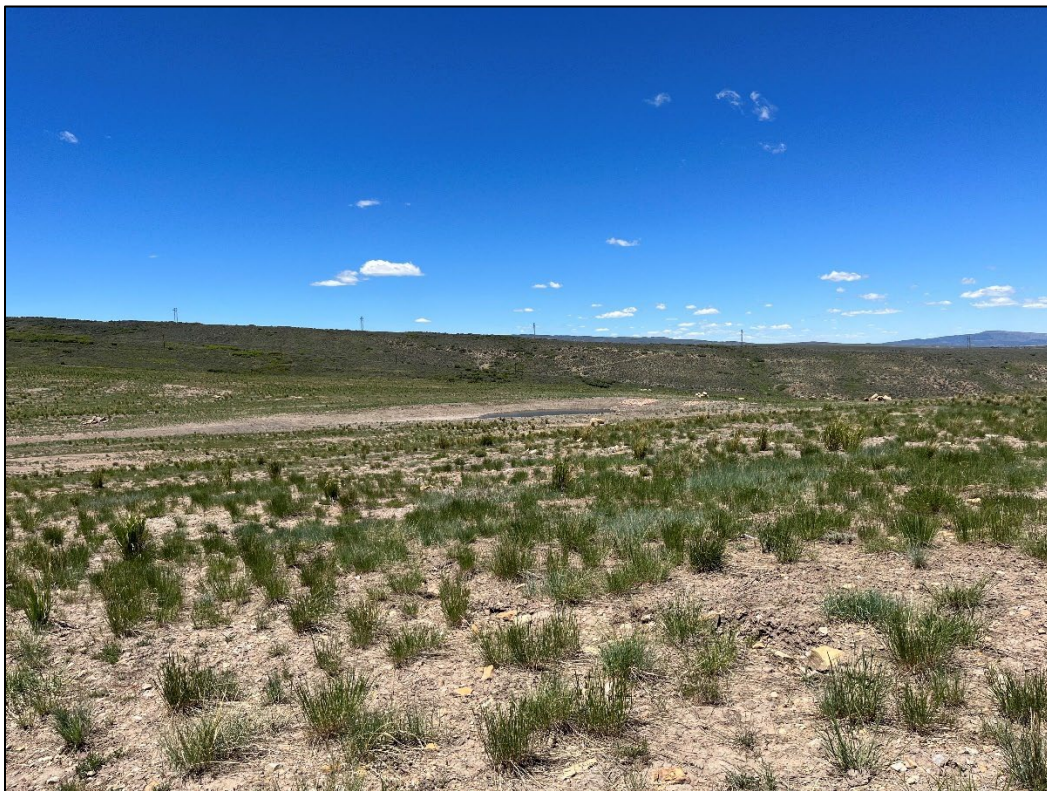
The following Ponds in the West Pit area were inspected this month: East Taylor Pond and West Pit Pond. Both ponds were holding water and were stable. East Taylor Pond was discharging at the time of inspection (Photo 9). The ETD1 stock pond was also inspected, which was holding a small amount of water (Photo 8). No issues were observed.

*Photo 8: View northwest of West Pit reclamation areas, ETDI is visible.*

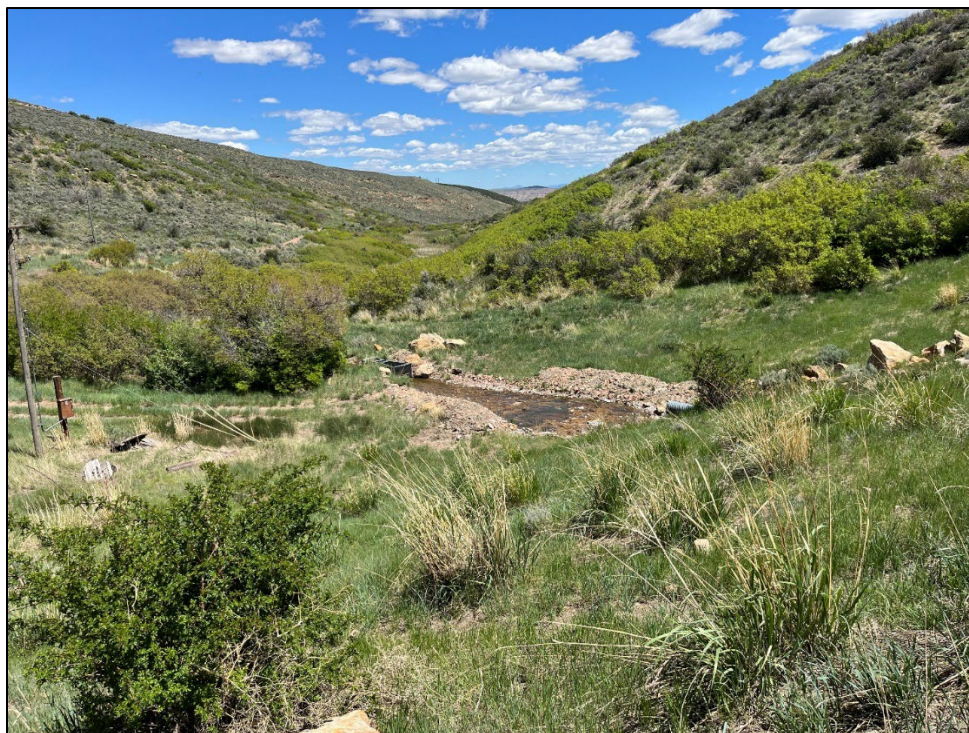
*Photo 9: View north of the discharge point for East Taylor Pond.*

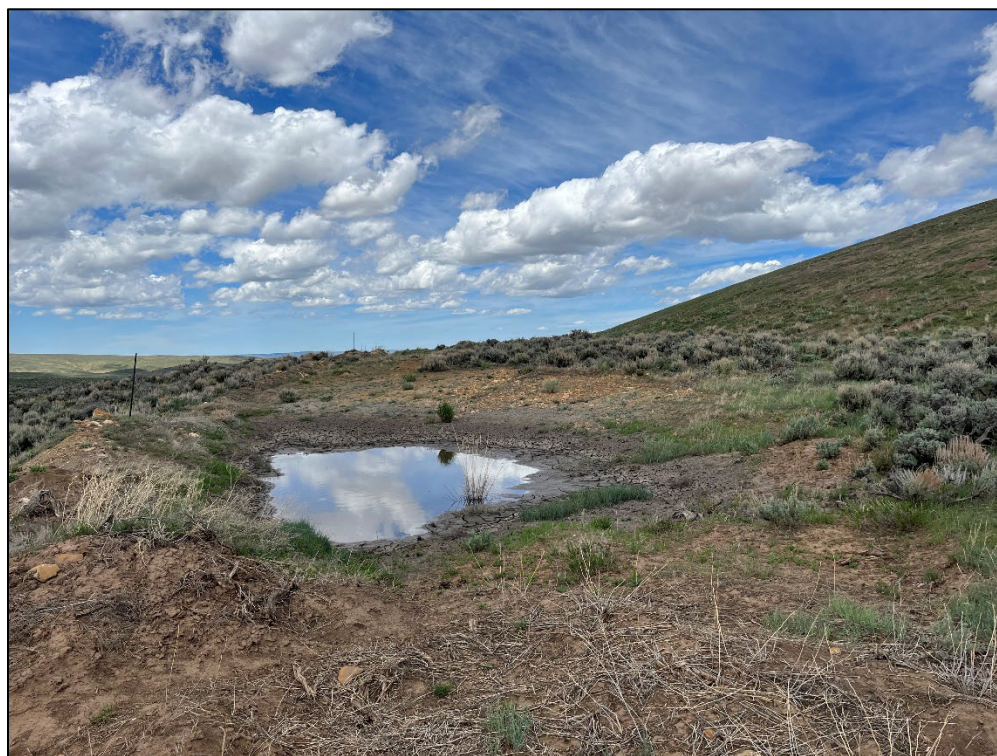
Topsoil piles across the site contained appropriate markers. The topsoil pile behind Section 26 Pond will need to be shaped and seeded when conditions allow (Photo 15). Mr. Fry stated that the most recent activity on this pile was around Fall of 2023. He also indicated that mature vegetation growth around the base of the topsoil pile allows for the specialty silt fence which is in place to be removed if the site wishes to do so. The sump which collects runoff from this northern Collom topsoil pile was inspected and found to be functioning properly and holding a small amount of water (Photo 10).

*Photo 10: View north of the sump located at the toe of the northern Collom topsoil pile.*

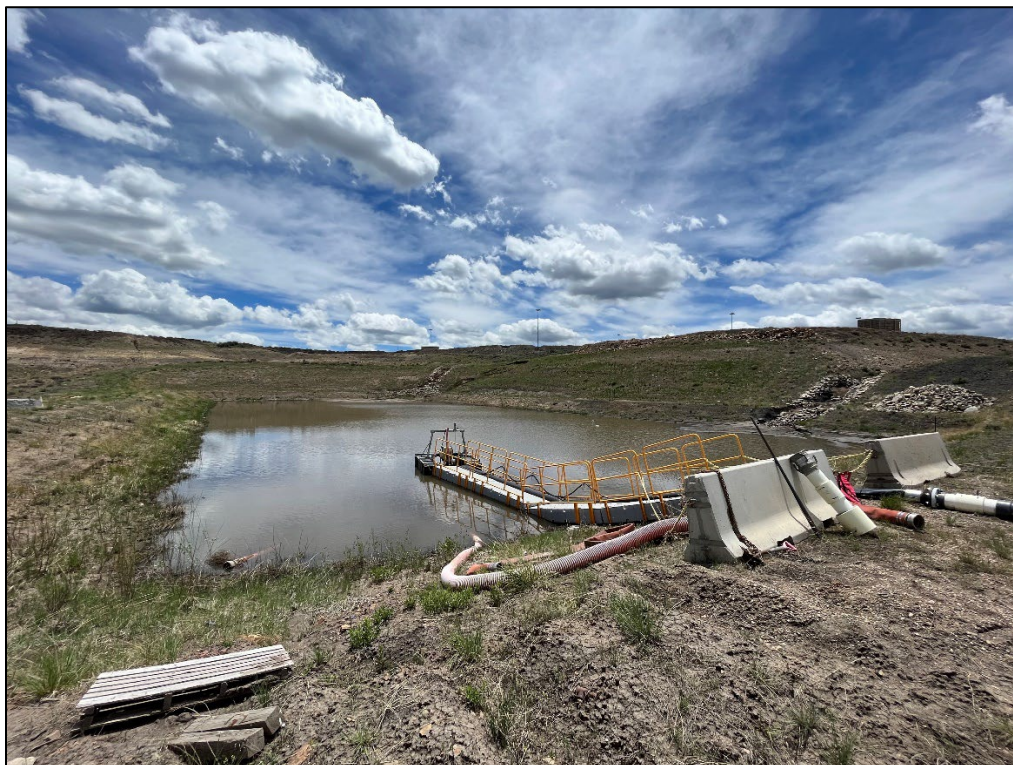
The following Ponds in the Collom Pit area were inspected this month: Section 36 Pond, Sidehill Pond, Middle Pond, Section 25 Pond, Coal Stockpile Pond (Photo 11), and Section 26 Pond (Photo 12). No outstanding problems were noted at any of the ponds. Discharge points remain clear of blockages.

*Photo 11: View of the Coal Stockpile Pond in Collom Pit.*

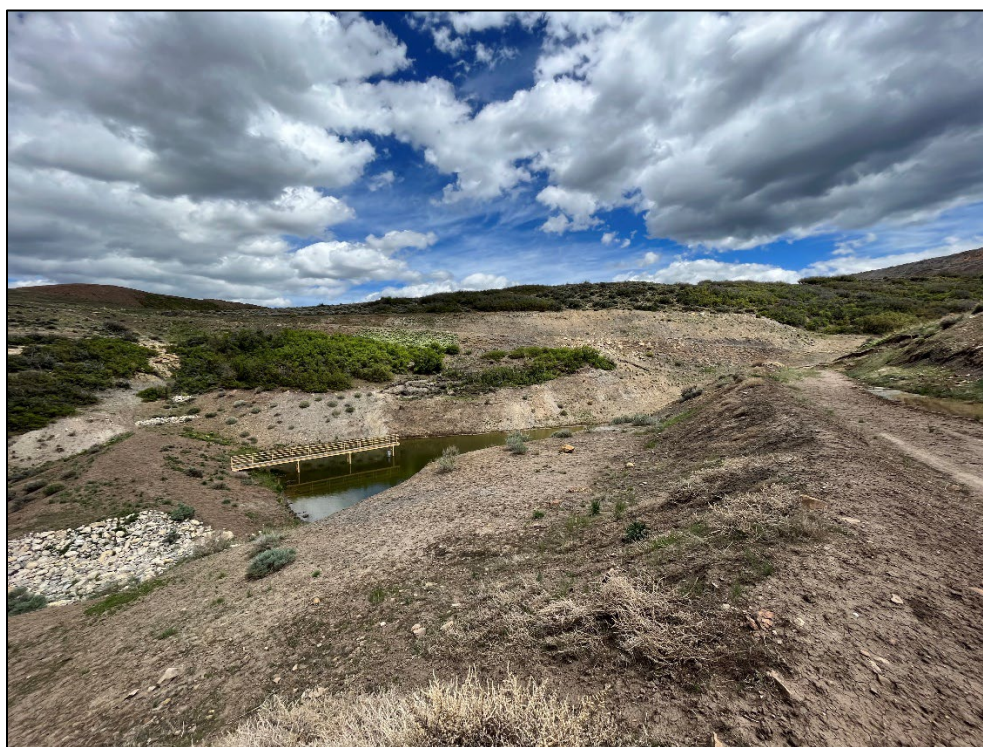
Mr. Fry stated that the slump area on the east side of Section 26 Pond has experienced slight movement in the past year but remains stable. The slump area on the southwest side has not moved in recent years and has not impacted the road below. This slump is likely due to a natural seep located on the southwest side of Section 26 Pond. Colowyo should continue to monitor this area closely for exaggerated signs of movement or degradation.

*Photo 12: View east of Section 26 Pond.*

- Monitor the slump area at Section 26 Pond
- Regrade and seed the topsoil pile in the northern section of Collom Pit when conditions allow
- Monitor the small erosional feature in D4, repairs will be necessary if conditions worsen

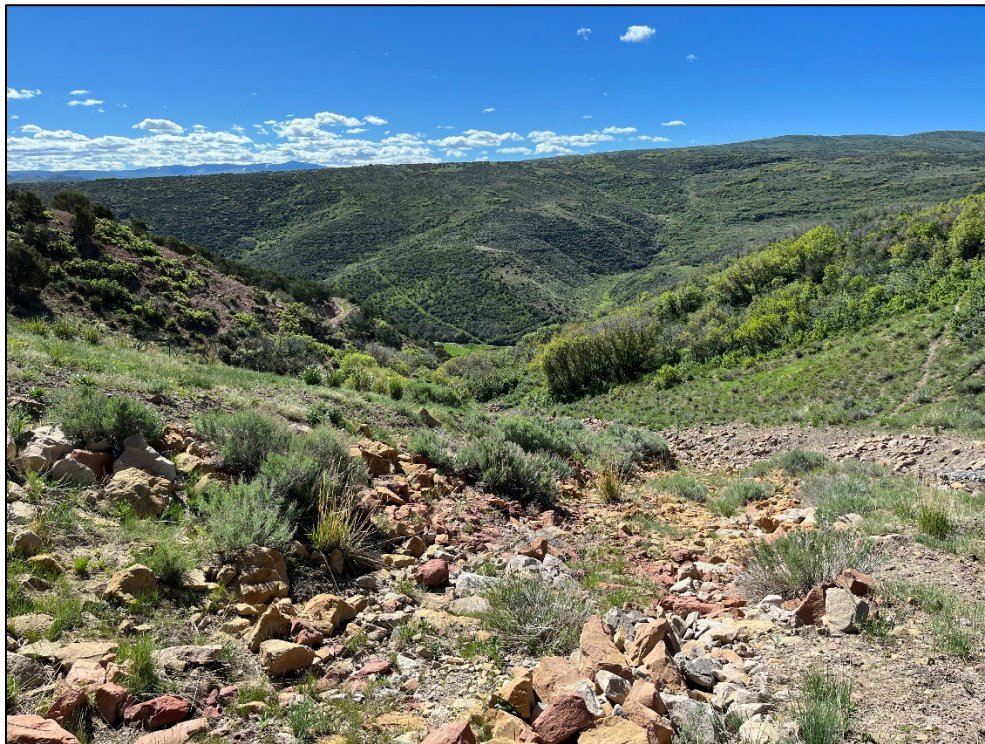
*Photo 13: View east of the steep portion of Streete Ditch, South Collection Ditch is visible to the north.*

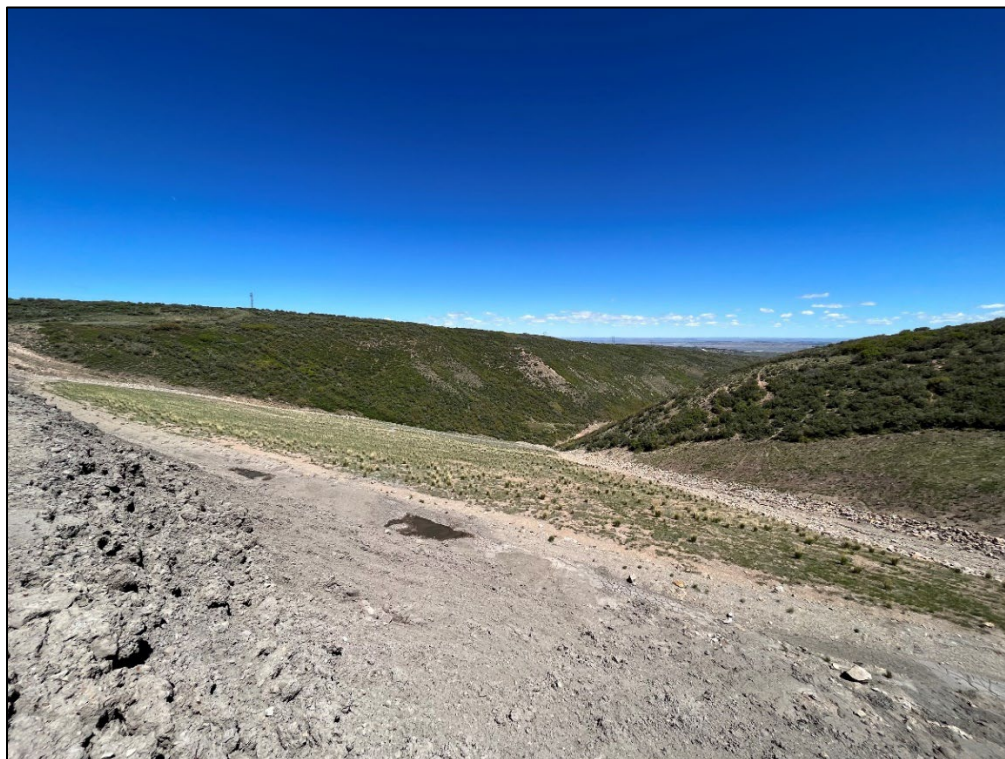
The West Taylor Valley Fill area was inspected (Photo 14). No signs of erosional issues were noted. The face is well covered with vegetation, a majority of this being made up of thick sagebrush habitat. Water which flows through the fill's undrain eventually flows to the West Taylor Pond.

*Photo14: View north of the West Taylor Valley Fill.*

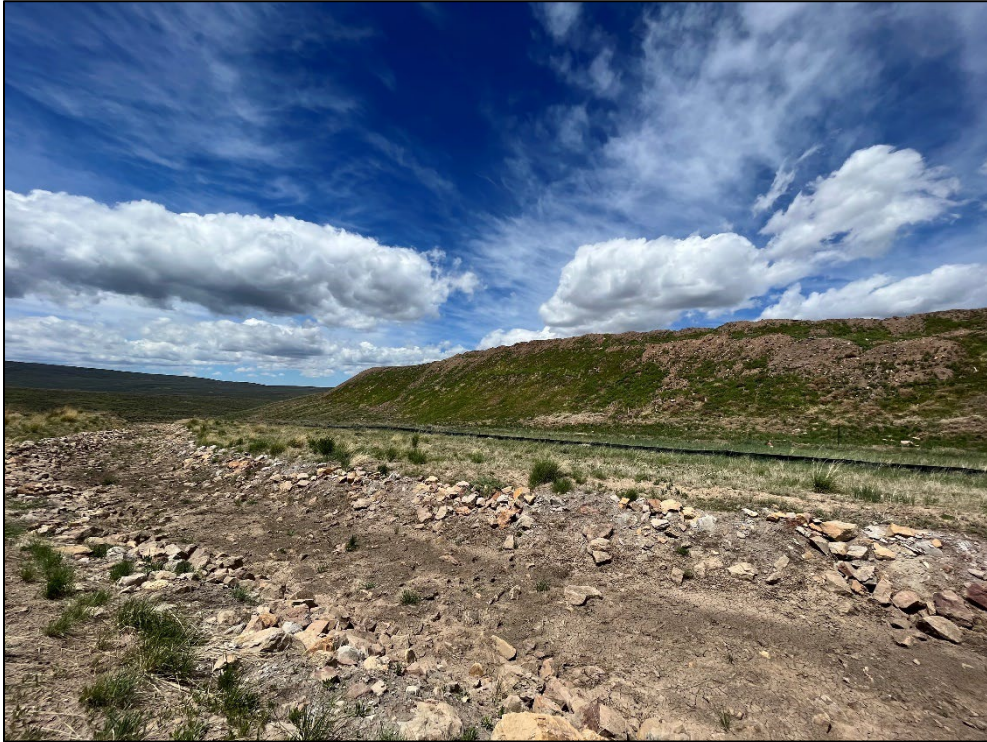
*Photo 15: View north of the Collom topsoil pile and D-2.*

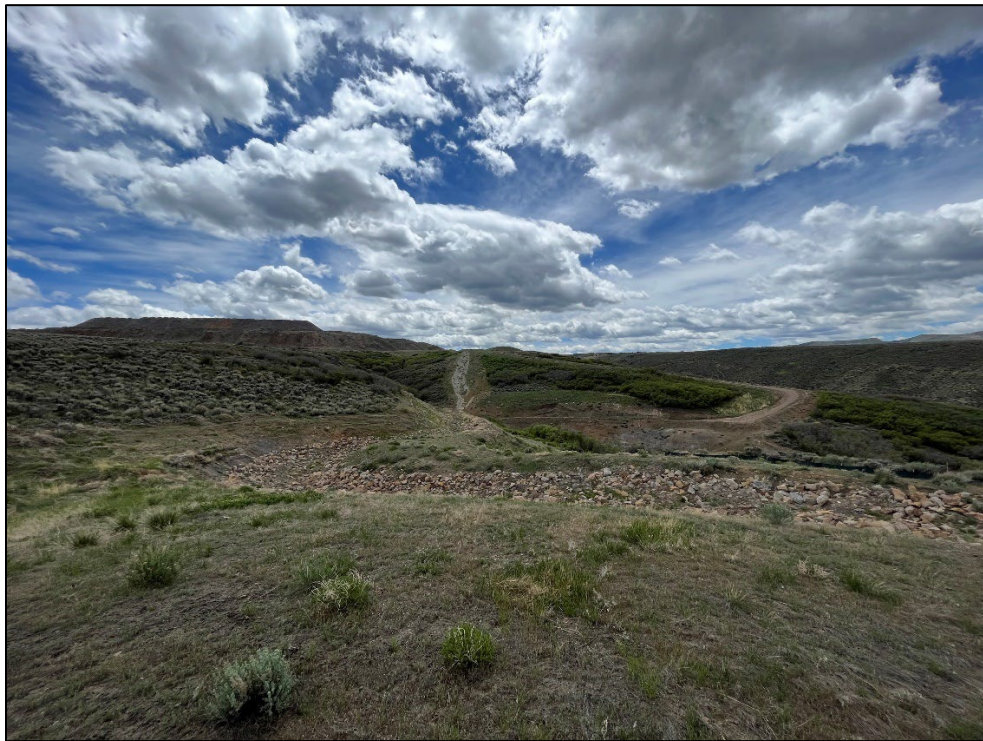
accessible. All channels appeared to be stable and functioning properly with no signs of major erosion or slides.

*Photo 16: View southwest of D-1.*

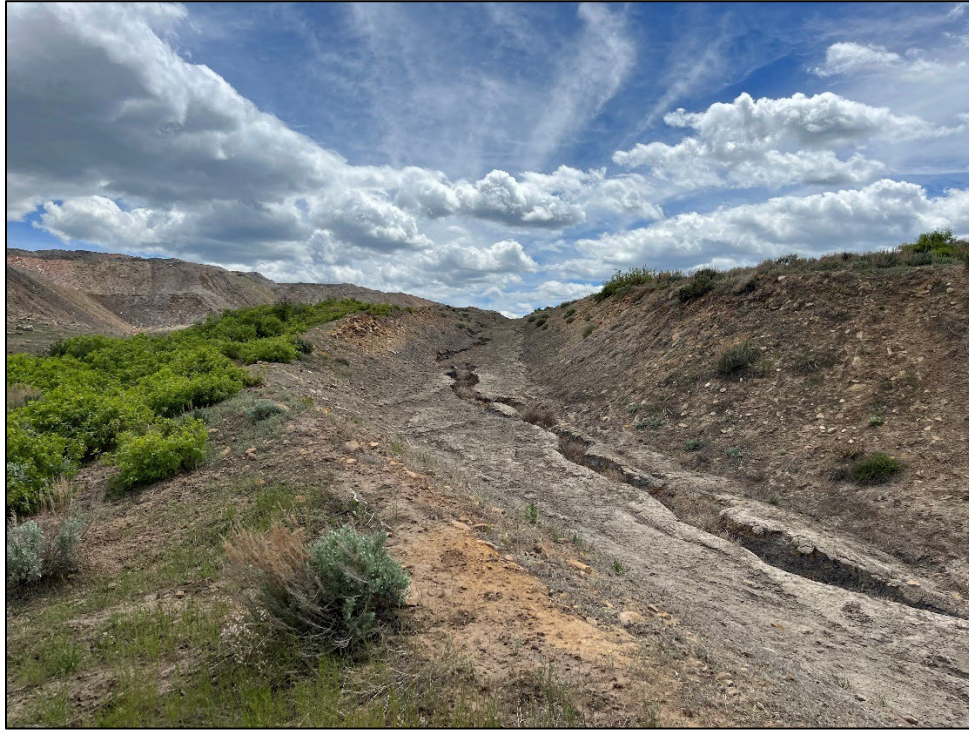
*Photo 17: View south of D-4.*
