C1980007, West Elk Mine, June Inspection Report

PERMIT INFORMATION

Permit Number: C-1980-007 Mine Name: West Elk Mine Operator: Mountain Coal Company, LLC Operator Address: Jessica Wilczek 5174 Highway 133 Somerset, CO 81434	County: Delta, Gunnison Operation Type: Underground Permit Status: Active Ownership: Private
	Operator Representative Present: Chase Hiatt
Operator Representative Signature: (Field Issuance Only)

Inspection Start Date: June 12, 2024 Inspection Start Time: 12:00 Inspection End Date: Inspection End Time:	Inspection Type: Coal Partial Inspection Inspection Reason: Normal I&E Program Weather: Clear
Joint Inspection Agency: None	Joint Inspection Contacts:
Post Inspection Agency: None	Post Inspection Contacts:
Inspector(s): Leigh Simmons	Inspector's Signature:

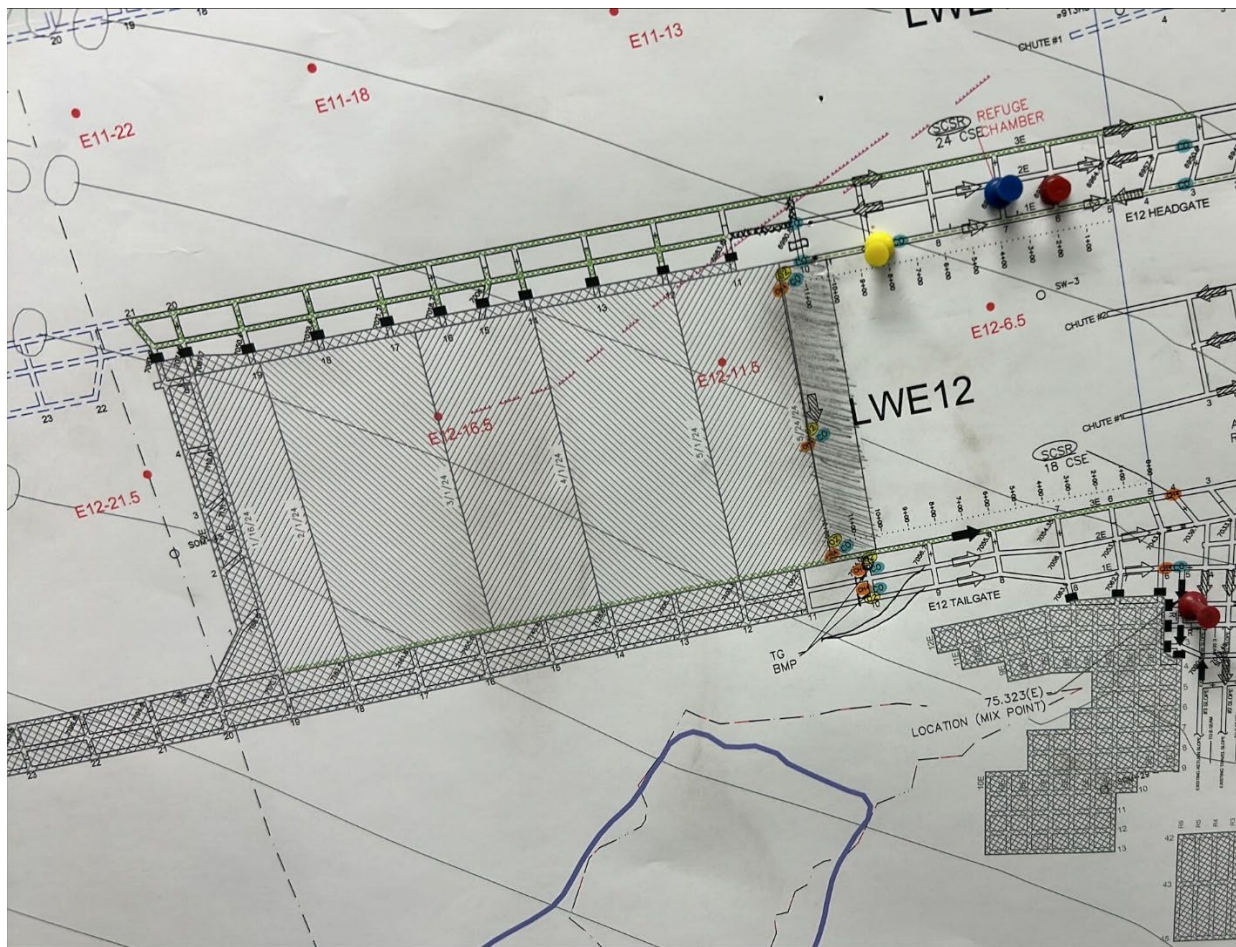
Longwall mining of the LWE12 panel was in progress, between crosscuts 10 and 9 on the headgate.

Figure 1: Mine map showing longwall progress in LWE12

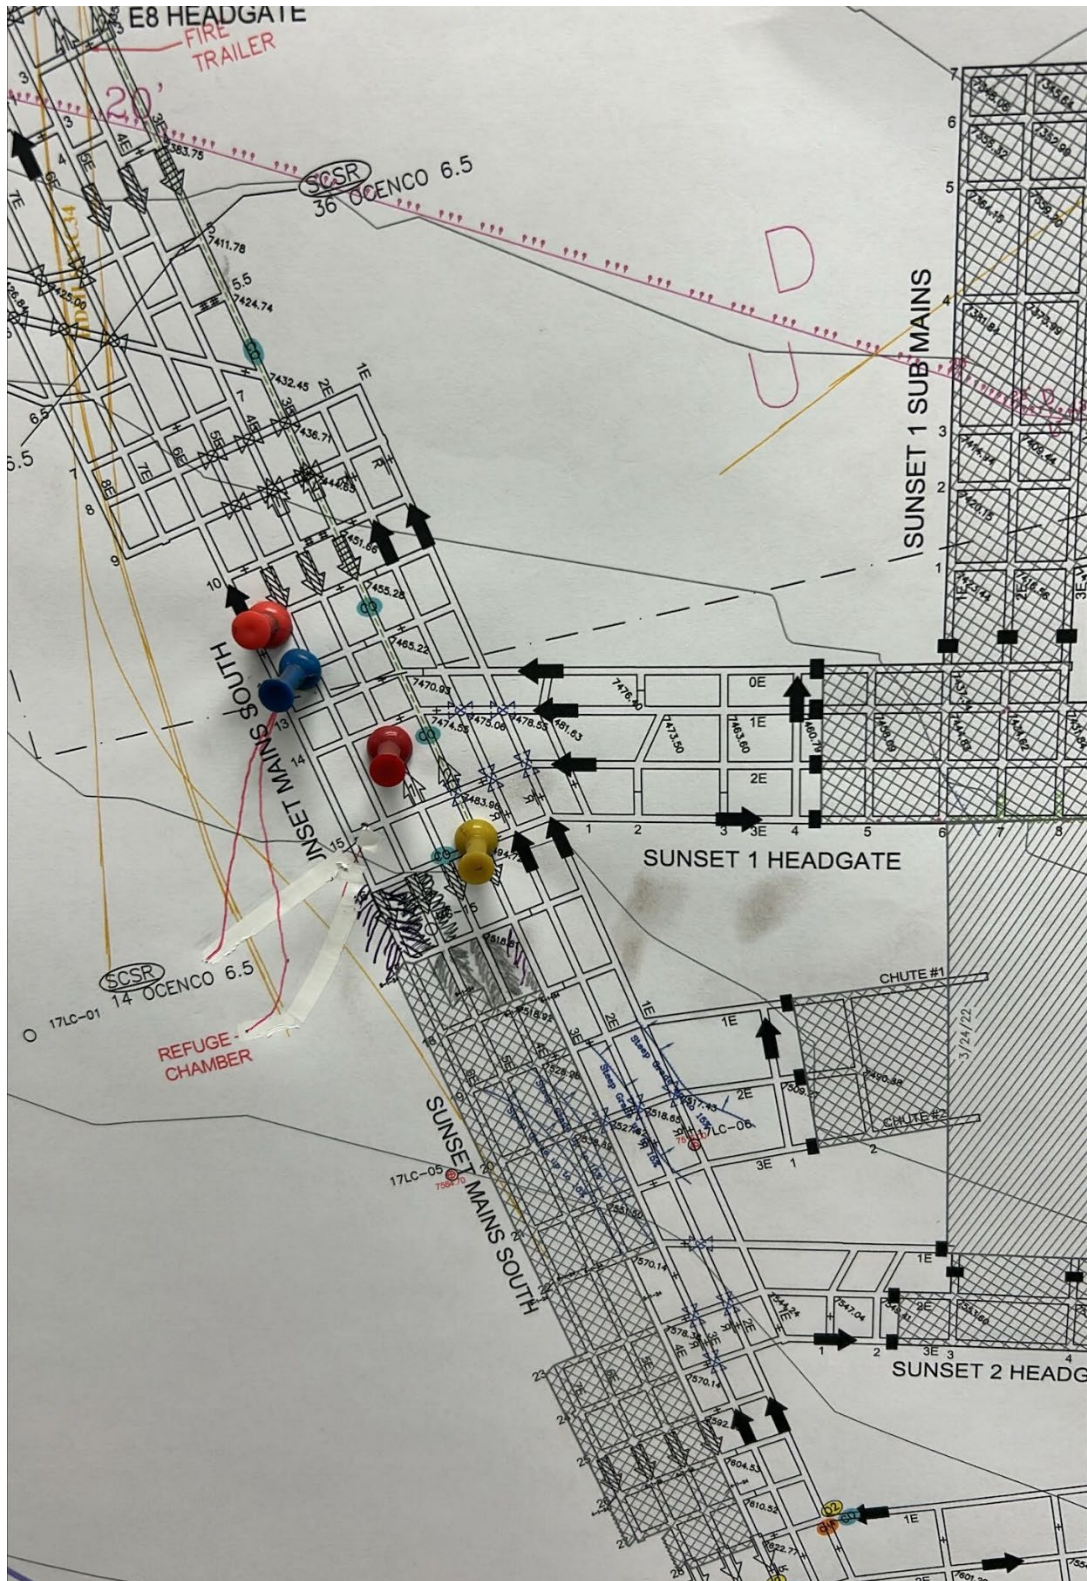
Pillaring of the Sunset Mains South was in progress, at around crosscut 16. The work was being done by contractors with Phoenix Mining.

Figure 2: Mine map showing pillaring progress in Sunset Mains South

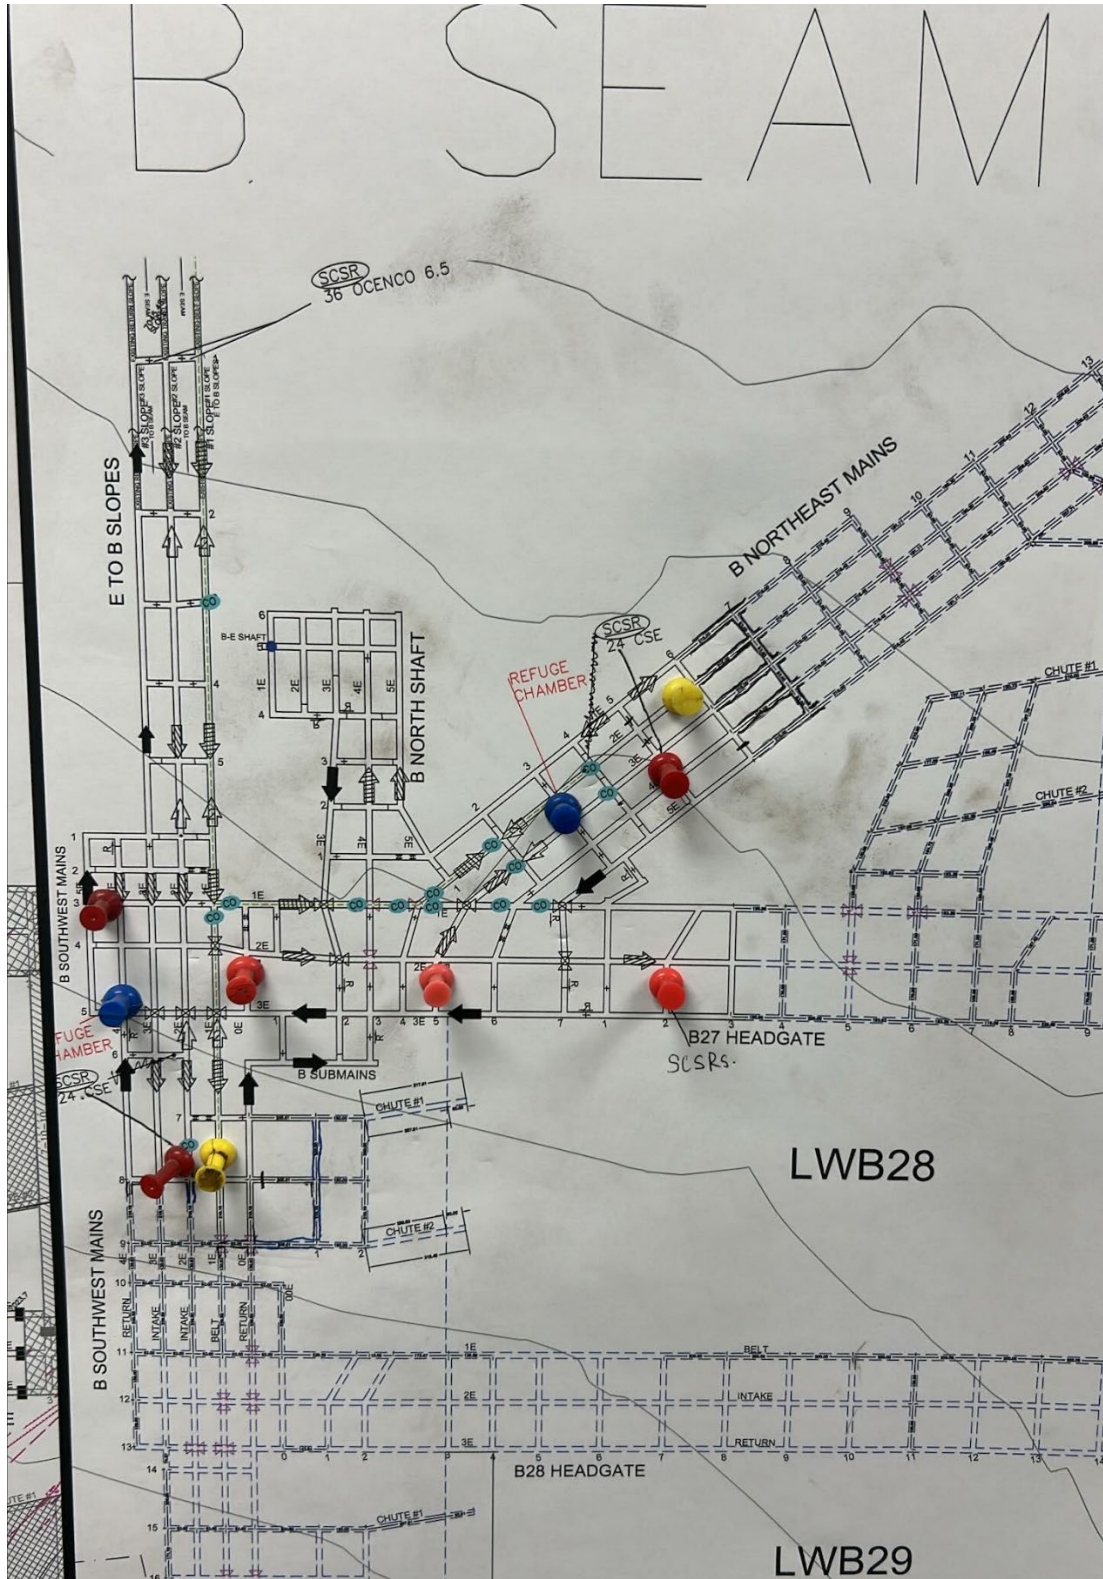
Development work in the B-seam was in progress.

Figure 3: Mine map showing development progress in the B-Seam

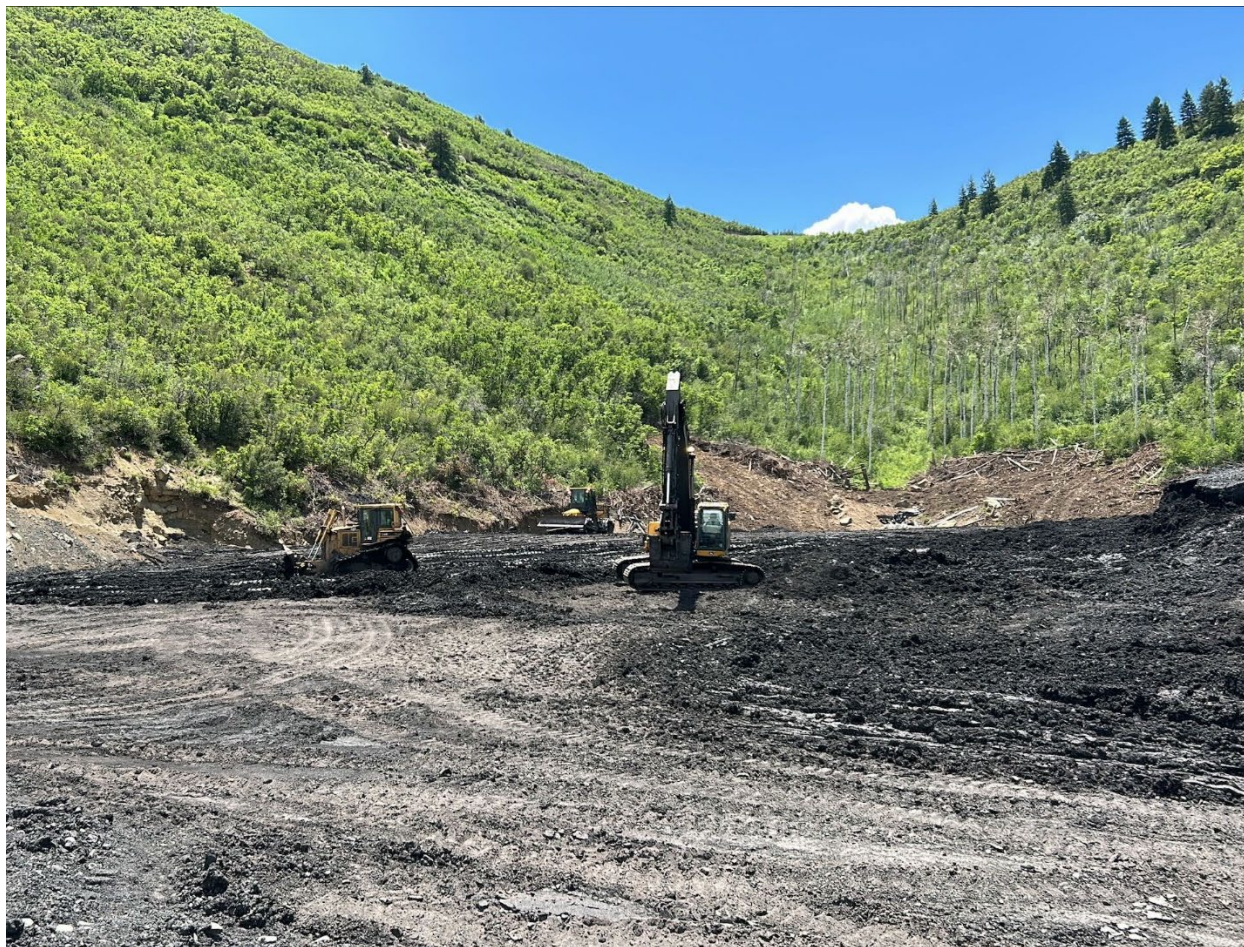
Refuse was being generated at the time of the inspection. New refuse was being temporarily stockpiled on the RPE. No refuse was being transported to the RPEE, but work was in progress on the RPEE to spread, dry and compact material that had been transported before the winter. An excavator was moving material from the west side of the pile to the east, where it was being spread with a dozer, then compacted with a sheep's foot compactor. Until the material already on the RPEE has been compacted it will be difficult to handle new material on the pile.

Figure 4: Excavator, dozer and sheep's foot compactor working on RPEE

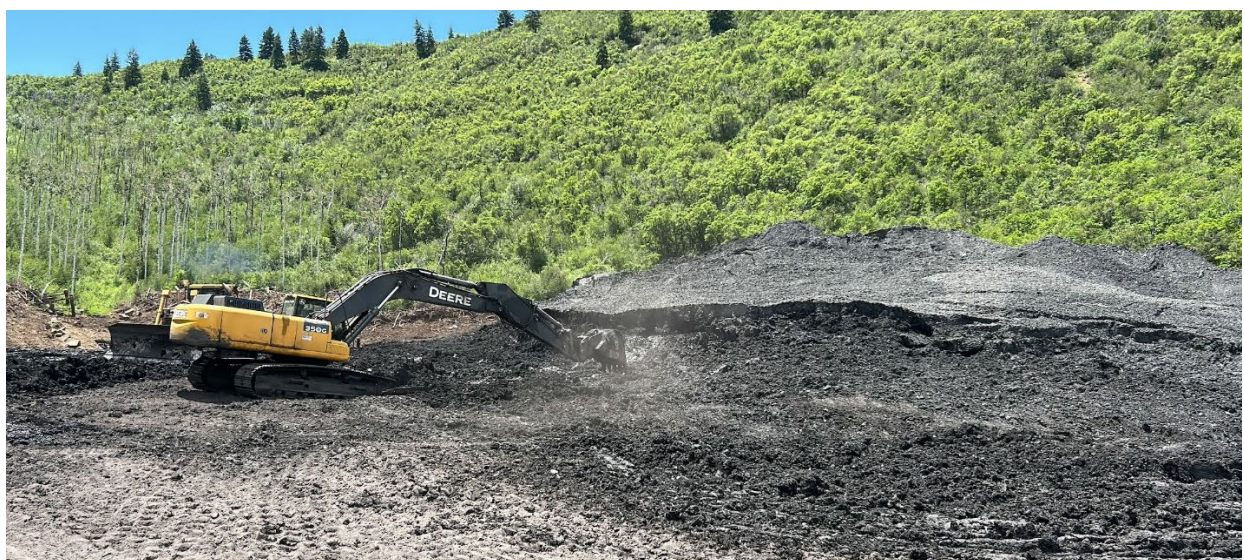
Figure 5: Excavator reaching for wet material on RPEE

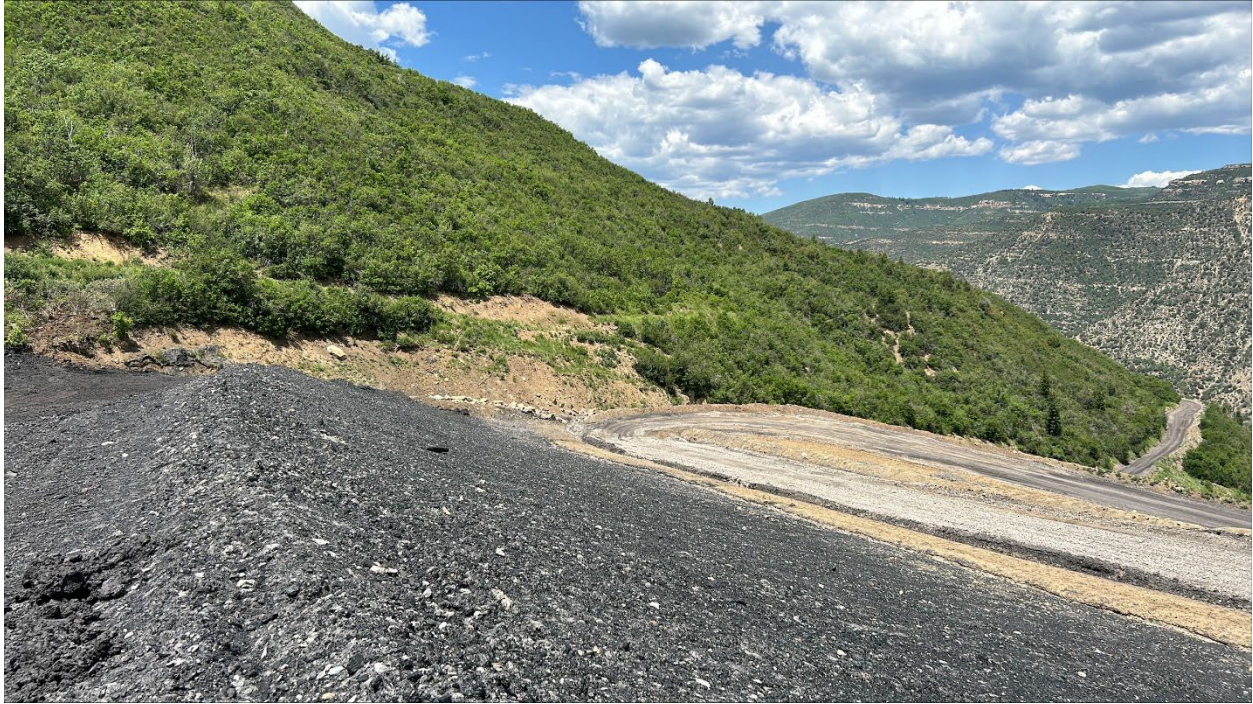
Some soil had recently been spread on graded outcrops of the pile, and beside the road. Some areas of graded outcrop had not yet been covered with soil. It appeared that some topsoil had been stripped to allow the underdrain to be extended, and that the side drain on the western edge of the pile had also been extended.

Figure 6: Graded outslope of RPEE

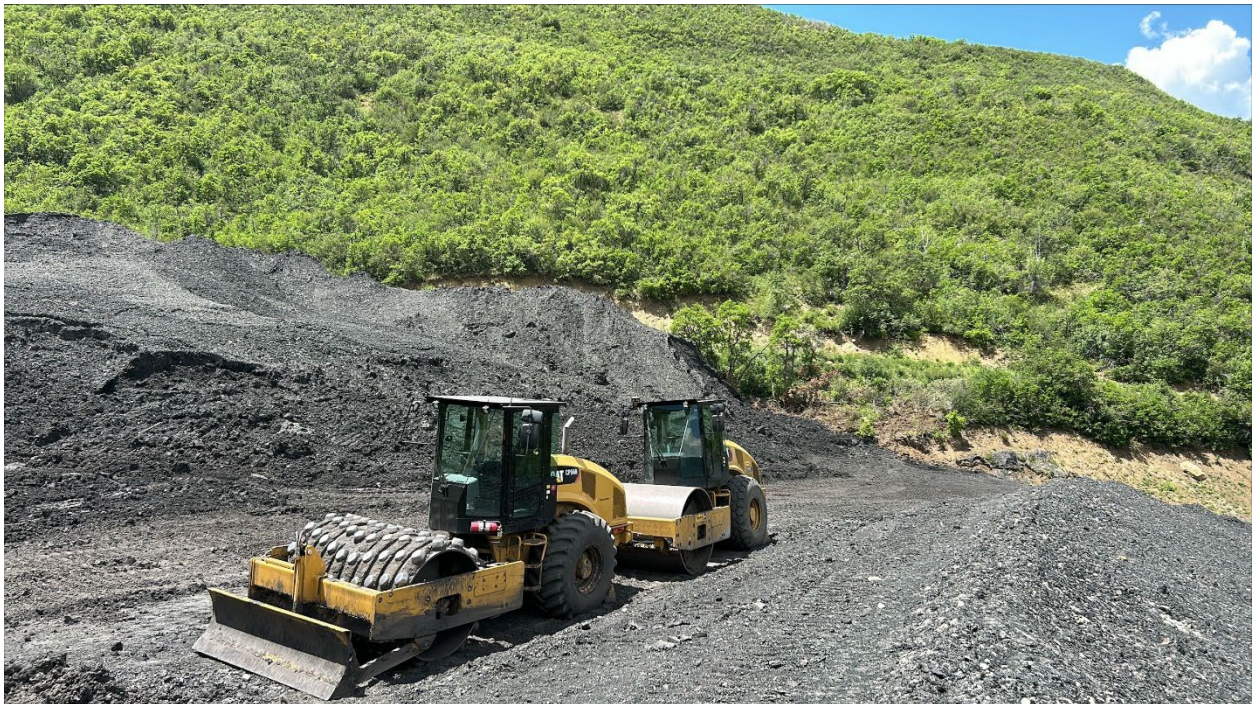
Figure 7: Compaction equipment not in use on RPEE

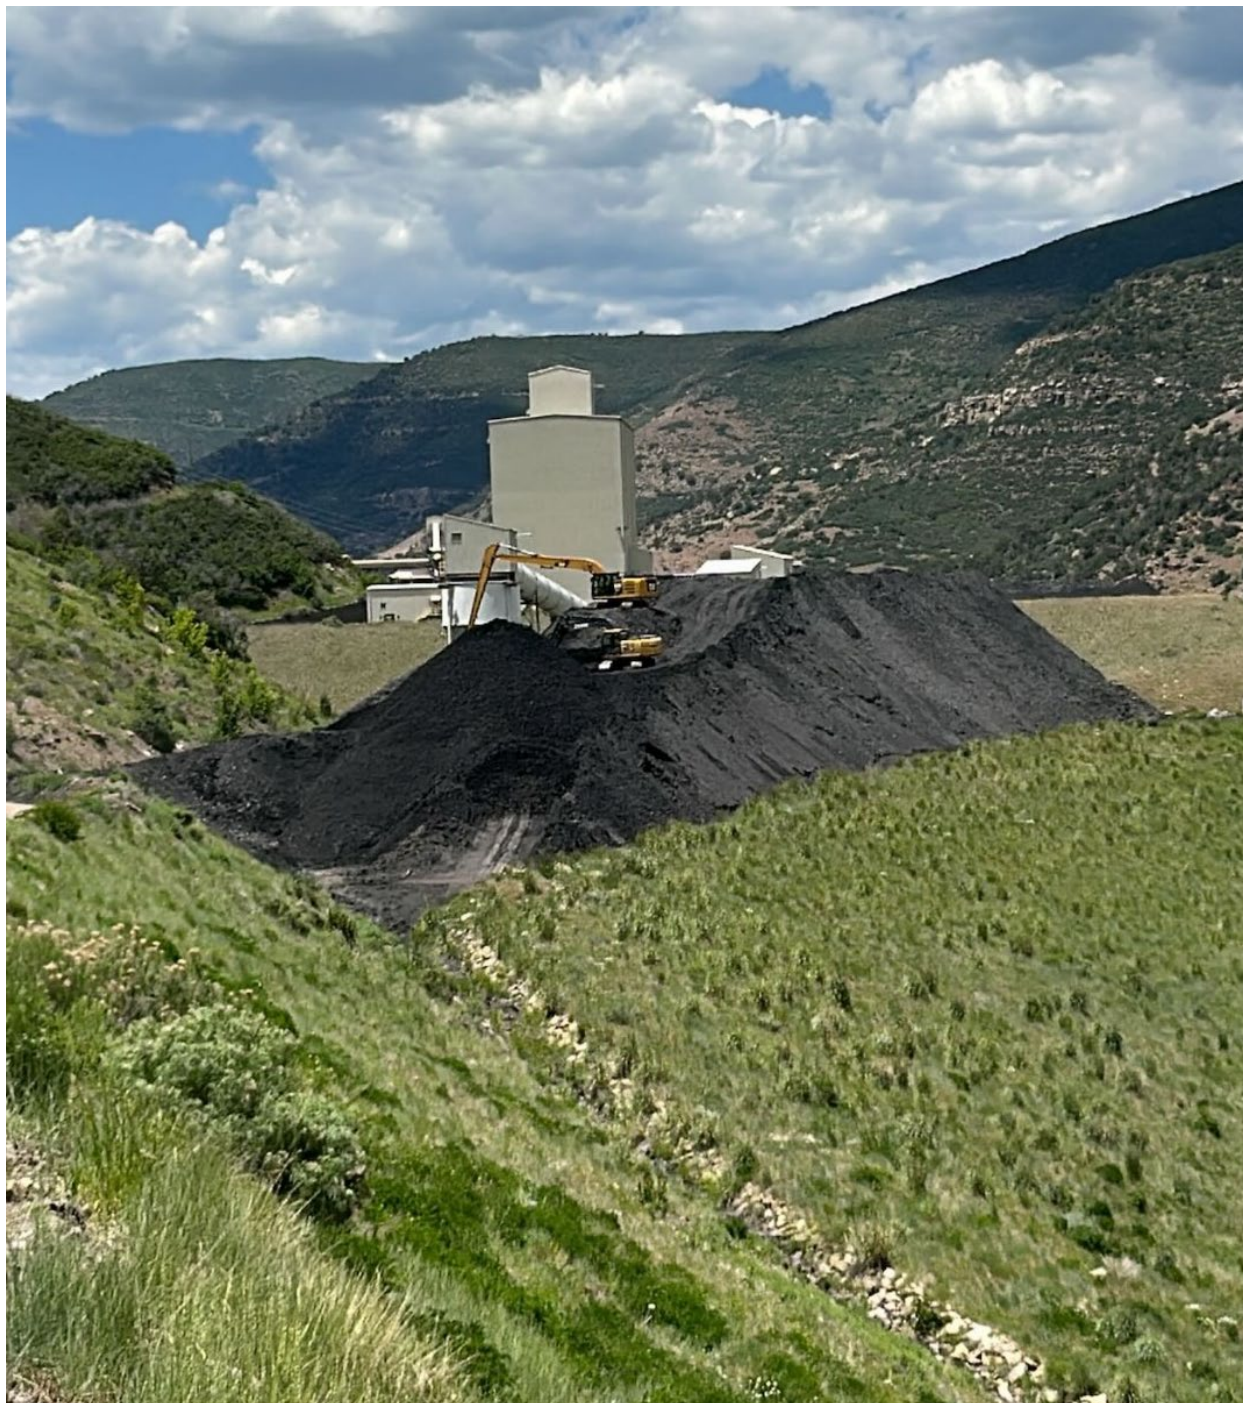
Figure 8: Refuse temporarily stockpiled on RPE

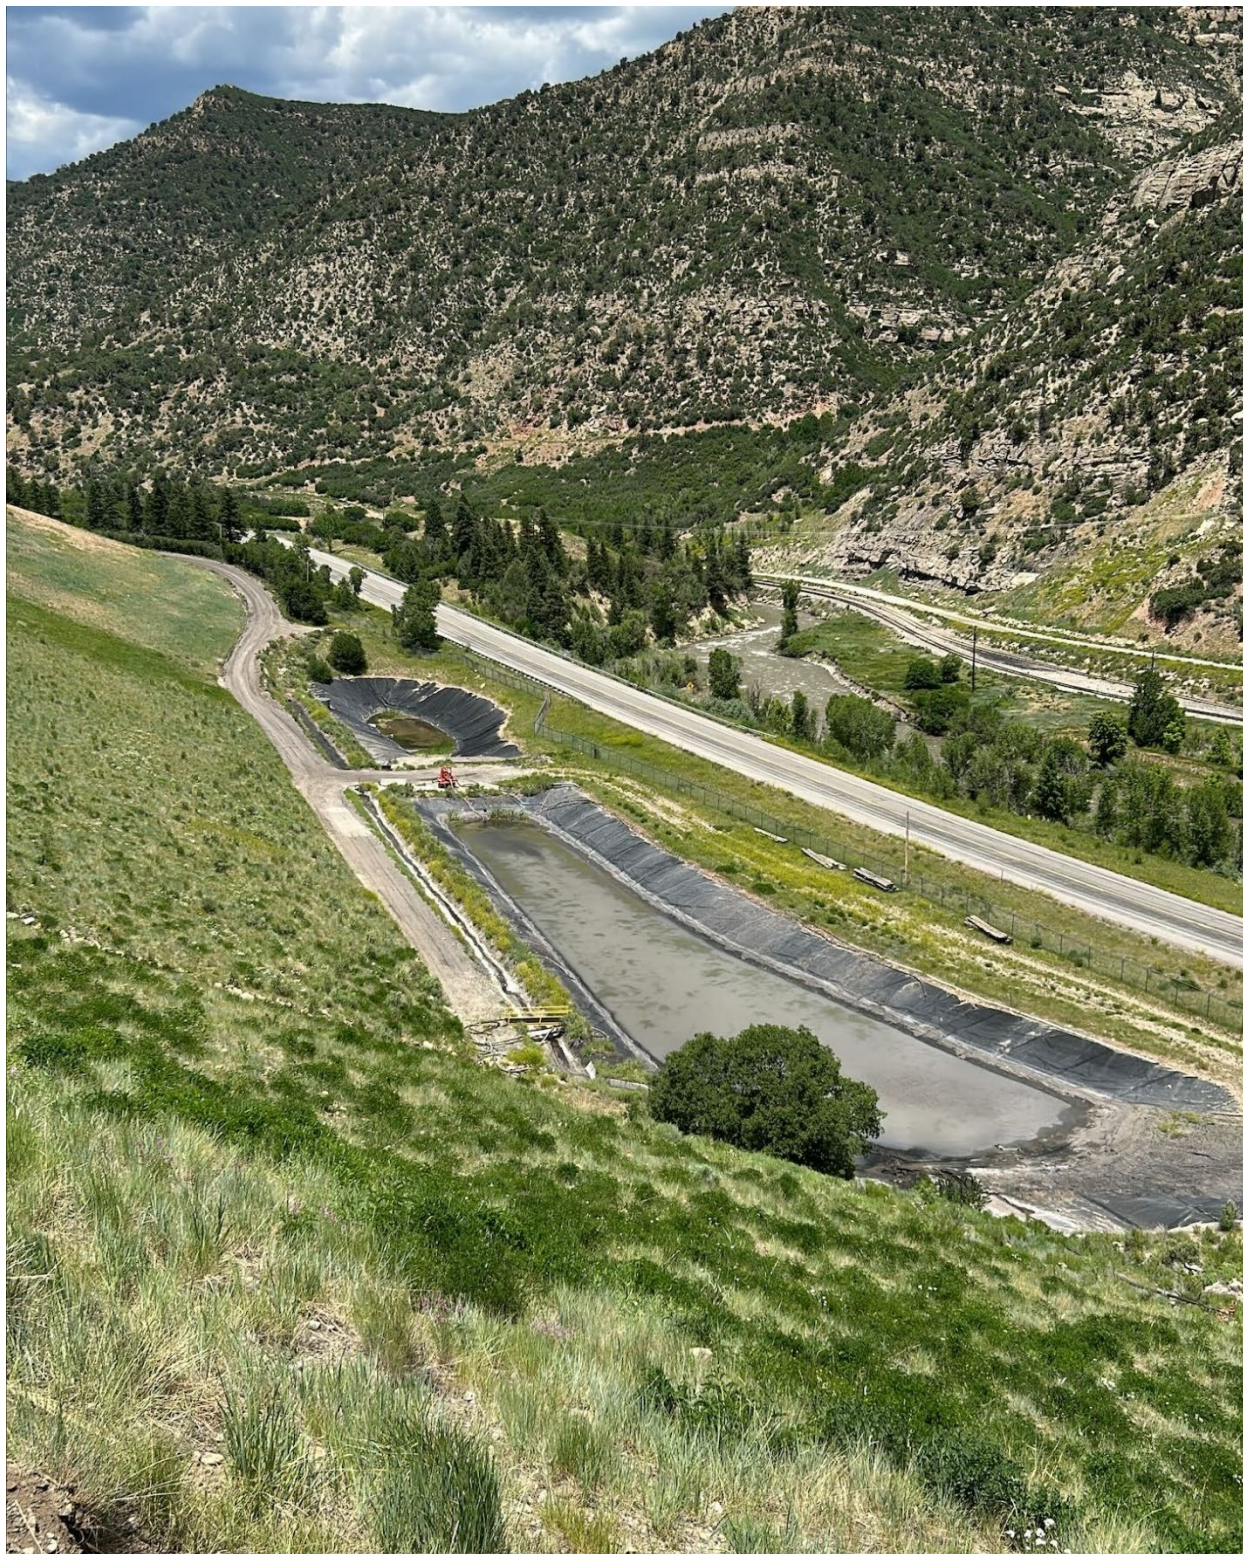
Figure 9: RPE pond

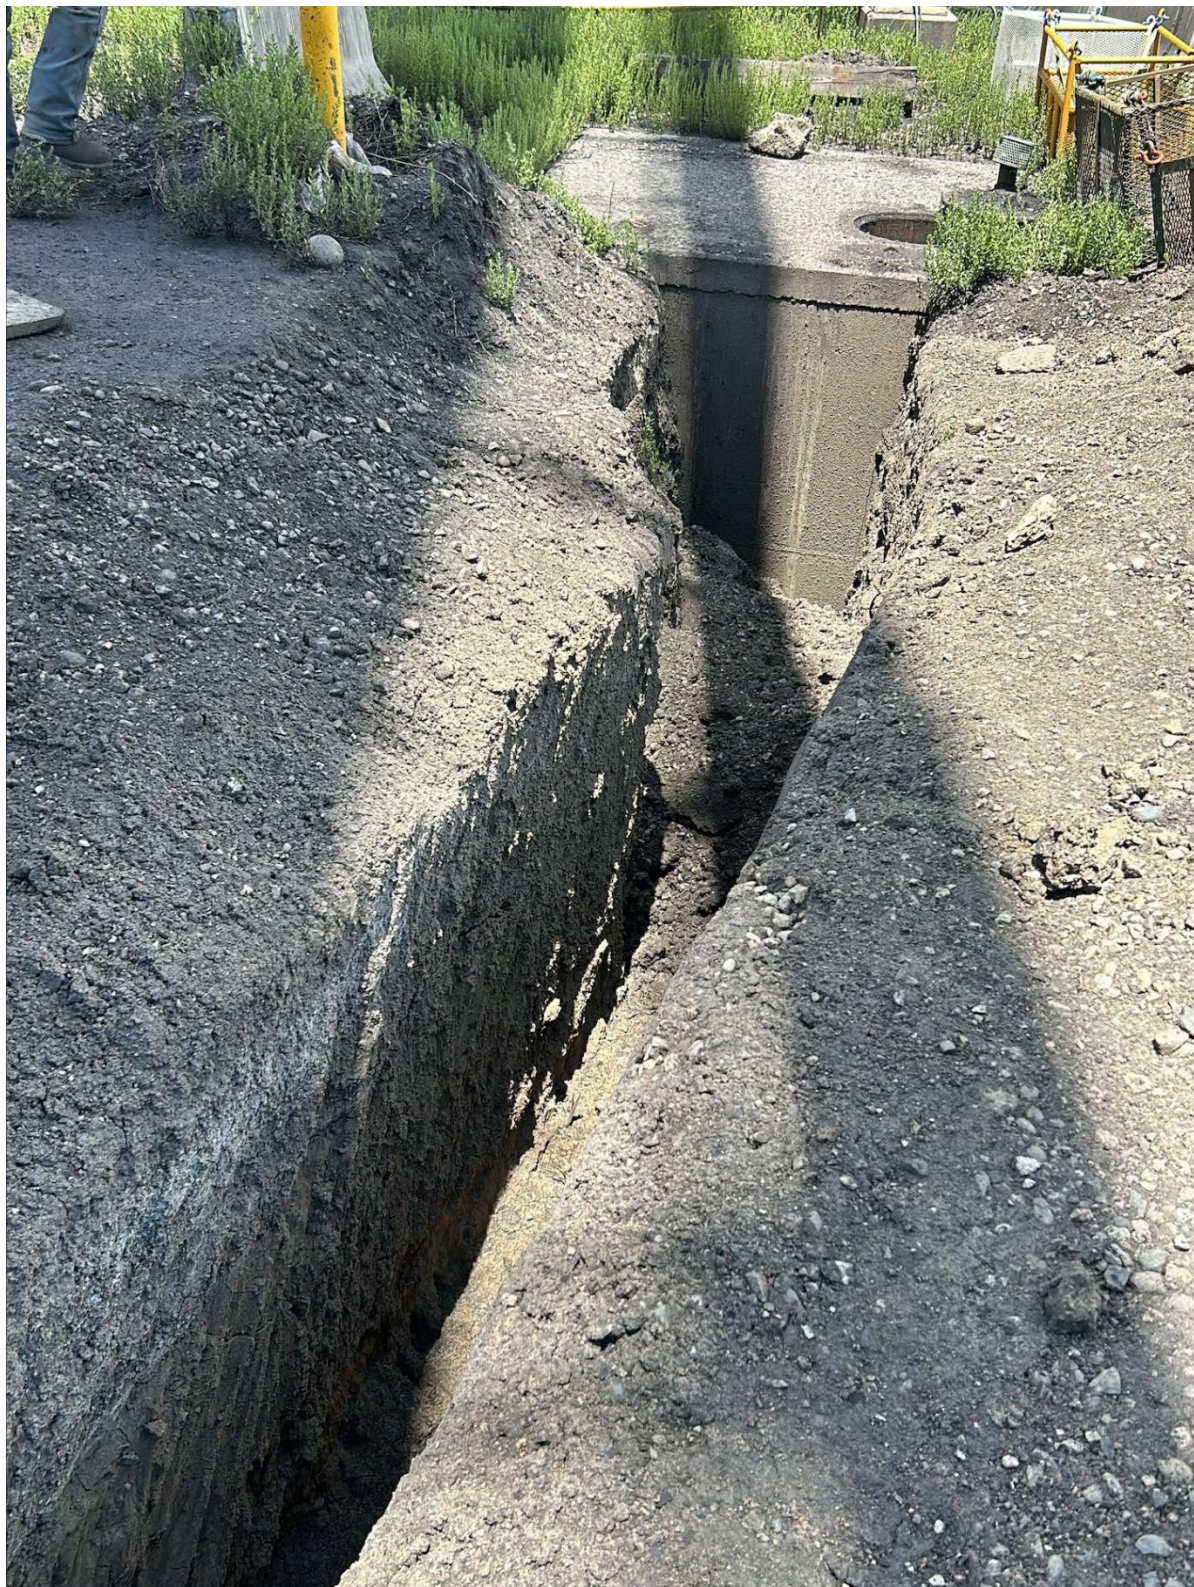
The Box Canyon North pipeline project was still in progress. The east section of pipeline was complete. The trench for the west section had been dug, but MCC were waiting on a pipe fuser. The buildings for the pump houses were not yet on-site, and the pumps would not be set until the buildings were ready.

Figure 10: Lower end of trench for western BCN pipeline segment

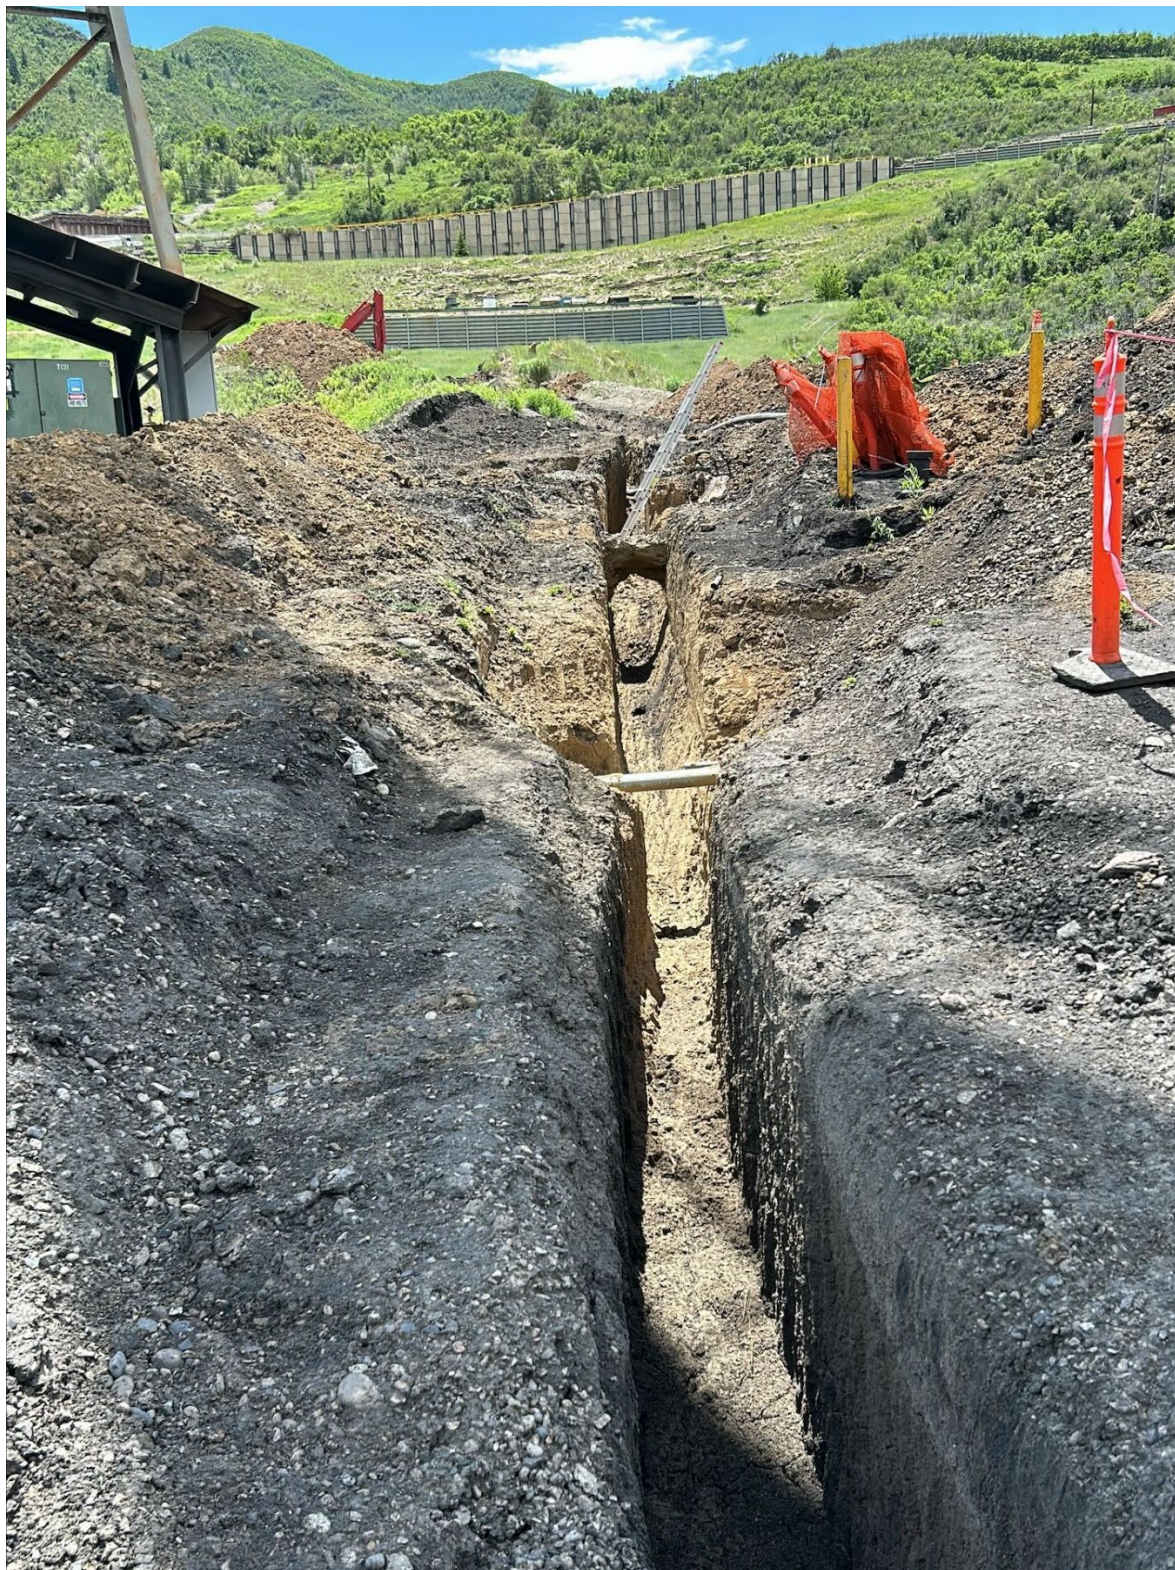
Figure 11: Upper end of trench for western BCN pipeline segment
