MINERALS PROGRAM INSPECTION REPORT
PHONE: (303) 866-3567

MINE NAME: Bulldog Mine Operation	MINE/PROSPECTING ID#: M-1977-215	MINERAL: Lead and silver	COUNTY: Mineral
INSPECTION TYPE: Monitoring	WEATHER: Clear	INSP. DATE: May 14, 2024	INSP. TIME: 09:00
OPERATOR: Rio Grande Silver, Inc.	OPERATOR REPRESENTATIVE: Randy McClure	TYPE OF OPERATION: 112d-2 - Designated Mining Operation	
REASON FOR INSPECTION: Normal I&E Program	BOND CALCULATION TYPE: None	BOND AMOUNT: \$163,228.13	
DATE OF COMPLAINT: NA	POST INSP. CONTACTS: None	JOINT INSP. AGENCY: None	
INSPECTOR(S): Todd Jesse	INSPECTOR'S SIGNATURE:

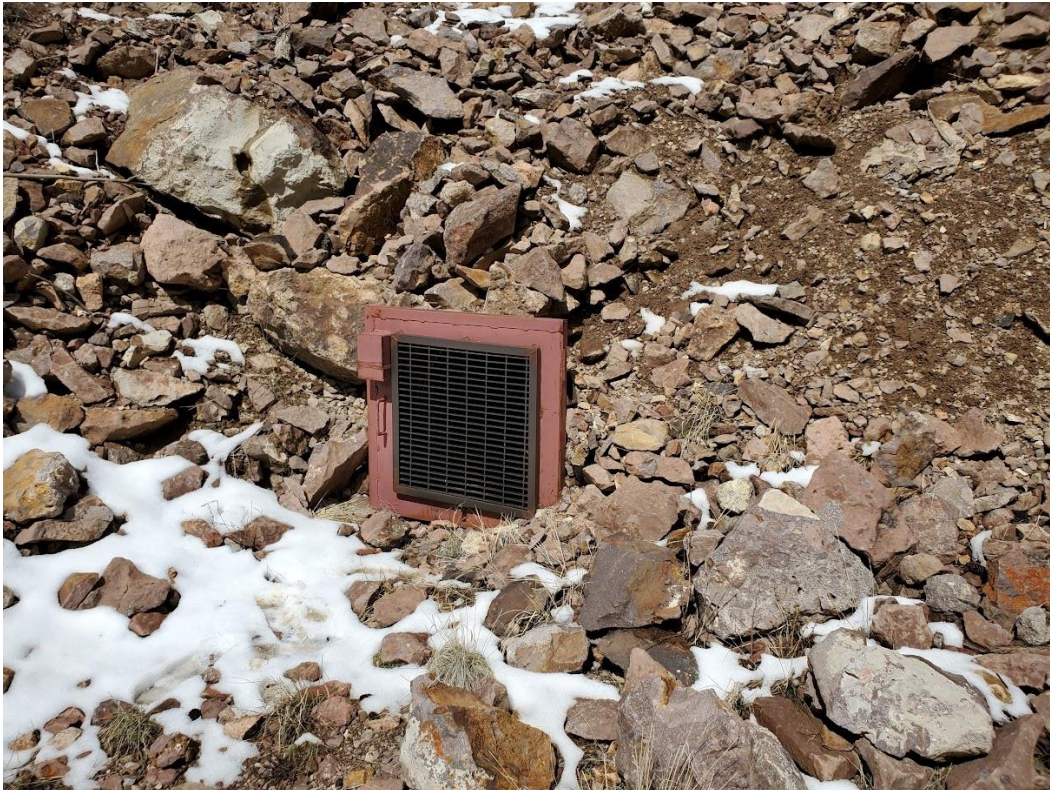
The 9700 Level Portal has been reclaimed and is not used in operations (Photo 1). The bat gate at the portal was secured at the time of the inspection. The portal closure is stable. There are no signs of displacement around the gate. The slopes above and adjacent to the closure are stable and show no signs of slumping or erosion.

Photo 1: View to the northwest of 9700 Portal.

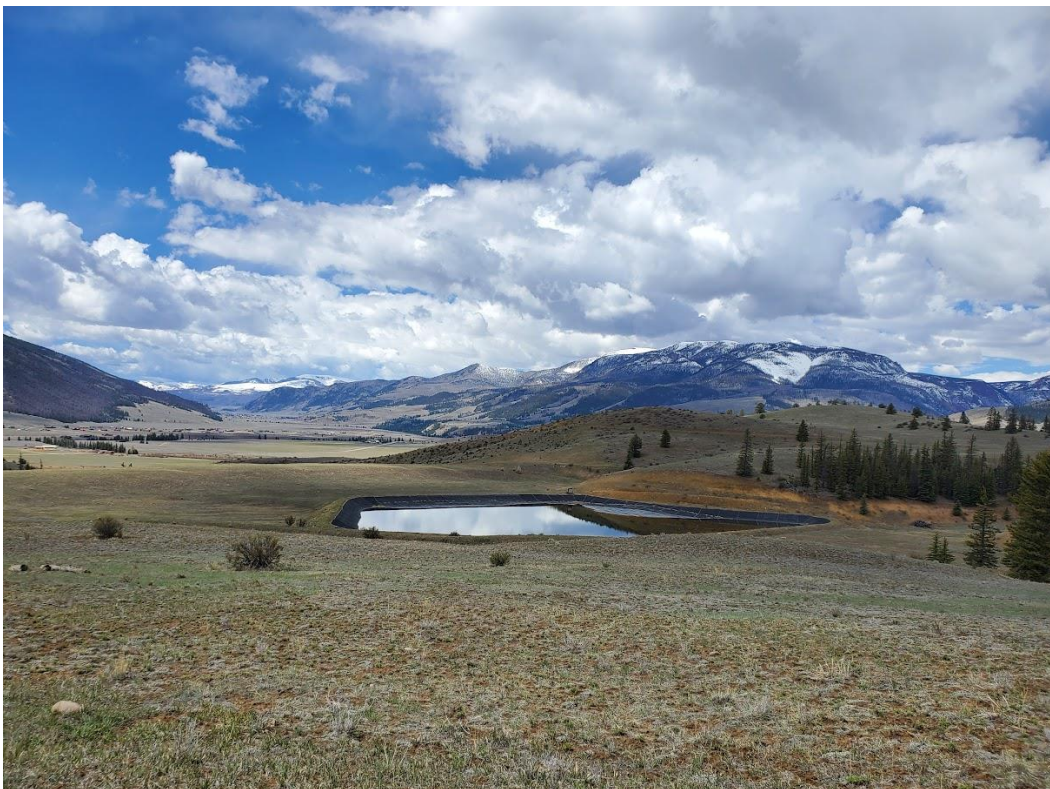
The mine is not being dewatered at this time and no water is being trucked to the lined contact water pond on TP-2. There is a small amount of meteoric water that has collected in the lined contact water pond (Photo 2). No evaporators were in use at this time. The operator submitted a technical revision in the fall of 2023 to install infrastructure to discharge to Windy Gulch. The TR was approved, but infrastructure has yet to be constructed. The operator is also awaiting issuance of a discharge permit from CDPHE. Water was flowing in Windy Gulch and the culverts appeared to be functioning as designed (Photo 3).

Photo 2: View to the southwest of meteoric water in lined pond on TP-2

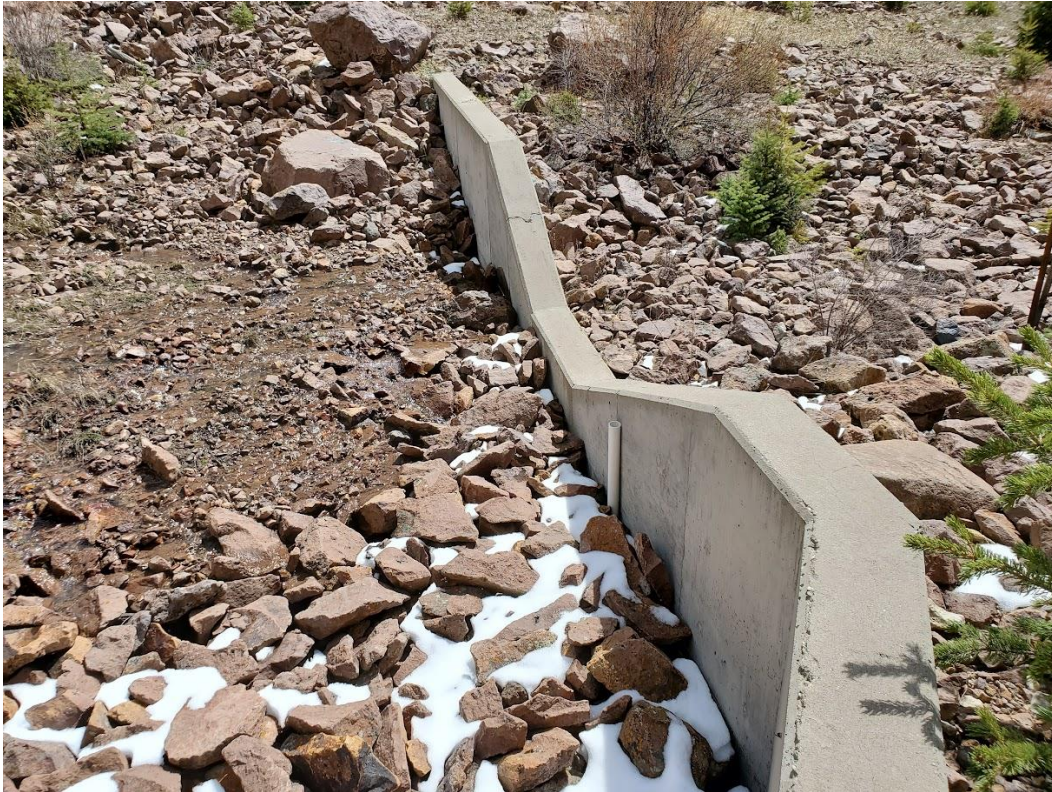
Photo 3: View to the east of culvert in Windy Gulch near the 9700 Portal.

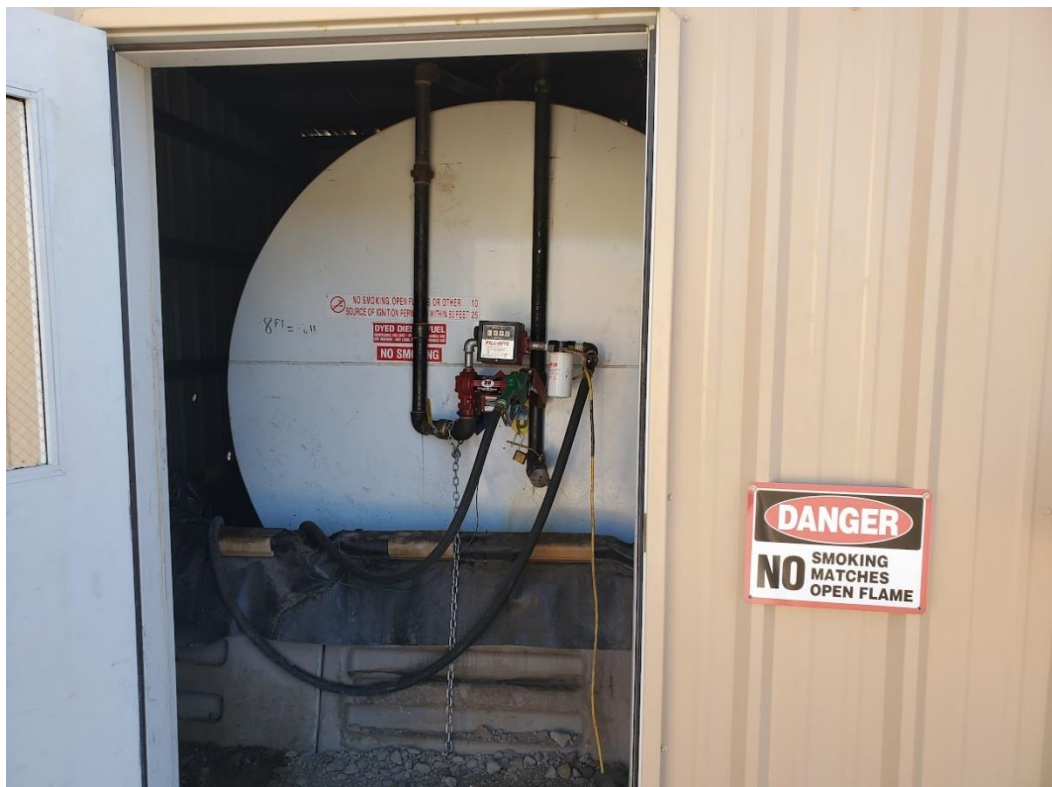
All hydrocarbons are stored in the facilities area near the 9400 Portal. On site fuel storage is an above ground diesel tank. The tank is double walled and set within a lined containment structure providing tertiary spill containment (Photo 4). A spill pad has been installed in the front of the building to prevent spills. All other hydrocarbons are stored on secondary containment and no spills or leaks were observed.

Photo 4: View to the northwest of 9700 Portal.

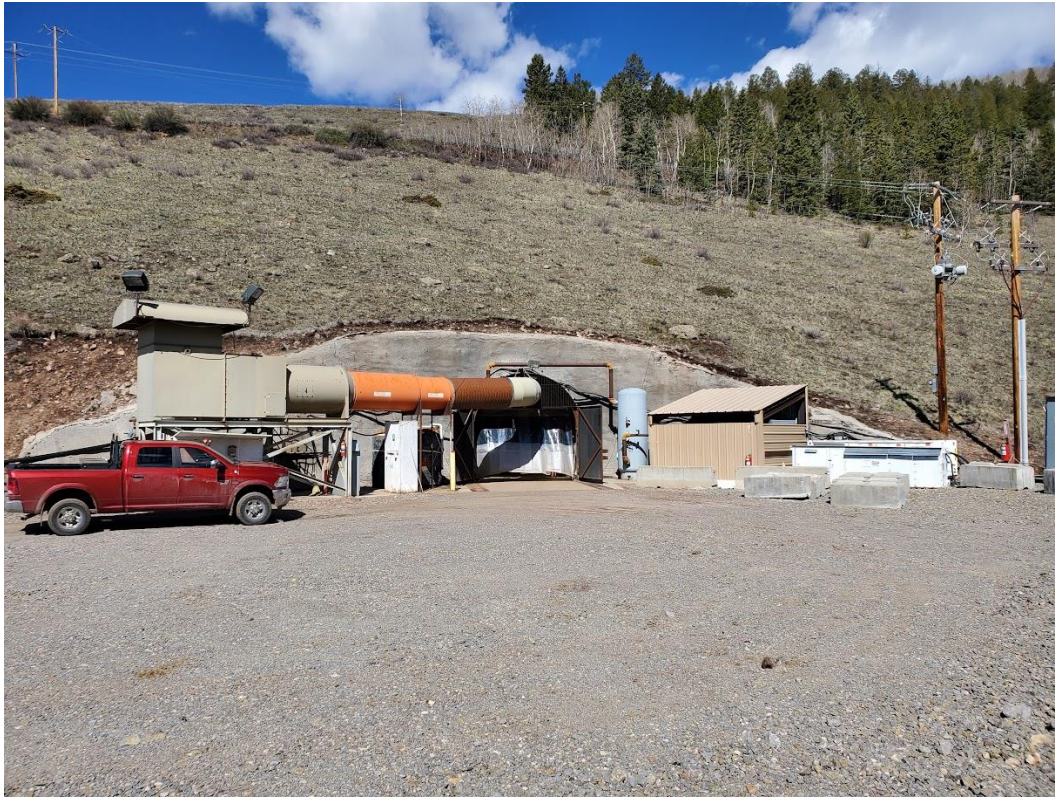
The site was not active at the time of the inspection. The 9400 Level portal is the main access and ore removal for underground workings (Photo 5). The main portal was open at the time of the inspection for maintenance work. The portal door is in excellent condition and shows no signs of damage or vandalism. The vent fan is in good condition. There are no signs of settling, slumping, or erosion above or around the portal.

Photo 5: View to the west of 9400 Portal.

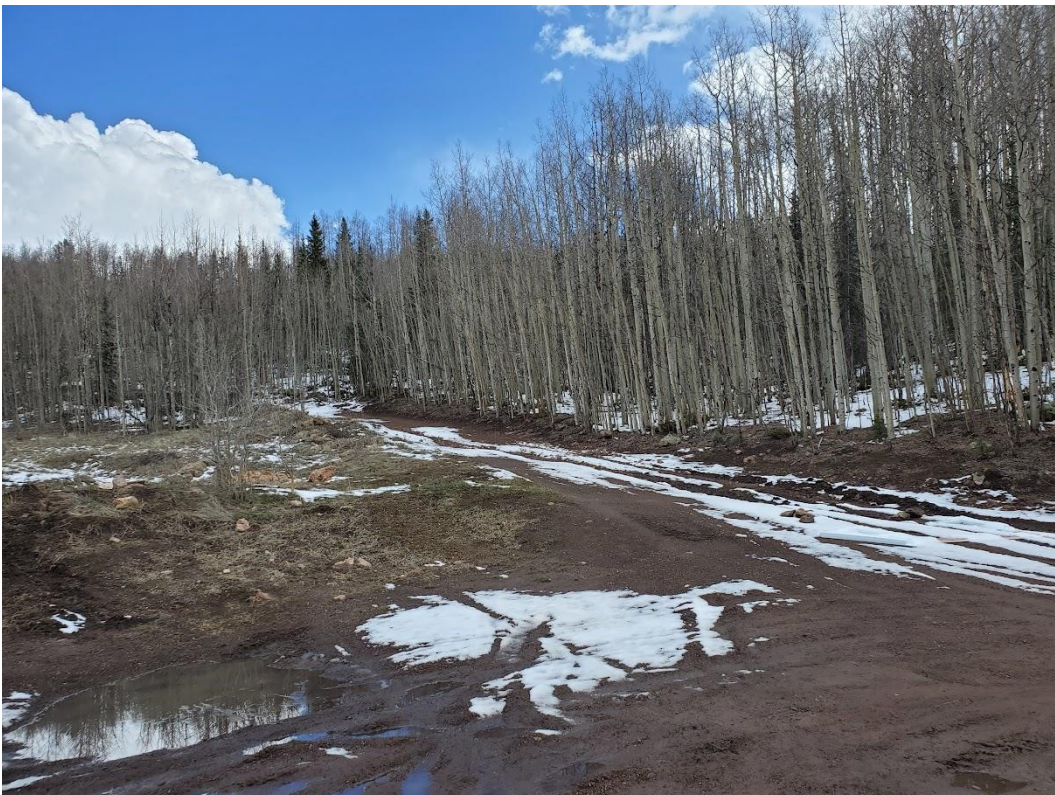
The majority of the roads were accessible and well maintained. Auxiliary roads to access the 9700 Portal Area were in good conditions. There was still a large amount of mud and some snow along the road to the Windy Gulch Vent Shaft (Photo 6). No significant erosion or instability was noted along the roadways.

Photo 6: View to the northwest of mud on road to Windy Gulch Vent Shaft.

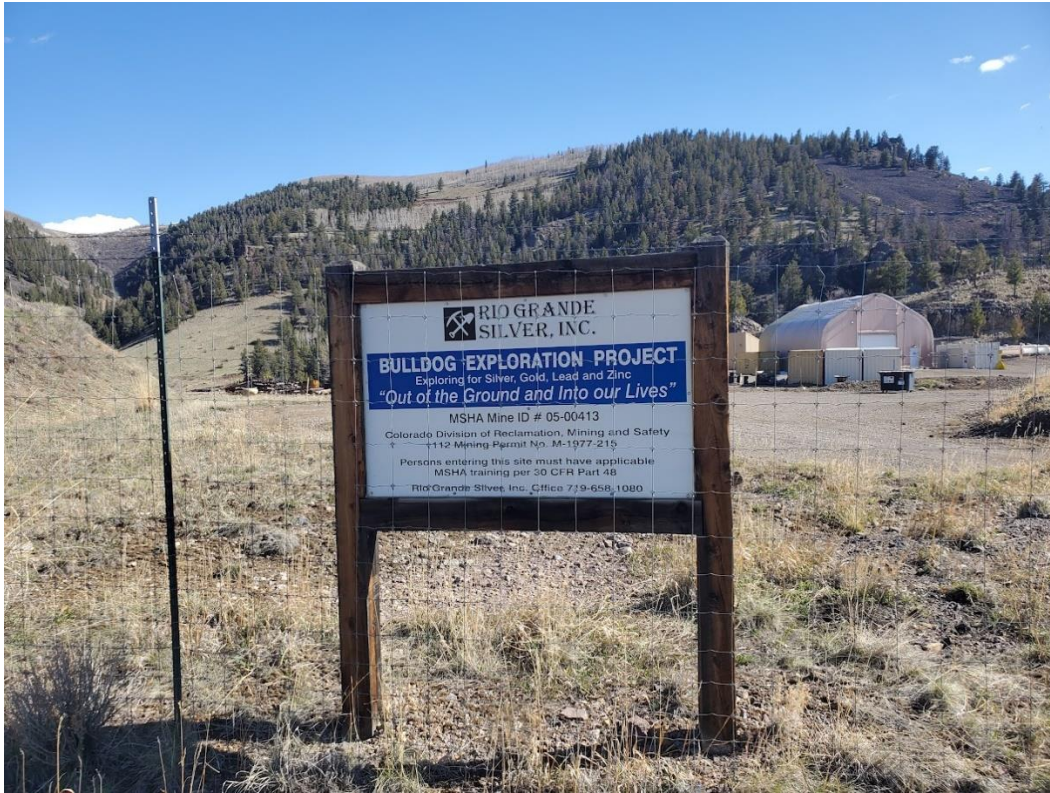
The proper Mine Identification Sign was posted at the entrance to the site (Photo 7) and throughout the various areas of the permit boundaries. Public access to the site is controlled by a locked gate along the access road to the office and facilities area, as well as a series of locked gates along the access roads of the ancillary facilities located across the permitted area.

Photo 7: View to the north of proper Mine ID signage at entrance to permit.
