MINERALS PROGRAM INSPECTION REPORT
PHONE: (303) 866-3567

MINE NAME: Ogilvy River Farm Pit	MINE/PROSPECTING ID#: M-2024-006	MINERAL: Sand and gravel	COUNTY: Weld
INSPECTION TYPE: Preoperation Inspection	WEATHER: Clear	INSP. DATE: May 29, 2024	INSP. TIME: 09:00
OPERATOR: Ogilvy River Farm, LLC	OPERATOR REPRESENTATIVE: JC York	TYPE OF OPERATION: 112c - Construction Regular Operation	
REASON FOR INSPECTION: Preoperational Inspection	BOND CALCULATION TYPE: None	BOND AMOUNT: \$0.00	
DATE OF COMPLAINT: NA	POST INSP. CONTACTS: None	JOINT INSP. AGENCY: None	
INSPECTOR(S): Brock Bowles	INSPECTOR'S SIGNATURE:

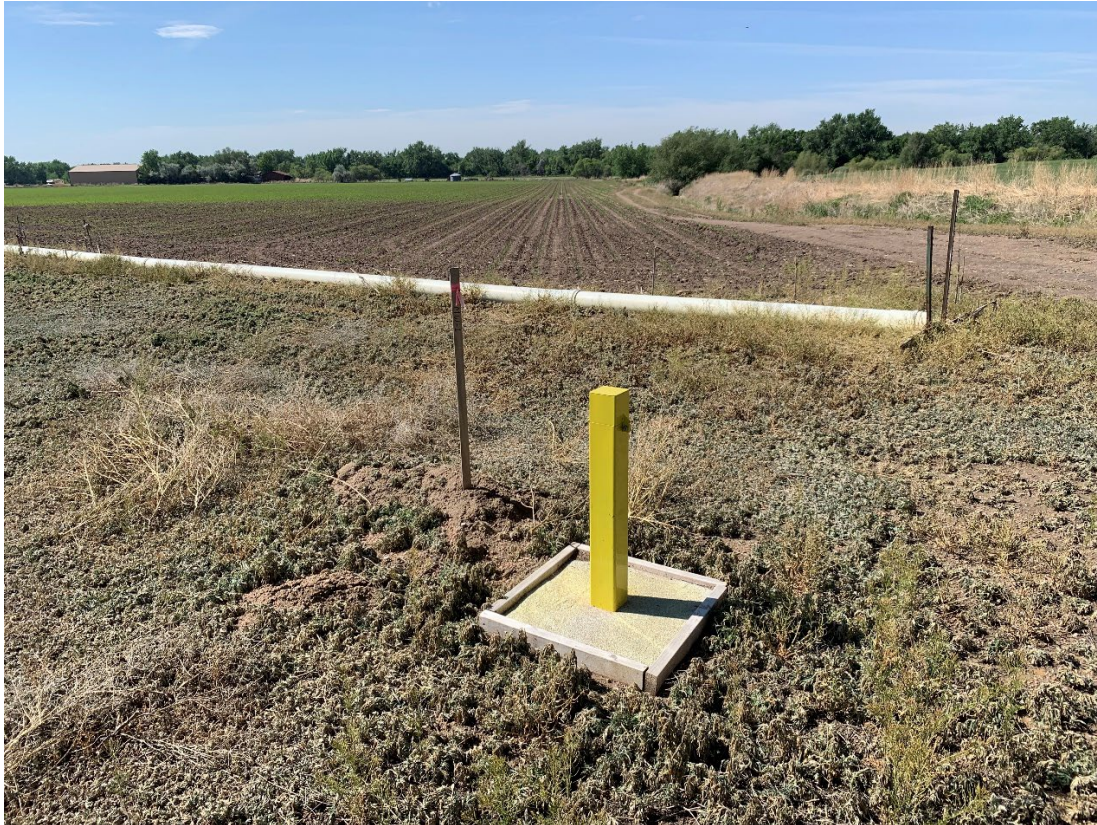
The groundwater monitoring wells are in place (photo 1). They are easily identified by a square yellow pipe and reinforced concrete base.

Photo 1 – Groundwater monitoring well in north west corner of permit area.

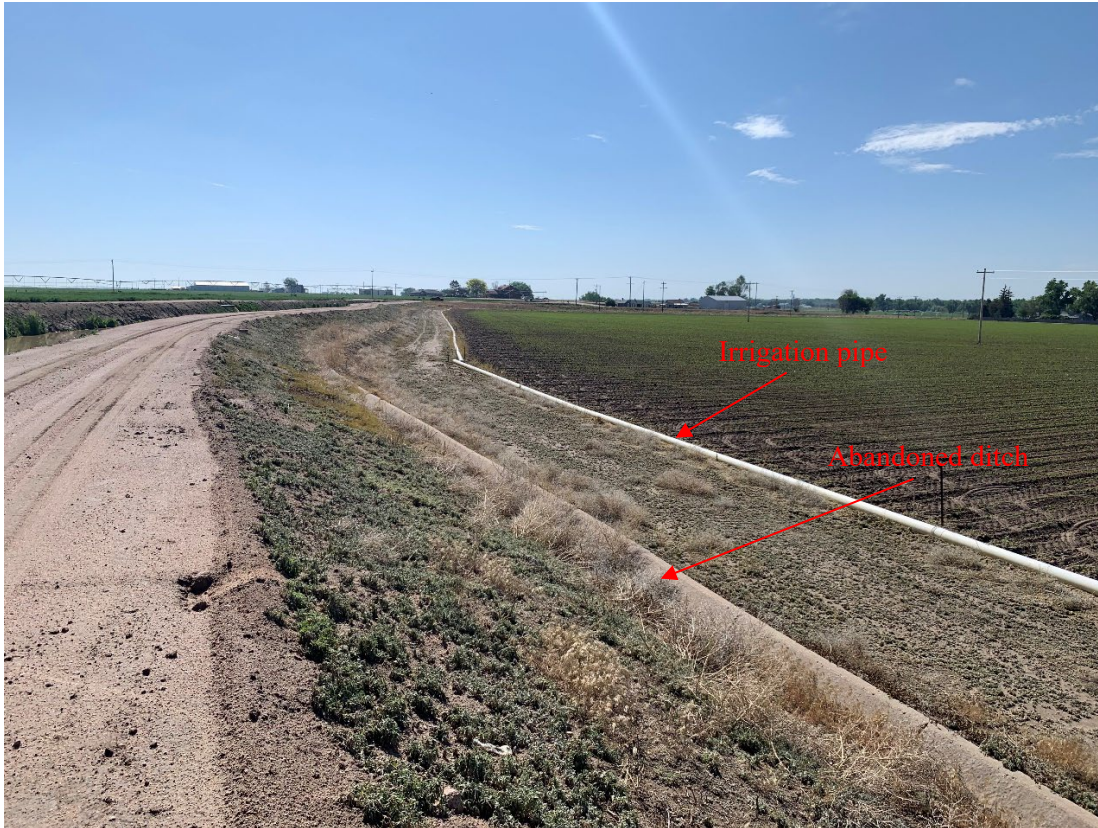
An old concrete irrigation ditch is located just below the access road on the northern part of the permit boundary (photo 2). This ditch appears abandoned because it is filled with dirt and debris. Mr. York stated this ditch is owned by the landowner/operator and it has been abandoned.

Photo 2 – Northern access road facing east. Corn field on right.

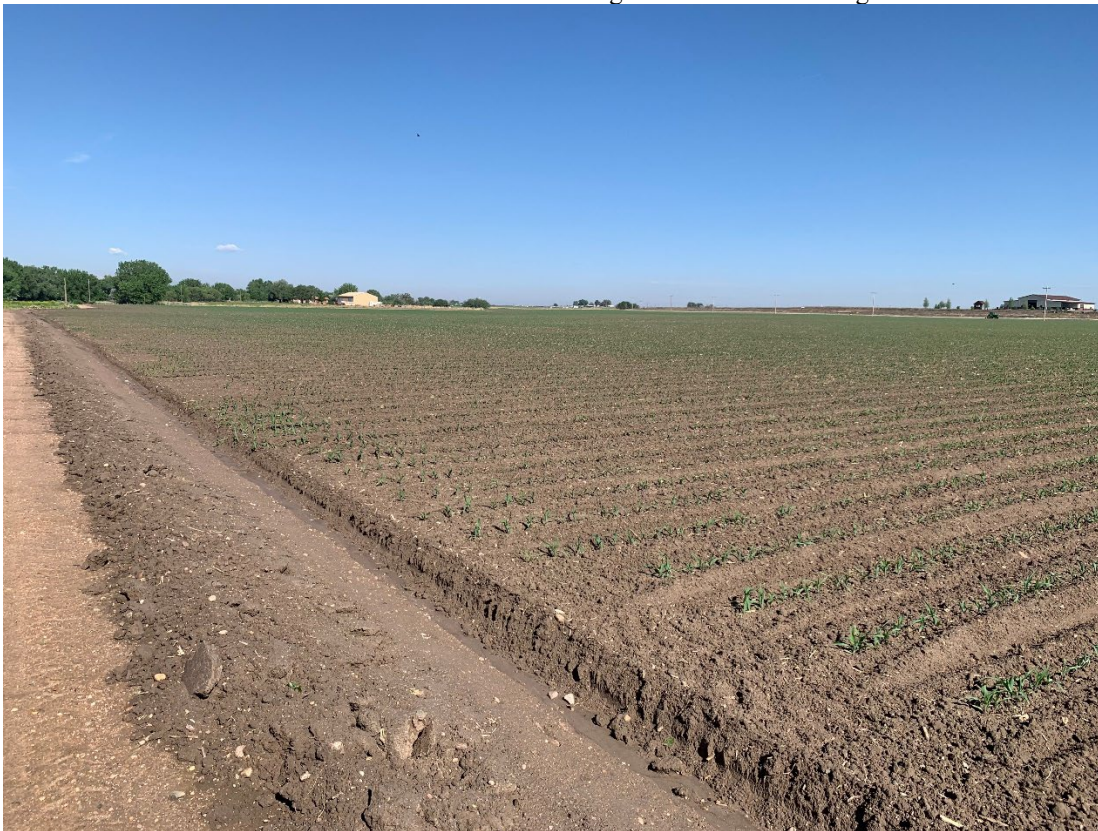
The main proposed pit area is currently an agricultural field (photos 2 & 3). A corn crop is planted and has begun to sprout. The field is irrigated by a flood gate system. Water is taken from the Ogilvy Ditch on the north side of the property and directed through a pipe into small ditches between the rows of corn (photo 2). The irrigation tailwater is collected on the south side of the field where it is directed through a series of ditches and culverts back to the South Platte River (photo 3).

Photo 3 – Southern side of corn field facing west. Tailwater ditch in foreground directs water to the river.

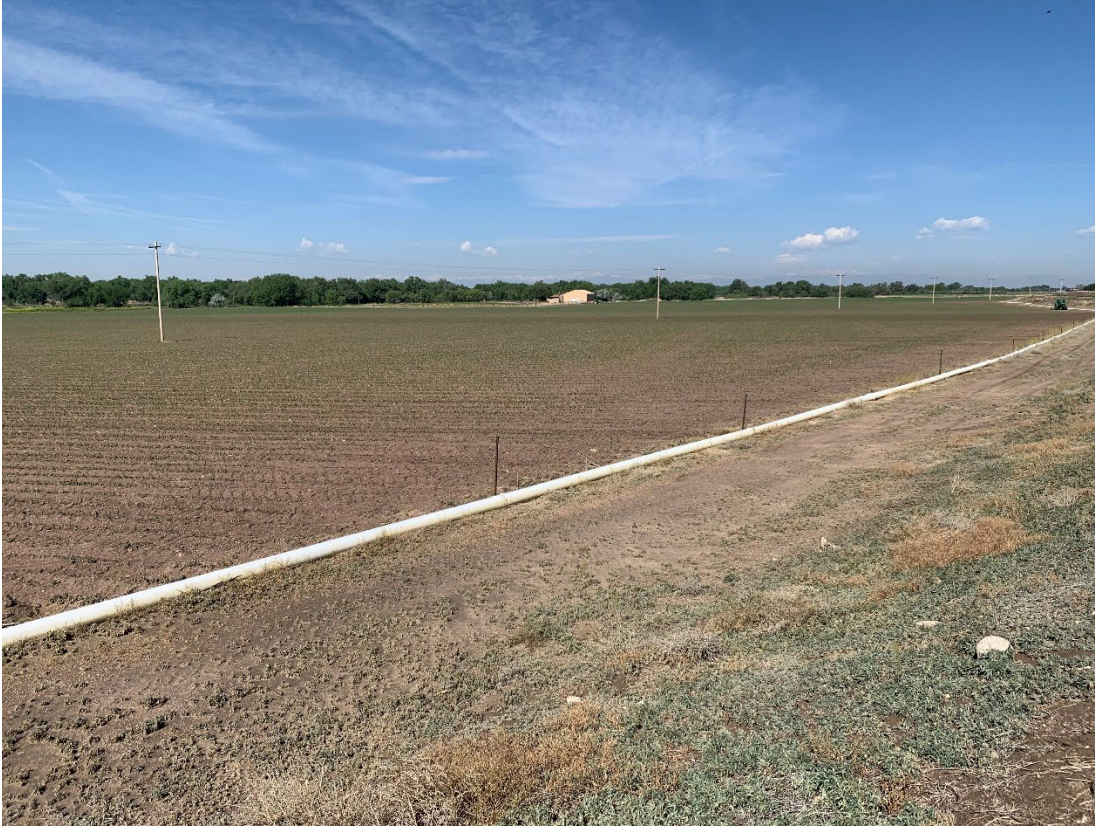
A set of power poles are located across the agriculture field (photo 4). These poles are proposed to be moved as part of the mining plan.

Photo 4 – Corn field facing southwest with power poles in middle of field.

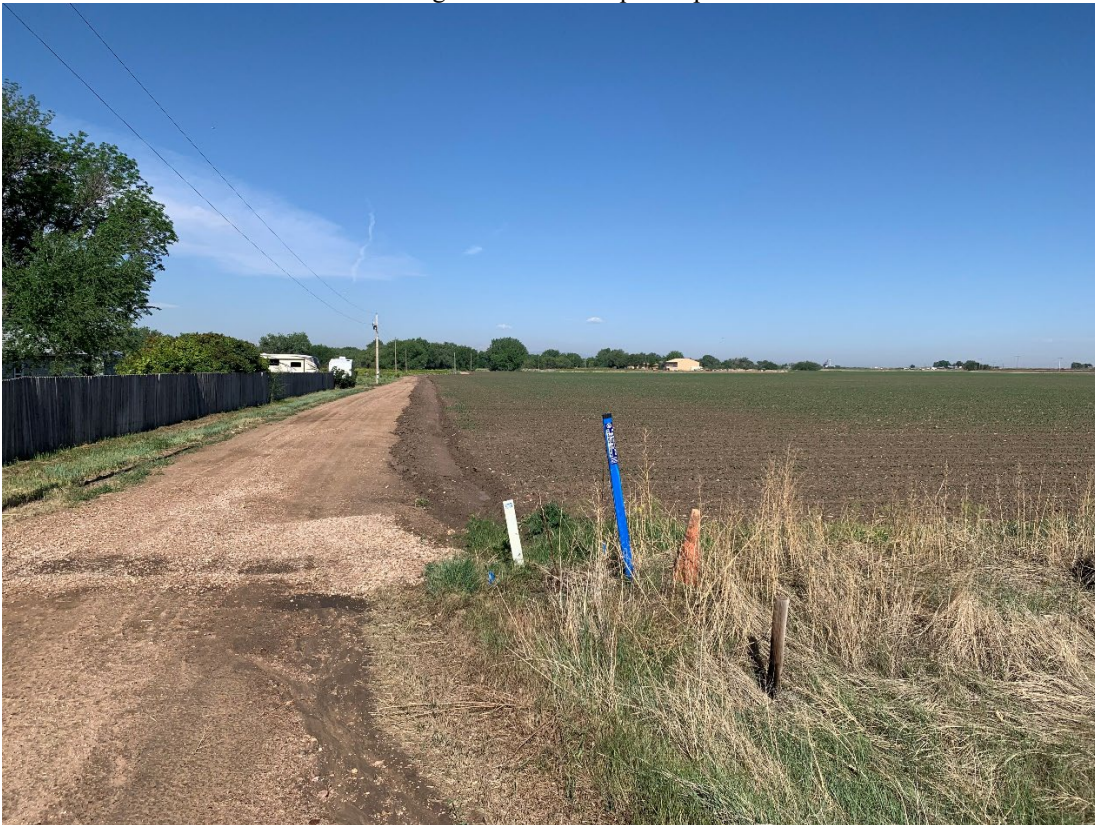
The Smith residence is accessed by a road across the Ogilvy property (photo 5). This road is proposed to remain in place for the life of mine. The Smith driveway begins at the southwest corner of the permit area where a fence line delineates the property and permit boundaries (photo 6).

Photo 5 – Access road, facing west, from CR 53 across Ogilvy property to Smith property.

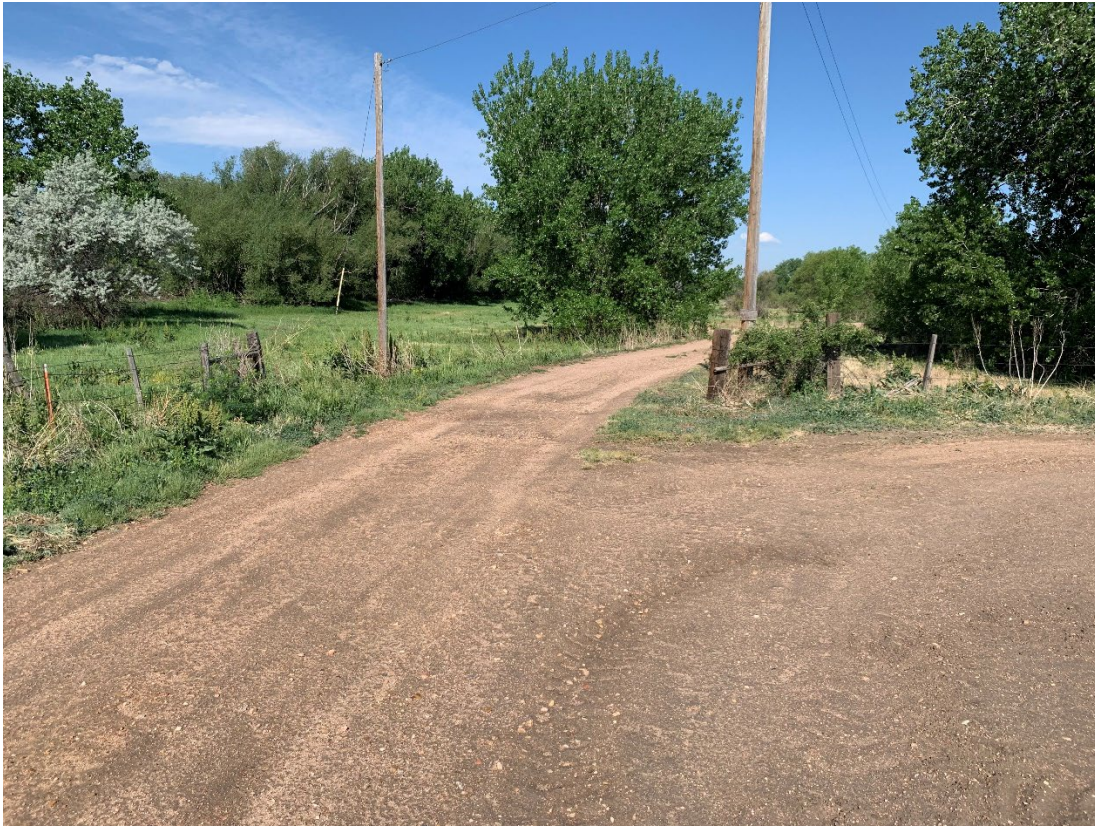
Photo 6 – West end of access road where the Smith driveway starts between the poles.

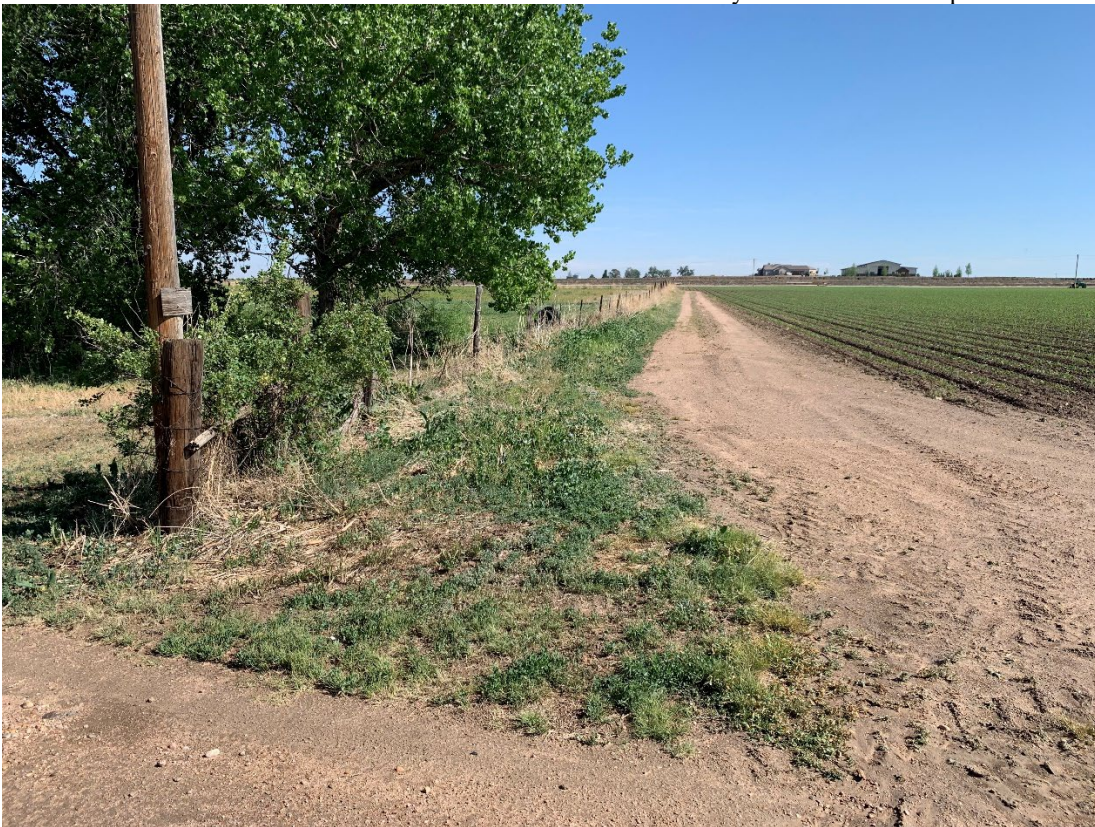
An access road is currently in place along the fence line around the Smith property on the southwest section of the permit boundary (photos 7 & 8). This access road is proposed to remain as part of the mine plan.

Photo 7 – Smith property eastern boundary, facing north, with driveway in lower left corner

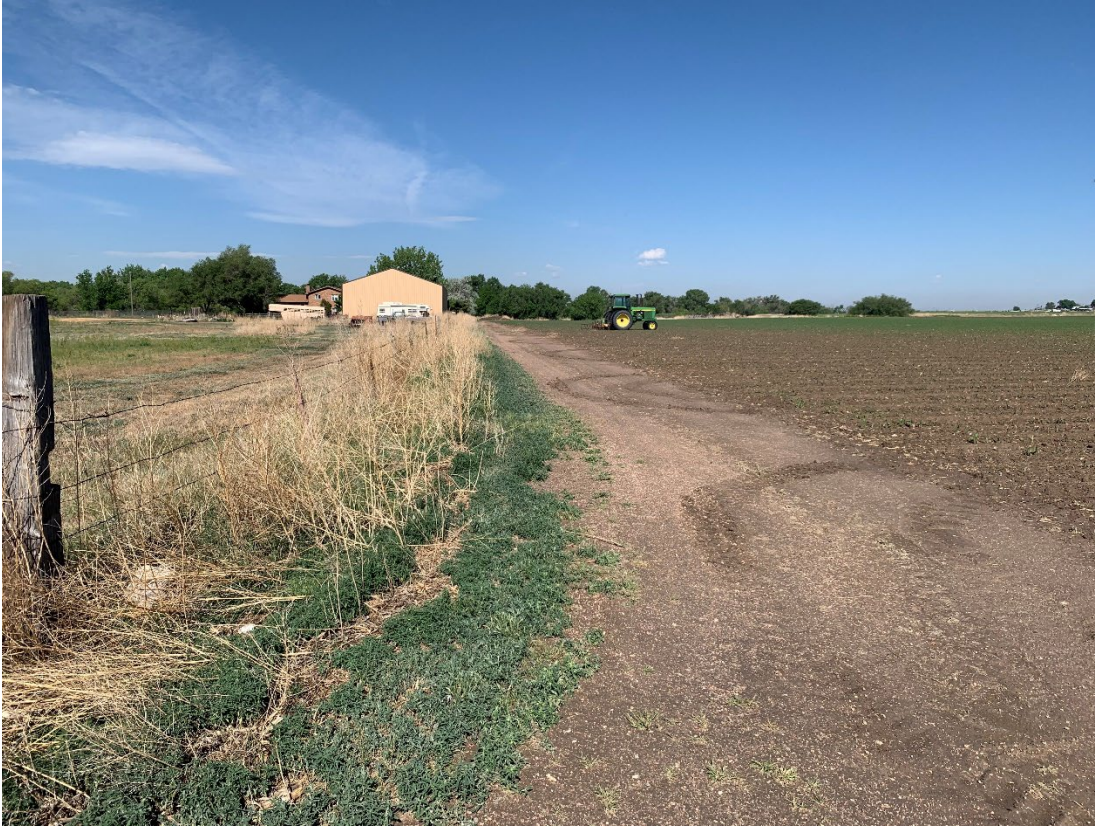
Photo 8 – Smith property northern boundary facing west. Access road will remain for the life of mine.

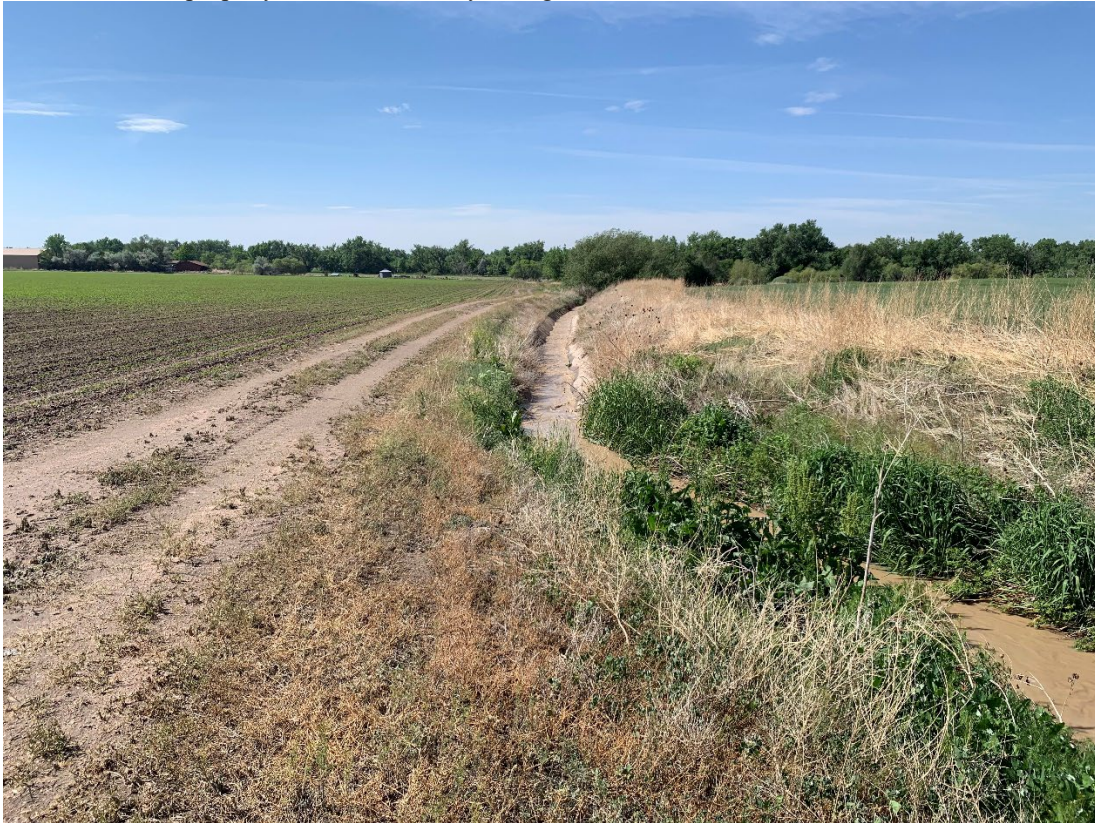
An access road is located on the western boundary (photo 9). This road will remain in place as part of the mining plan. A return ditch is located west of this road returning water from the Ogilvy Ditch to the South Platte River. This western ditch is not in the permit boundary.

Photo 9 – Western boundary access road will remain for the life of mine. Photo facing south.

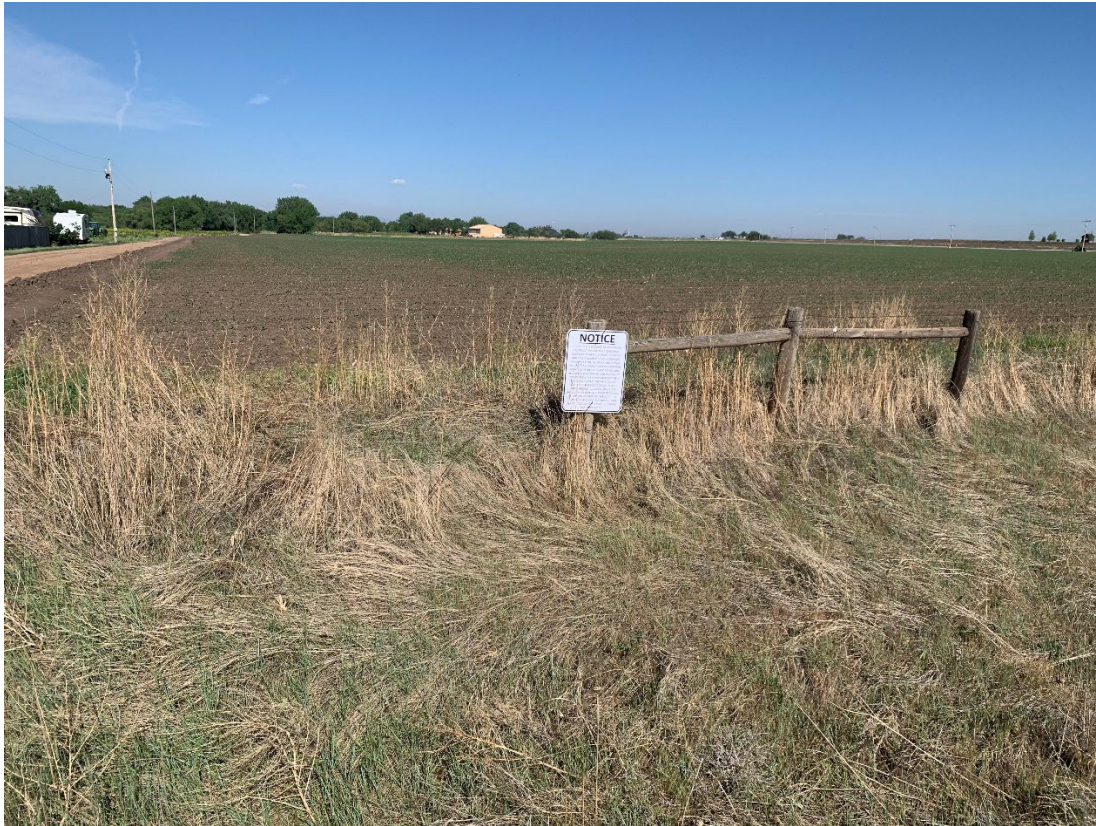
The notice sign required by 1.6.2(1)(b) was in place at the mine entrance (photo 10) and was facing CR 53.

Photo 10 – New permit application sign facing CR 53.
