MINERALS PROGRAM INSPECTION REPORT
PHONE: (303) 866-3567

MINE NAME: Thomas Pit	MINE/PROSPECTING ID#: M-1976-020	MINERAL: Sand and gravel	COUNTY: La Plata
INSPECTION TYPE: Monitoring	WEATHER: Clear	INSP. DATE: May 8, 2024	INSP. TIME: 12:15
OPERATOR: Oldcastle SW Group, Inc. dba Four Corners Materials	OPERATOR REPRESENTATIVE: Francesca Mallonee	TYPE OF OPERATION: 112c - Construction Regular Operation	
REASON FOR INSPECTION: Normal I&E Program	BOND CALCULATION TYPE: None	BOND AMOUNT: \$26,295.00	
DATE OF COMPLAINT: NA	POST INSP. CONTACTS: None	JOINT INSP. AGENCY: None	
INSPECTOR(S): Dustin Czapla	INSPECTOR'S SIGNATURE:

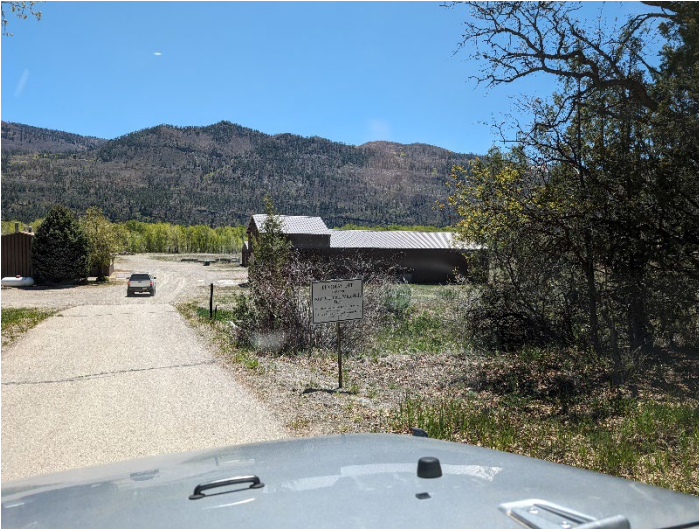
Adequate mine identification signage was noted on the gate at the entrance to the site.

Mine sign posted at site entrance

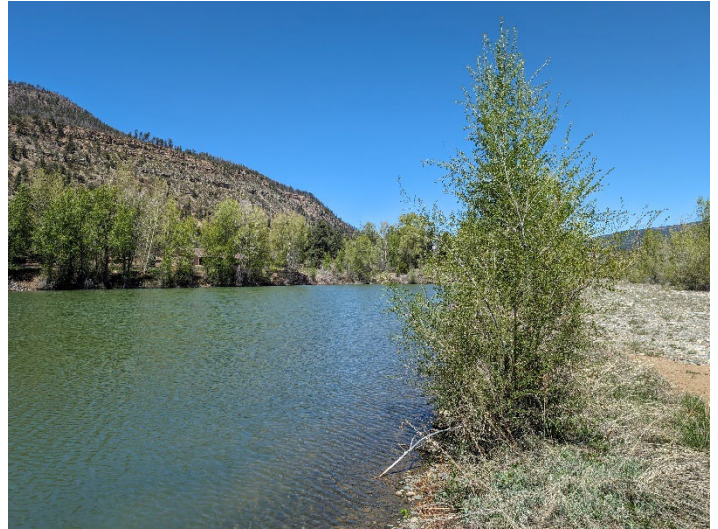
North pond

This site is in final reclamation. The post-mining land uses include industrial/commercial, wildlife habitat and cropland. Reclamation earthwork and grading has been completed in accordance with the approved reclamation plan. Grading appears adequate and no issues were noted. The pond at the north end of the permit area has been completed. The banks appear stable and well vegetated. The area south of the pond has been reclaimed for commercial use. The area has been graded flat and appears well maintained. The office/scale building, and other shed structures are to remain on site and appear to be in good repair. The area immediately south of the commercial area has been reclaimed to irrigated pasture. Grading appears adequate and no issues were noted. The south pond has been completed and the banks appear stable and well vegetated. No issues were noted. The permanent armoring along the west bank of the Animas River adjacent to the south pond appeared stable and effective.

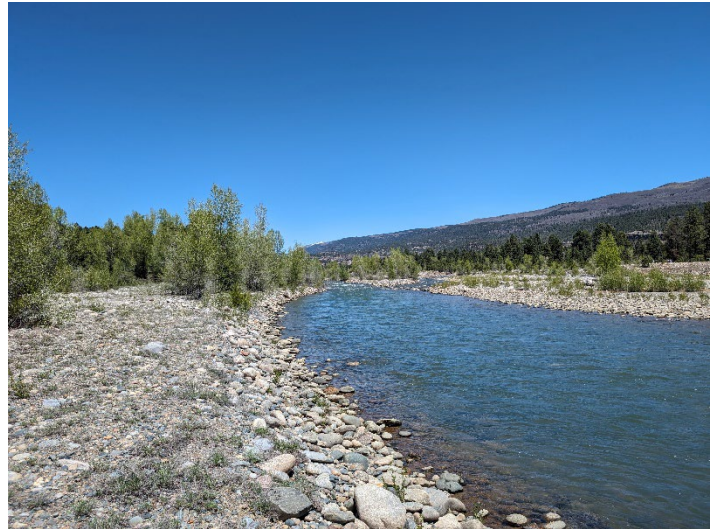
Animas riverbank adjacent to north pond

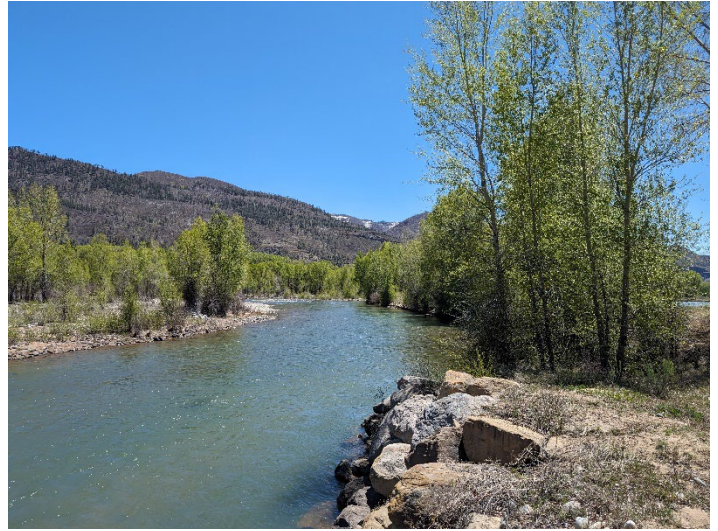
The landowner expressed concerns regarding the jetty construction and its effectiveness, as well as migration of the river channel and potential erosion of the west bank. However, work completed within the river appears to be in accordance with the plans approved by the Army Corp of Engineers (ACOE). Any modification, removal or repair of the instream structures would need authorization by the ACOE.

Jetty and armored bank
