## Lorencito Canyon Mine, C-1996-084, Partial Inspection, Inspection Report

<b>Permit Number:</b> C-1996-084 <b>Mine Name:</b> Lorencito Canyon Mine <b>Operator:</b> New Elk Coal Company, LLC <b>Operator Address:</b> Mr. John Terry 12250 Highway 12 Weston, CO 81091	<b>County:</b> Las Animas <b>Operation Type:</b> Surface <b>Permit Status:</b> Permanent Cessation <b>Ownership:</b> Private
	<b>Operator Representative Present:</b>  John Terry
<b>Operator Representative Signature: (Field Issuance Only)</b>

<b>Inspection Start Date:</b> June 13, 2024 <b>Inspection Start Time:</b> 11:15 <b>Inspection End Date:</b> June 13, 2024 <b>Inspection End Time:</b> 12:08	<b>Inspection Type:</b> Coal Partial Inspection <b>Inspection Reason:</b> Normal I&E Program <b>Weather:</b> Clear
<b>Joint Inspection Agency:</b>  None	<b>Joint Inspection Contacts:</b>
<b>Post Inspection Agency:</b>  None	<b>Post Inspection Contacts:</b>
<b>Inspector(s):</b>  Amber M. Gibson	<b>Inspector's Signature:</b>

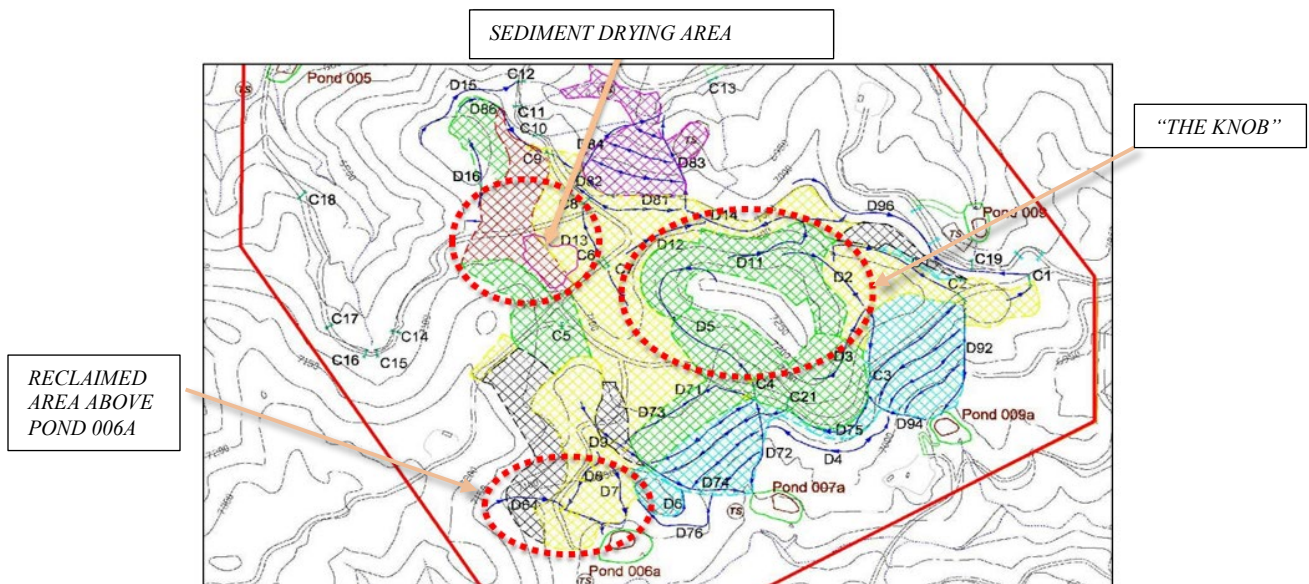
4. The following items pertain to ongoing erosional issues in the areas shown in Figure 1, that pursuant to Rule 4.14.6 need to be addressed. A Technical Revision will be required to expand on the current Rill and Gully plan in the PAP. **The Operator shall submit the technical revision, obtain approval, repair the erosion, and stabilize the slopes pursuant to the approved plan by December 31, 2024.**

FIGURE 1. AREAS WHERE RILLS, GULLIES AND SPARSE VEGETATION HAS BEEN FOUND TO BE A PERSISTENT PROBLEM AT THE SITE ARE WITHIN THE DOTTED CIRCLE AREAS. BACKGROUND IMAGE IS THE 2020 ANNUAL REPORT MAP.

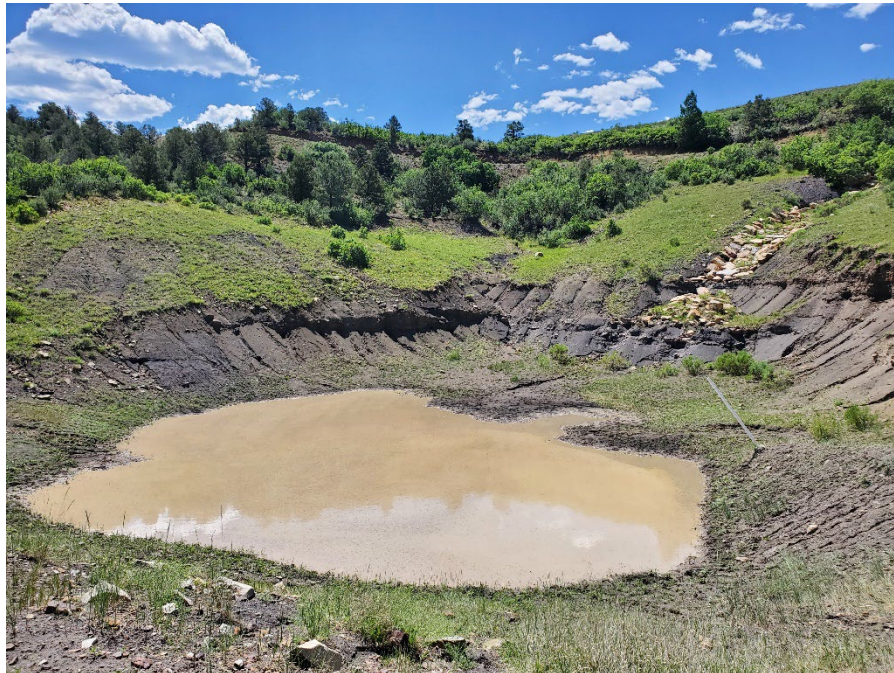
- Pond 009:
  - The pond held some water at the time of the inspection. (Photo 1).
  - The pond embankment was stable and vegetated.
  - The primary and emergency spillways appeared clear and functional.
  - The flume was dry and was not discharging.

*Photo 1: Pond 009*

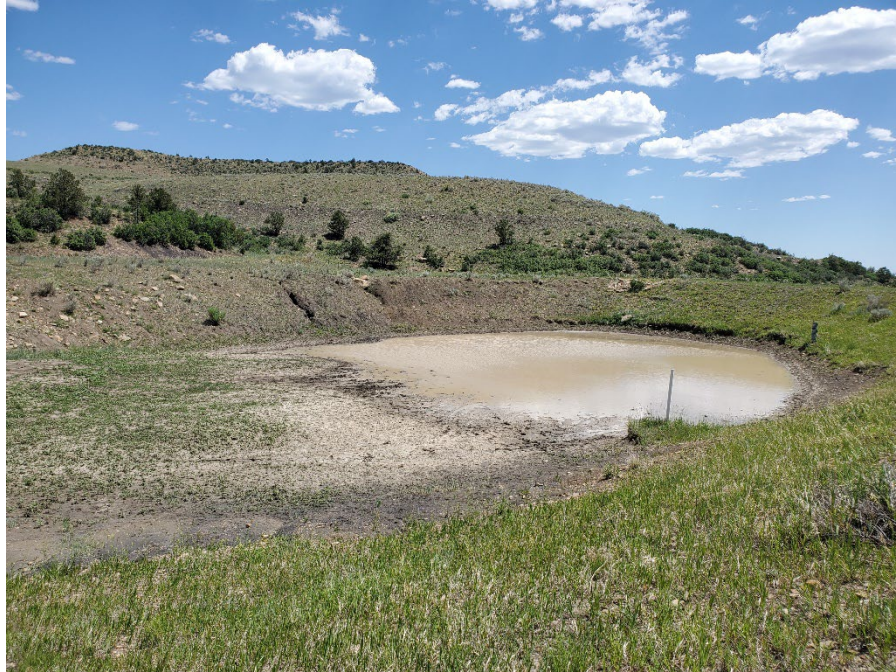
1. Erosion rills are forming on the north and west banks of Pond 006a. The erosion on the north bank appears to have been addressed at some point, because rebar is placed above the rills. However, it appears that the prior BMPs are no longer functioning adequately. **Pursuant to Rule 4.05.5(1)(c), the Operator shall address the erosion and repair the north bank.** The erosion on the west bank appears to have been caused by runoff from the road located east of Pond 006a. **Pursuant to Rule 4.05.5(1)(c), the Operator shall address the erosion and repair the west bank.**

- Pond 006A:
  - The pond held a small amount of water at the time of the inspection. (Photo 2).
  - The pond embankment still requires maintenance (see Item 1 in the outstanding maintenance items list on the first page of this report).
  - The primary and emergency spillways appeared clear and functional.

*Photo 2: Looking east across Pond 006a.*

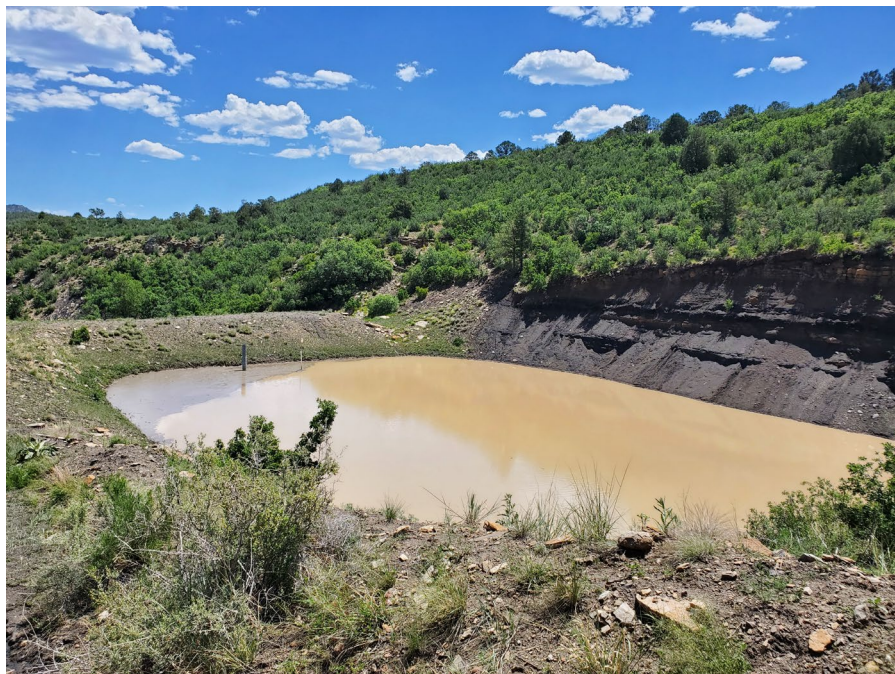
2. The majority of Pond 008's embankment was stable and vegetated, however, the west bank contains some erosion rills and gullies. The erosion appears to have been caused by run-off from the roads above and down to the pond. **Pursuant to Rule 4.05.5(1)(c), the Operator shall repair the erosion and stabilize the west bank of Pond 008.** The Operator stated that they will likely install additional rock berms along the western-most road to help prevent run-off from running down the slopes and into the pond. The Operator also stated that they plan to remove the sediment (deposited as a result of the bank erosion) along the west bank of Pond 008.

- Pond 008:
  - The water in the pond was higher than it had been in recent inspections, but the pond still had plenty of available capacity (Photos 3 and 4).
  - The pond embankment still requires maintenance (see Item 2 in the outstanding maintenance items list on the first page of this report).
  - The primary and emergency spillways appeared clear and functional.
  - The flume was nearly full but was not discharging and did not appear to have been discharging recently (Photo 5). The flume has collected some sediment that the Operator may need to remove within the next few months.

*Photo 3: Looking north-east across Pond 008.*

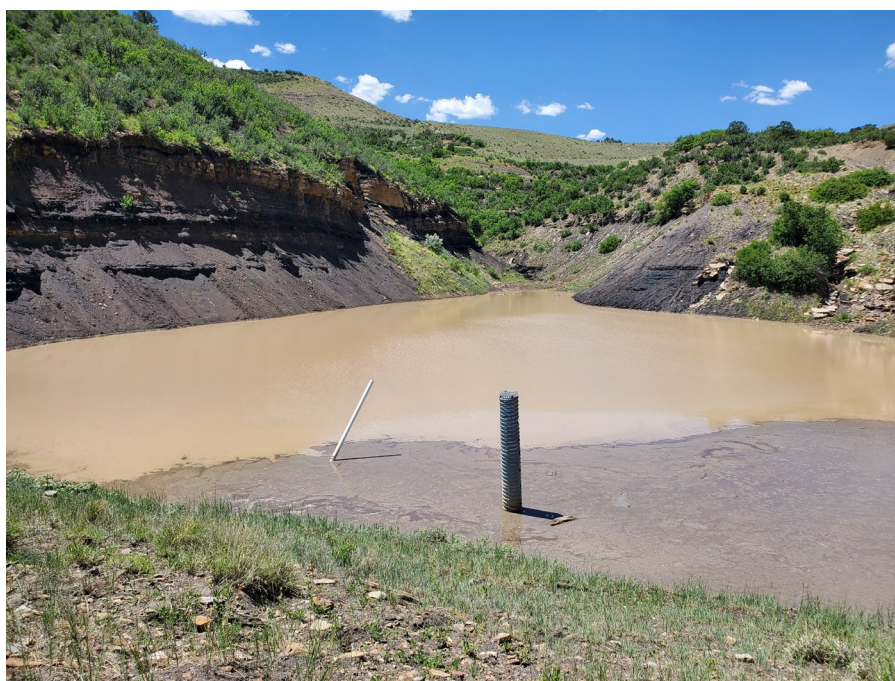
*Photo 4: Looking south across Pond 008.*

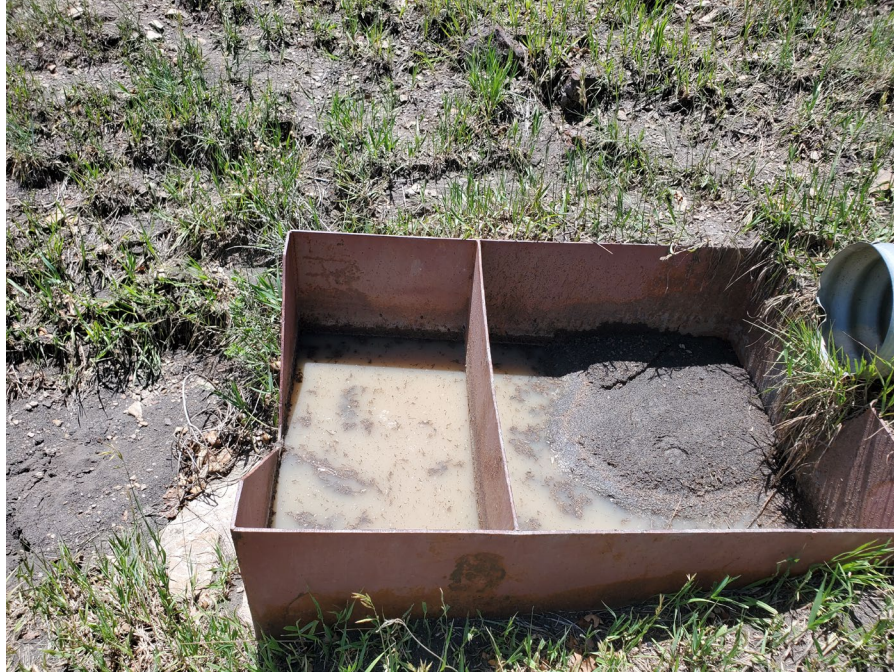
*Photo 5: Flume for Pond 008.*

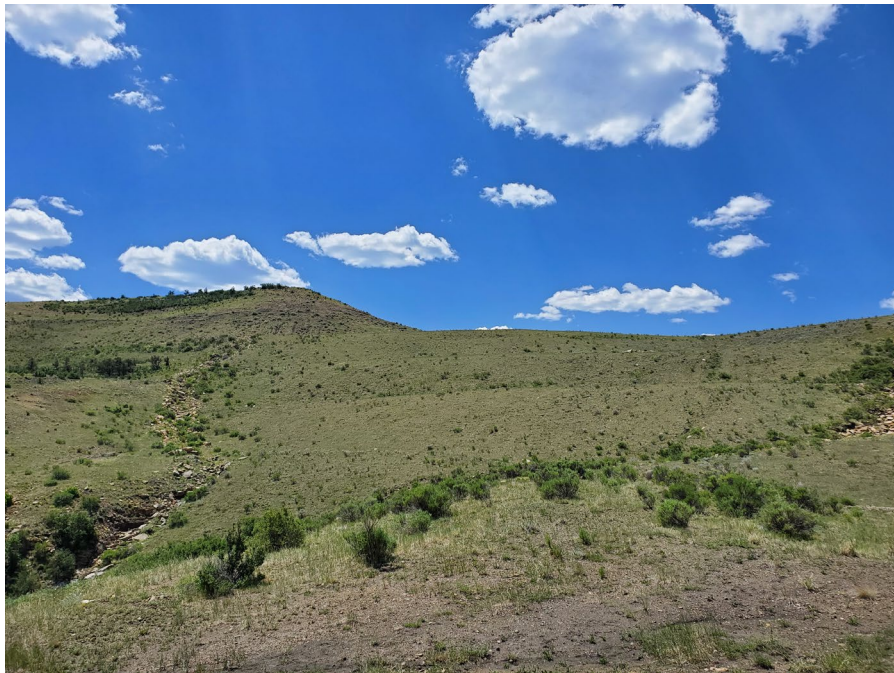
- Fill 007 was observed. Fill 007 was well vegetated and appeared stable.
- Fill 008 was observed. Fill 008 was well vegetated and appeared stable (Photo 6).

*Photo 6: Looking south-east at Fill 008.*

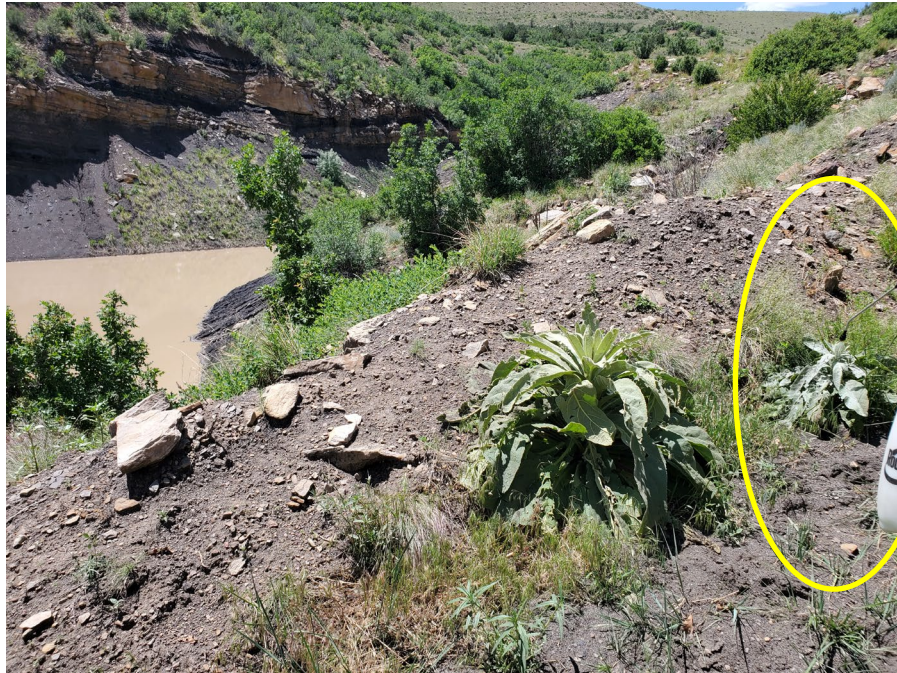
- Mullein, a Colorado State listed noxious weed, was observed along the west bank of Pond 008. The Operator brought weed spray and treated the Mullein observed along Pond 008 during the June inspection (Photo 7).

*Photo 7: Mullein observed along the west side of Pond 008. The yellow circle highlights the weed control being applied by the Operator during the inspection.*
