C-1981-035 King June 2024 Partial Inspection Report

Permit Number: C-1981-035 Mine Name: King Coal Mine Operator: GCC Energy, LLC Operator Address: Mr Jordan McCourt 6473 County Road 120 Hesperus, CO 81326	County: La Plata Operation Type: Underground Permit Status: Active Ownership: Private
	Operator Representative Present: Jordan McCourt
Operator Representative Signature: (Field Issuance Only)

Inspection Start Date: June 11, 2024 Inspection Start Time: 12:57 Inspection End Date: June 11, 2024 Inspection End Time: 15:00	Inspection Type: Coal Partial Inspection Inspection Reason: Normal I&E Program Weather: Clear
Joint Inspection Agency: None	Joint Inspection Contacts:
Post Inspection Agency: None	Post Inspection Contacts:
Inspector(s): Lucas West	Inspector's Signature:

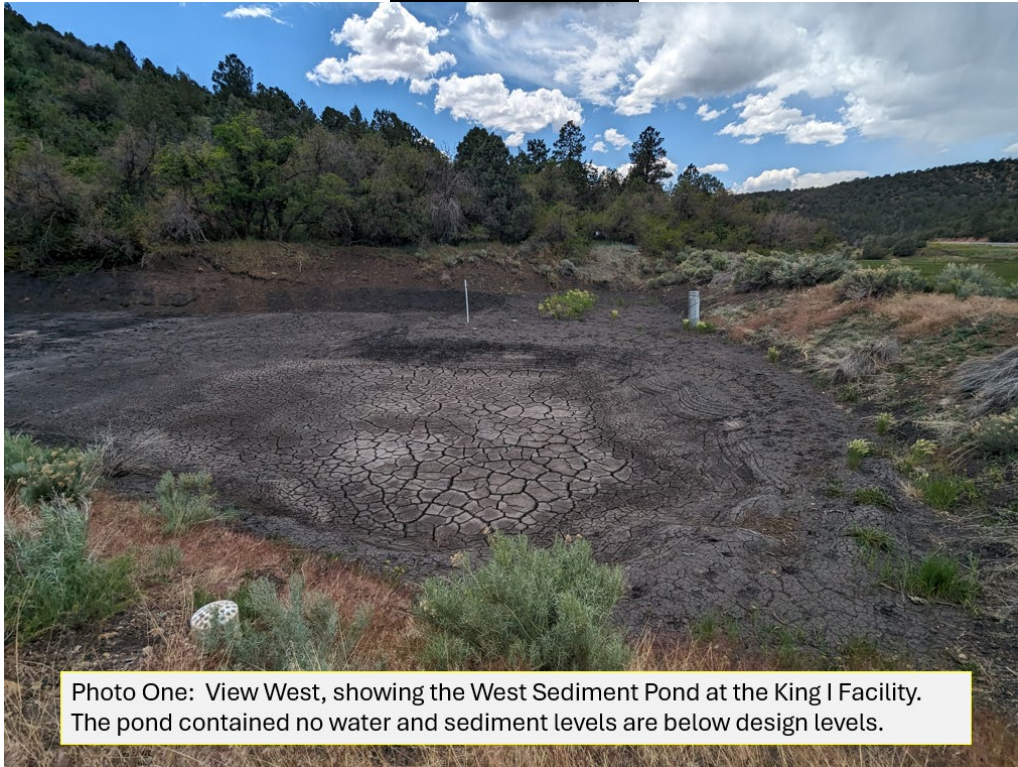
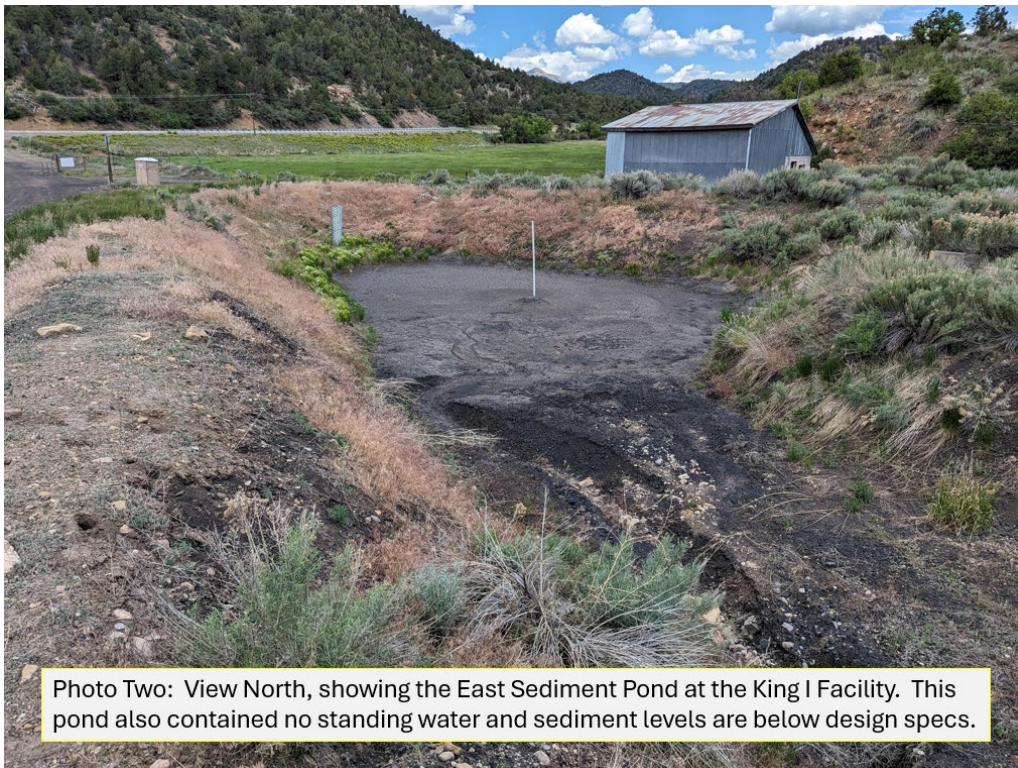
At the King I facility both the East and West Sediment Ponds were observed. Both ponds were in good condition and cleanout efforts started last summer have not yet resumed. The West Pond contained no standing water and sediment loads are well below design levels. The East Pond also contained no standing water and sediment levels are well below design levels. No evidence of discharge was observed and the inlet structures for both ponds are free from obstruction and able to function as designed. The ponds can be seen in Photos One and Two.

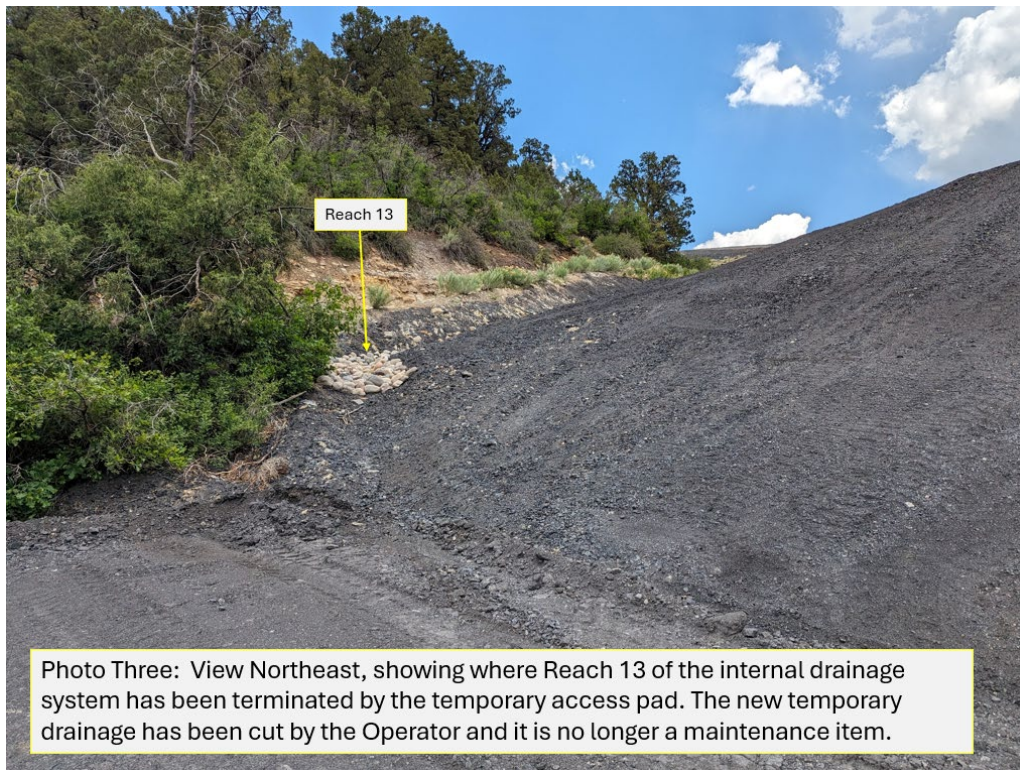
At the Lower Refuse Pile (LRP) a temporary access road has been constructed to place waste material on the face of the slope. The details of that plan will be discussed later in this report, however in doing so, the temporary access road and pad area that was constructed obstructed the path of Reach 13 of the internal drainage system. Reach 13 is designed to flow along the Northeast side of the LRP terminating in a sump that connects to Reach 7. The termination point of Reach 13 can be observed in Photo Three and was listed as a maintenance item as

mentioned in the introduction to this report. In the days following the inspection, the Operator has re-established Reach 13 and provided photo documentation of such. According to the Photos the drainage is able to function as designed and this maintenance item is considered resolved. A second drainage was also observed that needed to be re-established as well. The section of Reach 10 that crosses the access point to the LRP was observed to be temporarily filled in as seen in Photo Four. During times when the Operator is hauling Gob material to the LRP, that drainage is filled in to allow for truck traffic, and re-established at the end of the shift. At the time of the inspection they had anticipated hauling Gob material, however, due to personnel issues hauling activities were not active. Similar to Reach 13, the drainage was re-established the same day. Both maintenance items are considered resolved and no further action is needed from the Operator.

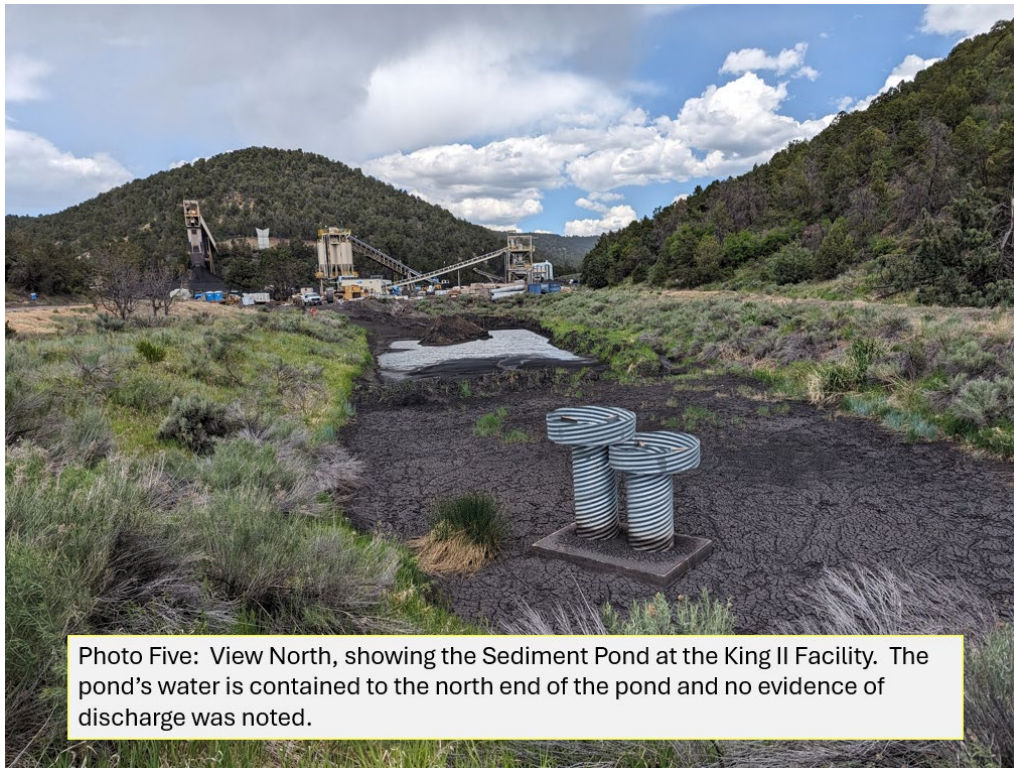
At the King II facility the main sediment pond was observed to be in good condition. The pond, as seen in Photo Five, contained standing water that was focused more on the North end of the Pond. Cleanout efforts that were started last summer have not yet resumed, and no evidence of discharge was noted. The banks are well vegetated and appeared stable at the time, and the inlet culverts were free from obstruction and able to function as designed. The upgradient culverts leading to the sediment pond were mostly clear and free from obstruction. The inlet of one culvert, identified as C5, along the access road needed to be cleaned of sediment. The culvert was actively being cleared as the inspection concluded and the Operator provided photo documentation that the work had been completed. This maintenance item is considered resolved and no further action is needed from the Operator.

Photo Five: View North, showing the Sediment Pond at the King II Facility. The pond's water is contained to the north end of the pond and no evidence of discharge was noted.

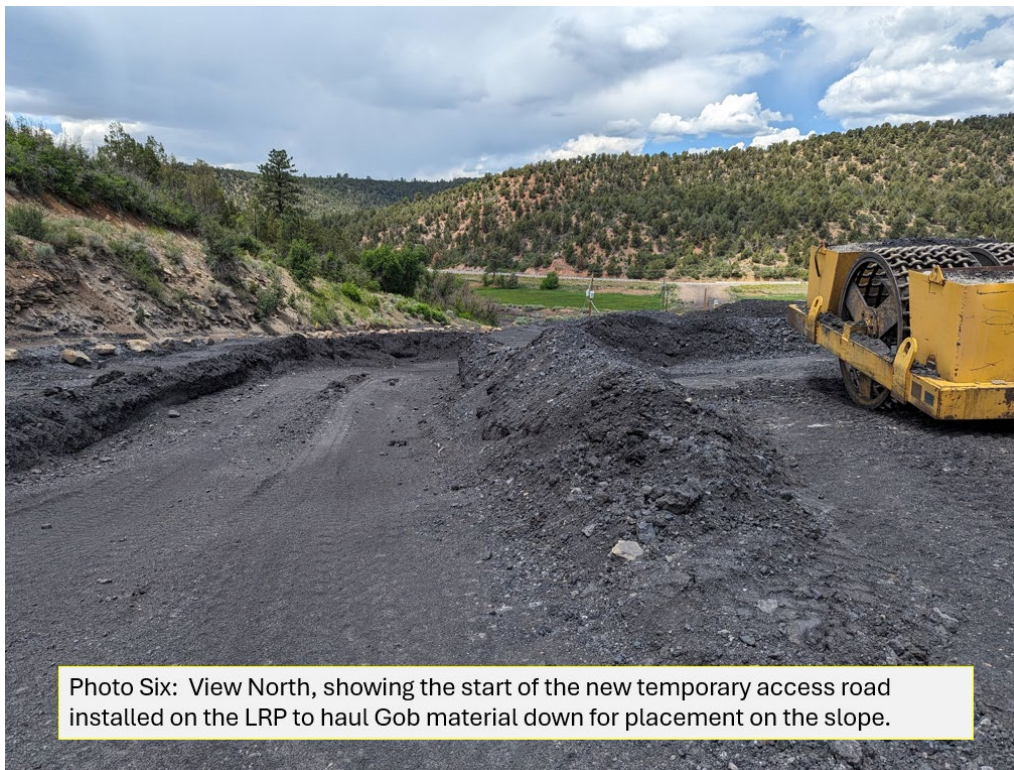
As stated previously in this report, the Operator has constructed a small access road from the top of the LRP to the toe of the existing slope for hauling operations to bring the existing stockpile of Gob material down to the toe of the slope for placement and compaction along the length of the slope. According to the Operator, recent surveys found that there was excess fill capacity along the slope to bring it up to final design levels. The access road and landing at the bottom of the road are both temporary in order to achieve this goal. According to the Operator the material will be trammed to the bottom, placed in lifts and compacted until the final slope is achieved. Any excess material will be cut with a dozer and placed on the top of the pile. The access road is in good condition and signs of settling or erosion was noted. The access road and lower landing can be seen in Photos Six through Eight. The outcome of the temporary road should result in the LRP matching the final designs as permitted and no problems were noted with this activity. On top of the LRP, the stockpile is in good condition and appeared stable at the time of the inspection.

Photo Six: View North, showing the start of the new temporary access road installed on the LRP to haul Gob material down for placement on the slope.

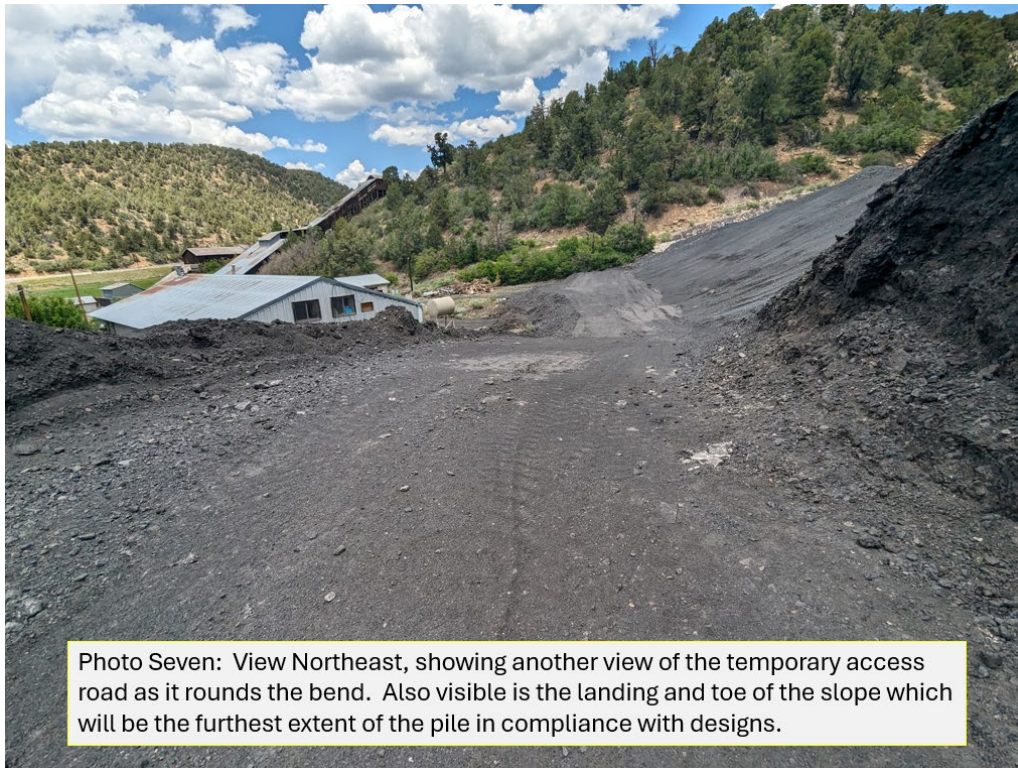
Photo Seven: View Northeast, showing another view of the temporary access road as it rounds the bend. Also visible is the landing and toe of the slope which will be the furthest extent of the pile in compliance with designs.

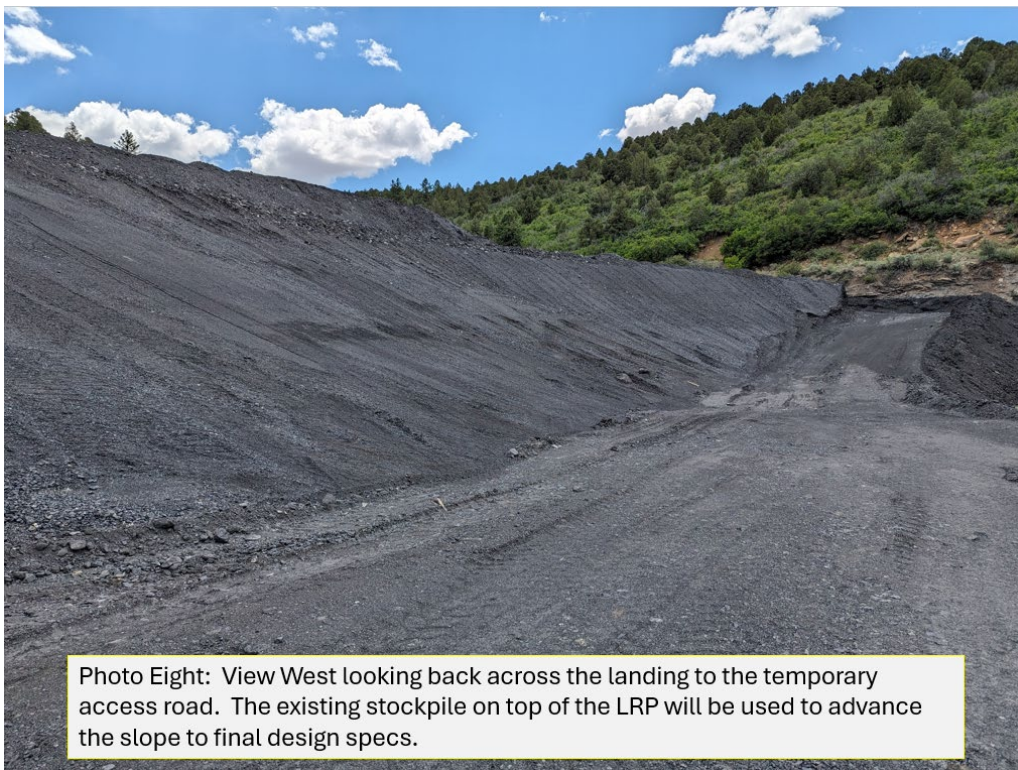
Photo Eight: View West looking back across the landing to the temporary access road. The existing stockpile on top of the LRP will be used to advance the slope to final design specs.
