June 13, 2024 Project No.: 19125 350 Indiana Street, Suite 750 Golden, Colorado 80401 303.625.9502

Regarding: Daniels Sand Pit 2, Permit No. M-1973-007-SG

Slope Stability Monthly Monitoring Report

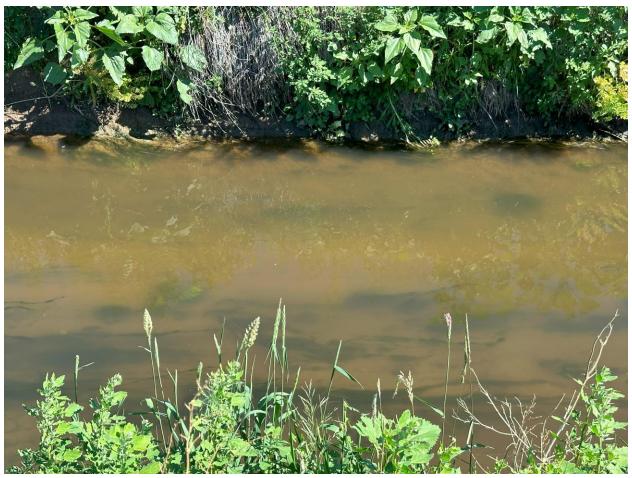
Photo 1. Water flowing in ditch

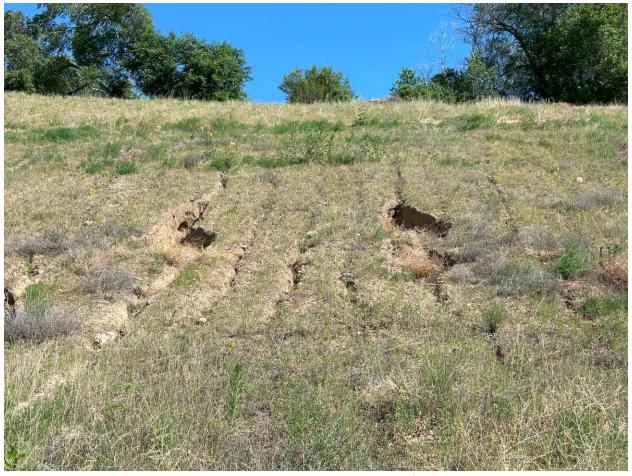
- 1) Several erosion gullies exist within the embankment slope. We recommend those areas be reconstructed ASAP and that the areas be seeded per the reclamation plan.
- 2) Weather: 85°, sunny, slight wind
- 3) Visual observation of the Fountain Mutual Ditch and ditch road:
 - a) No tension cracks.
 - b) Vegetation growing on banks of ditch and on invert.
 - c) Flowing water.
- 4) Visual observations of the Buttress Slope
 - a) The buttress slope varies from 3H:1V to 4H:1V.
 - b) It is our understanding that seeding of the buttress will take place this summer. Majority of the buttress is covered in natural vegetation/weeds.
 - c) Several locations show visible evidence of surface water runoff and expanding erosion gullies throughout the buttress.
 - d) Several broken trees exist on the slope/buttress crest near the ditch access road.

Photo 2. Erosion gullies in western area of buttress

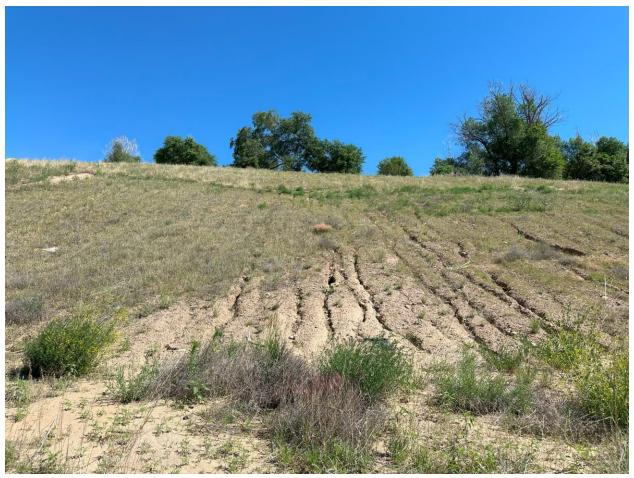
Photo 3. Erosion gullies in western area of buttress

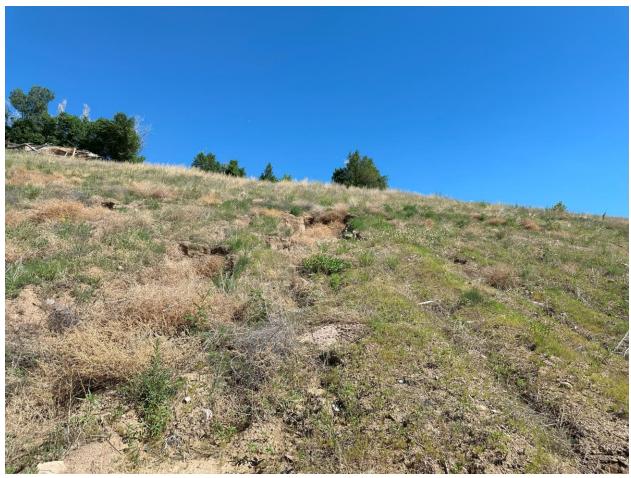
Photo 4. Erosion gully in eastern portion of buttress

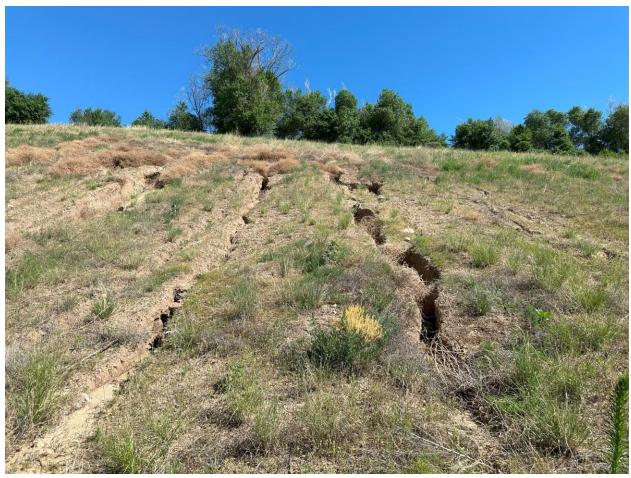
Photo 5. Erosion gullies in central area of buttress

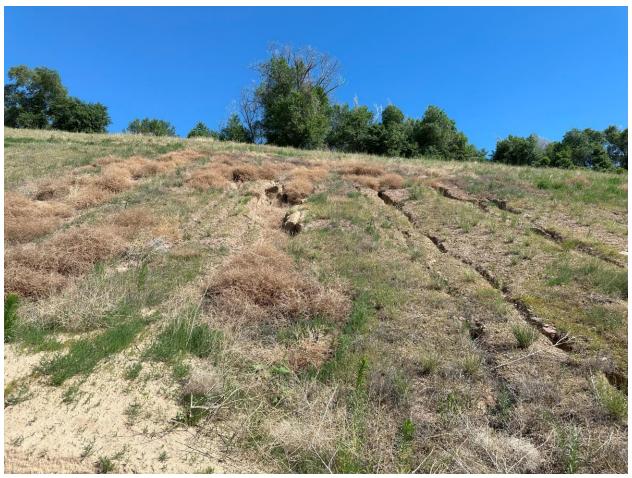
Photo 6. Erosion gullies in central area of buttress

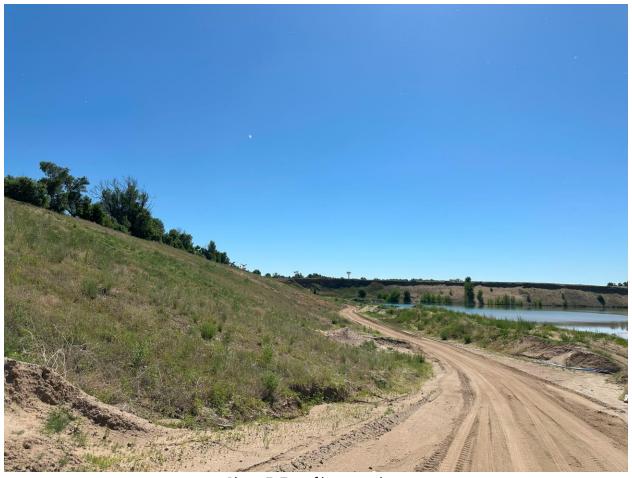
Photo 7. Toe of buttress slope

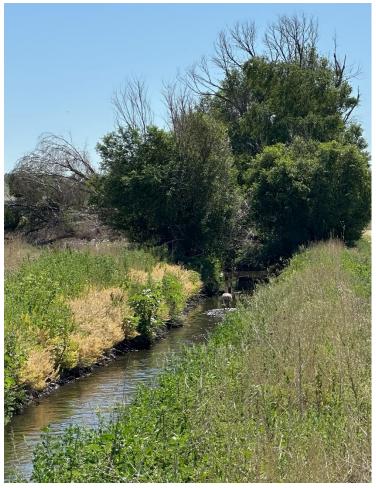
Photo 8. Deer in ditch

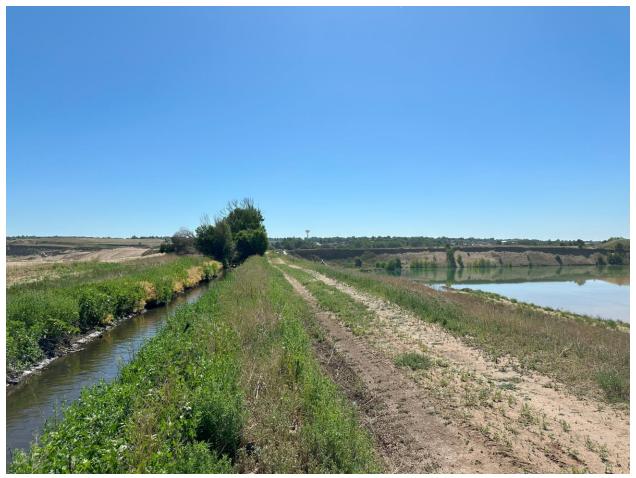
Photo 9. Ditch and access road looking east

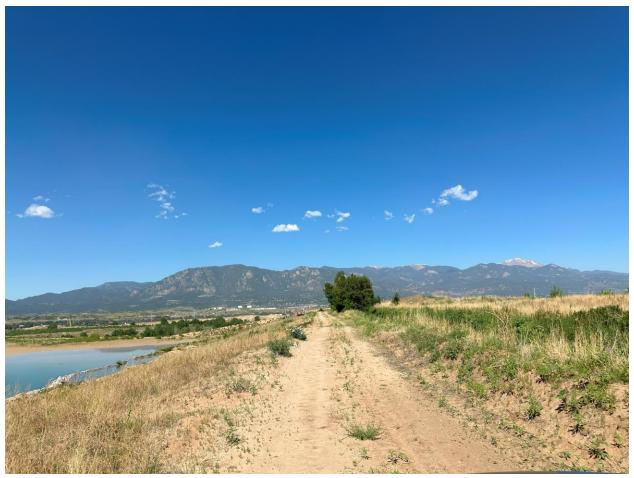
Photo 10. Ditch and access road looking west

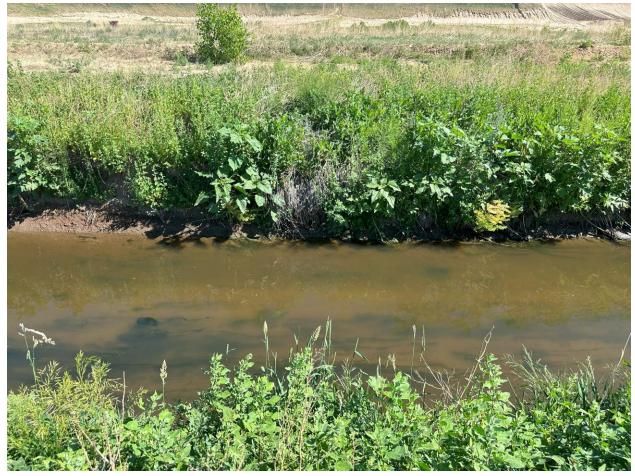
Photo 11. Ditch looking north
