MINERALS PROGRAM INSPECTION REPORT

MINE NAME: AFS - Bennett Pit	MINE/PROSPECTING ID#: M-2001-038	MINERAL: Sand & borrow material	COUNTY: Adams
INSPECTION TYPE: Monitoring	WEATHER: Clear	INSP. DATE: May 21, 2024	INSP. TIME: 13:00
OPERATOR: Albert Frei & Sons Inc.	OPERATOR REPRESENTATIVE: Joel Boldoc and Martina Gilbert	TYPE OF OPERATION: 112c - Construction Regular Operation	
REASON FOR INSPECTION: Citizen Complaint	BOND CALCULATION TYPE: None	BOND AMOUNT: \$487,175.00	
DATE OF COMPLAINT: April 23	POST INSP. CONTACTS: None	JOINT INSP. AGENCY: County	
INSPECTOR(S): Nikie Gagnon	INSPECTOR'S SIGNATURE:

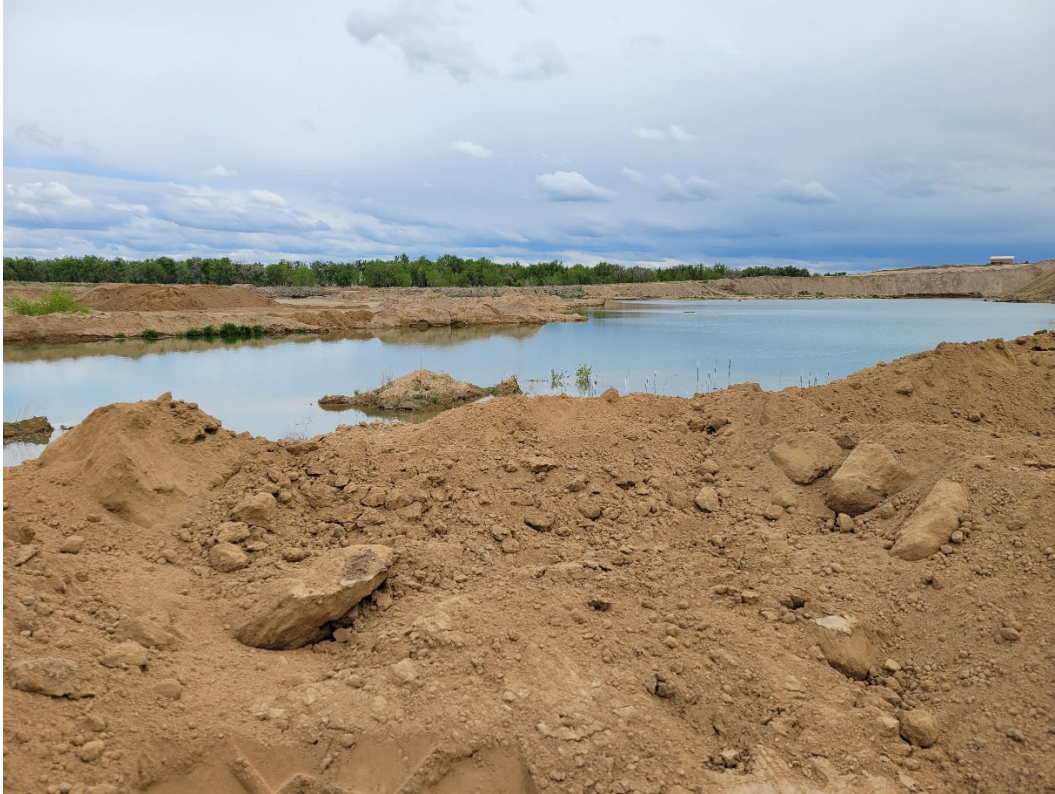
During this inspection, the Division observed exposed groundwater in the southern pit area (Photos 1-3). The water was estimated to be 2-5 feet in the bottom of the pit, which runs south to north in this area. The Operator has begun backfilling the north end of the pit and the current exposed groundwater is approximately 8 acres. Based on observations during this inspection, the Operator is not in compliance with Section 34-32.5-116(4)(h) of the Colorado Revised Statutes and Rule 3.1.6(1)(a) of the Construction Materials Rules and Regulations governing injury to existing water rights (See Problem 1 above). Therefore, within 60 days, the Operator shall provide proof to the Division they have submitted an application for a well permit and Substitute Water Supply Plan through the Colorado Division of Water Resources to address the exposed groundwater. The Operator shall continue to backfill the pit to 2 feet above current groundwater level, and/or, per the approved AM1, the Operator shall submit an amendment application to the Division to update the mining and reclamation plans to incorporate mining below the water table and the associated pit lining in the southern portion of the permit area.

Photo 1: Looking southeast at ponded water in the southern pit.

CORRECTIVE ACTIONS: The operator shall demonstrate that the operation is in compliance with the Office of the State Engineer, show evidence that the operator is taking measures to bring the site into compliance with the SEO, or backfill the pits to at least two feet above the groundwater surface by the corrective action date specified.

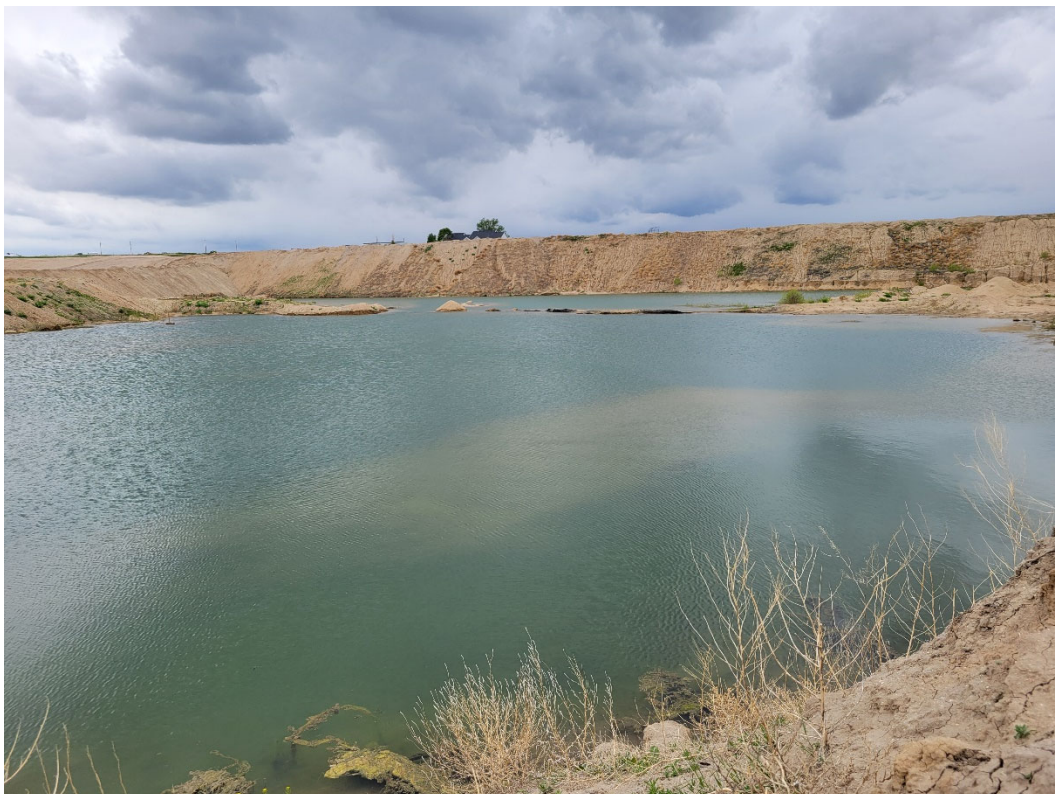
Photo 2 Looking west towards the highwall in the southern pit.

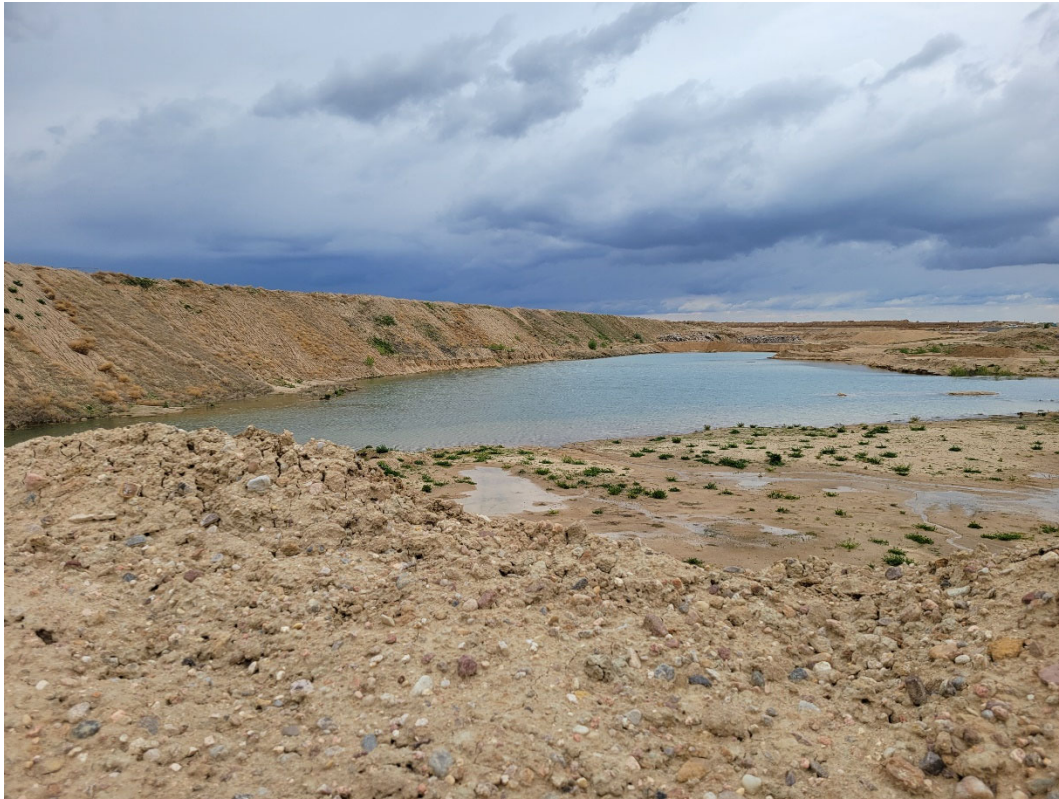
Photo 3: Looking north across the southern mined pit.

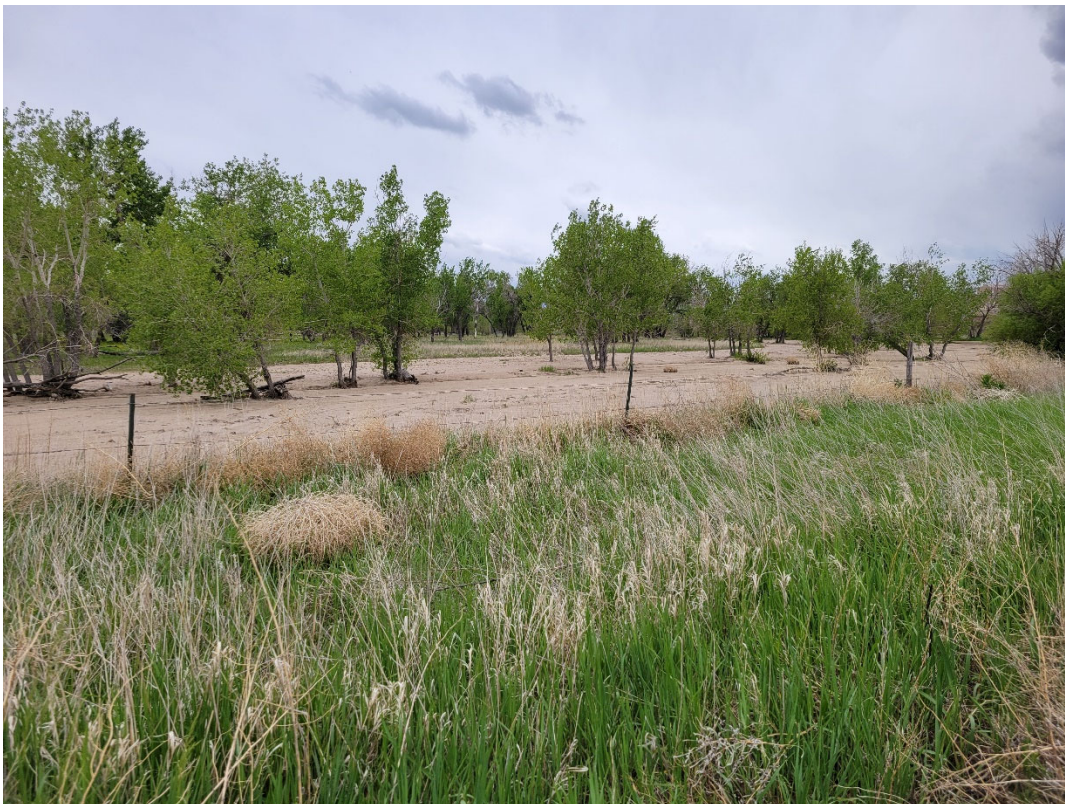
Photo 4: Looking southeast at Kiowa Creek, adjacent to the eastern side of the permit area.

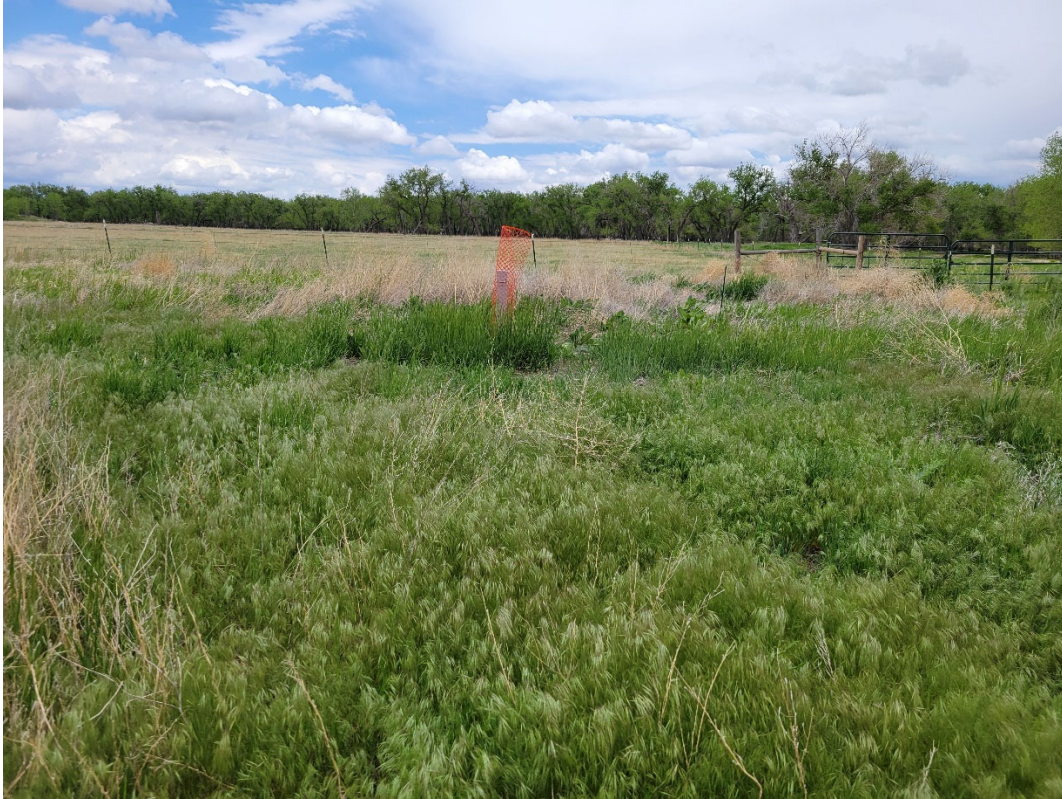
Photo 5: Monitoring Well #4 on the southeastern side of the permit area.

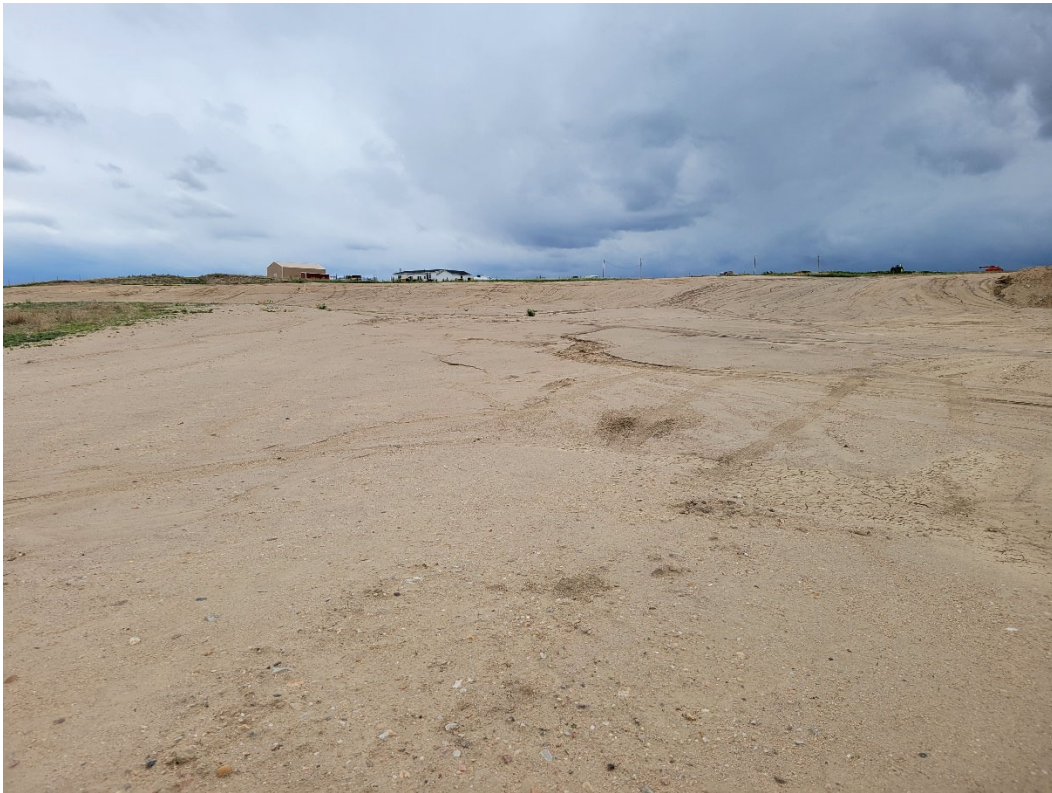
Photo 6: Looking at recently backfilled and graded area at the southern end of the permit area. Slopes are generally 3H:1V.

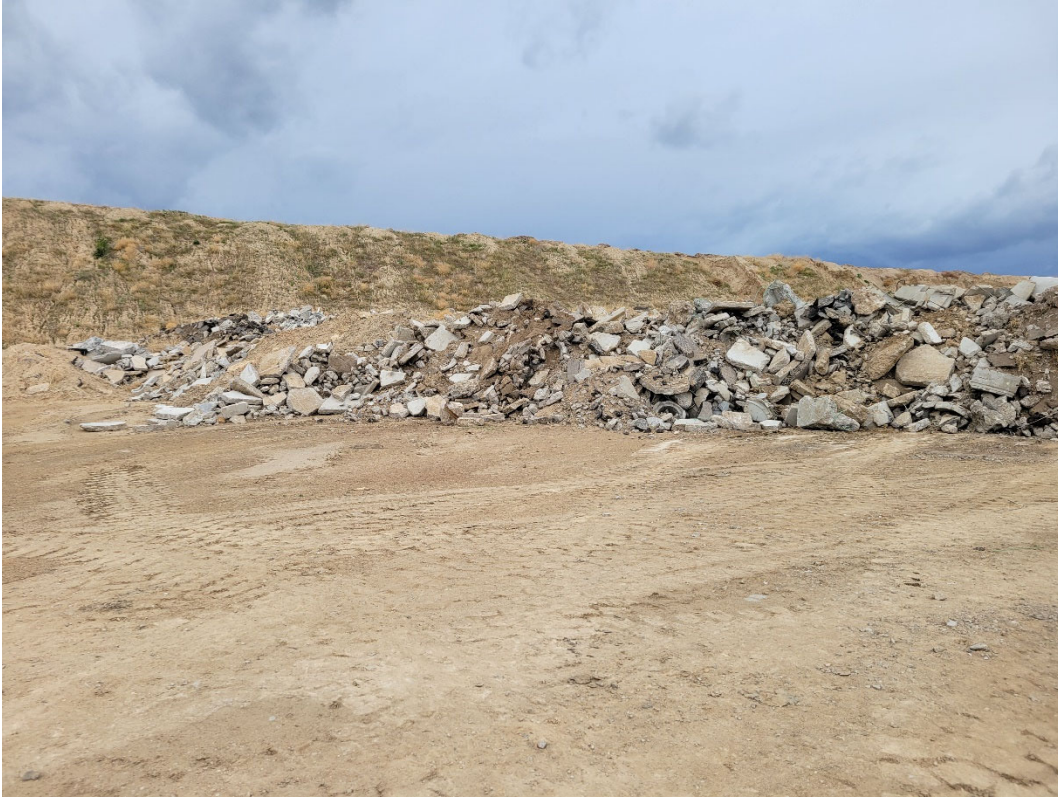
Photo 7: Center of the previously mined area. Inert fill placed along the western highwall.

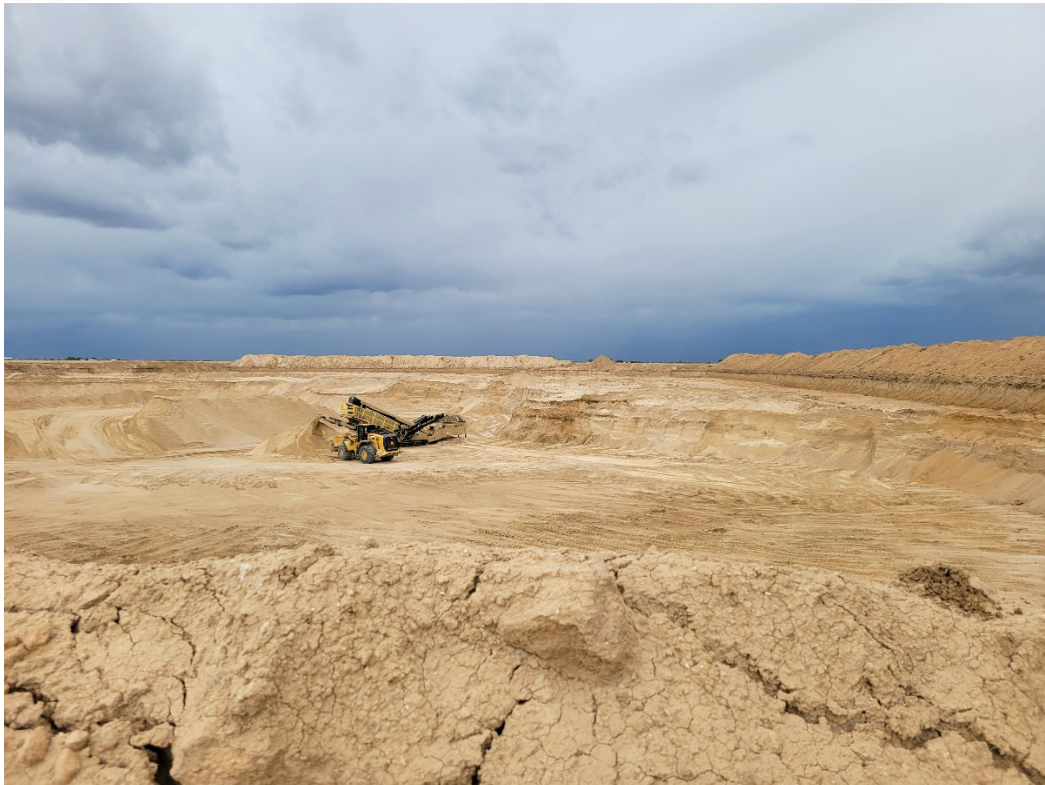
Photo 8: Active mining on the north end of the permit area.

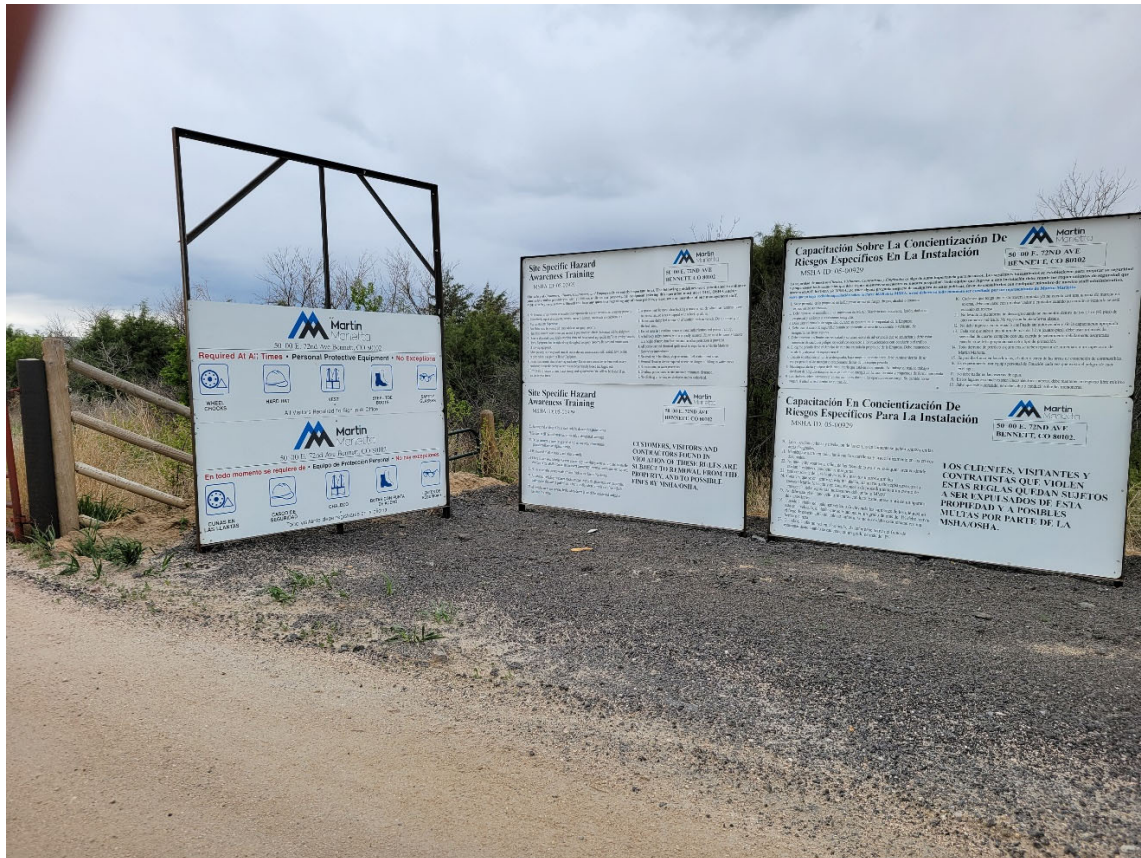
PROBLEM: The mine identification sign was not posted at the entrance of the mine site. This is a problem for failure to post a mine identification sign as required by Section 3.1.12(1) of the rule. The Operator shall, at the entrance of the mine site post a sign, which shall be clearly visible from the access road, with a minimum size equaling one hundred and eighty-seven (187) square inches, such as eleven (11) inches in height and seventeen (17) inches in width, with appropriate font size, with the following: the name of the Operator, a statement that

The Division observed the mine signage at the entrance to the permit area (Photo 9). The required mine identification sign was not posted at the entrance. This is a problem for failure to post a mine identification sign as required by Section 3.1.12(1) of the rule (See Problem 2 above). The Operator shall, at the entrance of the mine site post a sign, which shall be clearly visible from the access road, with a minimum size equaling one hundred and eighty-seven (187) square inches, such as eleven (11) inches in height and seventeen (17) inches in width, with appropriate font size, with the following: the name of the Operator, a statement that a reclamation permit for the operation has been issued by the Colorado Mined Land Reclamation Board; and the permit number. Please note, Martin Marietta is not the current operator of the permit. According to correspondence submitted to the Division on January 13, 2024, Albert Frei and Sons remains a viable company within Martin Marietta. Therefore, the mine sign must show Albert Frei and Sons as the operator, or Martin Marietta shall submit a Transfer of Mineral Permit and Succession of Operator application to the Division.

Photo 9: Signage placed at the entrance to the site. Required mining permit sign is missing.

CORRECTIVE ACTIONS: The operator shall, at the entrance of the mine site, post a sign which shall be clearly visible from the access road with the following: the name of the operator, a statement that a reclamation permit for the operation has been issued by the Colorado Mined Land Reclamation Board; and the permit number. The operator shall submit photo documentation that a proper sign has been posted by the corrective action date.

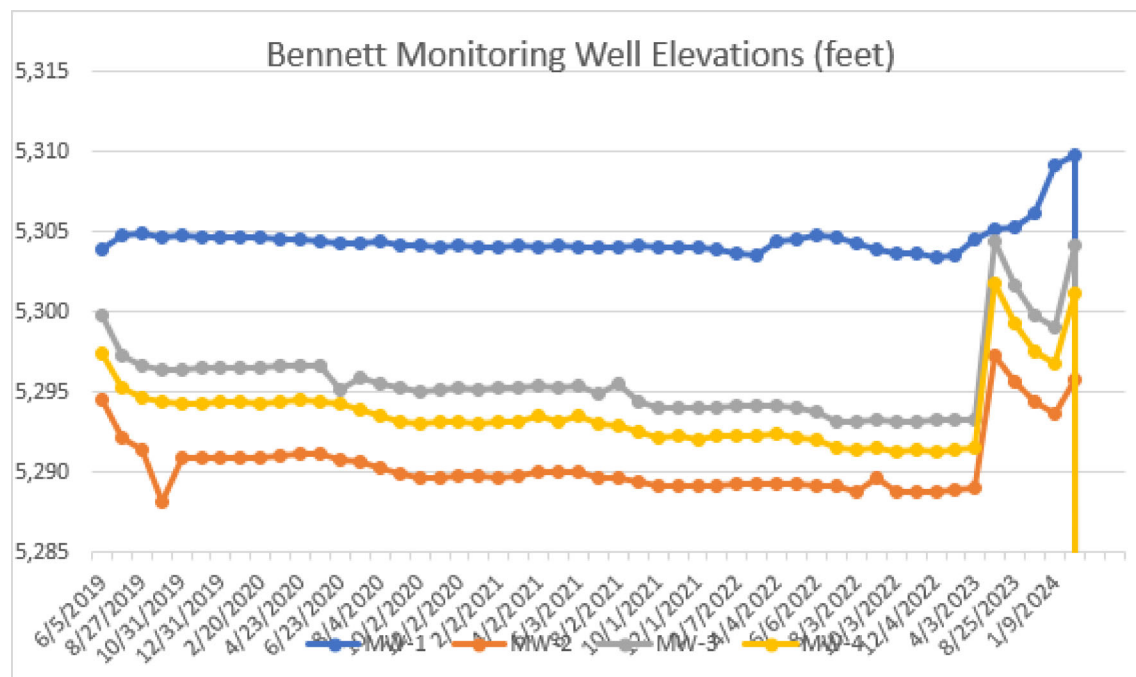
Below is the updated groundwater chart. MW-2, MW-3 and MW-4 are adjacent to the creek and MW-1 is further west (away) from the creek.
