New Elk Mine, C-1981-012, Inspection Report

PERMIT INFORMATION

Permit Number: C-1981-012 Mine Name: New Elk Mine Operator: New Elk Coal Company, LLC Operator Address: Mr. John Terry 12250 Highway 12 Weston, CO 81091	County: Las Animas Operation Type: Underground Permit Status: Active Ownership: Private
	Operator Representative Present: John Terry
Operator Representative Signature: (Field Issuance Only)

Inspection Start Date: June 12, 2024 Inspection Start Time: 12:05 Inspection End Date: June 13, 2024 Inspection End Time: 10:40	Inspection Type: Coal Complete Inspection Inspection Reason: Normal I&E Program Weather: Clear
Joint Inspection Agency: None	Joint Inspection Contacts:
Post Inspection Agency: None	Post Inspection Contacts:
Inspector(s): Amber M. Gibson	Inspector's Signature:

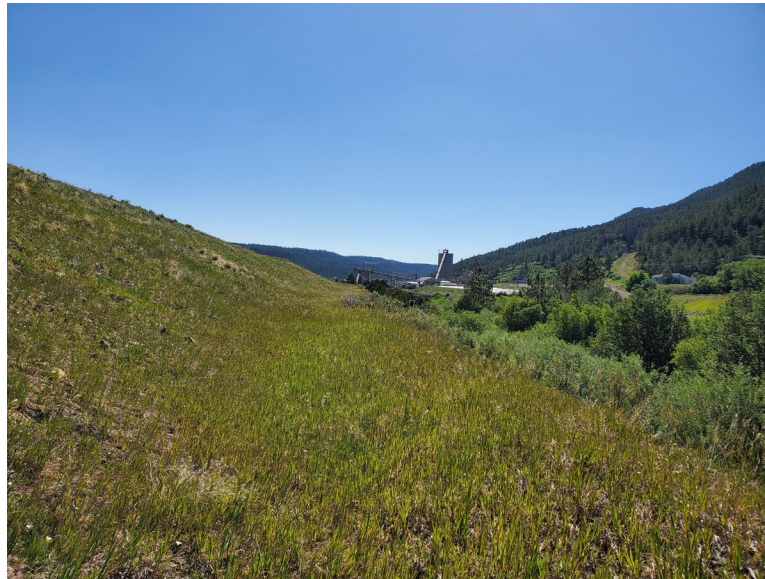
- The Division and the Operator walked along the berms around the south and west sides of DWDA #1 and #2 (Photos 1 and 2). The berms appear to be stable and are functioning at this time.

Photo 1: Looking east along D4, south of DWDA #1.

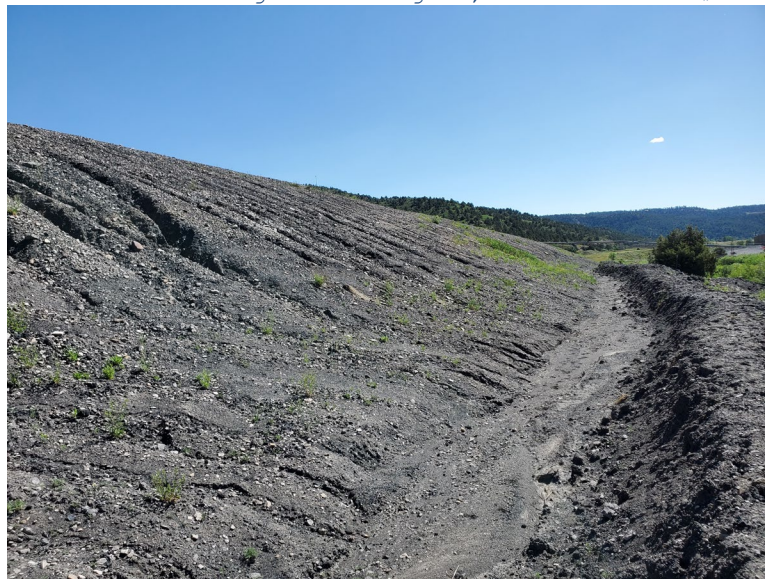
Photo 2: Looking east along D14, south of DWDA #2.

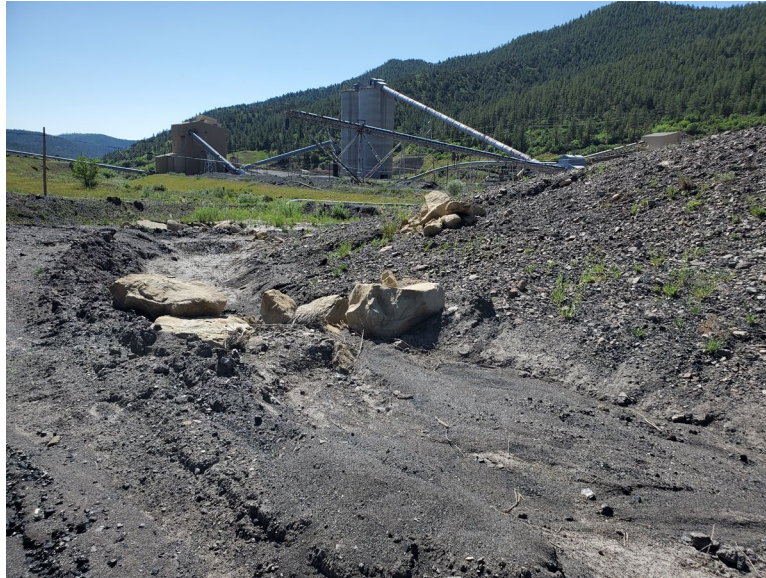
- The sediment basin at the east end of DWDA #2 held water at the time of the inspection. The berm around the basin appeared to be stable and has recently been improved. The check dam in the north-east corner of ditch D14 (around the DWDA #2) is beginning to fill with sediment (Photo 3). The Operator shall monitor the check dams and clean them of sediment within the next few months. The check dams still appear to be functional at this time.

Photo 3: First check dam, located on the north-east side of DWDA #2.

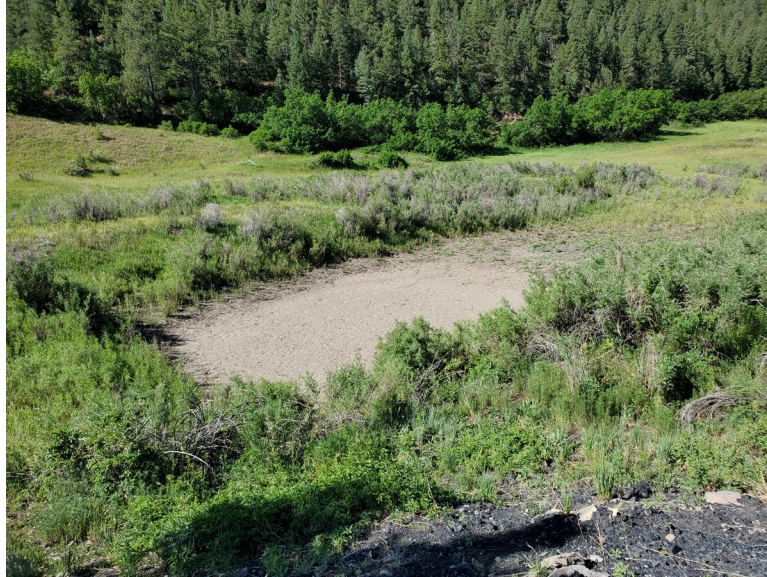
Photo 4: Containment 1

- Containment area #1 was dry (Photo 4). No signs of erosion were observed.

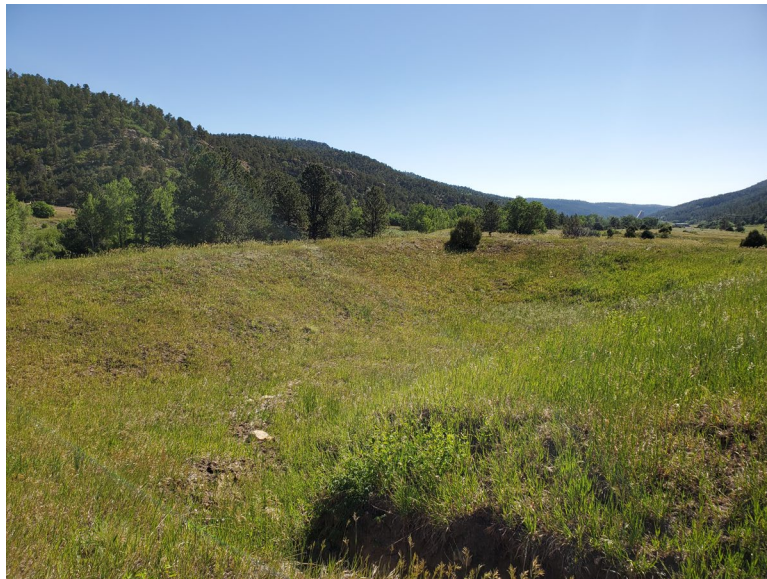
Photo 5: Containment 2

- Containment area #2 was dry (Photo 5). No signs of erosion were observed.

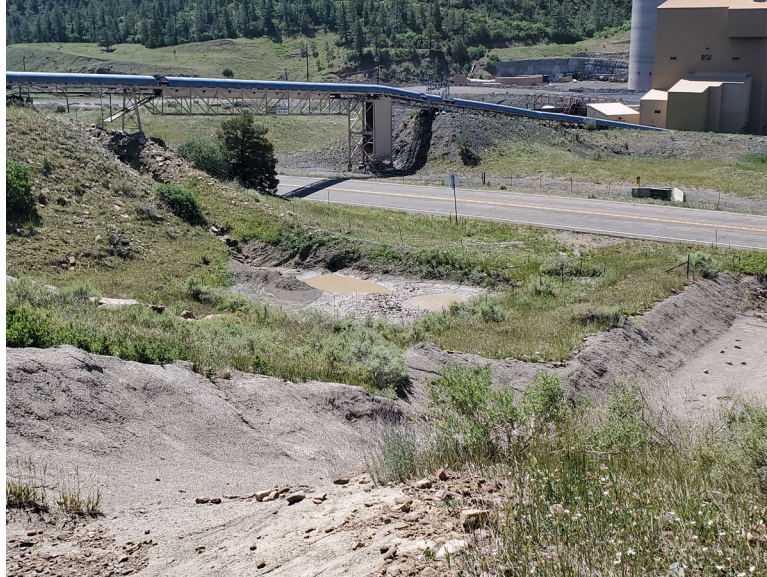
Photo 6: Containment 5 (north of Highway 12)

- Containment area #3 was dry. No signs of erosion were observed.
- Containment area #4 was dry. No signs of erosion were observed.
- Containment area #5 contains water and is below capacity (Photo 6).

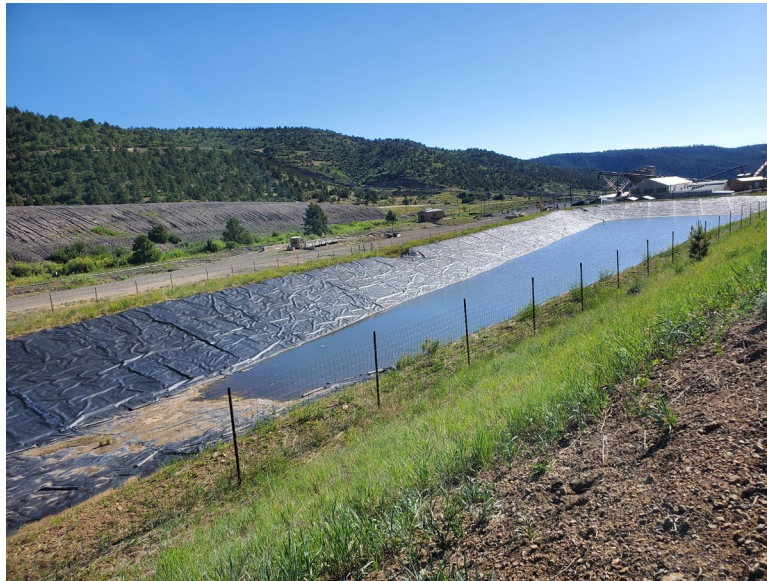
Photo 7: Pond 001A

- Stream buffer zones were observed throughout the site.
- Pond 001A held water at the time of the inspection, and was not discharging (Photo 7).

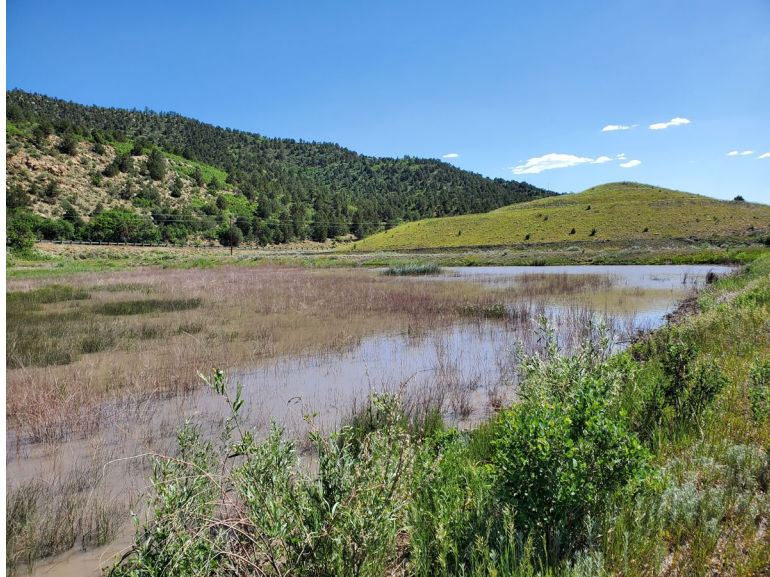
Photo 8: Pond 004A.

- Pond 004A contained water, primarily from water pumped from Ponds 007a, 006a, and 08 (Photo 8). Pond 004A was not discharging. The bank appeared to be stable.

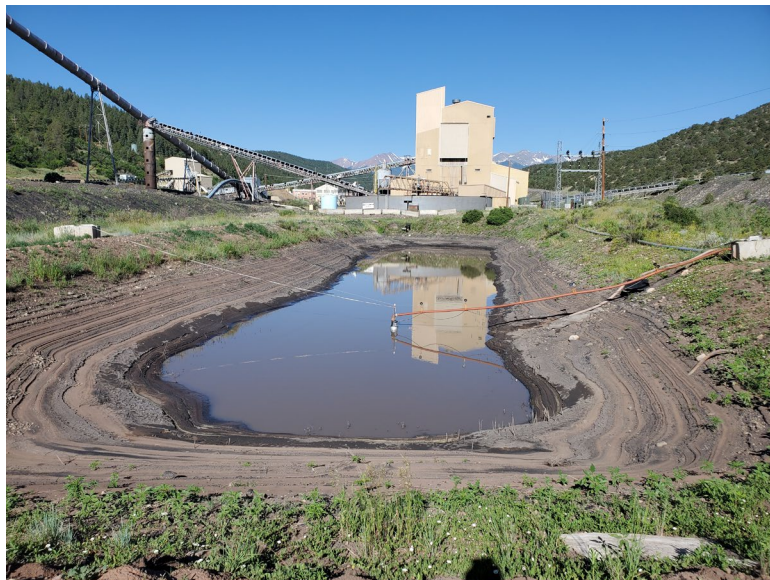
Photo 9: Pond 006A

- Pond 006A contained some water and was being pumped at the time of the inspection (Photo 9). The Operator stated that that was the last day that the site would have the generator that was being used to pump the pond. He stated that there was still one more generator, and that they also have gas pumps that may be used if needed.

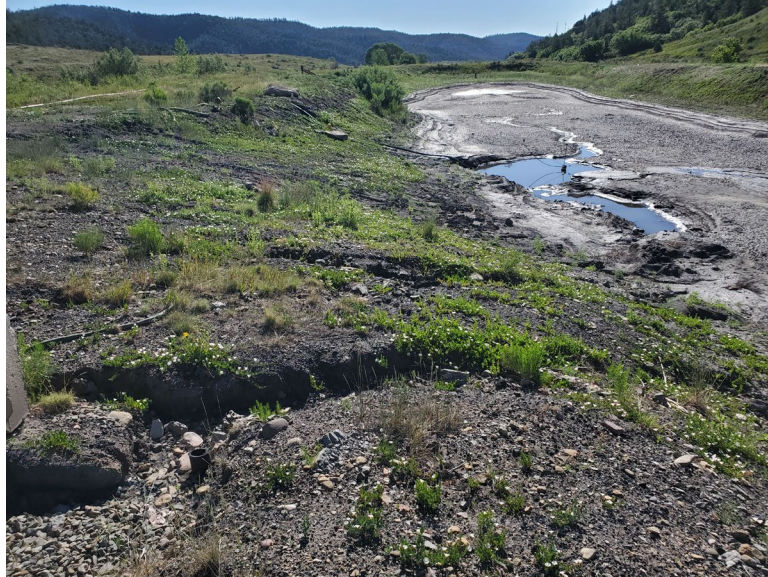
- Pond 007A contained a small amount of water but was not discharging. The emergency spillway was free of obstructions and the embankment appeared to be stable. The Operators had recently repaired the north and west banks of Pond 007A. However, the Division observed what seems to be new erosion on the north-west side of the northern bank. **The Operator shall repair the erosion on the bank** (Photo 10).

Photo 10: Looking east across Pond 007A. In the foreground of the photo is the erosion along the north-west bank of Pond 007A.

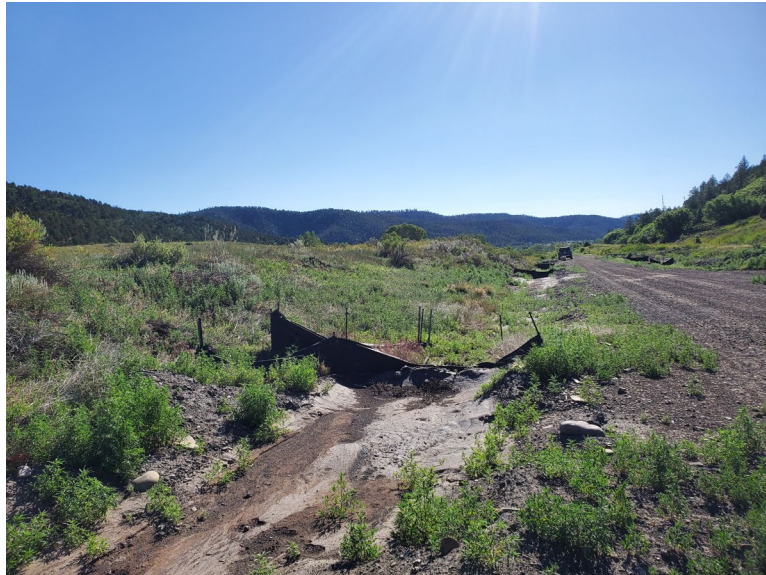
- **The silt fences along the SAE near Pond 007A that were damaged as a result of snowfalls, mentioned in the January - May 2024 reports, still need to be repaired.** The western-most silt fence on the north side of the access road and the south side of Pond 007A (Photo 11) is in the most disrepair. The following silt fences in the sequence are in decent condition and appear to be functioning properly.

Photo 11: Western-most silt fence along the north side of the access road and south side of Pond 007A.

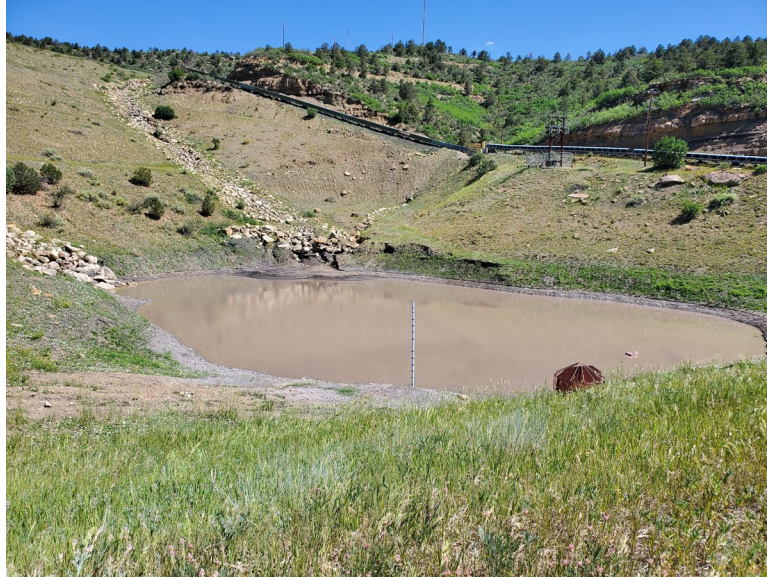
Photo 12: Pond 08

- Pond 08 contained some water, and was well below its capacity (Photo 12). The spillways appeared clear, and the banks were stable. Pond 08 was not discharging.

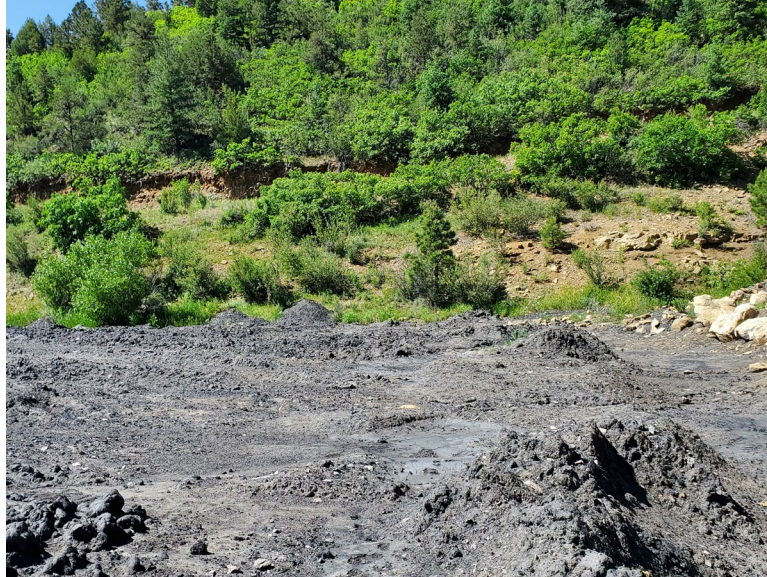
- The mine was idle at the time of the inspection. Therefore, the wash plant was not processing coal at the time of the inspection. The RDA appears to exhibit positive drainage at this time (Photo 13). The underdrains in the northeast and northwest corners appear to be clear of obstructions, and appear to be functioning as intended.

Photo 13: Looking west at the north-west corner of the RDA. Ditch D55 is clear of obstructions.

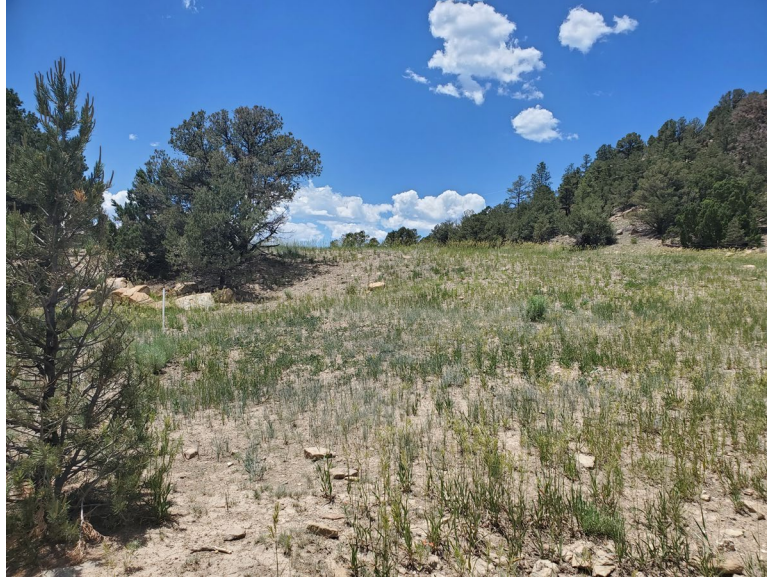
- During the November 2024 inspection, the Division observed that the former Golden Eagle ventilation shaft area had been grazed. The grazing and cattle occupancy at the vent shaft area had significantly impacted the revegetation reclamation efforts within the area. The Operator was advised that they may need to re-vegetate this area prior to consideration of its release. During the March 2024 inspection, it appeared that some vegetation had been able to re-establish, but may still need to be re-vegetated prior to consideration of its release. During the current June 2024 inspection, a lot more vegetation had established (Photo 14), however there are still a few bare spots. The Operator is advised to monitor this area and consider re-seeding if necessary.

Photo 14: Establishment of some grasses in the Golden Eagle ventilation shaft area.

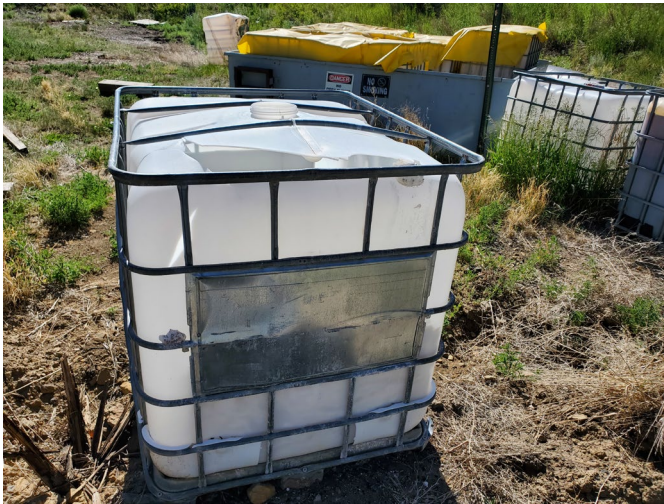
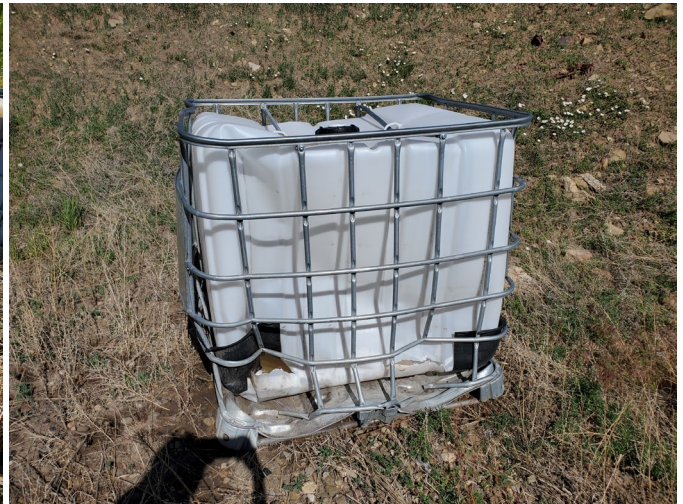
- The berm separating the yard from the Purgatoire River appears to be stable.
- The Portable Explosives and Chemical Storage area was overall stable. However, the Division observed a broken tank containing a small amount of Magnesium Chloride (Photo 15 – Left) and a broken empty tank (Photo 15 - Right). **The Operator stated that they will either replace or remove these tanks.**

Photo 15: Left - The top is cracked on the Magnesium Chloride tank. Right - Cracked and crushed empty tank.

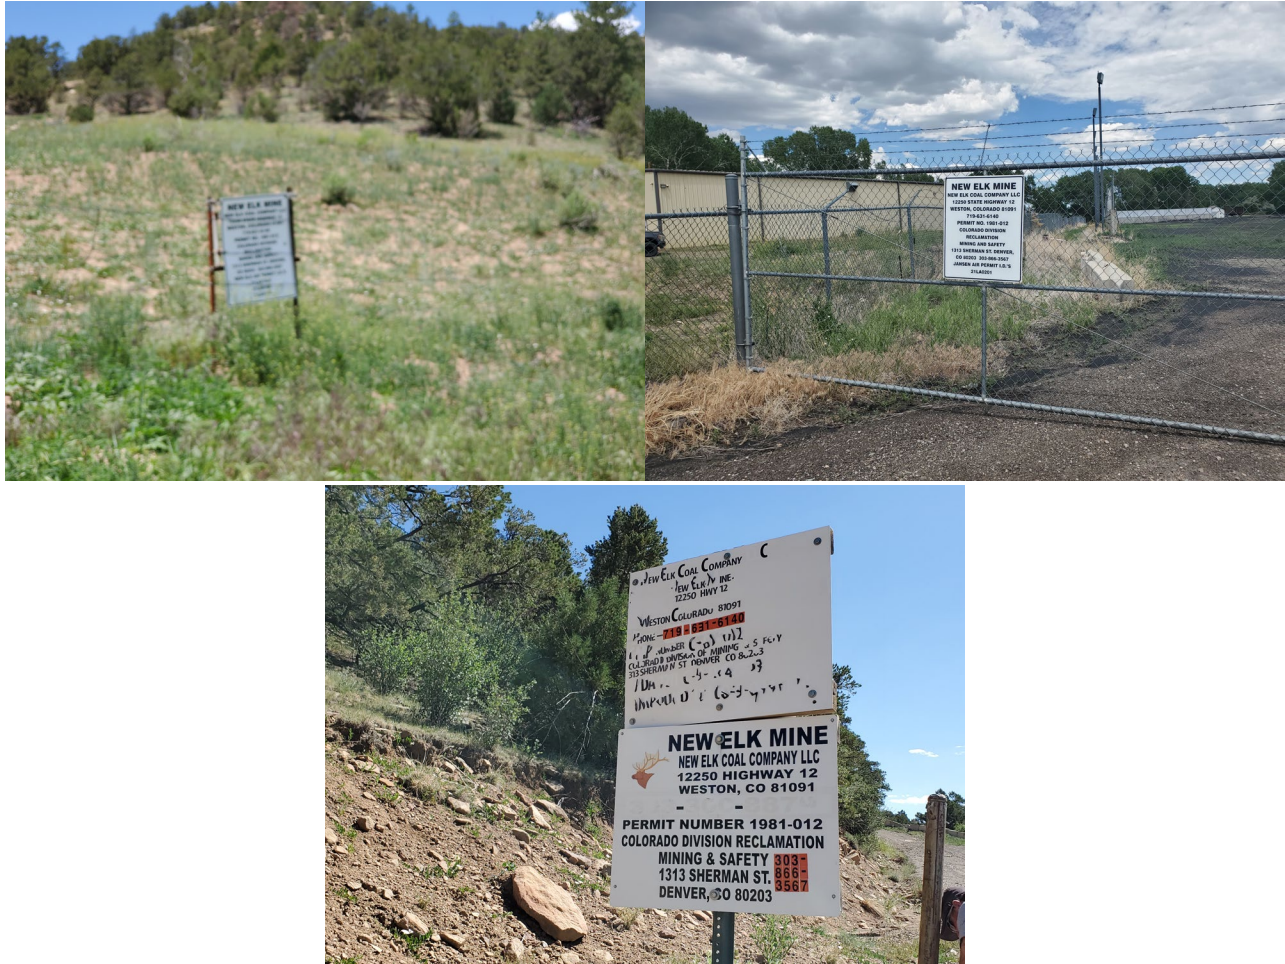
- A mine sign was posted at the main entrance to the New Elk mine site, the Golden Eagle ventilation shaft area, and at the Jansen Loadout in compliance with Rule 4.02 (Photo 16).

Photo 16: Top left – Sign at Golden Eagle Entrance. Top right – Sign at Jansen Loadout Entrance. Bottom – Sign at entrance to the RDA.

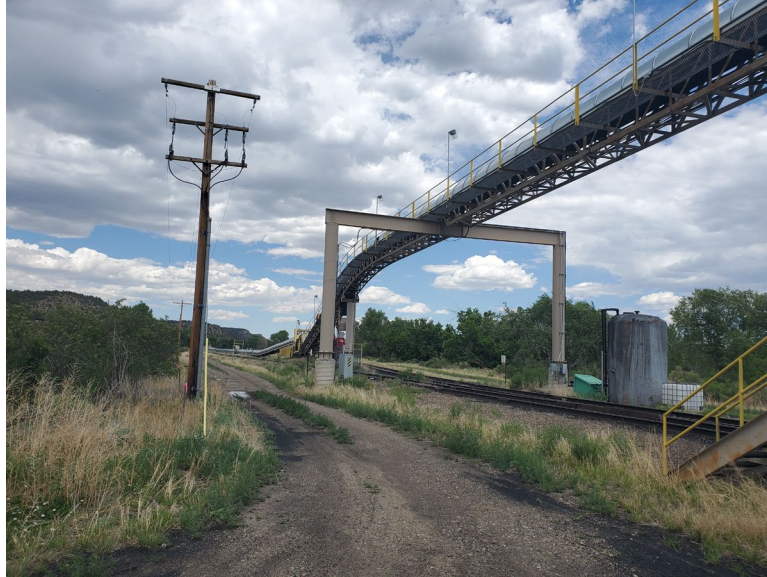
- The facilities at the Jansen Loadout were observed. All equipment on-site appears to be stable at the time of the inspection (Photo 17).

Photo 17: Conveyor belt at the Jansen Loadout
