MINERALS PROGRAM INSPECTION REPORT

MINE NAME: Climax Mine	MINE/PROSPECTING ID#: M-1977-493	MINERAL: Molybdenum	COUNTY: Lake, Summit
INSPECTION TYPE: Monitoring	WEATHER: Clear	INSP. DATE: June 12, 2024	INSP. TIME: 12:00
OPERATOR: Climax Molybdenum Company	OPERATOR REPRESENTATIVE: Eric Detmer	TYPE OF OPERATION: 112d-3 - Designated Mining Operation

INSPECTION TOPIC: Acid And Toxic Materials

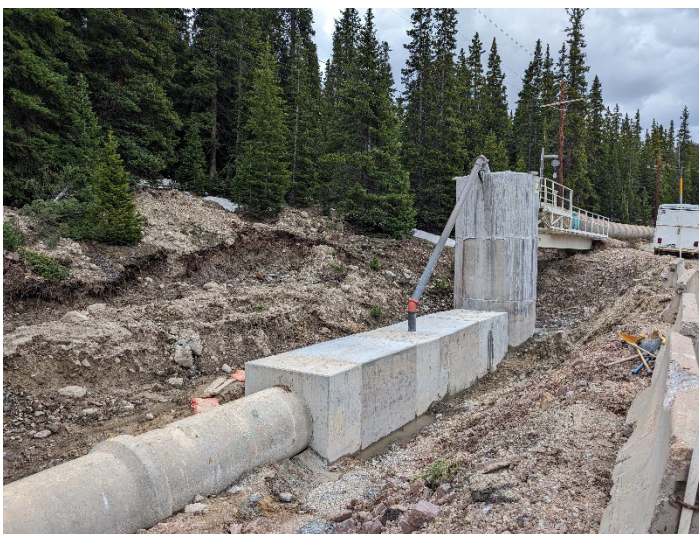
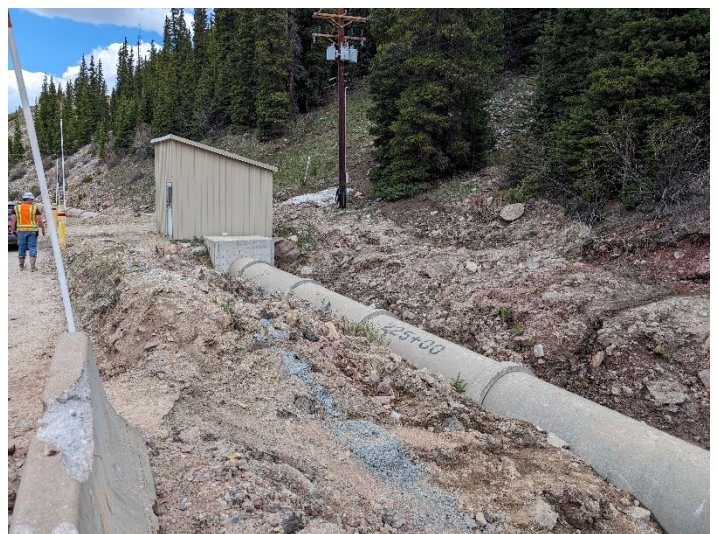
Tailings Deliver Line (TDL)

PROBLEM: The Tailings Delivery Line developed a leak on June 3, 2024, just up-gradient from the Clinton Cutout. The TDL was promptly shutdown and has now been temporarily repaired. However, further work needs to be done to address the drainage and stability issues at the leak area that caused the concrete pipe separation, in order to prevent future leaks at this TDL section.

The Tailings Delivery Line developed a leak on June 3, 2024, just up-gradient from the Clinton Cutout near Drop Tower 13. The leak was due to separation of a joint section of the 42" concrete pipe. The operator notified the Division of the leak right away and promptly shutdown the TDL, which has now been temporarily repaired. There appeared to be a seep developed just uphill from the leak location causing saturation of the soil, which likely caused settling and failure of the pipe. The operator has been instructed to develop a plan to address the drainage and stability issues at this area in order to prevent similar future failures of the TDL here.

CORRECTIVE ACTIONS: Develop a plan to address the drainage and stability issues at the TDL leak area and submit the plan to the Division in the form of a Technical Revision.

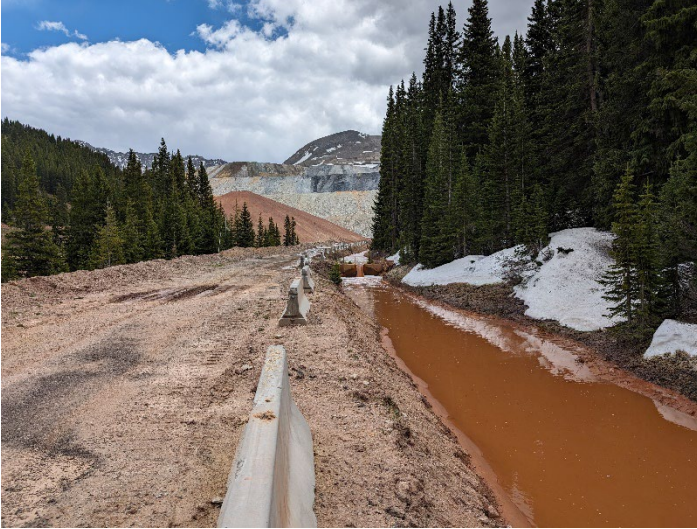
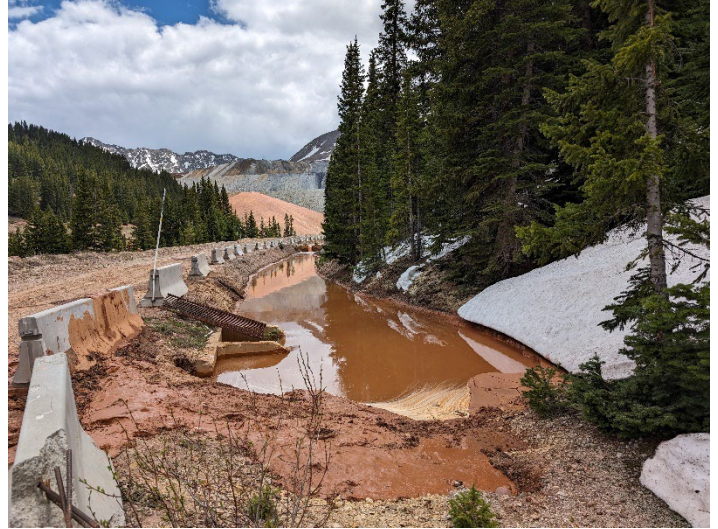
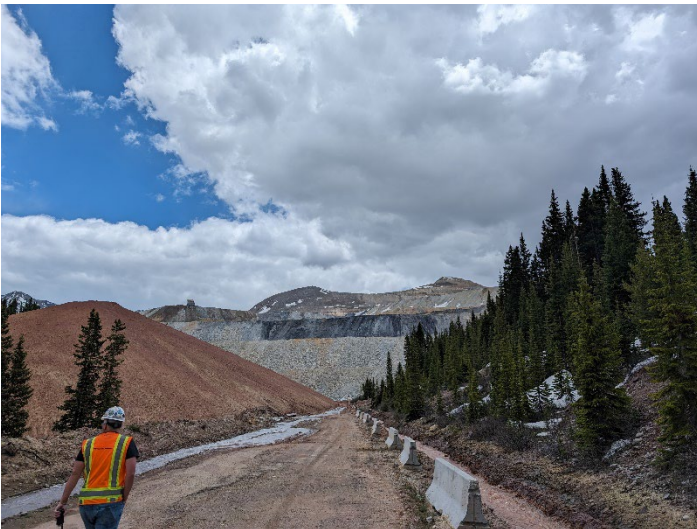
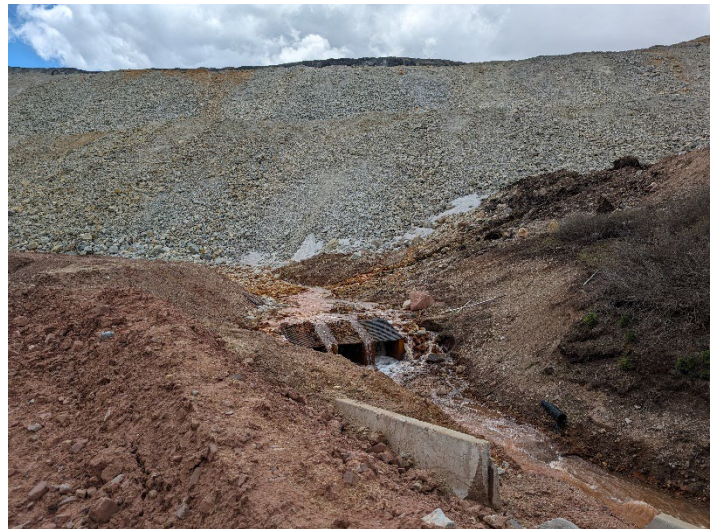
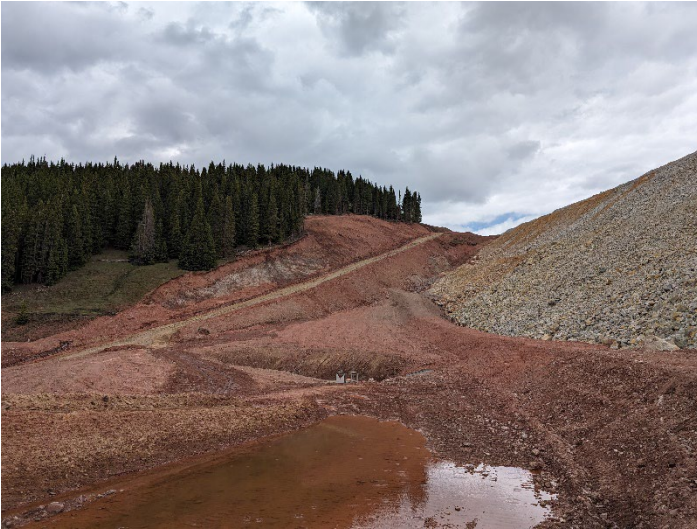
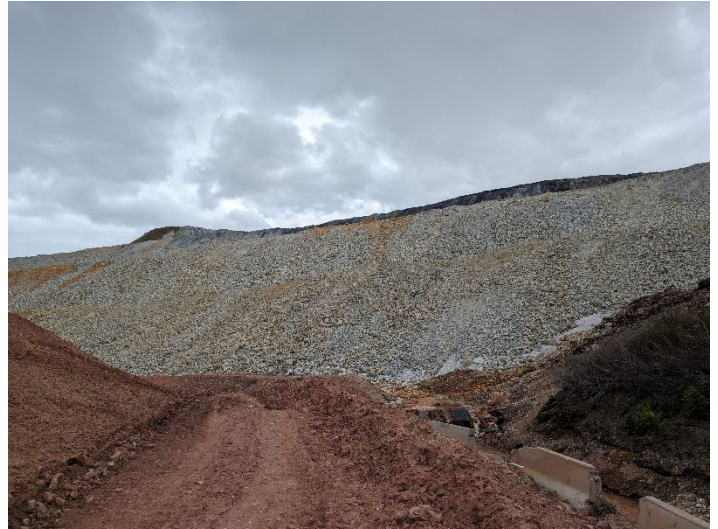
Operations at the McNulty OSF appear to be in accordance with the approved operating plan. Topsoil is stockpiled at the base. The pile was recently seeded and appeared stable. The underdrains and diversion structures appeared to be functioning. The clear water ditch was flowing and transporting water below the highway towards the Tenmile TSF.

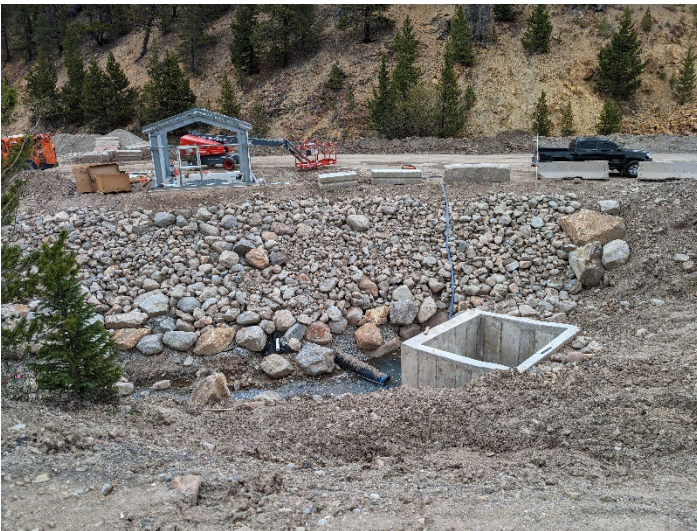
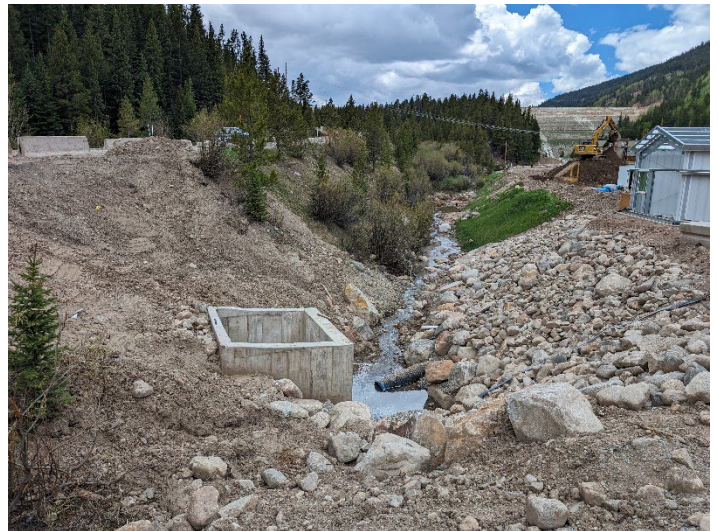
Construction is nearing completion on the 5 Dam Seepwater Collection System approved through TR36. The project was delayed due to difficulties procuring a transformer. Construction is expected to be completed this summer. Work completed thus far appears to be following the approved plans.
