**MINERALS PROGRAM INSPECTION REPORT**  
**PHONE: (303) 866-3567**

<b>MINE NAME:</b> Climax Mine	<b>MINE/PROSPECTING ID#:</b> M-1977-493	<b>MINERAL:</b> Molybdenum	<b>COUNTY:</b> Lake, Summit
<b>INSPECTION TYPE:</b> Monitoring	<b>WEATHER:</b> Clear	<b>INSP. DATE:</b> May 22, 2024	<b>INSP. TIME:</b> 09:00
<b>OPERATOR:</b> Climax Molybdenum Company, Climax Mine	<b>OPERATOR REPRESENTATIVE:</b> Eric Detmer	<b>TYPE OF OPERATION:</b> 112d-3 - Designated Mining Operation	
<b>REASON FOR INSPECTION:</b> Normal I&E Program	<b>BOND CALCULATION TYPE:</b> None	<b>BOND AMOUNT:</b> \$91,011,850.00	
<b>DATE OF COMPLAINT:</b> NA	<b>POST INSP. CONTACTS:</b> None	<b>JOINT INSP. AGENCY:</b> None	
<b>INSPECTOR(S):</b> Todd Jesse	<b>INSPECTOR'S SIGNATURE:</b>

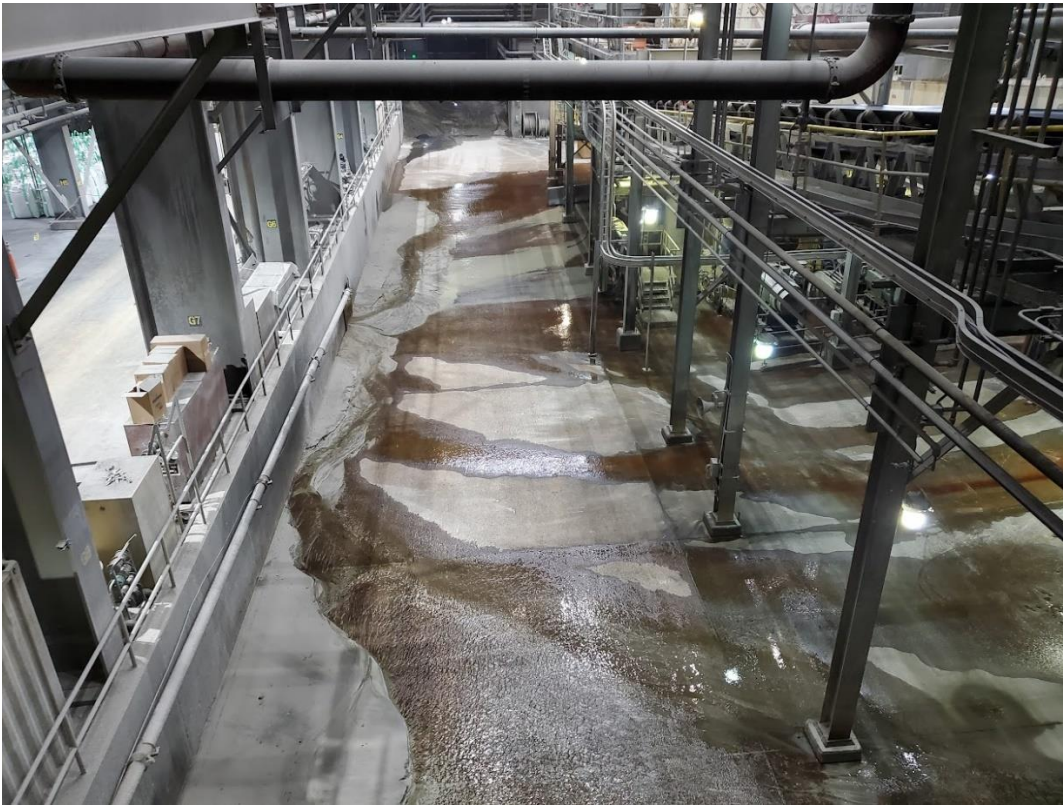
Containments under the crushing circuit had some sediment being washed down and returned to the process. (Photo 1). No cracks, fractures or evidence of compromise was noted. Some chemicals are stored under the floatation circuit in IBC Totes (Photo 2). The floor in this area was mostly dry and the sump was clean at the time of the inspection. Water was entering the sumps below the floatation cells. This overflow material is returned to the process. Sumps observed below the floatation circuit were free from obstruction and able to function as designed with sprayers directing materials into the sumps. Minor amounts of water were also observed beneath the thickener. The thickener sump was free of obstruction and functioning as designed (Photo 3)

Photo 1: View to the north of containment beneath the crushing circuit.

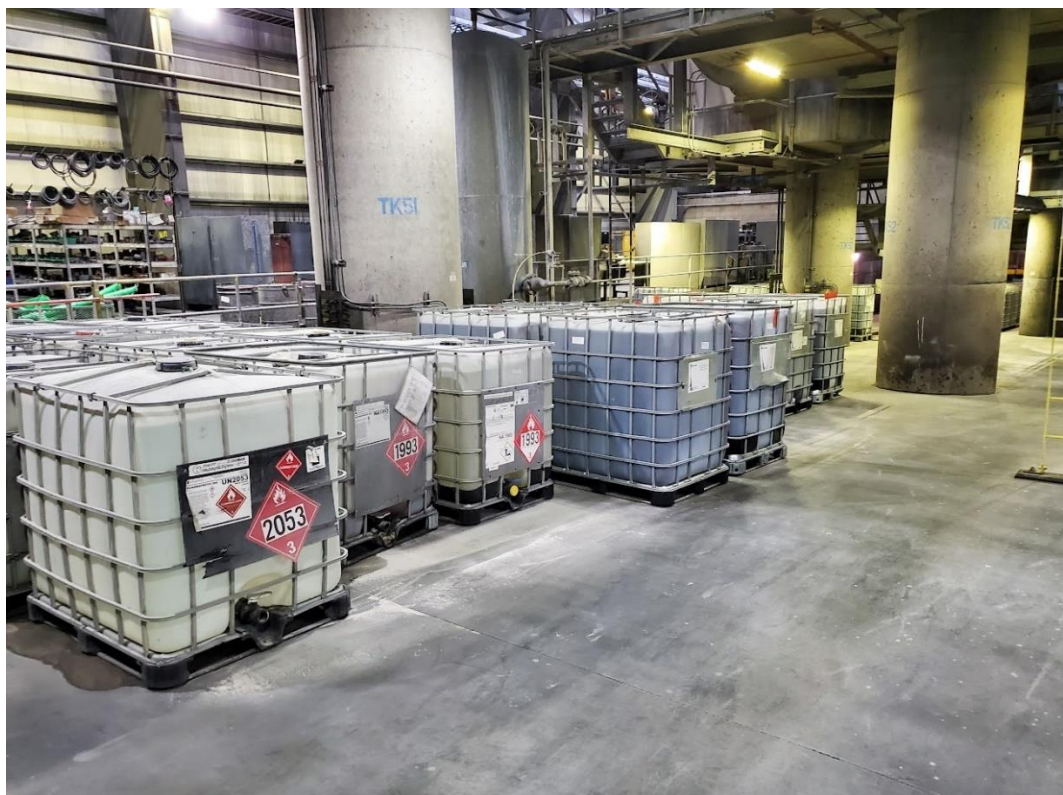
Photo 2: View to the west of chemical totes stored beneath the floatation circuit.

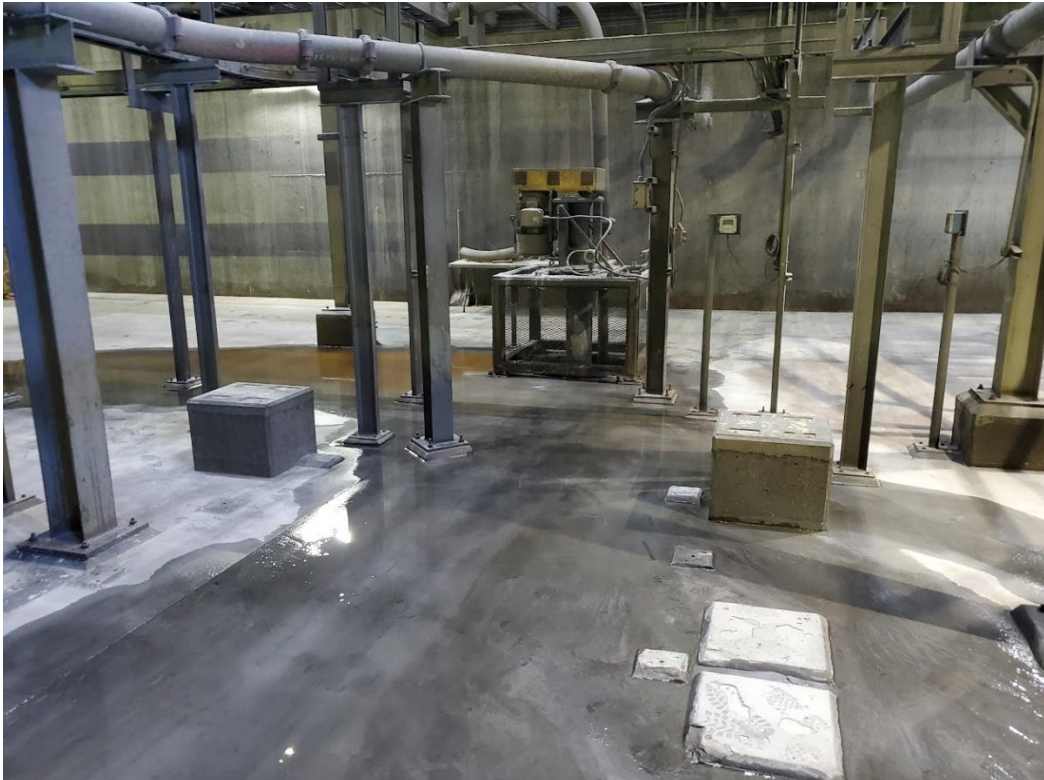
Photo 3: View to the east of sump below the thickener.

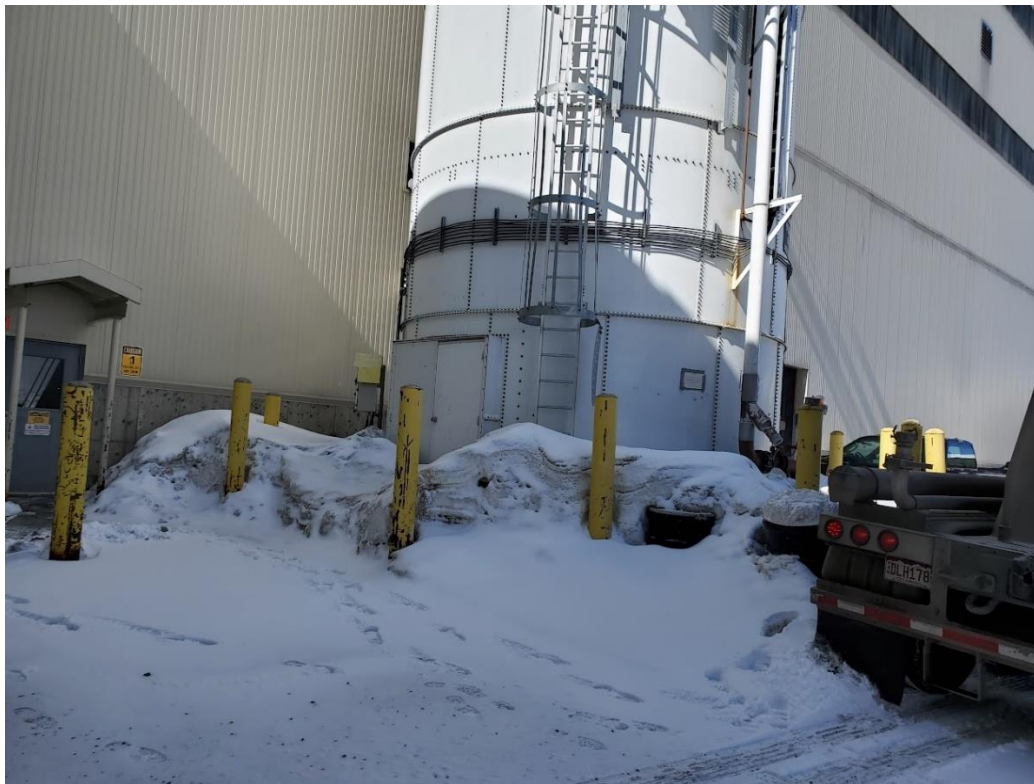
The external lime storage silo was also observed to be in excellent condition (Photo 4). No evidence of spillage or lime scaling was observed on or around the silo. Secondary containment for the silo is achieved by the pads surrounding the Mill Facility that would contain any possible spillage. A lime truck was about to unload into the silo during the inspection.

Photo 4: View to the southwest of lime silo at Mill Facility. Truck was waiting to unload.

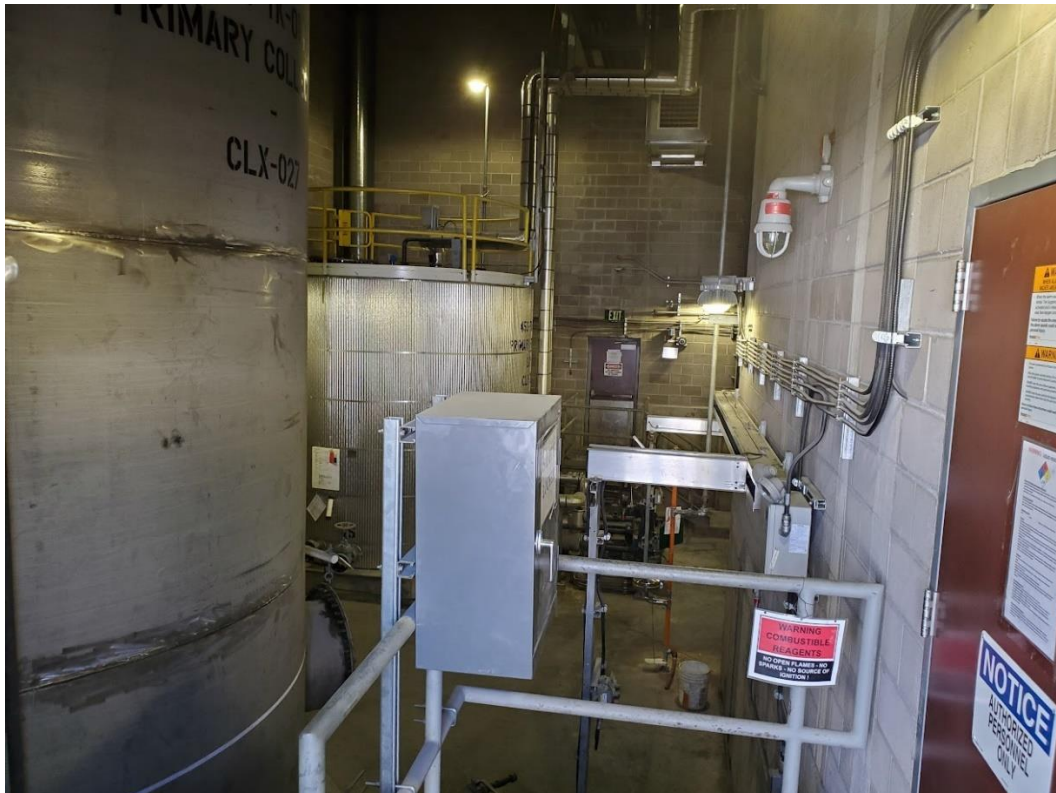
The Reagent Storage room is a separate room attached to the Mill Facility to provide containment of the chemicals and is accessed from an exterior man door. No evidence of spillage or containment concerns were observed, the sump is clean and clear from obstructions (Photo 5). No cracks, fractures, or evidence of compromise were noted.

Photo 5: View to the north of containment in reagent storage area.

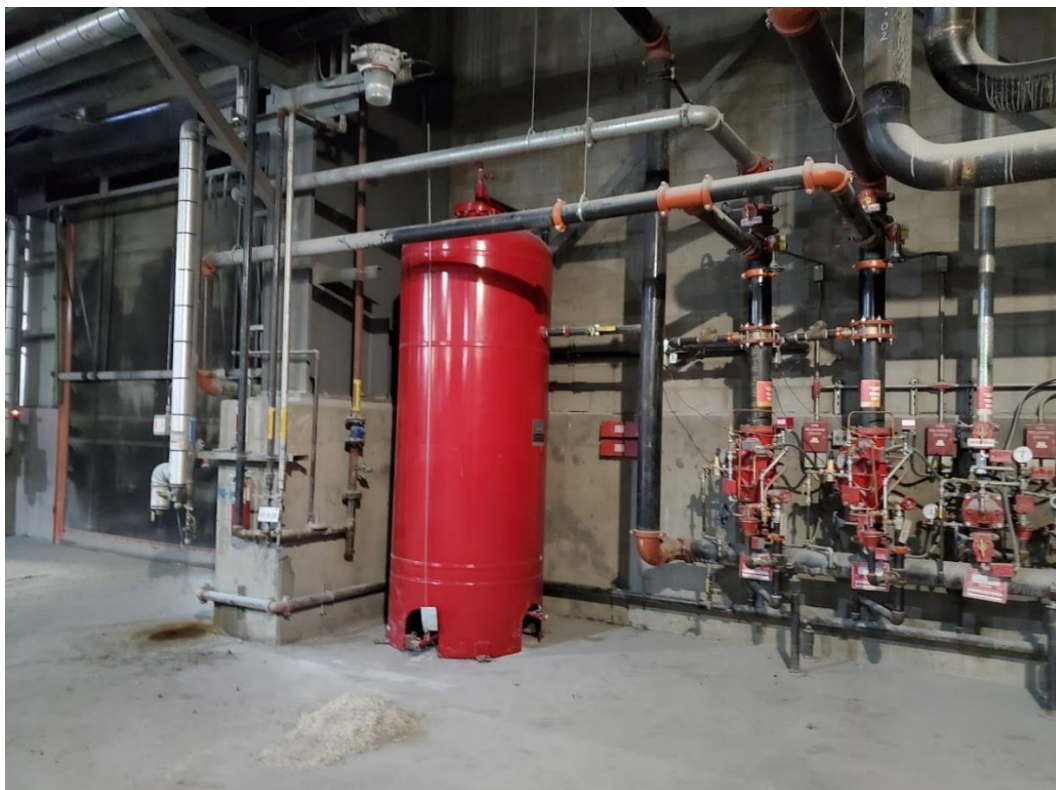
The operator has also installed a new Non-Fluorine Fire Fighting unit in the mill facility (Photo 6). This is a proactive action ahead of regulations on PFAS. The operator invested significant time and financial resources to modify the fire suppression system so that it could be run with PFAS free foam.

Photo 6: View to the east of NFFF unit in the Mill Facility.

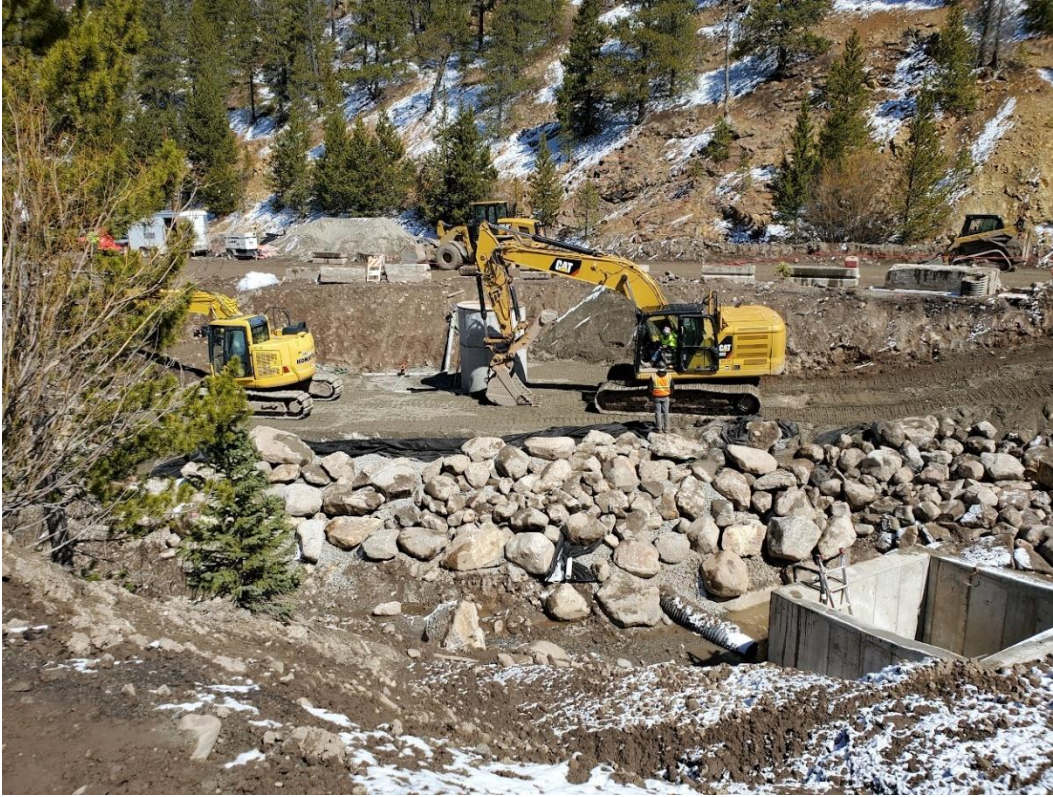
Construction has resumed on the 5 Dam Seepwater Collection System, approved under TR-36. The project was delayed due to difficulty procuring a transformer. The Operator is working with their contractor to complete construction this summer. Contractor crews are currently working around the 72" RCP Wet Well below the Secondary Seepage Pump Station (Photo 7). Crews are also working on achieving the proper grade to tie lines into the well. The completed work appears to be consistent with the approved designs and no issues were noted within the construction area.

Photo 7: View to the west of progress on the 5 Dam Seepwater Collection System.

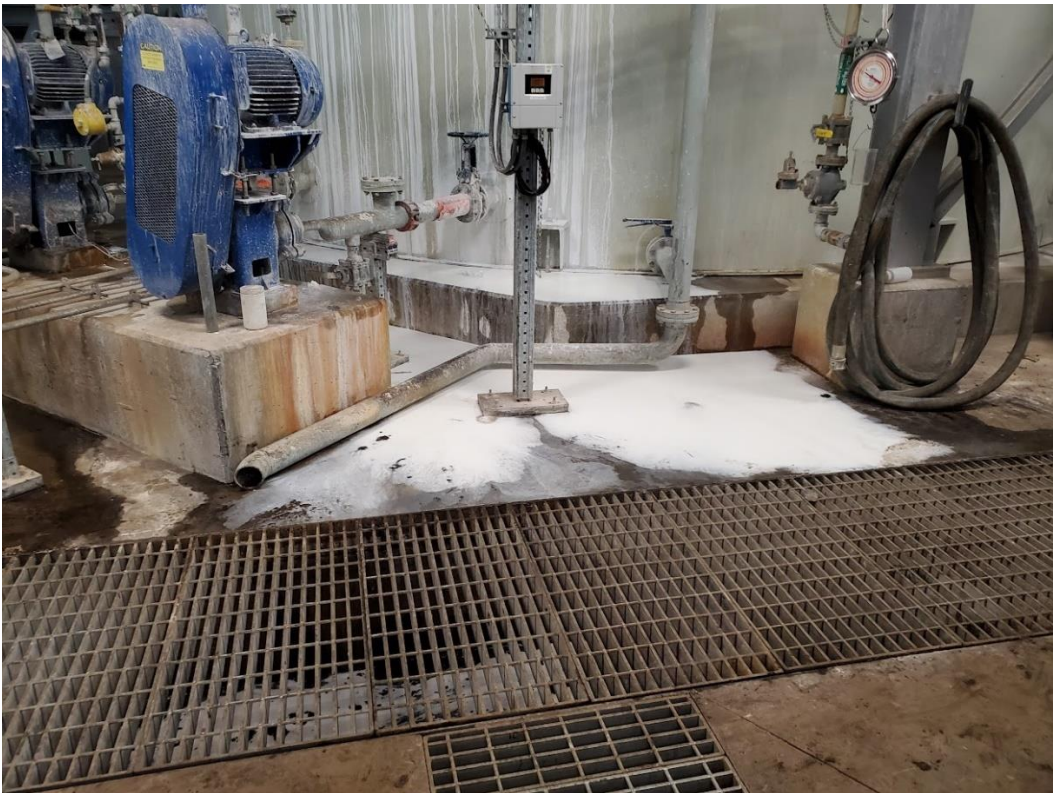
The PDWTP was operational at the time of the inspection. The operator plans to draw down the ponds and will stop discharge sometime in June until a call is made on the river. The PDWTP is located below 5 Dam and is intended to remove metals such as manganese, iron, copper, and zinc. The plant discharges to Tenmile Creek and provides final treatment before affected water leaves the property. The facilities were clean and well kept. Secondary containment is adequate and floor drains/sumps appear free of obstruction. The treatment process utilizes lime, flocculant, and sulfuric acid as reagent chemicals. Reagent lines and containers were clearly labeled. The lime is turned into a slurry and mixed with affected water in reactor tanks to raise the pH. There was a leak in one of the lines at the time of inspection, but the operator was in the process of repairs and leaked material was captured by secondary containment (Photo 8). The Slurry and Reactor Tanks are in good condition. Solids from the PDWTP are transported via a cement truck to the sludge cells. The filter press in the facility is not being utilized. Once the water leaves the reactor tanks it enters clarifiers and is dosed with flocculant. The clarifiers were in good working conditions and operating at the time of the inspection. Adjacent to the clarifiers is the Filter Building which houses a series of sand filters. Filter tanks appear in good condition. Sulfuric acid is also used in this facility to lower the pH before water is discharged. The sulfuric acid storage is isolated from the rest of the plant and located in an epoxy coated containment area (Photo 9). No spills or other problems were noted within the PDWTP during the inspection.

Photo 8: View to the west of leak in slurry line. Secondary containment is functioning properly.

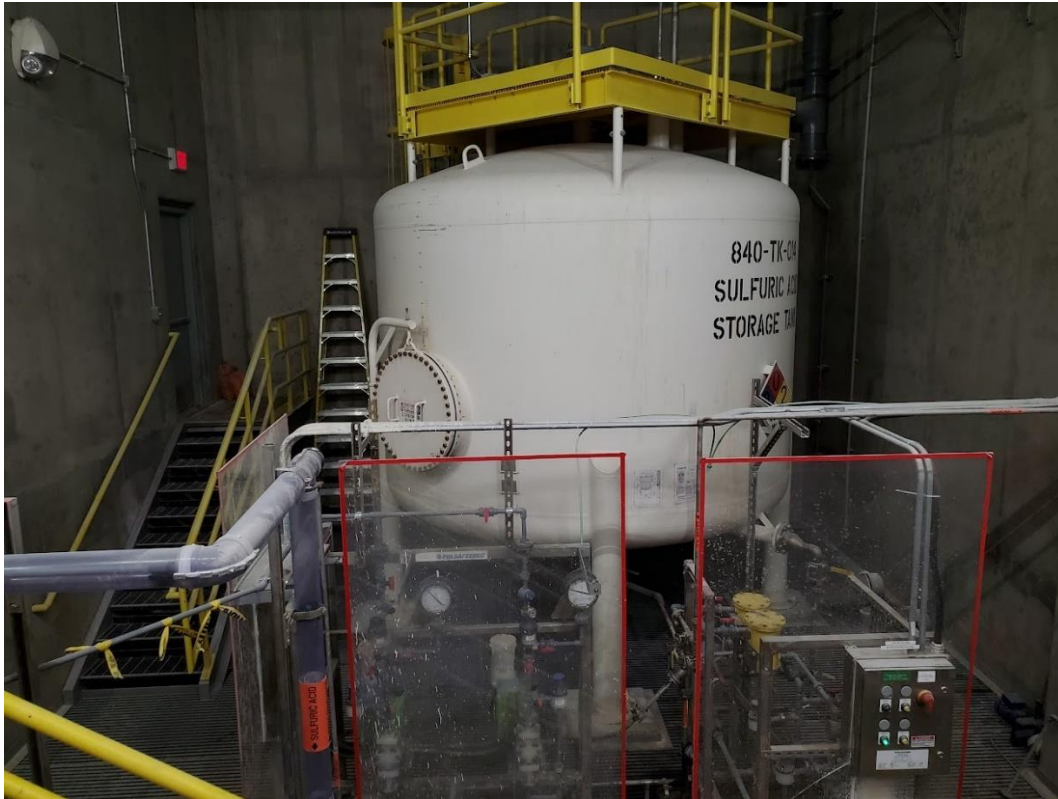
Photo 9: View to the west of Sulfuric Acid storage in PDWPT

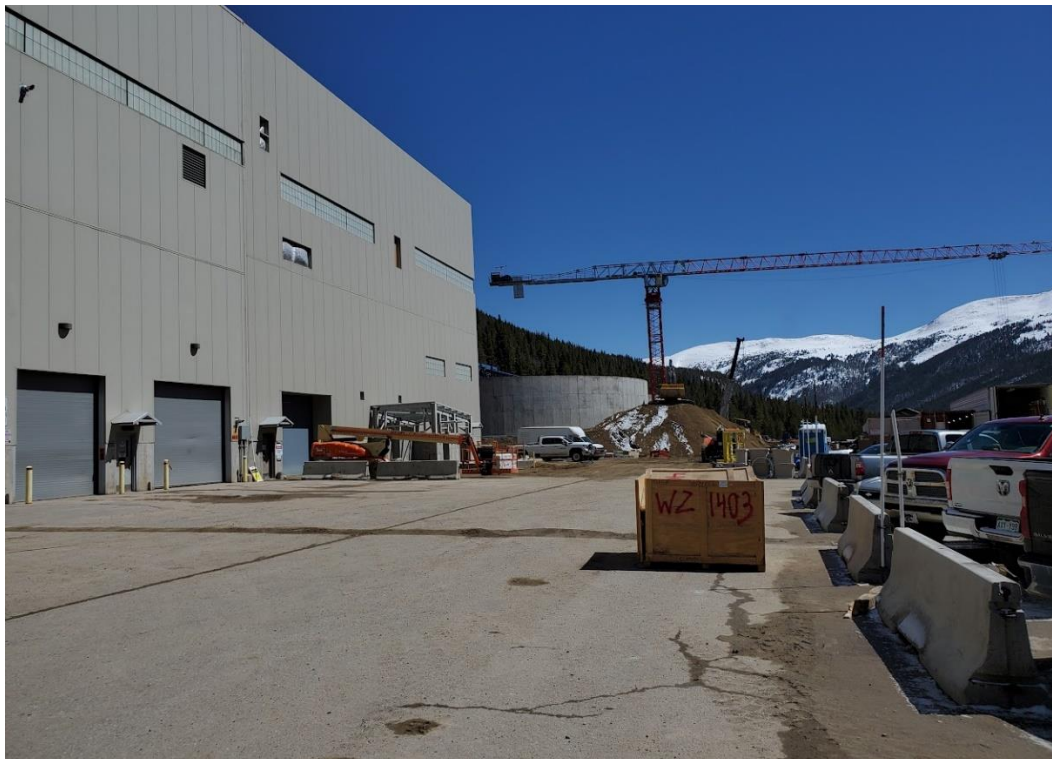
Construction continues on the new MRWTP building approved under TR-34. This is a supplementary process to Climax's PDWTP. Once online the raw water will first go into the Moly building, then water will go to the existing PDWTP building. A crane and several crews were observed working on the thickener tanks. The building still on schedule to be online in the first quarter of 2025. Construction progress can be seen in Photo 10.

Photo 10: View to the north of progress on the MRWTP.
