## Inspections June 2024 Yoast and Seneca IIW

**PERMIT INFORMATION**

<b>Permit Number:</b> C-1994-082 <b>Mine Name:</b> Yoast Mine  <b>Operator Address:</b> Seneca Property LLC Ms. Miranda Kawcak 29515 Routt County Road No. 27 Oak Creek, CO 80467	<b>County:</b> Routt <b>Operation Type:</b> Surface <b>Permit Status:</b> Permanent Cessation <b>Ownership:</b> Private  <b>Operator Representative Present:</b>  Michael Howard
<b>Operator Representative Signature: (Field Issuance Only)</b> This report was issued electronically from the Divisions' Denver Office.

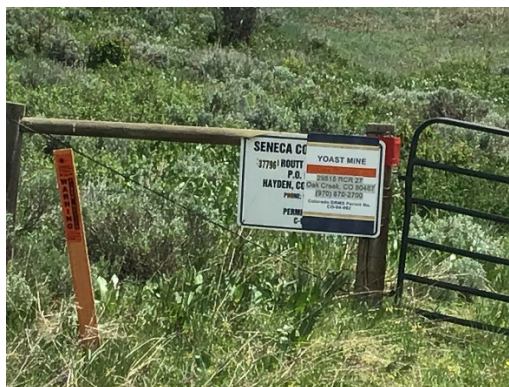
- The mine identification signs were in place at the site entrance and along County Road 37 where the ponds are accessed. The sign was intact, displaying all required information: mine name, operator name, address, phone number, DRMS permit number and contact information.

***Photo 1: Yoast permit identification sign on County Road 37.***

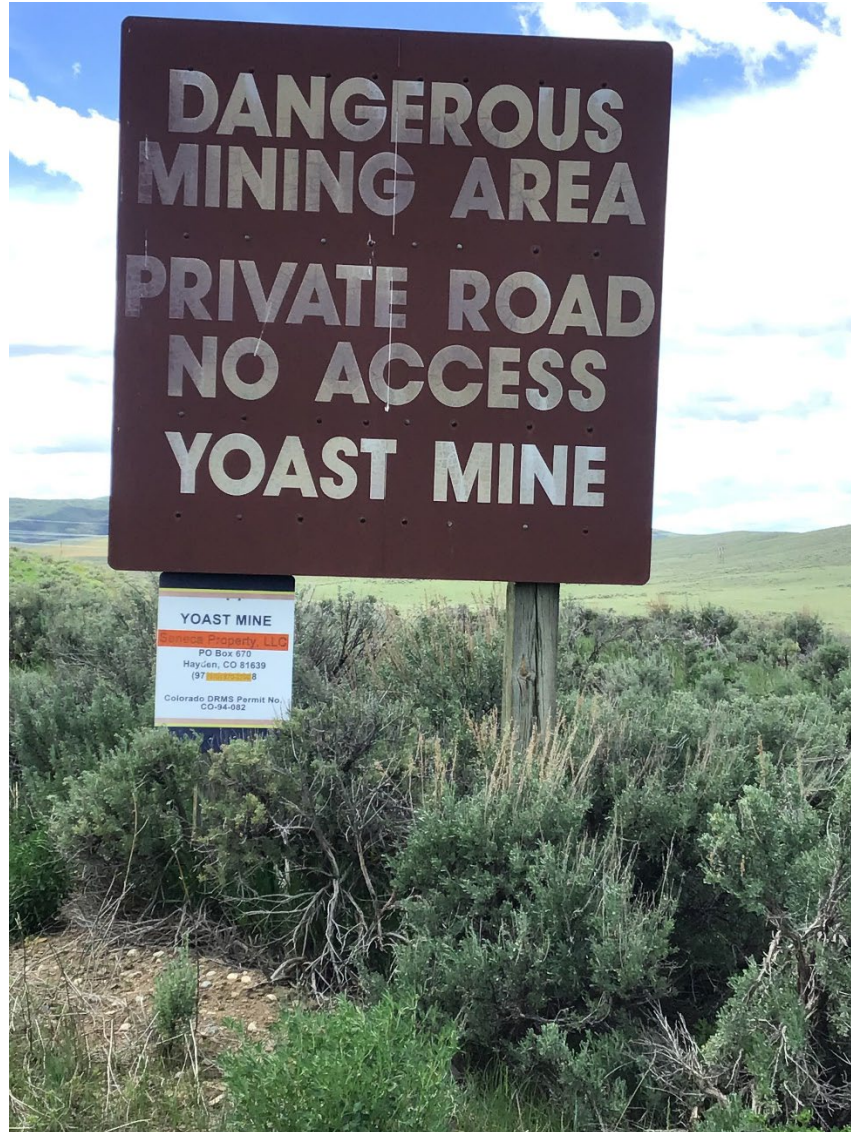
*Photo 2: Yoast permit identification sign at main entrance.*

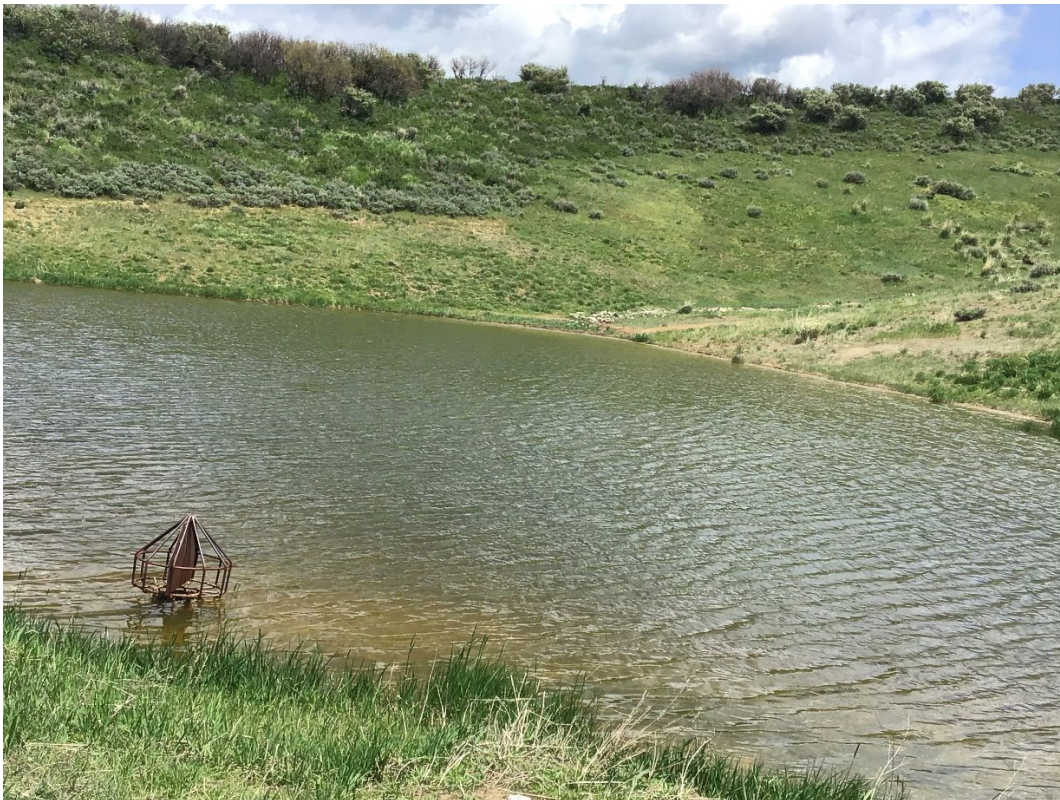
*Photo 4: Pond 13.*

- Pond12 was discharging clear water at the time of inspection.
- Pond 12 staff gauge read 0.25 feet.
- Pond 13 appeared slightly turbid and was discharging a trickle at the time of inspection.

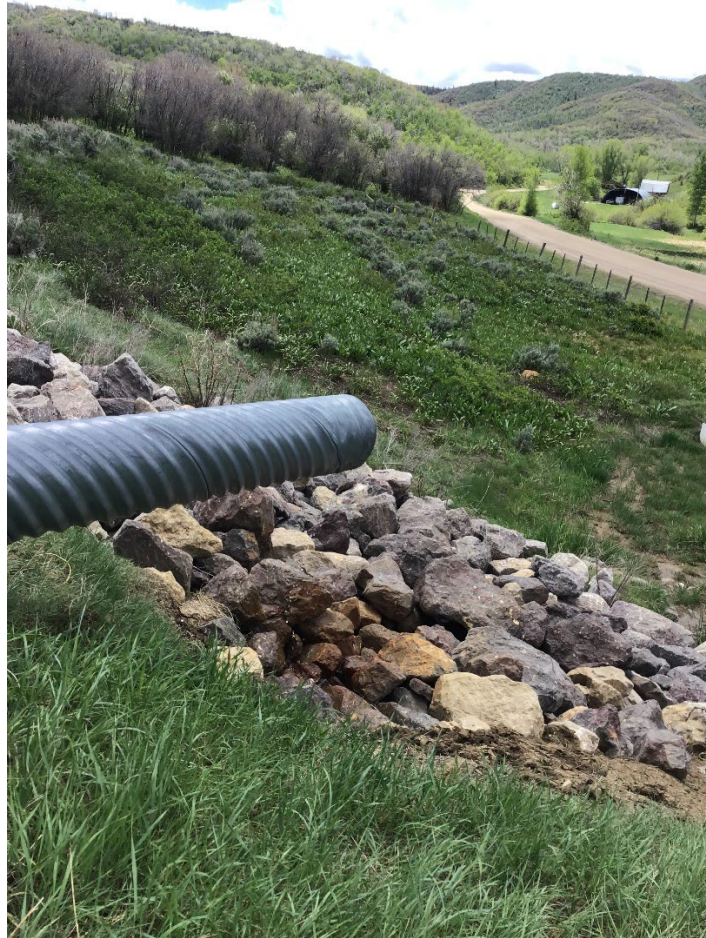
- Discharge was not reaching the flume below the discharge culvert.
- Pond 13 is scheduled for a dye treatment in the next few days to prevent summer algal growth.
- Springs above Pond 13 were dry at the time of inspection.
- Pond 14 had no inflow and was discharging at the time of inspection.
- Pond banks and dam out slopes appeared stable and well vegetated at the time of inspection.
- No seepage through the dams was observed.
- Pond emergency spillways appeared to be functioning adequately.

*Photo 5: Pond 13 discharge culvert.*

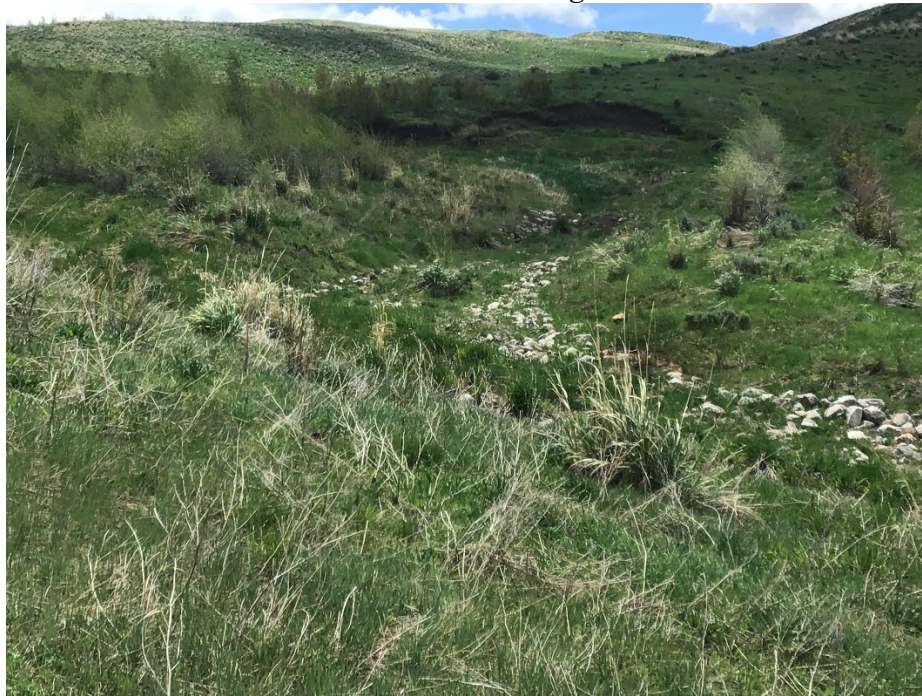
- No areas of new instability, slumping or sliding were noted above the ponds at the time of inspection.
- Known slumps and springs above ponds 12 and 13 appeared dry and exhibited no new activity.

*Photo 6: Spring area and slump scarp above Pond 13.*

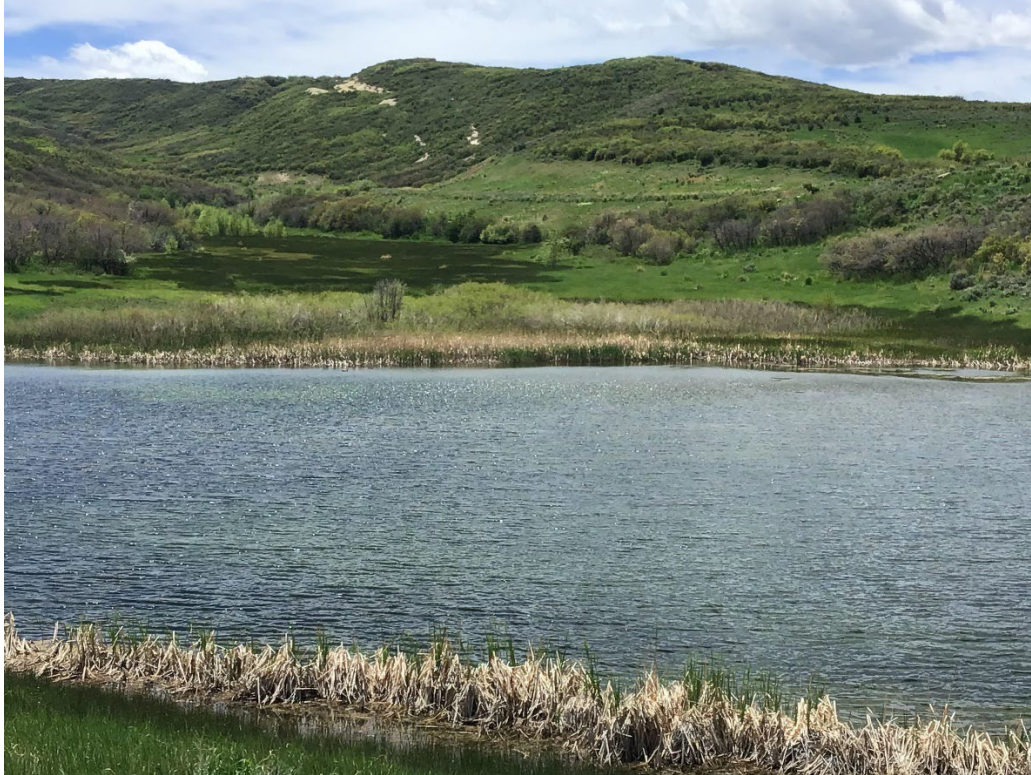
*Photo 9: Pond 10 and wetlands looking up valley.*

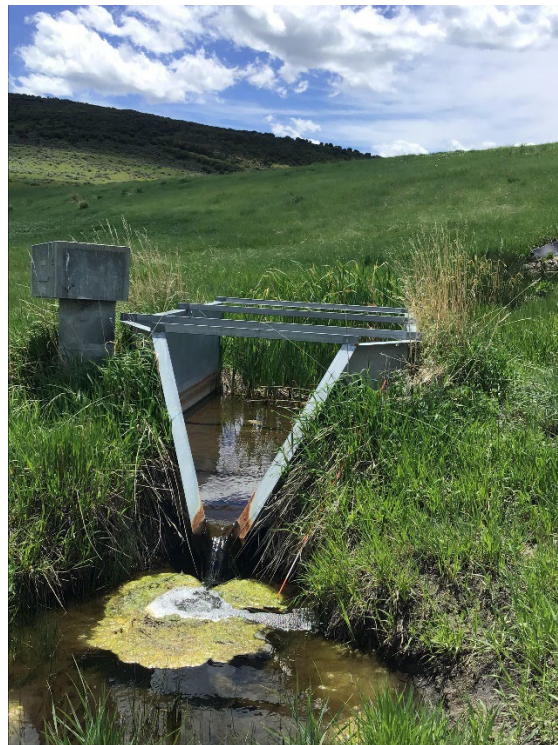
*Photo 9: Pond 10 flume with some algae in plunge pool*

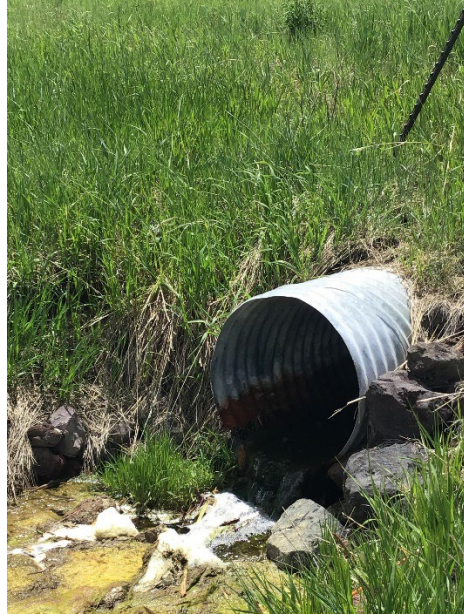
***Photo 10:** Pond 10 discharging culvert with alge in channel.*
