2024 May Inspections Yoast, Seneca IIW

Permit Number: C-1994-082 **Mine Name:** Yoast Mine

This was a Partial inspection of the Yoast Mine, C1994082, operated by Seneca Property LLC. The inspection was conducted aerially by Brock Bowles of the DRMS, and the report prepared by me, Robin Reilley of the DRMS. No mine representative was present during the inspection. No hydrologic or air quality issues were detected at the time of inspection. The weather appeared clear.

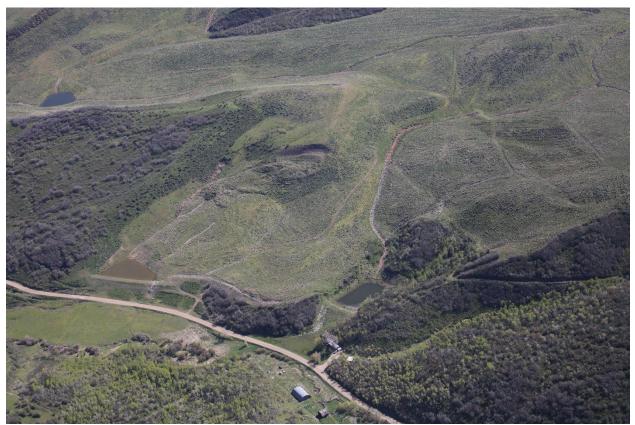
- No areas of new instability, slumping or sliding were noted above the ponds at the time of inspection.
- Known slumps and springs above ponds 12 and 13 appeared dry and exhibited no new activity.

Photo 1: Ponds 13 (left) and 14 (right) with old slump above Pond 13.

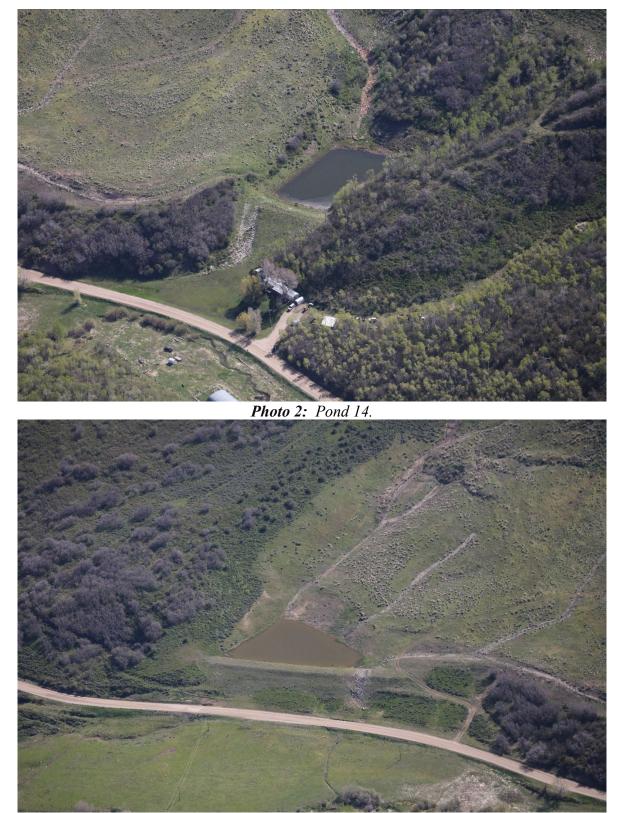
- Pond12 appeared turbid.
- Pond 12A appeared clear.
- Pond 13 appeared turbid and was not discharging at the time of inspection.
- Springs above Pond 13 appeared dry at the time of inspection.
- Pond 14 had no inflow and did not appear to be discharging.
- Pond banks and dam outslopes appeared stable at the time of inspection.
- Pond emergency spillways appeared to be functioning adequately.

Photo 3: Pond 13 appearing turbid and springs above.

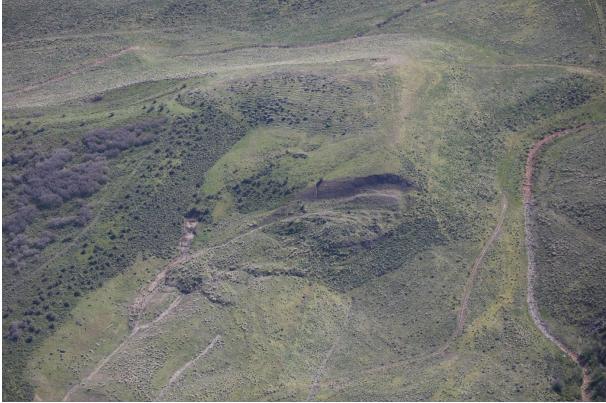
Photo 4: Spring and slump area above Pond 13

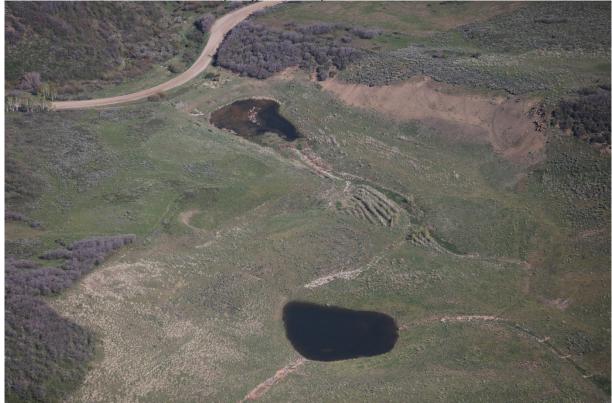
Photo 5: Ponds 12 and 12A (foreground).

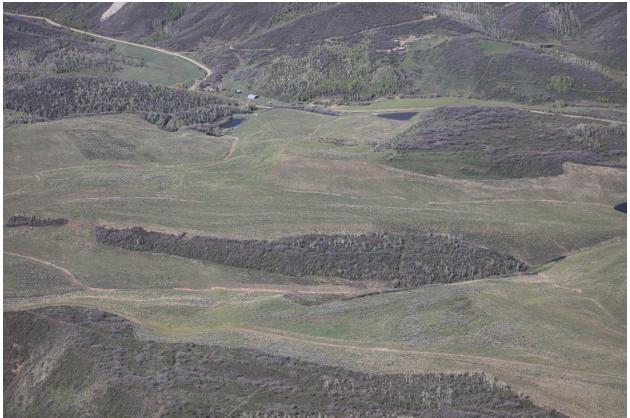
Photo 6: Site overview with Ponds 14 (left) and 13.
