Inspections June 2024 Yoast and Seneca IIW

PERMIT INFORMATION

COMMENTS

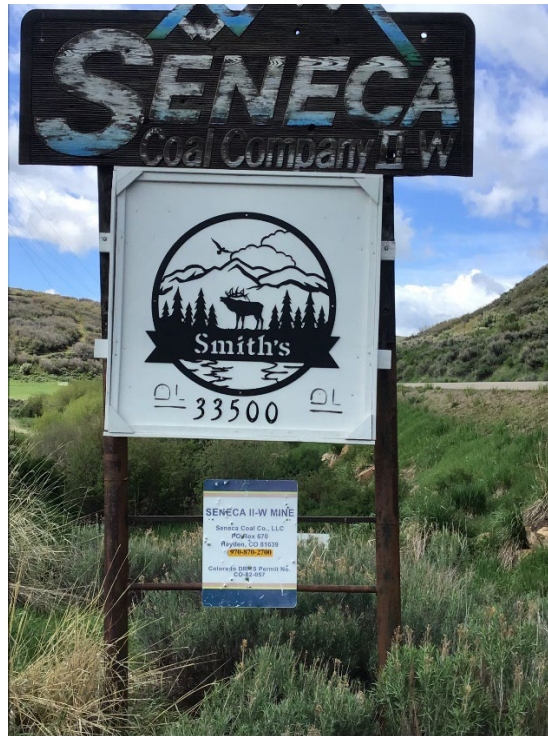
- The mine identification sign was in place at the site entrance from the County Road. The sign was intact, displaying all required information: mine name, operator name, address, phone number, DRMS permit number and contact information.

Photo 1: Mine Identification sign at site entrance.

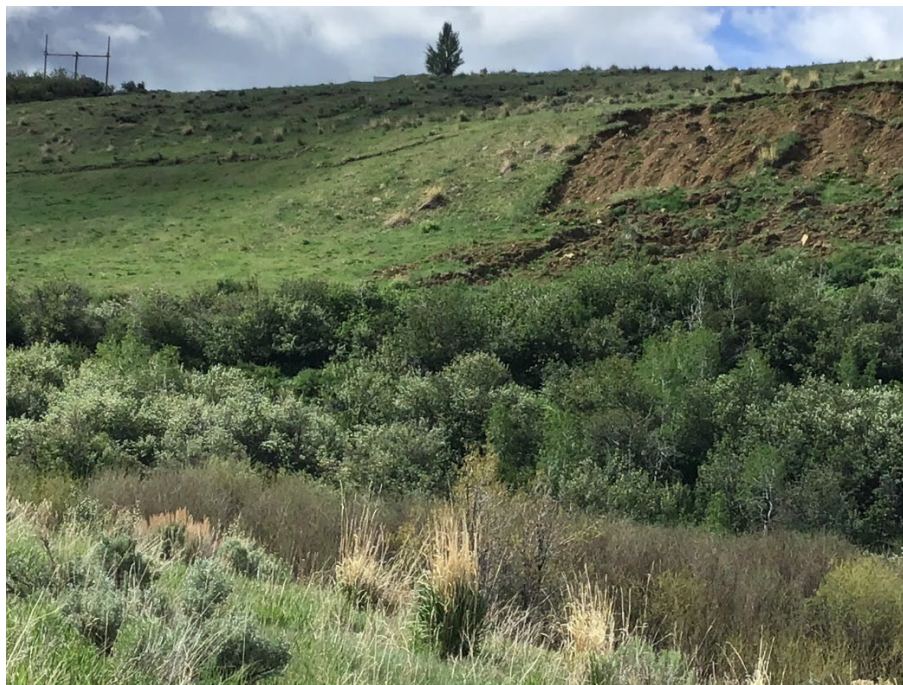
The two slumps and associated crack between them at Pond 6 were documented. No new movement was noted at the time of inspection.

Photo 2: Pond 6 spring 2023 slump with crack going across the slope.

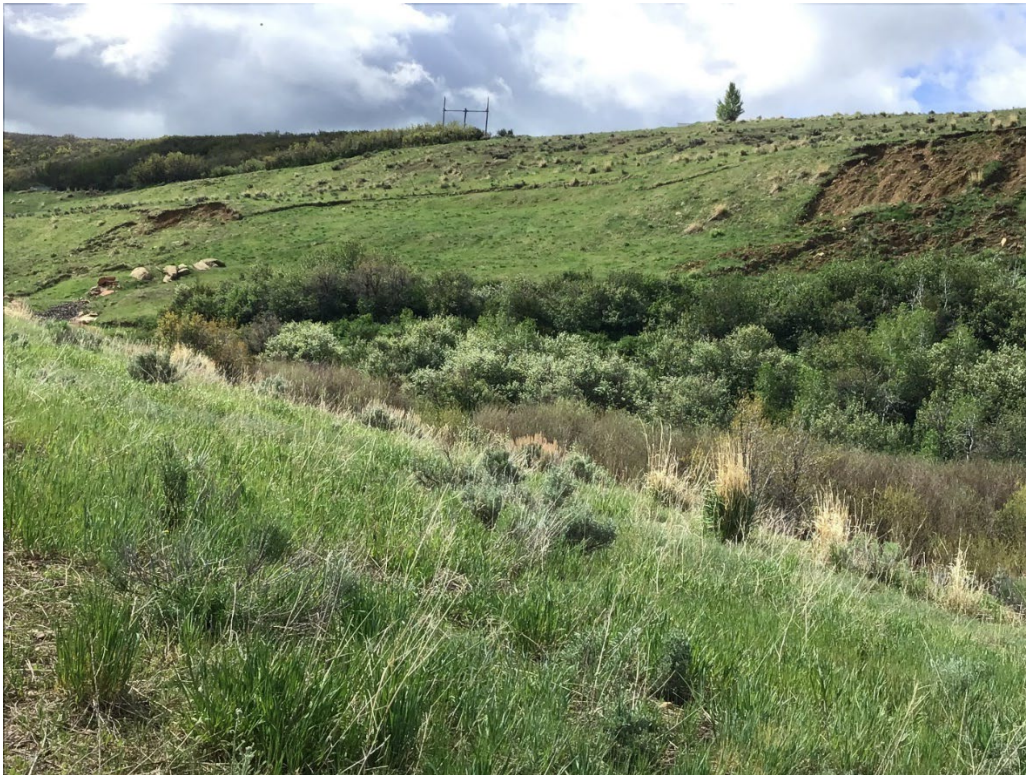
Photo 3: Pond 6 slumps with crack going across the slope.

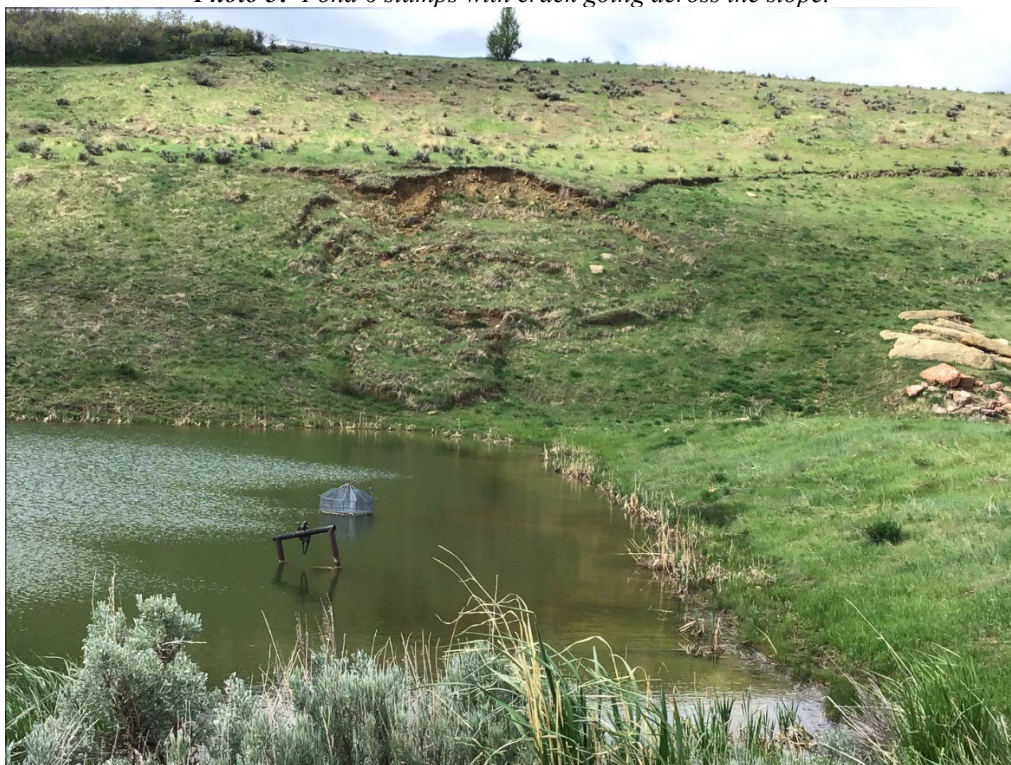
Photo 4: Pond 6 old slump with crack going across the slope.

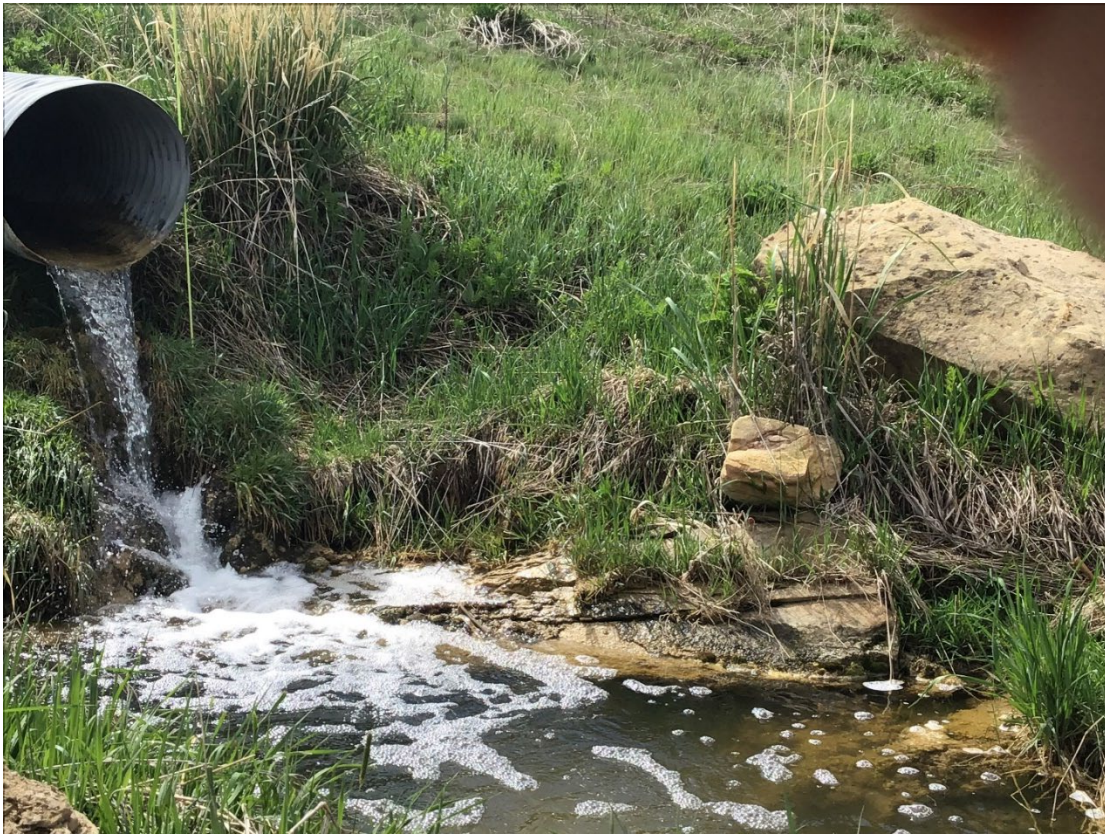
Photo 5: Pond 6 discharge culvert.

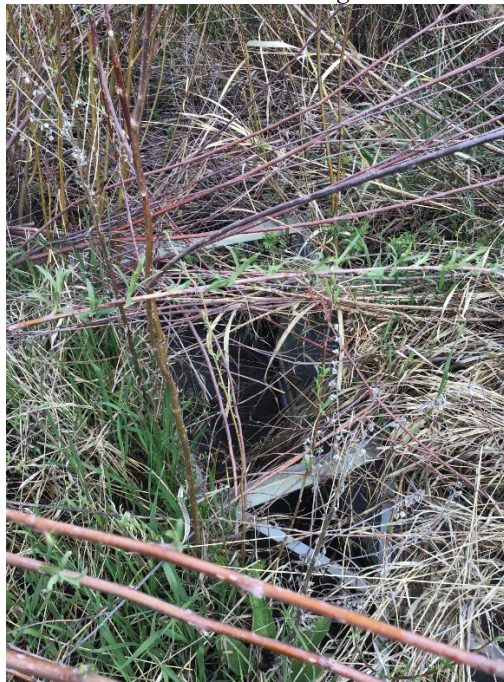
- Pond 6 was discharging clear water. Discharge at staff gauge read 0.15. Ft through the flume.
- Vegetation willows and grasses should be cleared from flume entrance and exit.
- Pond 16 was discharging. The staff gauge read 0.02 feet. The water appeared slightly turbid. Grasses around flume need to be removed.
- Pond 17 was discharging. The staff gauge read 0.02 feet. Cattails at flume entrance require removal.
- Stock tanks T2 and T3 held turbid water.

Photo 6: Pond 6 flume requires clearing of vegetation.

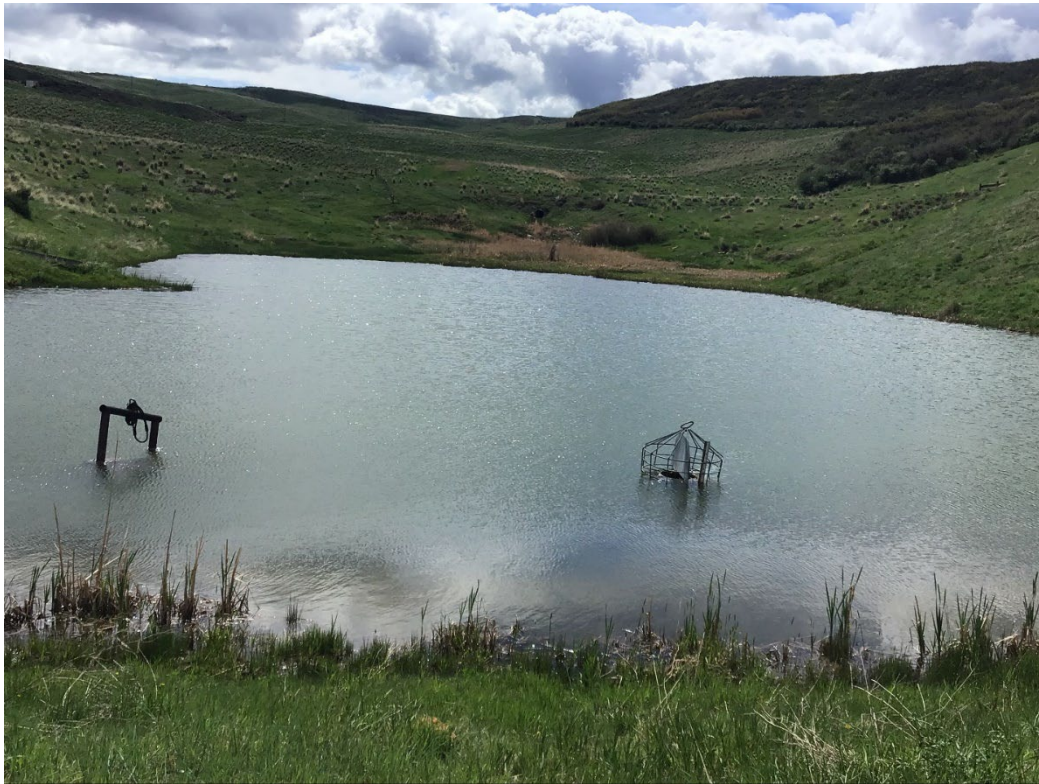
Photo 7: Pond 6 looking upvalley.

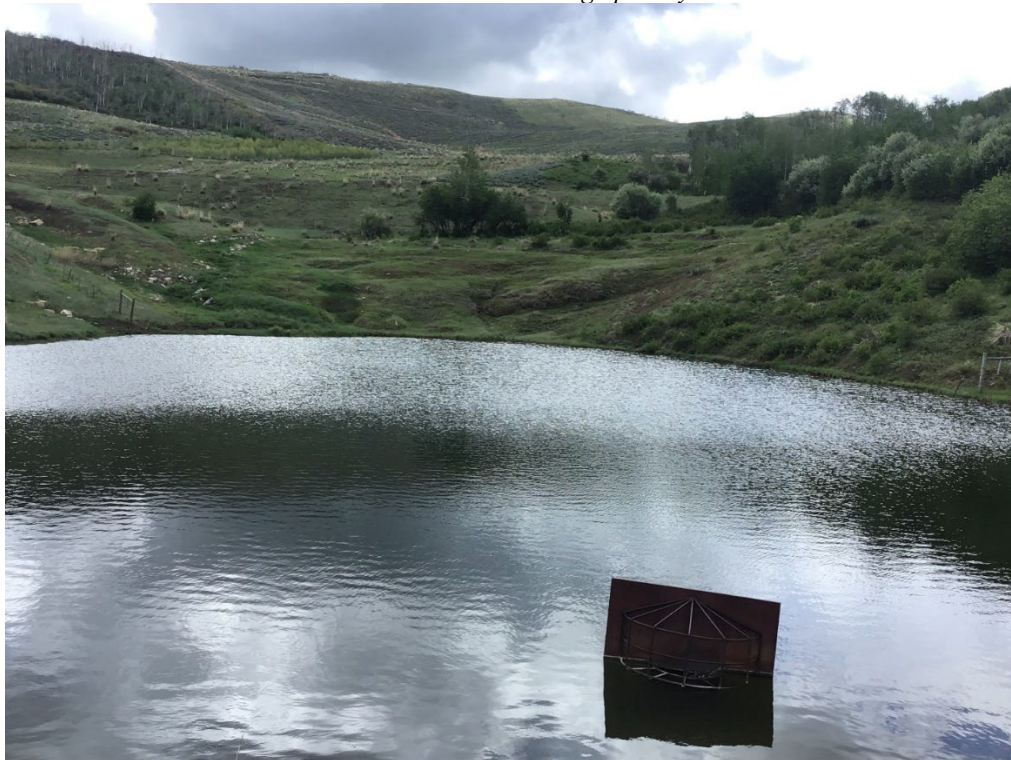
Photo 8: Pond 16 looking up valley.

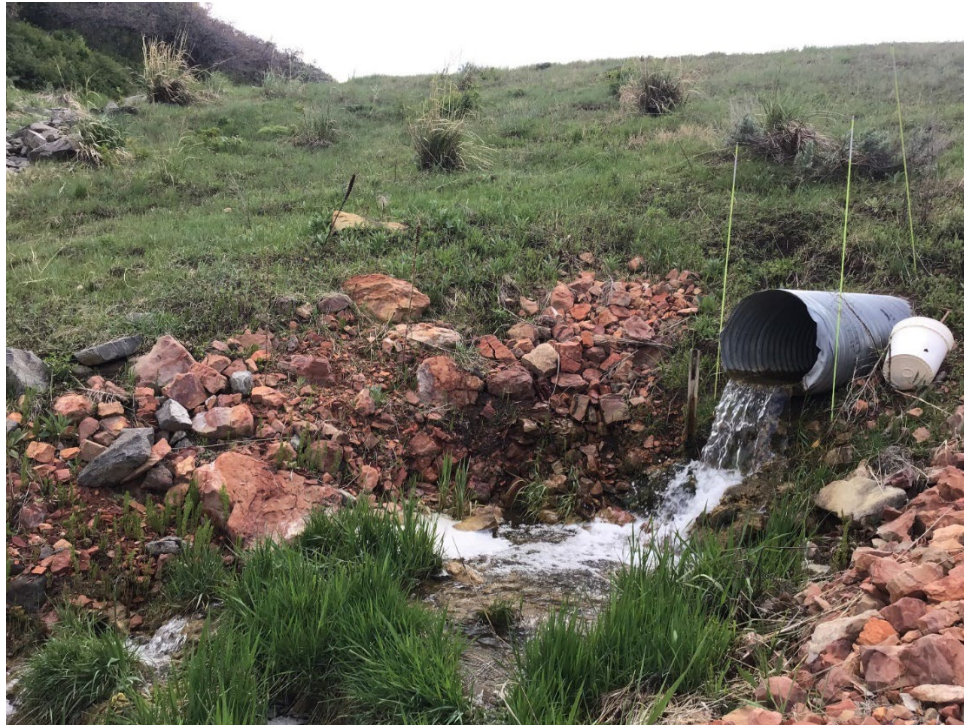
Photo 9: Pond 16 discharge culvert.

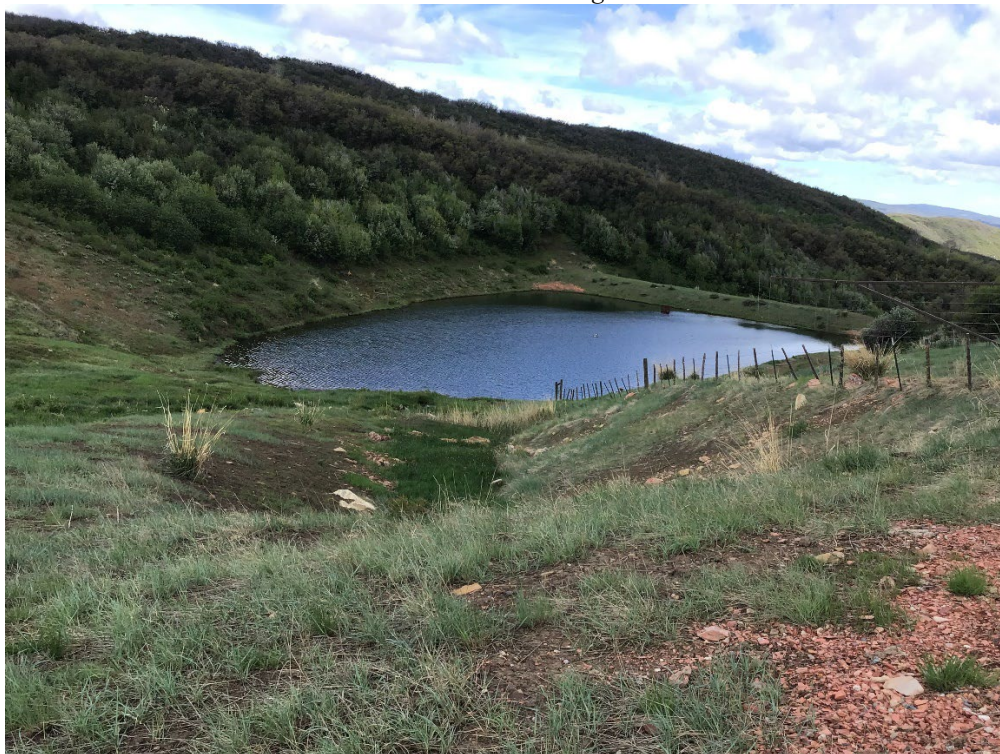
Photo 10: Pond 16 looking down valley.

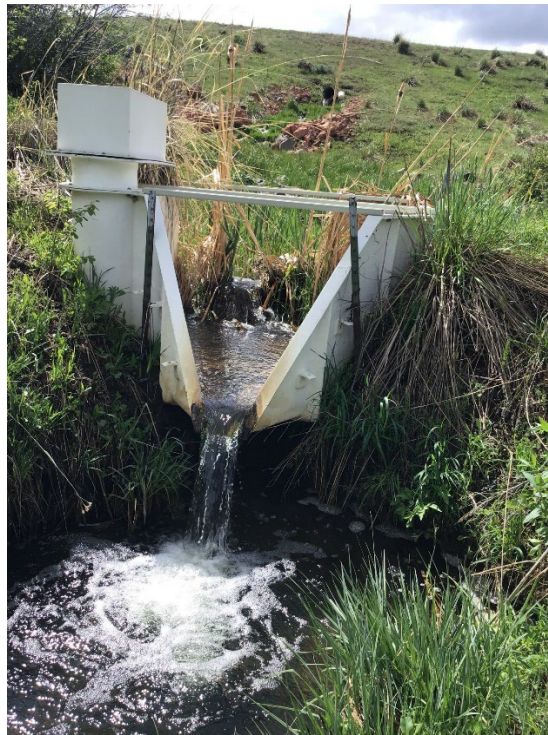
Photo 11: Pond 16 flume, vegetation requires clearing.

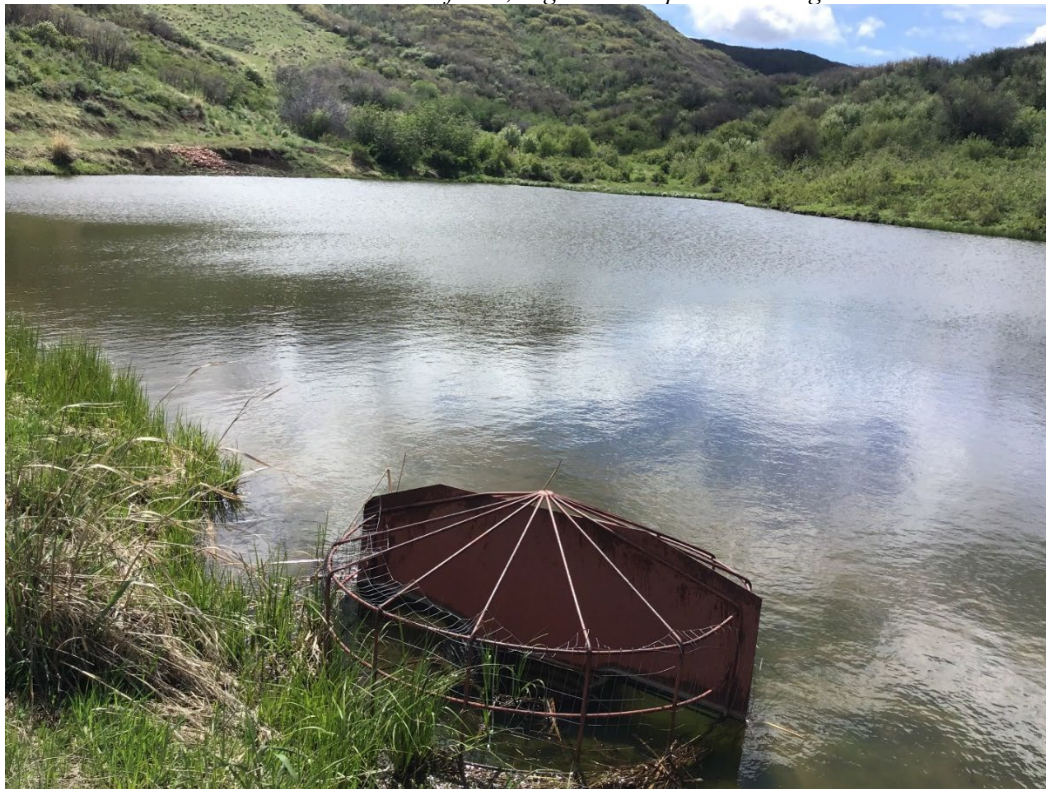
Photo 12: Pond 17 looking up valley.

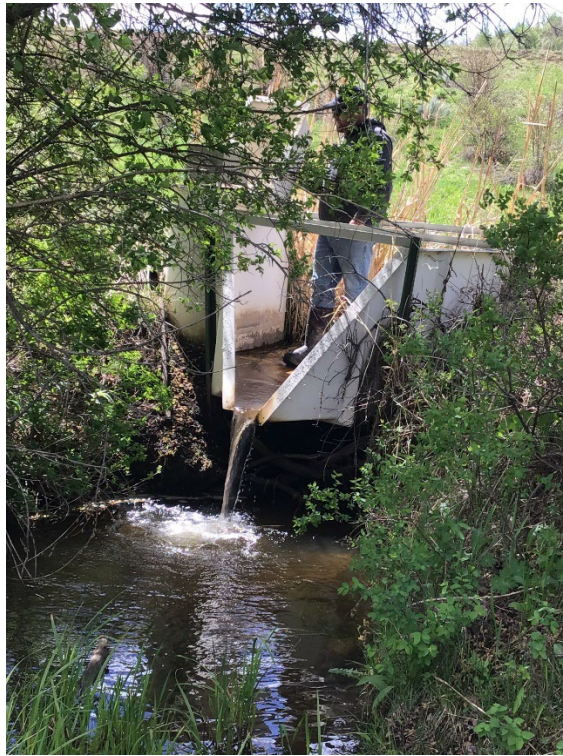
Photo 13: Pond 17 flume. Grasses at flume entrance require removal.
