# Inspection Aerial\_2024\_05May

### 28 May 2024

**Permit Number:** C-1981-044 **Mine Name:** Williams Fork Mines **Operator:** Moffat County Mining, LLC

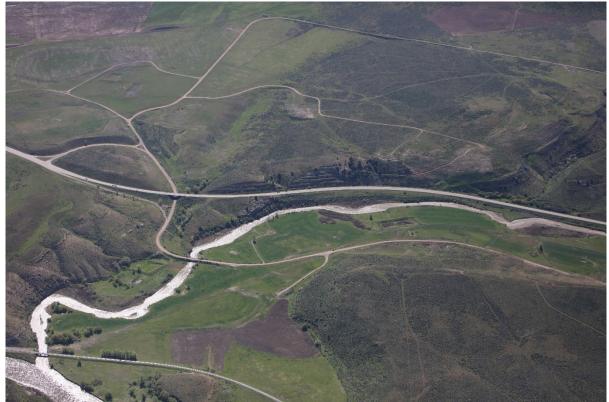
Photo 1: Site overview and associated reclamation.

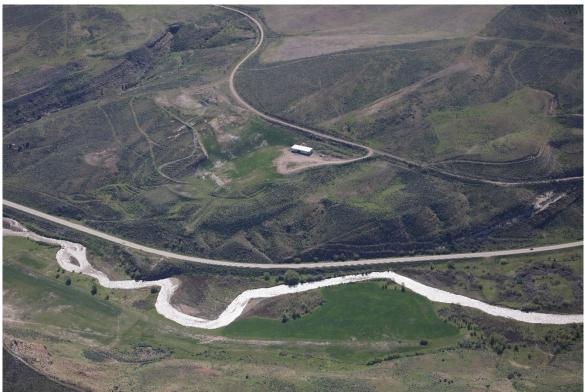
- Reclamation of the 5A Portal area is complete.
- Backfilling, grading, topsoil and seeding occurred in 2023 at the 5A Portal.
- The 5A Portal slopes appeared uniformly green. White areas on south facing slopes appear to be mulch.

Photo 2: Backfilled and graded 5A Portal and associated slope to pond.

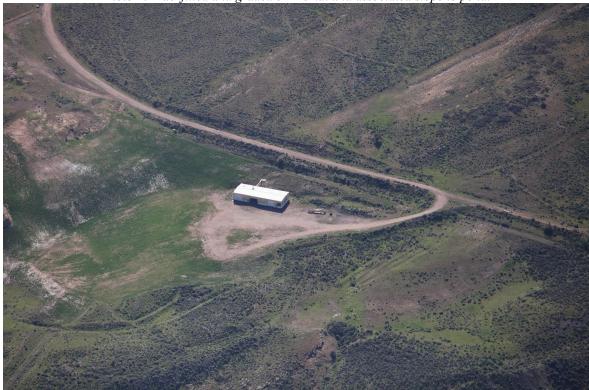
*Photo 3:* Service Building at the 5A Portal and associated reclamation.

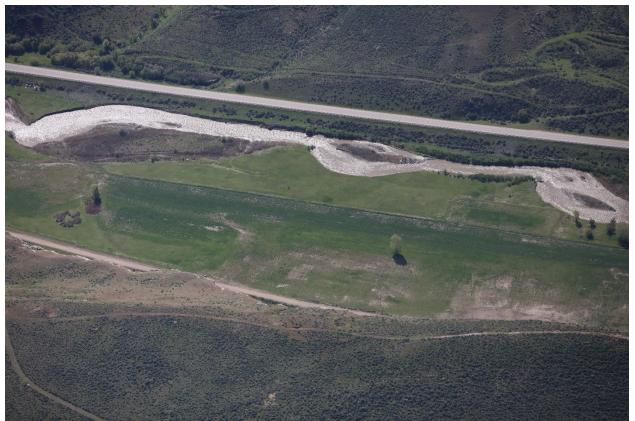
- Revegetated areas of reclamation appear stable and were beginning to green at the time of inspection.
- 5A Portal area exhibits grasses, clover and emerging sage shrubs.
- Croplands are greening with grasses some kosha and a few small patches of thistles.

Photo 4: Overview of cropland area adjacent to the Williams Fork River.
