Oak Creek Gravel Pit M-1989-084 Inspection Report

MINERALS PROGRAM INSPECTION REPORT

MINE NAME: Oak Creek Gravel Pit	MINE/PROSPECTING ID#: M-1989-084	MINERAL: Gravel	COUNTY: Fremont
INSPECTION TYPE: Monitoring	WEATHER: Clear	INSP. DATE: May 23, 2024	INSP. TIME: 11:30
OPERATOR: Rockbottom, LLC	OPERATOR REPRESENTATIVE: Beckie Kagan	TYPE OF OPERATION: 112c - Construction Regular Operation

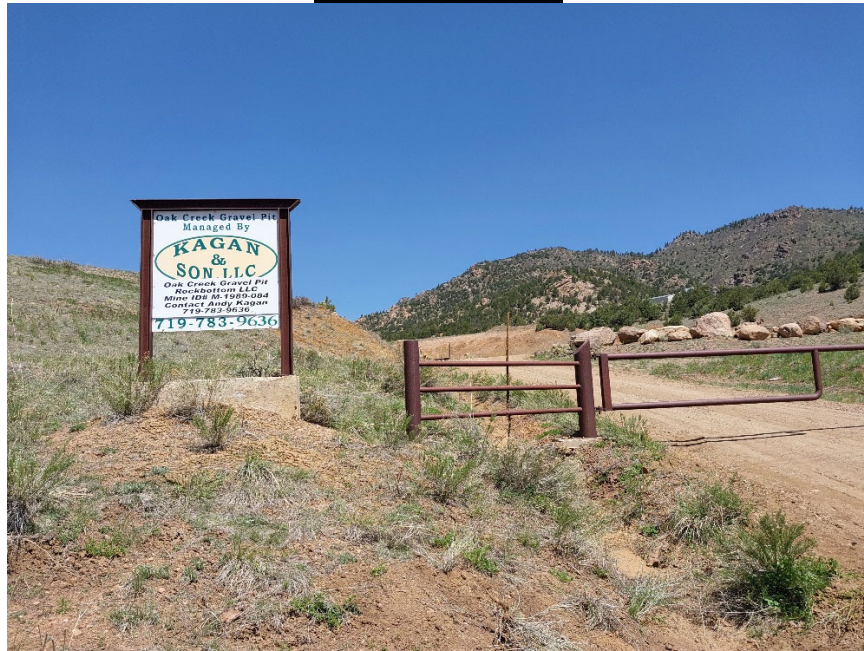
There is a mine sign at the entrance in accordance with Rule 3.1.12(1) (see Photo #1). The boundary markers were all verified as well. There were two boundary markers that were not present at the time of the inspection. The marker on the northeast side of the entrance/haul road and the southwest side of the entrance/haul road were not observed during the inspection. The Operator has since re-installed those markers and sent photographs to me. The Division considers this issue to be resolved.

Photo #1: Mine sign, per Rule 3.1.12(1) and entrance gate.

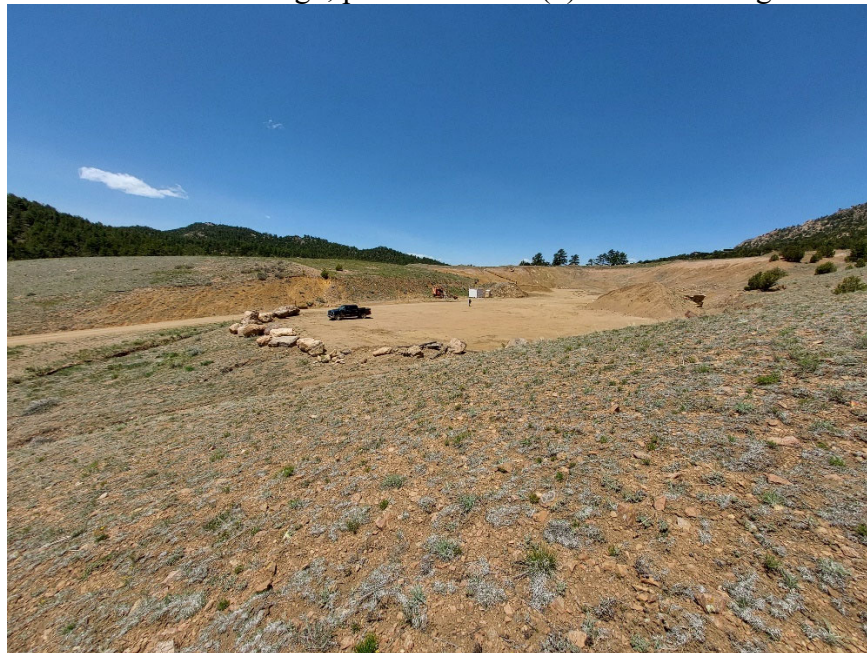
Photo #2: View of the active mining area from the southeast of the disturbed area, looking to the northwest.

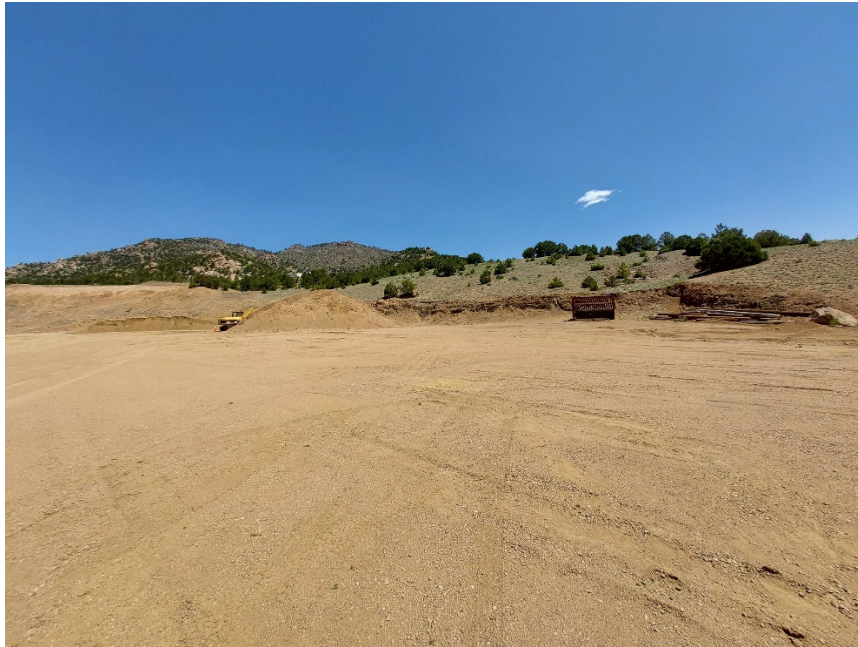
Photo #3: View of the eastern portion of the active mining area, looking to the northeast from the pit floor. The screener can be seen in front of a highwall.

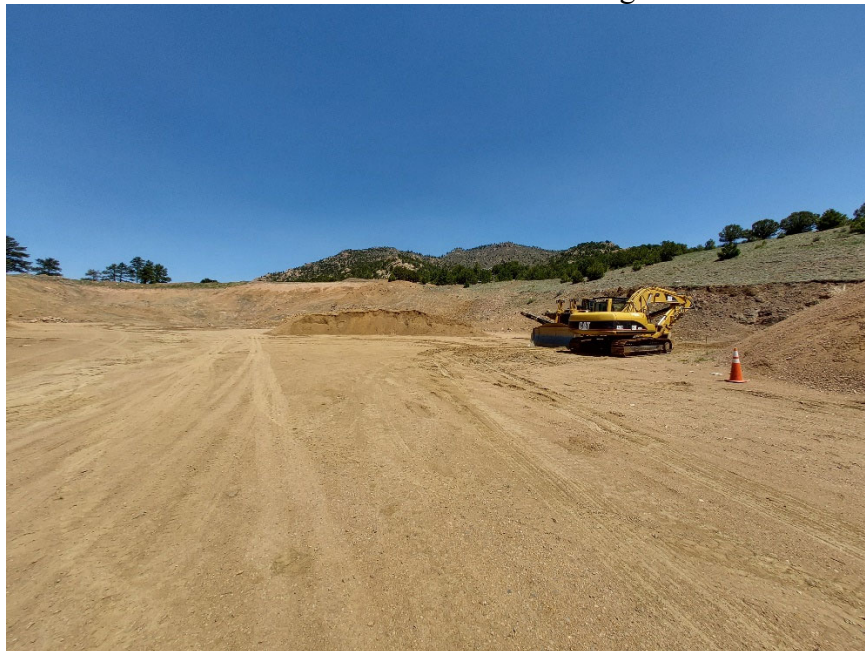
Photo #4: View of the parked bulldozer and the northeast portion of the active mining area, looking to the northwest from the pit floor.

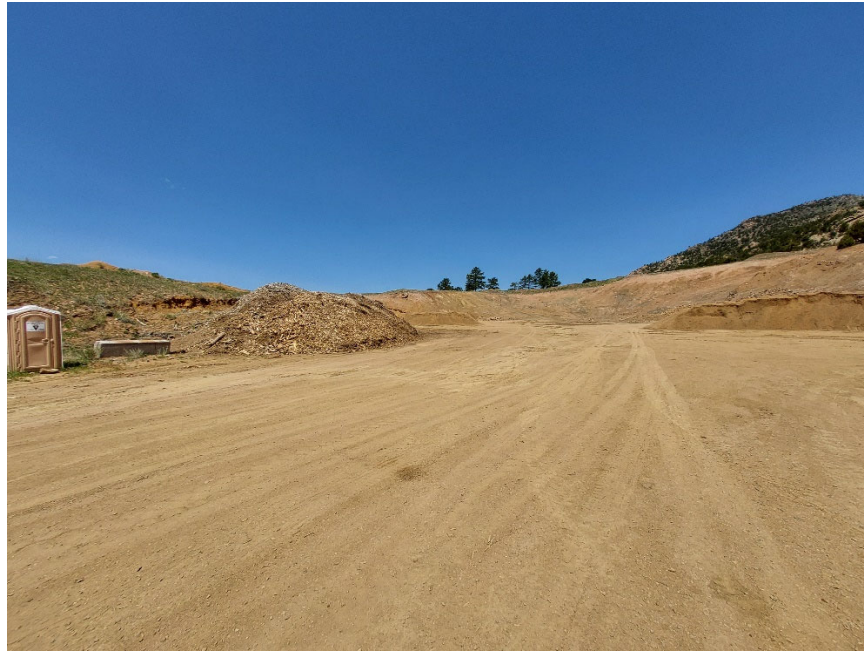
Photo #5: View of the northwest active mining area, looking to the northwest from the pit floor.

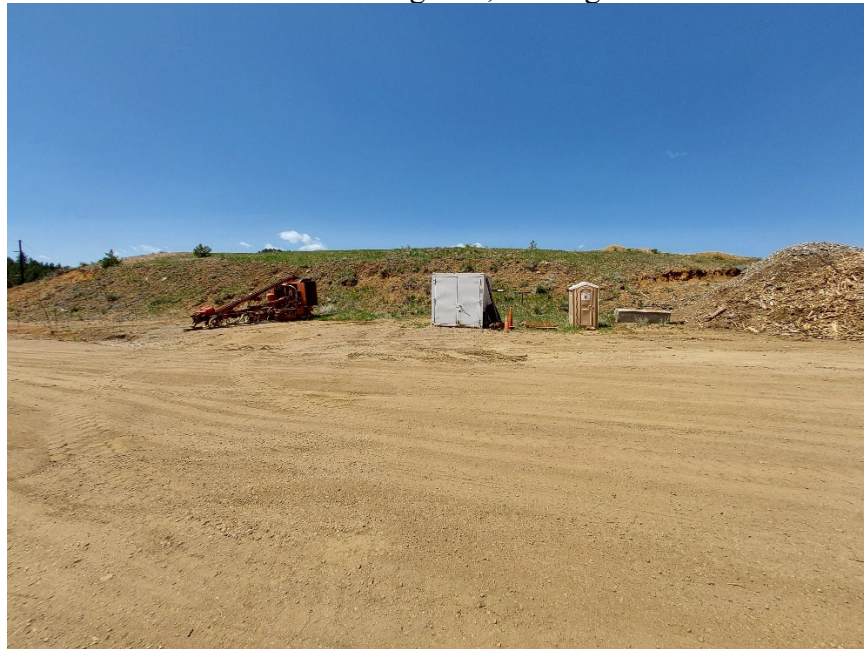
During the February 13, 2020, inspection, Tim Cazier made note of an above ground fuel/oil tank with adequate secondary containment. The fuel/oil tank and the secondary containment have since been removed and were not present during this inspection (see Photo #6).

Photo #6: View of the southwest area of the active mining area. Wooded material appears to have been stockpiled and segregated, seen in the right of the photo. There is another machine viewed on the left. In the center of the photo is a storage container and a portable toilet, the fuel/oil storage and secondary containment was located between these two but has since been removed.

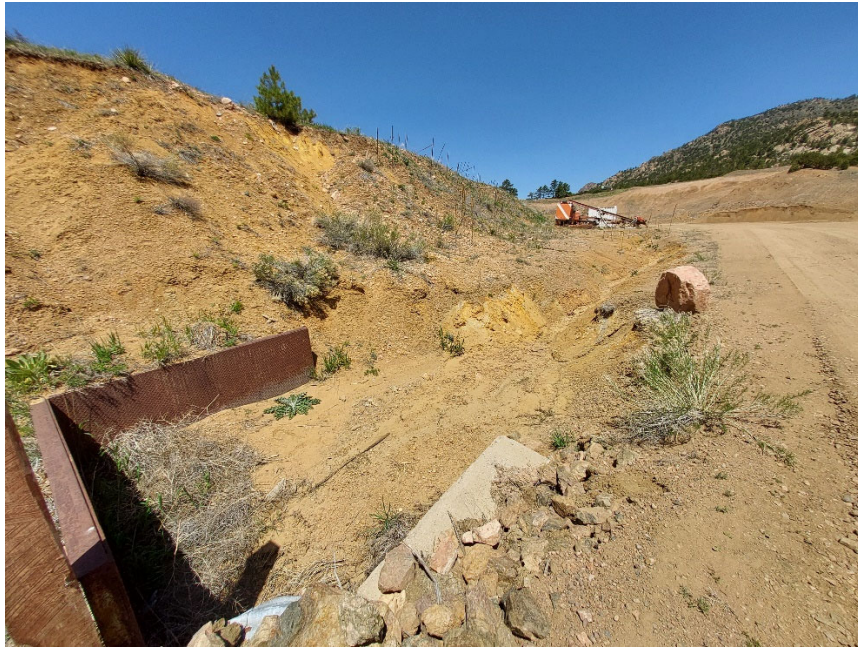
There is a spill way that is along the disturbed area that goes under the haul road and leads to a settling pond just to the northeast of the mine entrance (see Photos #7 and #8). The settling pond was dry at the time of the inspection and the spill way appeared to be stable and clear of debris. There was a small amount of standing water on the pit floor from recent precipitation and snowmelt. There is no apparent issue with the hydrologic balance in the area.

Photo #7: View of the stormwater ditch and spillway entrance, looking to the northwest from the access/haul road.

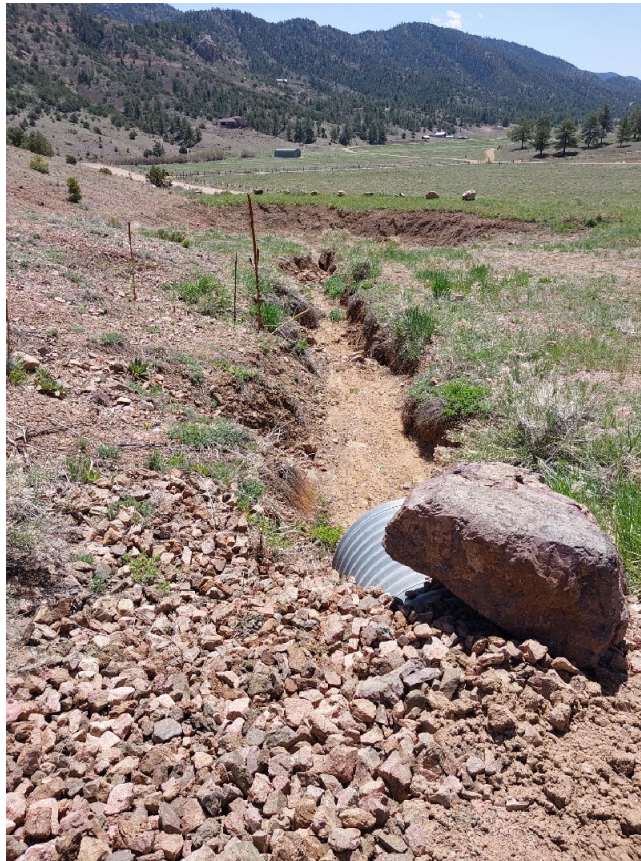
Photo #8: View of the spillway into the settling/retention pond, looking to the southeast from the road.

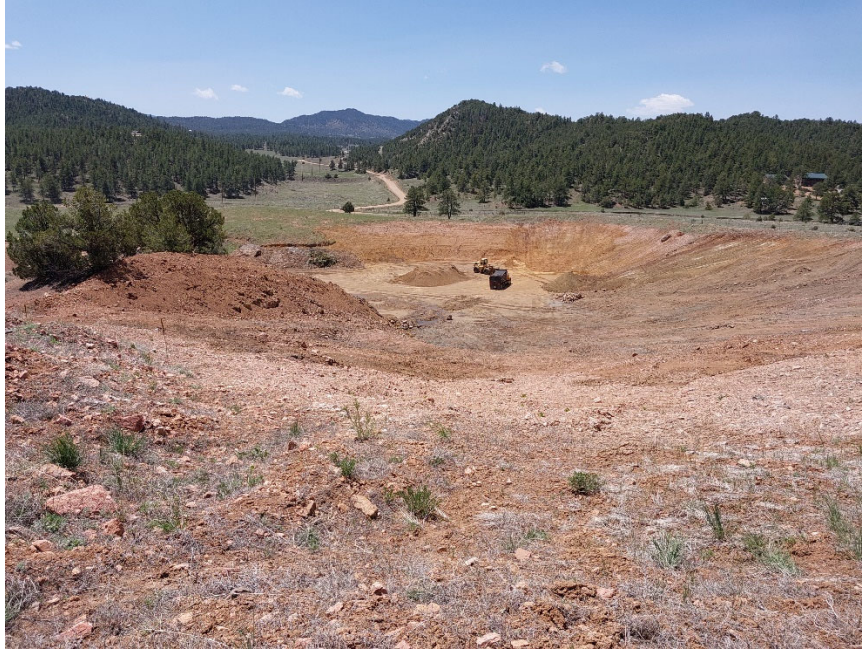
Photo #9: View of the active mining area from the northeast portion of the permit area, looking to the southwest. The road in the background is County Road 143/Oak Creek Grade.

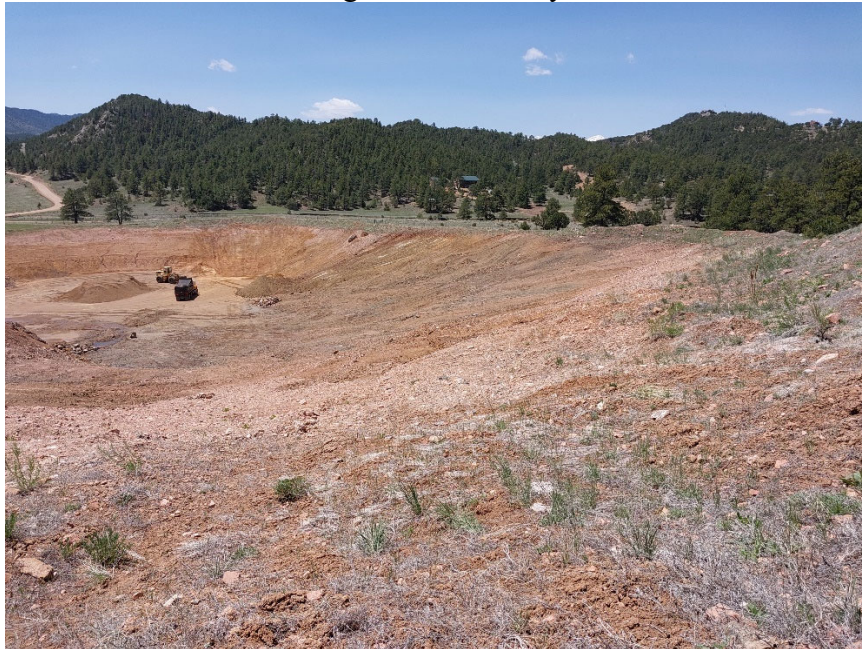
PROBLEM: The current mine plan needs to be updated and clarified regarding topsoil stockpile placement during mining operations pursuant to Rule 3.1.9(4). The stockpiled topsoil was not located in the approved area of the current mining plan and map.

There is a problem cited regarding the location of the topsoil stockpile. The approved mine plan has the topsoil located along the northwest permit boundary. Topsoil was not observed to be stored at that location during the inspection and according to my observations and recent satellite imagery from Google Earth on October 12, 2023, the topsoil appeared to be stored at the edges of the mined areas. There is also a problem cited for the mine plan compliance. Additional structures were observed to be either within the permit area or within 200 feet of the permit area. Two maps are provided below, Map #1 shows what was observed on site and Map #2 is the current approved mining plan map. Please see the above problem citation for more information. ***Note: both problems can be addressed in one Technical Revision submission; two Technical Revision applications are not required to satisfy the required corrective actions.***

Photo #10: View of the topsoil stockpile along the northwest portion of the active mining area.

CORRECTIVE ACTIONS: The operator shall submit a Technical Revision, with the required \$216 revision

fee, to update and clarify the current approved mine plan to reflect existing and proposed activities by the corrective action date. Provide an updated Mining Plan and Mining Map that indicates the current location of the topsoil stockpile.

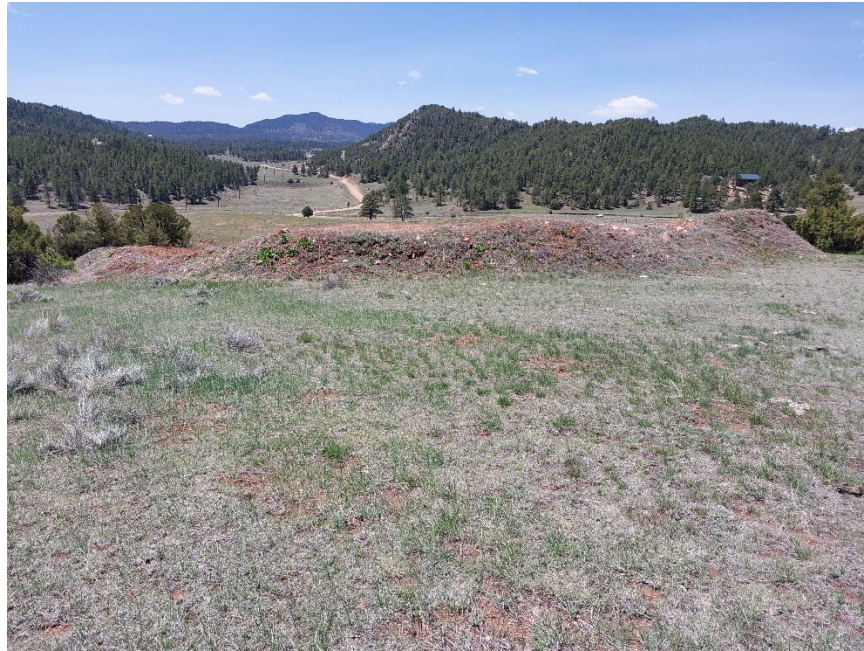
Photo #11: View of the backside of the topsoil stockpile along the northwest portion of the active mining area.

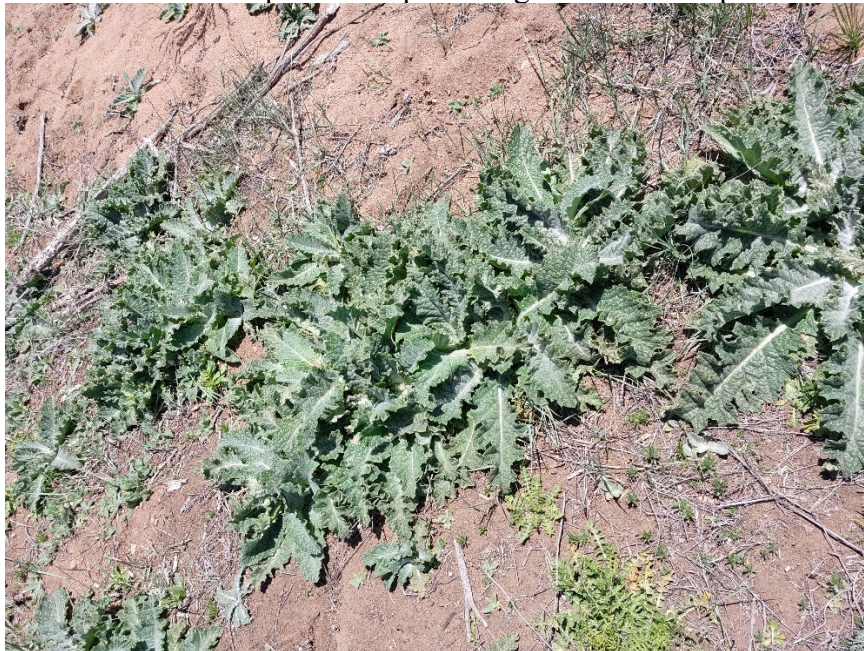
Thistles were observed in the northwest portion of the permit area along the drainage that flows to the southwest (see Photo #12). The Operator supplied photos of the area after the removal of the thistles. The Division considers this issue resolved.

Photo #12: Thistles growing in the drainage along the northwest portion of the permit area. These have since been removed.

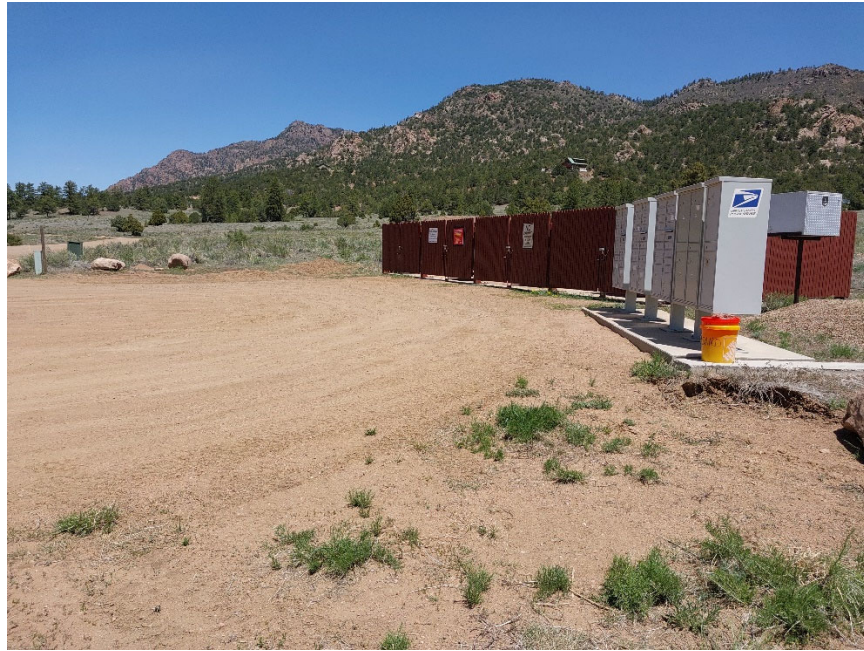
PROBLEM: The current mine plan and reclamation plan need to be updated and clarified pursuant to C.R.S. 34-32.5-112 (1) and C.R.S. 34-32.5-112 (2). The operator must provide sufficient information to describe and identify how the operator intends to conduct the operation given the presence of the additional fence line along Access Road 6227, the mailboxes, and dumpster observed during the inspection.

The operation does not appear to be following the approved mining plan. Problems are cited at the beginning of this report. One pertaining to the location of the topsoil, which is discussed more under the Topsoil section below, and another pertaining to additional structures within the permit boundary. Ms. Kagan stated that the northwest corner of the permit area is being used by the local residential community for a mailbox and disposal site for the surrounding rural neighborhood. There are several mailboxes on concrete pads and large dumpsters behind fencing that are also on a concrete pad along with a maintain gravel parking area (see Photo #13). Additionally, along the southwest permit boundary and Access Road 6227, there is a fence that is not represented on the current mine plan map (see Photo #14). Map #1 below shows the location of the mailbox and disposal area along with the additional fence. Please see the above citation for more information.

Photo #13: The mailboxes and dumpster structures located on the western corner of the permit area, see the map below for location with respect to permit boundary.

CORRECTIVE ACTIONS: The operator shall submit a Technical Revision, with the required \$216 revision fee, to update and clarify the current approved mine plan and reclamation plan to reflect existing and any proposed activities by the corrective action date. Include an updated Mining Plan and Reclamation Plan narrative along with updated Mining Plan and Reclamation Plan maps. Provide information about the owners of these permanent man-made structures. If Operator is not the owner of the structures, provide notarized structure agreements in accordance with Rule 6.4.19.

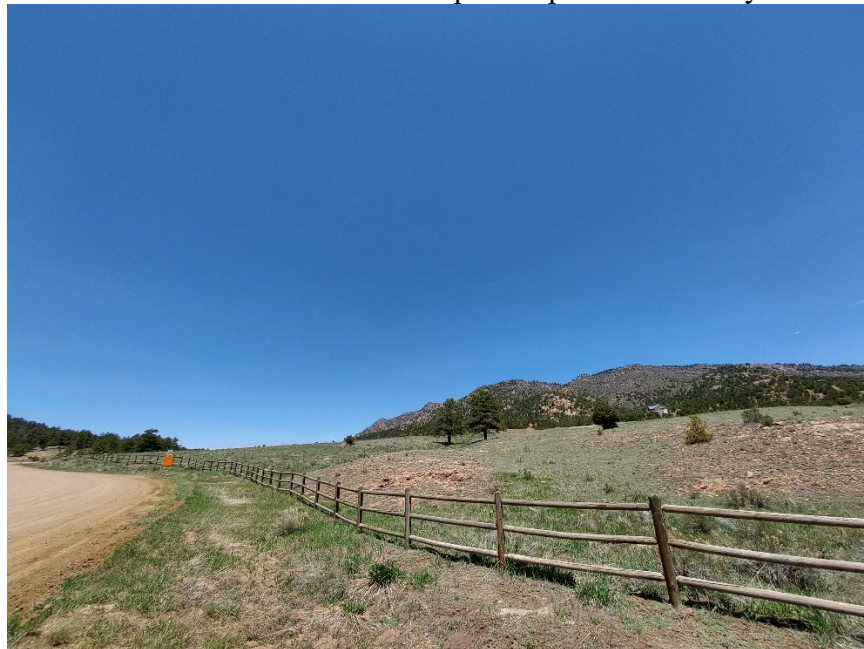
Photo #14: The new fence along the southwest portion of the permit boundary and Access Road 6227, see map below for location of fence with respect to permit boundary.

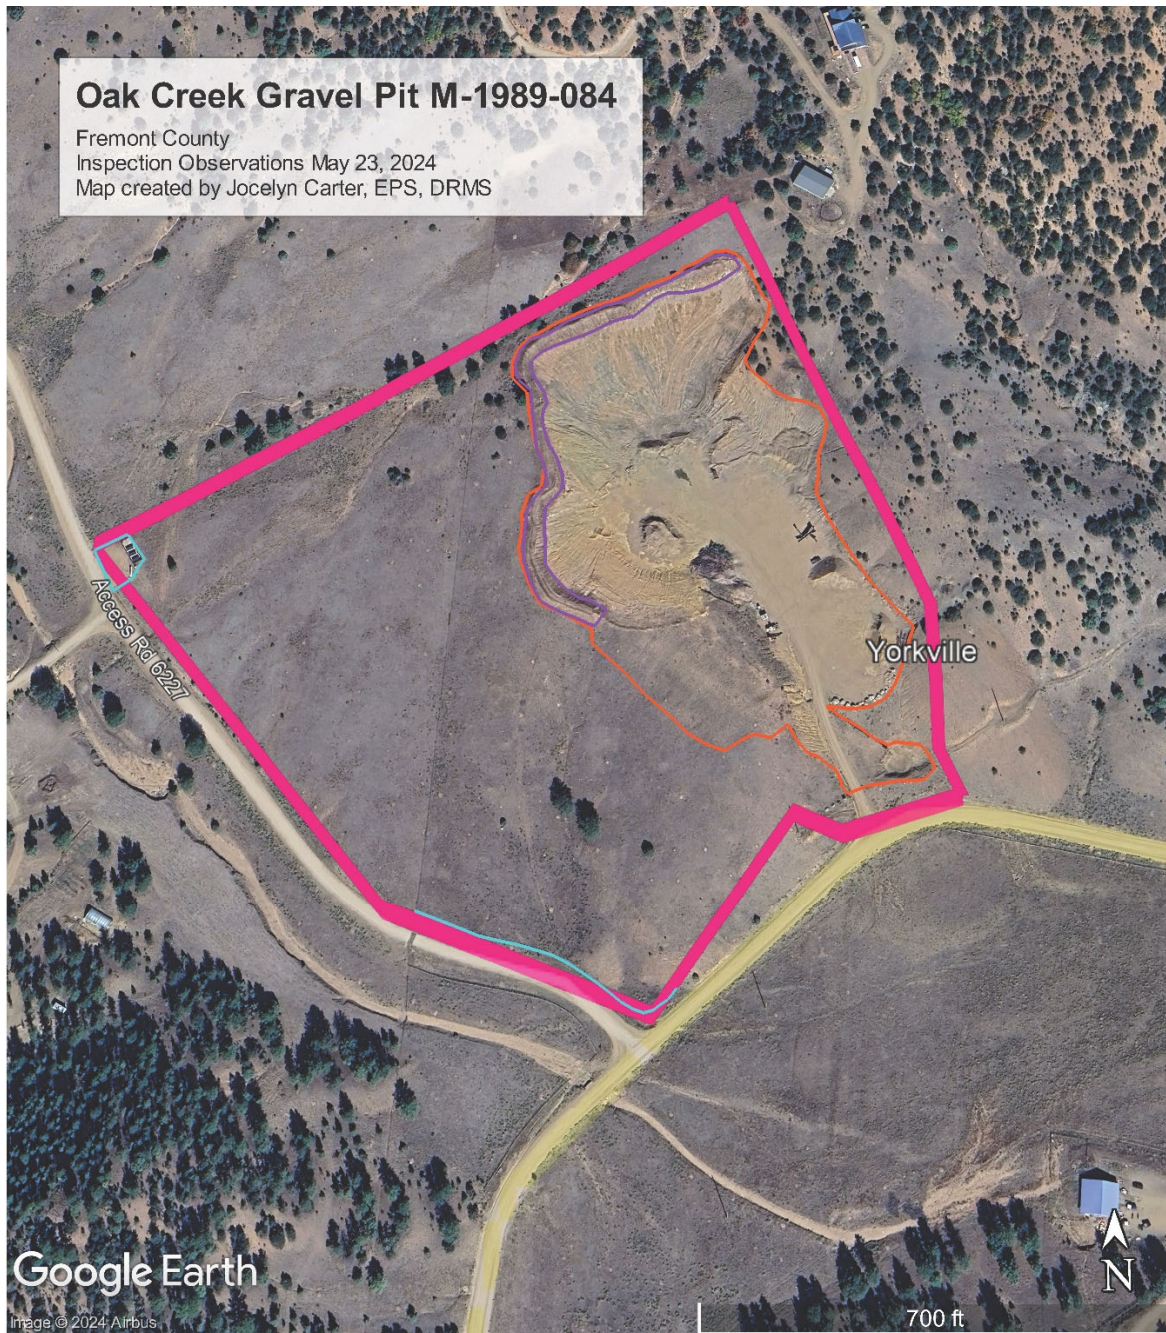
A problem regarding the topsoil was cited at the beginning of this report, please refer to the problem for the require corrective action. The Exhibit C – Mine Plan map submitted during the Conversion application, issued on November 15, 2001, provided at the end of this report, shows the topsoil stockpile was supposed to be along the northwest portion of the permit area. There did not appear to be any topsoil stockpiled in this area. It did appear that topsoil was being stored at the north extent of the disturbed area as well as at the edge of the most recent active area. See the two maps below of the approved mine plan and what was observed during the inspection.

Map #1: Created from the observations made during the inspection. The Pink polygon represents the permit boundary, the orange polygon represents the active mining area and the currently disturbed area, the purple polygon represents the topsoil stockpile that was observed, the teal polygon and line represent the new structures that were observed. The background satellite photo is dated October 12, 2023.

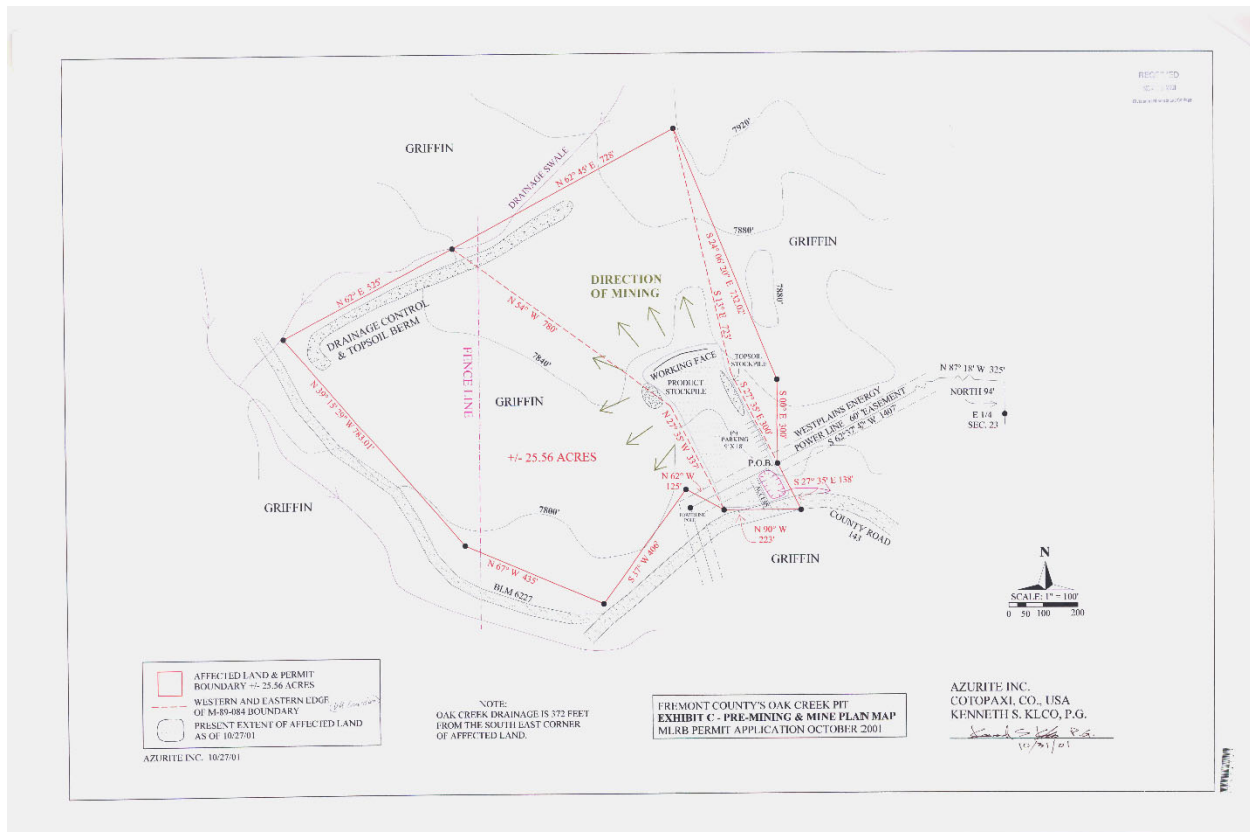
Map #2: The approved mining plan showing the location of the approved topsoil stockpile along the natural drainage in the northwest portion of the permit boundary. There is no indication of the additional fence, or the mailboxes and dumpsters represented on the approved map.
